THE LOWEST PRESSURE DROP Y-STRAINER ON THE MARKET, UPGRADED WITH A MAGNET TO CATCH IRON OXIDES.

ENERGY SAVING PUMP PROTECTION SOLUTIONS

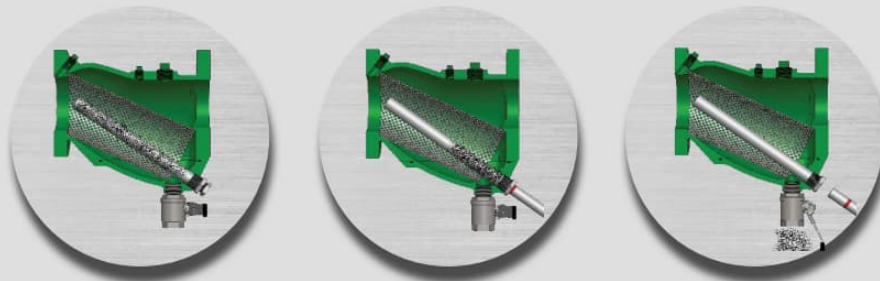
SIMPLE, IN-SERVICE BLOW DOWN PROCEDURE

The magnets are constantly collecting magnetic debris while at the same time larger foreign materials are being captured in the perforated stainless steel screen.

To ensure all the particles captured are blown out during the blow down process, slowly draw the magnet(s) out of the drywell and stop when you see the red line.

Open the valve and blow down for 3 to 5 seconds and at the same time pull the magnet the rest of the way out. Then shut the blow down valve. Re-insert the magnet.

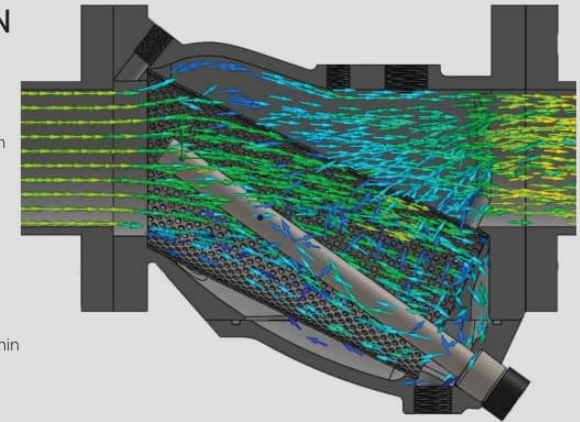
THE COLLECTION VORTEX

The very powerful Neodymium magnets work within the system to draw out metal fragments that have been unknowingly interfering with the life of your system. The LPD-Mag Y-Strainer will filter out both metallic and non-metallic debris. Metallic particles will collect and attract other debris, capturing 95% within the first days usage.

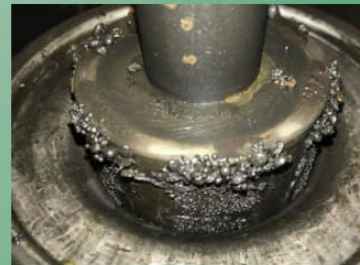
Accumulation of sludge within ECM Pump

It is very common for users looking for efficient systems to utilize pumps with ECM motors. However, it turns out that using the ECM motors has an unintended consequence. The larger, very powerful magnets within the motor draw iron oxide into the seal area of the pump, causing seal failures.

This large accumulation of iron oxides is known as "sludge". Overtime, sludge can work its way into even the smallest openings in your system, clogging and slowing down system performance and efficiency. This leads to seal failures in pumps, damaged boilers, chillers and heat exchangers.

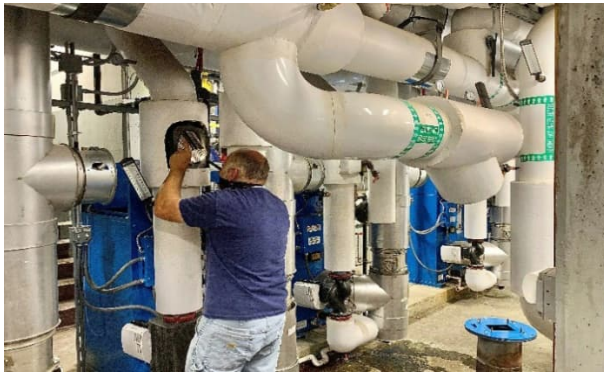
Servicing LPD Mag in vertical position to flush the iron particles and pictured close-up below.

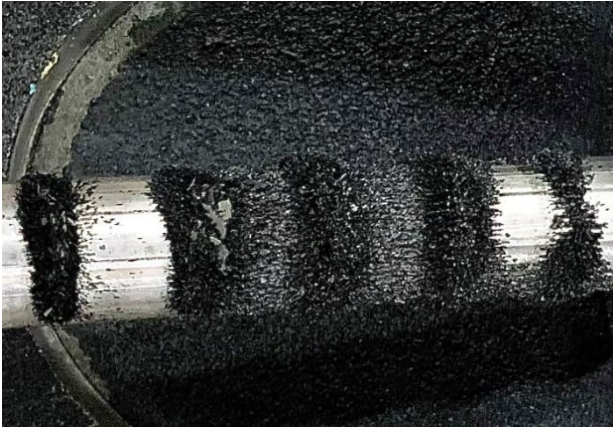
Close up of the LPD Strainer magnet assembly with bottom pulled off of the LPD strainer pictured above.

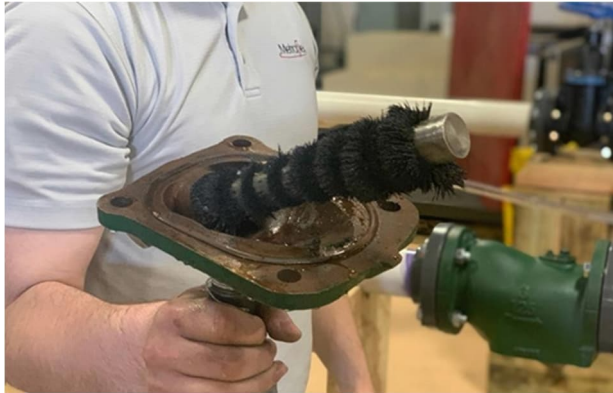
Pulling the bottom off the LPD Mag Separator to show the full effect of the magnetic effect.
