US 12 Road Safety Audit: Technical Report

Western Wright County Limit to Wayzata, MN

*Minnesota Department of Transportation (MnDOT) Metro
District and District 3*

September 11, 2015

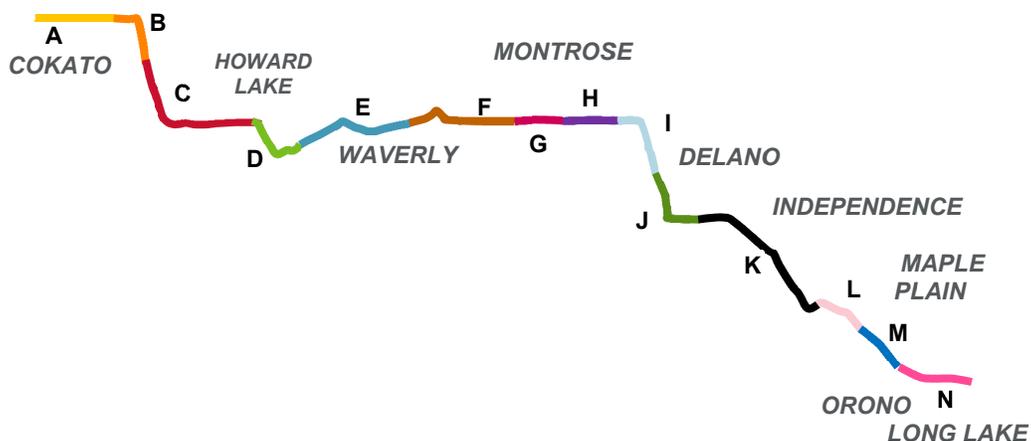
Figure 1-1: Segmentation of the Corridor

Table 1-1 and Table 1-2 summarize the recommendations for safety solutions along the US 12 corridor. These recommendations were developed from the road safety audit review process. Please refer to Section 5.2 for more detailed descriptions of solutions for corridor-wide improvements, as well as improvements to specific locations. Please refer to Figure 1-1 to see how the corridor was divided into segments.

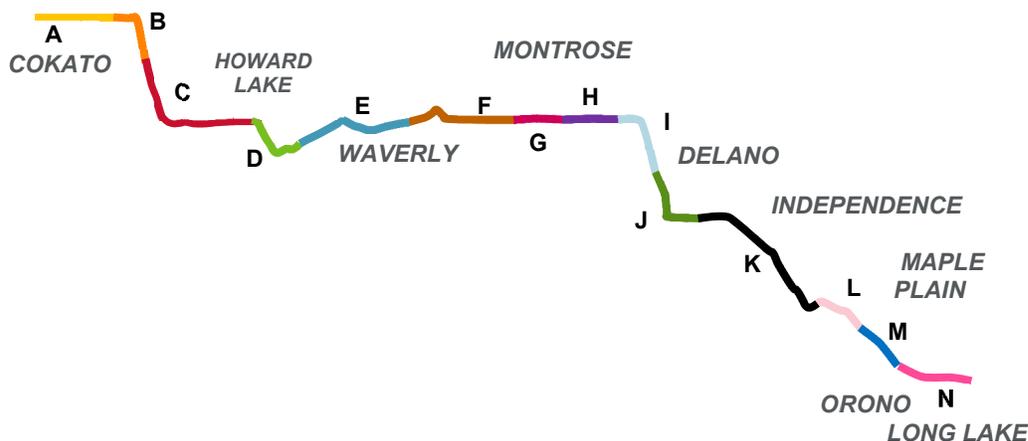
Figure 3-1: Segmentation of the Corridor

In order to better perform an analysis, the roadway was divided up into segments. Segment breaks were chosen wherever the road character changed. The corridor alternates primarily between three-lane⁵ urban and two-lane rural segments. For the most part, urban segments had reduced speed limits (i.e. around 30mph) while rural segments had speed limits around 50-55mph. Google Earth was used to determine where road geometry and character changes occurred. AADT data was considered in the segmenting process as well. Refer to Figure 3-1 and Table 3-1 for more information about segments.

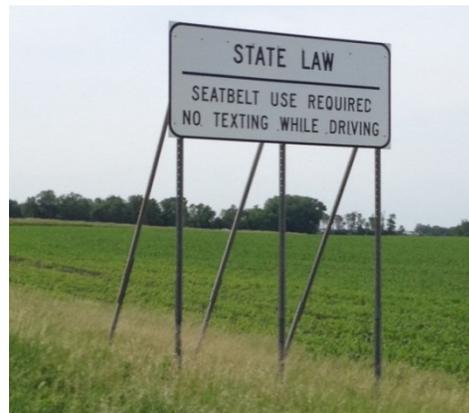
Figure 5-1: State Law Informational Sign²⁰

In addition to reducing speeding, the presence of officers can also increase driver awareness and decrease the amount of distraction related crashes. According to a study by Cohen Children’s Medical center “drivers are 23 times more likely to be in a crash if they are texting while driving¹⁹”. State law informational signs can be strategically placed to educate drivers that texting while driving is illegal and unsafe. The state law informational sign shown in Figure 5-1 was installed on Highway 14 in Nicollet, Minnesota to emphasize the importance of wearing a seatbelt and not texting while driving.

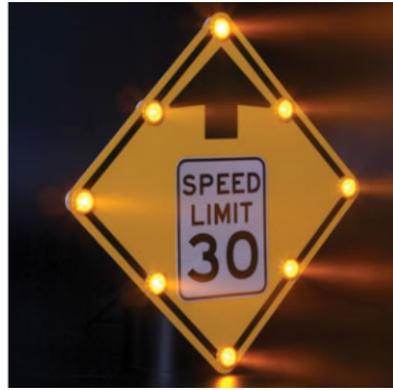
Figure 5-2: Reduced Speed Limit Ahead Blinker Sign²³

- Speed Limit Signing: A short-term solution to this is to start by updating the speed limit signs across each city. An example would be to have 55mph, 45 mph and 30 mph signing.
- Intelligent Transportation System (ITS) Speed Technologies: In addition to speed limit signing updates, ITS technology can be used to accent the speed reductions. “Reduced Speed Ahead” flasher systems (see Figure 5-2) have been used and can bring more attention to reduced speed zones. Furthermore, speed detection systems can be installed to alert drivers of their speed (see Figure 5-3).

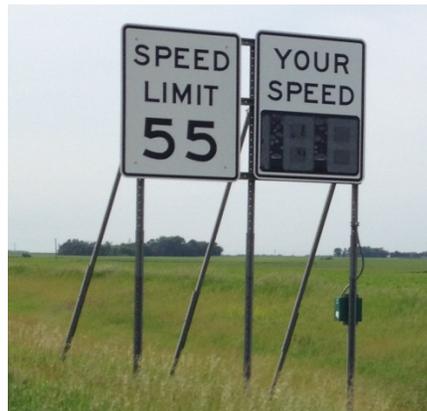
Figure 5-3: “Your Speed” Sign²⁴

It should be noted that although speed limit signing updates and ITS technologies can provide some benefit, changes to the road cross section from Complete Streets solutions (see discussion in future sections) will likely be much more effective at reducing and managing speed.

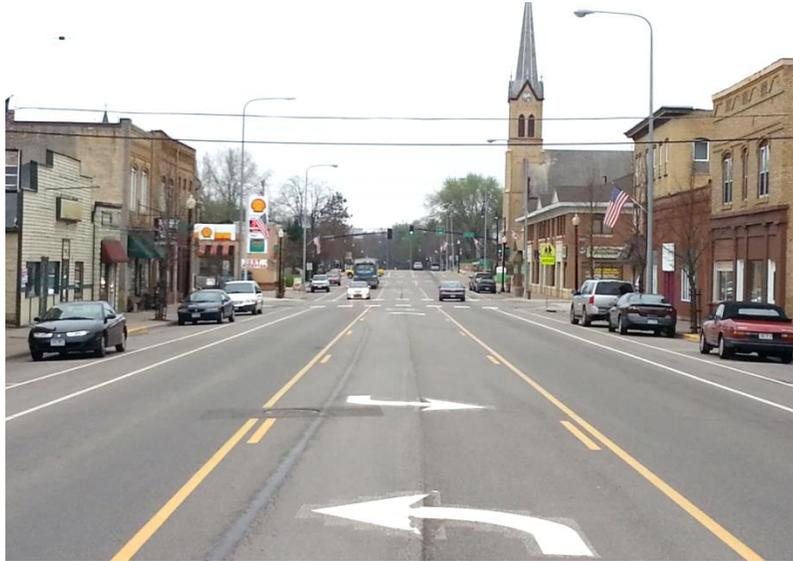
Figure 5-5: Preservation Retrofit in Jordan, MN²⁵

Various case studies can be used as examples when assessing complete streets ideas. Figure 5-5 shows the results of a retrofit that took place in Jordan, MN. As can be seen in the figure, the presence of bike lanes, parking stalls and narrow lanes gives the road an urban feel. The road was designed to accommodate pedestrians, bicyclists, and vehicles. Parking stalls further separate pedestrians from vehicular traffic as an extra safety measure. Figure 5-40 (found in Segment J recommendations section) also provides an example of a complete streets solution from a project in St. Paul, Minnesota.

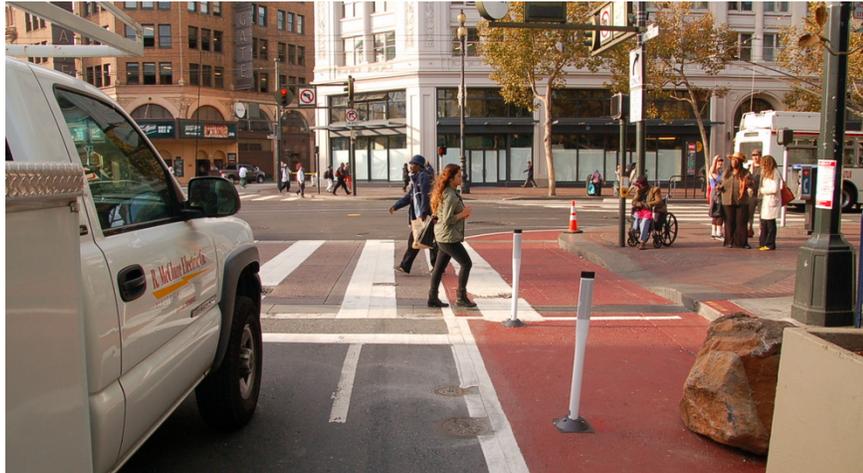
Figure 5-8: Temporary Curb Extensions²⁷

Because installation can be done on a short schedule, curb extensions should be added in the short-term. It is much more effective to install permanent curb extensions, however, if it is not possible to install right away, temporary curb extensions can be created using bollards and pavement markings, as shown in Figure 5-8. Although better than nothing, bollards can become a maintenance burden because they get hit easily and do not create as much physical protection for pedestrians.

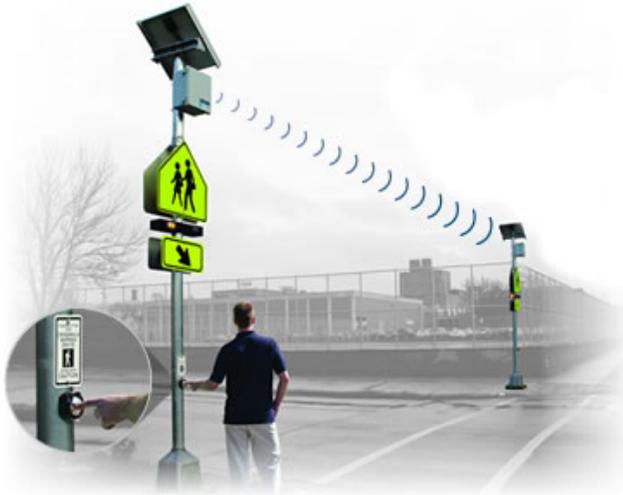
Figure 5-9: Rectangular Rapid Flash Beacon (RRFB)

Rectangular Rapid Flash Beacons (RRFBs): Existing pedestrian flashers should be updated to Rectangular Rapid Flash Beacons, also referred to as RRFBs. This can be done as a low cost and on a short schedule. Figure 5-9 shows what an

RRFB looks like. RRFBs are much more visually apparent than traditional flashers and only flash when triggered by a pedestrian. RRFBs are installed at unsignalized intersections and mid-block pedestrian crossings to increase driver awareness. Pedestrians are given a button that they can push to trigger a flashing pattern similar to emergency flashers on police vehicles. Solar panels can be used to provide electricity to the devices. Traditionally, local units of government have funded these kinds of safety improvements so funds will need to be pulled aside for these updates.

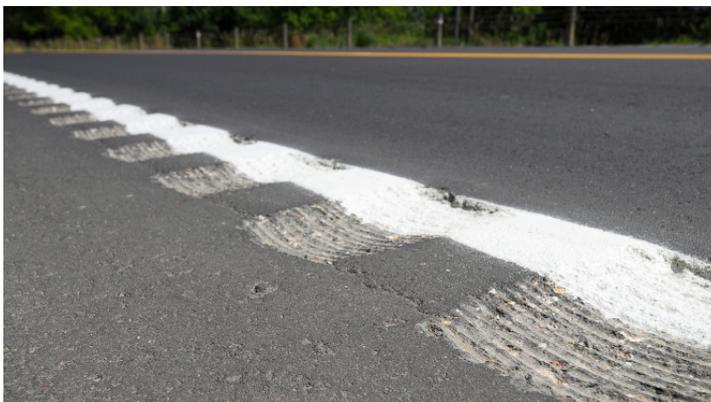
Figure 5-10: Mumble Strips²⁸

Mumble Strips: In various regions, the risk of drivers drifting out of their lane is present. Traditionally, rumble strips have been installed on the edges of lanes to notify drivers that they are drifting out of their lane. A downside to rumble strips is that they can produce an audible rumbling noise, which is an issue in residential areas. “Mumble” strips, which are rumble strips that produce less external noise, may be an option in areas with higher residential density. Figure 5-10 below gives a visual of what mumble strips look like. For comparison, refer to photos of rumble strips shown in Figure 5-11 and Figure 5-14.

In addition to recoverable attenuators, mumble strips could be installed to prevent drivers from drifting towards the barrier due to distraction or drowsiness. Like rumble strips, mumble strips provide vibration to alert drivers when they drift from their lane, however, they provide significantly less external noise than the traditional design. Figure 5-10 provides a visual of mumble strips.

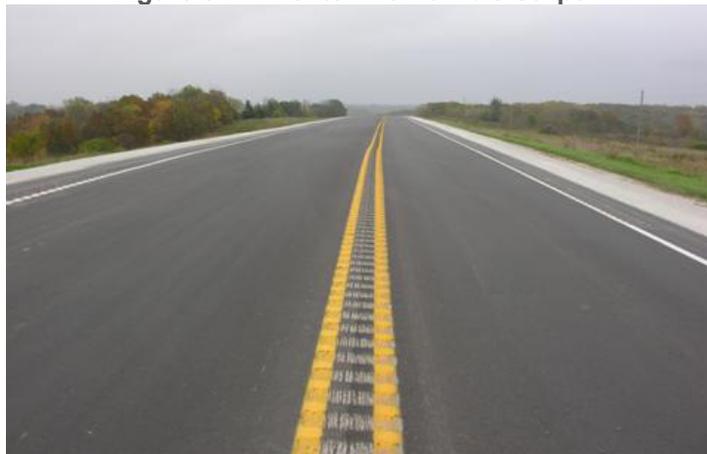
Figure 5-11: Centerline Rumble Strips²⁹

- In short-term, **centerline rumble strips** should be installed on all rural segments that do not currently have rumble strips. Rumble strips are composed of a series of grooves installed in a series across the direction of travel. When drivers drift from their lanes, a vibration runs through the tires of the cars and warns the driver that they are departing from their lanes. Rumble strips can be used as a counter measure against drifting caused by driver distraction, drowsiness, or impaired visibility caused by poor weather conditions and can be installed at a low cost and on a short time-line. Figure 5-11 shows an example of what centerline rumble strips look like.

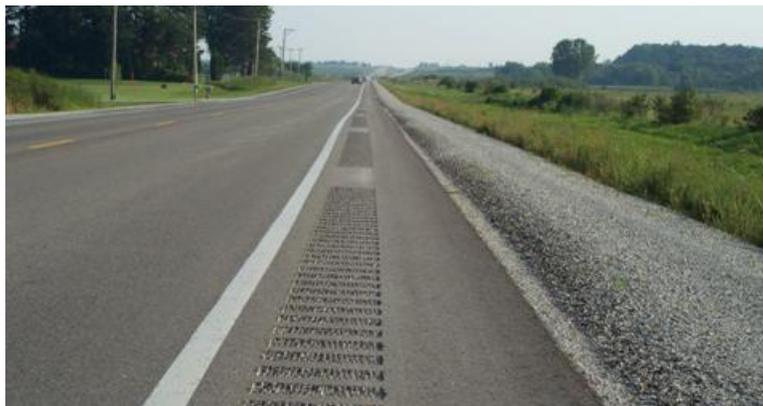
Figure 5-14: Edge Line Rumble Strips³²

Edge Line Rumble Strips: In addition to centerline rumble strips, edge line rumble strips should also be installed or repaired on rural segments to prevent lane departure off the road. Edge line rumble strips are installed on the shoulder at the edge of the travel lane (see Figure 5-14) and alert drivers that they are drifting off the road. These can be installed at a low cost and on a short schedule. If being installed on in place pavement, pavement quality must be sufficient to accept milled rumble strips.

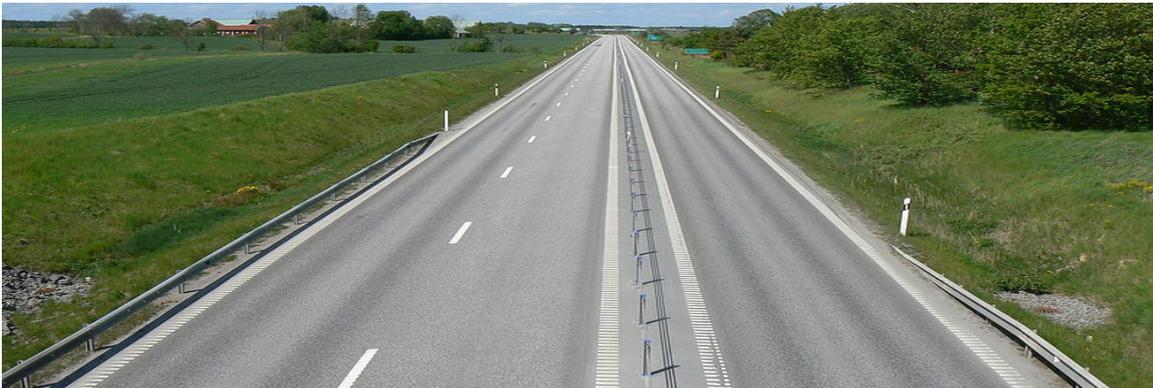
Figure 5-16: 2+1 Passing Lane Section³⁴

When developing a 2+1 section, strategized access management is crucial. The placement of turn lanes will have to be incorporated into the design and some four-way intersections may need to be modified such that through and left-turn movements are restricted. Intersection control methods, such as reduced conflict intersections (RCIs) should be considered. For a description of these methods, please refer to the intersection recommendations section.

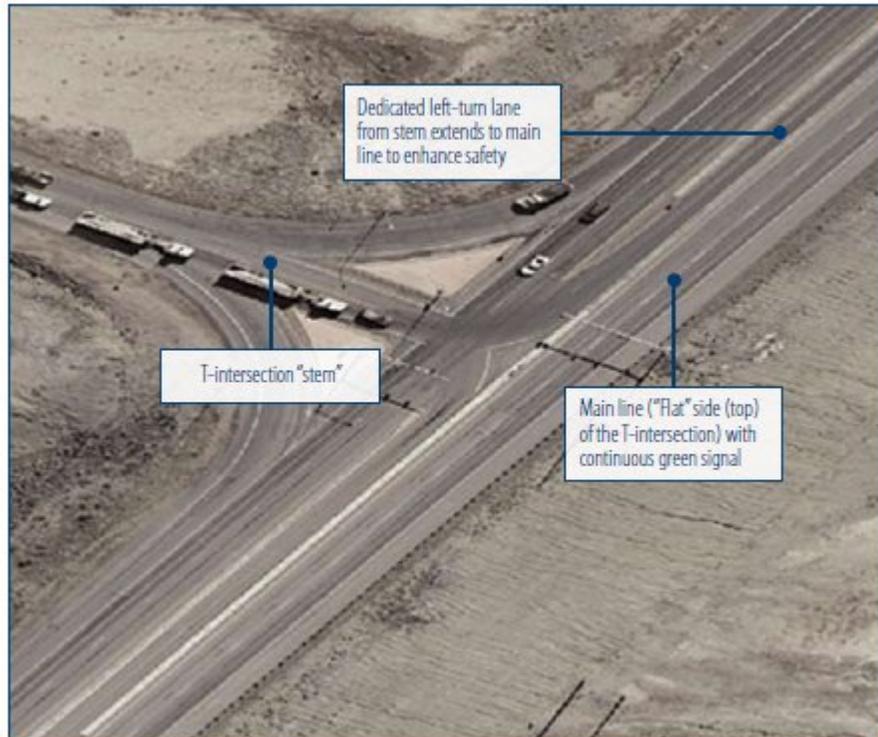
Figure 5-17: Aerial View of the Continuous Green T in Grand Junction, Colorado³⁵

One downside that should also be considered is that this configuration may promote more speeding. Pedestrians need to be taken into account when deciding whether to install this type of intersection control. If pedestrians need to cross the main road, then a Continuous Green T may not be appropriate. See Figure 5-17 below for further description on Continuous Green T intersections.

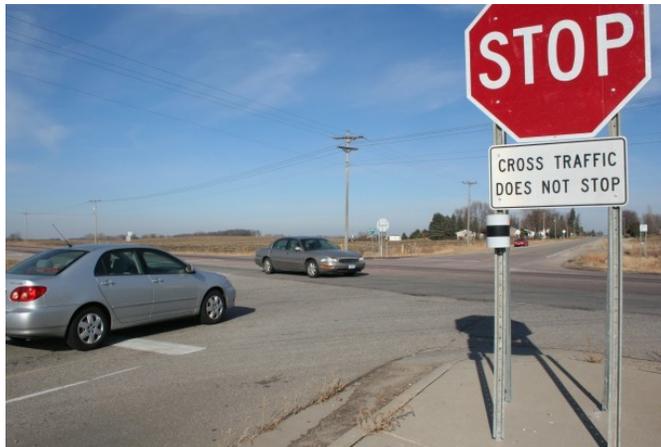
Figure 5-20: Example of “Cross Traffic Does Not Stop” Signage³⁹

Stop Sign Improvements at Through-Stop Intersections: At through-stop intersections that have a large amount of right angle or turning related crashes due to disregard of traffic control devices, improvements may be made to bring more attention to the stop sign. As shown in Figure 5-20, a “Cross Traffic Does Not Stop” panel can be added beneath the stop sign to bring attention to the fact that mainline traffic does not stop.

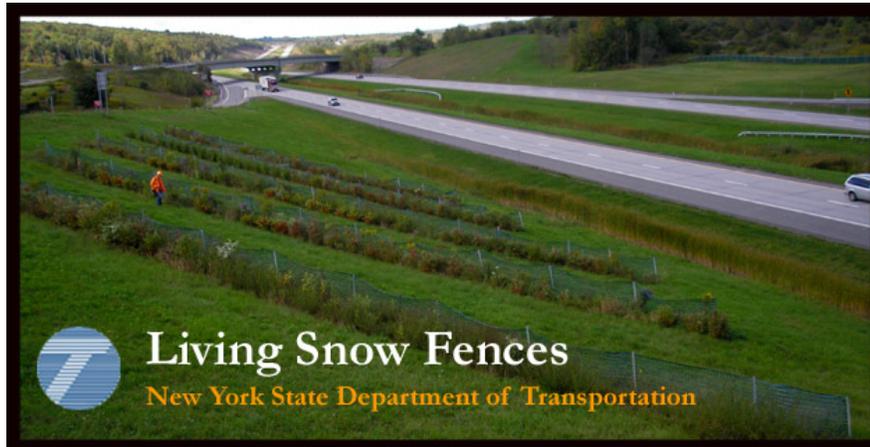
Figure 5-24: Living Snow Fences⁴²

the rail road during the winter. Another option is to construct a living snow fence (i.e. plant trees, bushes, or other vegetation to provide a natural barrier). Living snow fences provide more visually appealing results than traditional snow fences and can be installed easily. See Figure 5-24 for a visual of what a living snow fence could look like in practice. It will be important to inform businesses and residents who live along the road to not tamper with the planted vegetation.

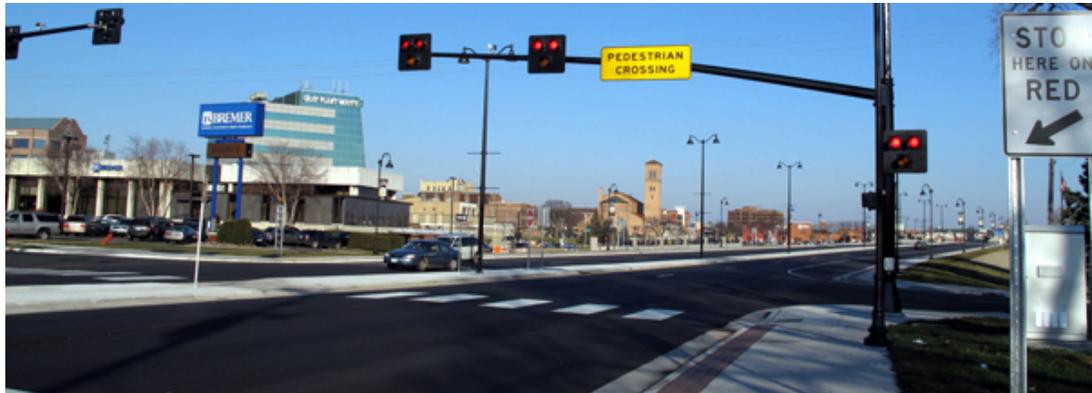
Figure 5-26: HAWK Signal Example⁴⁴

- Overhead pedestrian indications should be used to emphasize the presence of wide pedestrian crossings. High Intensity Activated Cross Walk (HAWK) signals are an option for doing this. HAWKs can be coordinated to work with stop and go traffic signals downstream. Refer to Figure 5-26 for a visual of a HAWK that was installed in St. Cloud, Minnesota.

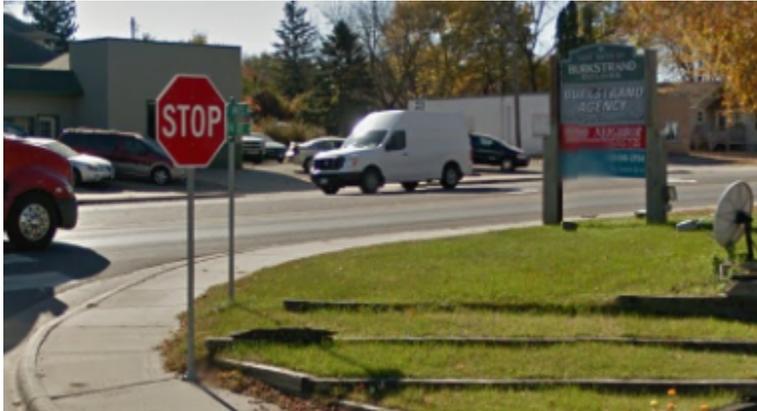
Figure 5-32: CSAH 6/10th Avenue North Approach⁵⁰

vehicles coming from the north leg of 10th Avenue. It is recommended that this sign be relocated as a short-term solution.

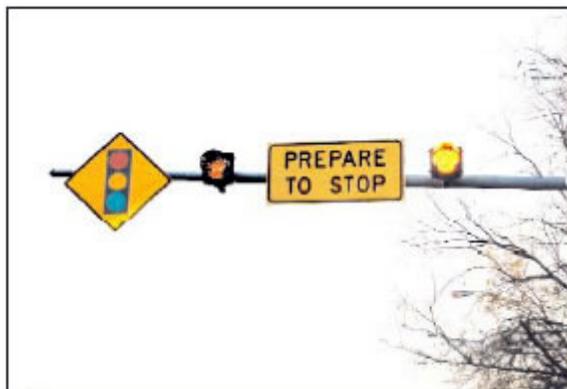
Figure 5-35: Prepare to Stop Flasher System Example⁵³

Buffalo Avenue/TH 25: The percentage of rear-end crashes at the Buffalo Avenue/TH 25 signalized intersection exceeded state averages during the five-year study period. Many crashes were attributed to tailgating or driver distraction. To bring more attention to stopped traffic at the signal, advanced warning signs or flashers could be added for mainline traffic as a short-term solution. A flasher system, such as the one shown in Figure 5-35 below, could be used to bring attention to westbound traffic entering the city.

The Buffalo Avenue Signal is located near an urban/rural transition point to the east. In addition to tailgating and driver distraction, crash data reflected that speeding is an issue in this region. Speed enforcement and other measures described in previous sections may assist with crash reduction at this intersection.

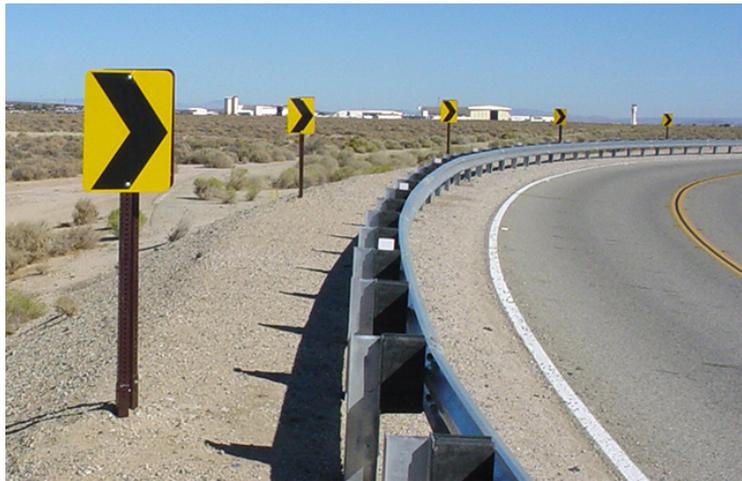
Figure 5-43: Chevrons on Horizontal Curve⁶²

Horizontal Curve: During the road safety audit review, it was noted that a horizontal curve around Mile 144 could pose some risk to driver safety. As a safety measure, it is recommended that chevrons be added to this curve to raise driver awareness. Refer to Figure 5-43 for an example of chevron signing on a horizontal curve.

If not already in place, edge line rumble strips should be added along the curve. Rumble strips can provide further notification to drivers if they are drifting off of the travel lane and that they need to turn their wheels to stay on the road.

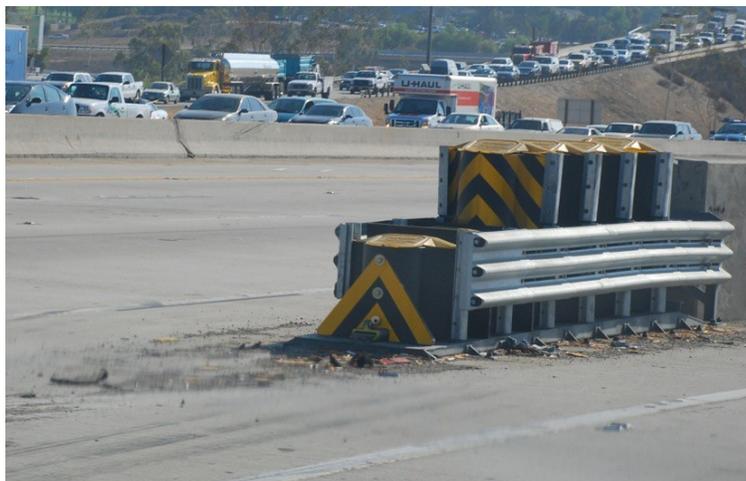
Figure 5-45: Recoverable Attenuator⁶⁴

Attenuator at Railroad Median Barrier: Local officers indicated that the median barrier which protects a railroad bridge on the western side of Maple Plain frequently gets hit by drivers. A suggestion was made to install a recoverable attenuator in front of the medium barrier to provide some additional protection for the driver. Recoverable attenuators are often placed in front of in place structures that are at risk of getting hit by vehicles. They are intended to reduce damage to structures, vehicles, and motorists resulting from collisions by absorbing the colliding vehicle's energy and can take repeated impacts without having to be replaced.

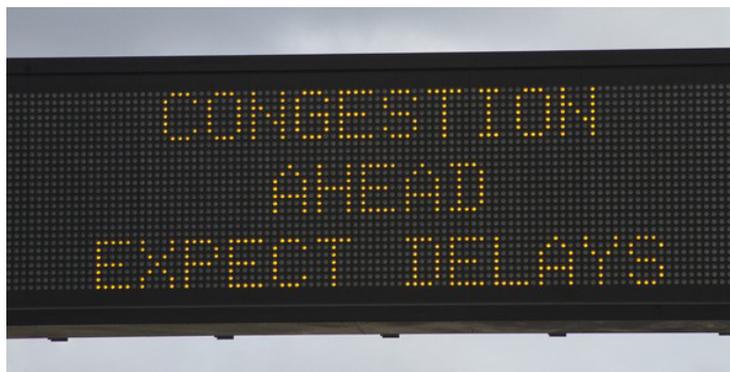
Figure 5-47: Congestion Ahead Sign⁶⁶

ITS Solutions: Various ITS solutions could be implemented to help raise driver awareness. One solution would be to install Congestion Ahead signs, such as the one shown in Figure 5-47, to inform drivers to keep their eyes open for slowed or stopped traffic.

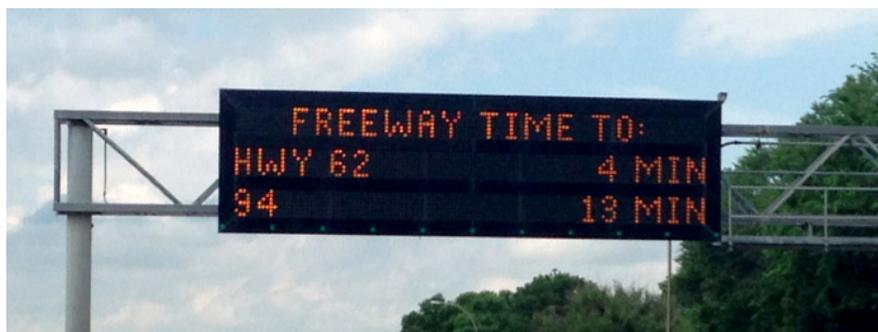
Figure 5-48: Travel Time Signing⁶⁷

The use of dynamic travel time signs, such as the one shown in Figure 5-48, could help drivers make informed decisions about the routes that they choose to take. If other routes, such as TH 55, have shorter travel times, this may lead to a decrease in congestion along US 12. These signs could be placed in other regions of the corridor to address congestion from eastbound traffic as well.

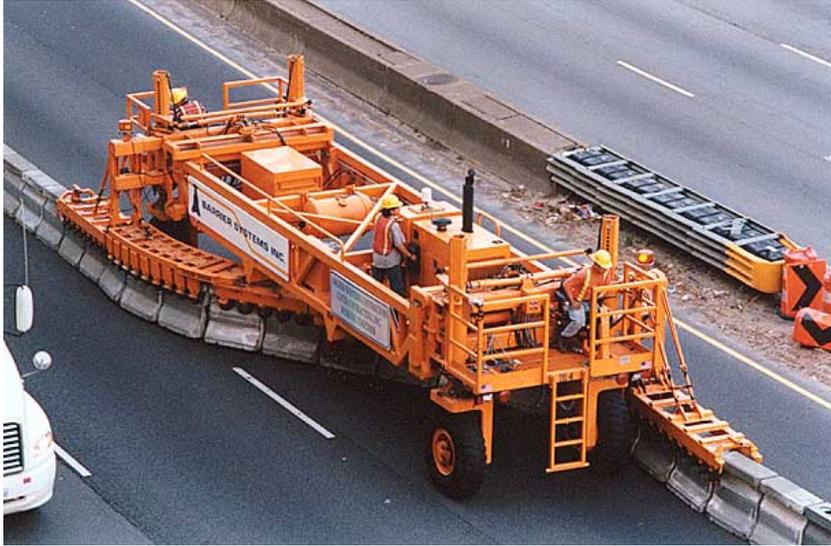
Figure 5-49: Moveable Median Barrier⁶⁸

Moveable Median Barrier: To accommodate peak hour traffic, a moveable median barrier could be utilized as a long-term solution. Moveable median barriers are

often used for construction staging in regions where space for lanes is limited and heavy traffic directions occur during morning and evening peak hours. Using a “zipping” device, median barrier can be transferred during non-peak hours to provide an extra lane for peak flow traffic. Installing a moveable median barrier requires extra funding for maintenance during week days and will have an upfront equipment cost. These costs should be evaluated against the benefits provided for congestion alleviation along the corridor.

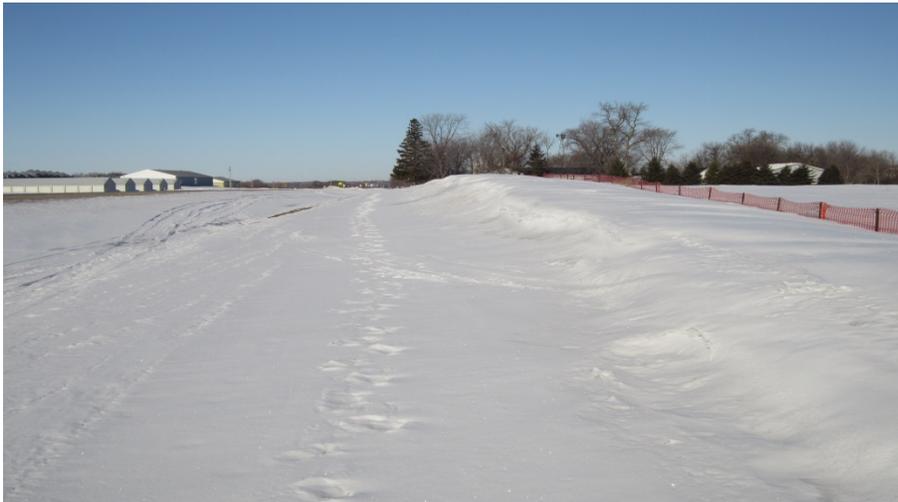
Road is to the left. Snow continues to blow over snow fence and onto roadway.
