# AMERISPEC<sup>®</sup> INSPECTION SERVICES

Doc #:	41519	Inspector:	Todd Newman
Date:	4/11/2019		
Dwelling Address:	4100 Lincoln Louisville KY 40217		
Client Name:	Steve Grant		
Client's Agent:	Terry Golladay	Real Estate Company:	Schuler Bauer

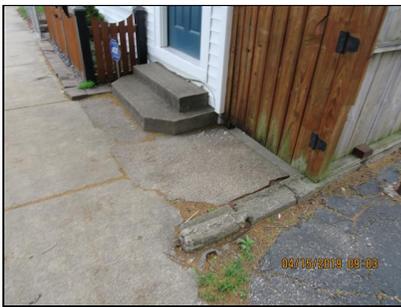
1.1 Item 1(Picture)

Common cracks observed, primarily a cosmetic concern. We suggest sealing all cracks in concrete/asphalt/brick surfaces to prevent water penetration as a routine maintenance effort.

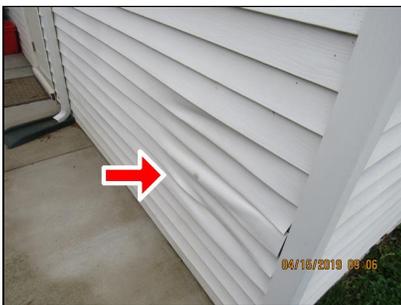
1.2 Item 1(Picture)

(1) Siding is warped, cracked, bending or damaged in various locations. Recommend replacement as necessary or repairs as needed.

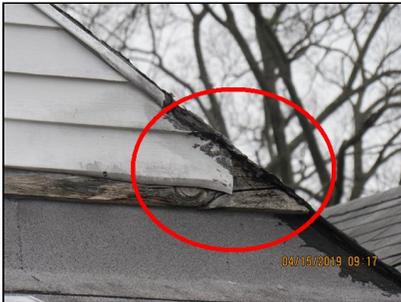
1.2 Item 6(Picture)

(2) Wood deterioration observed at rear of home. Possible improper install. Siding is missing in this area which may have contributed to damage. Suggest repairs/replacement as needed.

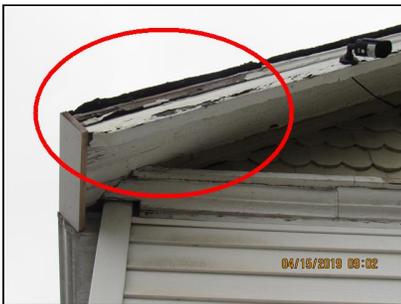
1.3 Item 1(Picture)

(2) Peeling paint observed at various locations; suggest scraping and painting as necessary as part of normal maintenance.

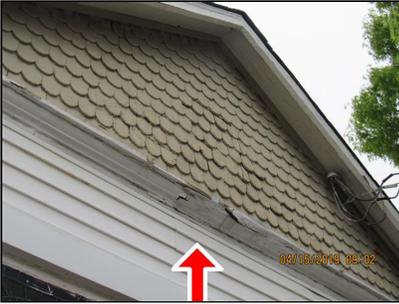
1.3 Item 2(Picture)

(3) Damaged/deteriorated trim observed at front of home various locations. Recommend repairs to prevent further damage.

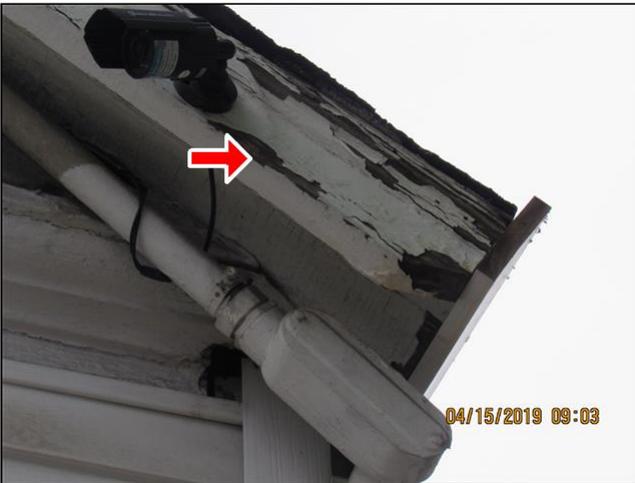
1.3 Item 3(Picture)

(4) Wood deterioration observed at various locations. Suggest repairs/replacement as needed.

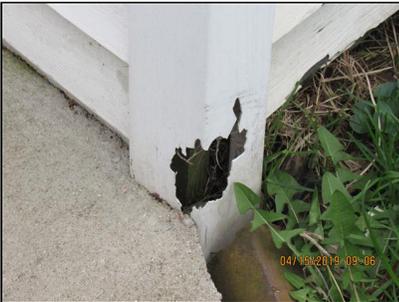
1.3 Item 4(Picture)

(5) Damaged/deteriorated trim observed at rear of home. Recommend repairs to prevent further damage.

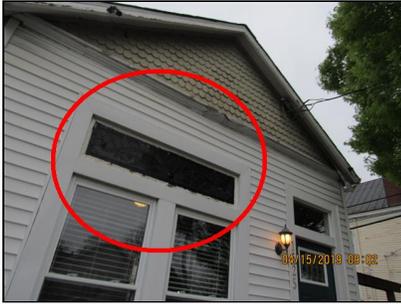
1.4 Item 1(Picture)

Wood deterioration, peeling paint and rusting observed at front of home - stained glass window. Suggest repairs/ replacement as needed.

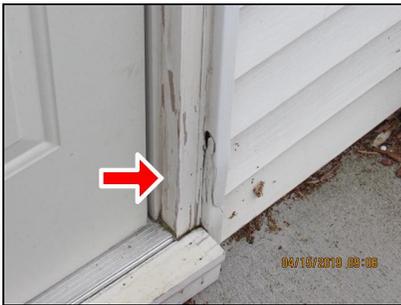
1.5 Item 1(Picture)

Peeling paint, wood deterioration observed at the rear entry door. Suggest repairs/replacement as needed.

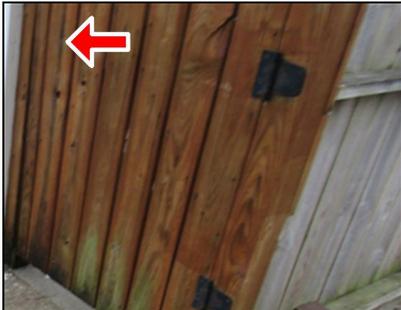
1.6 Item 1(Picture)

Gate is not easy to open. Rubs jam. Recommend review for repair or replacement as necessary.

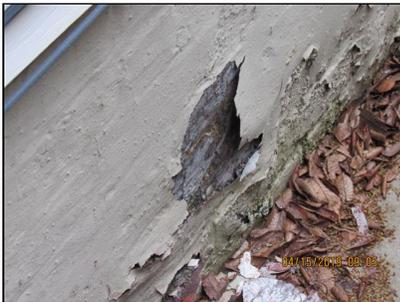
2.1 Item 1(Picture)

Cement parging is flaking/deteriorated at various locations. Recommend review for repair as necessary.

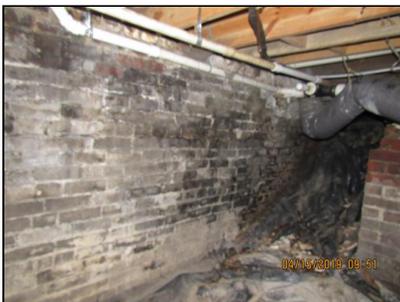
2.3 Item 1(Picture)

The left wall in the basement shows signs of leaning and is not perfectly straight. Being an older home this may be settlement over time. Brick may be unstable. It is advised to seek a licensed structural engineer's opinion or contractor for further review.

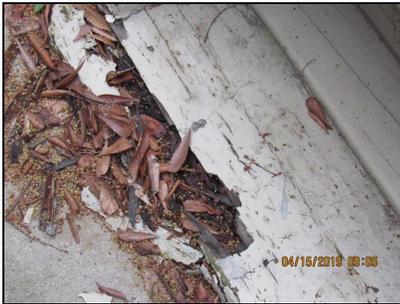
2.9 Item 1(Picture)

(1) Peeling paint observed; suggest scraping and painting as necessary as part of normal maintenance.

(2) Window wood rot, moisture damage observed. Recommend review for corrections/repairs as needed.

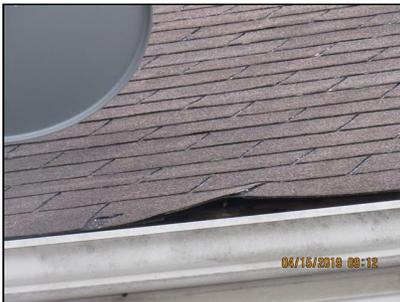
3.0 Item 1(Picture)

- (1) Roofing materials show extensive wear and deterioration and are at the end of their useful life. A licensed roofer should be consulted for further review prior to closing for repairs/replacement as required.
- (2) Granular loss and deterioration observed. Shingles are dry, brittle, cracked, cupping, and curling. Roof is at the end of its useful life. Suggest further review by a licensed roofer prior to closing for repairs/replacement as needed.
- (3) Curling, damaged, or missing shingles observed at various locations. Recommend review by a licensed roofer for repair or replacement, as necessary, prior to close.

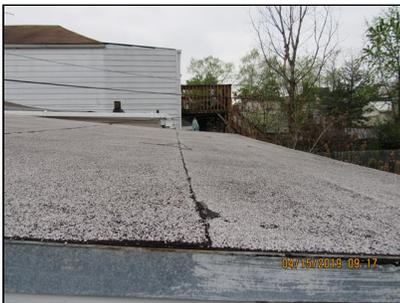
3.0 Item 4(Picture)

- (4) Roll roofing is aged and has wear and some damage in areas. Recommend review by licensed roofing contractor.

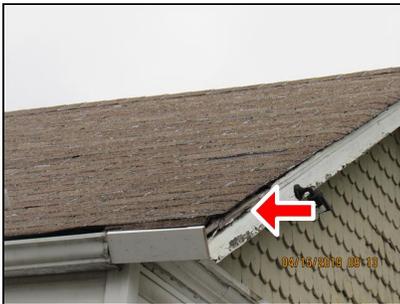
3.1 Item 1(Picture)

Wood and metal flashing is rotted/damaged at front and damaged in various areas of the home. Flashing is important for shedding water. Recommend review by licensed roofer for corrections as needed.

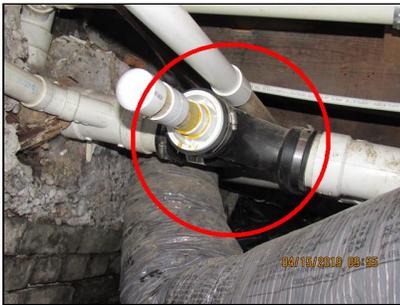
4.1 Item 1(Picture)

Rubber Fernco flexible drain pipe connector observed. These can over time sag, flex or collapse. Recommend replacement or monitoring over time for leaking.

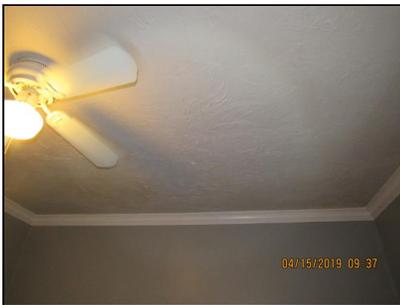
5.2 Item 1(Picture)

Common cracks noted, appears to be primarily a cosmetic issue. Recommend corrections a needed.

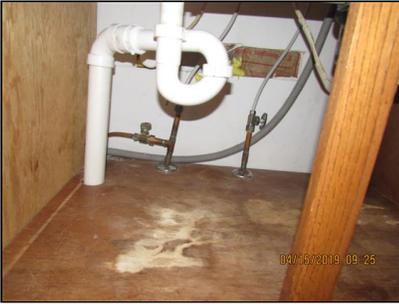
5.7 Item 1(Picture)

Dry stains observed in/on the cabinet. No active leaks at time of inspection under the kitchen sink,.

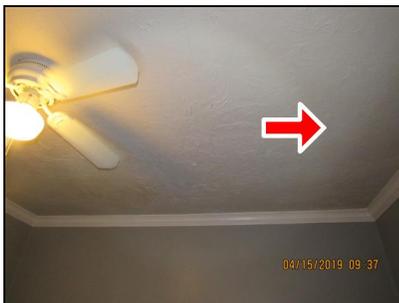
7.2 Item 1(Picture)

(1) Common cracks noted in the living room bedroom, appears to be primarily a cosmetic issue. Recommend corrections as needed.

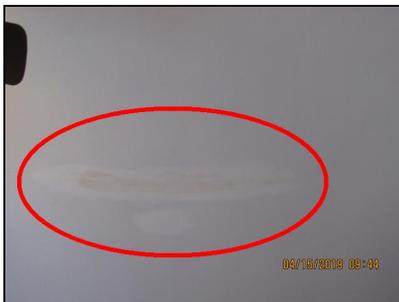
7.2 Item 2(Picture)

(2) Evidence of repairs observed in the living room. Recommend consulting sellers for additional information.

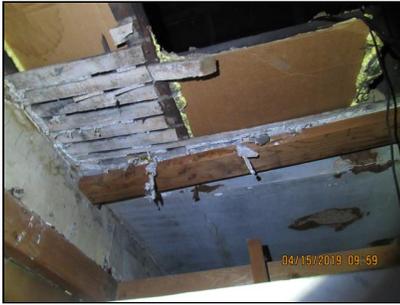
7.2 Item 3(Picture)

(3) Damage/deterioration, cutting of materials observed in a possible prior ceiling area in the attic. At one time this may have been the original ceiling or an area of the closet that was opened for access to the attic area. Recommend review by a qualified professional for repair or replacement, as needed.

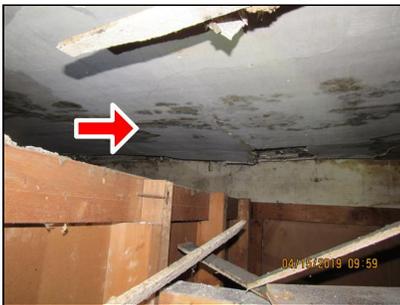
7.2 Item 4(Picture)

(4) Signs of possible fungi growth are present on ceiling in the older ceiling visible in the attic space. This may be caused by water leaking from the holes in the shingles of the roof. We did not inspect, test or determine if this growth is or is not a health hazard. The underlying cause is moisture or dampness. It is recommended that you contact a mold inspector or expert for investigation or correction if needed.

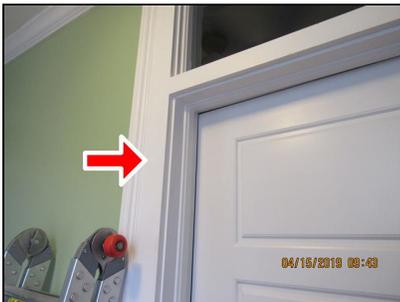
7.3 Item 1(Picture)

The door in the upstairs hallway rubs the jamb, adjustments are needed for smooth operation.

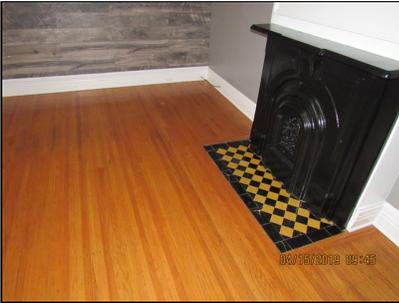
7.9 Item 1(Picture)

(1) Fireplace is blocked/permanently closed and not accessible.

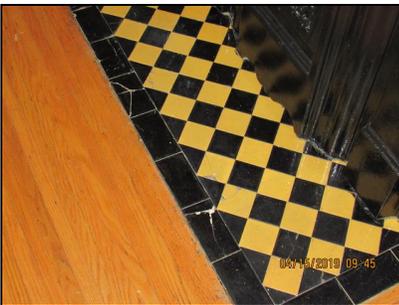
7.9 Item 2(Picture)

(2) Cracked tile observed on hearth. Recommend repair or replacement as needed.

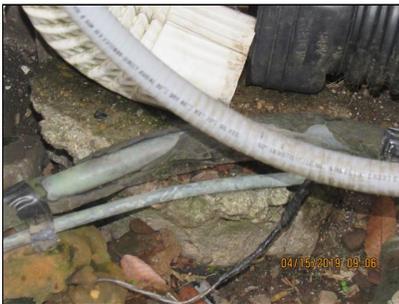
10.0 Item 1(Picture)

- (1) As most manufacturers warn against operating air conditioning units when the outside temperature is below 60 degrees, this unit was not tested. Recommend referring to the Sellers Disclosure Statement regarding the condition of this unit. This unit is a 1998 model by Goodman based on its serial number. Recommend review by a licensed HVAC contractor for a more detailed evaluation, prior to close.
- (2) Refrigerant suction line insulation is deteriorated; recommend replacing insulation for improved performance.

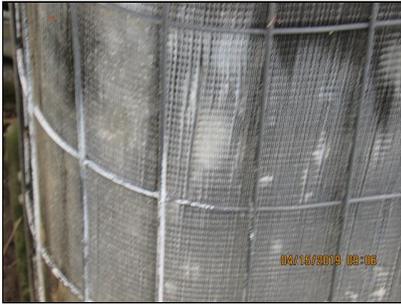
10.0 Item 2(Picture)

(3) The condenser fins at the outside compressor are bent or damaged. Recommend straightening the outside condenser cooling fins on the exterior condenser to help assure adequate airflow and operation or have HVAC contractor review for corrections as needed..

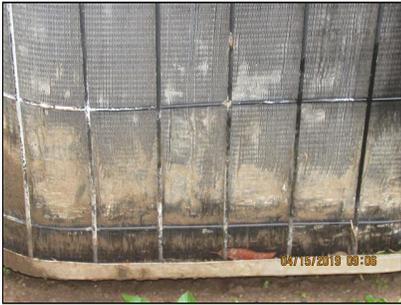
10.0 Item 4(Picture)

(4) The outside condenser coil fins are dirty and need to be cleaned by a licensed heating and air contractor to help assure serviceability.

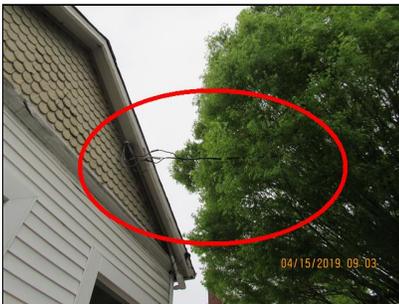
12.0 Item 1(Picture)

Service entrance is overhead. The utility company wires coming into the service mast are sagging and strung through trees. Client is advised to contact the utility company prior to closing to correct the condition or verify its safety.

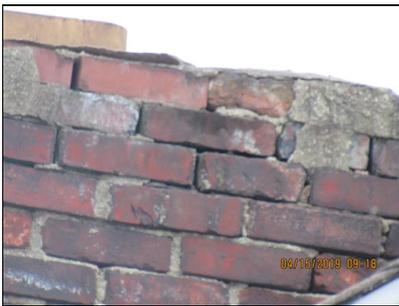
14.0 Item 1(Picture)

Loose/missing mortar and brick deterioration observed, recommend review for tuck pointing and repair as necessary.

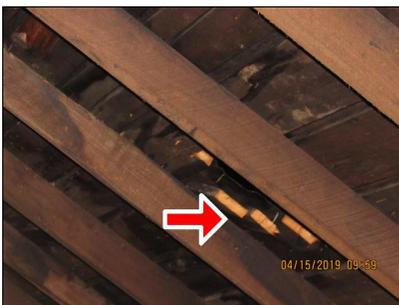
15.2 Item 1(Picture)

**Deterioration/damage observed. Recommend review by a qualified professional for repair or replacement.**

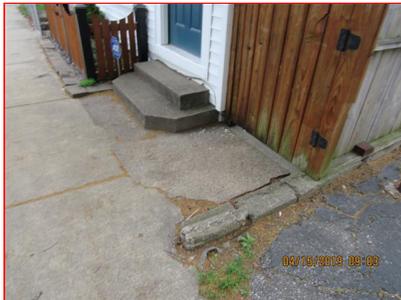
1.1 Item 1(Picture)

Common cracks observed, primarily a cosmetic concern. We suggest sealing all cracks in concrete/asphalt/brick surfaces to prevent water penetration as a routine maintenance effort.

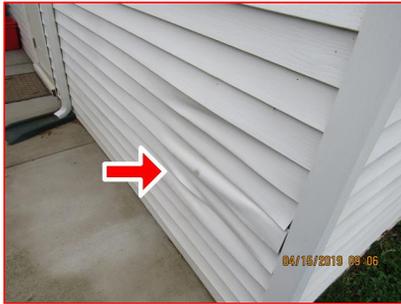
1.2 Item 1(Picture)

(1) Siding is warped, cracked, bending or damaged in various locations. Recommend replacement as necessary or repairs as needed.

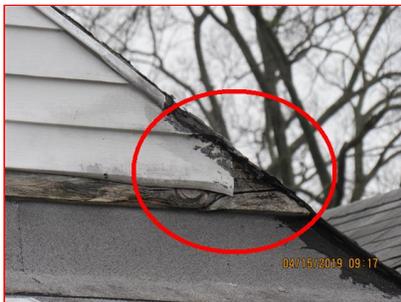
1.2 Item 6(Picture)

(2) Wood deterioration observed at rear of home. Possible improper install. Siding is missing in this area which may have contributed to damage. Suggest repairs/replacement as needed.

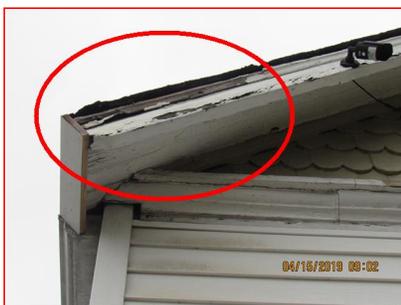
1.3 Item 1(Picture)

(2) Peeling paint observed at various locations; suggest scraping and painting as necessary as part of normal maintenance.

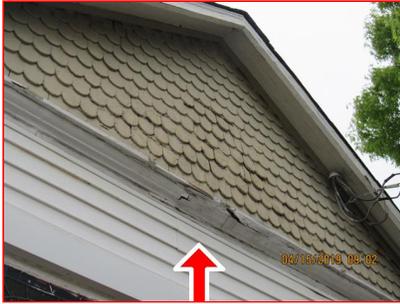
1.3 Item 2(Picture)

(3) Damaged/deteriorated trim observed at front of home various locations. Recommend repairs to prevent further damage.

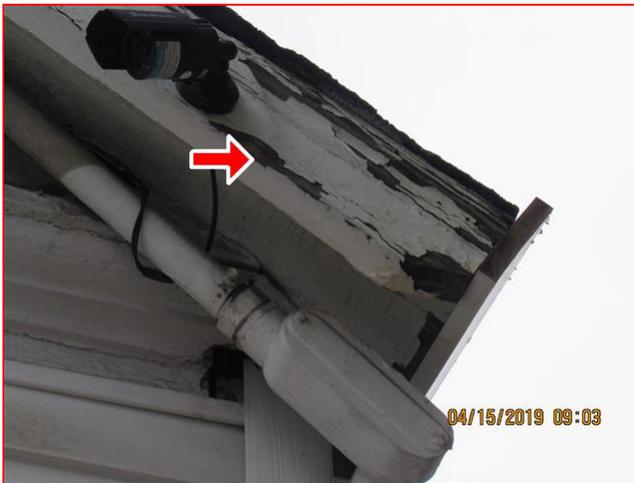
1.3 Item 3(Picture)

(4) Wood deterioration observed at various locations. Suggest repairs/replacement as needed.

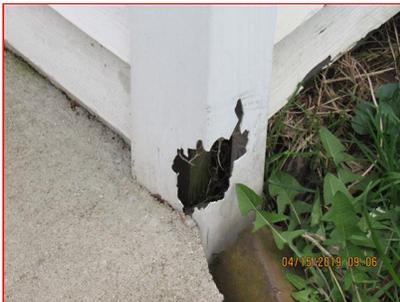
1.3 Item 4(Picture)

(5) Damaged/deteriorated trim observed at rear of home. Recommend repairs to prevent further damage.

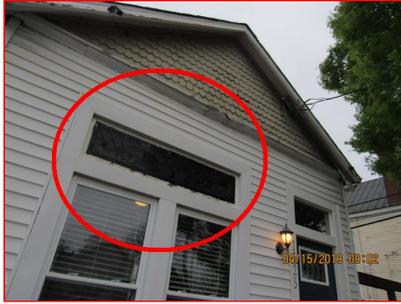
1.4 Item 1(Picture)

Wood deterioration, peeling paint and rusting observed at front of home - stained glass window. Suggest repairs/replacement as needed.

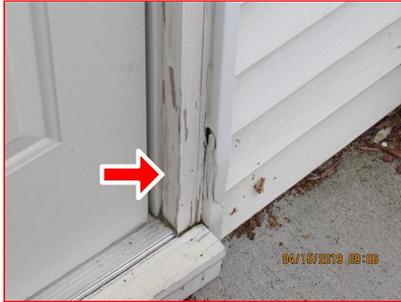
1.5 Item 1(Picture)

Peeling paint, wood deterioration observed at the rear entry door. Suggest repairs/replacement as needed.

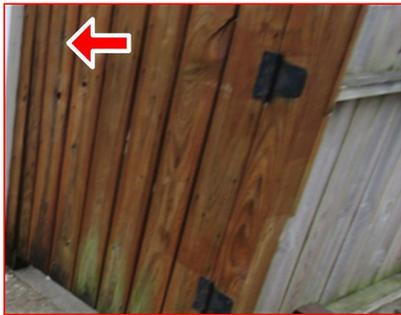
1.6 Item 1(Picture)

Gate is not easy to open. Rubs jam. Recommend review for repair or replacement as necessary.

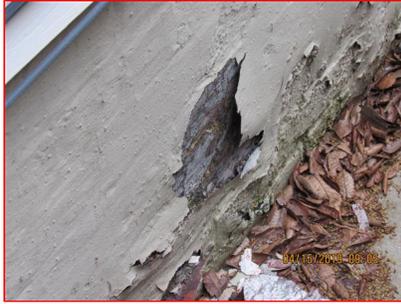
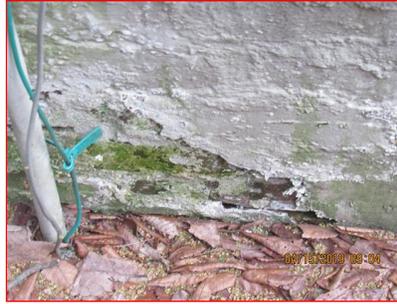
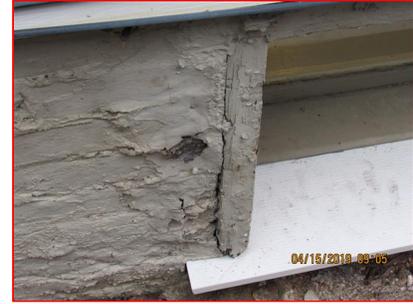
Cement parging is flaking/deteriorated at various locations. Recommend review for repair as necessary.

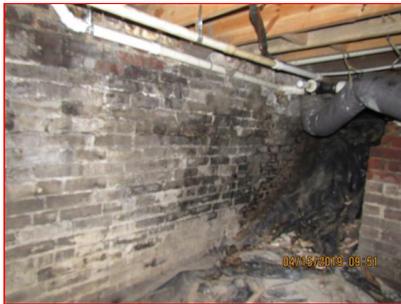
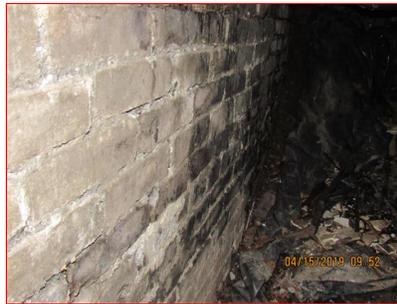
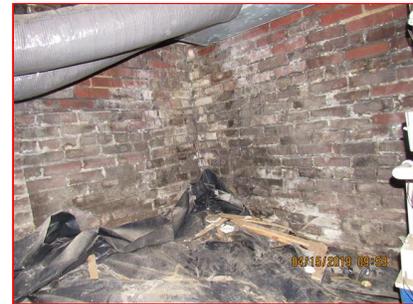
The left wall in the basement shows signs of leaning and is not perfectly straight. Being an older home this may be settlement over time. Brick may be unstable. It is advised to seek a licensed structural engineer's opinion or contractor for further review.

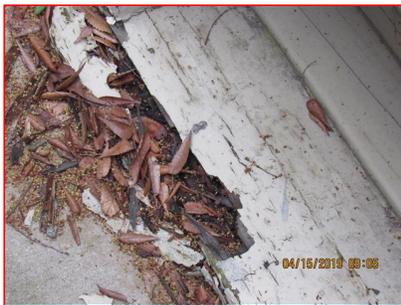
2.9 Item 1(Picture)

- (1) Peeling paint observed; suggest scraping and painting as necessary as part of normal maintenance.
- (2) Window wood rot, moisture damage observed. Recommend review for corrections/repairs as needed.

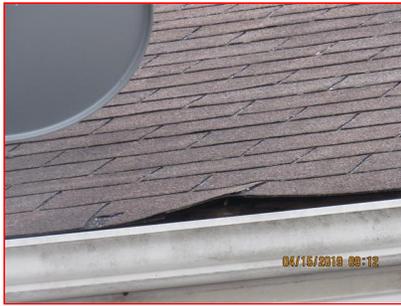
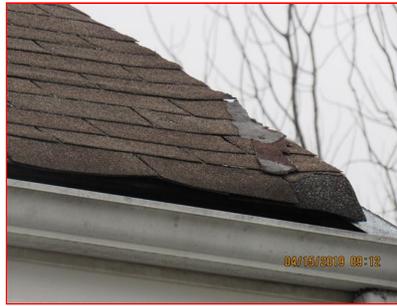
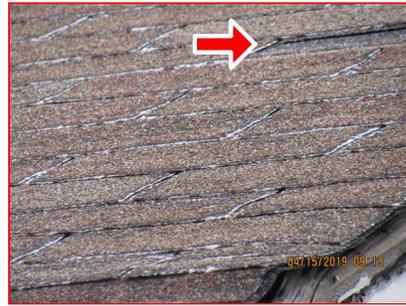
(3) Curling, damaged, or missing shingles observed at various locations. Recommend review by a licensed roofer for repair or replacement, as necessary, prior to close.

- (1) Roofing materials show extensive wear and deterioration and are at the end of their useful life. A licensed roofer should be consulted for further review prior to closing for repairs/replacement as required.
- (2) Granular loss and deterioration observed. Shingles are dry, brittle, cracked, cupping, and curling. Roof is at the end of its useful life. Suggest further review by a licensed roofer prior to closing for repairs/replacement as needed.

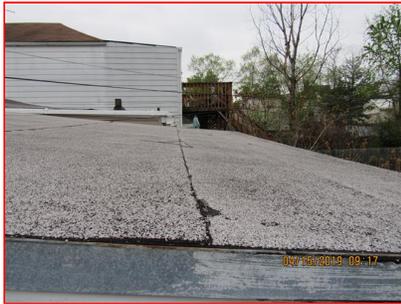
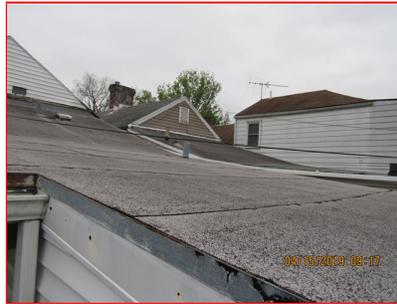
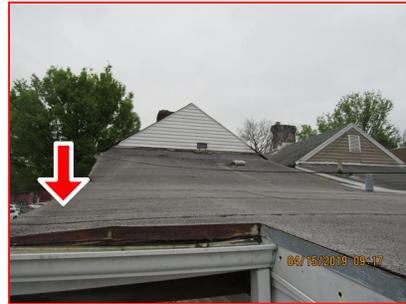
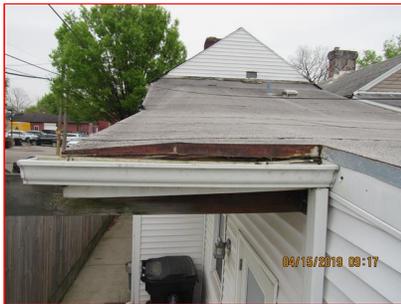
(4) Roll roofing is aged and has wear and some damage in areas. Recommend review by licensed roofing contractor.

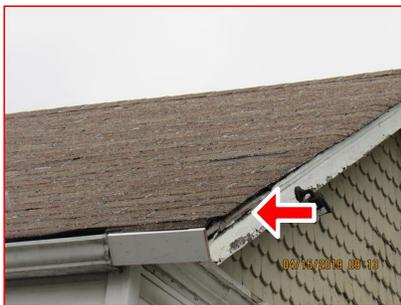
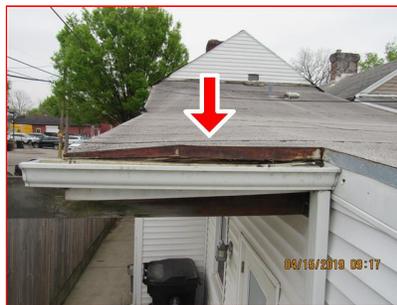
Wood and metal flashing is rotted/damaged at front and damaged in various areas of the home. Flashing is important for shedding water. Recommend review by licensed roofer for corrections as needed.

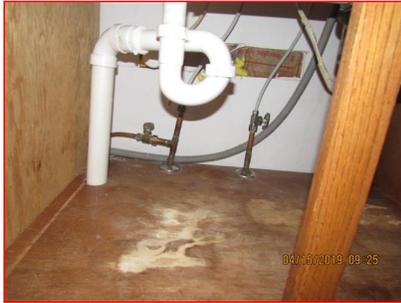
5.7 Item 1(Picture)

Dry stains observed in/on the cabinet. No active leaks at time of inspection under the kitchen sink,.

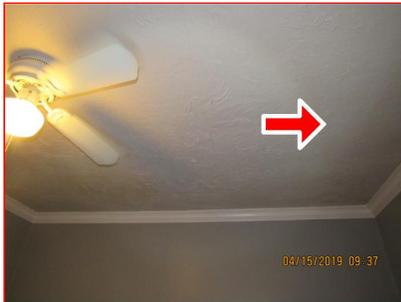
7.2 Item 1(Picture)

(1) Common cracks noted in the living room bedroom, appears to be primarily a cosmetic issue. Recommend corrections a needed.

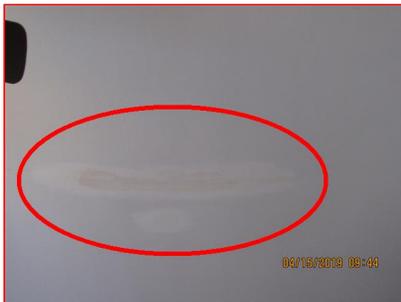
7.2 Item 2(Picture)

(2) Evidence of repairs observed in the living room. Recommend consulting sellers for additional information.

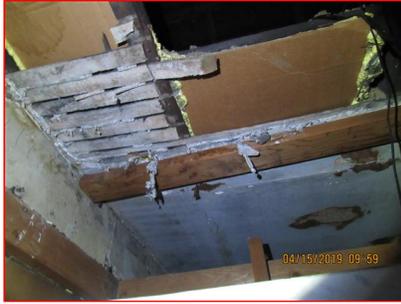
7.2 Item 3(Picture)

(3) Damage/deterioration, cutting of materials observed in a possible prior ceiling area in the attic. At one time this may have been the original ceiling or an area of the closet that was opened for access to the attic area. Recommend review by a qualified professional for repair or replacement, as needed.

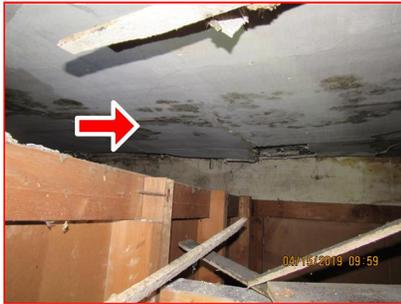
7.2 Item 4(Picture)

(4) Signs of possible fungi growth are present on ceiling in the older ceiling visible in the attic space. This may be caused by water leaking from the holes in the shingles of the roof. We did not inspect, test or determine if this growth is or is not a health hazard. The underlying cause is moisture or dampness. It is recommended that you contact a mold inspector or expert for investigation or correction if needed.

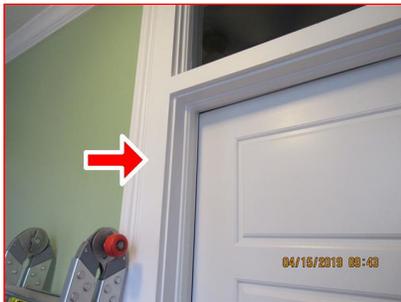
7.3 Item 1(Picture)

The door in the upstairs hallway rubs the jamb, adjustments are needed for smooth operation.

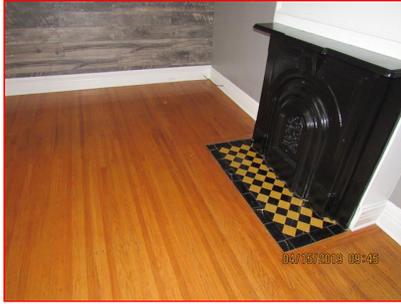
7.9 Item 1(Picture)

(1) Fireplace is blocked/permanently closed and not accessible.

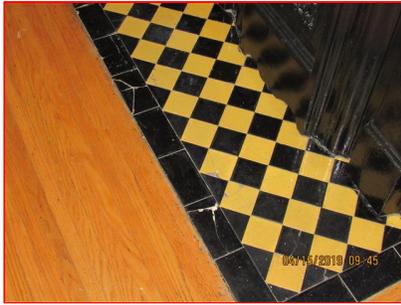
7.9 Item 2(Picture)

(2) Cracked tile observed on hearth. Recommend repair or replacement as needed.

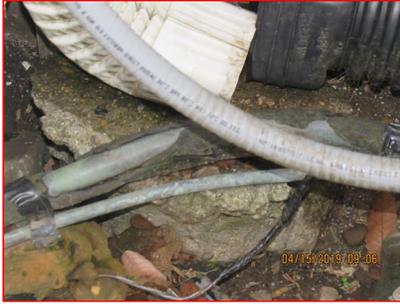
10.0 Item 1(Picture)

(2) Refrigerant suction line insulation is deteriorated; recommend replacing insulation for improved performance.

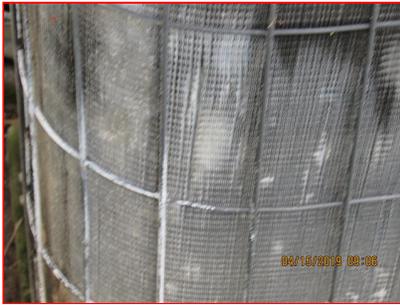
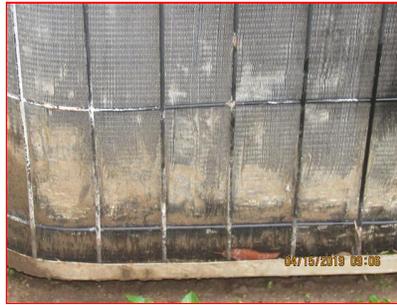
(3) The condenser fins at the outside compressor at bent or damaged. Recommend straightening the outside condenser cooling fins on the exterior condenser to help assure adequate airflow and operation or have HVAC contractor review for corrections as needed..

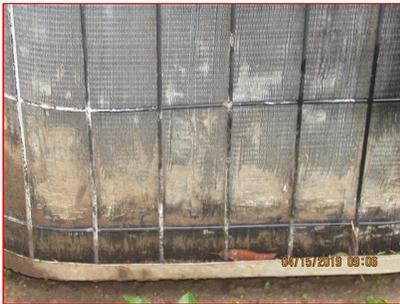
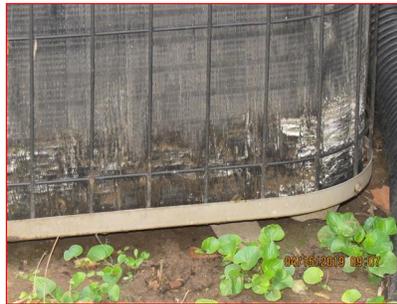
(4) The outside condenser coil fins are dirty and need to be cleaned by a licensed heating and air contractor to help assure serviceability.

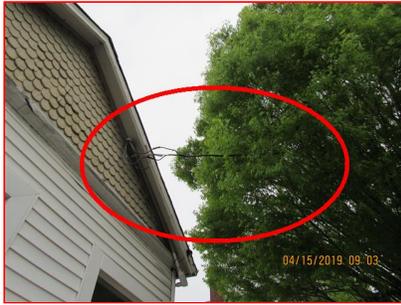
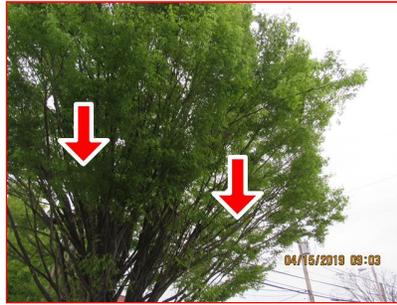
Service entrance is overhead. The utility company wires coming into the service mast are sagging and strung through trees. Client is advised to contact the utility company prior to closing to correct the condition or verify its safety.

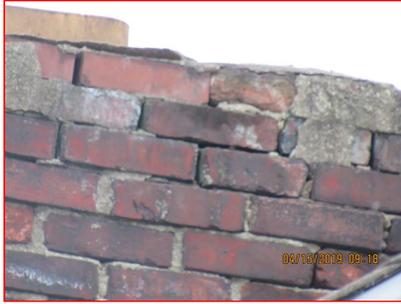
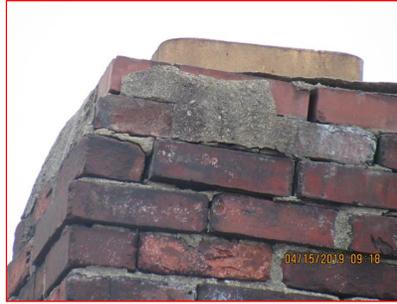
Loose/missing mortar and brick deterioration observed, recommend review for tuck pointing and repair as necessary.

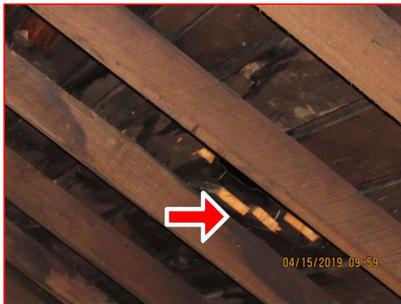
15.2 Item 1(Picture)

Deterioration/damage observed. Recommend review by a qualified professional for repair or replacement.
