West Virginia Data Collection - Final

Investigation of data points along the Kanawha River and Coal Rivers.

October 26, 2022

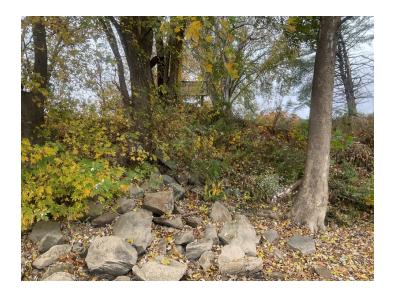
Site Locations - 1. Kanawha River - KR, 1

Weather	
Air Temperature (c)	13.1
Weather Condition	Overcast
Wind Speed (mph)	12.1
Humidity (%)	86
Precipitation (mm)	0
Way Point Prefix	Kanawha River - KR
Way Point Number	1
Time at Way Point	12:00
Way Point Description	Sign
Are there visible signs indicating a cable crossing?	Yes
Identify what the signs say.	Submarine Crossing. 2nd sign flanking the telecom sign.
Is there buried or visible cable at location?	No
Was there a general site sample collected?	No

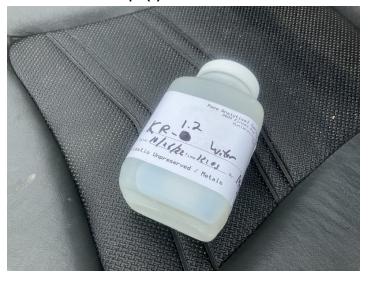
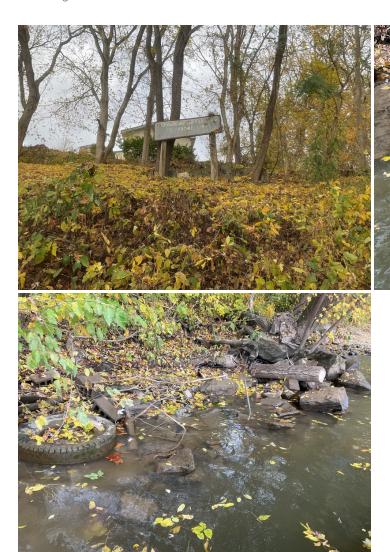
Site Locations - 2. Kanawha River - KR, 1.2

Weather	
Air Temperature (c)	13.1
Weather Condition	Overcast
Wind Speed (mph)	12.1
Humidity (%)	86
Precipitation (mm)	0
Way Point Prefix	Kanawha River - KR
Way Point Number	1.2
Time at Way Point	12:01
Way Point Description	Sign
Are there visible signs indicating a cable crossing?	Yes
Identify what the signs say.	Underground Cable Crossing. C&P Tel. Co. of W.VA.
Is there buried or visible cable at location?	N/A
Was there a general site sample collected?	Yes

Location of Collected Sample - No Visible Cable	Surface Sample.
Time of Collection - No Visible Cable	12:05
Sample Prefix - No Visible Cable	Kanawha River - KR
Sample ID (#) - No Visible Cable	1.2 Water
Additional Notes - No Visible Cable Sample (if any)	Two signs indicating cable crossings.

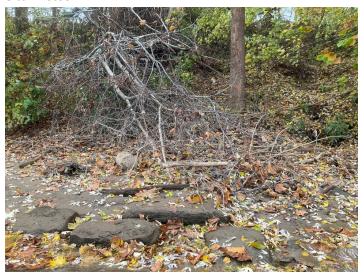
Site Locations - 3. Kanawha River - KR, 1.1

Weather	
Air Temperature (c)	12.8
Weather Condition	Overcast
Wind Speed (mph)	5.6
Humidity (%)	89
Precipitation (mm)	0
Way Point Prefix	Kanawha River - KR
Way Point Number	1.1
Time at Way Point	12:14
Way Point Description	Cable Corridor, Some ballast that would have been placed over the cable. No visible cable. No sign.
Are there visible signs indicating a cable crossing?	N/A

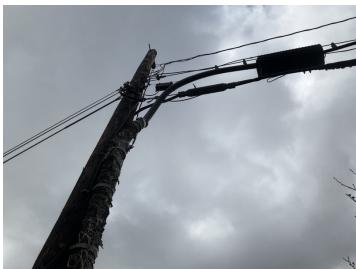
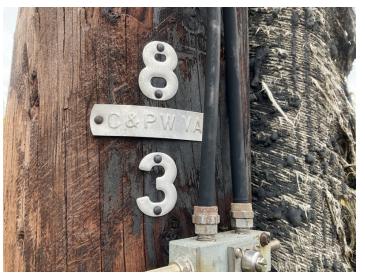
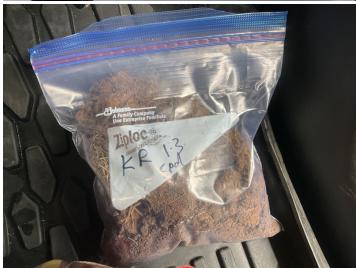
Site Locations - 4. Kanawha River - KR, 1.3

Weather	
Air Temperature (c)	15
Weather Condition	Partly cloudy
Wind Speed (mph)	12.1
Humidity (%)	80
Precipitation (mm)	0
Way Point Prefix	Kanawha River - KR
Way Point Number	1.3
Time at Way Point	12:43
Way Point Description	Cable Location, Old Pliny Ferry Crossing. Aka 113 Frazier Bottom.
Are there visible signs indicating a cable crossing?	N/A
Is there buried or visible cable at location?	Yes
How many cables are visible?	2
Is lead visible?	Yes
Was there a general site sample collected?	See Specific Cable or Water

Cable #	1
Visible Length (ft)	20
Type of Cable (Power, Telecom, Fiber Optic, Other)	Telecom
Is this a leaded cable?	Yes
Is the cable(s) Terrestrial, Submarine or Both?	Both
Was there a sample collected?	Yes
How many samples collected?	1

Cable #	2
Visible Length (ft)	20
Type of Cable (Power, Telecom, Fiber Optic, Other)	Telecom
Is this a leaded cable?	Yes
Is the cable(s) Terrestrial, Submarine or Both?	Both
Was there a sample collected?	Yes

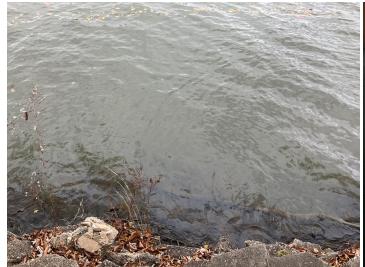
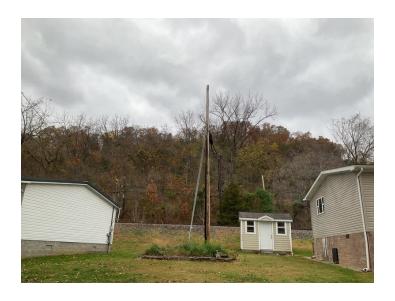
Site Locations - 5. Kanawha River - KR, 2

Weather	
Air Temperature (c)	14.1
Weather Condition	Overcast
Wind Speed (mph)	13.4
Humidity (%)	72
Precipitation (mm)	0
Way Point Prefix	Kanawha River - KR
Way Point Number	2
Time at Way Point	13:46
Way Point Description	Cable Location, Spoke with homeowner for sediment sample as the cable is on her property. She refused access. We did collect a water sample nearby.
Are there visible signs indicating a cable crossing?	N/A

Type of Sample for No Visible Cable (Water, Sediment, Cable, Manhole, Splice Box, etc.)	Water: Cable Corridor
Location of Collected Sample - No Visible Cable	Surface Sample.
Time of Collection - No Visible Cable	13:48
Sample Prefix - No Visible Cable	Kanawha River - KR
Sample ID (#) - No Visible Cable	2 Water
Additional Notes - No Visible Cable Sample (if any)	None.

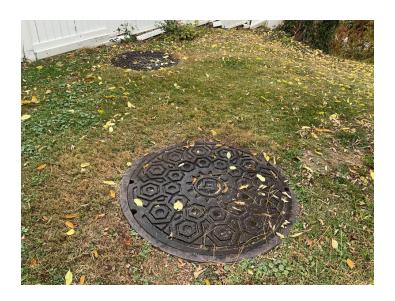
Site Locations - 6. Kanawha River - KR, 2.1

Weather	
Air Temperature (c)	12.3
Weather Condition	Overcast
Wind Speed (mph)	12.1
Humidity (%)	77
Precipitation (mm)	0
Way Point Prefix	Kanawha River - KR
Way Point Number	2.1
Time at Way Point	13:58
Way Point Description	Manhole, Bell systems x2.
Are there visible signs indicating a cable crossing?	N/A
Is there buried or visible cable at location?	N/A
Was there a general site sample collected?	No

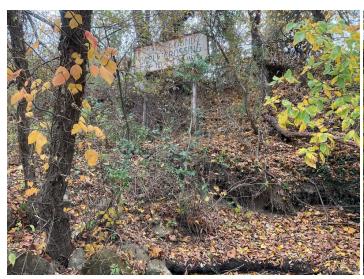
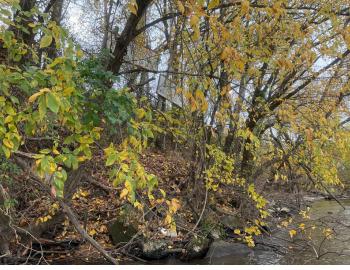
Site Locations - 7. Kanawha River - KR, 3

Weather	
Air Temperature (c)	14.4
Weather Condition	Overcast
Wind Speed (mph)	9.4
Humidity (%)	65
Precipitation (mm)	0
Way Point Prefix	Kanawha River - KR
Way Point Number	3
Time at Way Point	15:07
Way Point Description	Sign, 3 visible signs. All say the same. Adjacent to industry.
Are there visible signs indicating a cable crossing?	Yes
Identify what the signs say.	Underground Cable Crossing. C&P Tel. Co. of W.VA.
Is there buried or visible cable at location?	No
Was there a general site sample collected?	No

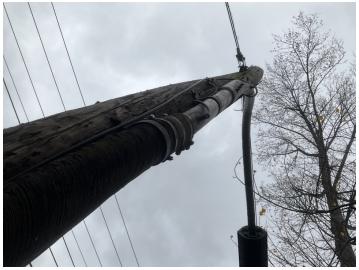
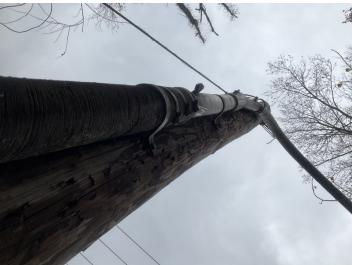
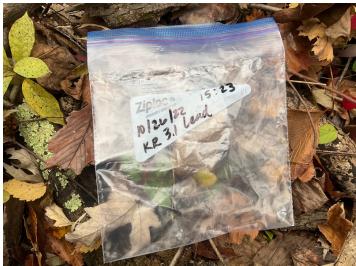
Sample Information - Specific Cable - 1. Lead Scraping, 3.1 Lead

Weather	
Air Temperature (c)	13.3
Weather Condition	Overcast
Wind Speed (mph)	12.5
Humidity (%)	64
Precipitation (mm)	0
Way Point Prefix	Kanawha River - KR
Way Point Number	3.1
Time at Way Point	15:16
Way Point Description	Cable Location, Telephone Pole
Are there visible signs indicating a cable crossing?	Yes
Identify what the signs say.	Underground Cable Crossing. C&P Tel. Co. of W.VA.
Is there buried or visible cable at location?	Yes
How many cables are visible?	2
Is lead visible?	Yes
Was there a general site sample collected?	See Specific Cable or Water

Cable #	1, 2
Visible Length (ft)	20
Type of Cable (Power, Telecom, Fiber Optic, Other)	Telecom
Is this a leaded cable?	Yes
Is the cable(s) Terrestrial, Submarine or Both?	Both
Was there a sample collected?	Yes
How many samples collected?	2

Type of Sample (Water, Sediment, Cable, Manhole, Splice Box, etc.)	Lead Scraping
If more than one cable, what Cable was Sample collected from?	1
Time of Collection - Specific Cable	15:23
Sample Prefix - Specific Cable	Kanawha River - KR
Sample ID (#) - Specific Cable	3.1 Lead
Additional Notes - Specific Cable Sample (if any)	None.

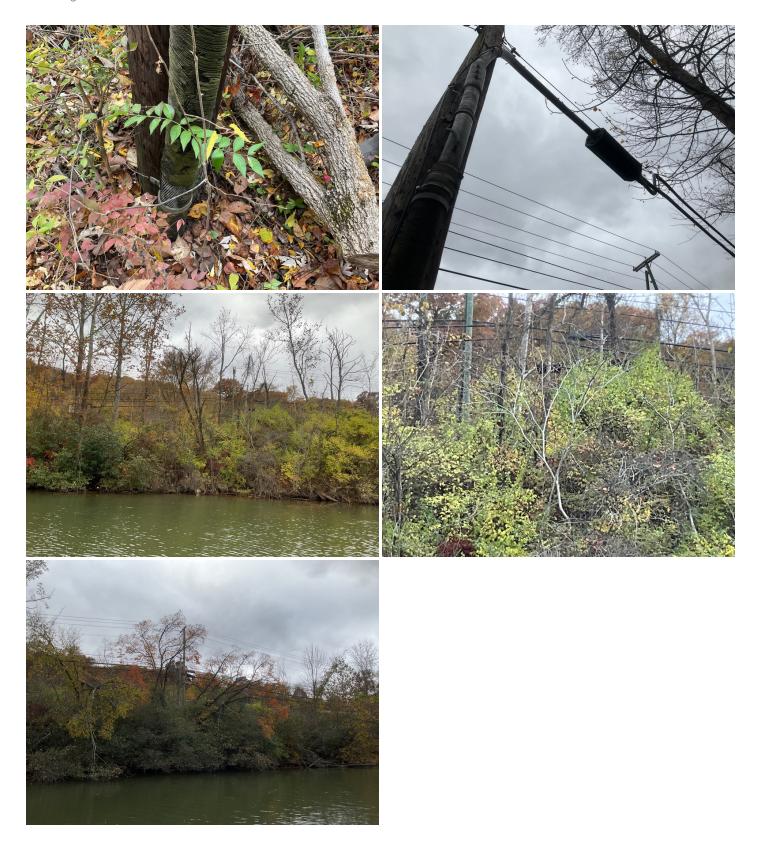
Sample Information - Specific Cable - 2. Sediment Collection, 3.1 Sediment

Type of Sample (Water, Sediment, Cable, Manhole, Splice Box, etc.)	Sediment Collection
If more than one cable, what Cable was Sample collected from?	1
Location of Collected Specific Cable Sample	Under the Cable
Time of Collection - Specific Cable	15:26
Sample Prefix - Specific Cable	Kanawha River - KR
Sample ID (#) - Specific Cable	3.1 Sediment
Additional Notes - Specific Cable Sample (if any)	None.

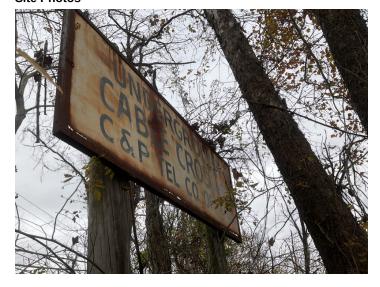
Site Locations - 9. Kanawha River - KR, 3.2

Air Temperature (c)	13.3
Weather Condition	Overcast
Wind Speed (mph)	12.5
Humidity (%)	64
Precipitation (mm)	0
Way Point Prefix	Kanawha River - KR
Way Point Number	3.2
Time at Way Point	15:35
Way Point Description	Sign
Are there visible signs indicating a cable crossing?	Yes
Identify what the signs say.	Underground Cable Crossing. C&P Tel. Co. W.VA.
Is there buried or visible cable at location?	N/A
Was there a general site sample collected?	No

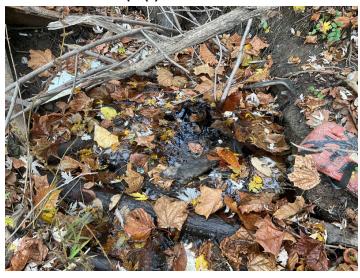
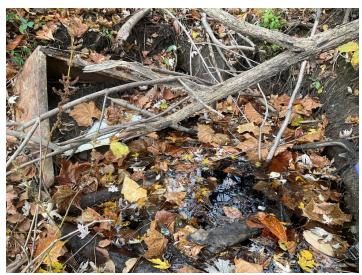
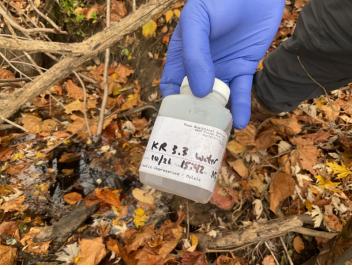
Site Locations - 10. Kanawha River - KR, 3.3

Way Point Number	3.3
Time at Way Point	15:42
Way Point Description	Water: Side Channel
Are there visible signs indicating a cable crossing?	N/A
Is there buried or visible cable at location?	N/A
Was there a general site sample collected?	Yes

Type of Sample for No Visible Cable (Water, Sediment, Cable, Manhole, Splice Box, etc.)	Water: Side Channel, Small Pool.
Location of Collected Sample - No Visible Cable	Surface Sample.
Time of Collection - No Visible Cable	15:43
Sample Prefix - No Visible Cable	Kanawha River - KR
Sample ID (#) - No Visible Cable	3.3
Additional Notes - No Visible Cable Sample (if any)	None.

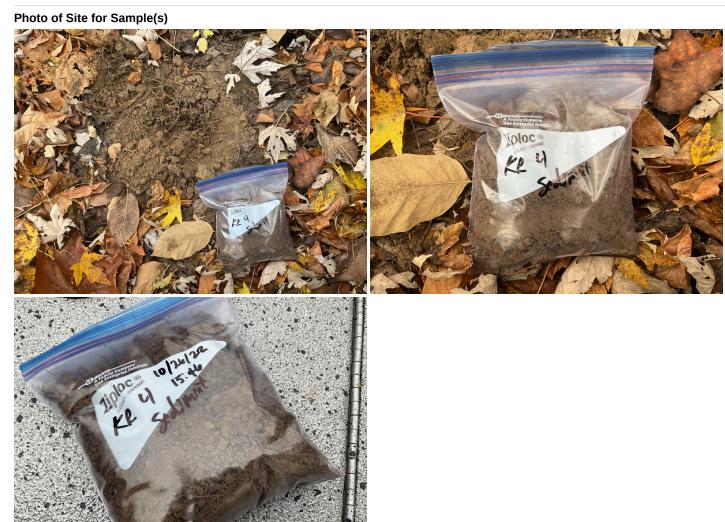
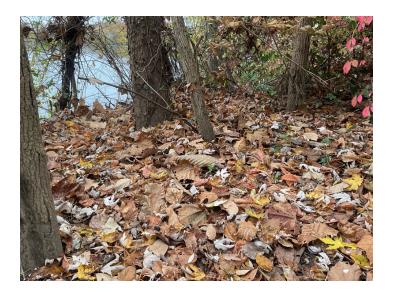
Site Locations - 11. Kanawha River - KR, 4

Weather	
Air Temperature (c)	13.3
Weather Condition	Overcast
Wind Speed (mph)	12.5
Humidity (%)	64
Precipitation (mm)	0
Way Point Prefix	Kanawha River - KR
Way Point Number	4
Time at Way Point	15:45
Way Point Description	Sediment Control
Are there visible signs indicating a cable crossing?	N/A
Is there buried or visible cable at location?	N/A
Was there a general site sample collected?	Yes

Location of Collected Sample - No Visible Cable	Surface Sample
Time of Collection - No Visible Cable	15:45
Sample Prefix - No Visible Cable	Kanawha River - KR
Sample ID (#) - No Visible Cable	4 Sediment
Additional Notes - No Visible Cable Sample (if any)	None.

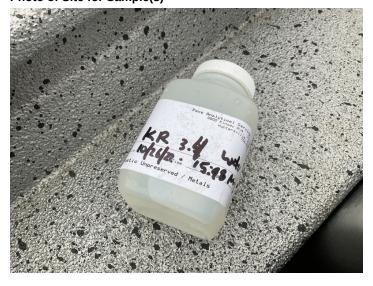
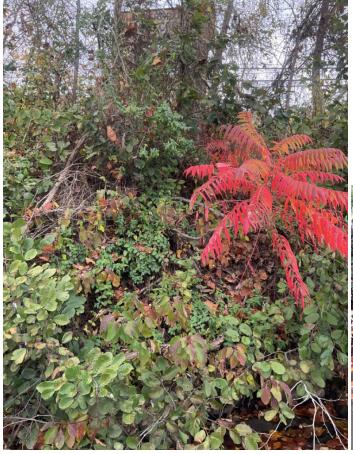
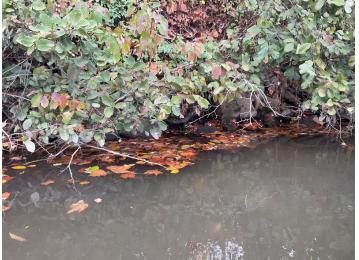
Site Locations - 12. Kanawha River - KR, 3.4

Weather	
Air Temperature (c)	13.3
Weather Condition	Overcast
Wind Speed (mph)	12.5
Humidity (%)	64
Precipitation (mm)	0
Way Point Prefix	Kanawha River - KR
Way Point Number	3.4
Time at Way Point	15:47
Way Point Description	Cable Corridor
Are there visible signs indicating a cable crossing?	N/A
Is there buried or visible cable at location?	N/A
Was there a general site sample collected?	Yes

Location of Collected Sample - No Visible Cable	Surface Sample.
Time of Collection - No Visible Cable	15:48
Sample Prefix - No Visible Cable	Kanawha River - KR
Sample ID (#) - No Visible Cable	3.4 Water
Additional Notes - No Visible Cable Sample (if any)	None.

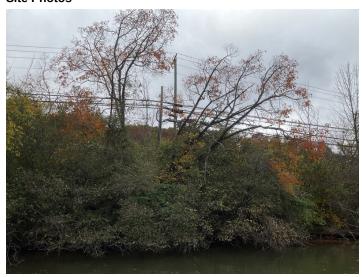
Site Locations - 13. Kanawha River - KR, 3.5

Weather	
Air Temperature (c)	13.3
Weather Condition	Overcast
Wind Speed (mph)	12.5
Humidity (%)	64
Precipitation (mm)	0
Way Point Prefix	Kanawha River - KR
Way Point Number	3.5
Time at Way Point	15:54
Way Point Description	Cable Location, Cable Corridor, 3rd cable on the the fourth pole for site 3 on the West Bank.
Are there visible signs indicating a cable crossing?	N/A
Is there buried or visible cable at location?	Yes
How many cables are visible?	1, Other
Is lead visible?	Yes
Was there a general site sample collected?	No

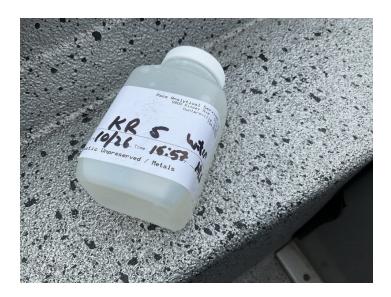
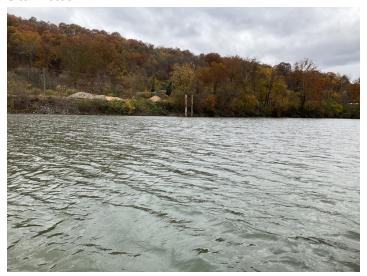
Site Locations - 14. Kanawha River - KR, 5

Weather	
Air Temperature (c)	13.3
Weather Condition	Overcast
Wind Speed (mph)	12.5
Humidity (%)	64
Precipitation (mm)	0
Way Point Prefix	Kanawha River - KR
Way Point Number	5
Time at Way Point	15:57
Way Point Description	Water Control
Are there visible signs indicating a cable crossing?	N/A
Is there buried or visible cable at location?	N/A
Was there a general site sample collected?	Yes

Type of Sample for No Visible Cable (Water, Sediment, Cable, Manhole, Splice Box, etc.)	Water: Control Away from Cable
Location of Collected Sample - No Visible Cable	Surface Sample.
Time of Collection - No Visible Cable	15:58
Sample Prefix - No Visible Cable	Kanawha River - KR
Sample ID (#) - No Visible Cable	5 Water
Additional Notes - No Visible Cable Sample (if any)	Sample information was recorded under "No Visible Cable" rather than "Water Control, Intake or Drinking Fountain".

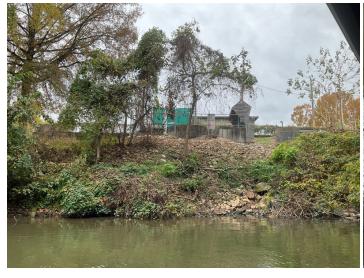
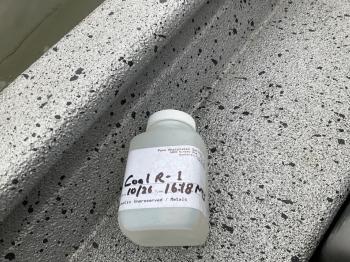
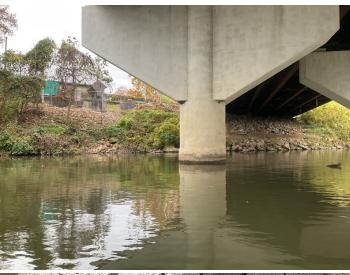
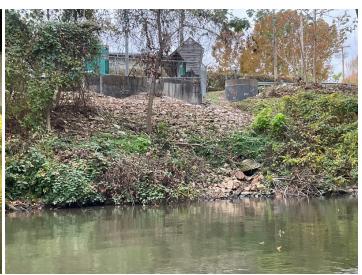
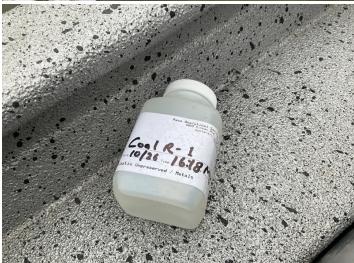
Site Locations - 15. Coal River - Coal, 1

Weather	
Air Temperature (c)	12.8
Weather Condition	Overcast
Wind Speed (mph)	9.4
Humidity (%)	66
Precipitation (mm)	0
Way Point Prefix	Coal River - Coal
Way Point Number	1
Time at Way Point	16:17
Way Point Description	Water Intake
Are there visible signs indicating a cable crossing?	N/A
Is there buried or visible cable at location?	N/A
Was there a general site sample collected?	See Specific Cable or Water

Location of Collected Water Control, Intake or Drinking Fountain Sample	Surface Sample
Time of Collection - Water Control, Intake, or Drinking Fountian	16:19
Sample Prefix - Water Control, Intake, or Drinking Fountain	Coal River - Coal
Sample ID (#) - Water Control, Intake, or Drinking Fountain	Coal R 1 Water
Duplicate Collected - Water Control, Intake, or Drinking Fountain?	No
Additional Notes - Water Control, Intake, or Drinking Fountain Sample (if any)	None.

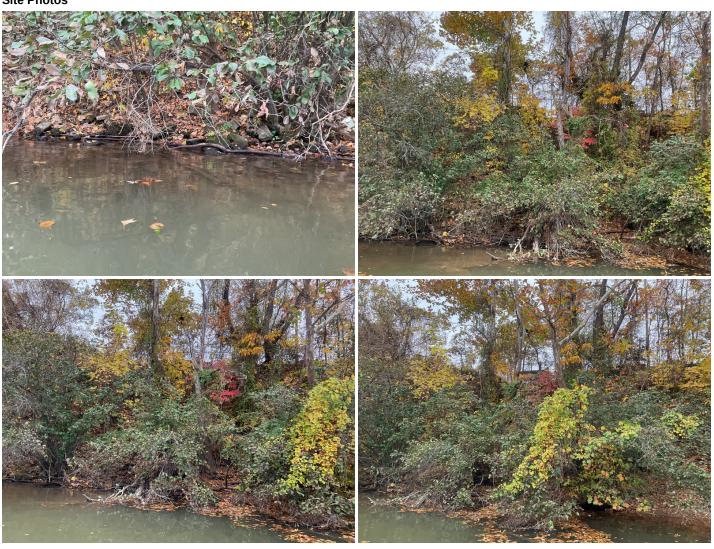
Site Locations - 16. Kanawha River - KR, 6

Weather	
Air Temperature (c)	12.8
Weather Condition	Overcast
Wind Speed (mph)	9.4
Humidity (%)	66
Precipitation (mm)	0
Way Point Prefix	Kanawha River - KR
Way Point Number	6
Time at Way Point	16:43
Way Point Description	No visible Cable. Sign post by school bus garage likely old signage, but could not confirm. East bank was also negative for visible cable/Signs. Residential area - not friendly.
Are there visible signs indicating a cable crossing?	N/A

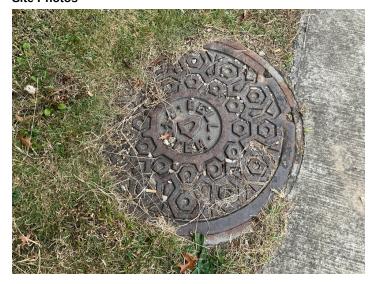
Site Locations - 17. Kanawha River - KR, 7

Time at Way Point	17:33
Way Point Description	Manhole, Bell Systems x1.
Are there visible signs indicating a cable crossing?	No
Is there buried or visible cable at location?	No
Was there a general site sample collected?	No

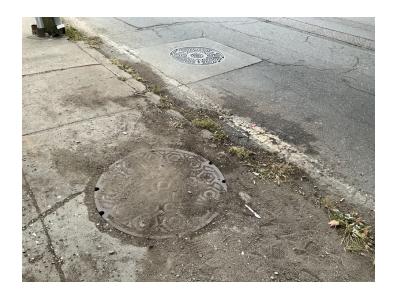
Site Locations - 18. Kanawha River - KR, 7.1

Weather	
Air Temperature (c)	12.2
Weather Condition	Overcast
Wind Speed (mph)	8.1
Humidity (%)	69
Precipitation (mm)	0
Way Point Prefix	Kanawha River - KR
Way Point Number	7.1
Time at Way Point	17:45
Way Point Description	Manhole, Bell systems x2.
Are there visible signs indicating a cable crossing?	N/A
Is there buried or visible cable at location?	N/A
Was there a general site sample collected?	No
