# New Jersey Data Collection - Final

Investigation of data points along the Hackensack River, Passaic River, and the South Kearny Neighborhood.

## January 9, 2023

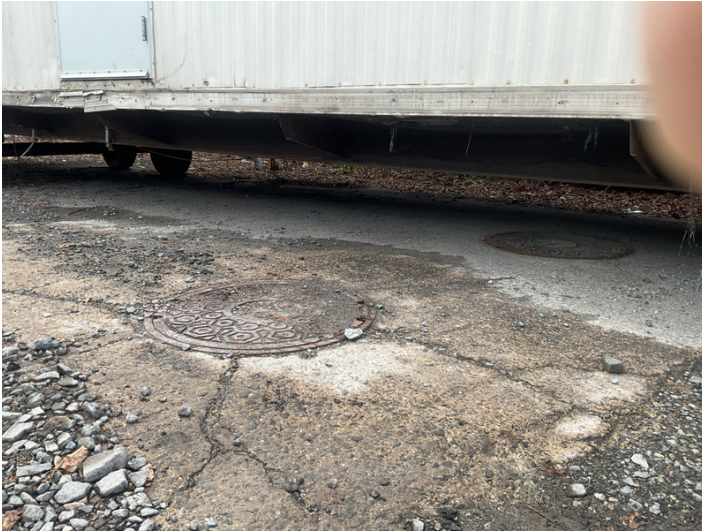
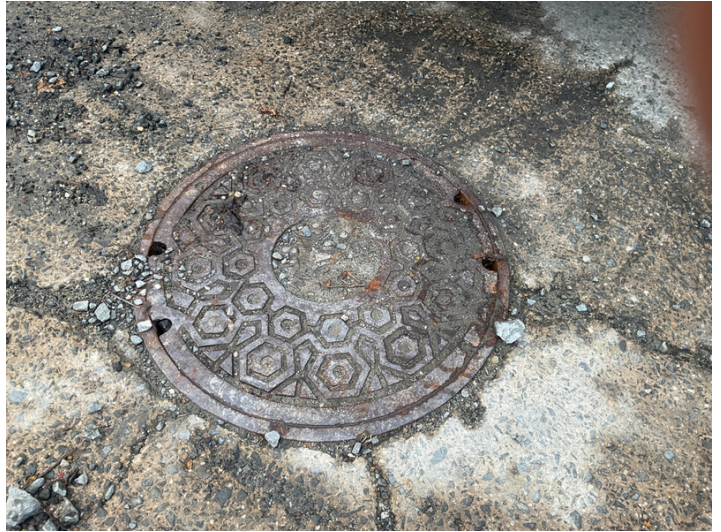
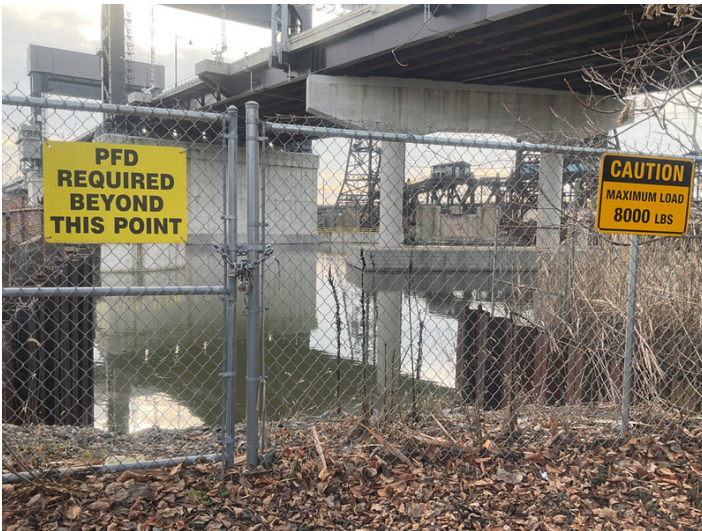
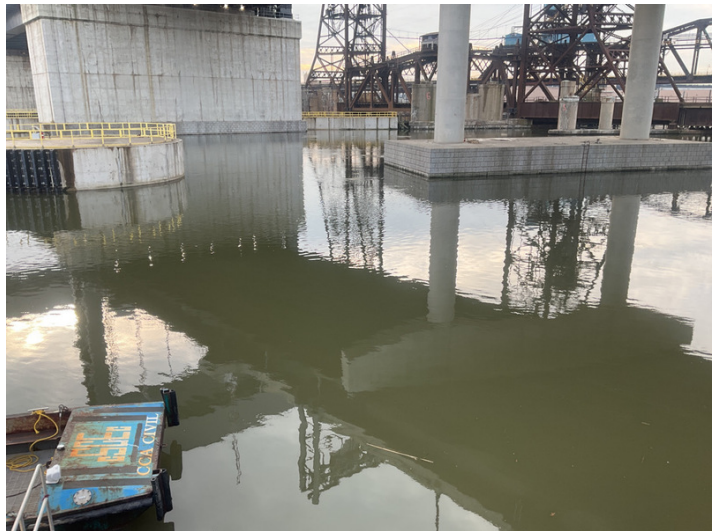
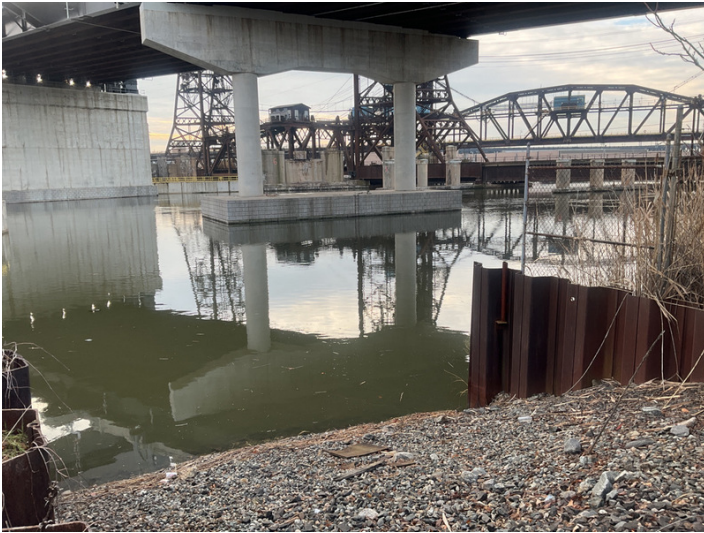
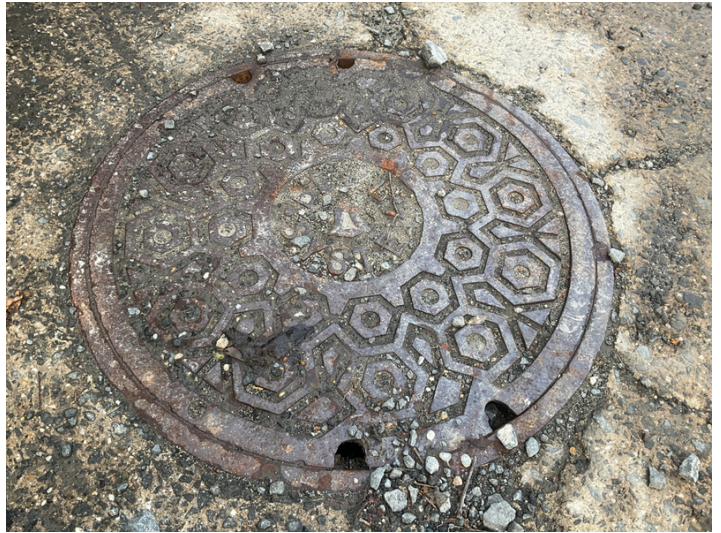
### Site Locations - 1. Hackensack, 1

Way Point Prefix	Hackensack
Way Point Number	1
Time at Way Point	09:14
Way Point Description	Manhole
Are there visible signs indicating a cable crossing?	No
Are there buried or visible cable(s) at location?	Yes
How many cables are visible?	Buried Cables at this location.
Is lead visible?	No

Active construction site. Bell Systems MHx4. Buried Cables at this location. Recommend coming back once construction wraps.

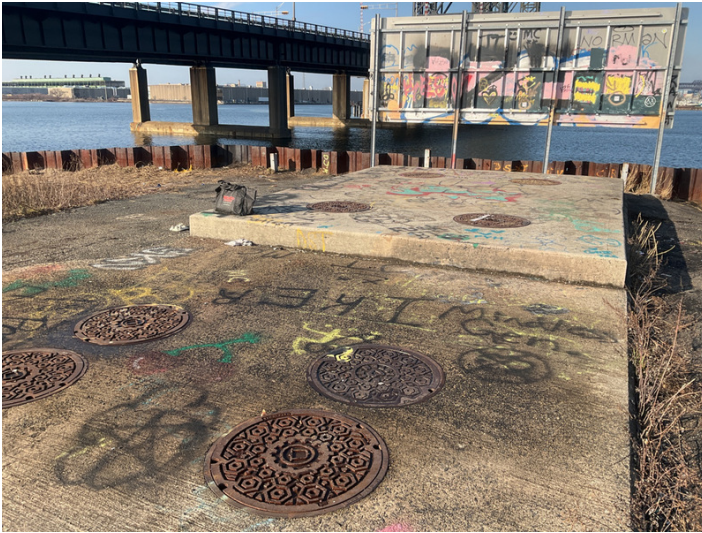
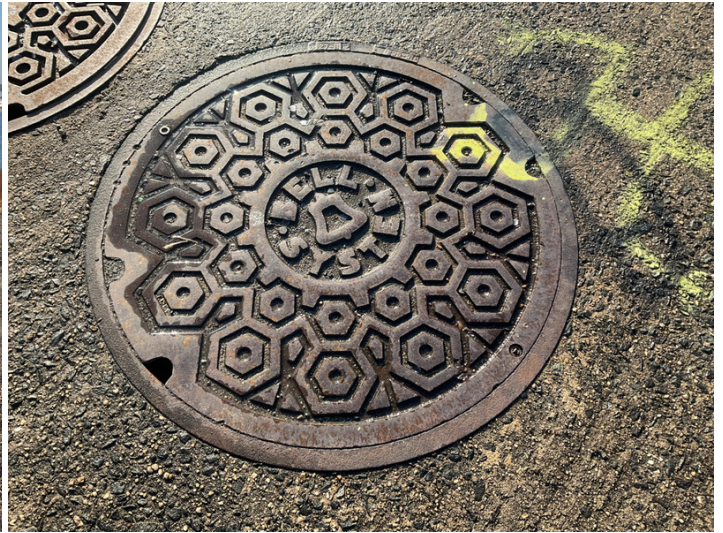
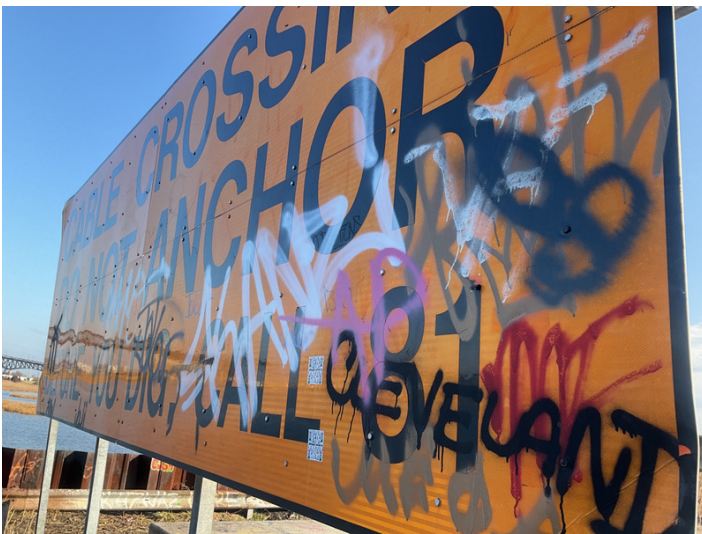
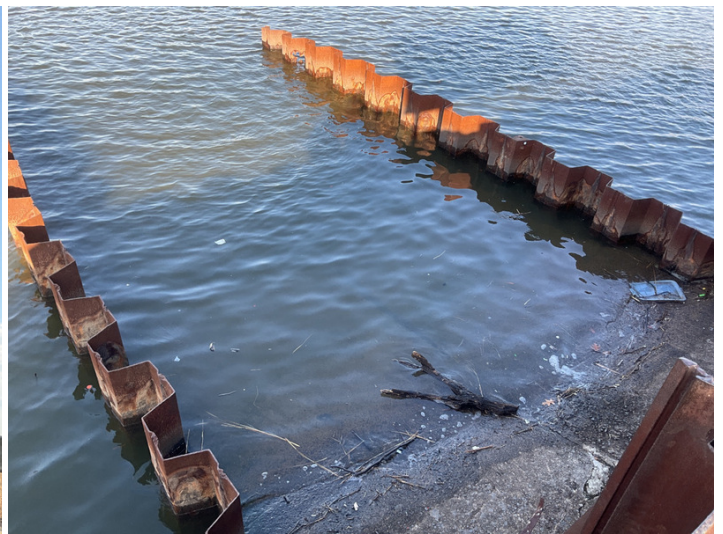
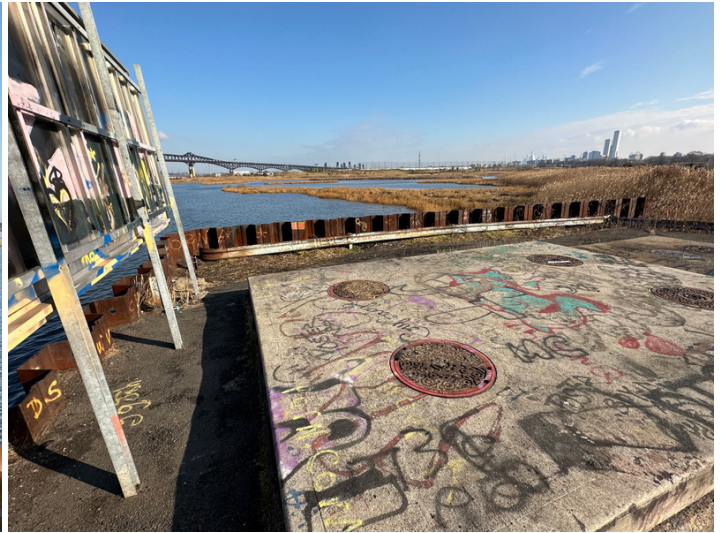
## Site Locations - 2. Hackensack, 2

Way Point Prefix	Hackensack
Way Point Number	2
Time at Way Point	09:58
Way Point Description	Manhole, Sign
Are there visible signs indicating a cable crossing?	Yes
Identify what the signs say.	Cable Crossing. Do Not Anchor. Call Before You Dig.
Are there buried or visible cable(s) at location?	Yes
How many cables are visible?	Buried Cables at this location.
Is lead visible?	No
Was there a general sample collected?	No

Signs on both sides of the river. Bell Systems Manhole x8. Lincoln Park Wetlands & Nature Trail. Public access next to wetlands. Large vault and corridor at this location that would contain numerous cables. Recommend further investigation.

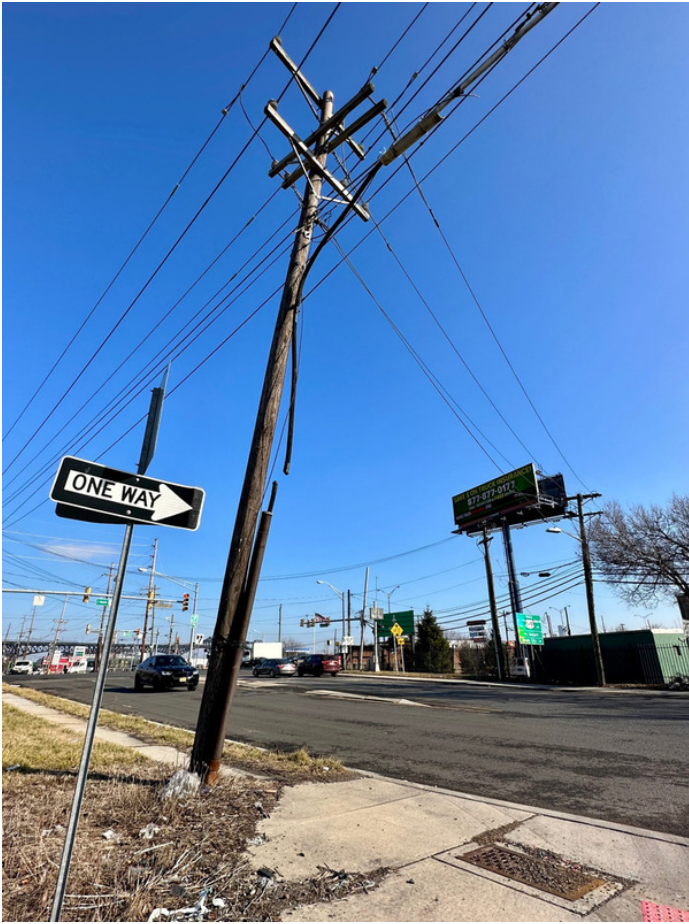
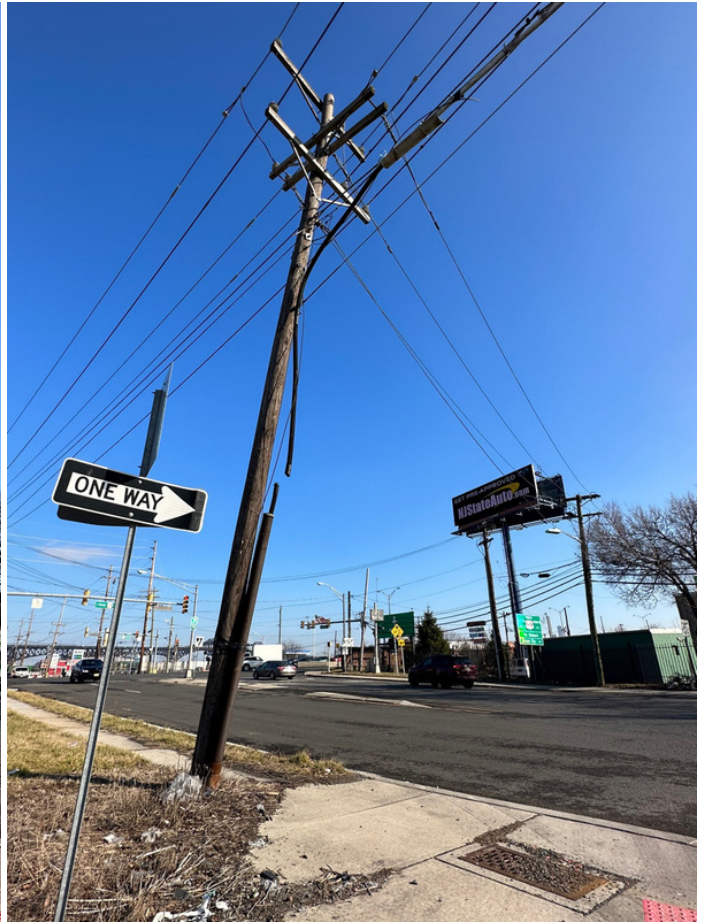
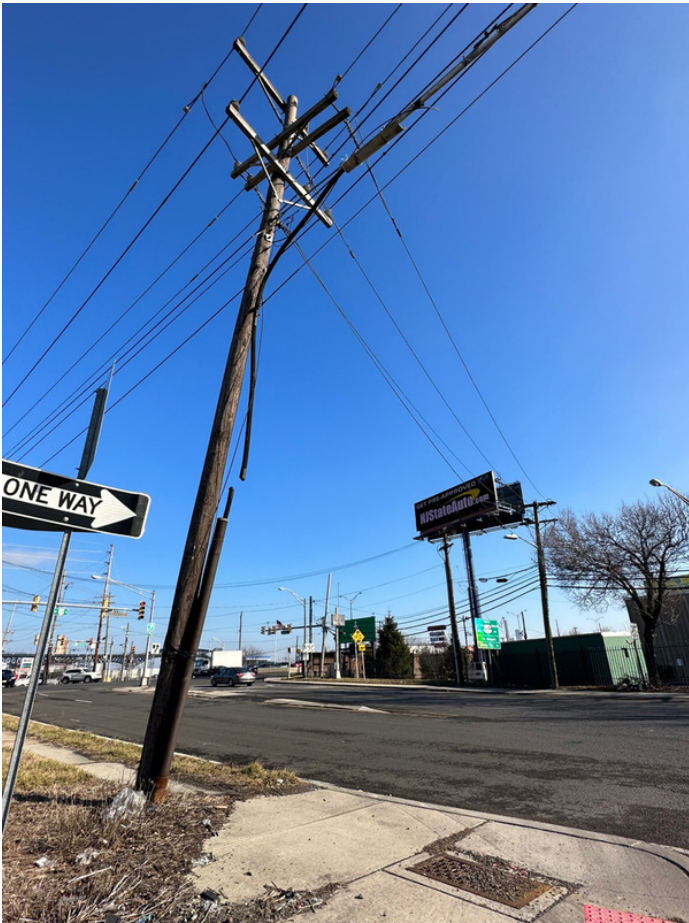
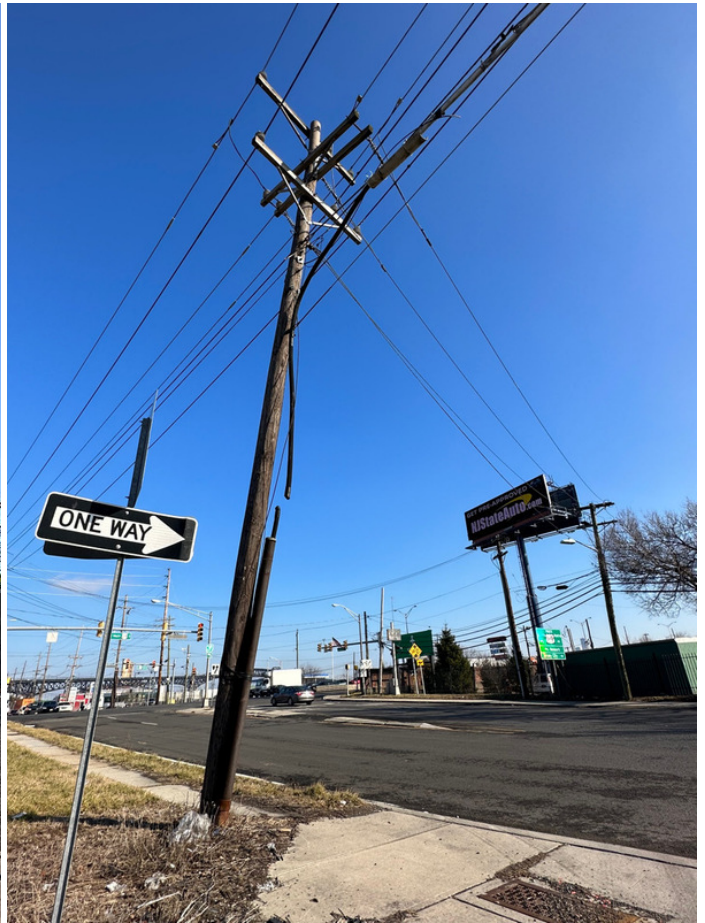
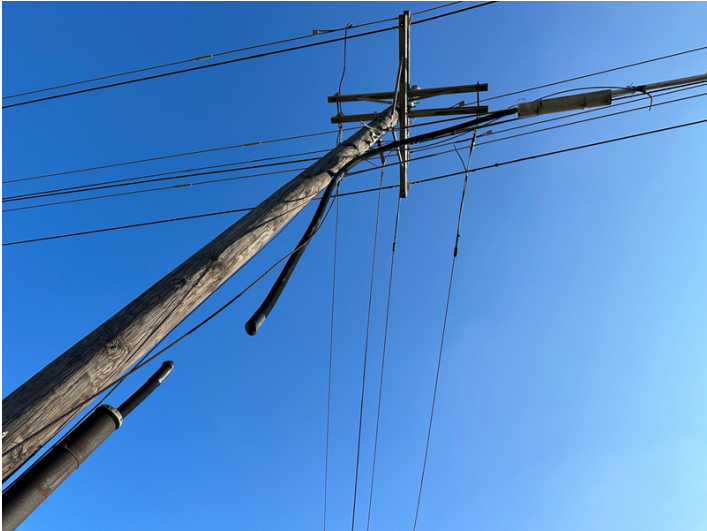
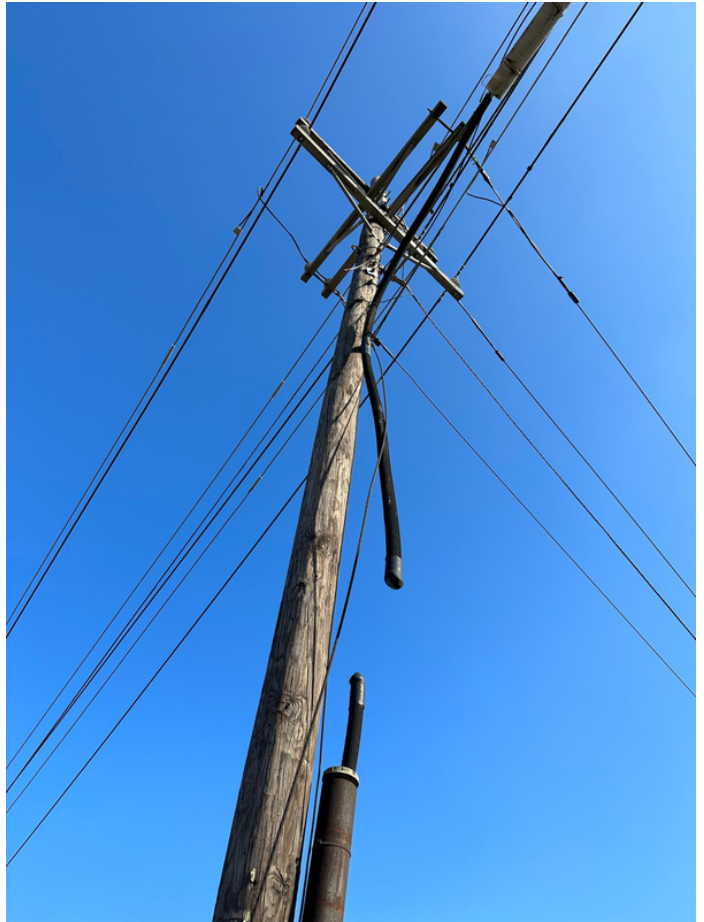
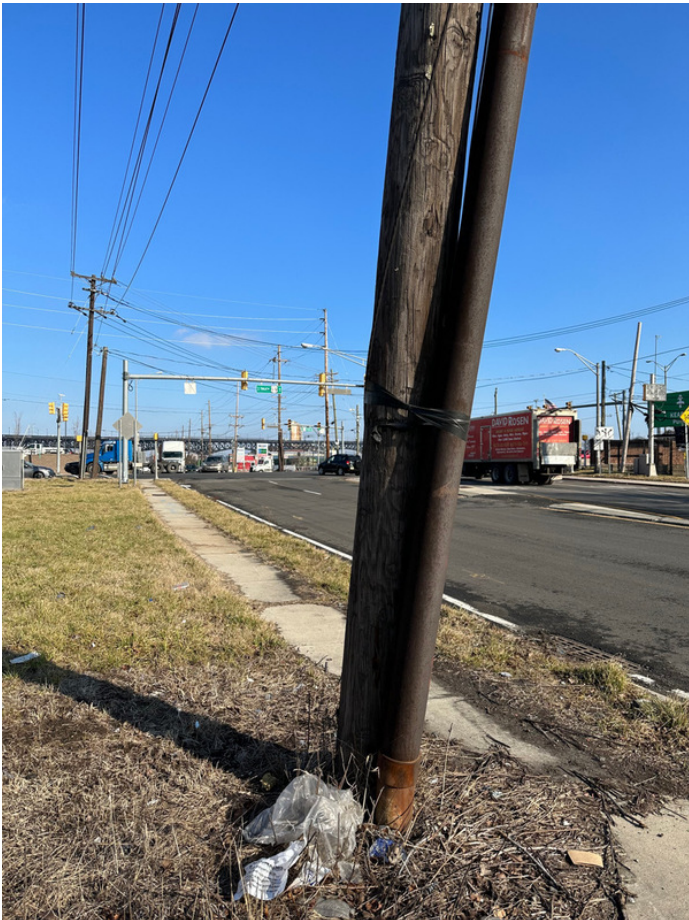
### Site Locations - 4. South Kearny, End B

Way Point Prefix	South Kearny
Way Point Number	End B
Time at Way Point	10:45
Way Point Description	Overhead, Exposed Leaded Telecom Cable
Are there visible signs indicating a cable crossing?	No
Are there buried or visible cable(s) at location?	Yes
How many cables are visible?	2
Is lead visible?	Yes
Was there a general sample collected?	No

Approximately .4 miles of exposed leaded cable (2 cables, 2" diameter). Both ends are cut and shrink wrapped. End B.

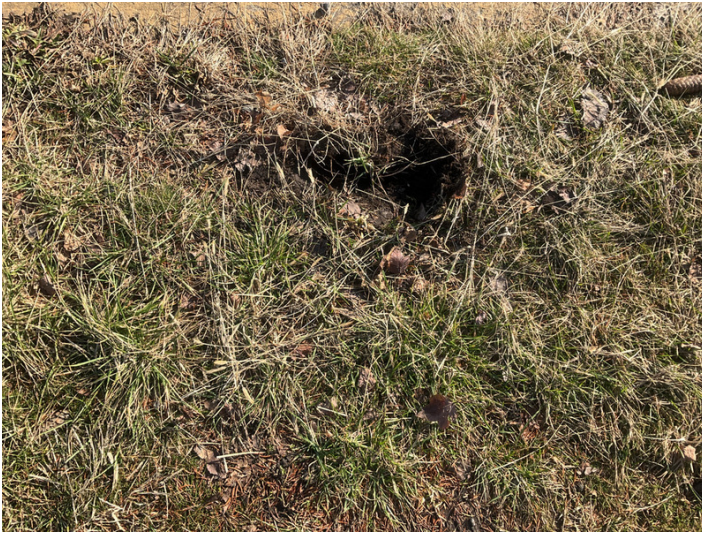
Type of Sample for GS	Sediment Collection
Location of Collected Sample - GS	Underneath Overhead Cable
Time of Collection - GS	11:04
Sample Prefix - GS	South Kearny
Sample ID (#) - GS	1
Additional Notes - GS (if any)	None.
Photo of GS Sample(s)

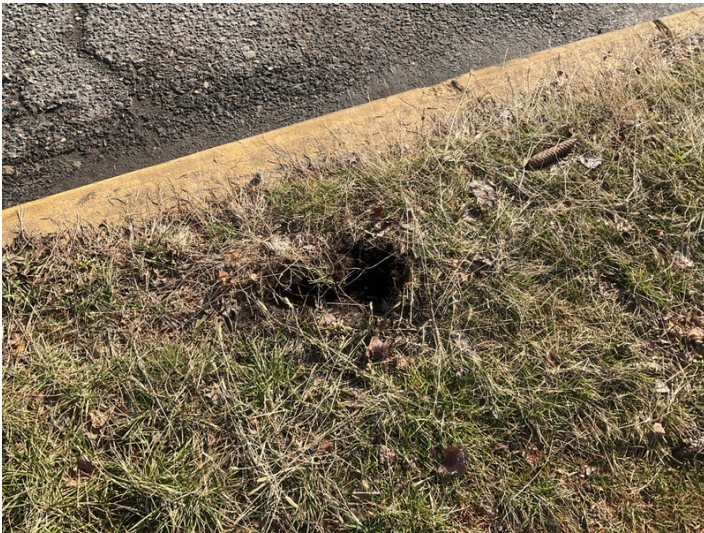
Visible overhead, exposed leaded cable between South Kearny End A and South Kearny End B.

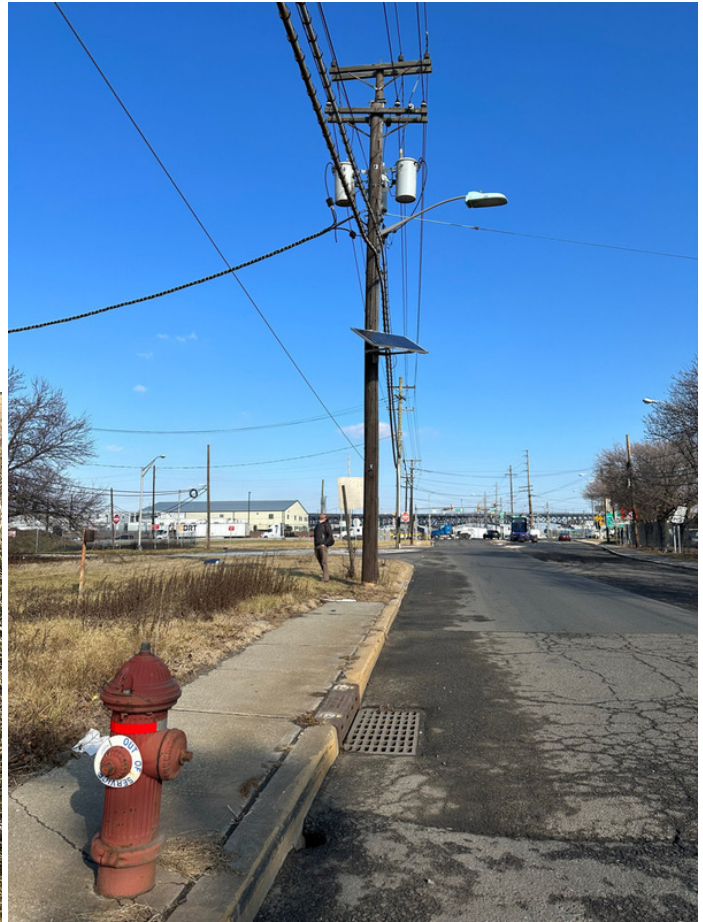
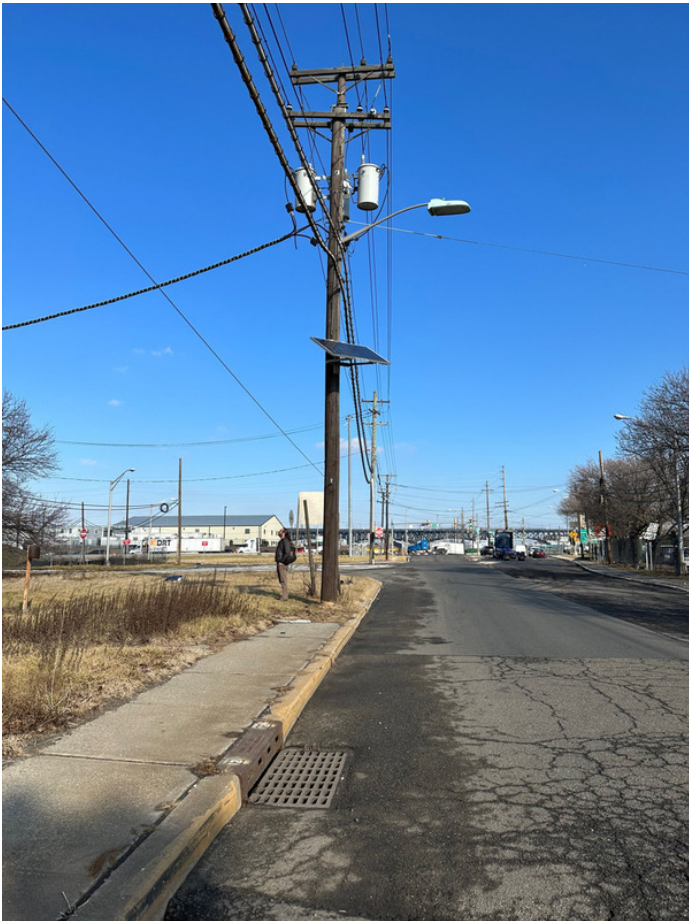
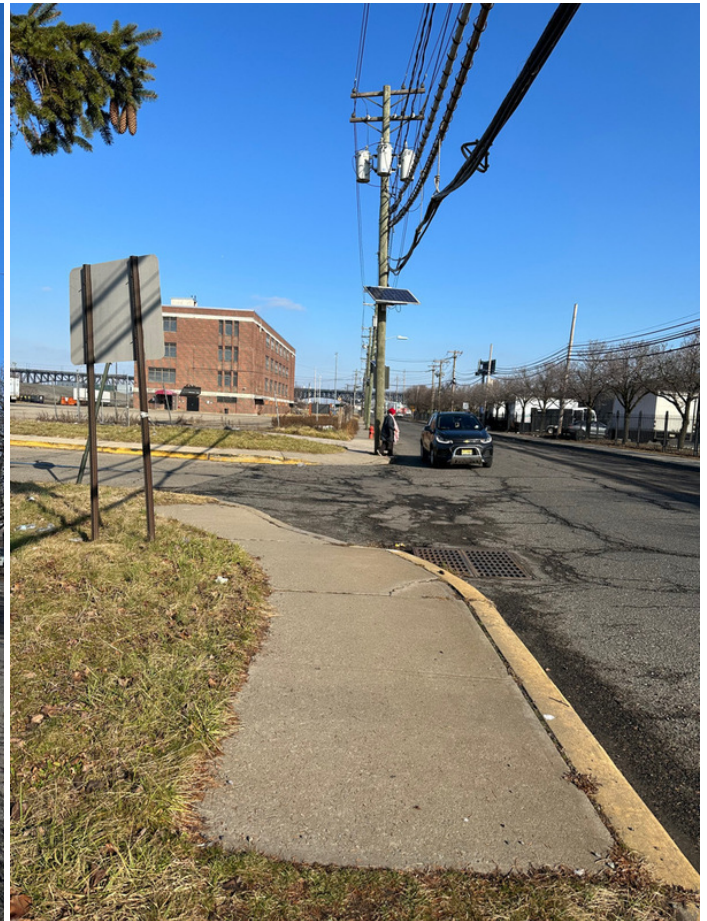
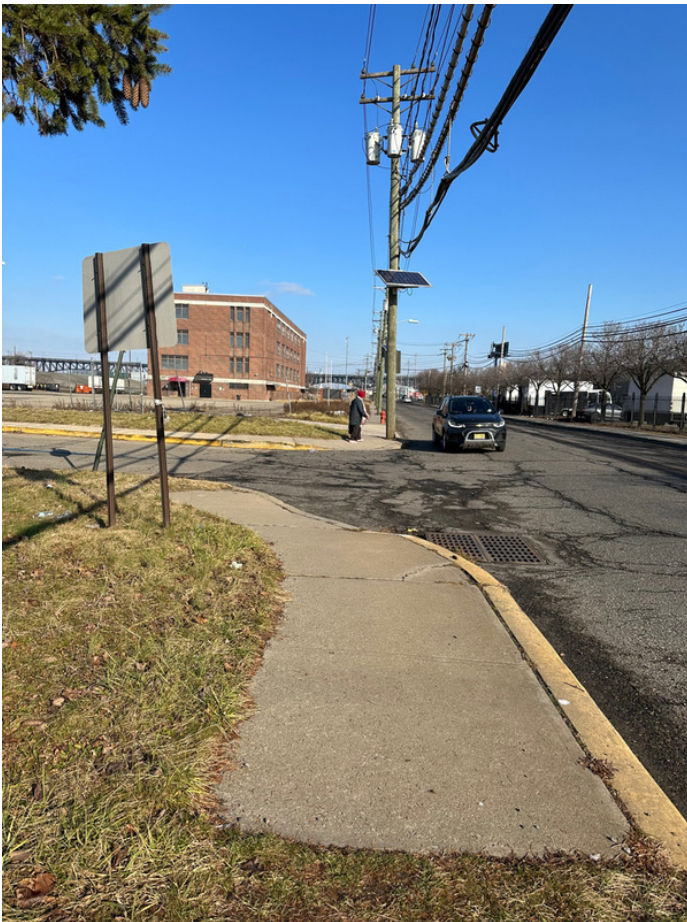
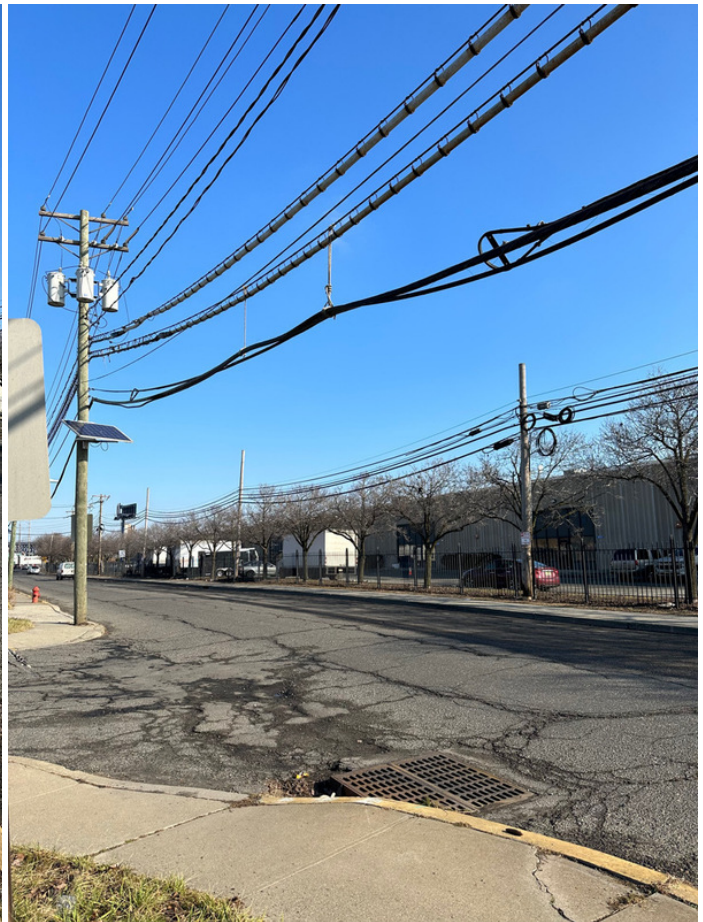
## Site Locations - 5. South Kearny, 1

Way Point Prefix	South Kearny
Way Point Number	1
Time at Way Point	11:03
Way Point Description	Overhead, Exposed Leaded Telecom Cable
Are there visible signs indicating a cable crossing?	No
Are there buried or visible cable(s) at location?	Yes
How many cables are visible?	2
Is lead visible?	Yes
Was there a general sample collected?	Yes

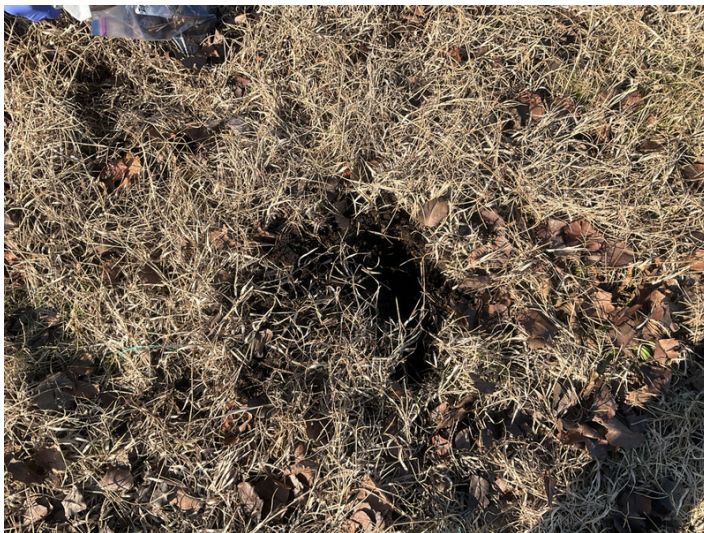
Type of Sample for GS	Sediment Collection
Location of Collected Sample - GS	Underneath Overhead Cable
Time of Collection - GS	11:10
Sample Prefix - GS	South Kearny
Sample ID (#) - GS	2
Additional Notes - GS (if any)	None.

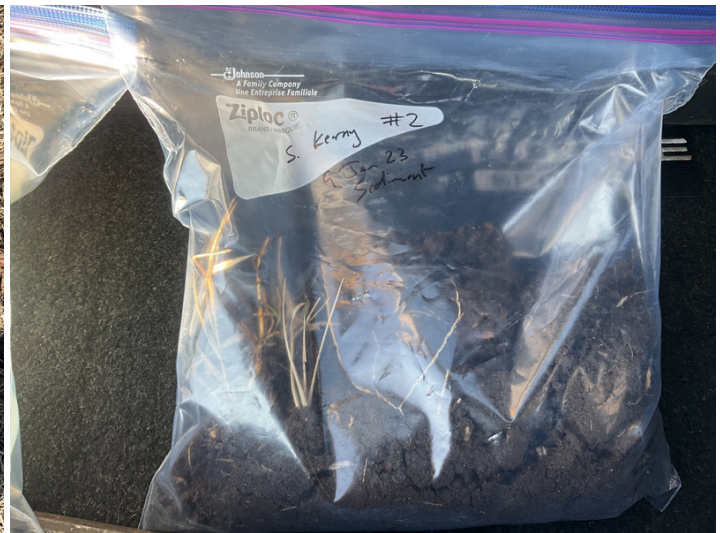
#### General Sample (GS) Information - 1. Sediment Collection, 2

General Site Notes	Visible overhead, exposed leaded cable between South Kearny End A and South Kearny End B.
--------------------	---

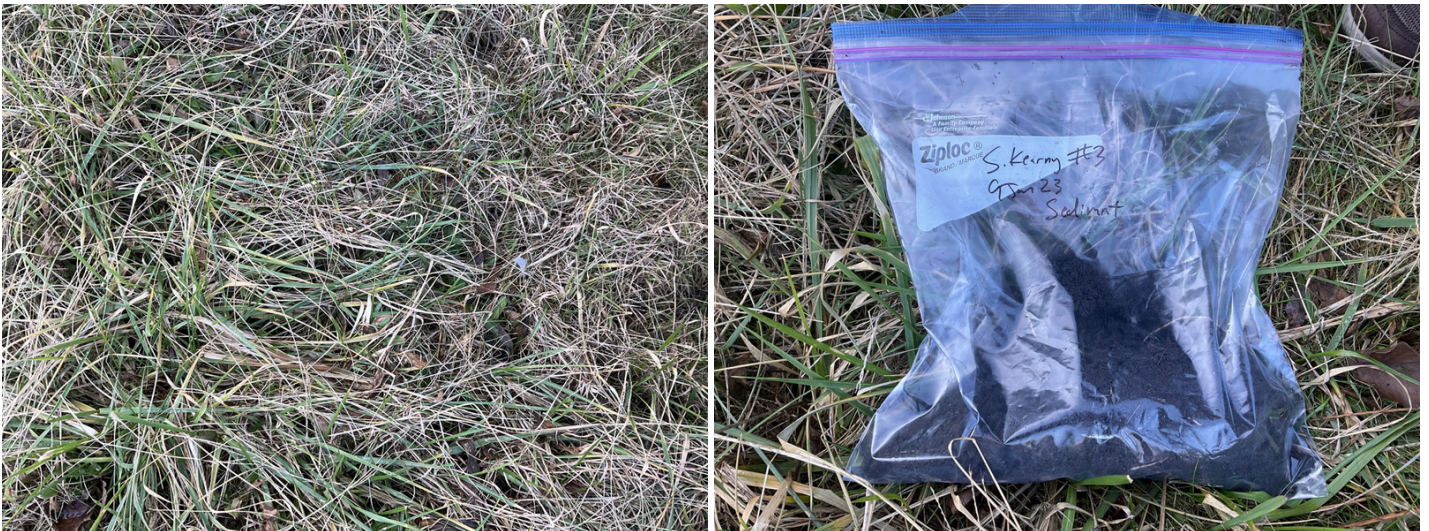
#### General Sample (GS) Information - 1. Sediment Collection, 3 Control

Type of Sample for GS	Sediment Collection
Location of Collected Sample - GS	Control Sample collected away from cable area.
Time of Collection - GS	11:18
Sample Prefix - GS	South Kearny
Sample ID (#) - GS	3 Control
Additional Notes - GS (if any)	None.

Control Site away from the .4 mile overhead, leaded telecom cable that runs between South Kearny End A and South Kearny End B.

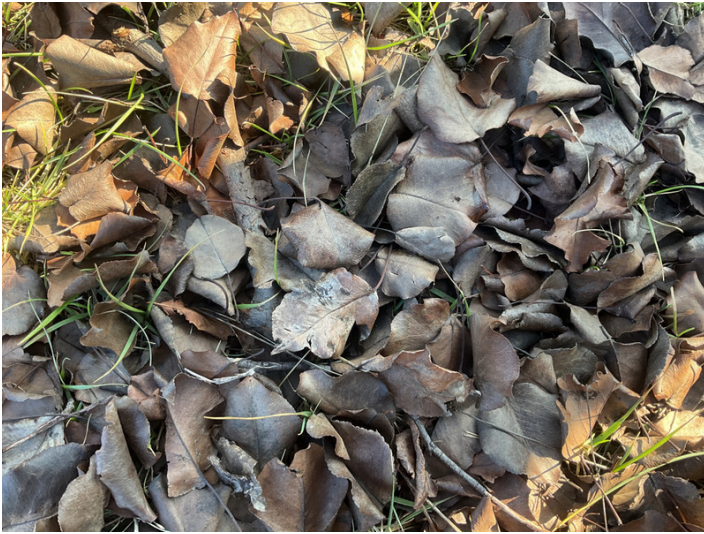
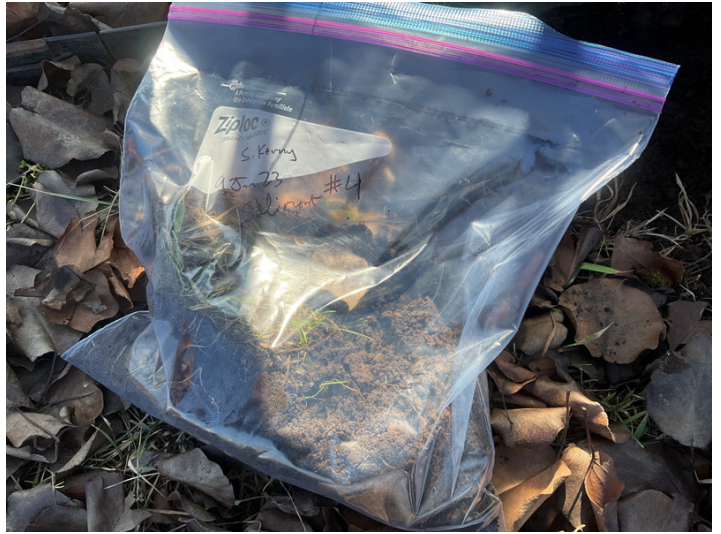
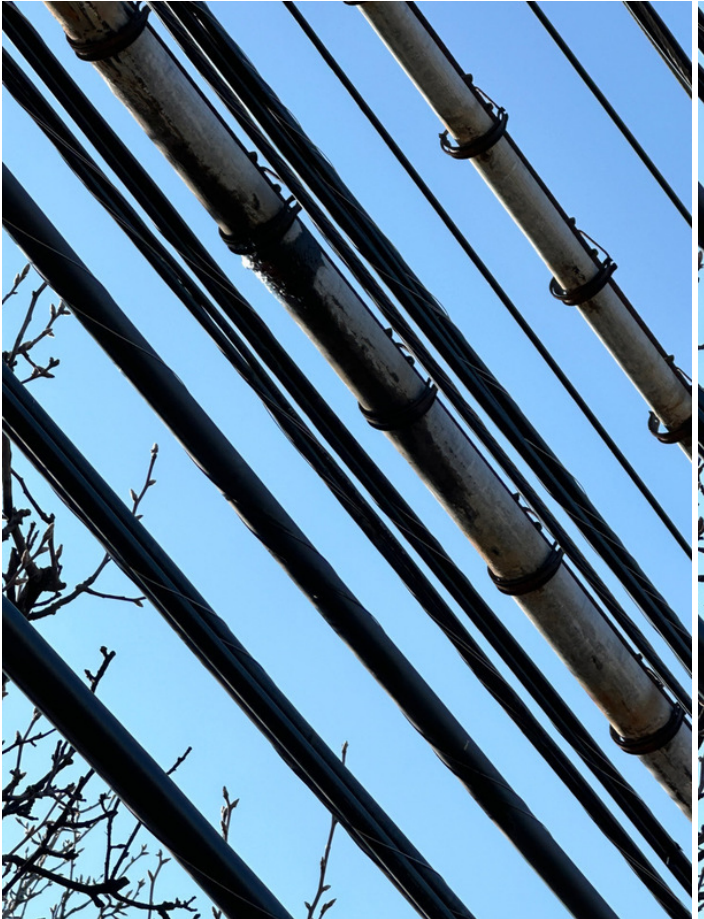
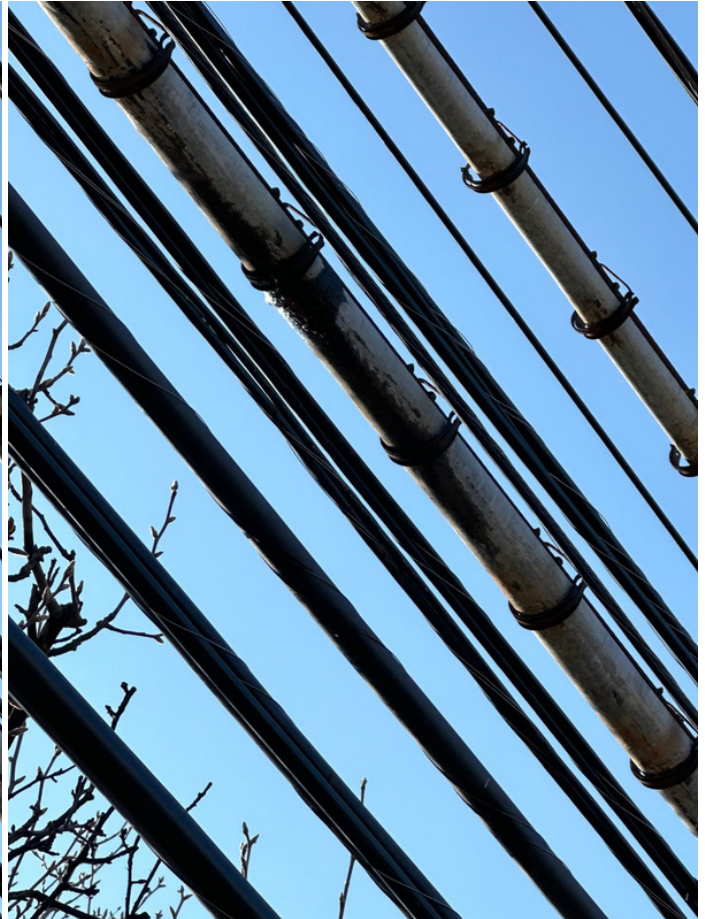
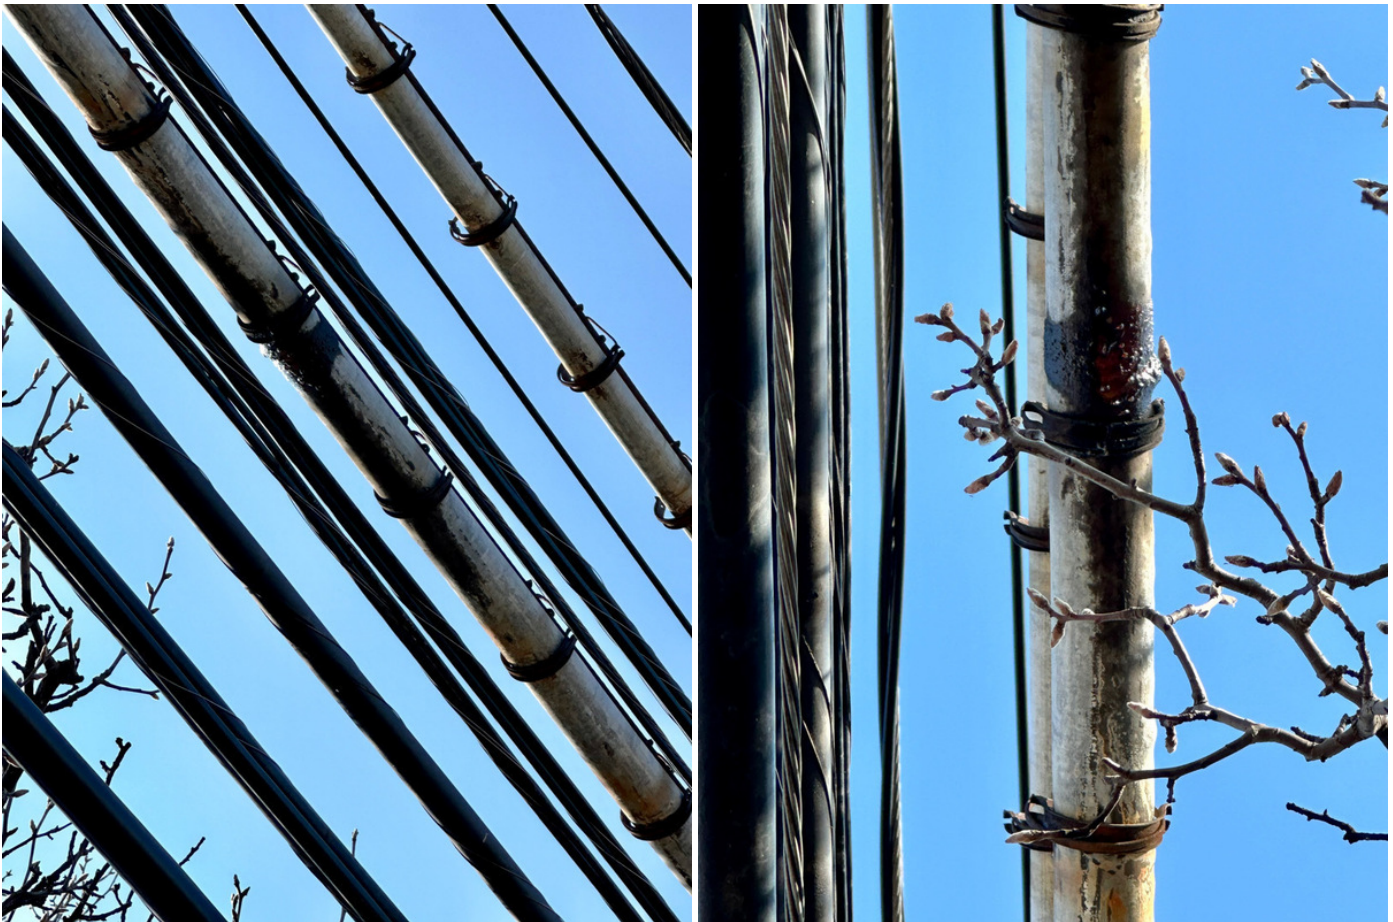
**General Sample (GS) Information (1 Item)****General Sample (GS) Information - 1. Sediment Collection, 4**

Type of Sample for GS	Sediment Collection
Location of Collected Sample - GS	Underneath Overhead Cable
Time of Collection - GS	11:28
Sample Prefix - GS	South Kearny
Sample ID (#) - GS	4
Additional Notes - GS (if any)	Wet drip marks on cable.

Visible overhead, exposed leaded cable between South Kearny End A and South Kearny End B. See Photos under GSS Sample.

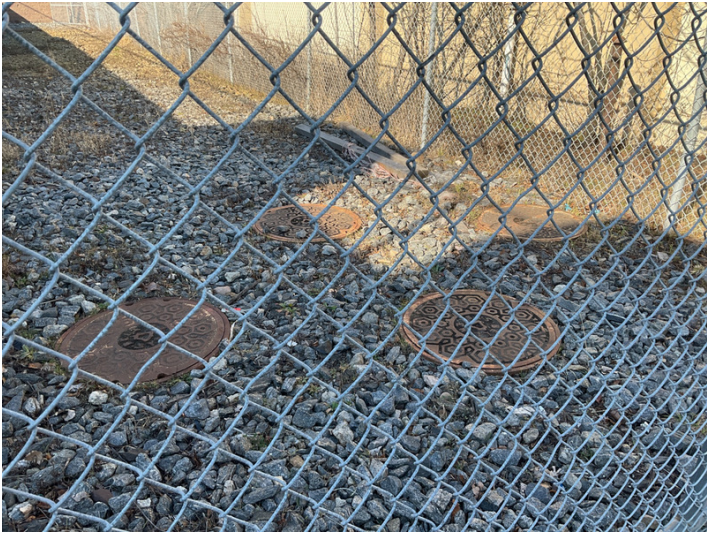
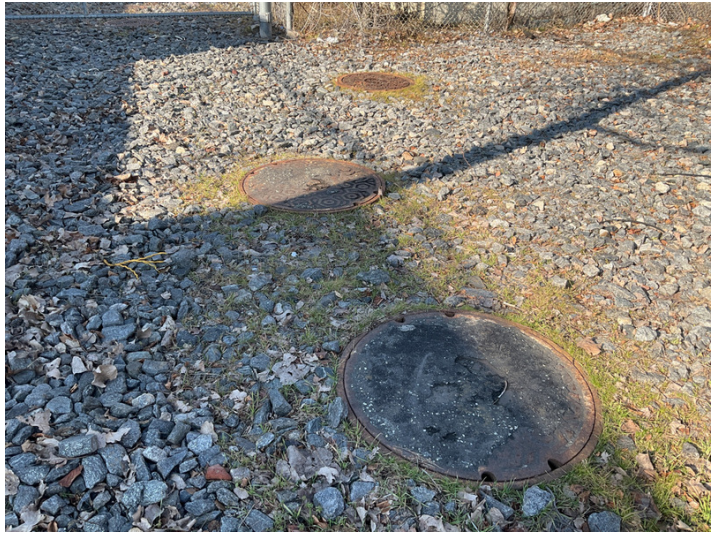
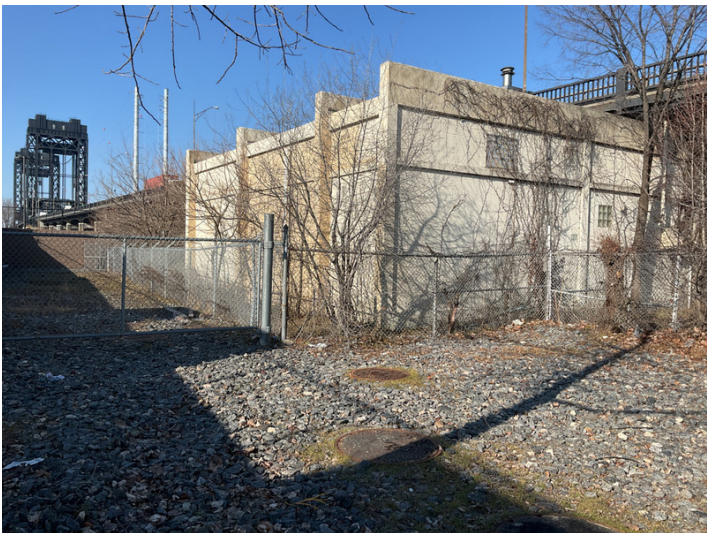
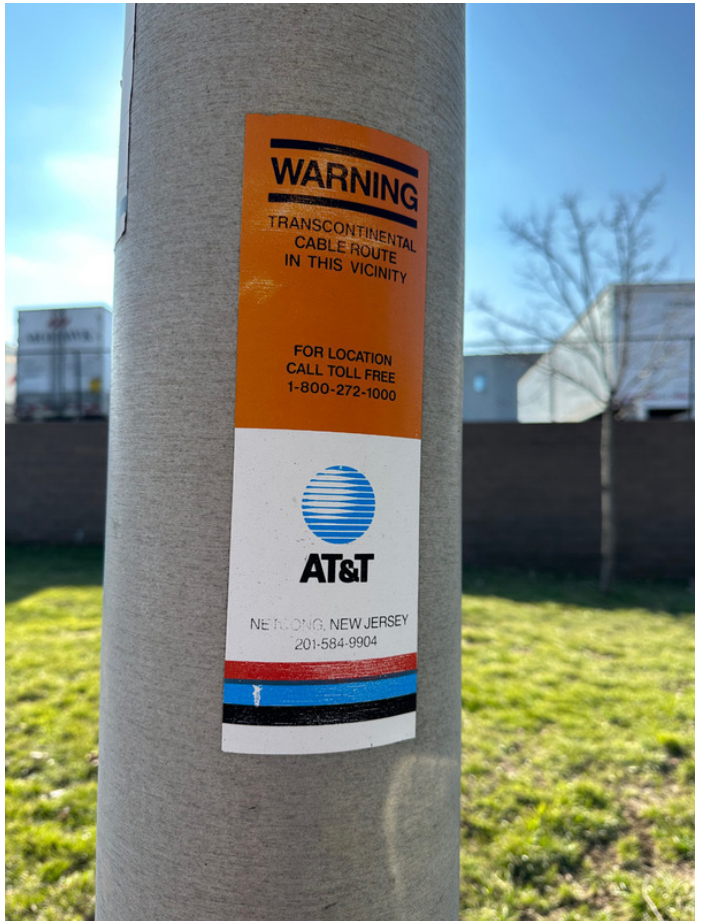
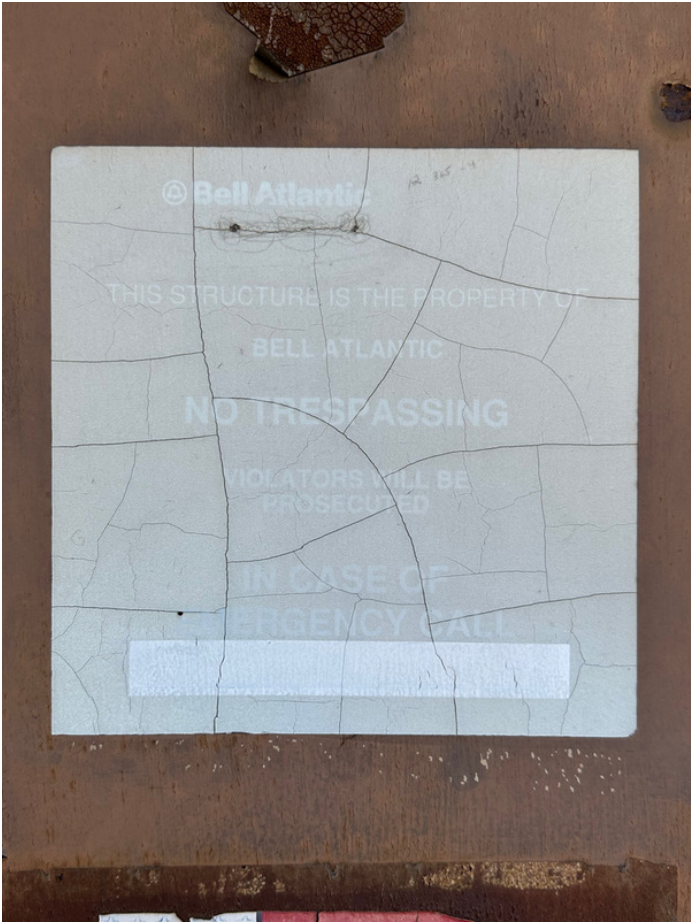
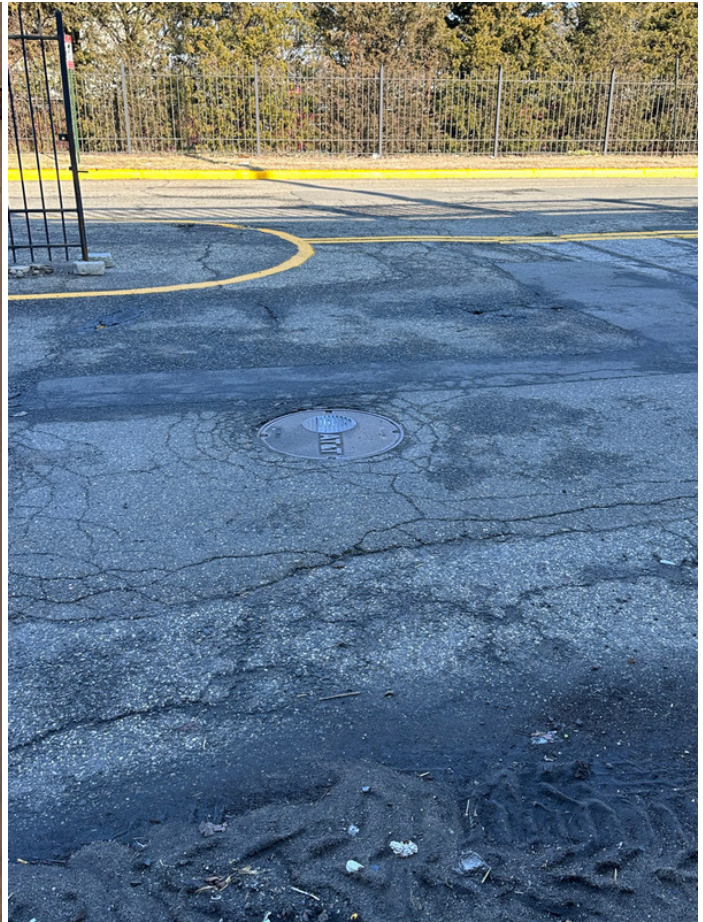
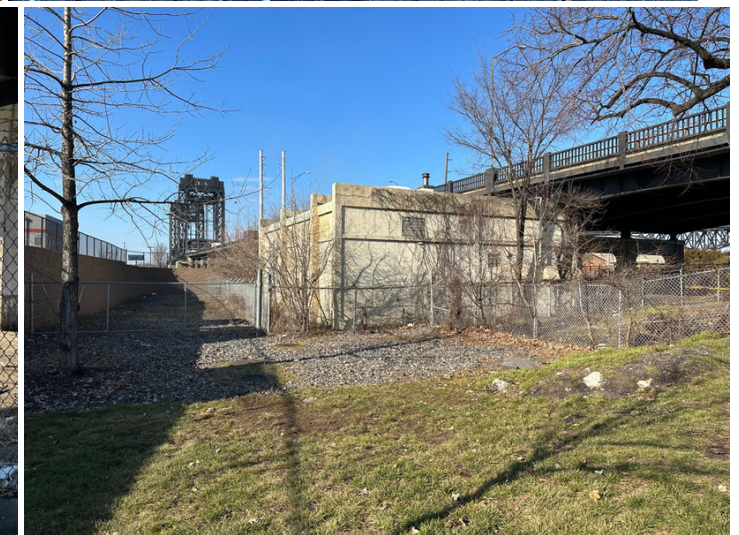
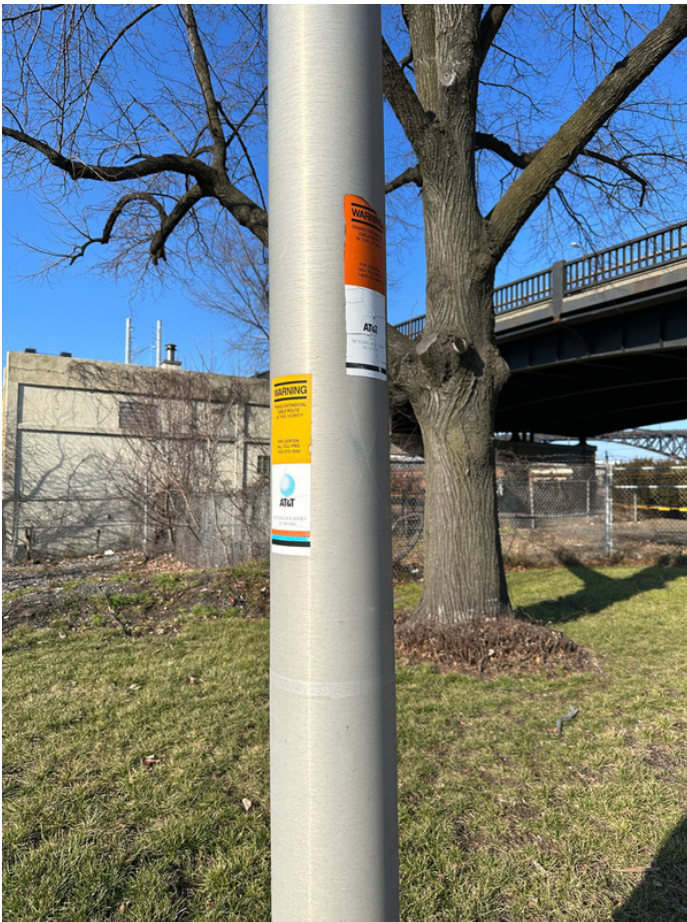
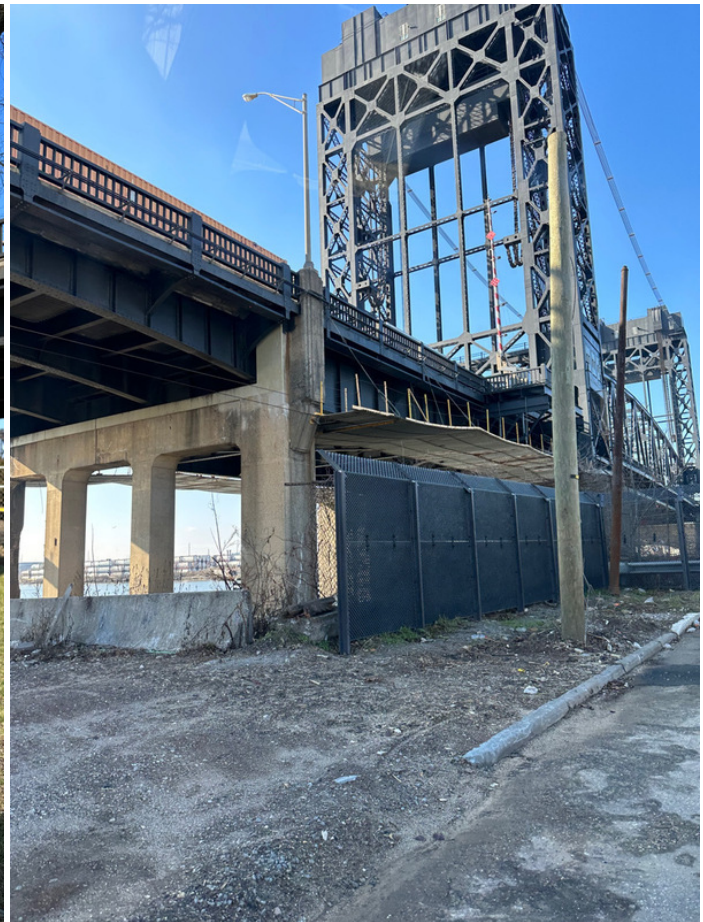
### Site Locations - 9. Passaic, 1

<b>Way Point Number</b>	1
<b>Time at Way Point</b>	11:54
<b>Way Point Description</b>	Manhole, Utility Building, ATT stickers on light post.
<b>Are there visible signs indicating a cable crossing?</b>	No
<b>Are there buried or visible cable(s) at location?</b>	Yes
<b>How many cables are visible?</b>	Buried Cable at this location.
<b>Is lead visible?</b>	No
<b>Was there a general sample collected?</b>	No

<b>General Site Notes</b>	Old Bell Utility Building. Bell Systems manholes, x7 (4 behind a chain link fence and 3 in the nearby grass area - all in close proximity to the building). New ATT Stickers on nearby light post. ATT Manhole x1 in the nearby street. This area is likely a hub or connection point for multiple cables.
---------------------------	--
