# New Jersey Data Collection - Final

Investigation of data points along the Hackensack River, Passaic River, and the South Kearny Neighborhood.

## January 9, 2023

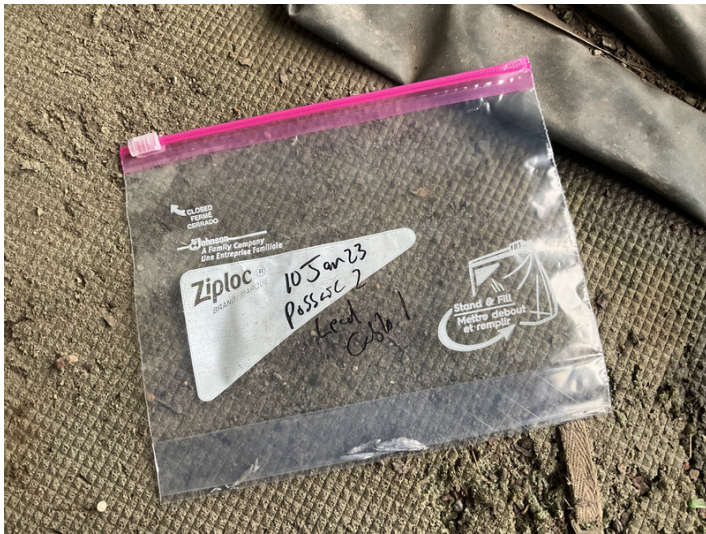
#### Sample Information - Specific Cable - 1. Lead Scraping, 2

Type of Sample	Lead Scraping
If more than one cable, what Cable was Sample collected from?	1
Time of Collection - Specific Cable	08:41
Sample Prefix - Specific Cable	Passaic
Sample ID (#) - Specific Cable	2
Additional Notes - Specific Cable Sample (if any)	No notes related to the field. The Sample was originally sent to the lab 12 January 2023. It was returned from the lab and resent 25 January 2023.

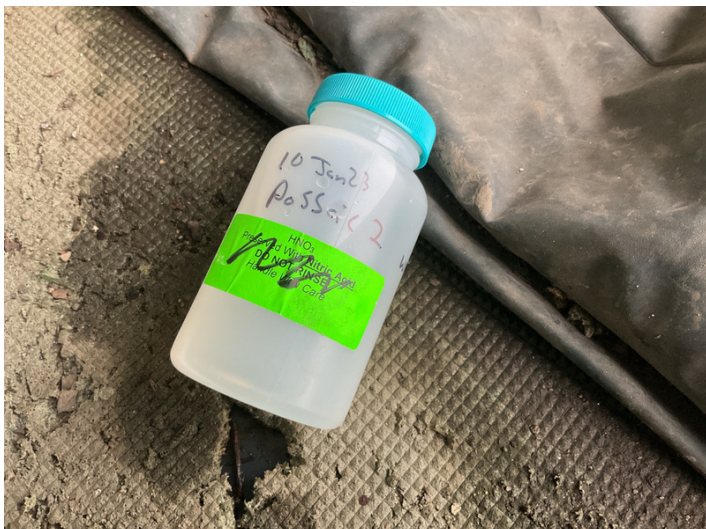
Type of Sample	Water: Directly on Cable
If more than one cable, what Cable was Sample collected from?	All
Time of Collection - Specific Cable	08:46
Sample Prefix - Specific Cable	Passaic
Sample ID (#) - Specific Cable	2
Additional Notes - Specific Cable Sample (if any)	Collected near high tide.

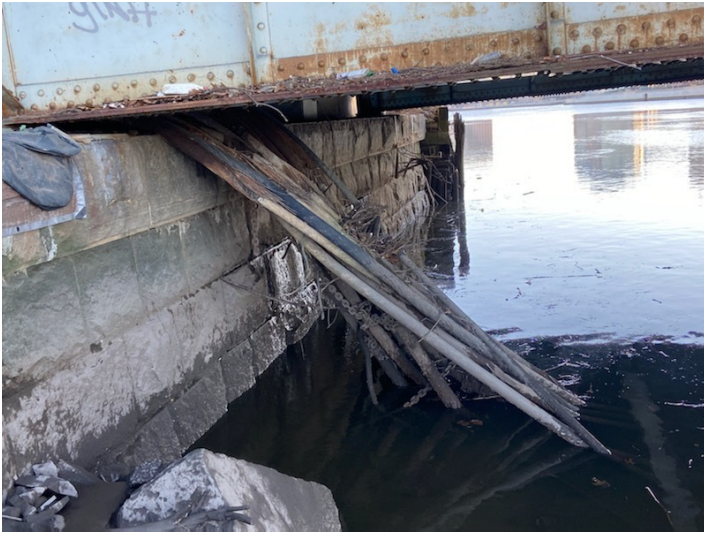
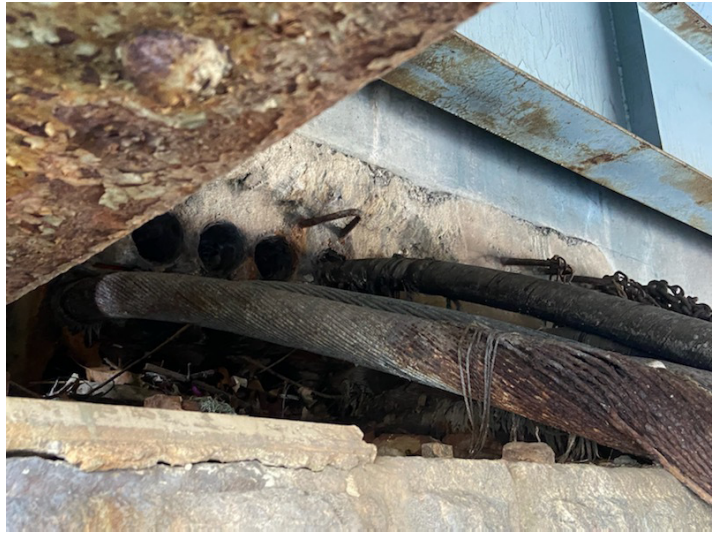
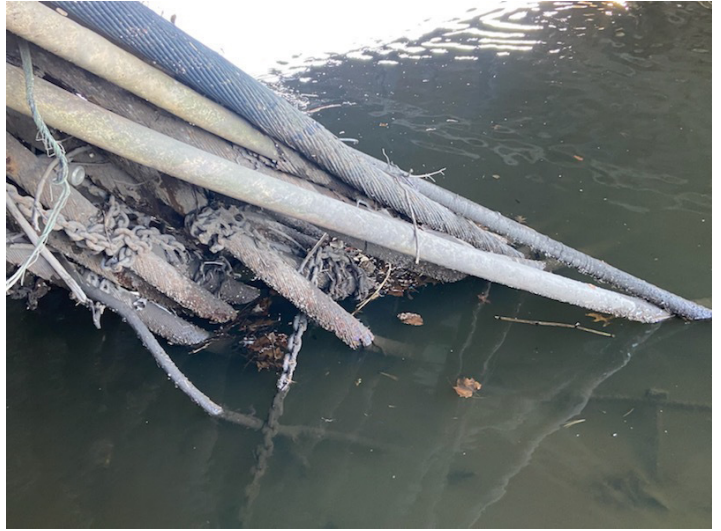
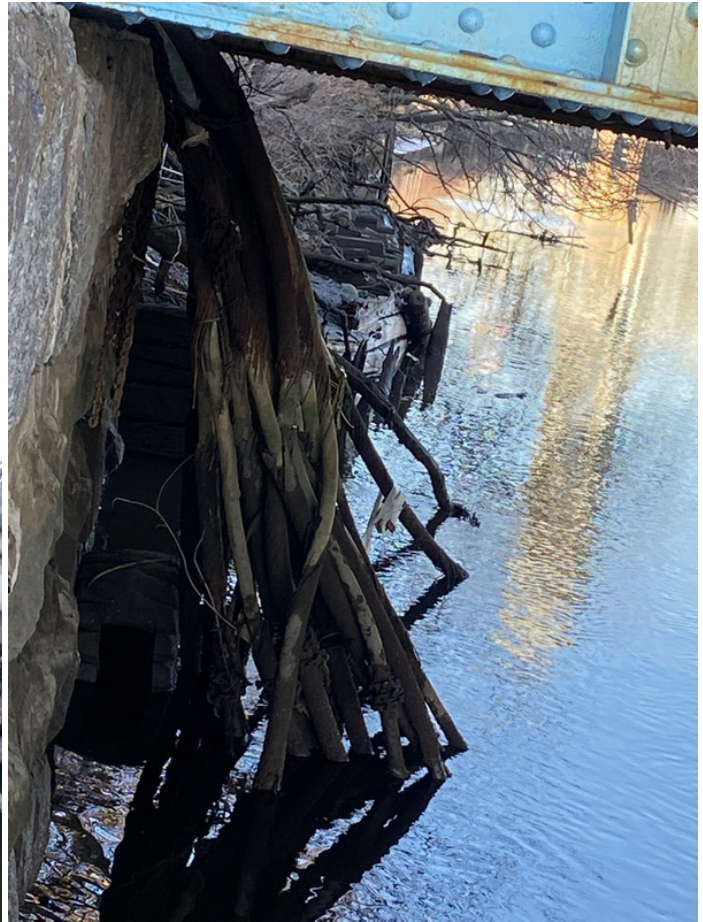
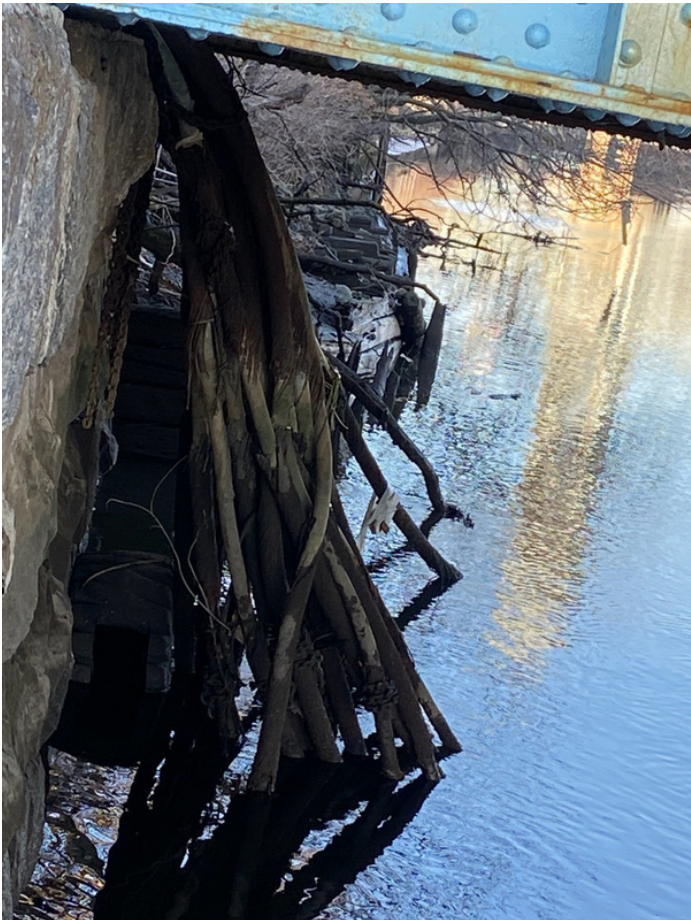
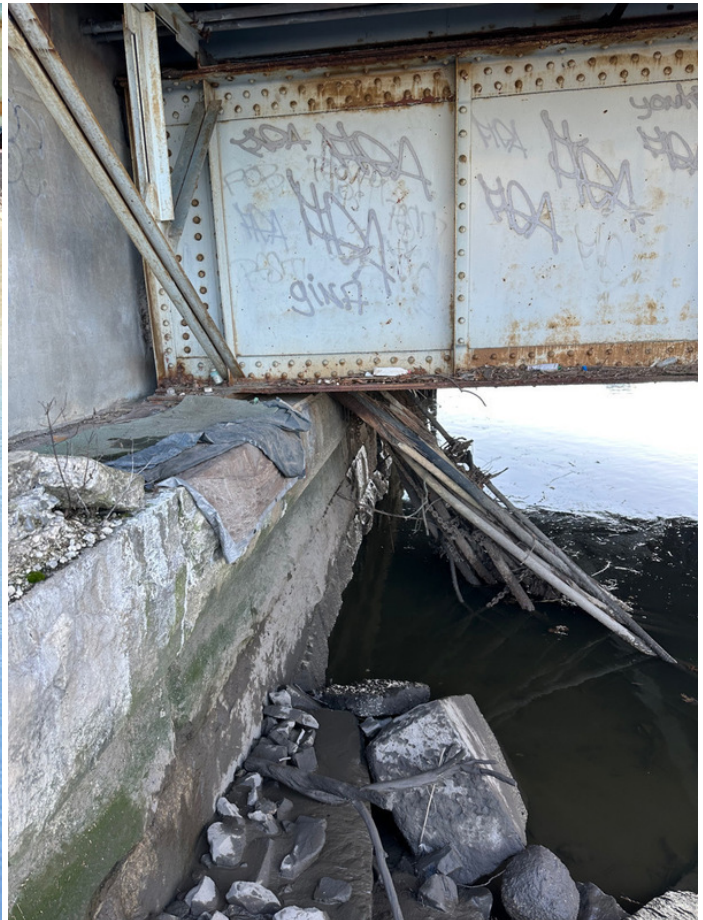
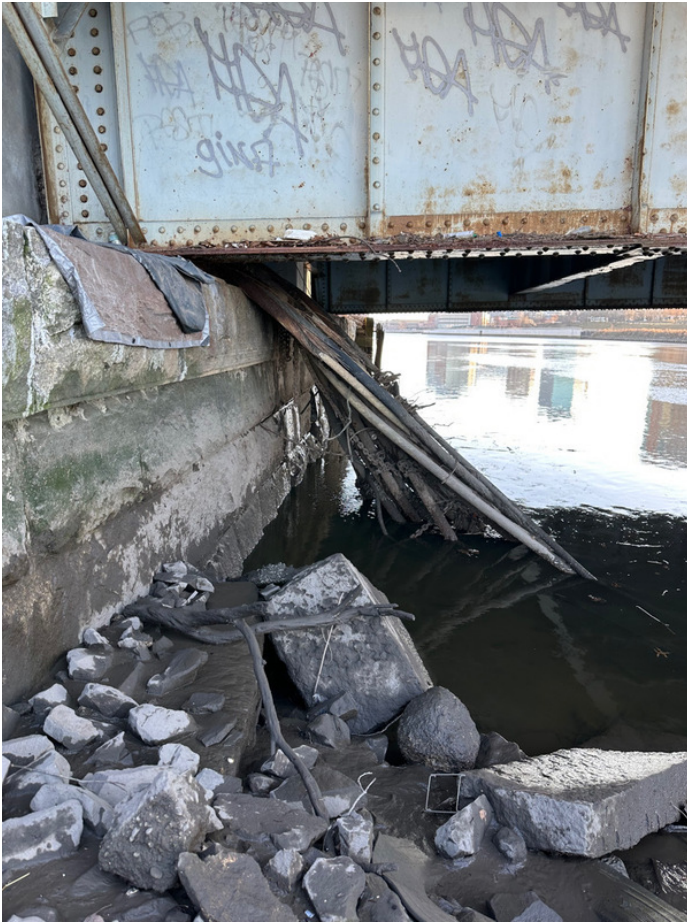
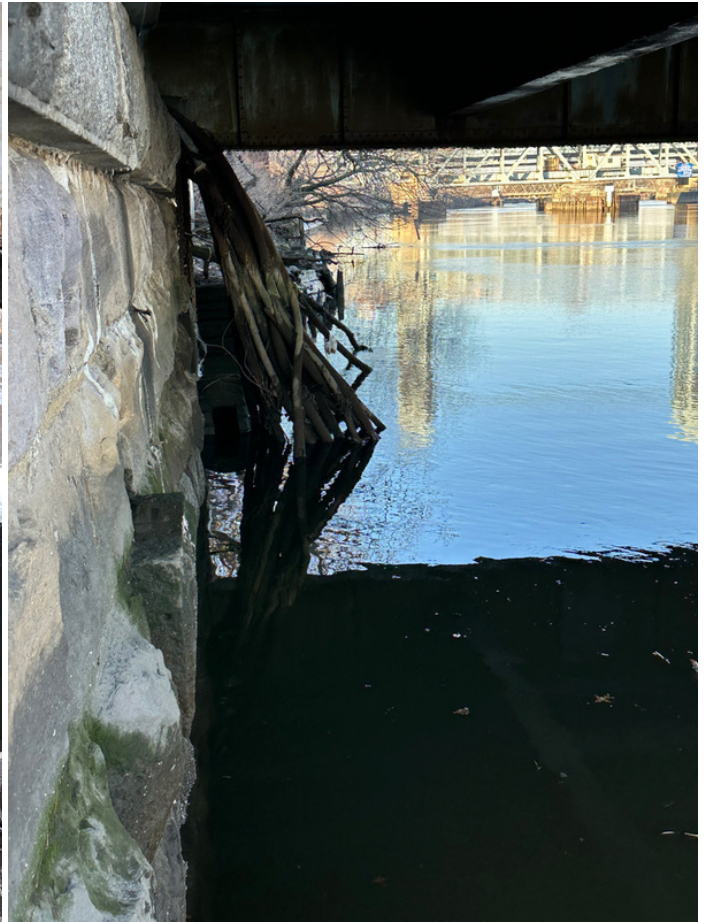
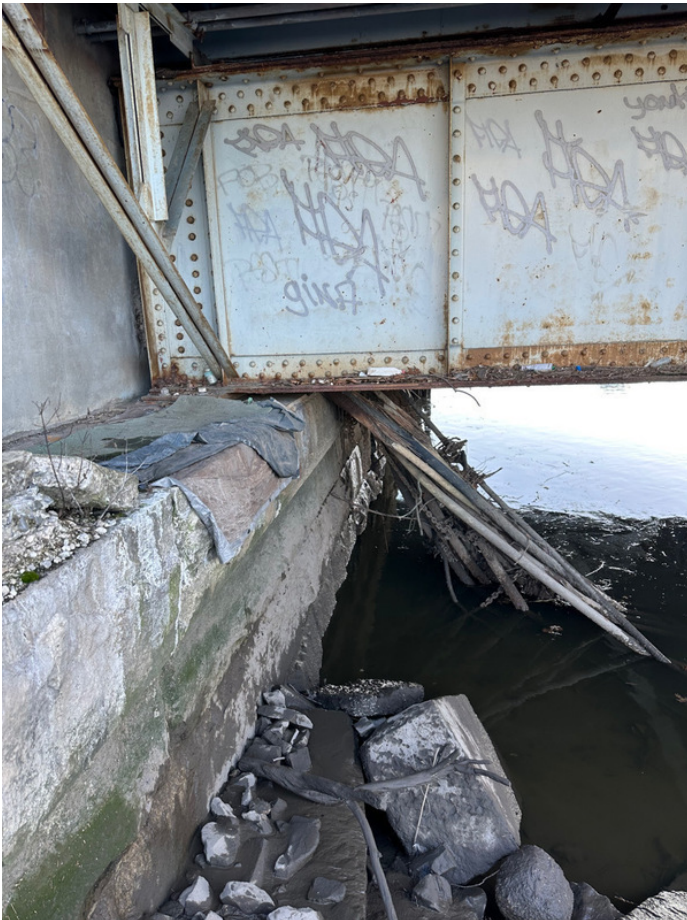
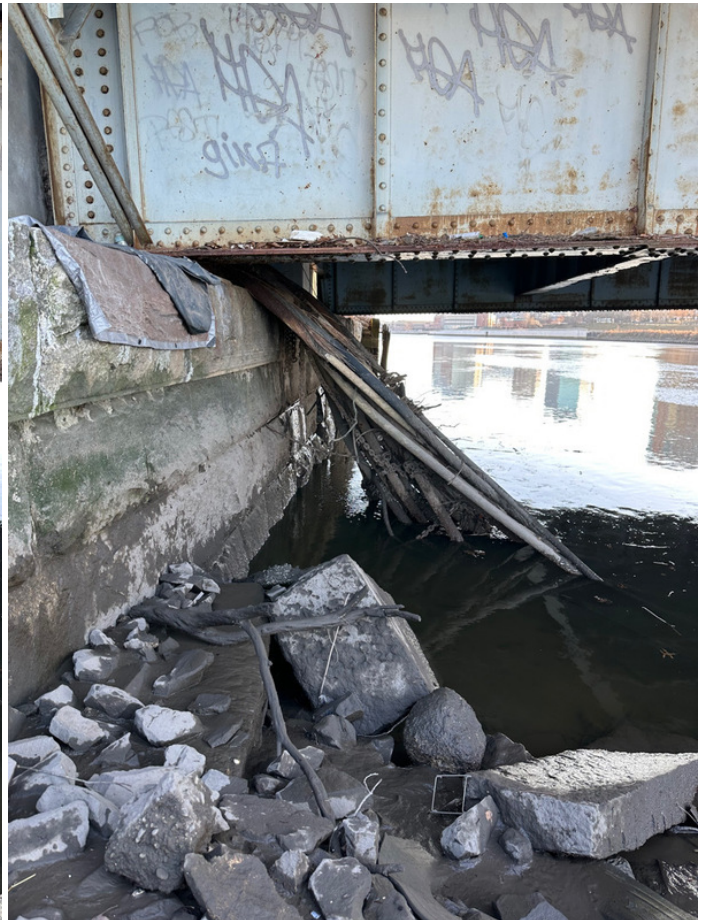
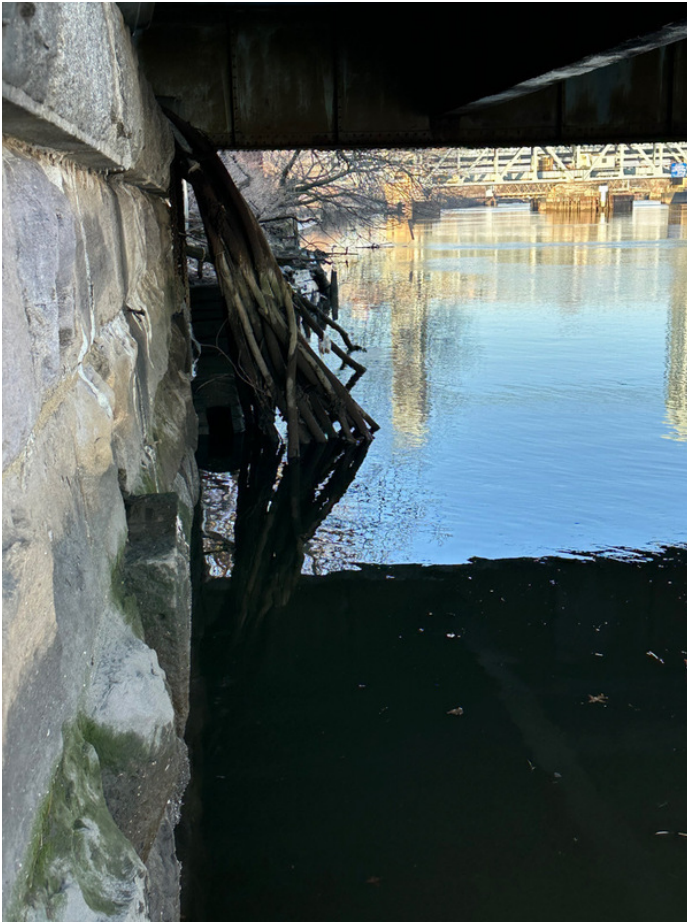
**Site Locations - 10. Passaic, 2**

Cable #	All
Visible Length (ft)	20
Type of Cable (Power, Telecom, Fiber Optic, Other)	Telecom
Is this a leaded cable?	Yes
Is the cable(s) Terrestrial, Submarine or Both?	Submarine
Was there a sample collected?	Yes
How many samples collected?	2

**General Site Notes** | There are approximately 20 cables underneath the bridge on both sides of the river.

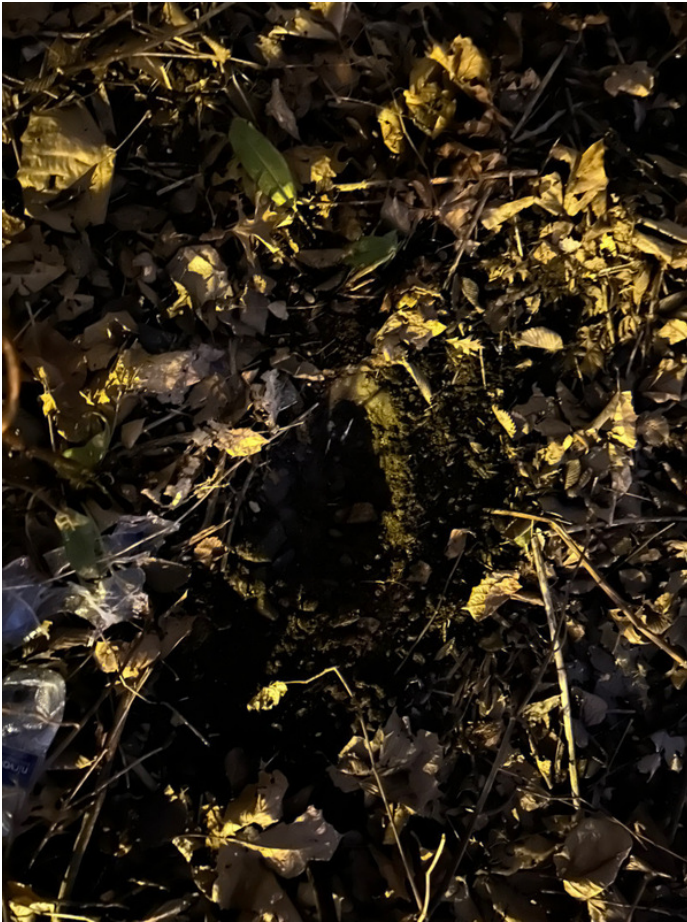
#### Sample Information - Specific Cable - 1. Sediment Collection, 3

<b>Type of Sample</b>	Sediment Collection
<b>If more than one cable, what Cable was Sample collected from?</b>	1
<b>Location of Collected Specific Cable Sample</b>	Near the Cable
<b>Time of Collection - Specific Cable</b>	17:24
<b>Sample Prefix - Specific Cable</b>	Passaic
<b>Sample ID (#) - Specific Cable</b>	3
<b>Additional Notes - Specific Cable Sample (if any)</b>	None.
<b>Photo of Specific Cable Sample(s)</b>

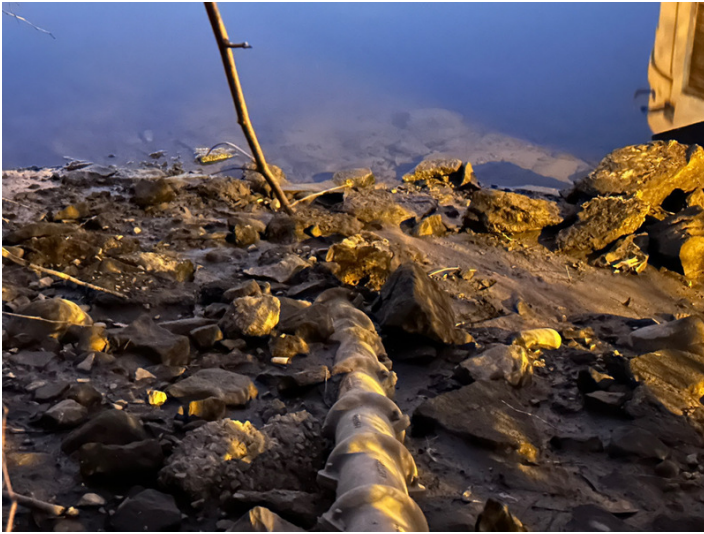
**Sample Information - Specific Cable - 2. Water: Directly on Cable, 3**

Type of Sample	Water: Directly on Cable
If more than one cable, what Cable was Sample collected from?	1
Time of Collection - Specific Cable	17:26
Sample Prefix - Specific Cable	Passaic
Sample ID (#) - Specific Cable	3
Additional Notes - Specific Cable Sample (if any)	None.

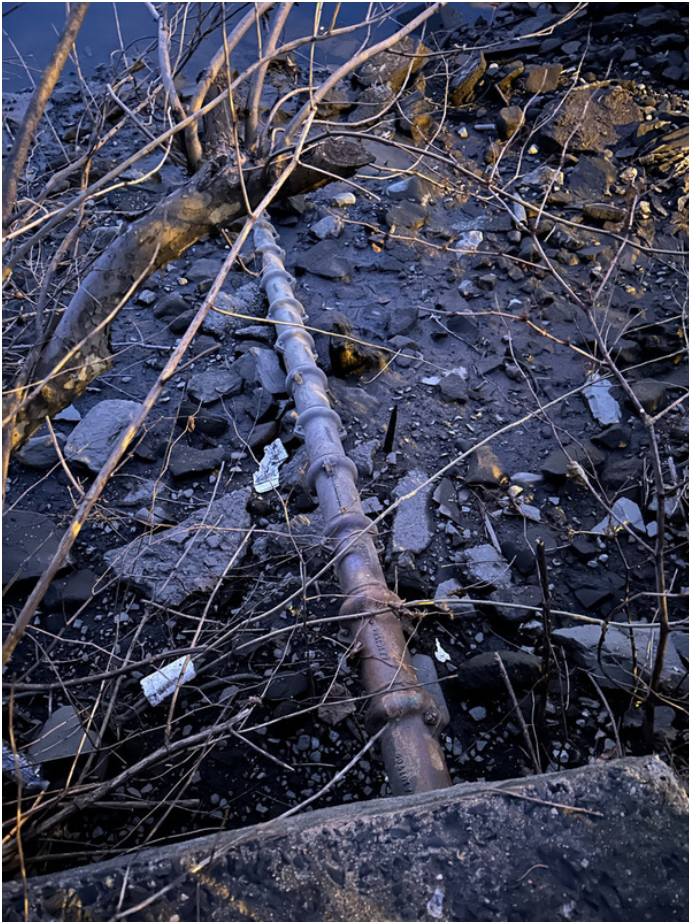
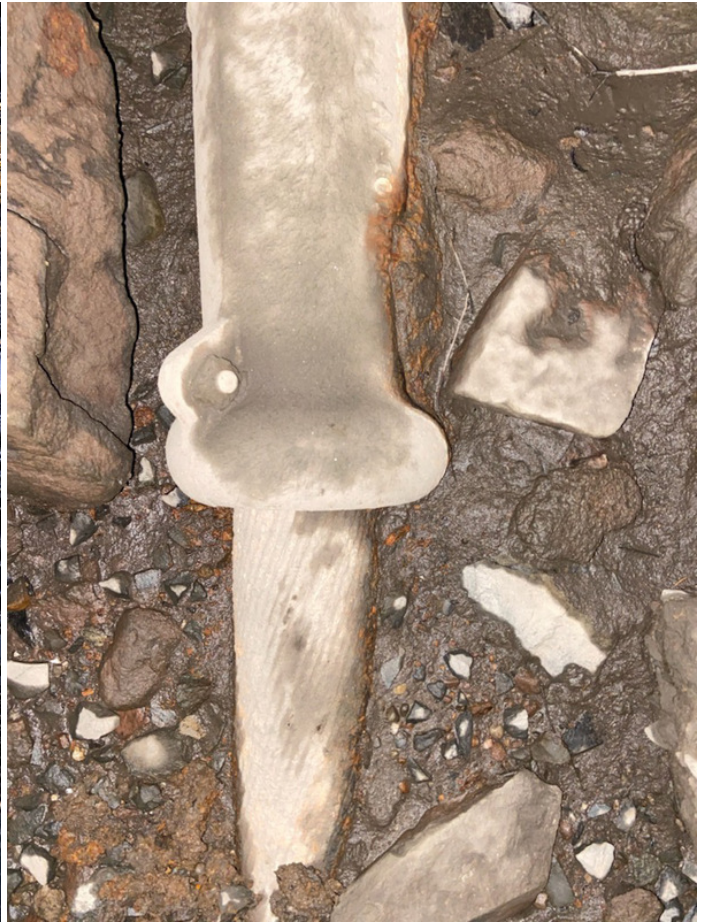
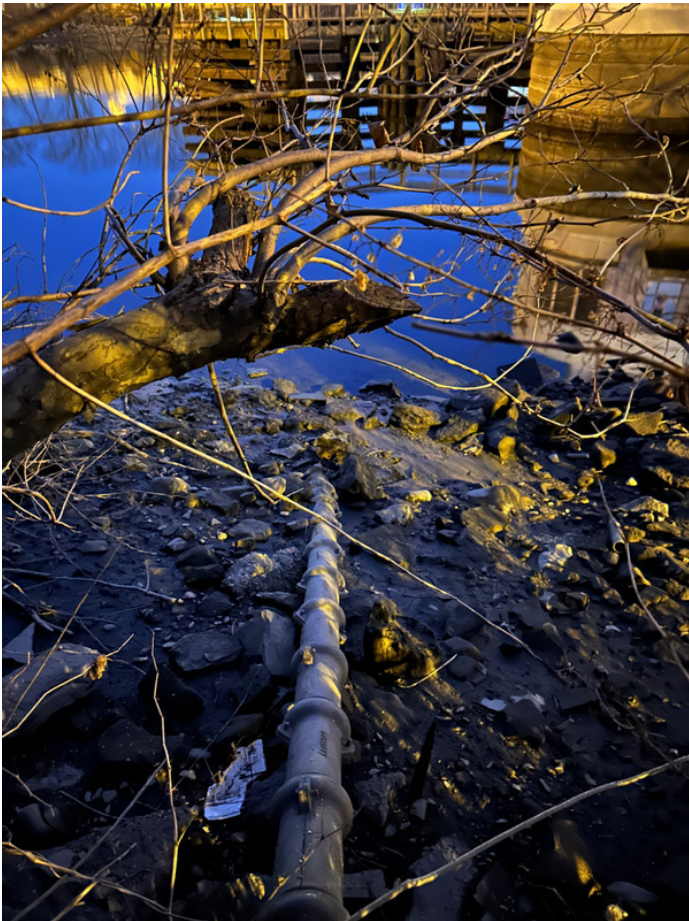
### Site Locations - 12. Passaic, 3

<b>Visible Length (ft)</b>	20
<b>Type of Cable (Power, Telecom, Fiber Optic, Other)</b>	Telecom, Armored
<b>Is this a leaded cable?</b>	Yes
<b>Is the cable(s) Terrestrial, Submarine or Both?</b>	Submarine
<b>Was there a sample collected?</b>	Yes
<b>How many samples collected?</b>	2

Cable is armored on the west side. About 15' of armoring before the cable is visible. Lead residue is visible near the water line, when the cable becomes visible.

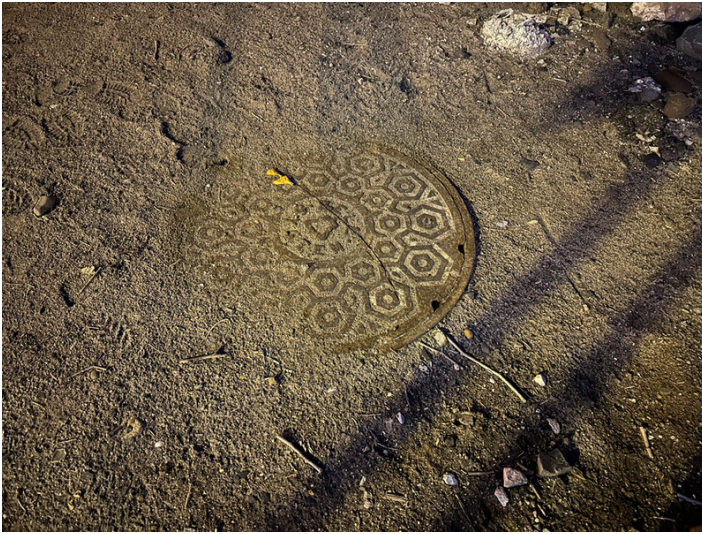
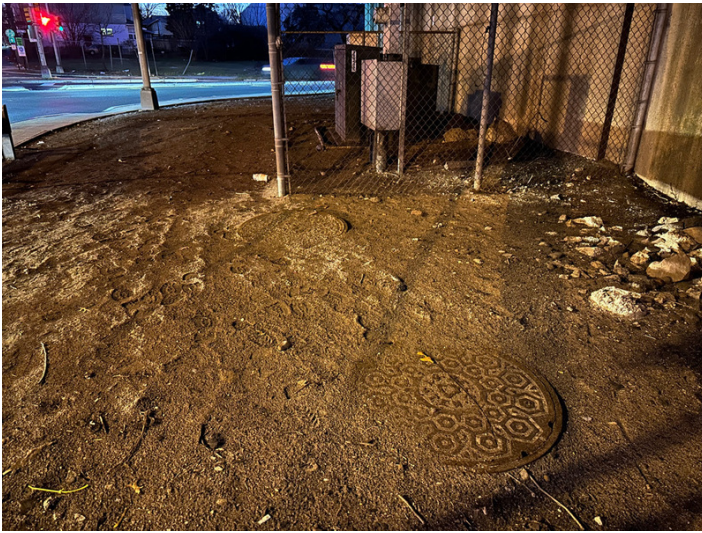
General Site Notes | Bell Systems MHx2. DNO.

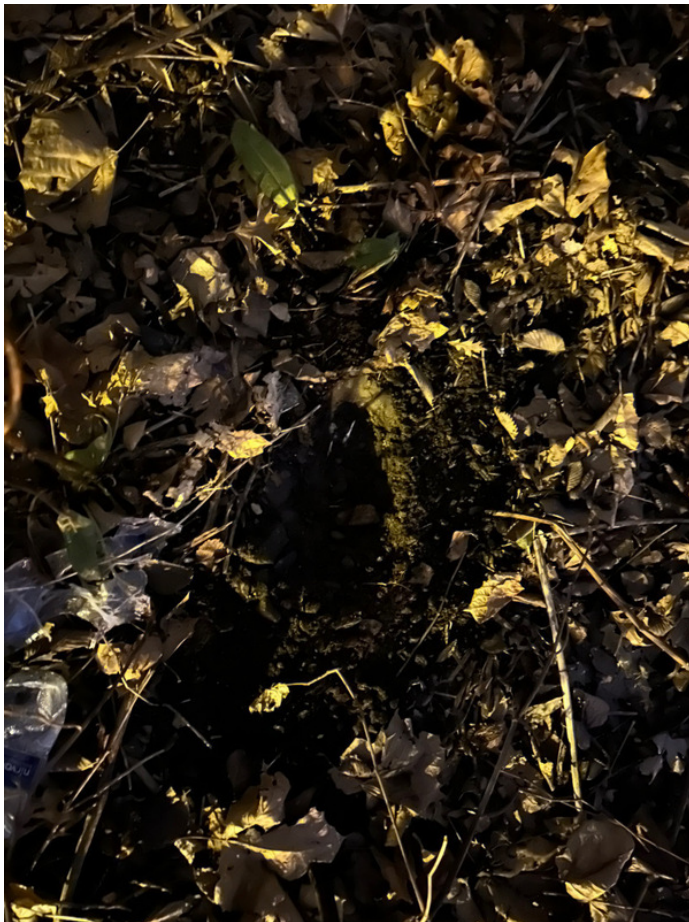
#### General Sample (GS) Information - 1. Sediment Collection, 4

Type of Sample for GS	Sediment Collection
Location of Collected Sample - GS	Within Control Sample Limits
Time of Collection - GS	17:33
Sample Prefix - GS	Passaic
Sample ID (#) - GS	4
Additional Notes - GS (if any)	None.

General Site Notes	See sample for site photo. Control sediment for Passaic 3
--------------------	---

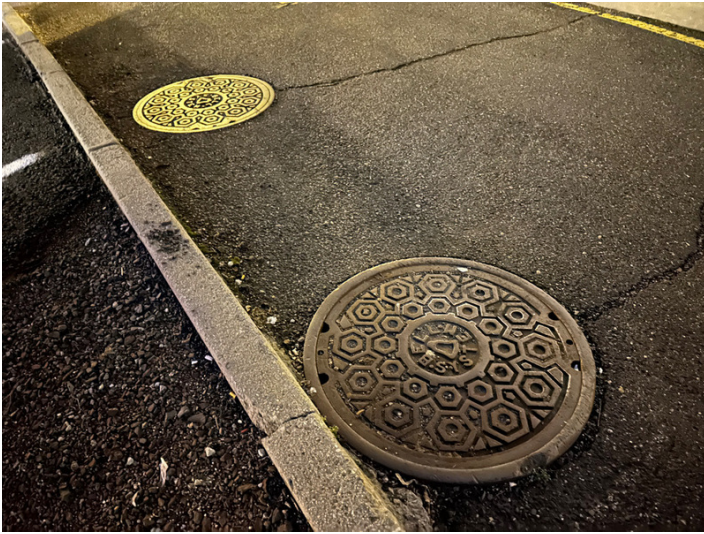
## Site Locations - 15. Passaic, 3.2

**General Site Notes** | Bell Systems MHx2. Associated with Passaic 3 Site.

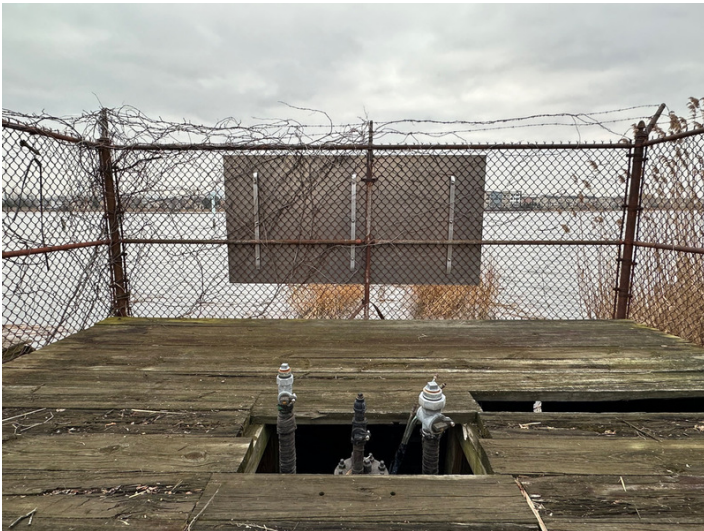
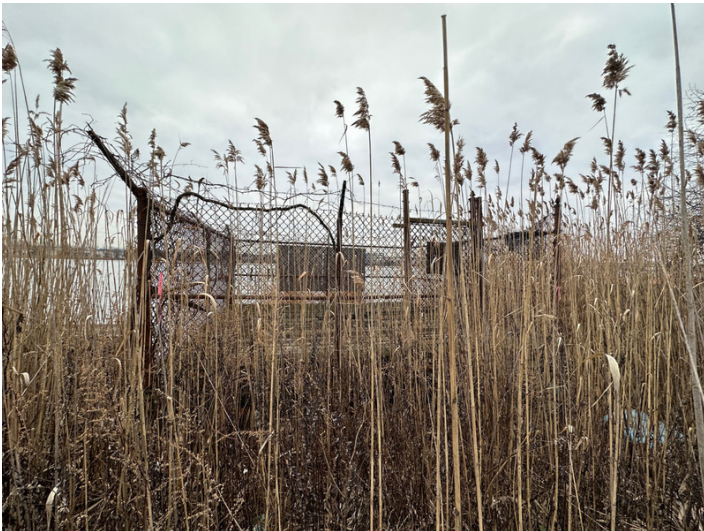
**General Site Notes** | Gas pipeline vault, possibly for the old ferry. Meadowlands Area. 2 different signs. On both sides of the river.

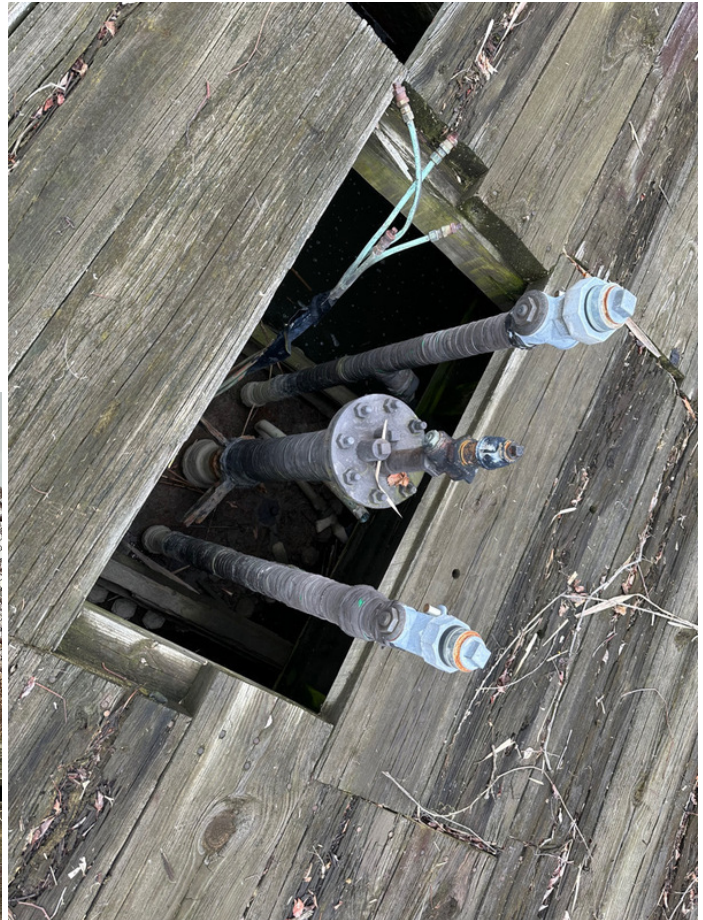
**Site Locations - 16. Hackensack, 3**

Way Point Prefix	Hackensack
Way Point Number	3
Time at Way Point	10:04
Way Point Description	Cable Corridor, Sign
Are there visible signs indicating a cable crossing?	Yes
Identify what the signs say.	Unable to read. Gas Pipeline storage, possibly for the old ferry.
Are there buried or visible cable(s) at location?	No
Was there a general sample collected?	No

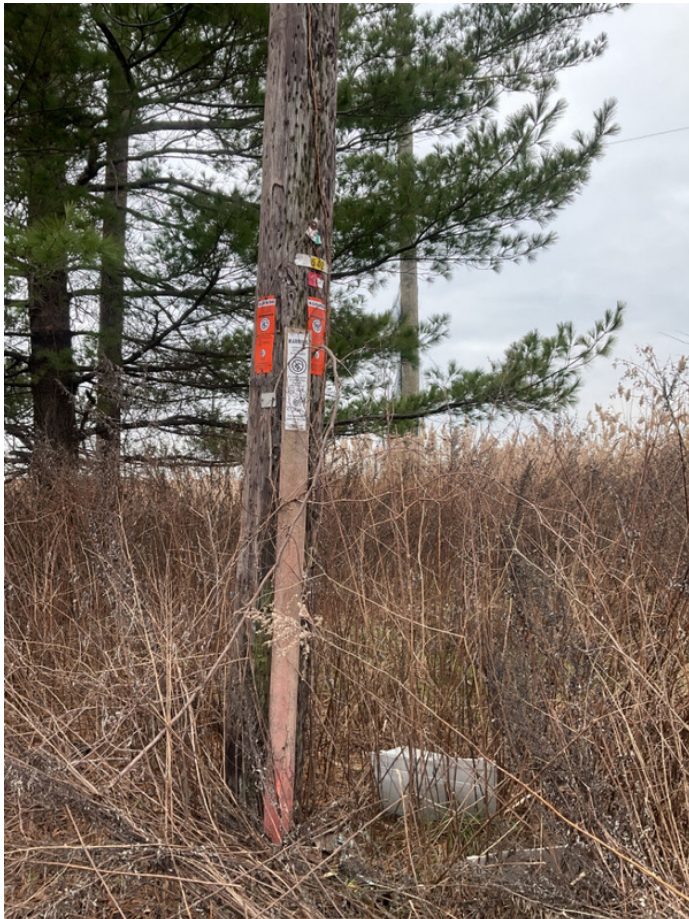
### Site Locations - 17. Hackensack, 3.1

**General Site Notes** | Old Bell Telephone Pole. No cables found. Heavily overgrown and abandoned area in general.

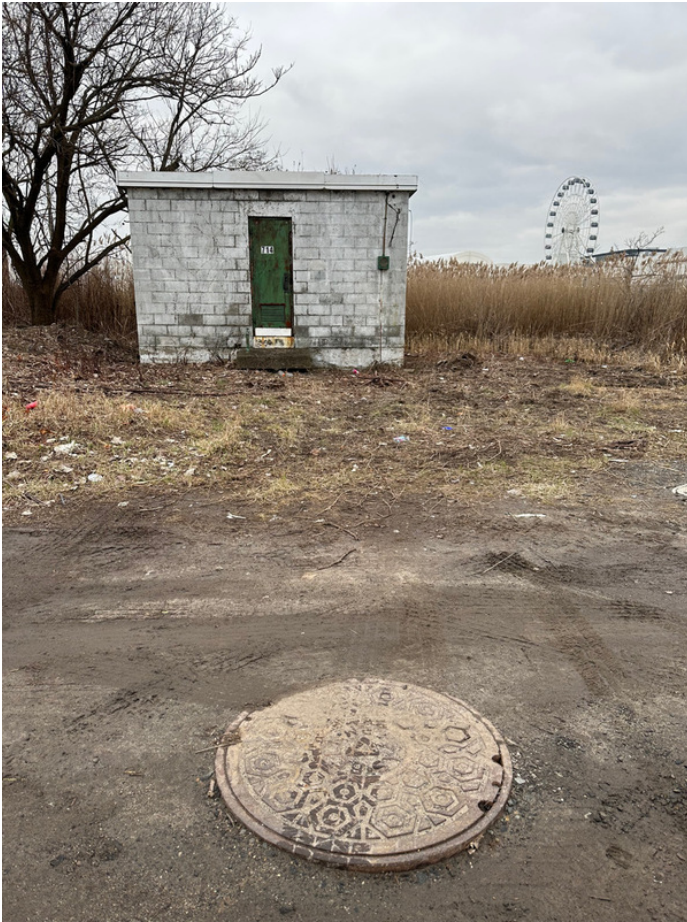
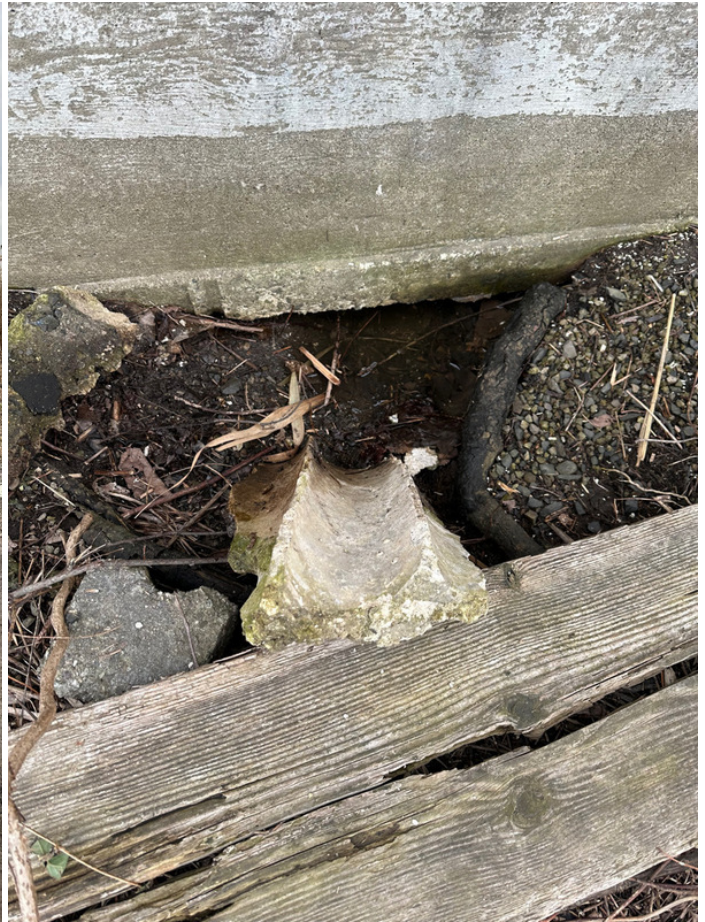
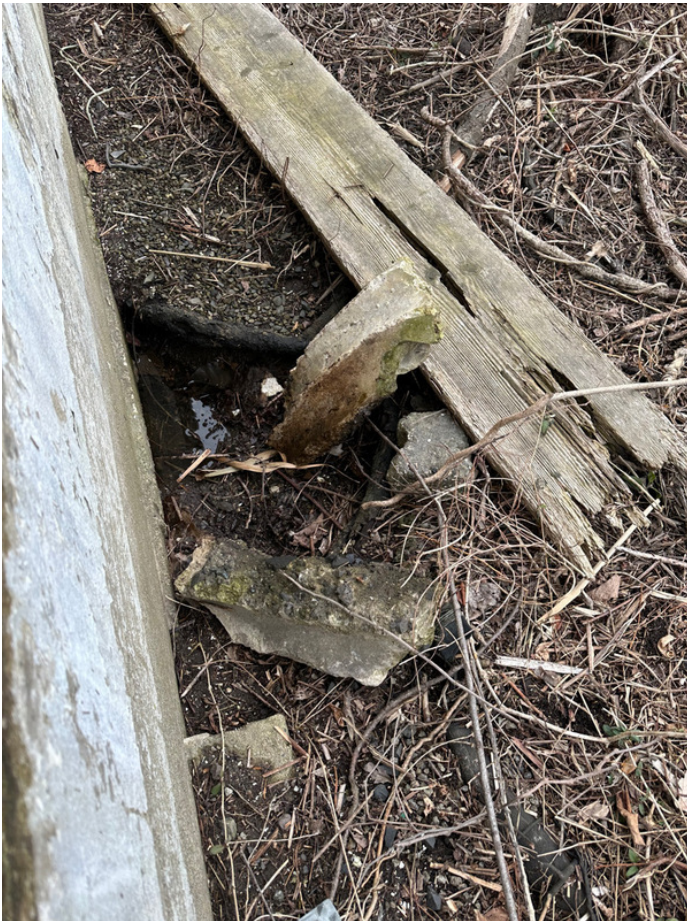
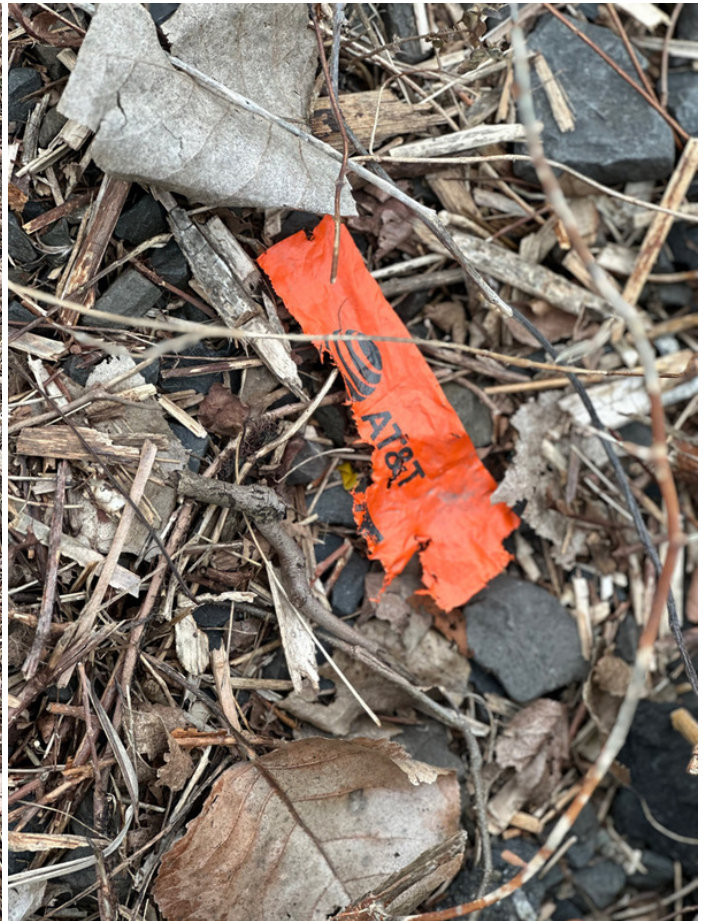
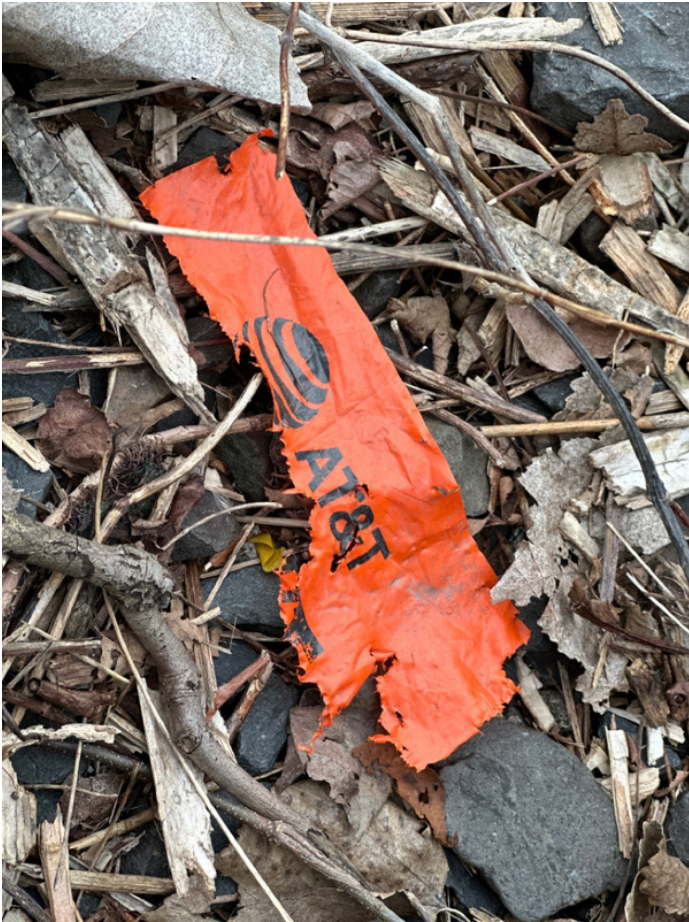
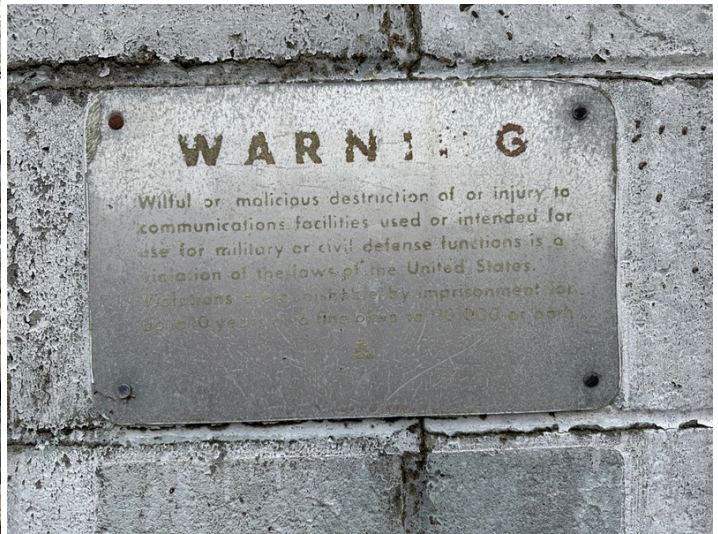
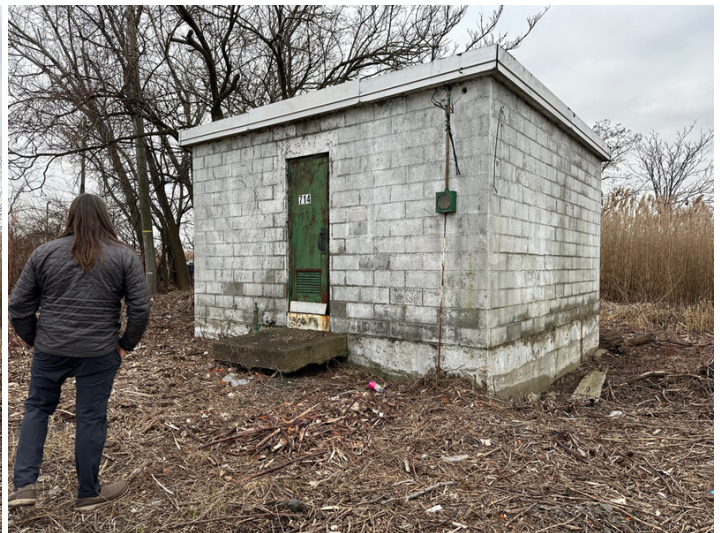
### Site Locations - 18. Hackensack, 3.2

**General Site Notes** | Old Bell Utility Building with indications that a cable was most likely present at one point going to the building. Bell Systems MHx1 (Reference Hackensack 3.3). There is newer AT&T flagging on the ground near the building.

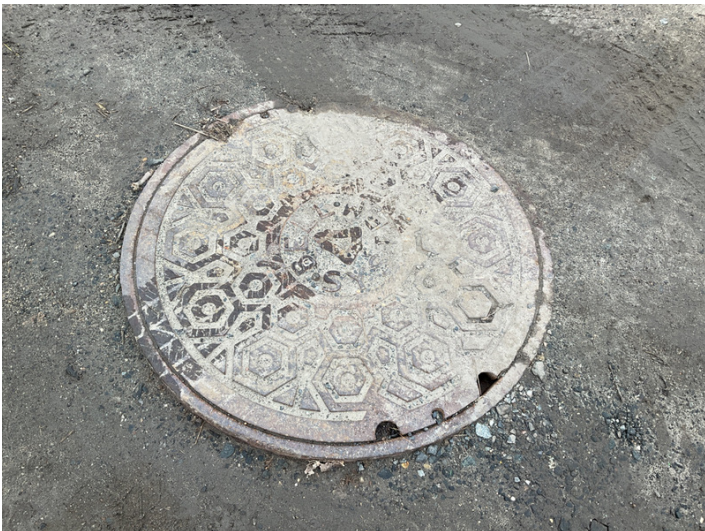
General Site Notes	Meadowlands Area. Largely overgrown and abandoned. This MH is the same referenced in Hackensack 3.2 near the Bell Utility Building. Buried cable at this location.
--------------------	--
