New Jersey Data Collection - Final

Investigation of data points along the Hackensack River, Passaic River, and the South Kearny Neighborhood.

January 10, 2023

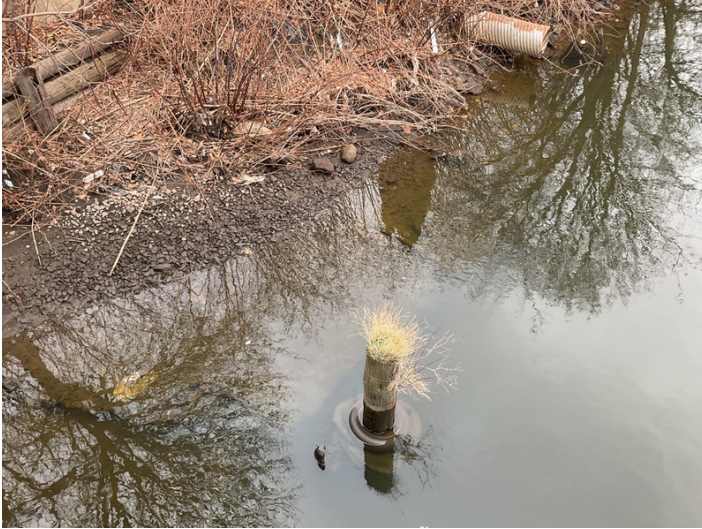
Site Locations - 1. Passaic, 5

Way Point Prefix	Passaic
Way Point Number	5
Time at Way Point	11:33
Way Point Description	Cable Location
Are there visible signs indicating a cable crossing?	No
Are there buried or visible cable(s) at location?	Yes
How many cables are visible?	7
Is lead visible?	Yes

General Site Notes	Site 5 is a complex site with 21 cables in total on initial investigation.
--------------------	--

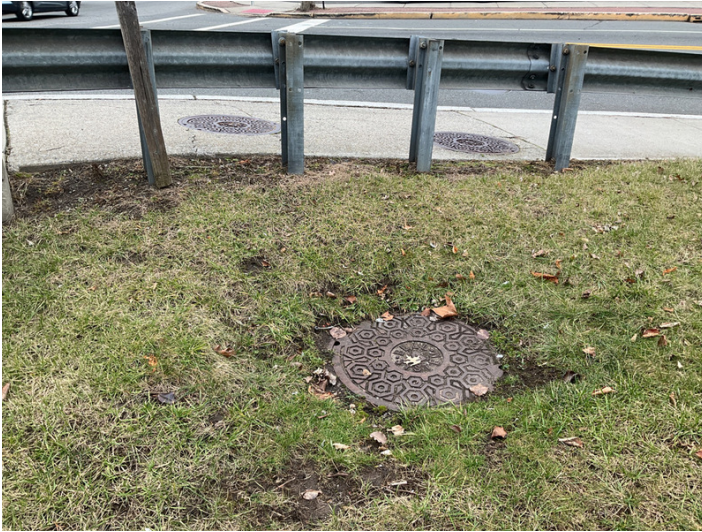
Site Locations - 2. Passaic, 5.1

Way Point Prefix	Passaic
Way Point Number	5.1
Time at Way Point	11:35
Way Point Description	Manhole, Buried Cable at this location.
Are there visible signs indicating a cable crossing?	No
Are there buried or visible cable(s) at location?	Yes
How many cables are visible?	Buried Cables at this location, associated with Site 5.
Is lead visible?	No

General Site Notes	Bell Systems MHx3, next to small sign post. Part of Site 5. Complex site with 21 cables in total.
--------------------	---

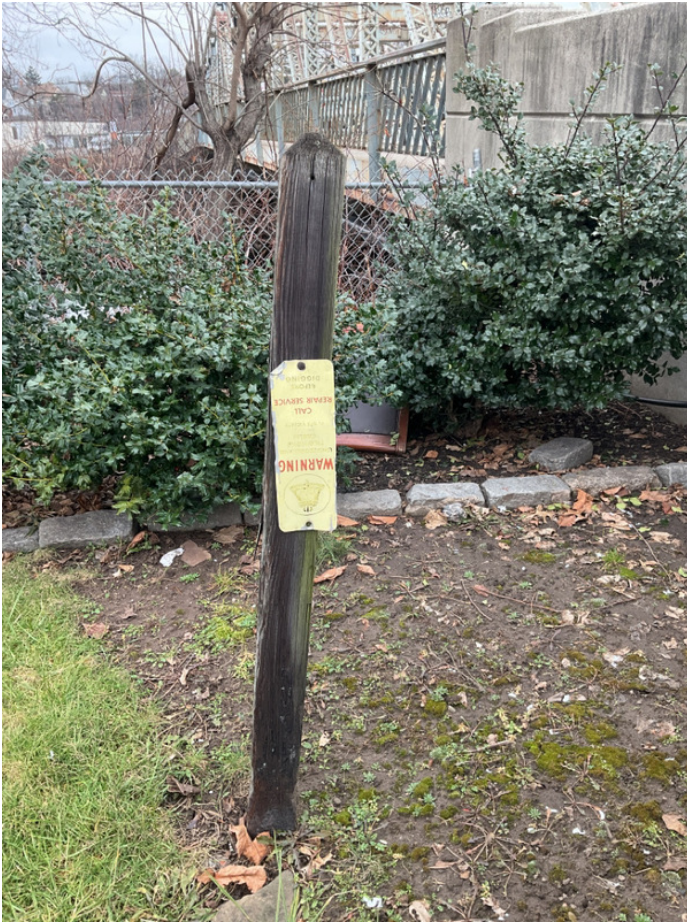
Site Locations - 3. Passaic, 5.2

Way Point Prefix	Passaic
Way Point Number	5.2
Time at Way Point	11:35
Way Point Description	Sign, Small Sign Post
Are there visible signs indicating a cable crossing?	Yes
Identify what the signs say.	Post. Call Repair Services. Underground Telephone Cables in Vicinity. Bell.
Are there buried or visible cable(s) at location?	No

General Site Notes	Part of Site 5. Complex site with 21 cables in total.
--------------------	---

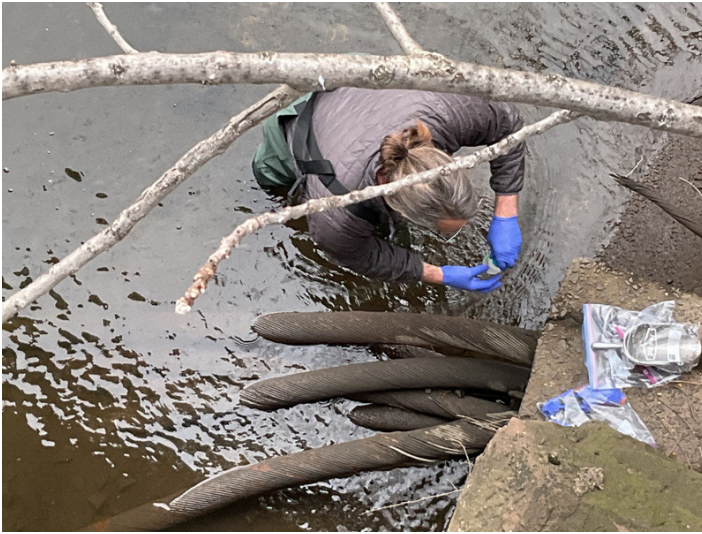
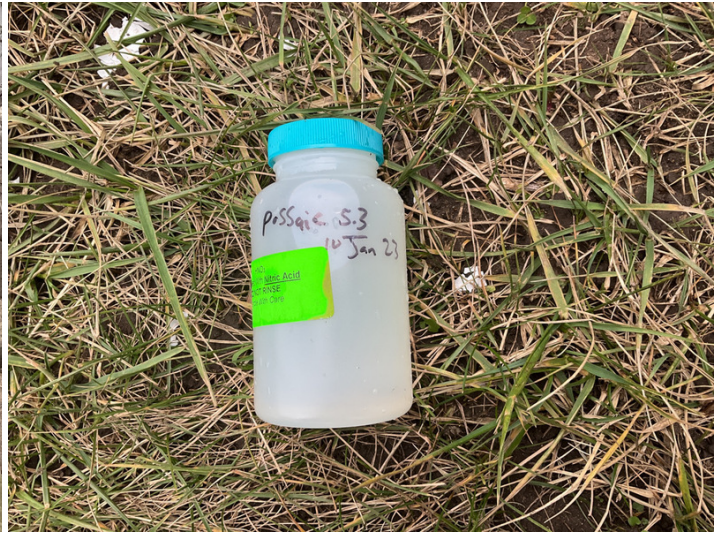
Sample Information - Specific Cable - 1. Water: Directly on Cable, 5.3

Type of Sample	Water: Directly on Cable
If more than one cable, what Cable was Sample collected from?	All
Time of Collection - Specific Cable	13:21
Sample Prefix - Specific Cable	Passaic
Sample ID (#) - Specific Cable	5.3
Additional Notes - Specific Cable Sample (if any)	6 telecom cables next to 1- 2" power cable.
Photo of Specific Cable Sample(s)

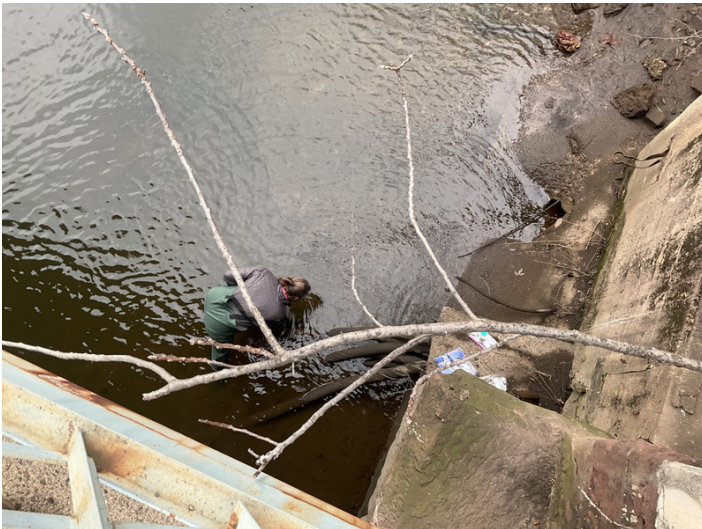
Sample Information - Specific Cable - 2. Sediment Collection, 5.3

Type of Sample	Sediment Collection
If more than one cable, what Cable was Sample collected from?	All
Location of Collected Specific Cable Sample	Under the Cable
Time of Collection - Specific Cable	13:22
Sample Prefix - Specific Cable	Passaic
Sample ID (#) - Specific Cable	5.3
Additional Notes - Specific Cable Sample (if any)	6 telecom cables next to 1-2" power cable.

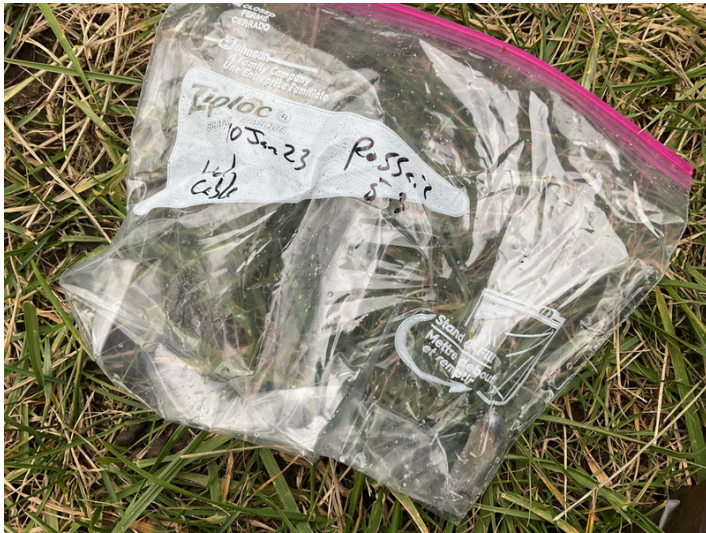
Sample Information - Specific Cable - 3. Lead Scraping, 5.3

Type of Sample	Lead Scraping
If more than one cable, what Cable was Sample collected from?	4" cable
Time of Collection - Specific Cable	13:26
Sample Prefix - Specific Cable	Passaic
Sample ID (#) - Specific Cable	5.3
Additional Notes - Specific Cable Sample (if any)	Sample collected from 1 of the 4" telecom cables. Sample was originally sent to the lab 12 January 2023. It was returned from the lab and resent 25 January 2023.

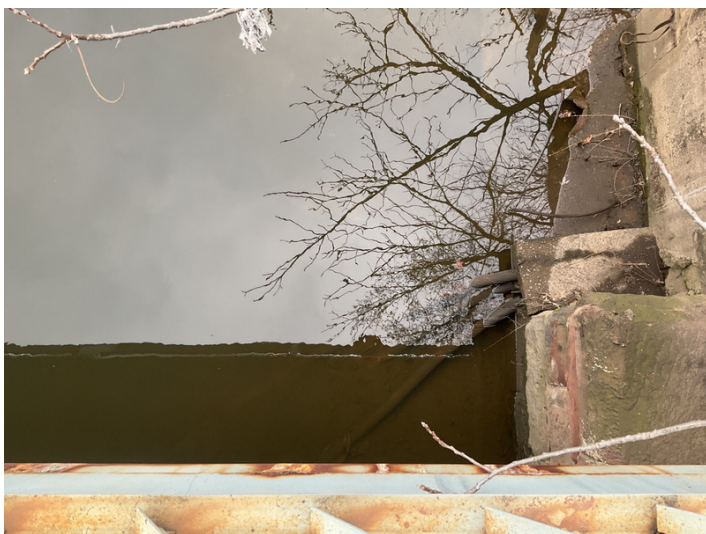
Site Locations - 4. Passaic, 5.3

Cable #	1, 2, 3, 4, 5, 6, 7
Visible Length (ft)	20
Type of Cable (Power, Telecom, Fiber Optic, Other)	Power, Telecom
Is this a leaded cable?	Yes
Is the cable(s) Terrestrial, Submarine or Both?	Submarine
Was there a sample collected?	Yes
How many samples collected?	3

General Site Notes	6 visible telephone cables and 1 small power cable, on the NW side of bridge. Part of Site 5. Complex site with 21 cables in total.
--------------------	---

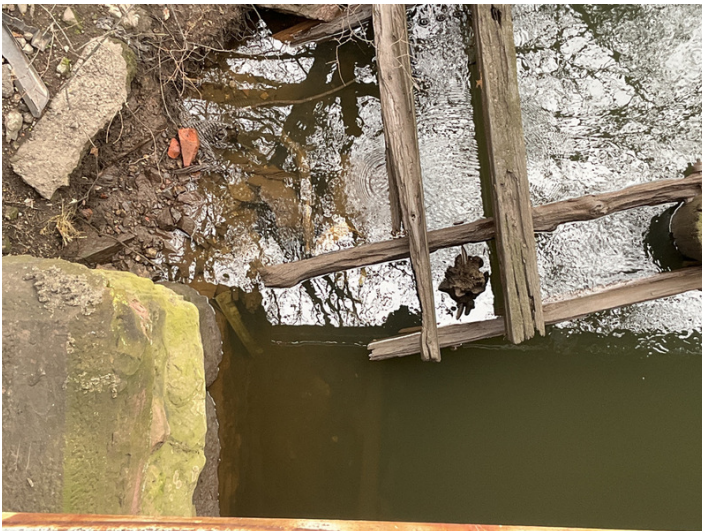
Site Locations - 5. Passaic, 5.4

Two cables run under the bridge perpendicular to the bridge. There is debris on the bridge that suggests metal scrapping/salvage in the area, using magnets. The shoreline also had evidence of cable scrapping, similar to what we found in LA. Part of Site 5. Complex site with 21 cables in total.

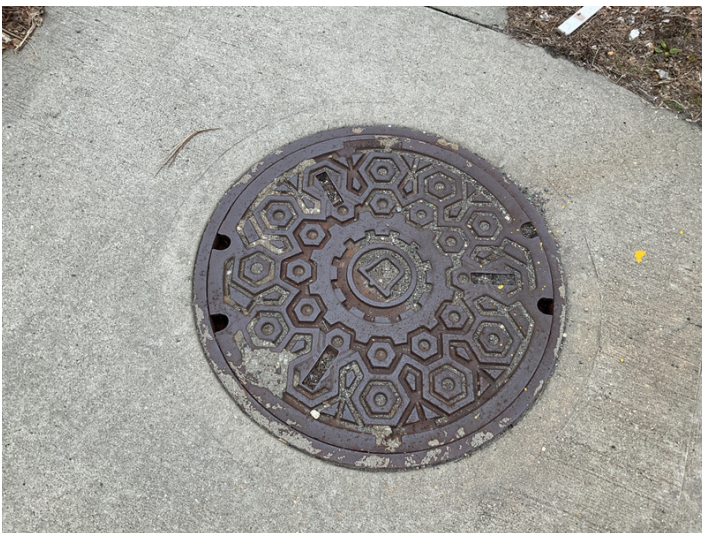
Site Locations - 6. Passaic, 5.5

General Site Notes	Bell Systems MHx1. Part of Passaic Site 5. Complex location.
--------------------	--

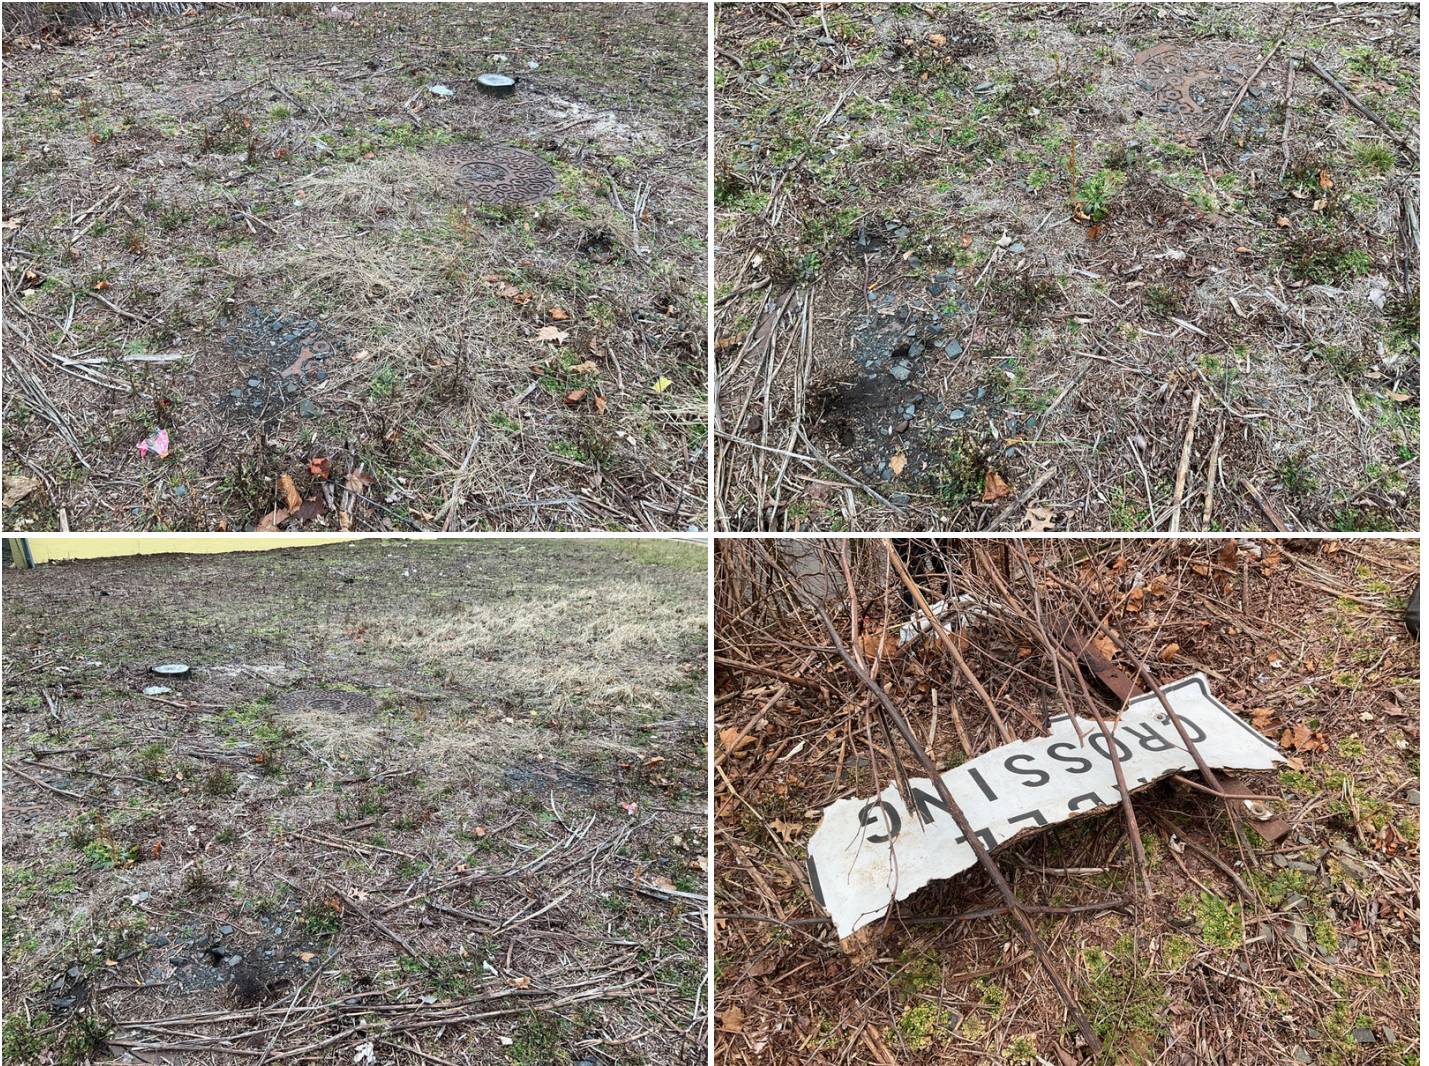
Site Locations - 7. Passaic, 5.6

General Site Notes | Bell Systems MHx4. Partially and mostly buried. DNO. Remnants of old Cable Crossing Sign. Part of Site 5. Complex site with 21 cables in total.

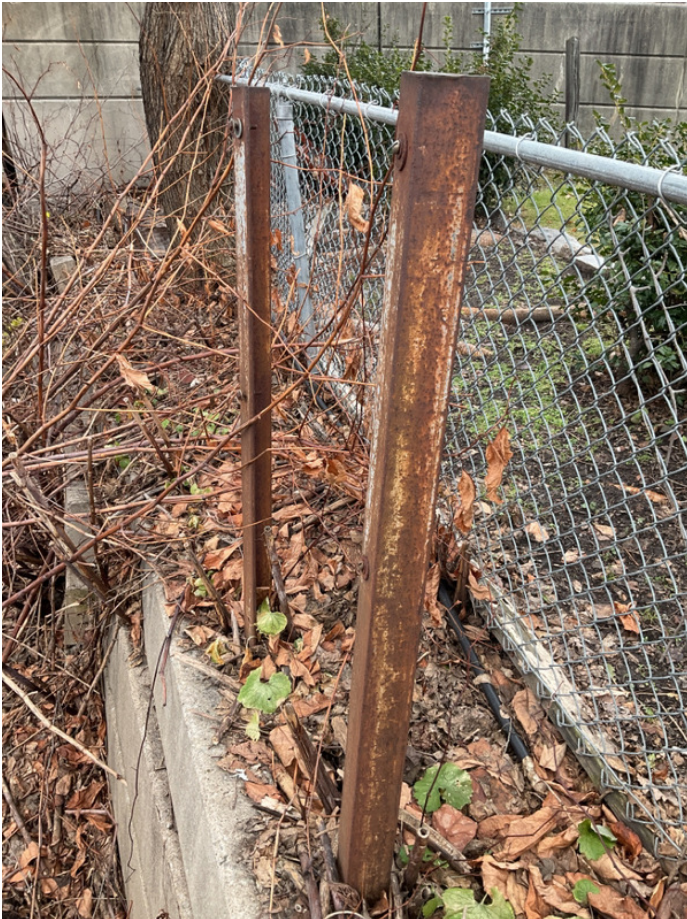
Site Locations - 8. Passaic, 5.7

Are there visible signs indicating a cable crossing?	Yes
Identify what the signs say.	Sign holder. No sign.
Are there buried or visible cable(s) at location?	Yes
How many cables are visible?	Cables are referenced and detailed in the other Site 5 data points.
Is lead visible?	Yes
Was there a general sample collected?	No

General Site Notes	South side of the bridge. Cables visible underneath the bridge. Part of Site 5. Complex site with 21 cables in total.
--------------------	---

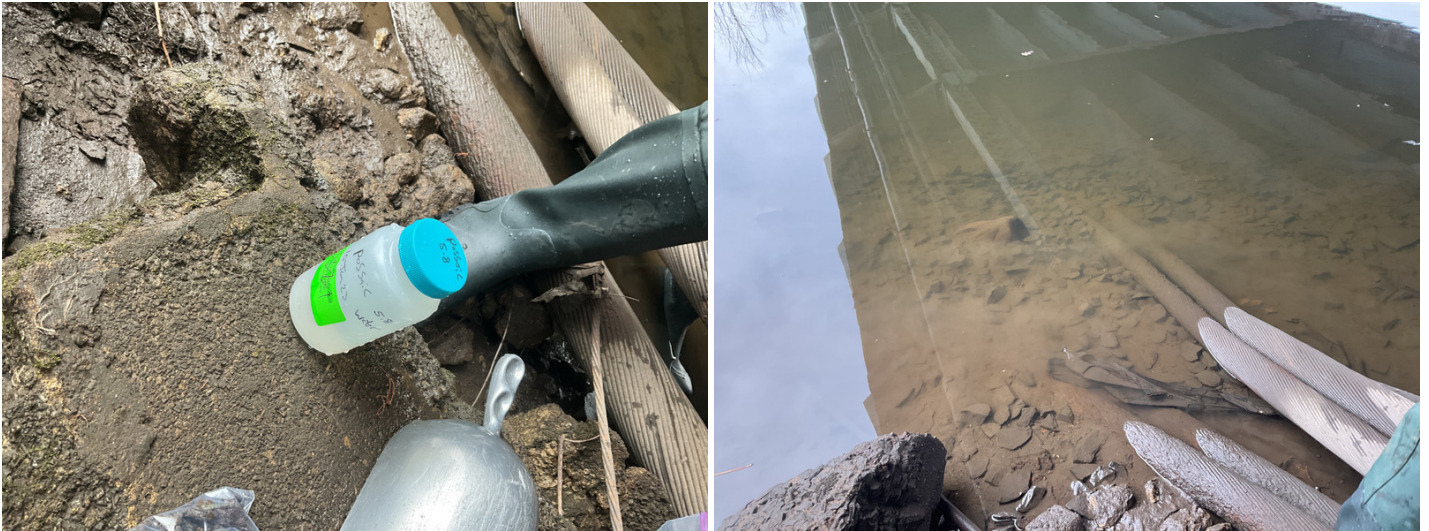
Sample Prefix - Specific Cable	Passaic
Sample ID (#) - Specific Cable	5.8
Additional Notes - Specific Cable Sample (if any)	None.

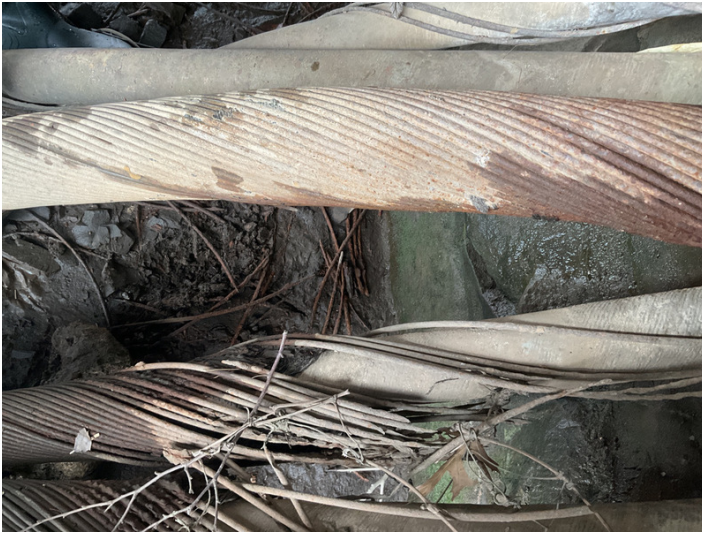
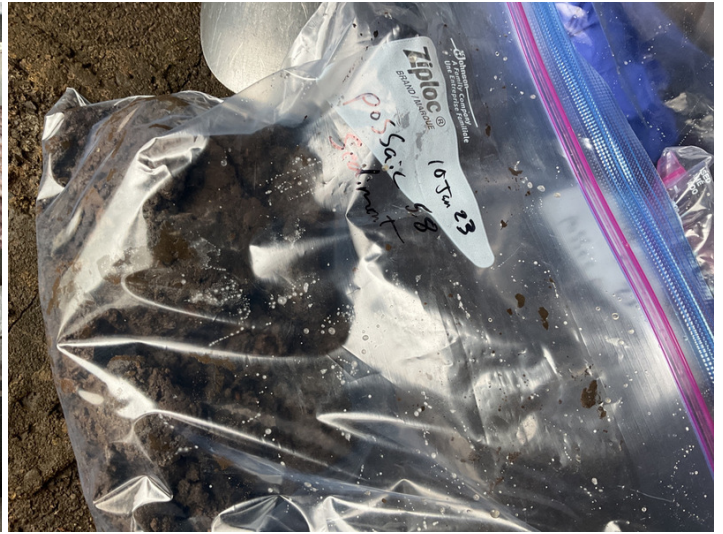
Sample Information - Specific Cable - 2. Sediment Collection, 5.8

Type of Sample	Sediment Collection
If more than one cable, what Cable was Sample collected from?	All
Location of Collected Specific Cable Sample	Under the Cable
Time of Collection - Specific Cable	12:31
Sample Prefix - Specific Cable	Passaic
Sample ID (#) - Specific Cable	5.8
Additional Notes - Specific Cable Sample (if any)	None.

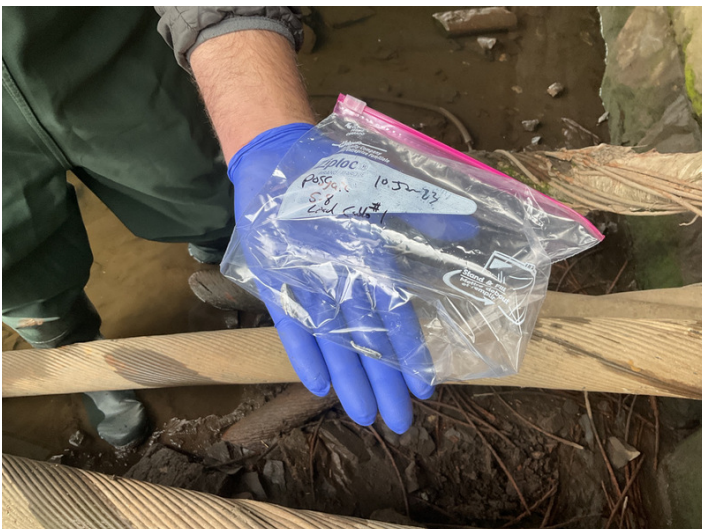
Sample Information - Specific Cable - 3. Lead Scraping, 5.8 Cable #1

Type of Sample	Lead Scraping
If more than one cable, what Cable was Sample collected from?	1
Time of Collection - Specific Cable	12:31
Sample Prefix - Specific Cable	Passaic
Sample ID (#) - Specific Cable	5.8 Cable #1
Additional Notes - Specific Cable Sample (if any)	Cable 1 (3.5"). Sample collected from smaller cable. Sample was originally sent to the lab 12 January 2023. It was returned from the lab and resent 25 January 2023.

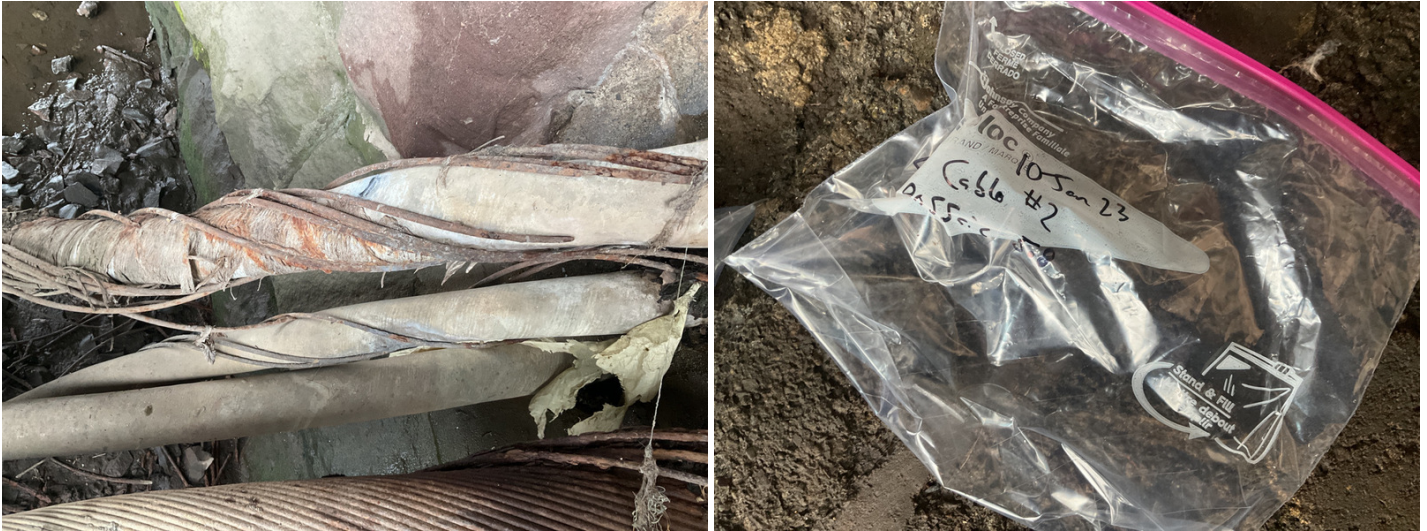
Sample Information - Specific Cable - 4. Lead Scraping, 5.8 Cable #2

If more than one cable, what Cable was Sample collected from?	2
Time of Collection - Specific Cable	12:33
Sample Prefix - Specific Cable	Passaic
Sample ID (#) - Specific Cable	5.8 Cable #2
Additional Notes - Specific Cable Sample (if any)	Cable 2 (4"). Sample was originally sent to the lab 12 January 2023. It was returned from the lab and resent 25 January 2023.

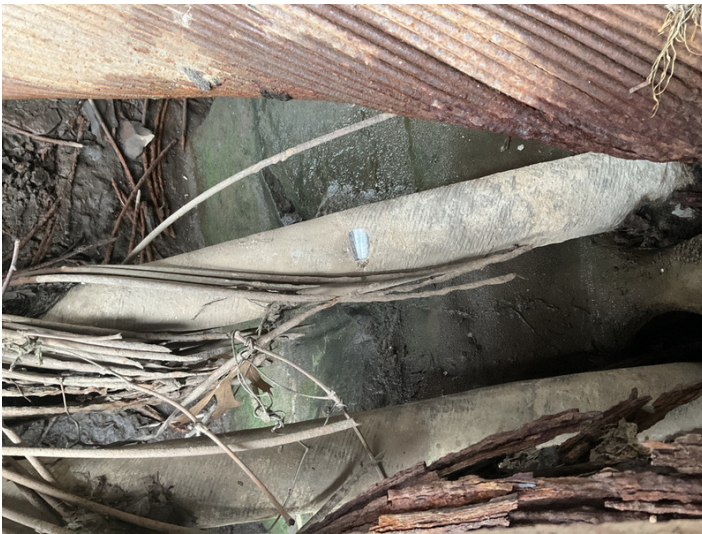
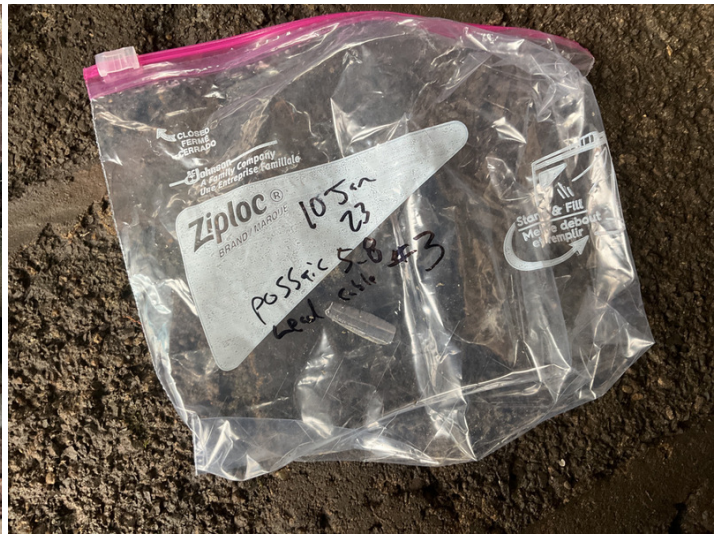
**Sample Information - Specific Cable - 5. Lead Scraping, 5.8 Cable #3**

Type of Sample	Lead Scraping
If more than one cable, what Cable was Sample collected from?	3
Time of Collection - Specific Cable	12:35
Sample Prefix - Specific Cable	Passaic
Sample ID (#) - Specific Cable	5.8 Cable #3
Additional Notes - Specific Cable Sample (if any)	Cable 3 (4"). Sample was originally sent to the lab 12 January 2023. It was returned from the lab and resent 25 January 2023.

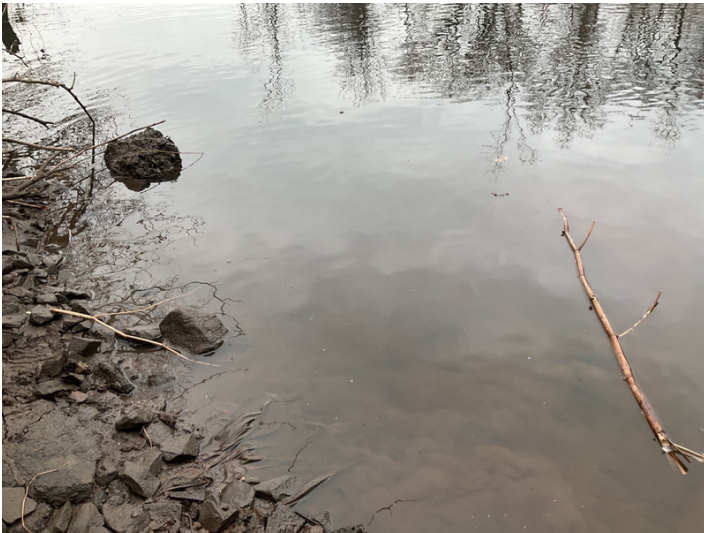
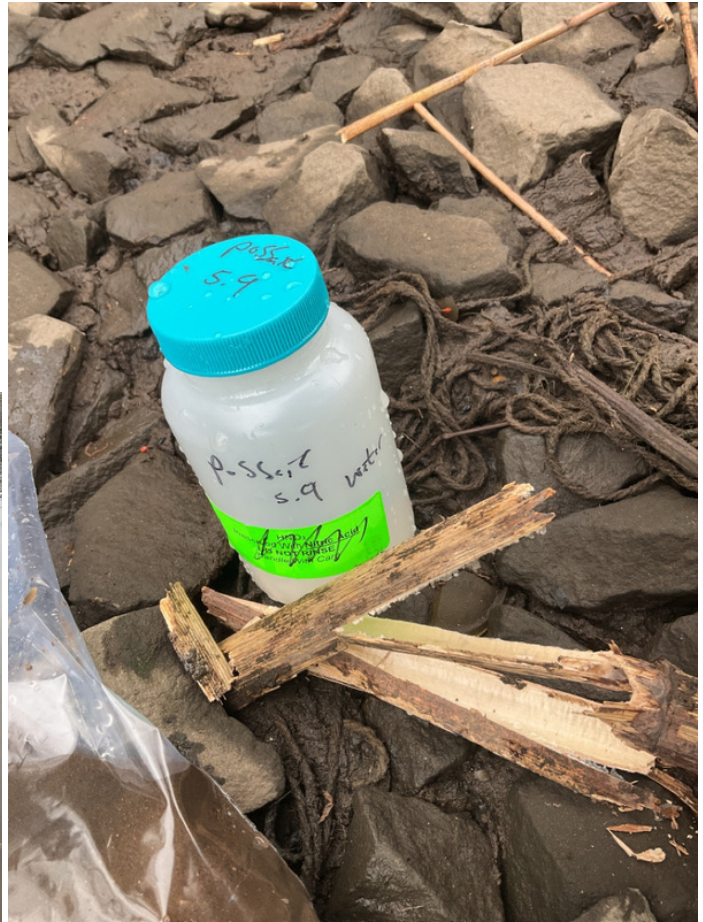
Sample Information - Specific Cable - 1. Water: Directly on Cable, 5.9

Type of Sample	Water: Directly on Cable
If more than one cable, what Cable was Sample collected from?	All
Time of Collection - Specific Cable	12:24
Sample Prefix - Specific Cable	Passaic
Sample ID (#) - Specific Cable	5.9
Additional Notes - Specific Cable Sample (if any)	Central to all cables.
Photo of Specific Cable Sample(s)

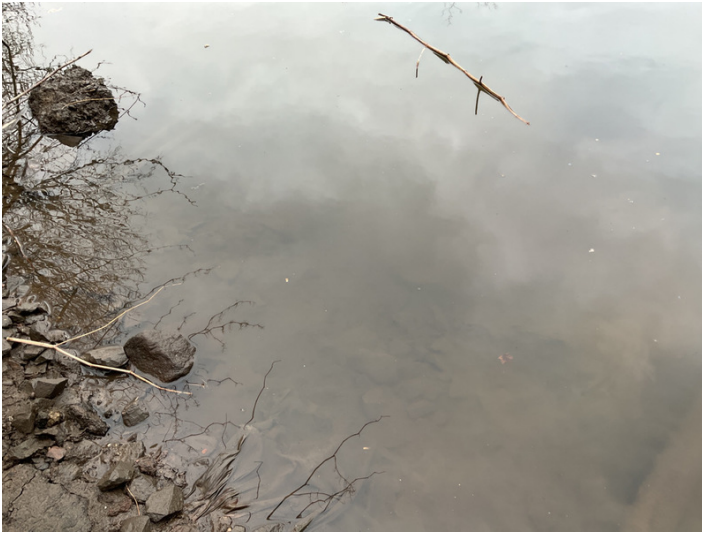
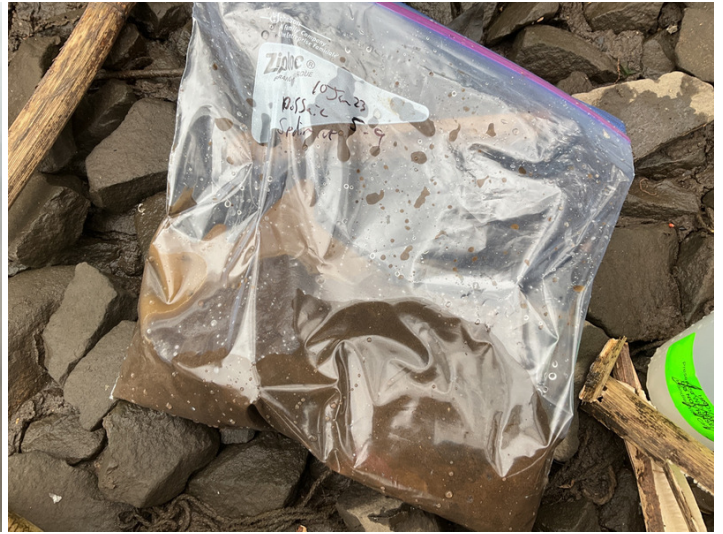
Sample Information - Specific Cable - 2. Sediment Collection, 5.9

Type of Sample	Sediment Collection
If more than one cable, what Cable was Sample collected from?	All
Location of Collected Specific Cable Sample	Near the Cable
Time of Collection - Specific Cable	12:26
Sample Prefix - Specific Cable	Passaic
Sample ID (#) - Specific Cable	5.9
Additional Notes - Specific Cable Sample (if any)	None.

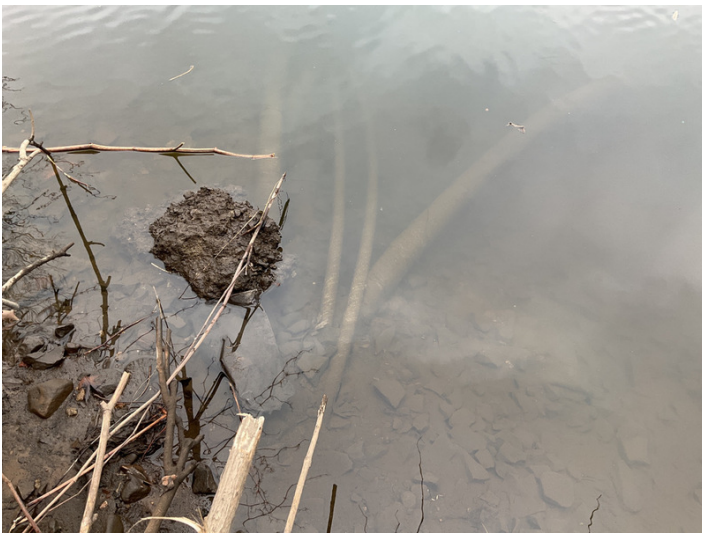
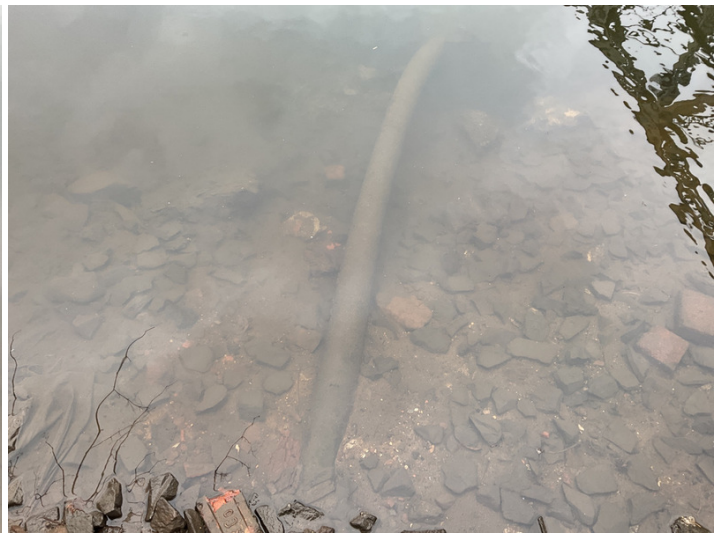
Part of Site 5. Complex site with 21 cables in total.

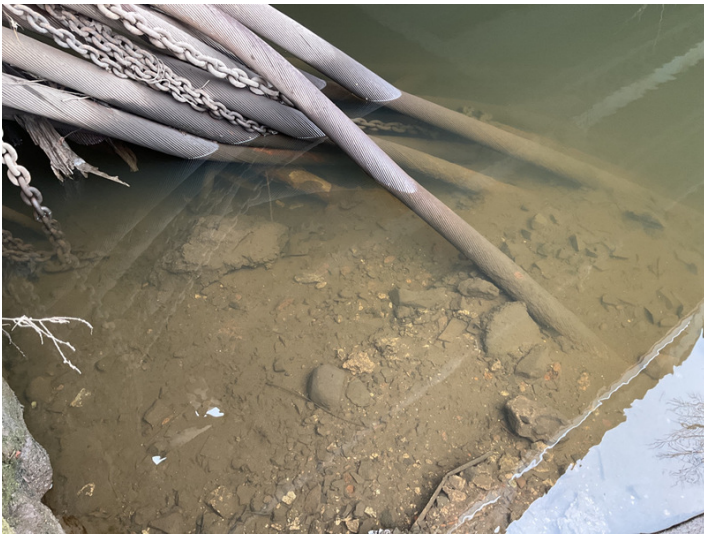
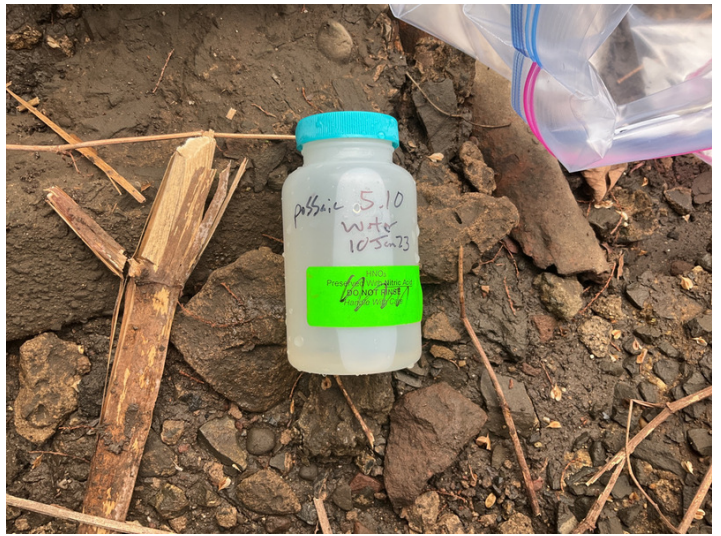
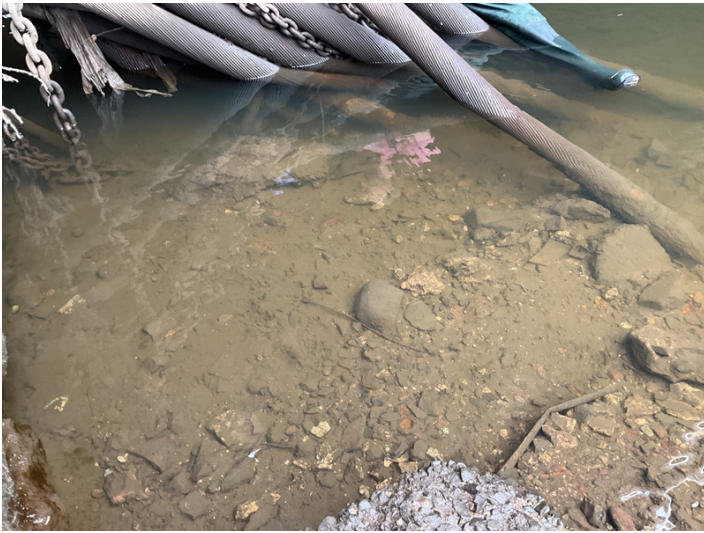
Type of Sample	Water: Directly on Cable
If more than one cable, what Cable was Sample collected from?	All
Time of Collection - Specific Cable	12:51
Sample Prefix - Specific Cable	Passaic
Sample ID (#) - Specific Cable	5.10
Additional Notes - Specific Cable Sample (if any)	None.

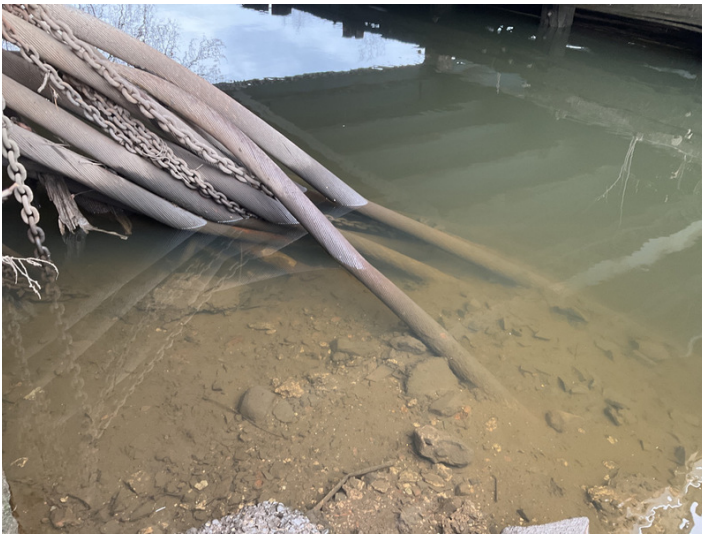
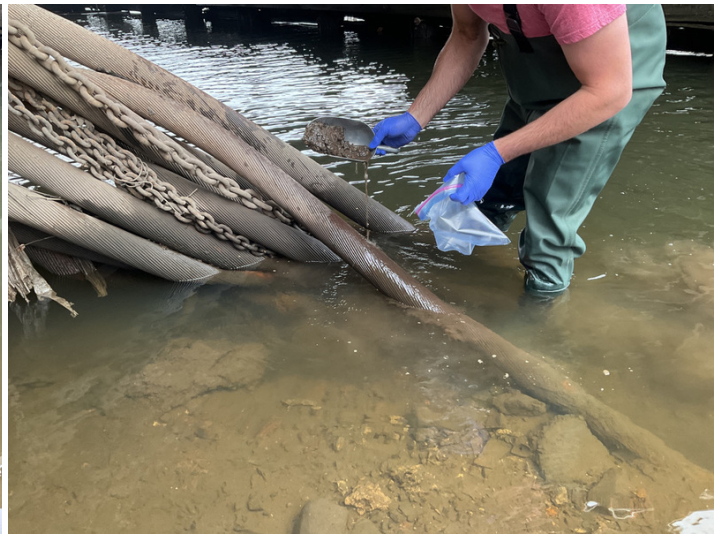
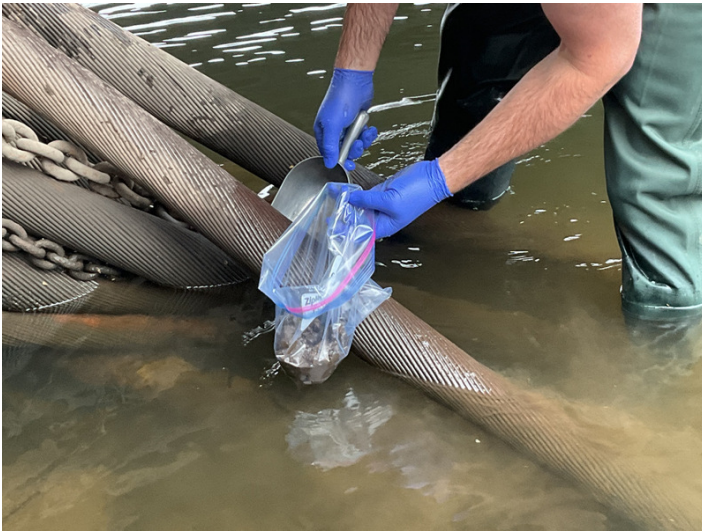
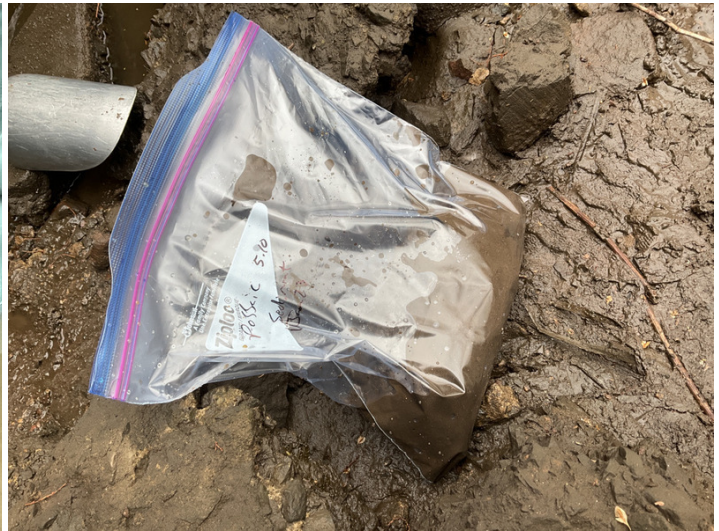
Sample Information - Specific Cable - 2. Sediment Collection, 5.10

Type of Sample	Sediment Collection
If more than one cable, what Cable was Sample collected from?	All
Location of Collected Specific Cable Sample	Under the Cable
Time of Collection - Specific Cable	12:53
Sample Prefix - Specific Cable	Passaic
Sample ID (#) - Specific Cable	5.10
Additional Notes - Specific Cable Sample (if any)	None.
Photo of Specific Cable Sample(s)

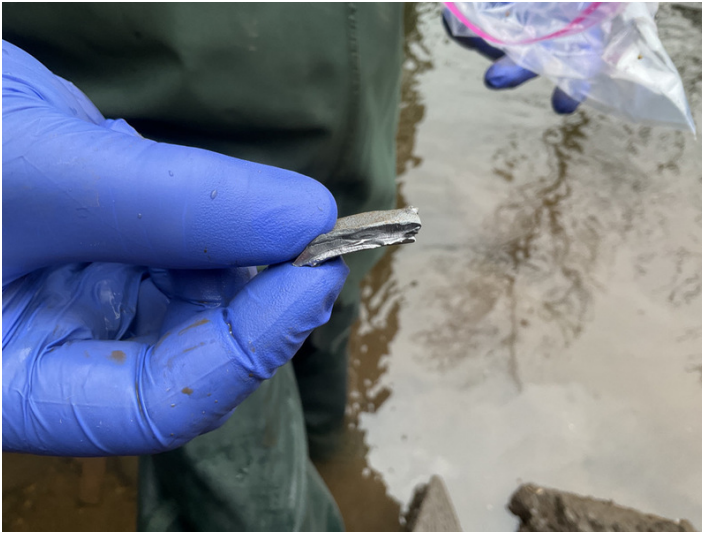
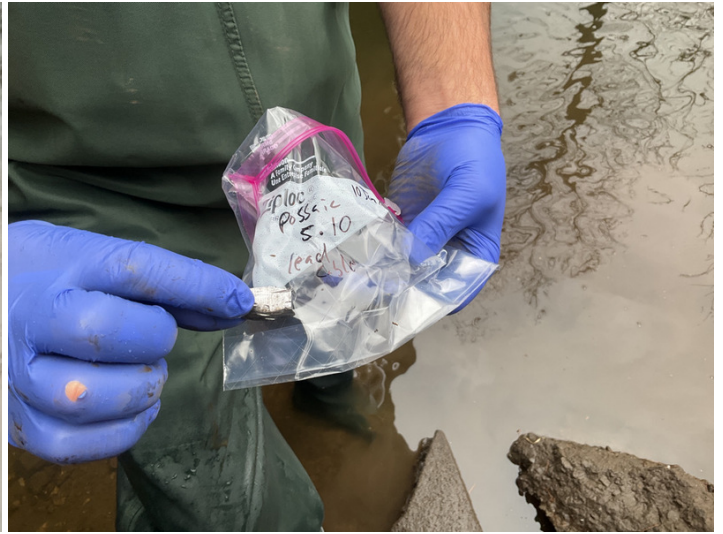
Sample Information - Specific Cable - 3. Lead Scraping, 5.10 Cable #1

Type of Sample	Lead Scraping
If more than one cable, what Cable was Sample collected from?	1
Time of Collection - Specific Cable	13:03
Sample Prefix - Specific Cable	Passaic
Sample ID (#) - Specific Cable	5.10 Cable #1
Additional Notes - Specific Cable Sample (if any)	Collected from 1 of the 3.5" cables. Sample was originally sent to the lab 12 January 2023. It was returned from the lab and resent 25 January 2023.
Photo of Specific Cable Sample(s)

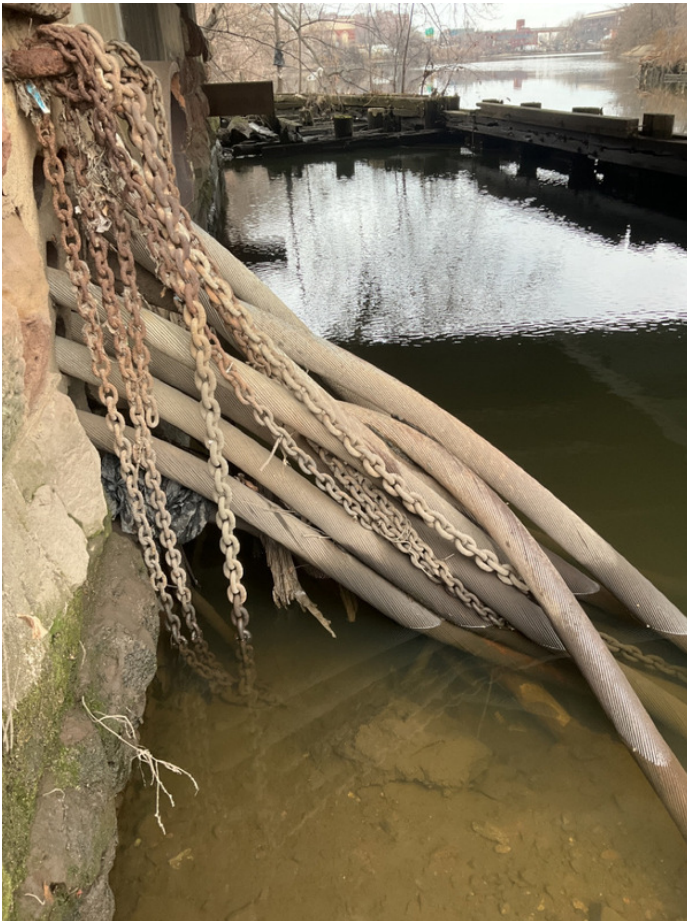
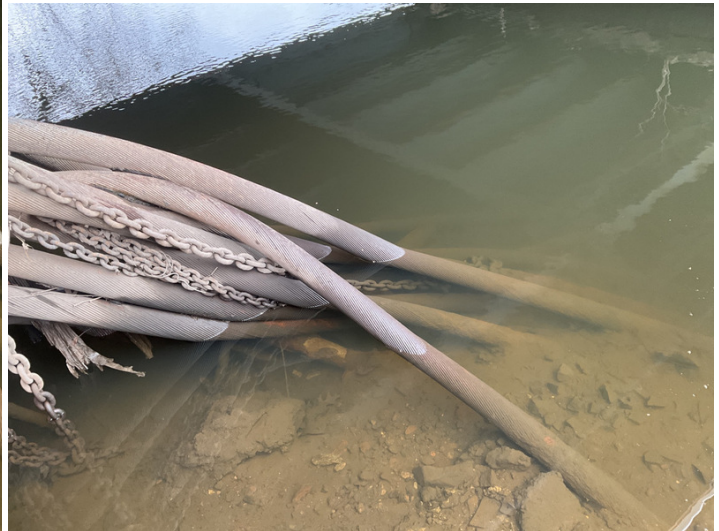
Part of Site 5. Complex site with 21 cables in total.

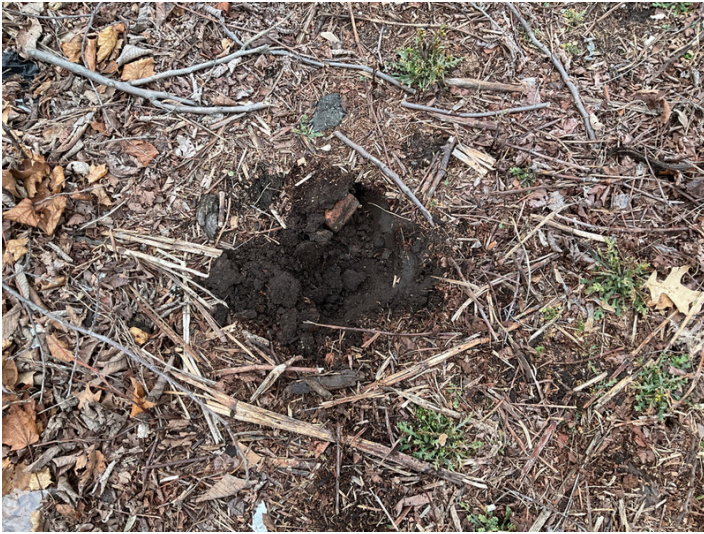
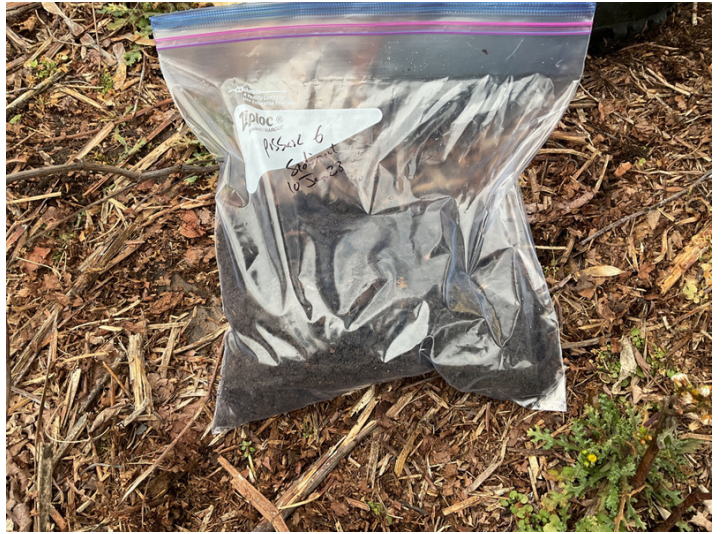
Type of Sample for GS	Sediment Collection
Location of Collected Sample - GS	Contol
Time of Collection - GS	13:13
Sample Prefix - GS	Passaic
Sample ID (#) - GS	6
Additional Notes - GS (if any)	None.

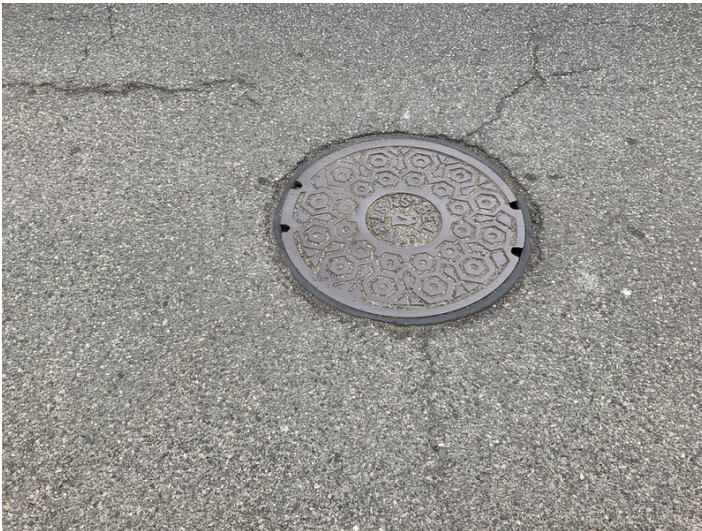
General Site Notes	Bell Systems MHx1. Part of Site 5. Complex site with 21 cables in total.
--------------------	--

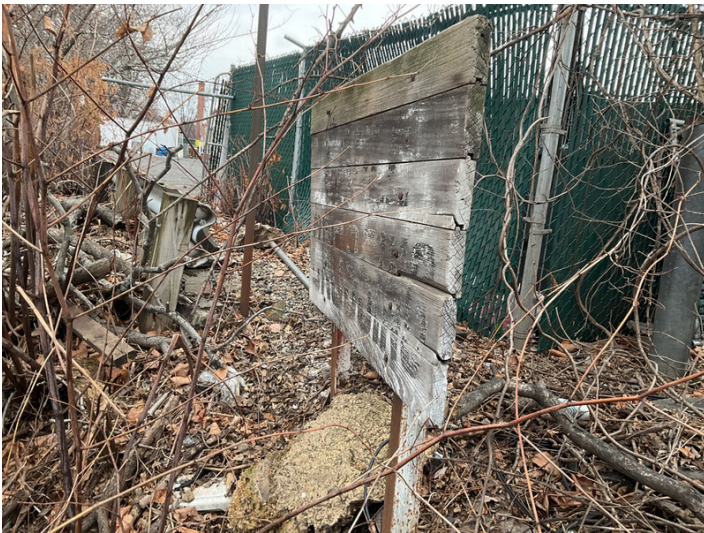
Site Locations - 14. Passaic, 5.12

General Site Notes This is the last sub point in Site 5. Points range from 5 to 5.12. Site 5 contains 21 known telecom cables, 3 different sizes. 4", 3", 3.5". Site 5 also has 4 smaller power cables, which are referenced but not necessarily accounted for in this data set.

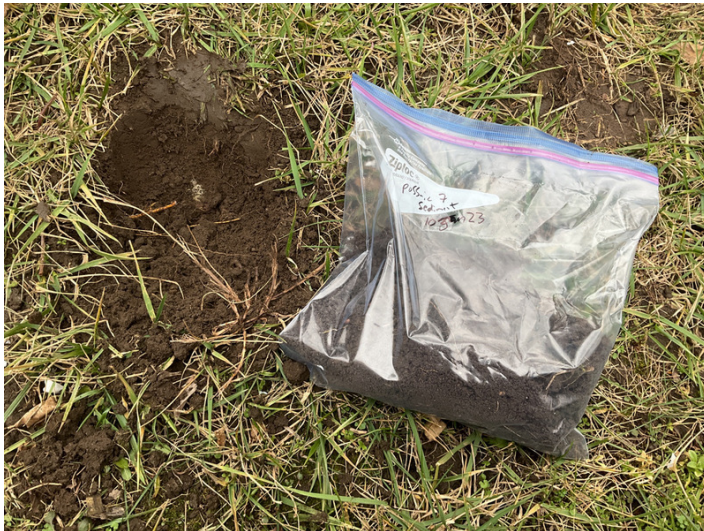
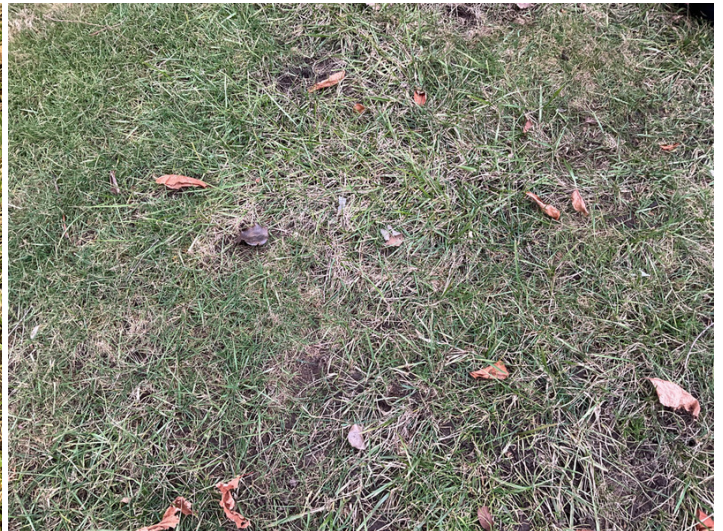
Type of Sample for GS	Sediment Collection
Location of Collected Sample - GS	Within Control Sample Limits
Time of Collection - GS	13:31
Sample Prefix - GS	Passaic
Sample ID (#) - GS	7
Additional Notes - GS (if any)	None.

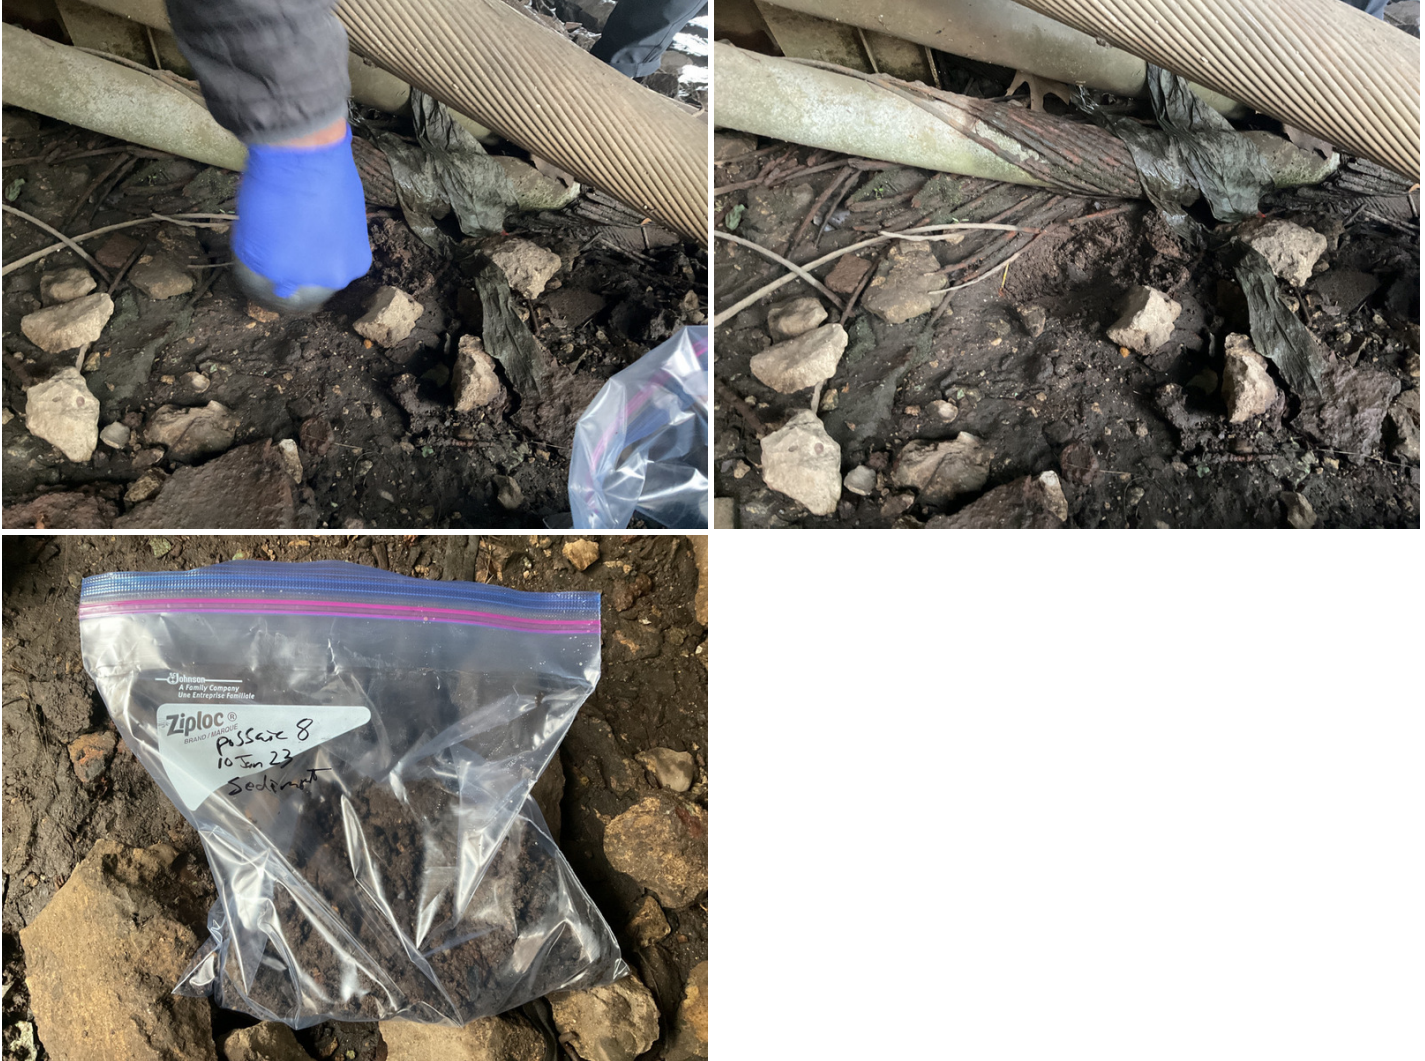
Time of Collection - Specific Cable	14:50
Sample Prefix - Specific Cable	Passaic
Sample ID (#) - Specific Cable	8
Additional Notes - Specific Cable Sample (if any)	None.
