New Jersey Data Collection - Final

Investigation of data points along the Hackensack River, Passaic River, and the South Kearny Neighborhood.

January 10, 2023

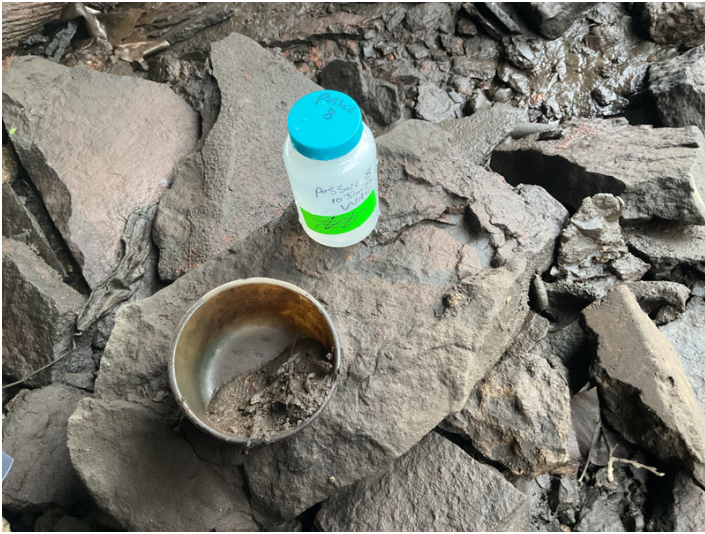
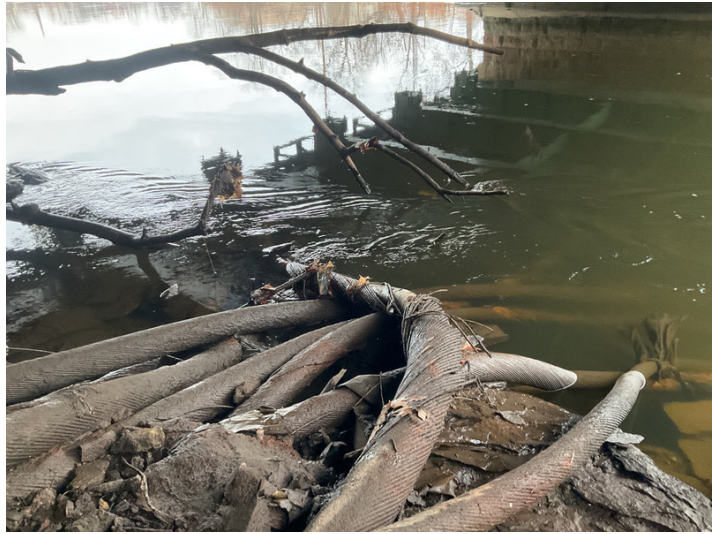
Sample Information - Specific Cable - 2. Water: Directly on Cable, 8

Type of Sample	Water: Directly on Cable
If more than one cable, what Cable was Sample collected from?	All
Time of Collection - Specific Cable	14:51
Sample Prefix - Specific Cable	Passaic
Sample ID (#) - Specific Cable	8
Additional Notes - Specific Cable Sample (if any)	None.

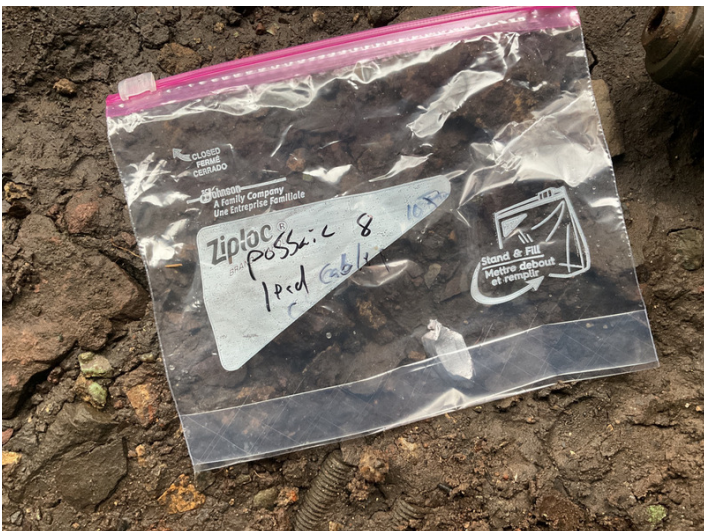
Sample Information - Specific Cable - 3. Lead Scraping, 8 Cable #1

Type of Sample	Lead Scraping
If more than one cable, what Cable was Sample collected from?	1 x 4"
Time of Collection - Specific Cable	14:54
Sample Prefix - Specific Cable	Passaic
Sample ID (#) - Specific Cable	8 Cable #1
Additional Notes - Specific Cable Sample (if any)	Cable 1 (4"). Sample was originally sent to the lab 12 January 2023. It was returned from the lab and resent 25 January 2023.

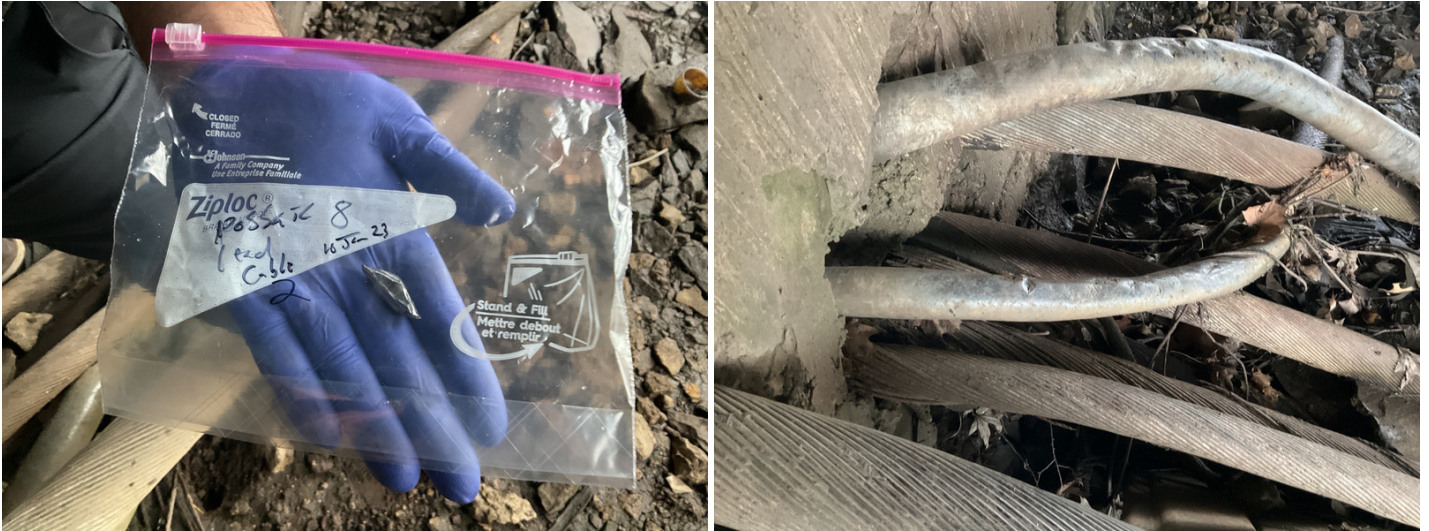
Sample Information - Specific Cable - 4. Lead Scraping, 8 Cable #2

If more than one cable, what Cable was Sample collected from?	2-3.5"
Time of Collection - Specific Cable	14:57
Sample Prefix - Specific Cable	Passaic
Sample ID (#) - Specific Cable	8 Cable #2
Additional Notes - Specific Cable Sample (if any)	Cable 2 (3.5"). Sample was originally sent to the lab 12 January 2023. It was returned from the lab and resent 25 January 2023.

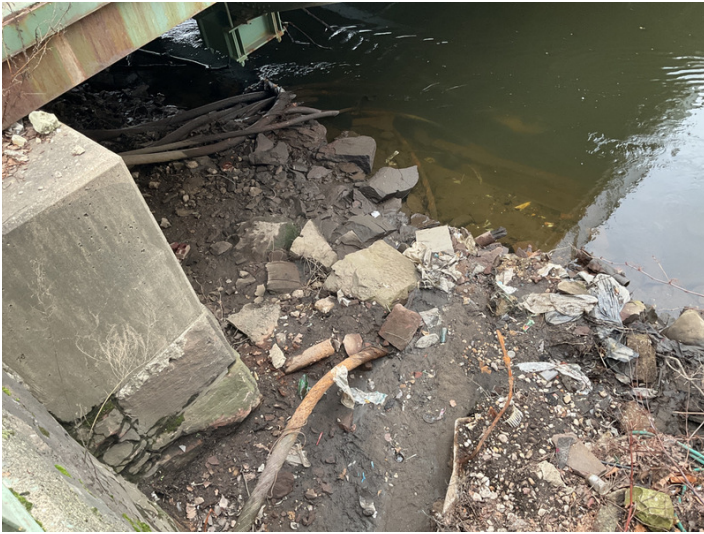
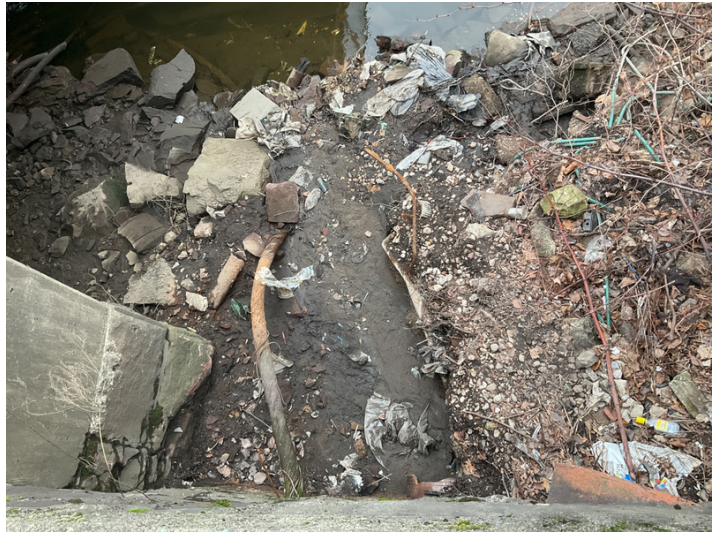
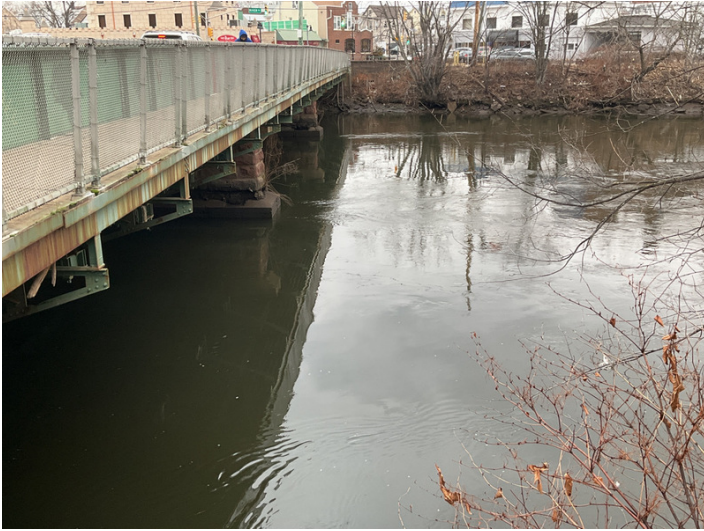
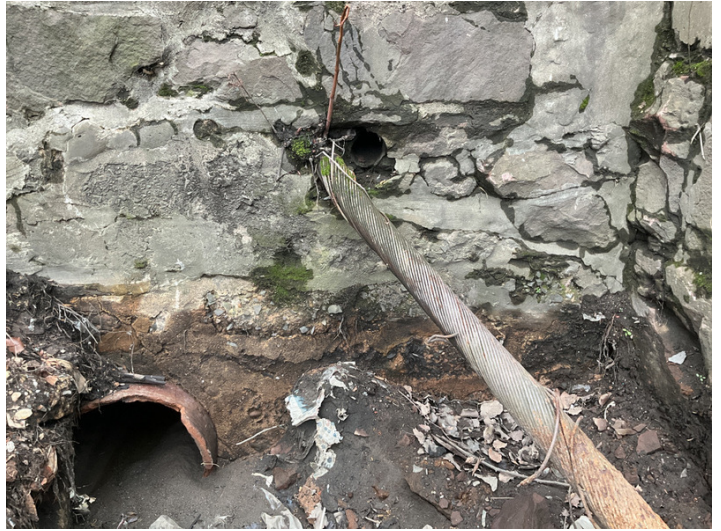
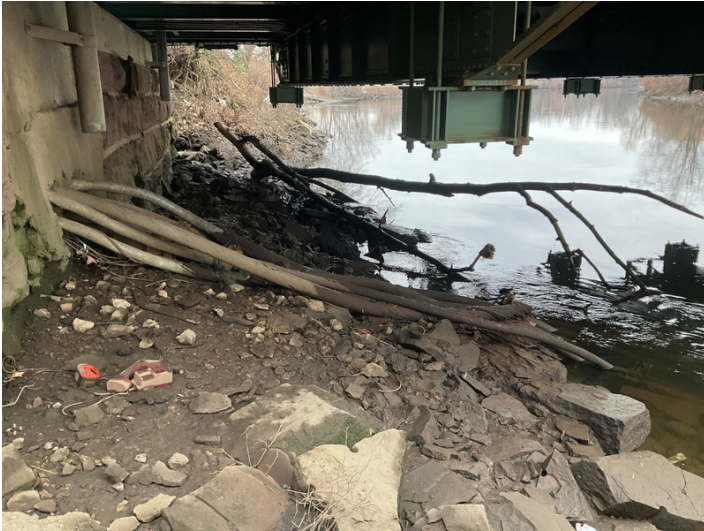
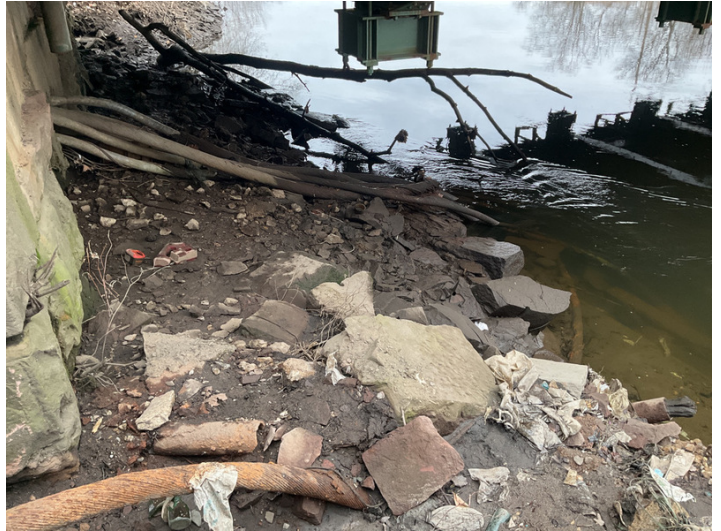
General Site Notes | 1 Wall Street. Both banks have existing visible cables.

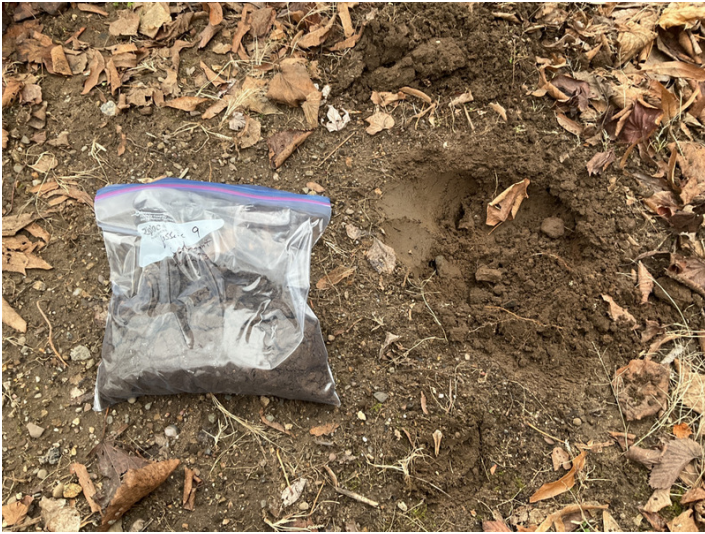
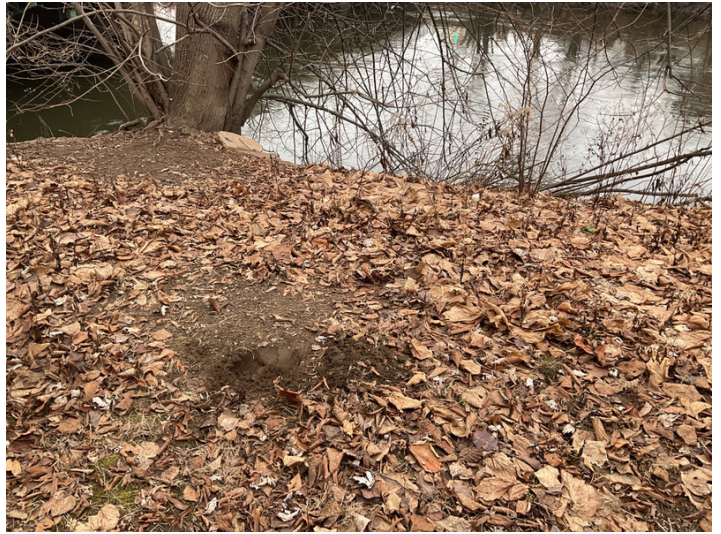
Type of Sample for GS	Sediment Collection
Location of Collected Sample - GS	Contol
Time of Collection - GS	15:01
Sample Prefix - GS	Passaic
Sample ID (#) - GS	9
Additional Notes - GS (if any)	None.

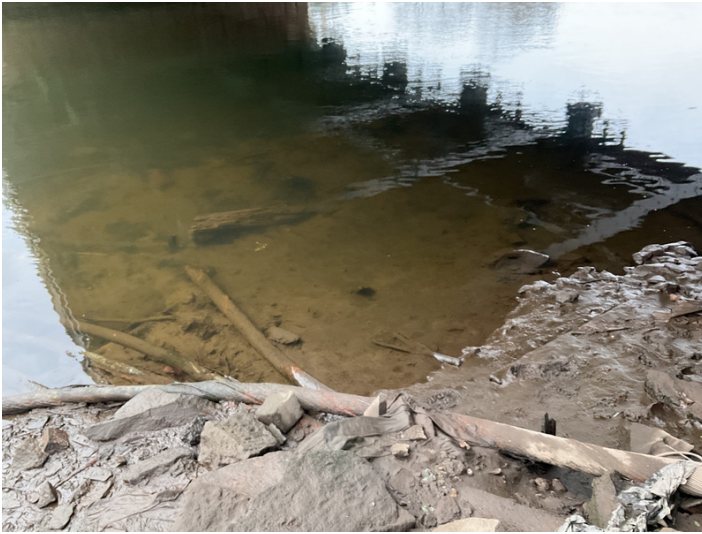
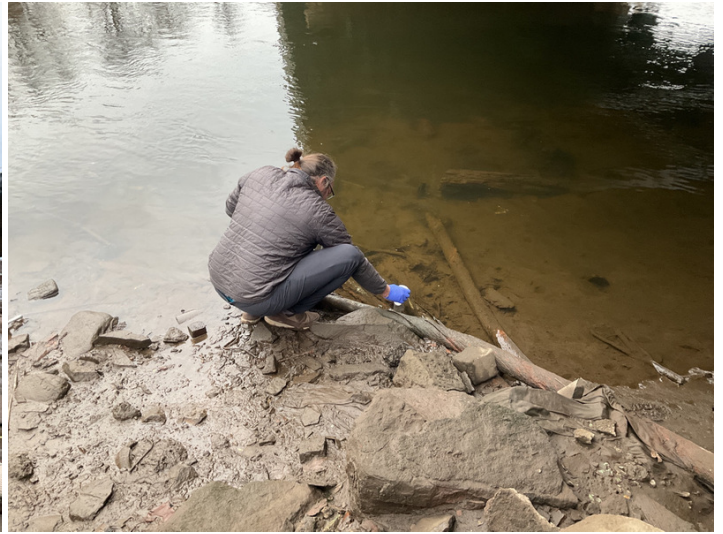
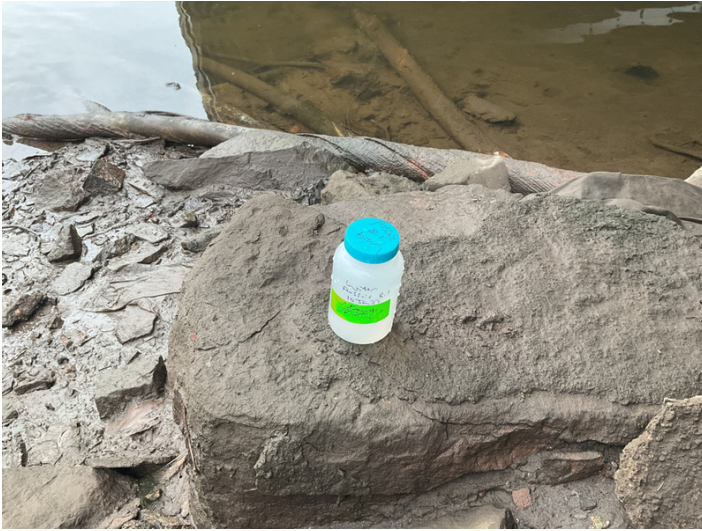
Sample Information - Specific Cable - 1. Water: Directly on Cable, 8.1

Type of Sample	Water: Directly on Cable
If more than one cable, what Cable was Sample collected from?	All
Time of Collection - Specific Cable	15:10
Sample Prefix - Specific Cable	Passaic
Sample ID (#) - Specific Cable	8.1
Additional Notes - Specific Cable Sample (if any)	All
Photo of Specific Cable Sample(s)

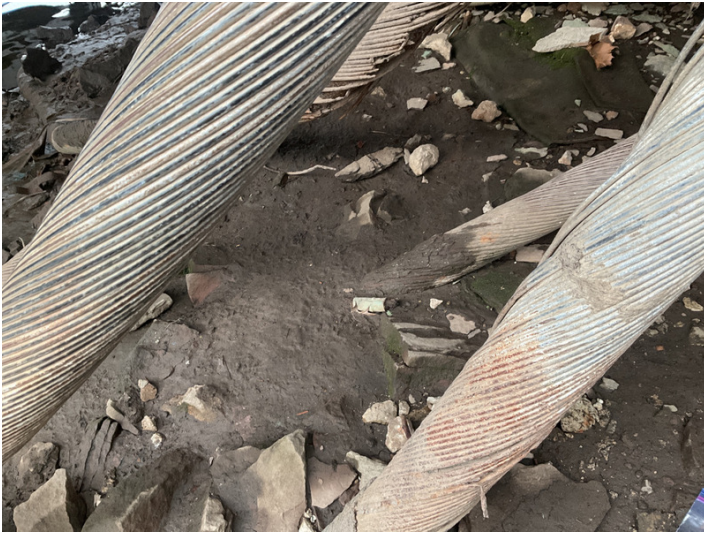
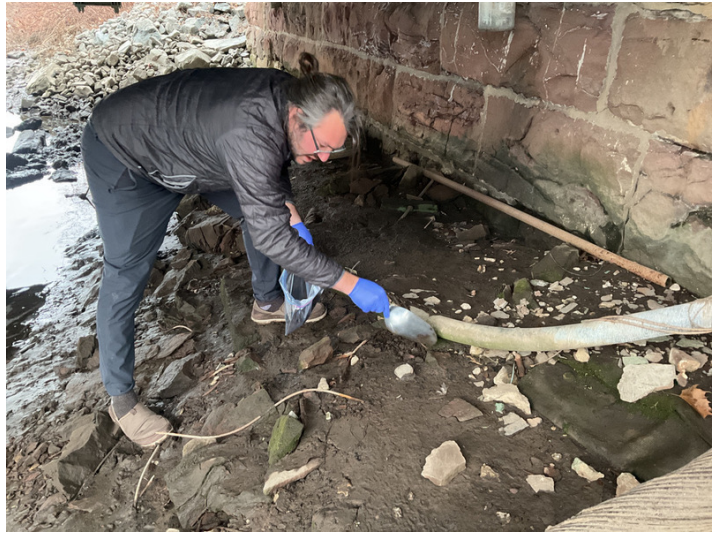
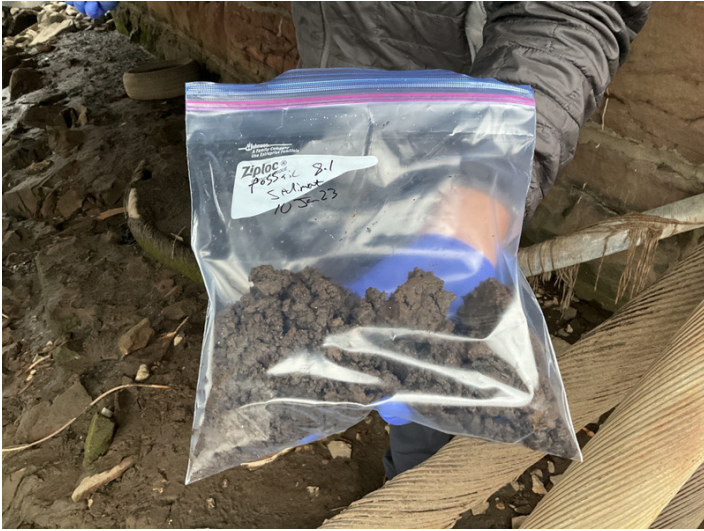
Sample Information - Specific Cable - 2. Sediment Collection, 8.1

Type of Sample	Sediment Collection
If more than one cable, what Cable was Sample collected from?	All
Location of Collected Specific Cable Sample	Under the Cable
Time of Collection - Specific Cable	15:11
Sample Prefix - Specific Cable	Passaic
Sample ID (#) - Specific Cable	8.1
Additional Notes - Specific Cable Sample (if any)	None.
Photo of Specific Cable Sample(s)

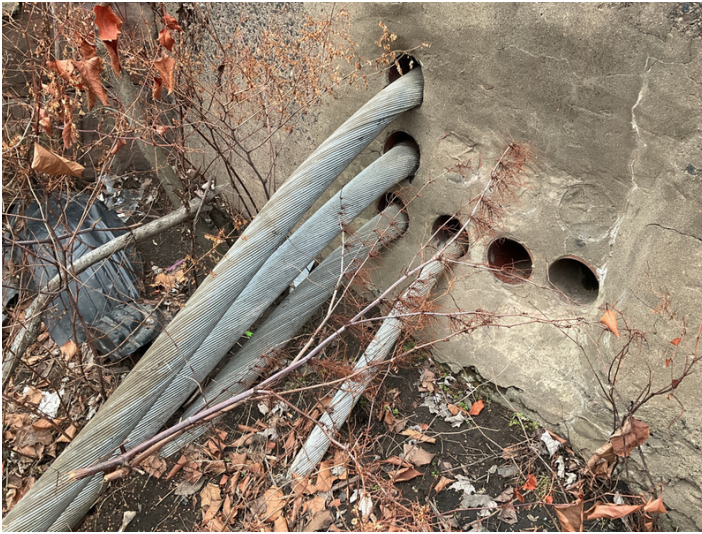
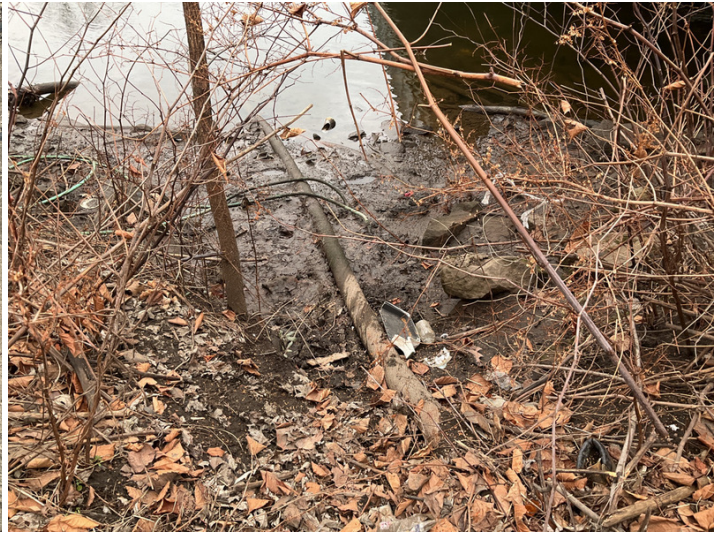
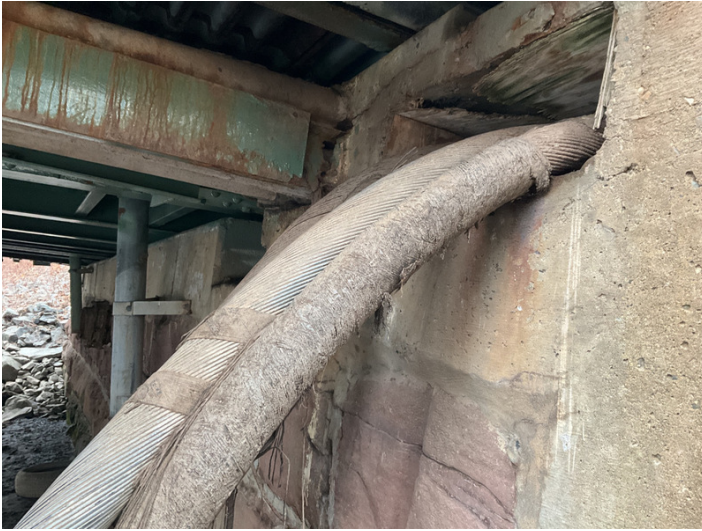
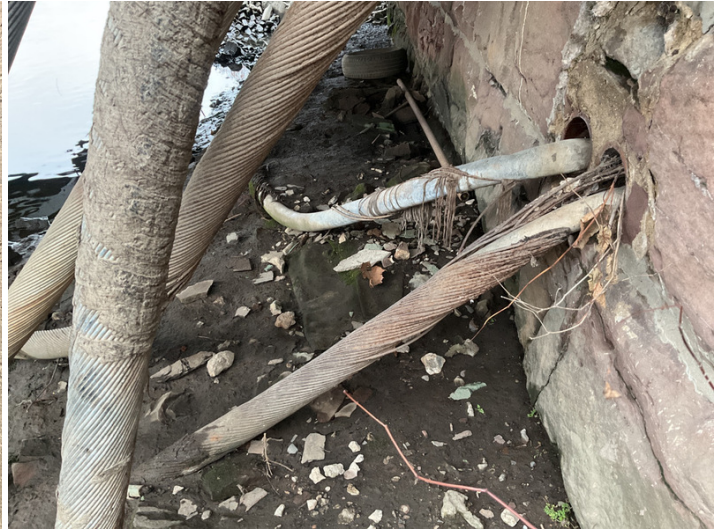
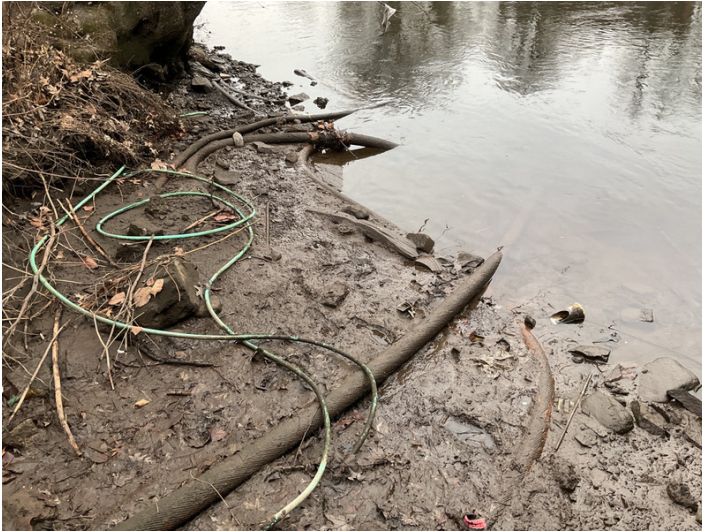
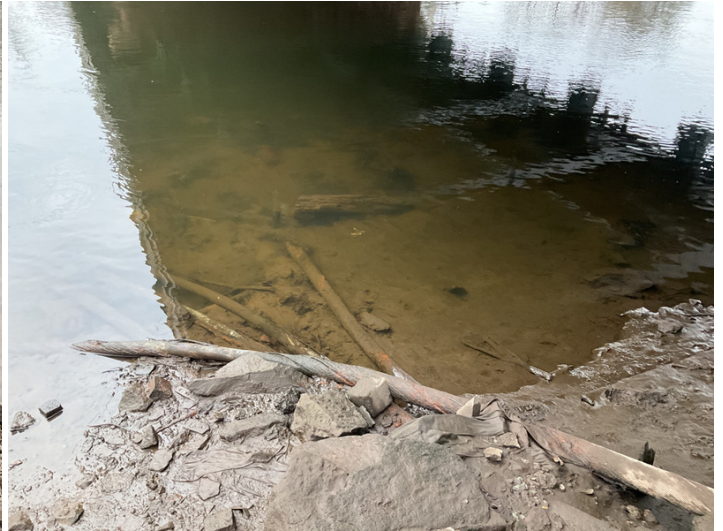
Bridge was built in 1898.

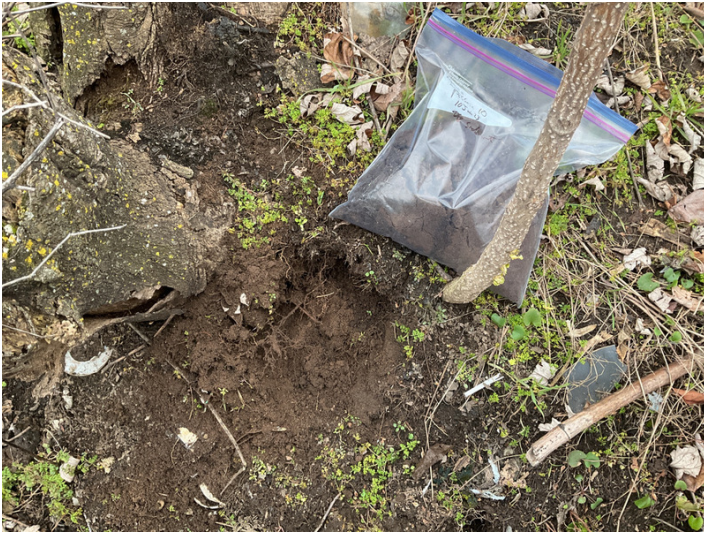
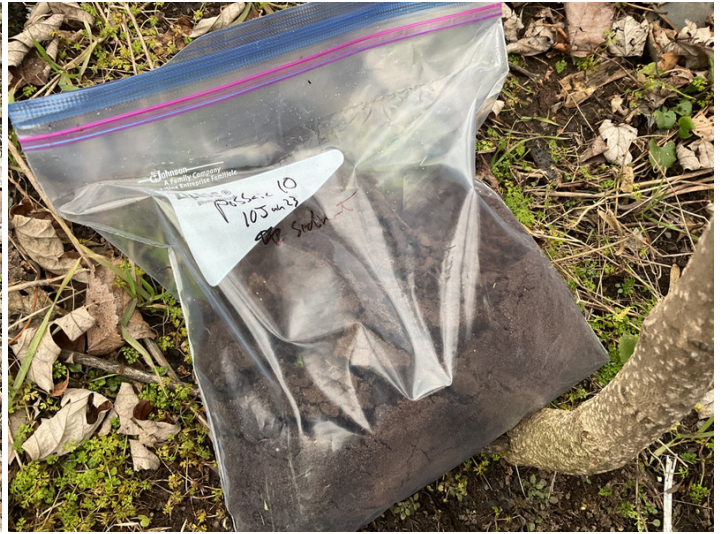
Photo of GS Sample(s)

Type of Sample for GS	Sediment Collection
Location of Collected Sample - GS	Within Control Sample Limits
Time of Collection - GS	15:19
Sample Prefix - GS	Passaic
Sample ID (#) - GS	10
Additional Notes - GS (if any)	None.

General Site Notes | Control Sediment.

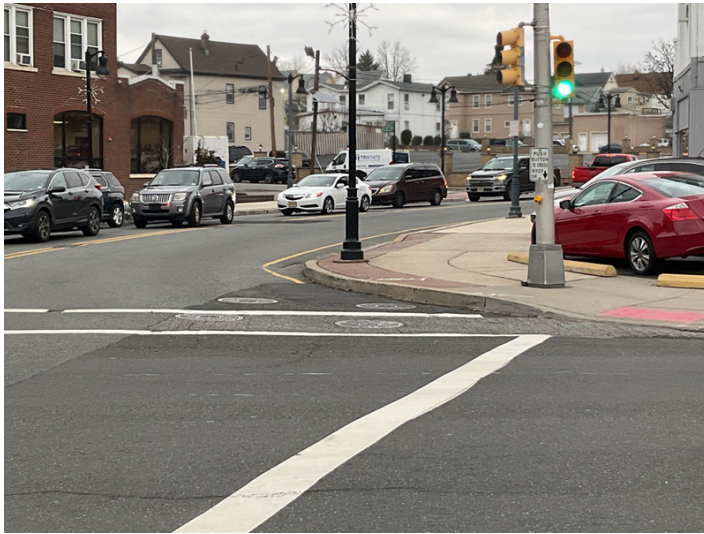
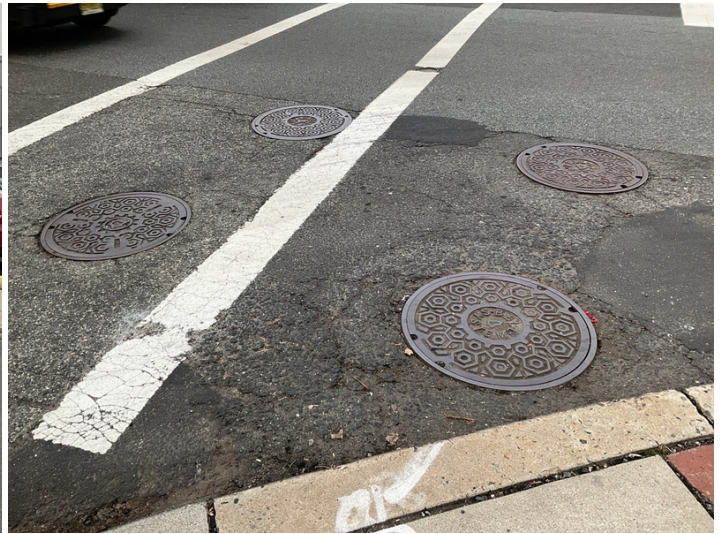
Bell Systems MHx4. Associated with Passaic Site 8.

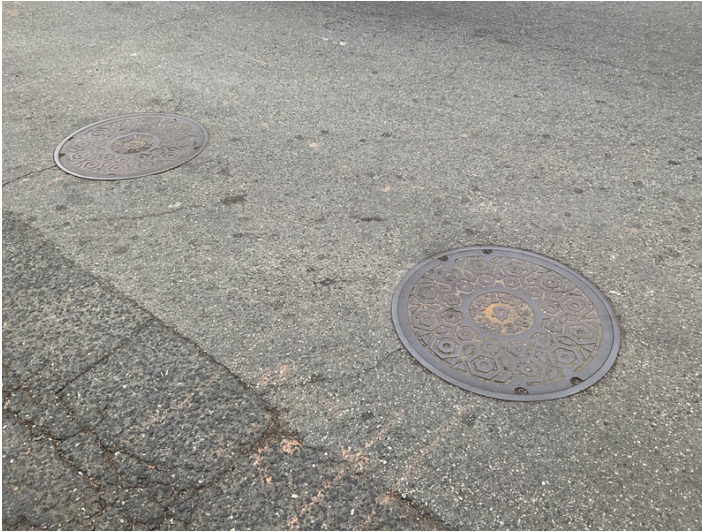
Bell Systems MHx2. Associated with Passaic Site 8.

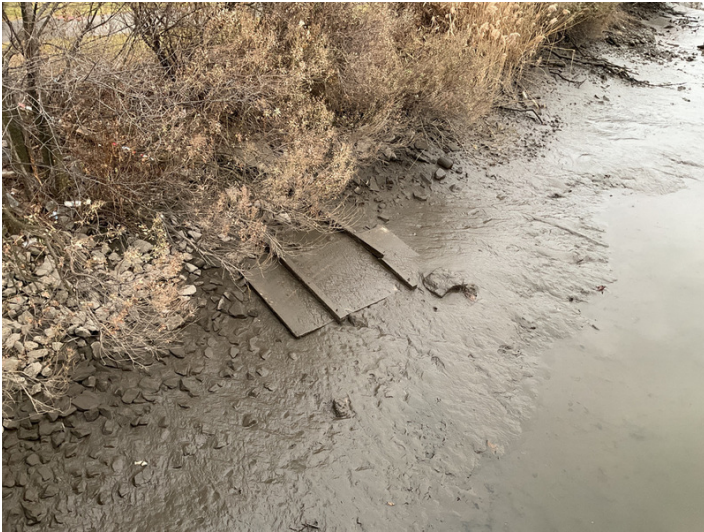
Sign posts are broken and the sign is face down along the river bank in the muck.

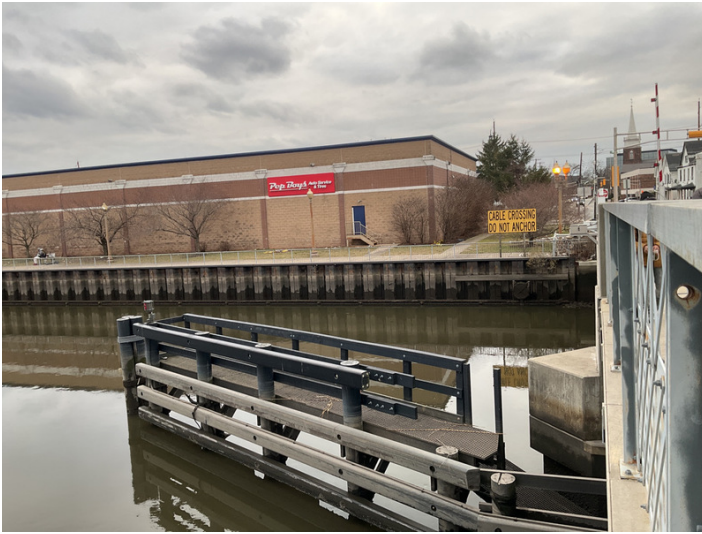
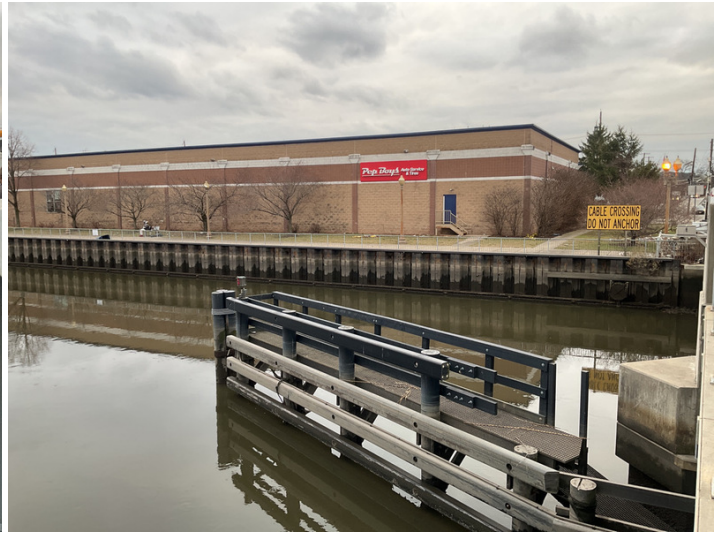
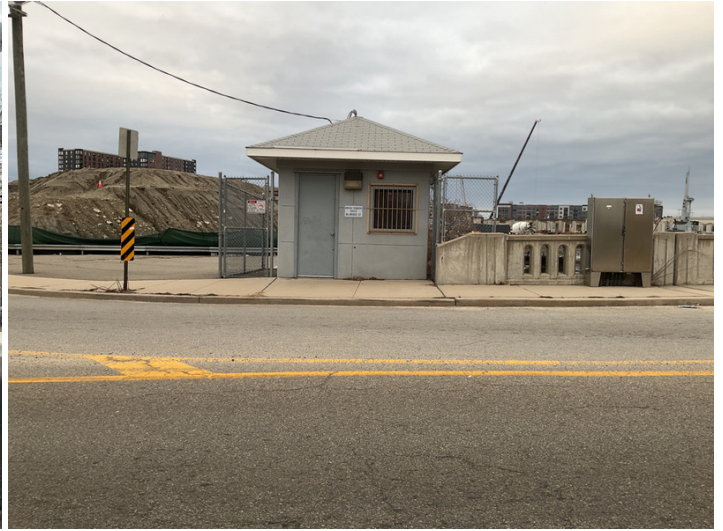
Site Locations - 23. Hackensack, 4.1

General Site Notes | Permit notes suggest that the bridge tender could see the cables at low tide in 1936. Bell Systems MHx2 on the west side of the bridge.

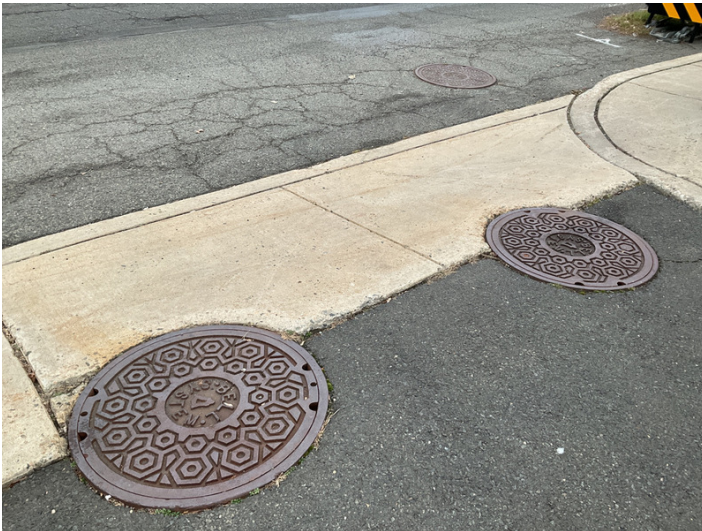
General Site Notes | Bell Systems MHx3.

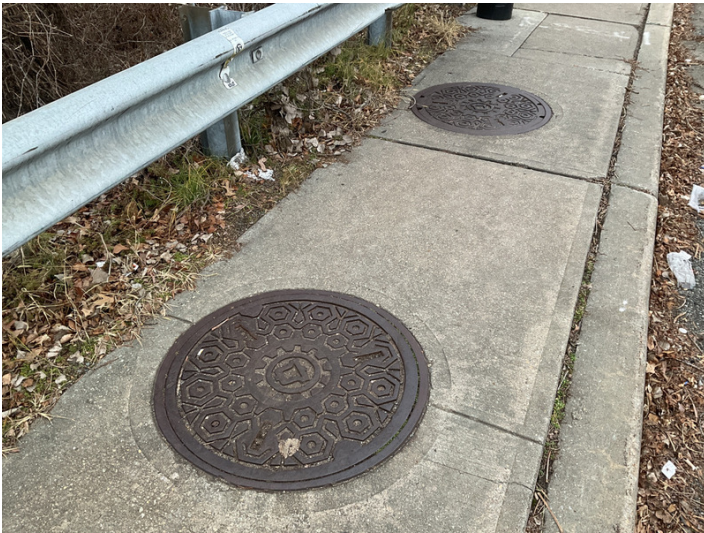
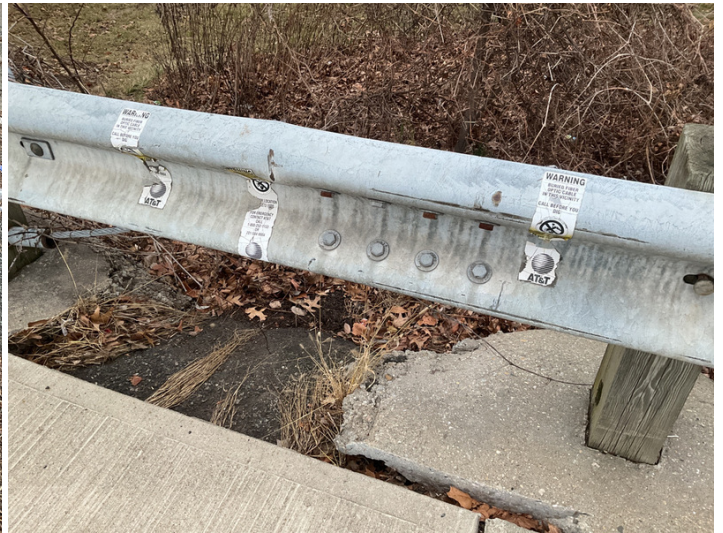
General Site Notes | Bell Systems MHx2. AT&T stickers along sidewalk railing.
