# RESIDENTIAL REPORT

1234 Main St. Jackson, Wyoming 83002

Buyer Name 01/14/2020 9:00AM

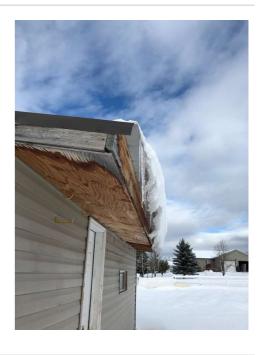
3.5.1 Eaves, Soffits & Fascia

#### **EAVES - DAMAGED**

One or more sections of the eaves are damaged. Recommend qualified roofer evaluate & repair.

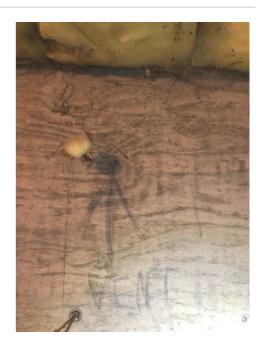
4.1.2 Foundation

# POOR VENTILATION OF FOUNDATION AREA

The foundation is poorly ventilated. All vent spaces are covered by insulation. Increased ventilation (introduction and movement of fresh air) is recommended. This can be accomplished by partially opening vents on opposite sides of the foundation on a regular basis (when weather is suitable).

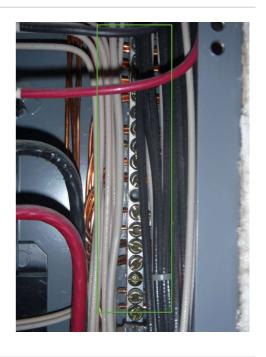
Best building practice method is each wire terminates to one terminal lug. Recommend evaluation.

Contact a qualified electrical contractor.

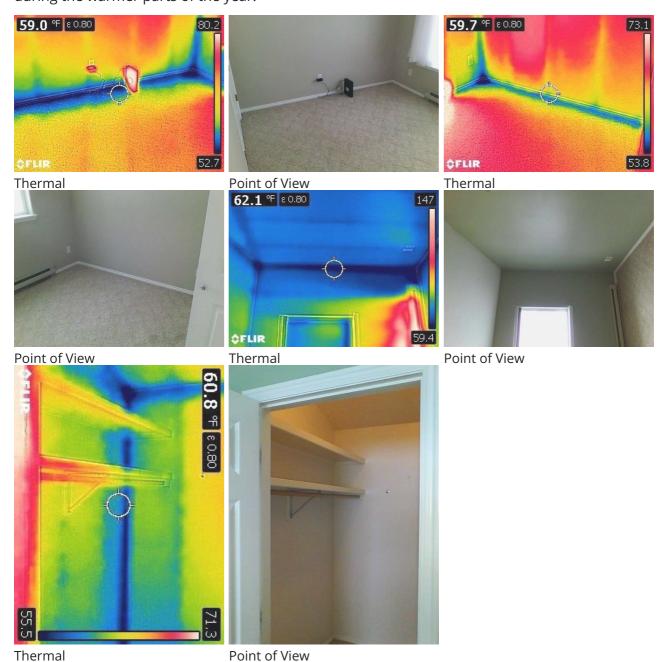
View images below from the left to right, first is the thermal image followed by it's point of view. Blue indicates a colder temperature range.

Infrared imaging reveled that points of the building had minimal insulation. This occurrence will increase the cost of heating during the coldest parts of the year and may also increase the interior temperatures during the warmer parts of the year.

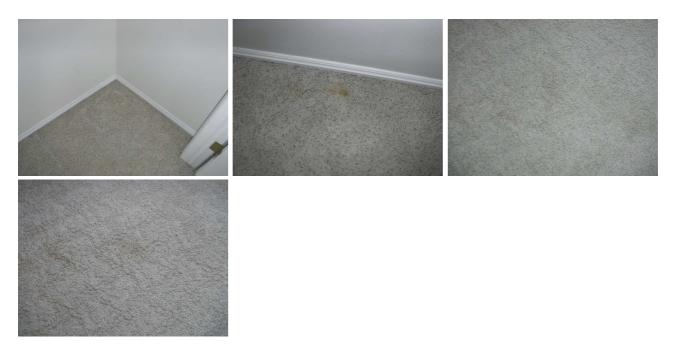
### **CARPET STAINS**

Carpet had areas of staining or discoloration. Recommend a thorough steam clean by a qualified carpet cleaning company

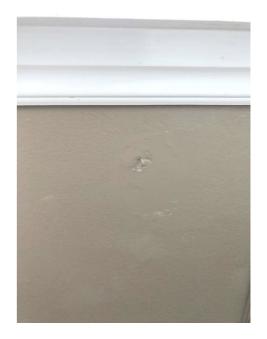
Wall had damage from doorknob. Recommend a qualified handyman or drywall contractor repair.

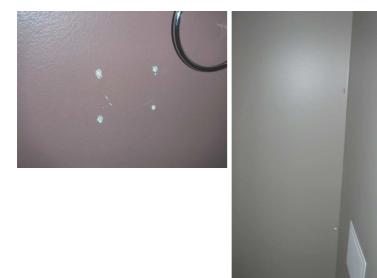
# MINOR DAMAGE TO WALLS
