COMMUNITY MONITOR COMMITTEE

Altamont Landfill Settlement Agreement

*COMMUNITY MONITOR
COMMITTEE
Altamont Landfill Settlement Agreement
Minutes of January 12, 2011*

*COMMUNITY MONITOR
COMMITTEE
Altamont Landfill Settlement Agreement
Minutes of April 13, 2011*

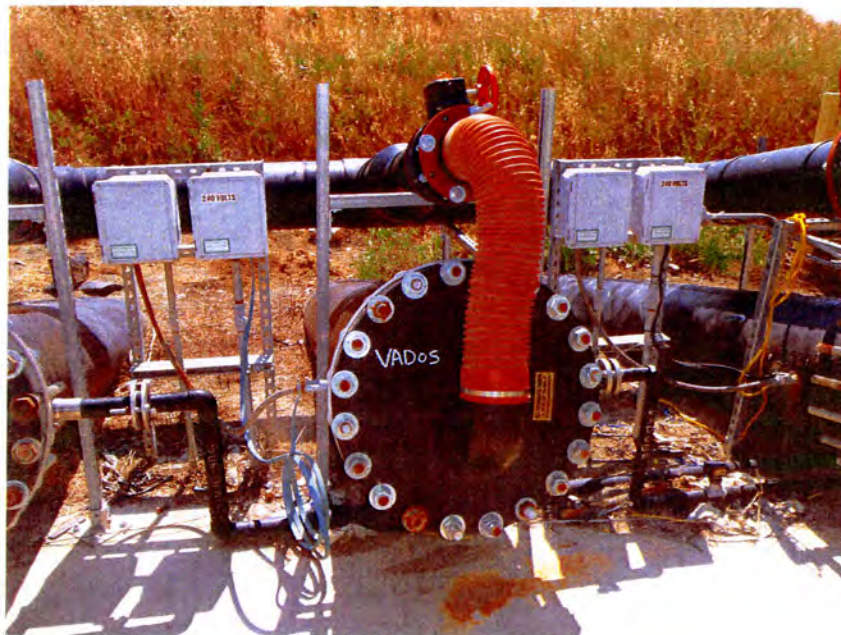
This photograph shows the vadose zone header for the Class II unit in fill area 1.

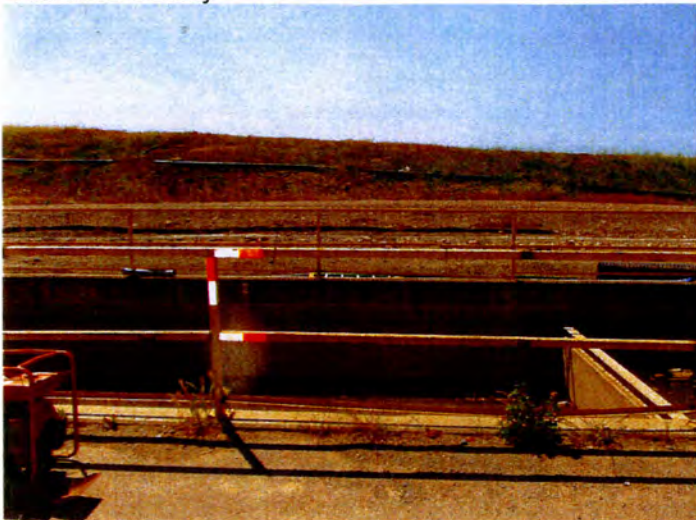
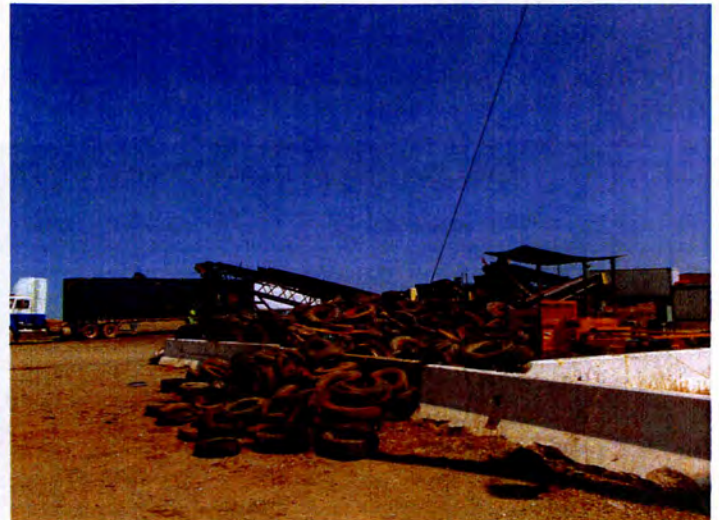
Adjacent to the scale house, at the entrance to the operations area, are the sumps for the truck washing operation. Across the access road from the sumps is the tire shredding operation. Both of these operations are identified in Finding 7 of the WDRs as an ancillary facility.

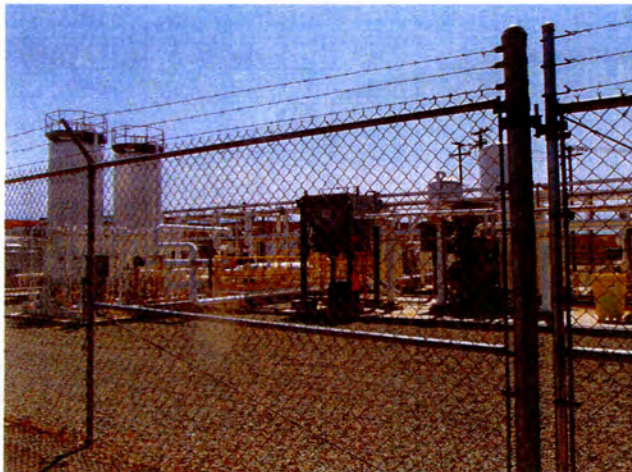
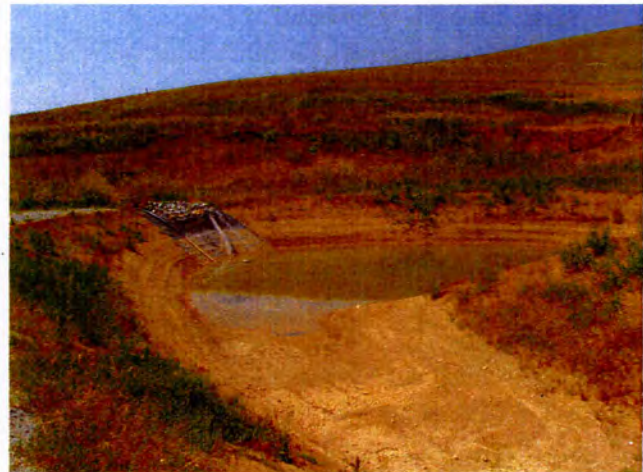
Adjacent to the tire shredding operation is the landfill gas liquefaction plant. Landfill gas is converted to a liquid where it is transported offsite as liquefied methane. Just west of the scale house, across the site access road, is an unlined basin. The Discharger uses this as a fresh water reservoir.

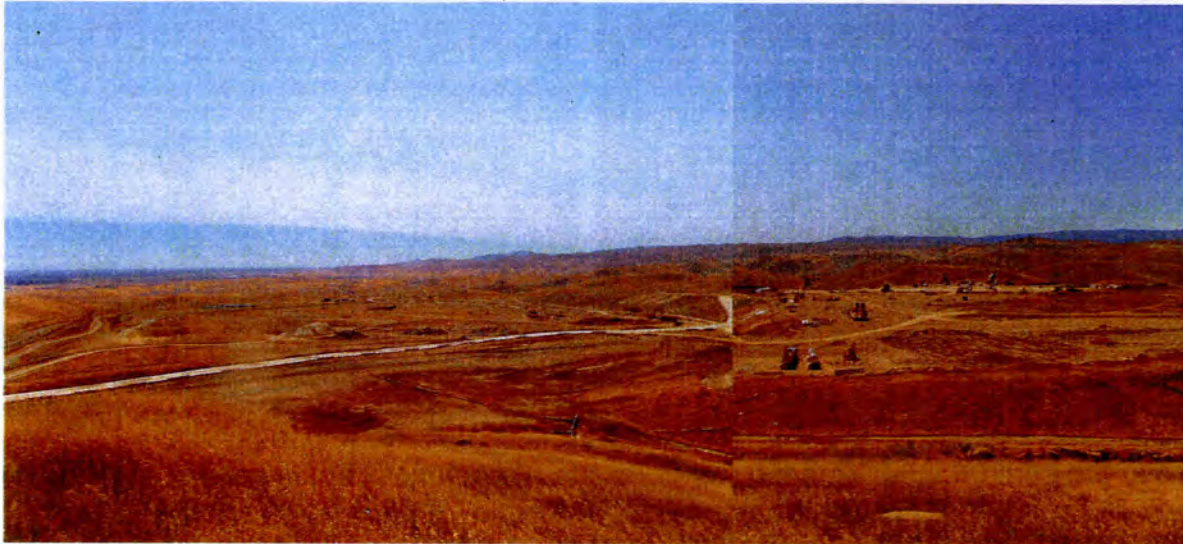
This photograph shows a portion of the operations area. The working face is directly ahead. The photograph shows that the entire area is under interim/daily cover. The only area that is unprotected is the working face.

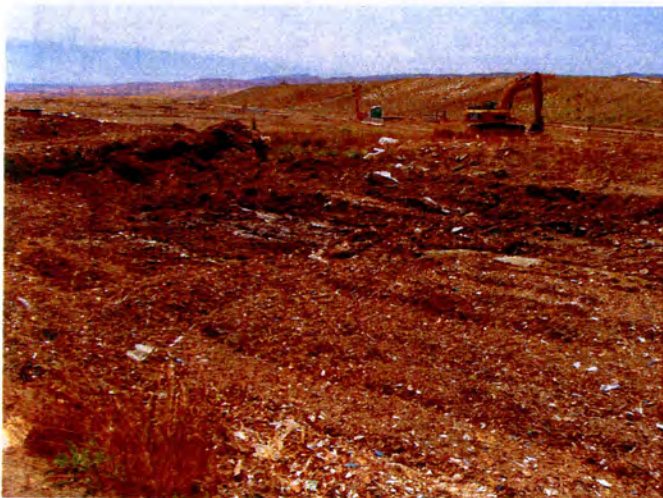
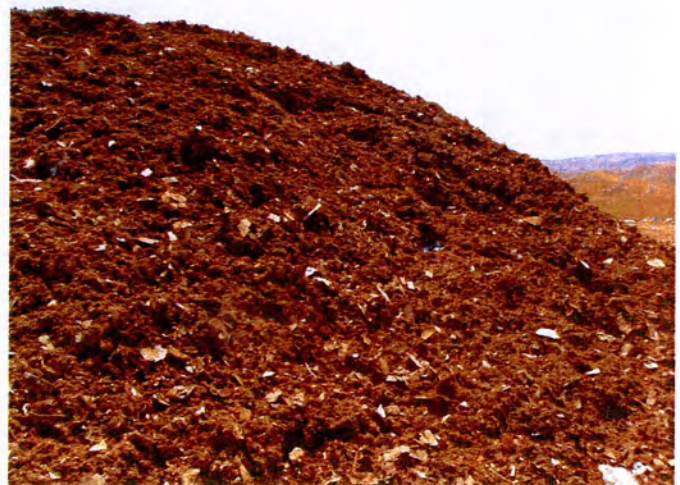
The first picture shows the Discharger's solidification process that receives non-hazardous liquid and semi-solid wastes and grease trap pumpings. Solidification of non-hazardous liquid and semi-solid wastes and grease trap pumpings takes place in clay-lined pits located in the Class II area to prevent rapid infiltration of the discharged liquid waste (see Finding 14 of the WDRs for more detail). The second photograph shows a pile of treated auto shredder waste that is used for alternate daily cover (see Finding 17 of the WDRs for more detail).

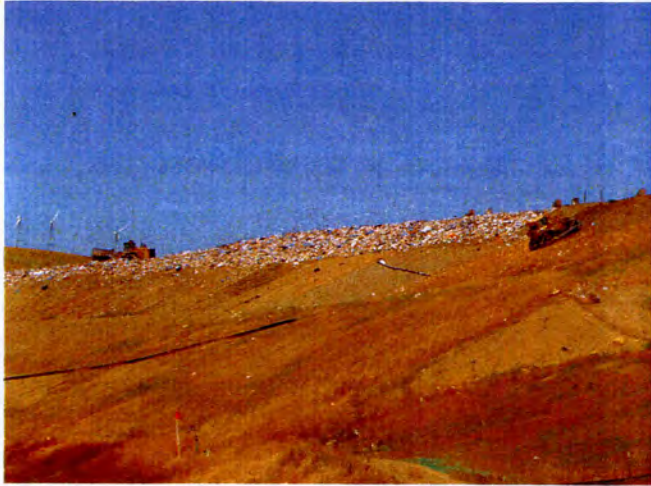
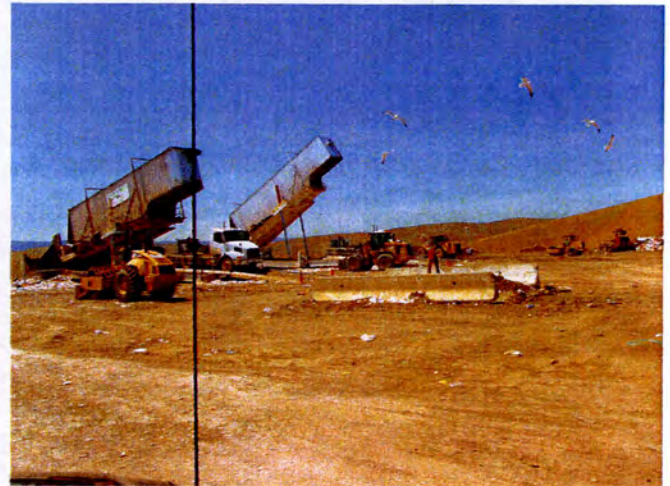
The first photograph shows the working face from below. The second photograph shows the trailer tippers lifting the trailers back to dump their loads.

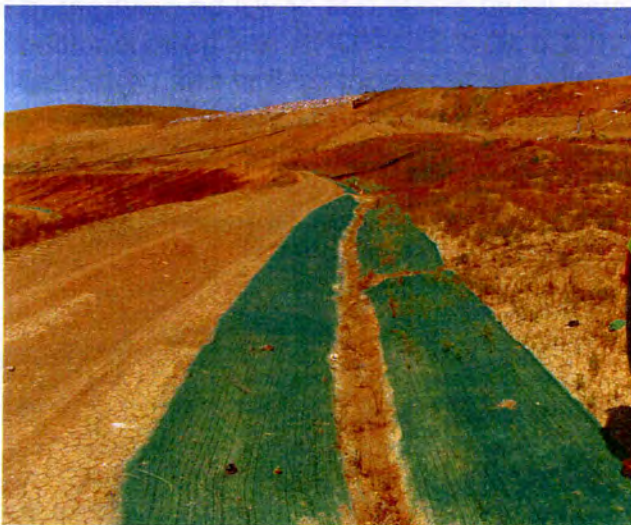
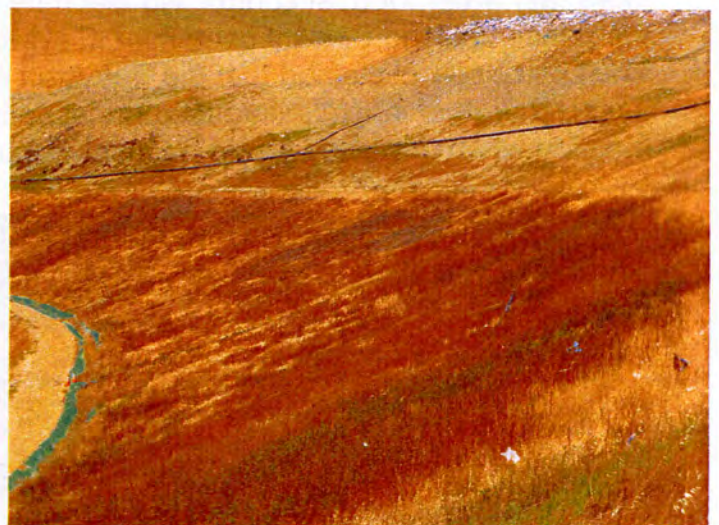
The first photograph shows the screen material that was installed in the runoff ditches as a method for controlling sediment running off the landfill. The presence of sediment in the trough indicates that additional controls are needed to control sediment runoff. The second photograph shows dead vegetation on the landfill slope. Improving the vegetation on the southern slope of the landfill should be part of the landfill's winterization program for the upcoming wet season.

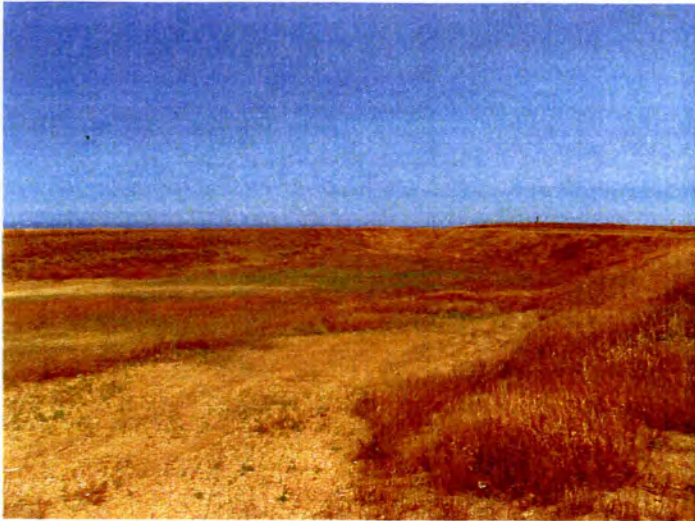
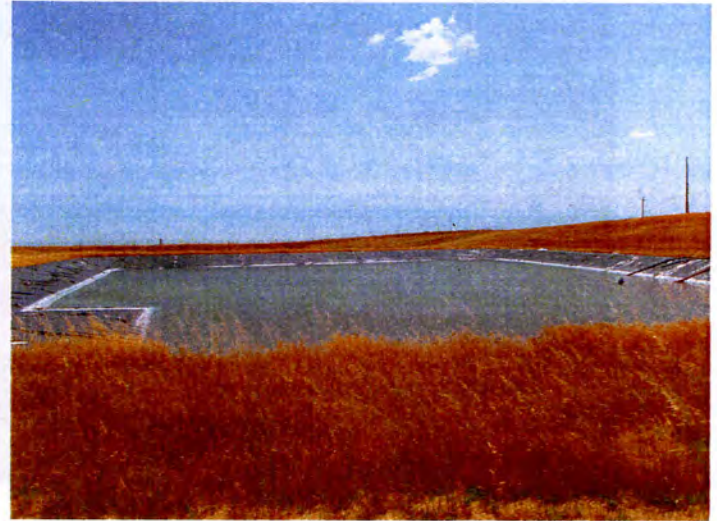
The Discharger has completed grading of the foundations for two new Class II surface impoundments. Currently, one of the impoundments has a sacrificial liner that is being used to store rain water for dust control. No leachate or other liquid waste has or will be discharged to the ponds until the Class II containment system, approved in the WDRs, has been installed. The Discharger explained that the Bay Area Air Quality Management District has prohibited the discharge of leachate into the ponds, because of the volatilization of VOCs. There was no mention when this issue would be resolved and construction would be completed.

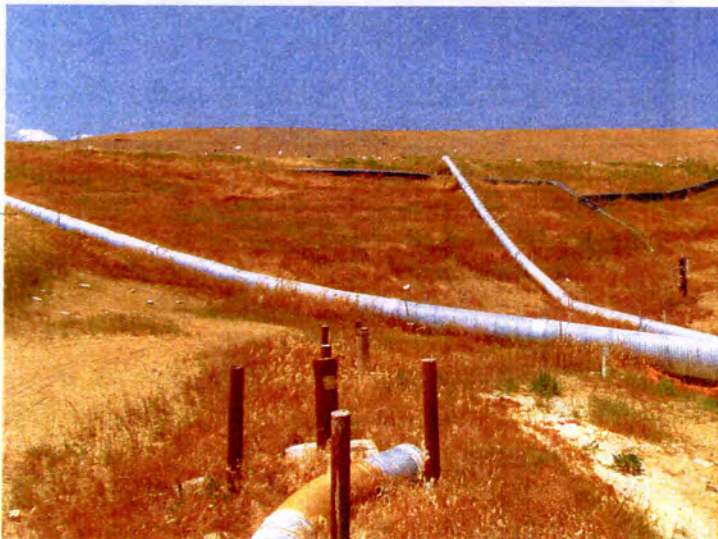
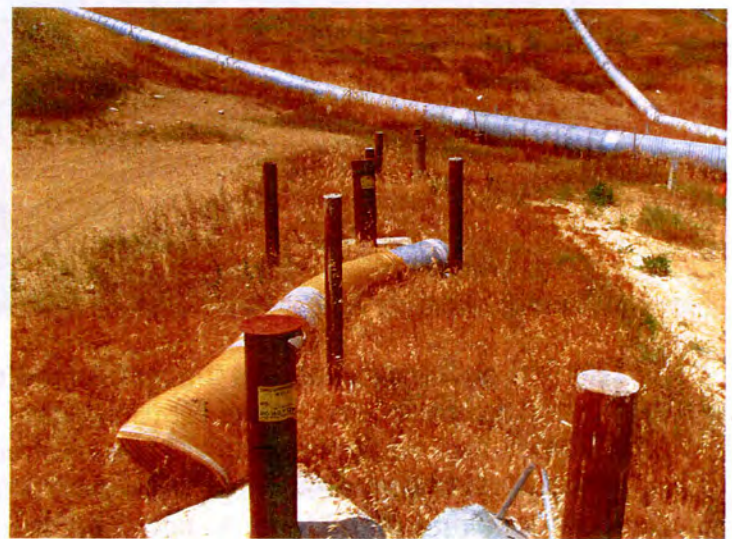
Monitoring well E20B sits on the eastern flank of the landfill. This well has detection of cis 1,2 DCE and vinyl chloride and is currently under corrective action. The photograph also shows the stormwater piping used to move stormwater off the site and into a retention basin.
