# COMMUNITY MONITOR COMMITTEE

## Altamont Landfill Settlement Agreement

## ALRRF Community Monitor Monthly Report

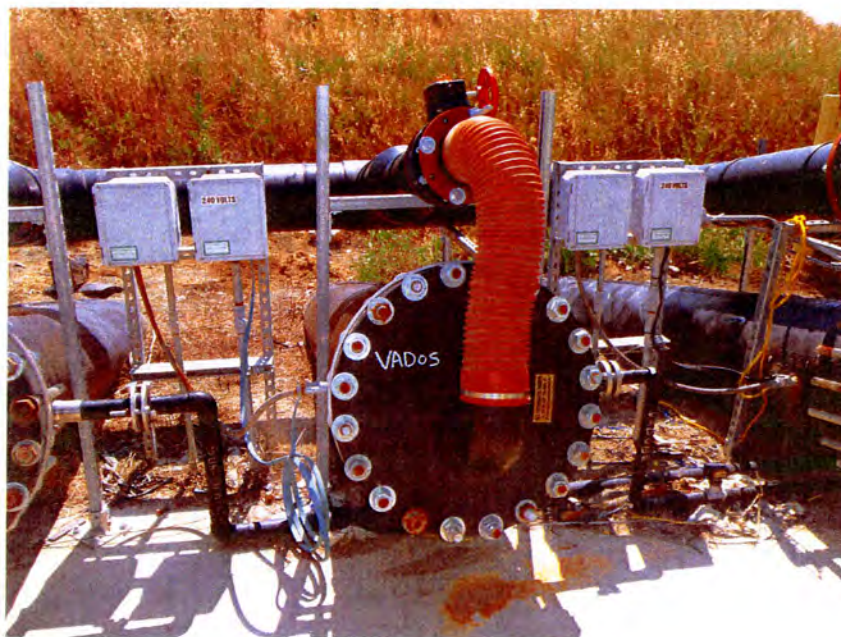
This photograph shows the vadose zone header for the Class II unit in fill area 1.

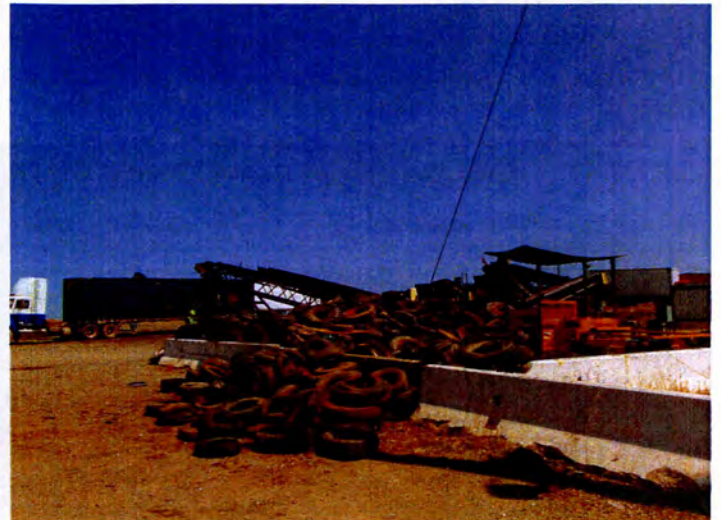
Adjacent to the scale house, at the entrance to the operations area, are the sumps for the truck washing operation. Across the access road from the sumps is the tire shredding operation. Both of these operations are identified in Finding 7 of the WDRs as an ancillary facility.

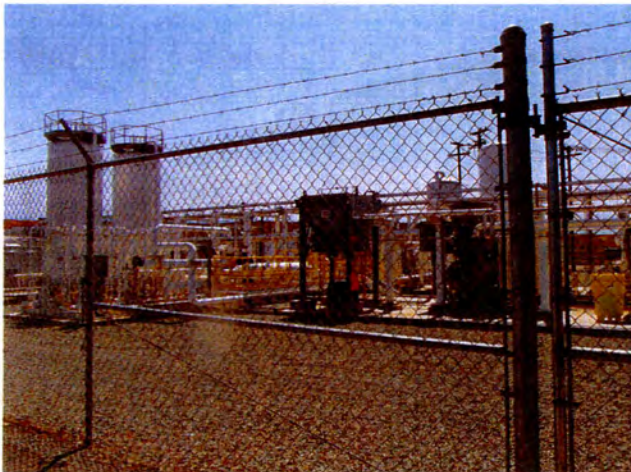
Adjacent to the tire shredding operation is the landfill gas liquefaction plant. Landfill gas is converted to a liquid where it is transported offsite as liquefied methane. Just west of the scale house, across the site access road, is an unlined basin. The Discharger uses this as a fresh water reservoir.

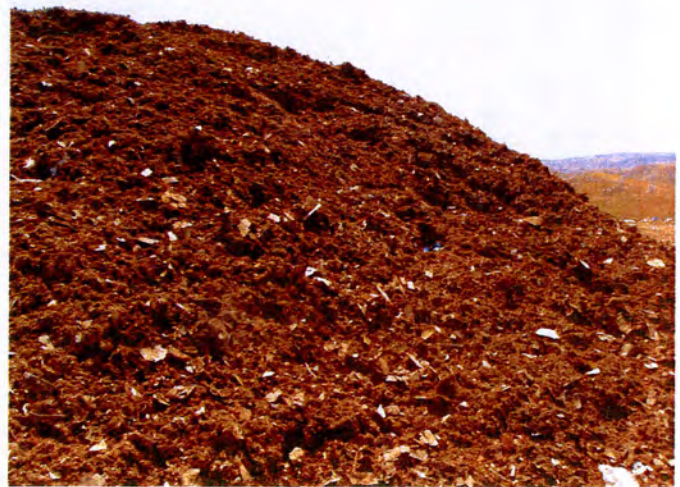
The first picture shows the Discharger's solidification process that receives non-hazardous liquid and semi-solid wastes and grease trap pumpings. Solidification of non-hazardous liquid and semi-solid wastes and grease trap pumpings takes place in clay-lined pits located in the Class II area to prevent rapid infiltration of the discharged liquid waste (see Finding 14 of the WDRs for more detail). The second photograph shows a pile of treated auto shredder waste that is used for alternate daily cover (see Finding 17 of the WDRs for more detail).

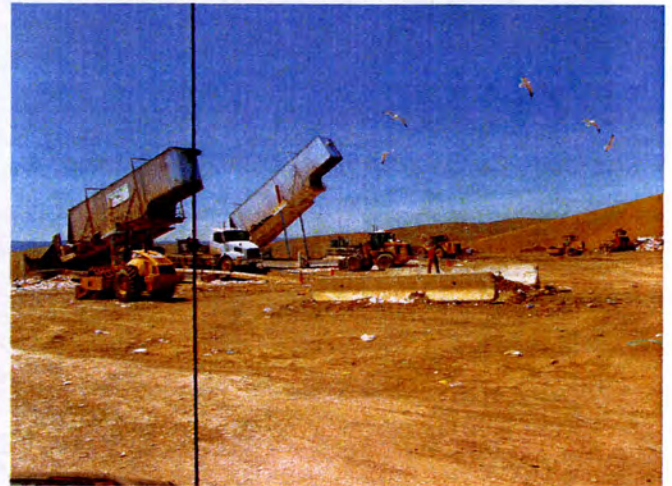
The first photograph shows the working face from below. The second photograph shows the trailer tippers lifting the trailers back to dump their loads.

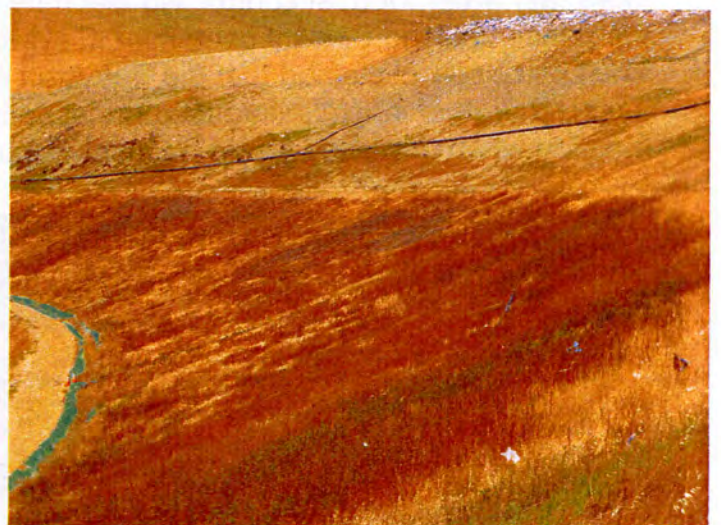
The first photograph shows the screen material that was installed in the runoff ditches as a method for controlling sediment running off the landfill. The presence of sediment in the trough indicates that additional controls are needed to control sediment runoff. The second photograph shows dead vegetation on the landfill slope. Improving the vegetation on the southern slope of the landfill should be part of the landfill's winterization program for the upcoming wet season.

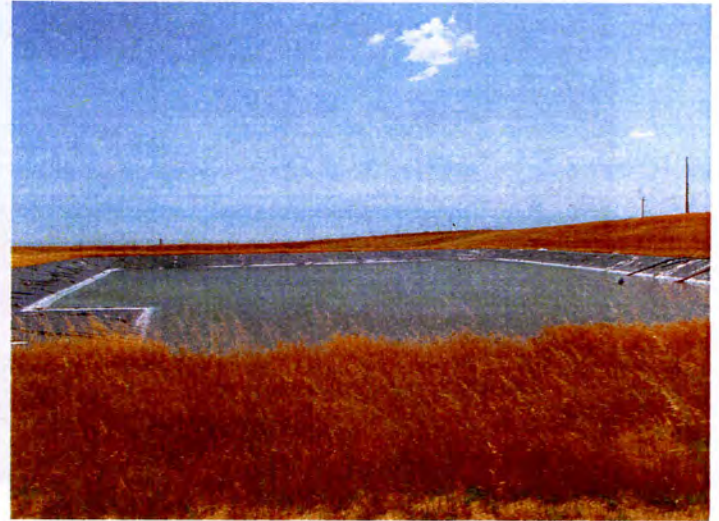
The Discharger has completed grading of the foundations for two new Class II surface impoundments. Currently, one of the impoundments has a sacrificial liner that is being used to store rain water for dust control. No leachate or other liquid waste has or will be discharged to the ponds until the Class II containment system, approved in the WDRs, has been installed. The Discharger explained that the Bay Area Air Quality Management District has prohibited the discharge of leachate into the ponds, because of the volatilization of VOCs. There was no mention when this issue would be resolved and construction would be completed.

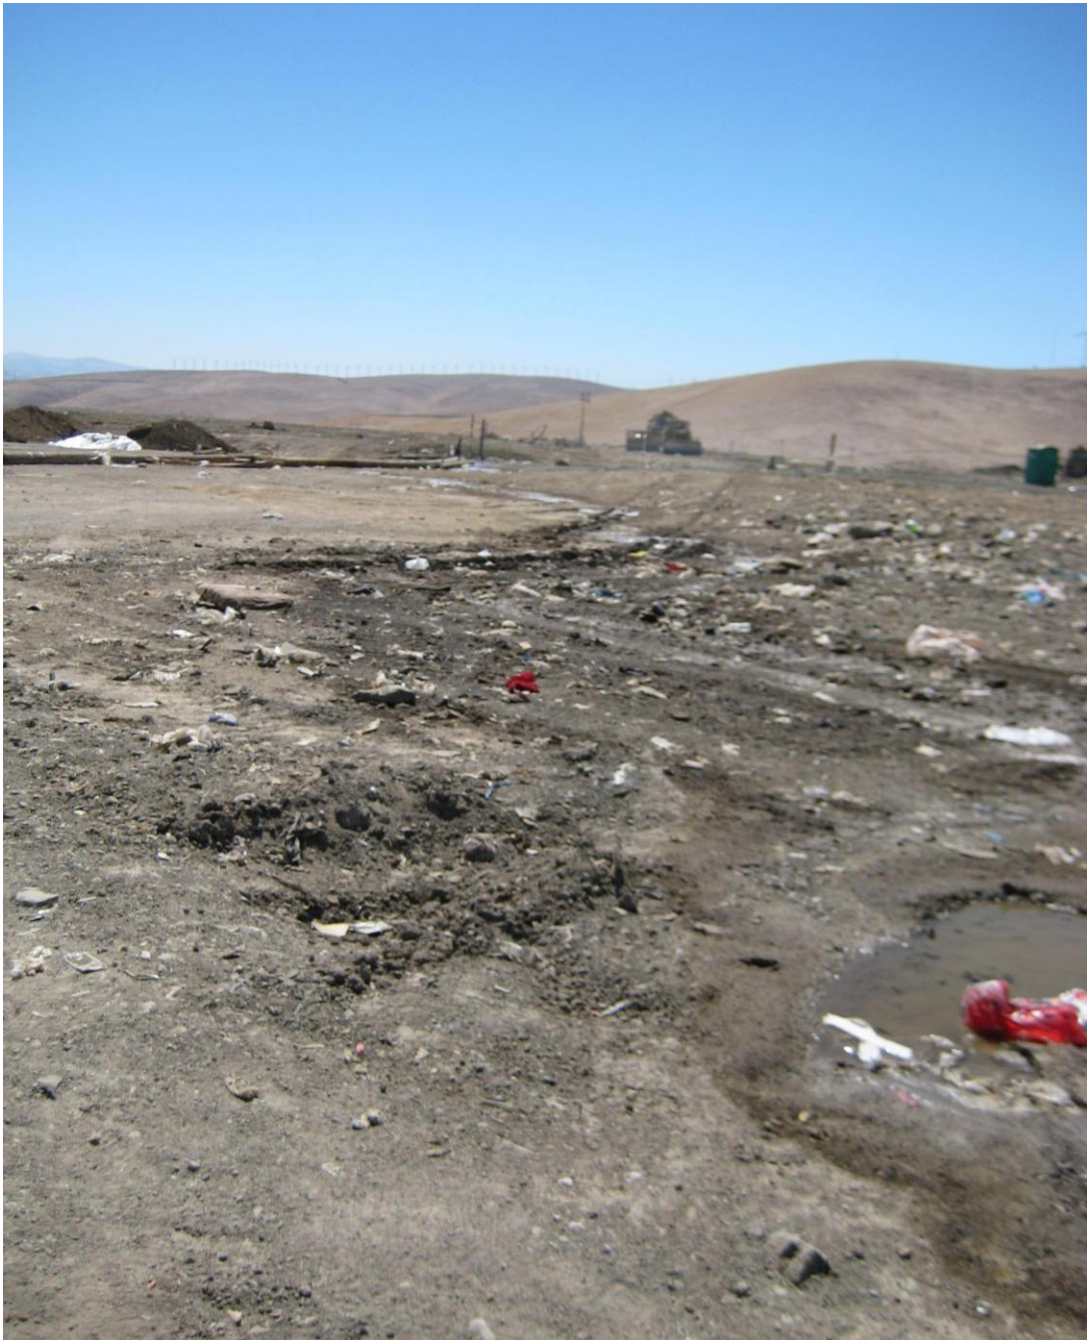
- Landfill gas system worker seen monitoring well risers for emissions.
- One bird cannon operating, one off-line but available as a back-up unit
- Minor ponding seen on top deck, east side. Appears to be from leakage from overnight parking of water wagon. See attached photo taken by LEA; wet area is in left side of photo.

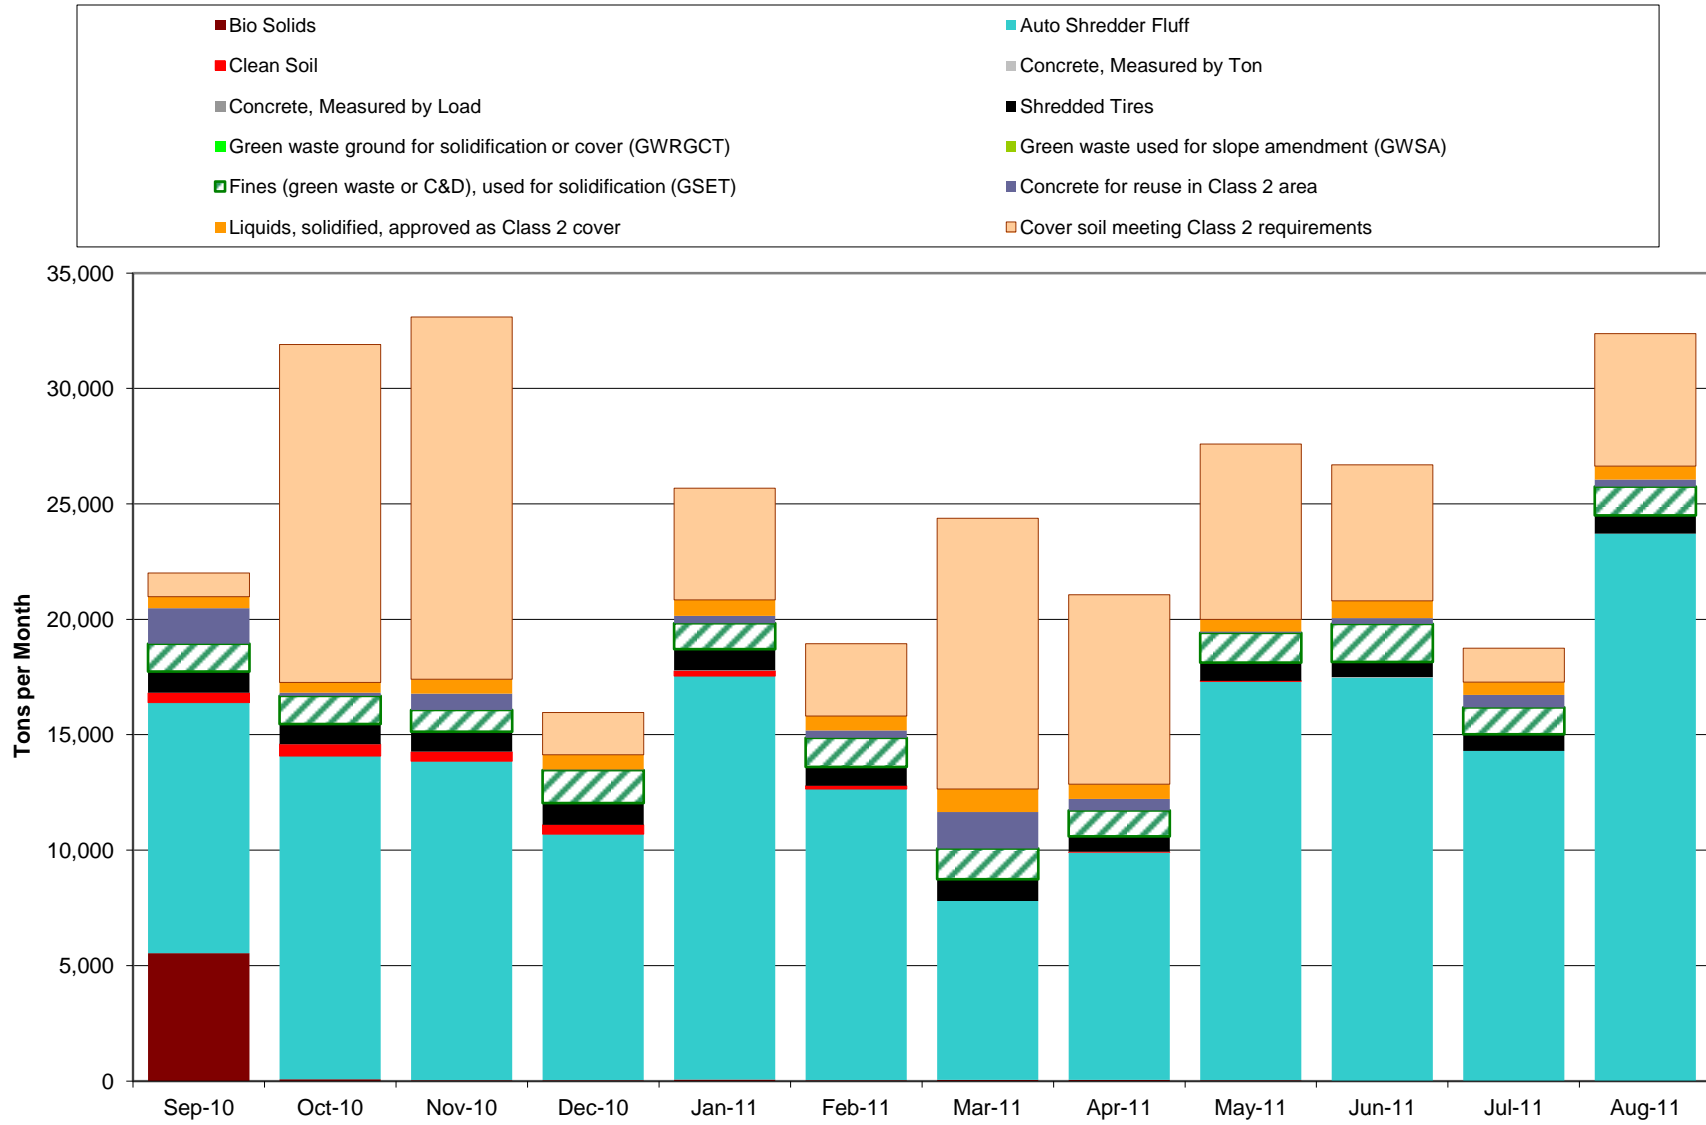
**Figure 6.3-1 Monthly Volumes of Revenue-Generating Cover**

Also attached are graphs showing monthly tonnages by type of material for the most recent 12-month period, as in prior reports. Figure 6.3-1 shows the breakdown of materials that make up Revenue-Generating Cover. Figure 6.3-2 shows these same quantities, plus the municipal solid waste tonnage on the lowest (and largest) part of each bar. It is noteworthy that no biosolids have been received by the ALRRF in a full year, and that an unusually large amount of Treated Auto Shredder Fluff was received in August. However, neither of these conditions presents a cause for concern from an environmental standpoint.

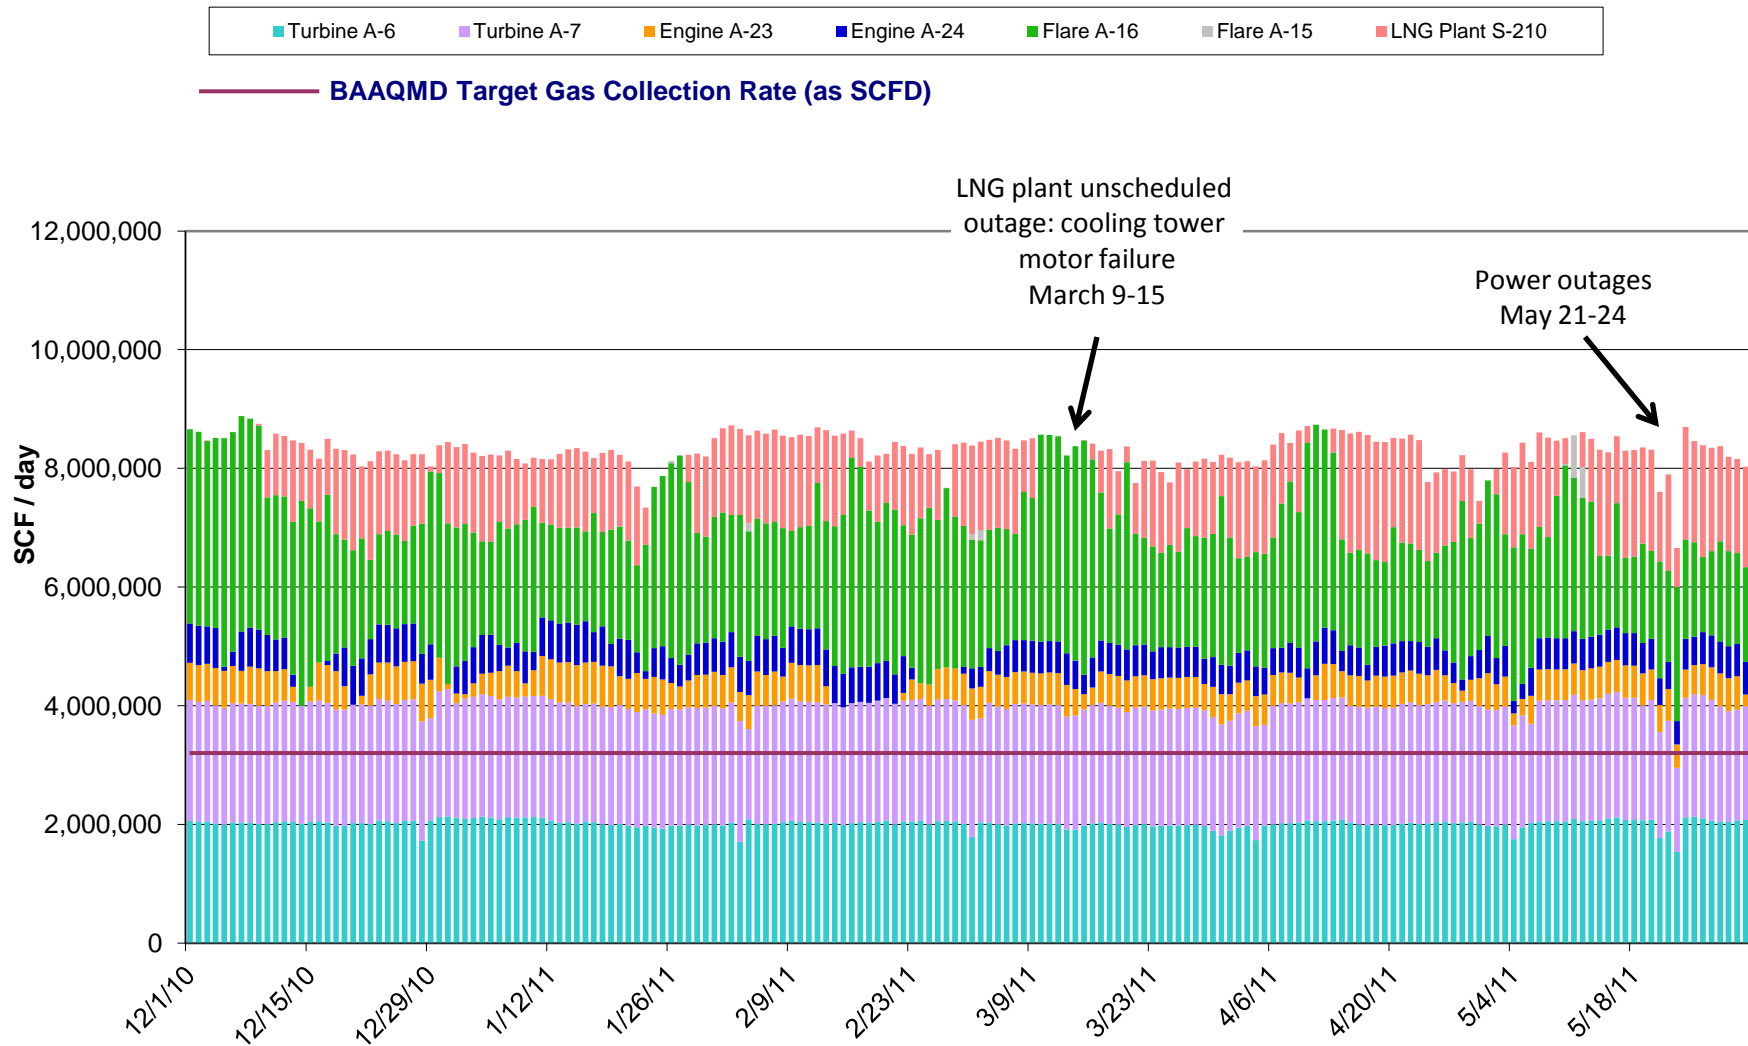
**Figure 6.4-1 - ALRRF Daily LFG Flow**  
 (values derived from Title V Report)

2. Landfill gas consuming devices (engines, turbines, flares, LNG plant) generally performed well with few outages. A power outage caused by PG&E equipment caused some disruption in the latter part of May, and the failure of a cooling tower motor kept the LNG plant from operating for 6 days in early March. Other interruptions to LNG plant operation were generally for scheduled maintenance and upgrades. Five brief outages occurred in the 6-month reporting period because of problems with the landfill gas flare associated with the plant. Figure 6.4-1, at the end of this memorandum, shows day-by-day gas consumption by all devices during this 6-month period.
