COMMUNITY MONITOR COMMITTEE

Altamont Landfill Settlement Agreement

AGENDA

ALRRF COMMUNITY MONITOR ANNUAL REPORT 2013

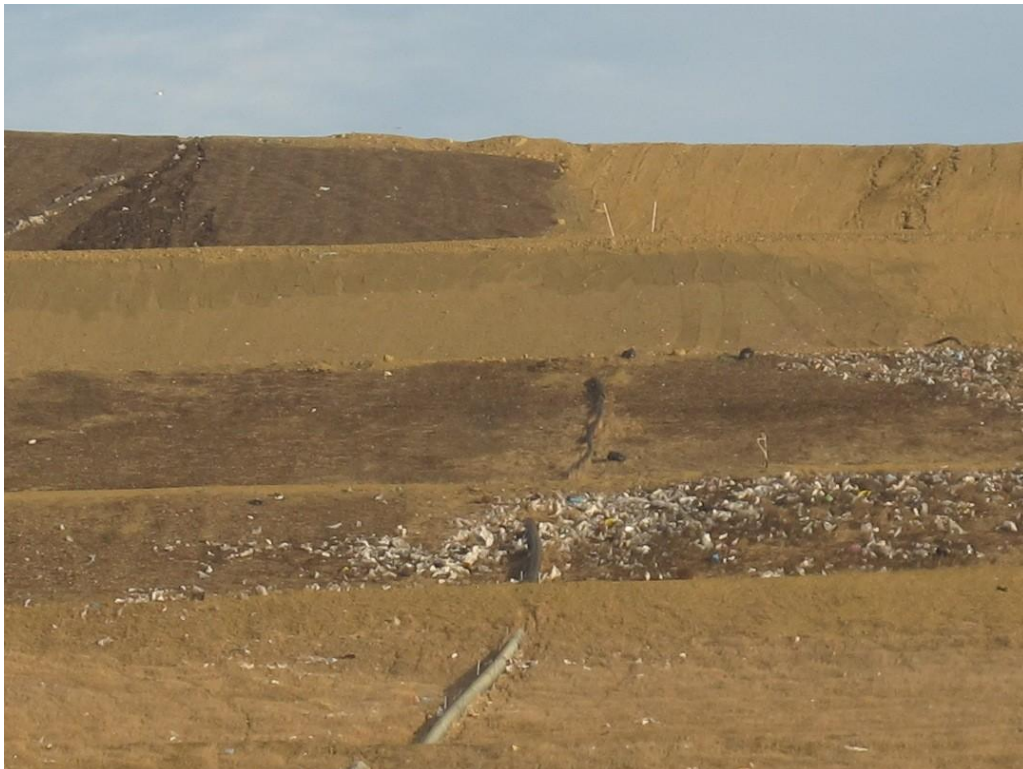
Windblown Litter. In the October 9 Committee meeting, Ms. Turner requested photos of the windblown-litter situation at the landfill. I took several such photos at the November site visit, illustrating how windblown plastics are distributed downwind of the working face, and how they tend to accumulate on slopes that block the wind. Out of an abundance of caution, most of these photos have not been included with this agenda packet. My concern is that they can be easily misunderstood to show an off-site impact of landfill operations. Also, they were taken shortly after a high wind event at the site, while the ALRRF was being filled at the very top of Fill Area 1, with the highest possible exposure to wind from all directions. Frequent changes in wind direction were confounding efforts to trap litter with fences. Moreover, the wastes received at the site originate from several distinct wastesheds that may have different amounts of plastics in their waste streams.

On December 5, the November photos were provided to ALRRF management for any comments or concerns, but there has been no response. The photo below, taken November 26, 2013, shows part of the south face of the landfill. There is a clear distinction between the areas that were cleaned very recently, and those still requiring cleaning.
