COMMUNITY MONITOR COMMITTEE

Altamont Landfill Settlement Agreement

AGENDA

ALRRF Community Monitor Monthly Report**March 2014**Fill Area 2

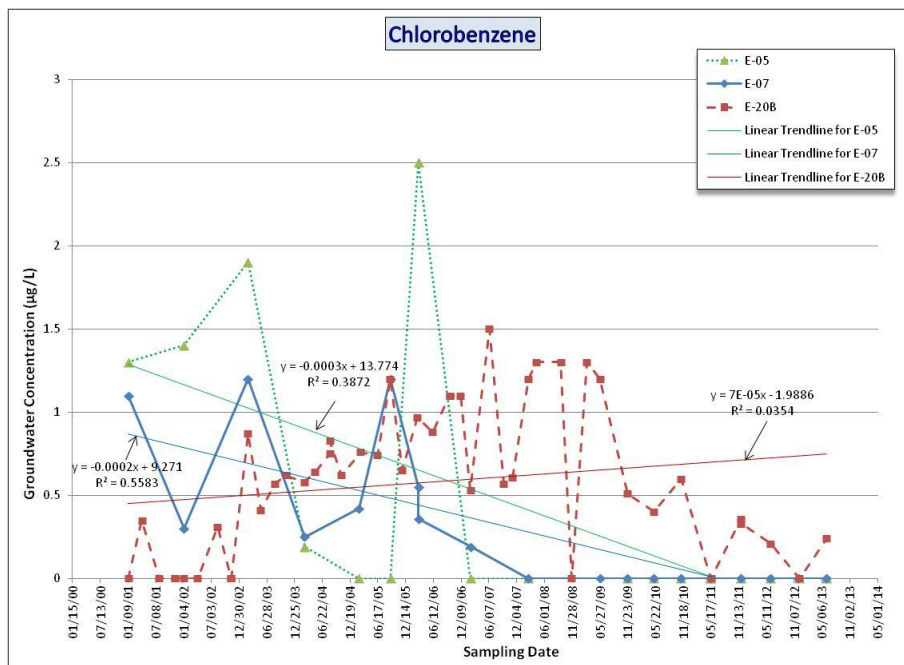
FIGURE 6.1-1

Trends and Trend Lines - Treadwell and Rollo staff have prepared graphs with trend lines for every potential contaminant that is reported semiannually. The trend lines are straight lines that provide a "best fit" to the data points, including samples that had concentrations too low to detect; these are treated as zero-concentrations. In most cases there are 10 years of test data or more. During that time span, testing techniques have improved, and some samples that were "non-detect" in the early 2000's could give numerical results. This could produce a "best fit" line that shows an increasing trend when in reality, concentrations stayed the same or declined. For example, see the red "best fit" line in Figure 6.1-1, the graph for chlorobenzene, below.

Table 6.1-1 compares the three wells in several ways: by relative concentrations (which well has more or less of each contaminant); by trends in concentration using the best-fit lines, and by the goodness-of-fit of those lines to the actual data. (A statistical parameter, R², is used to evaluate goodness of fit; higher values indicate a better fit of the straight line to the data.)

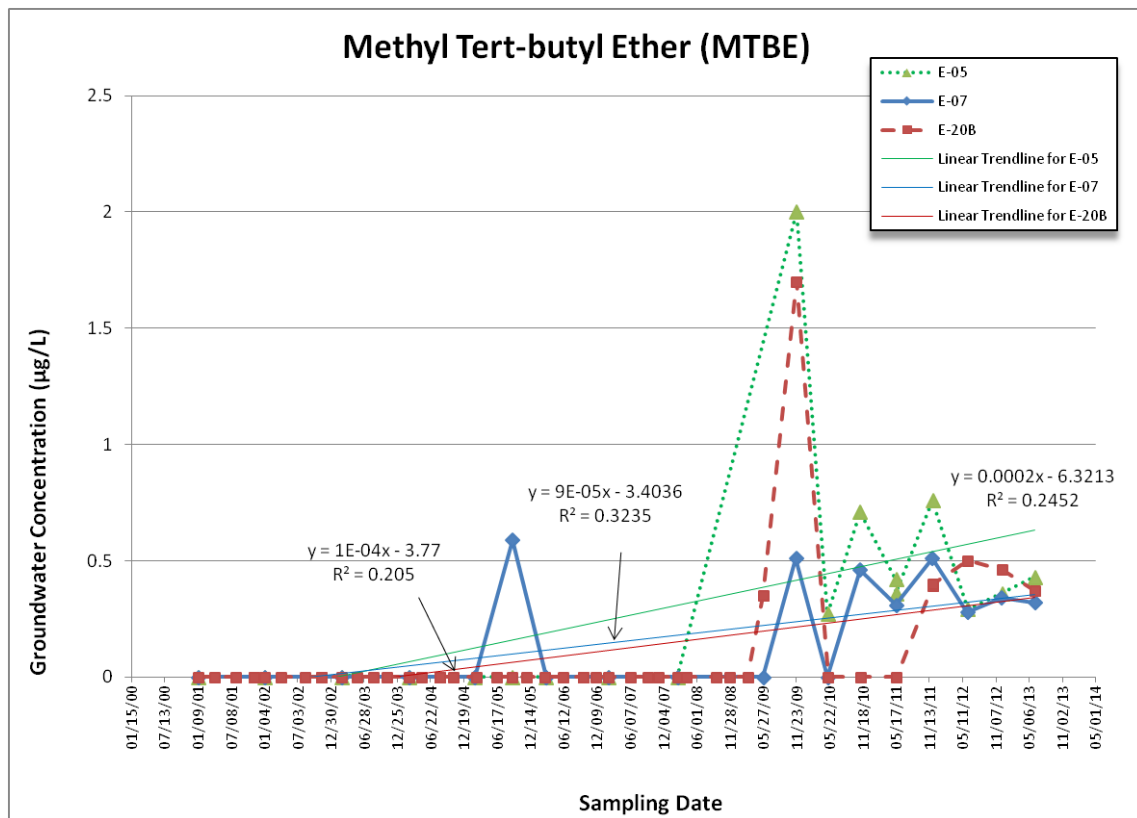
FIGURE 6.1-2

The only apparently-increasing trends appear to be in the gasoline additive MTBE, tert-butyl alcohol (TBA, a breakdown product of MTBE), and tetrahydrofuran (see below for a description of tetrahydrofuran, THF). Graphs of MTBE and TBA concentration over time are shown below in Figures 6.1-2 and 6.1-3. A description of THF is provided below the figures. We recommend that the Committee retain these data for future reference. If there appears to be a significant change in concentrations at one of these wells, the tables and graphs can be updated to aid in understanding.

The primary regulatory limit for MTBE in California is 13 µg/l (micrograms per liter, or parts per billion) with regard to public health. California has also established a secondary limit of 5 µg/l for taste and odor, and a detection/reporting limit of 3 µg/l. Concentrations above 3 µg/l must be reported to the Department of Public Health.¹

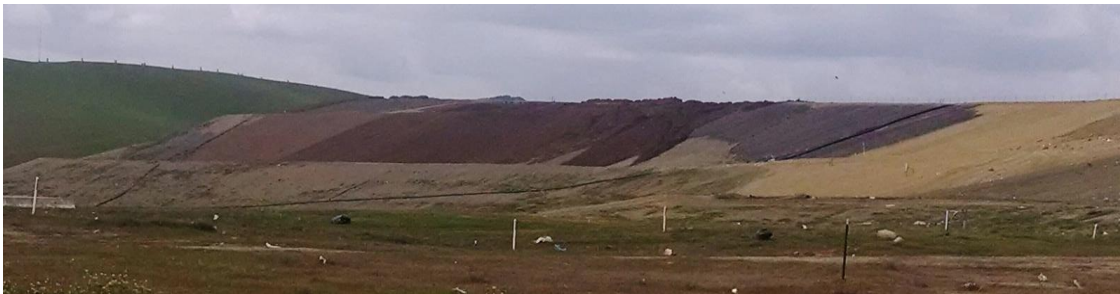
- Upper portion of south slope is being covered with ground plant debris, to support vegetative growth; see photo. Darker material is new cover.

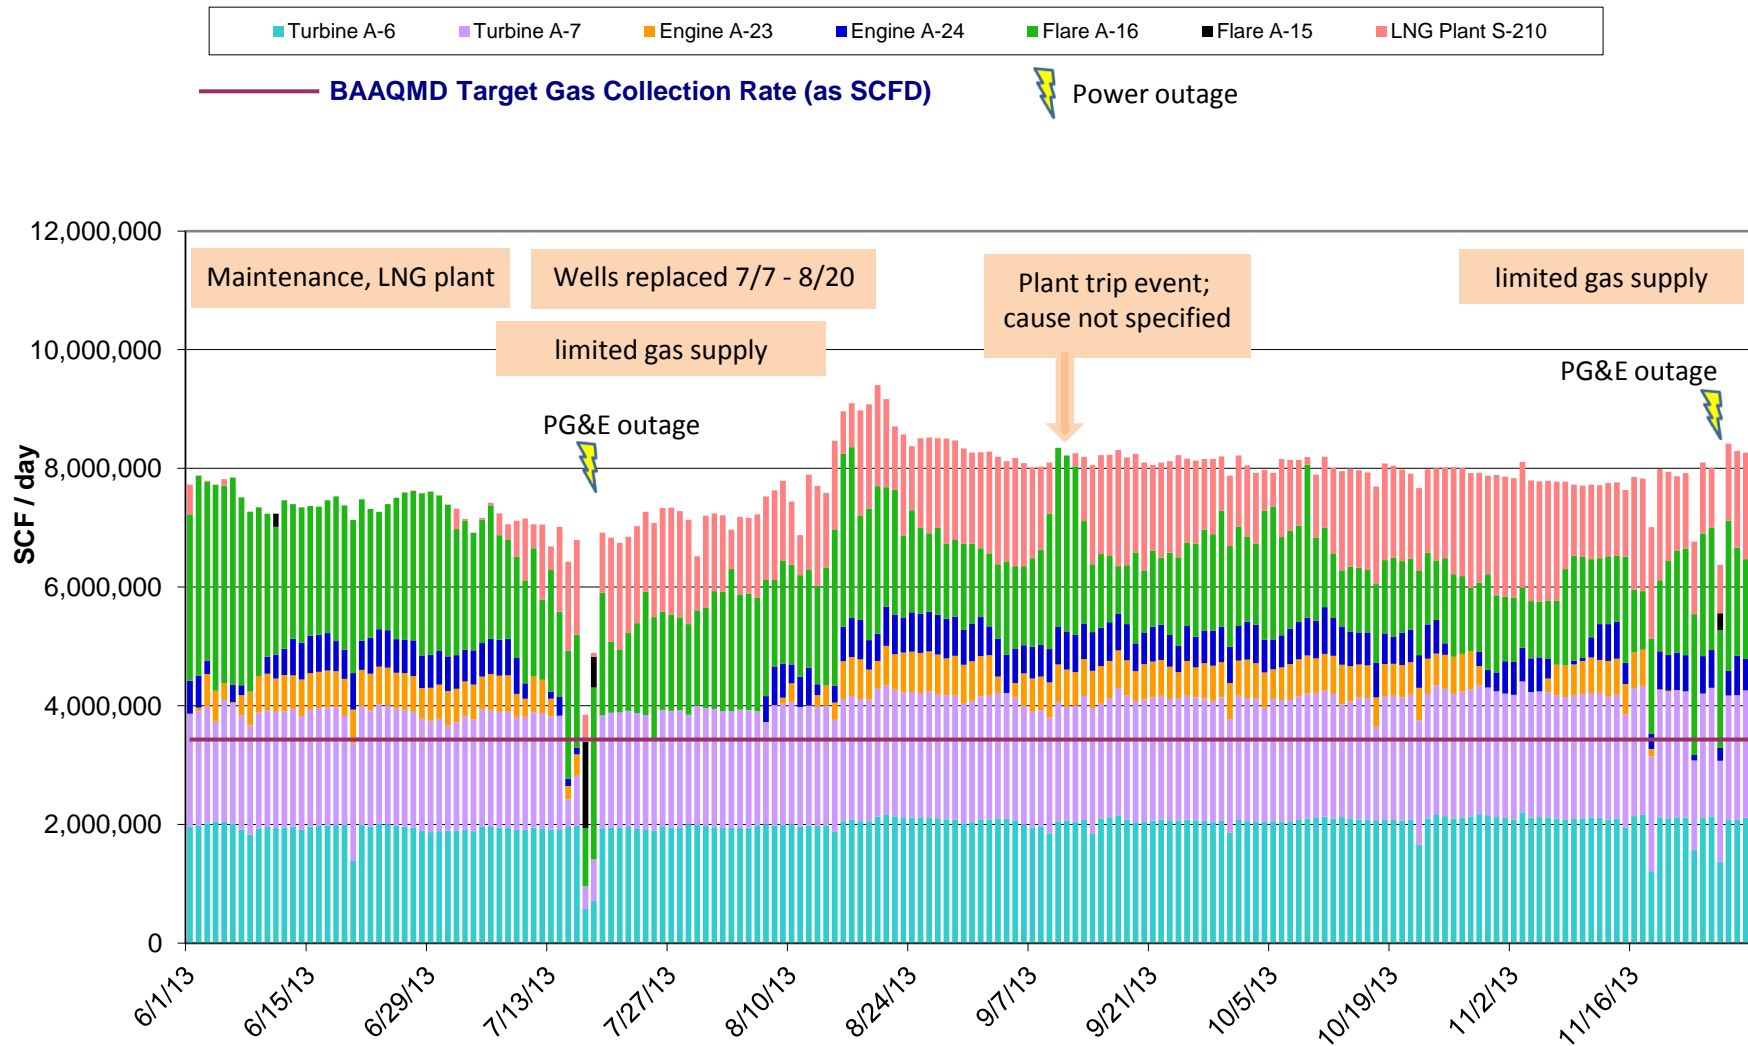
Figure 6.3-1 - ALRRF Daily LFG Flow
(values derived from Title V Report)

The report provides day-by-day volumes of gas consumed by each of the control devices. Figure 6.3-1, below, illustrates the general performance of the system and each of its major components (flares, LNG plant, IC engines and turbines). During this 6-month period, the LNG plant was down for approximately one month for maintenance. Immediately after that, the installation and decommissioning of gas wells constrained landfill gas extraction, but the system easily remained in compliance with the required Target Gas Collection Rate. Limited gas supply continued to be a limiting factor in gas consumption and energy production, especially from the latter part of October through November. When this occurs, the ALRRF appears to be managing this situation by "resting" one of the IC engines. These engines are relatively inefficient producers of energy, with high maintenance needs, so this (apparent) strategy is a sound one.
