# COMMUNITY MONITOR COMMITTEE

## Altamont Landfill Settlement Agreement

## AGENDA

*COMMUNITY MONITOR  
COMMITTEE  
Altamont Landfill Settlement Agreement  
Minutes of April 8, 2015*

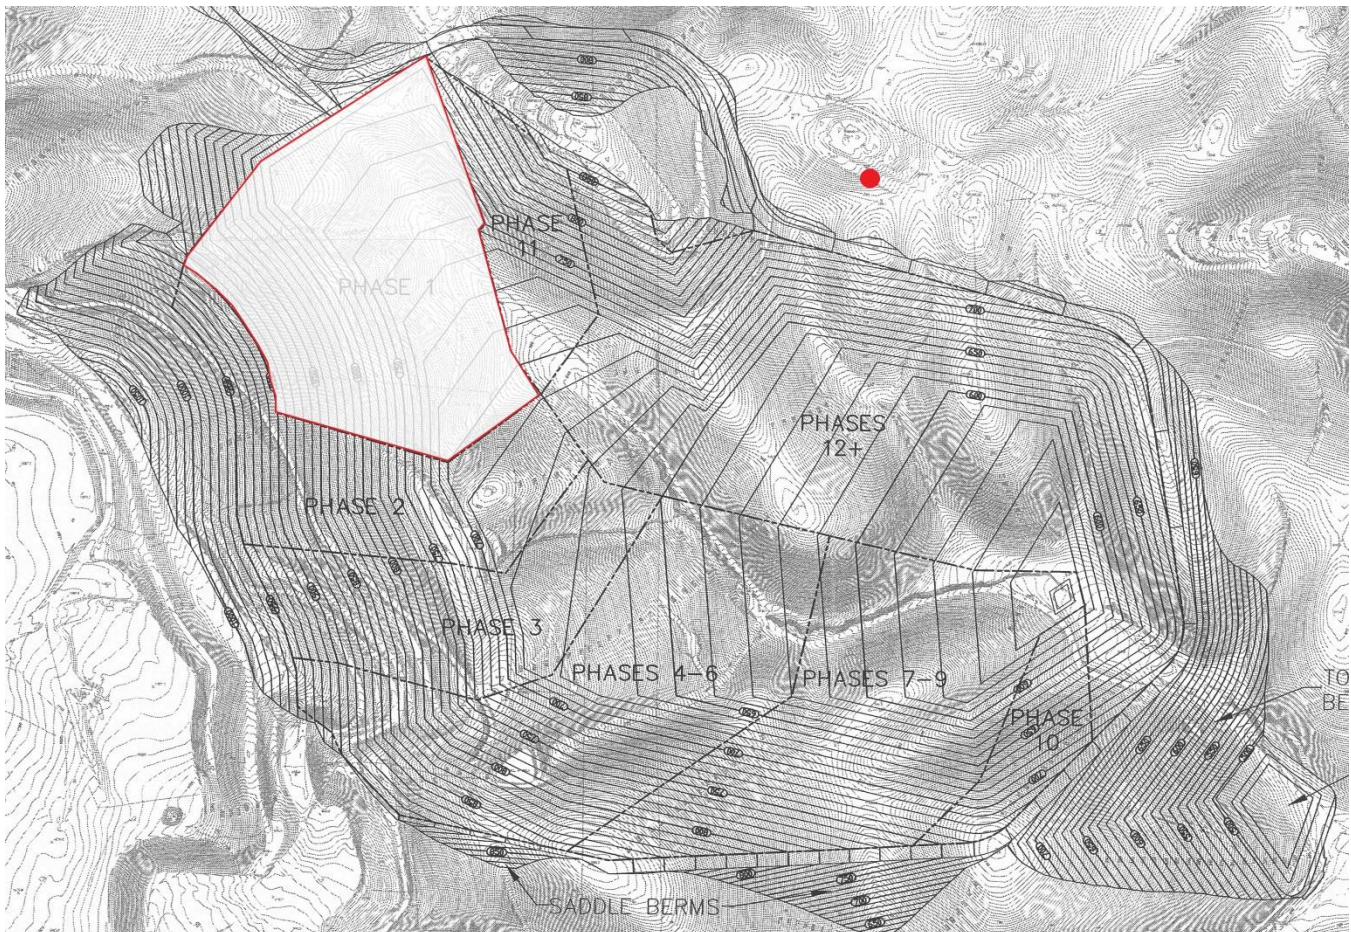
The current Joint Technical Document explains that refuse will be placed in Fill Area 2 in twelve distinct Phases, each having a distinct footprint, as shown in the drawing below. In the drawing, Phase 1 is shown with a red outline and white fill. The red spot near the top of the picture is the photo point that was used to make the panoramic photos on the last page of this memorandum.

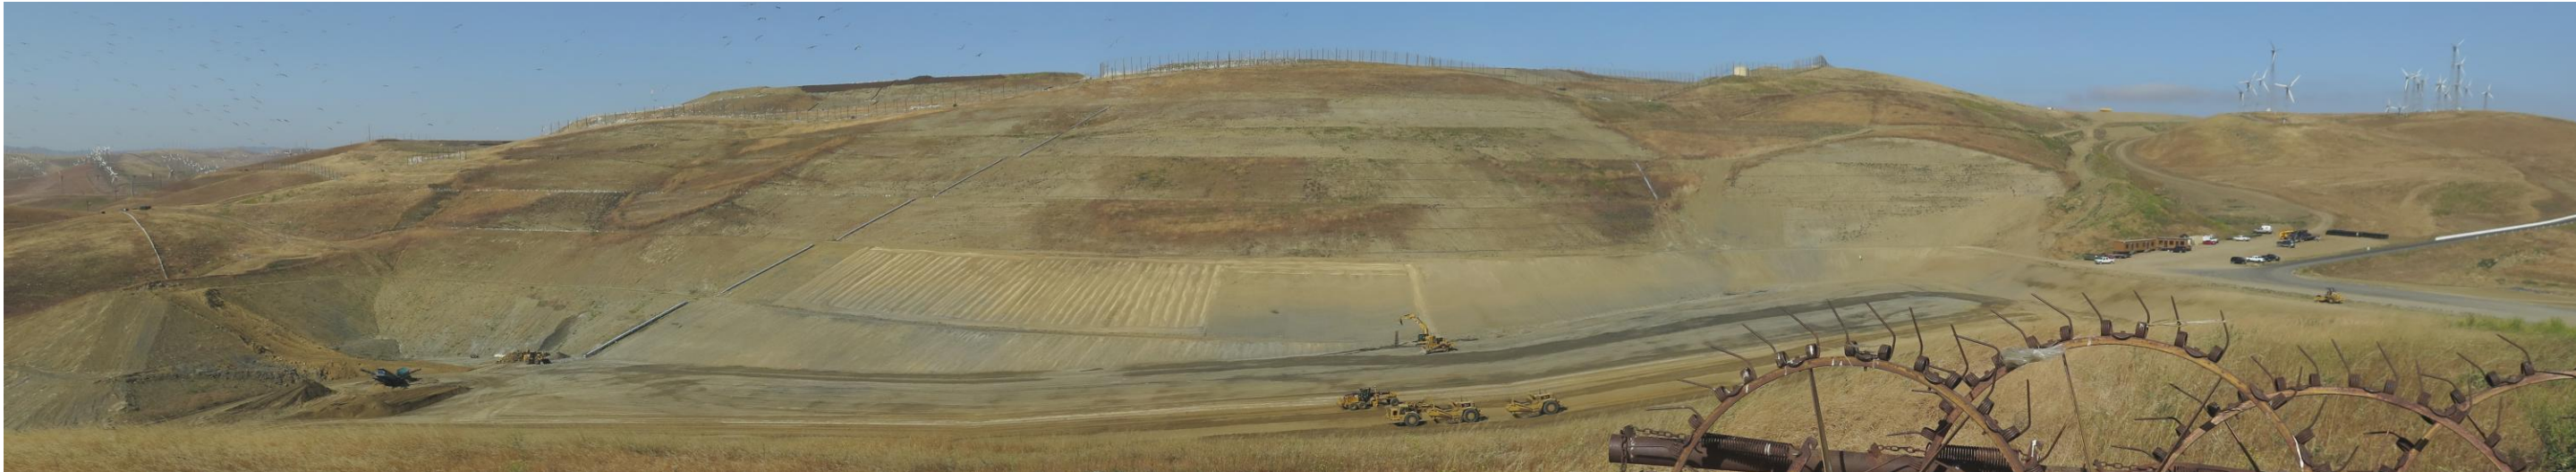
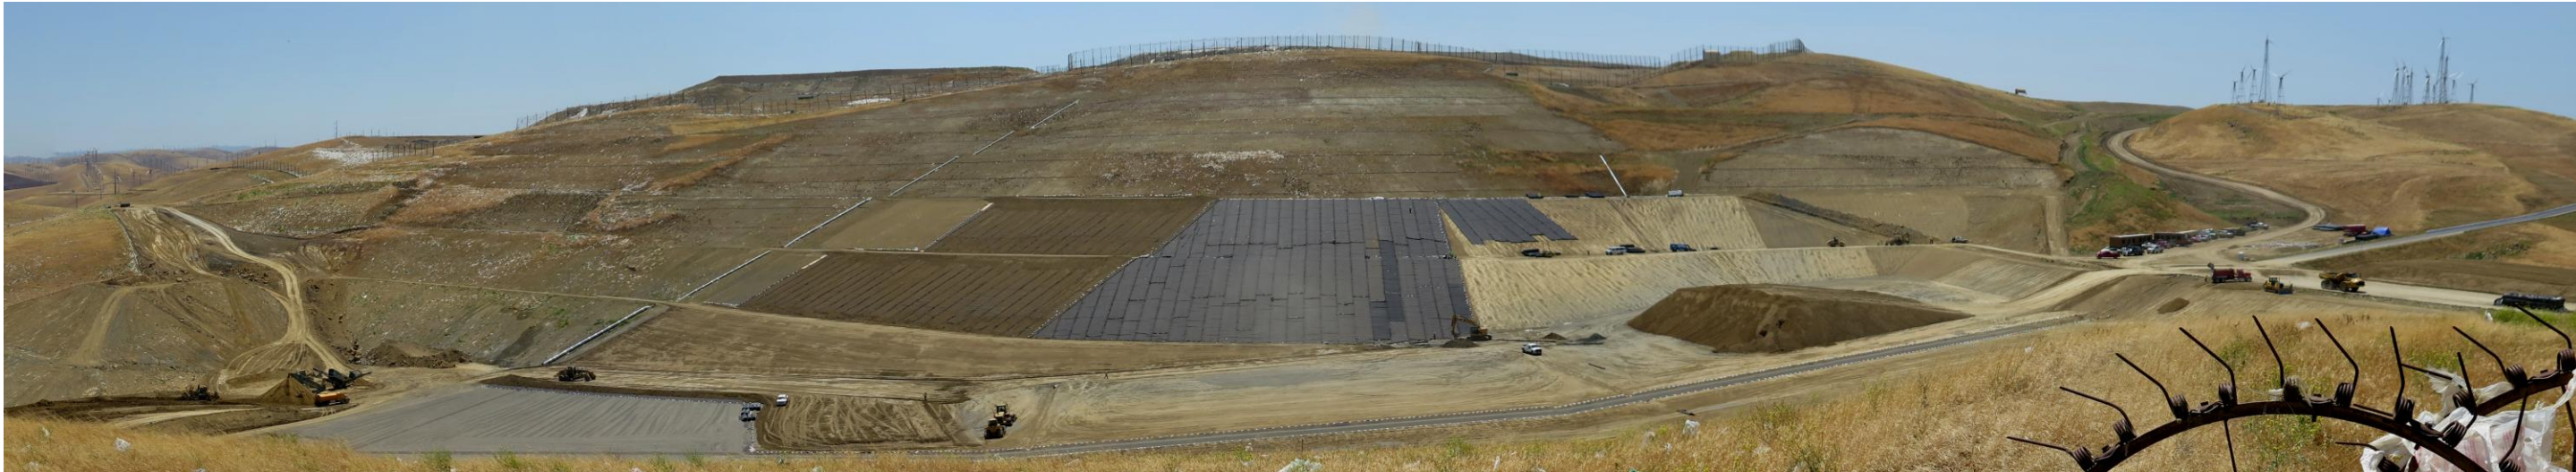
View of Fill Area 2, looking west from east side ridge

On the panorama photos, the activity in the May 2015 photo is the fine grading work that was observed in early May, preparatory to liner installation. In the June 2015 photo, the liner system is being installed on the side slope of the Phase 1 area, which is (approximately) the left half of the red-and-white polygon in the drawing on the preceding page. From left to right, the lower photo shows:

- Equipment and soil piles: Extraction and processing of native clay to be used as part of the low-permeability soil in the liner.
- Dark brown surface: Installed liner, covered with low-permeability soil.
- Black surface: Installed liner membrane, not yet covered with soil.
- Crew and equipment unrolling liner membrane material.
- Additional installed liner, not yet covered.
- Large soil pile: low-permeability soil to be used to cover membrane.
- To the right, beyond the photo: a blending plant where bentonite is mixed with on-site clay to form the low-permeability soil for the liner system.

clay source

HDPE liner, covered with soil

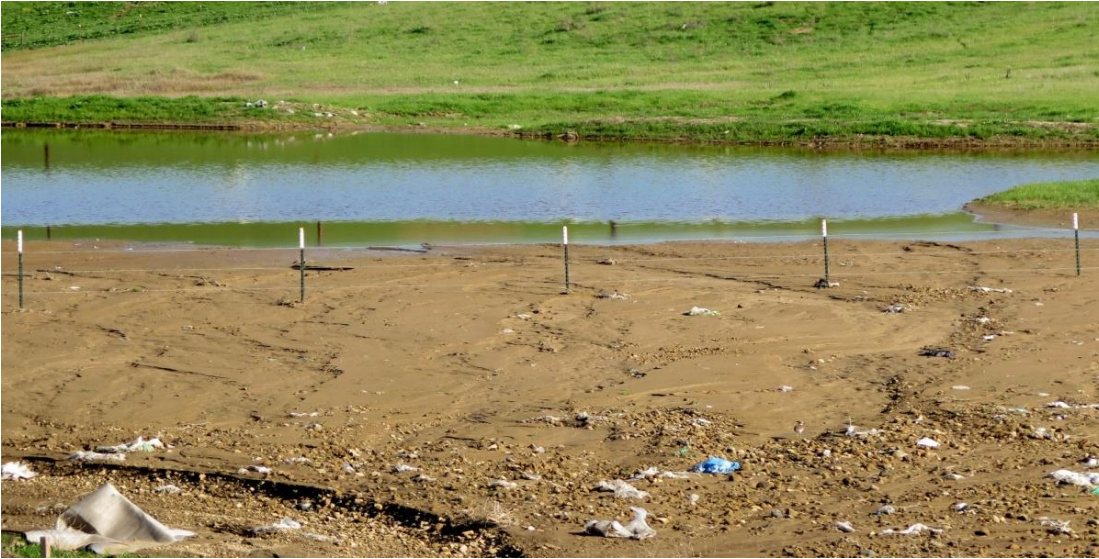
Mitigation Wetland

The condition of this wetland in February is shown in the photo immediately below:

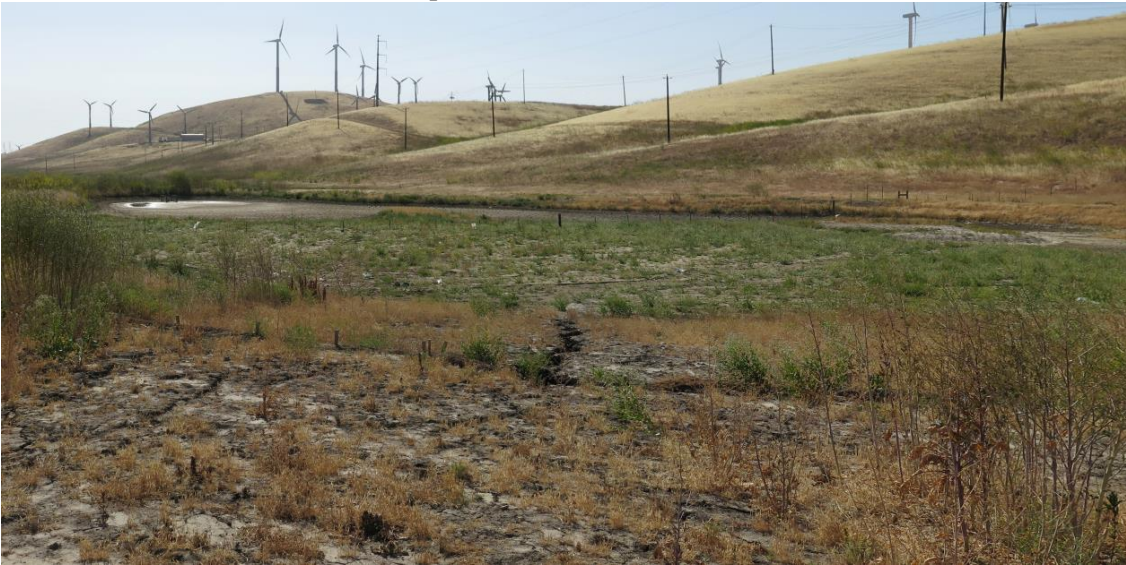
Conditions in May are shown below, from a slightly different vantage point (looking in the same direction, but farther back from the ponded area):

Local vegetation has begun to move in and could create a seed bank that would complicate the future establishment of wetland plants. This may present a very difficult compliance problem, in the long run.

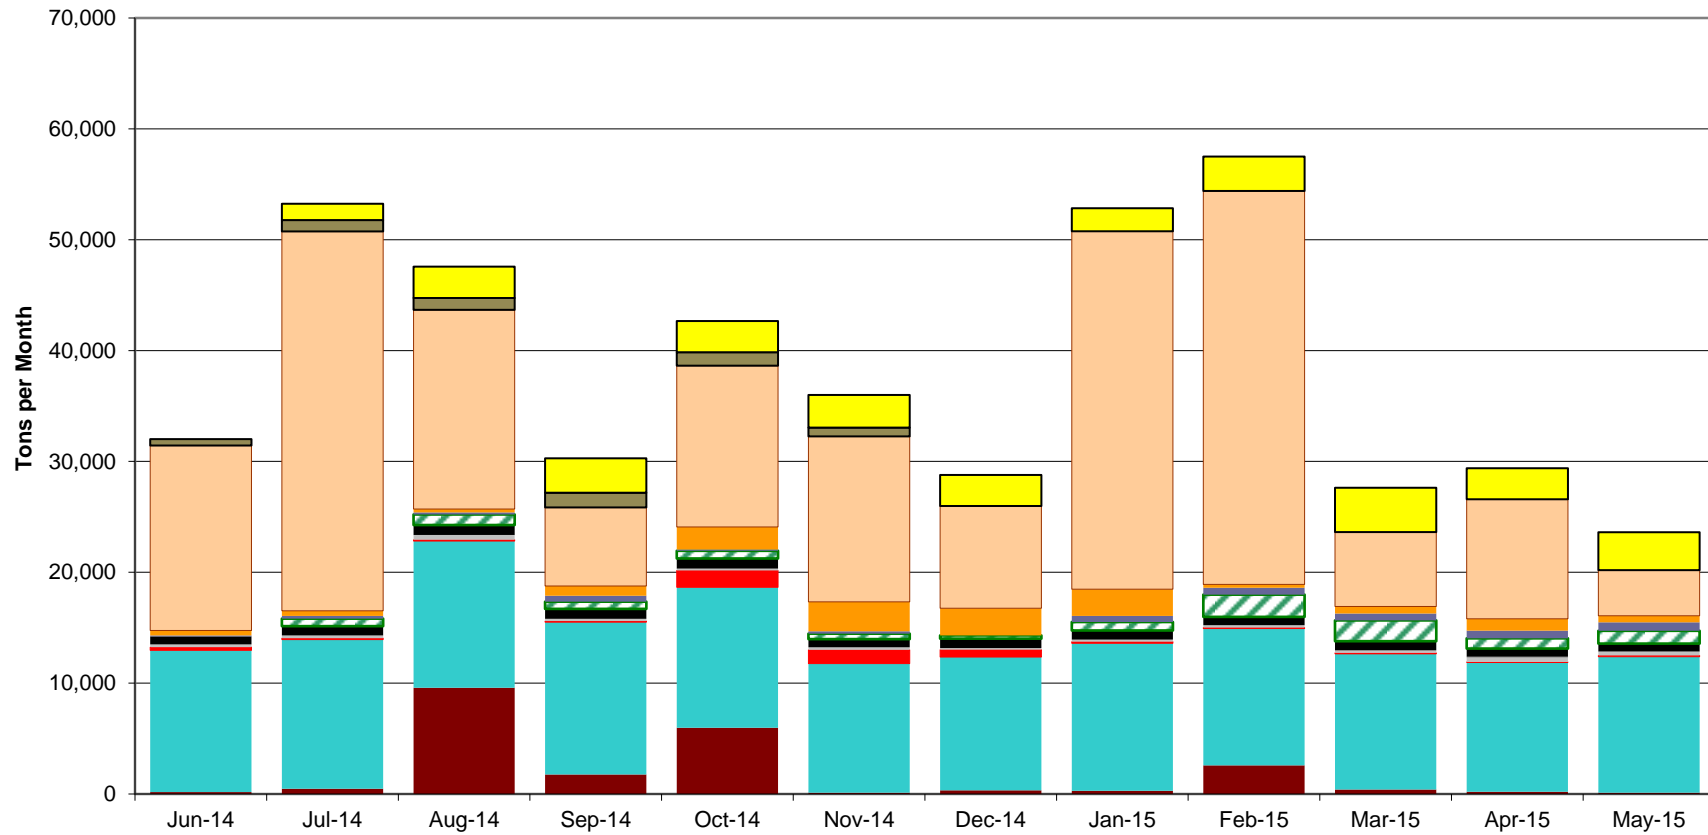
**Figure 6.3-1 Monthly Volumes of Revenue-Generating Cover**

Mr. Runyon then explained certain details from the tonnage graphs that are part of this report. He noted that (a) the December rains reduced the amount of cover soil brought to the ALRRF from construction projects; and (b) the dry weather in midwinter apparently enabled some wastewater treatment operations to deliver sludge in February; in normal years that material is generally held back until late summer when it is drier and easier to handle. He also noted that the average volume of solid waste brought fo disposal is essentially unchanged.
