COMMUNITY MONITOR COMMITTEE

Altamont Landfill Settlement Agreement

AGENDA

ALRRF COMMUNITY MONITOR ANNUAL REPORT 2015

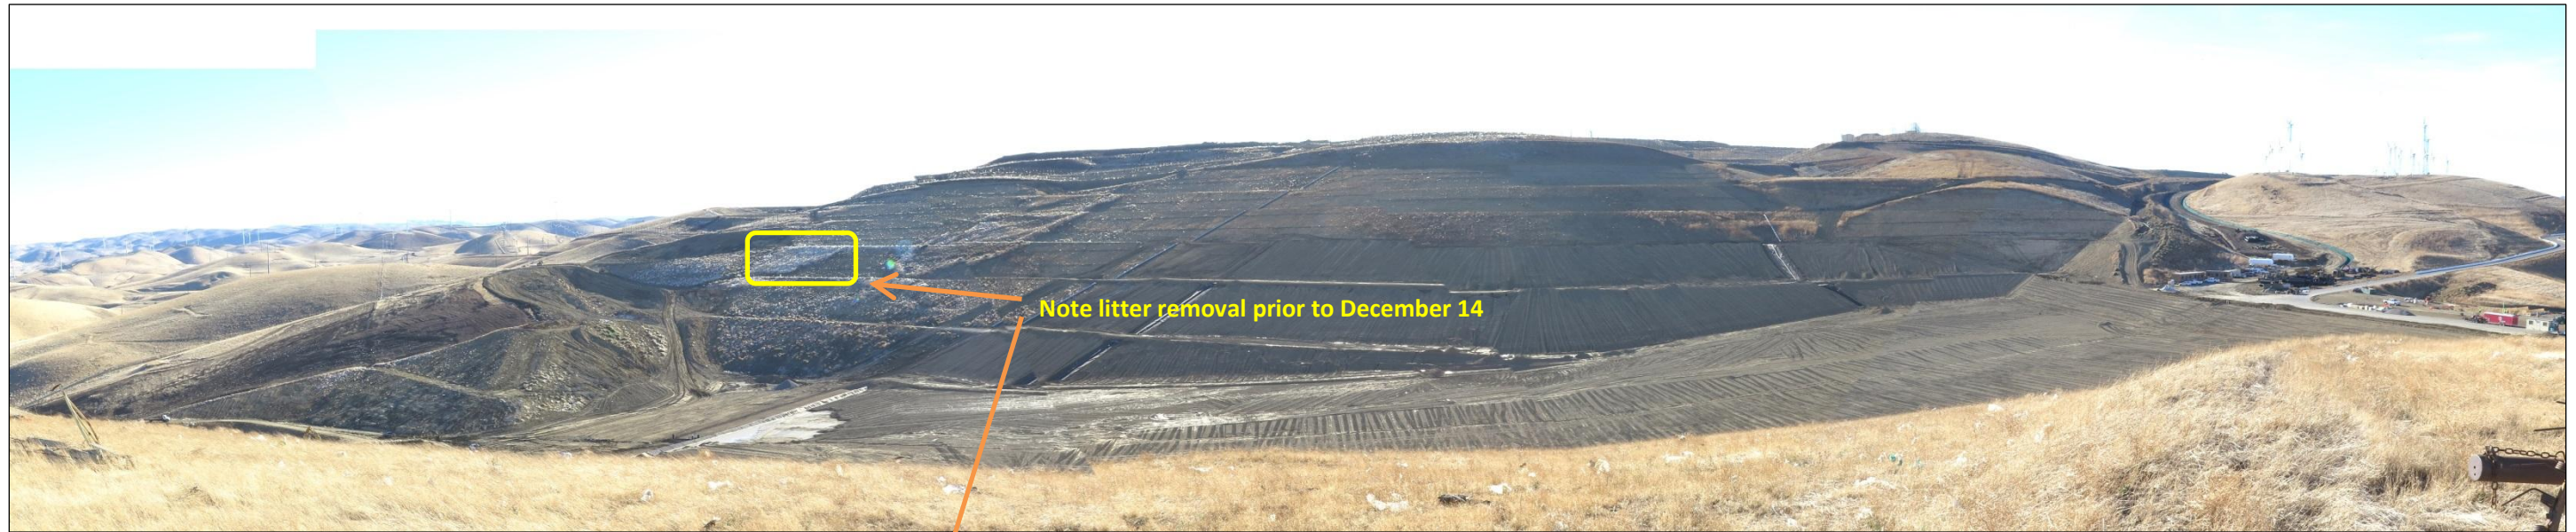
November 4, 2015

View of Fill Area 2, looking west from east side ridge

Note litter removal prior to December 14

erosion damage ↑

↑ operations layer in place, track-walked to minimize erosion

- At the toe (south end) of the prepared area, there has been a serious washout of the operations layer. This occurred because an earthworks contractor at the site removed a toe berm that the liner contractor had placed there to protect the toe. This is soon to be repaired. The wetland mitigation project, which is downslope of the entire phase 1 area, was not affected, according to ALRRF staff.

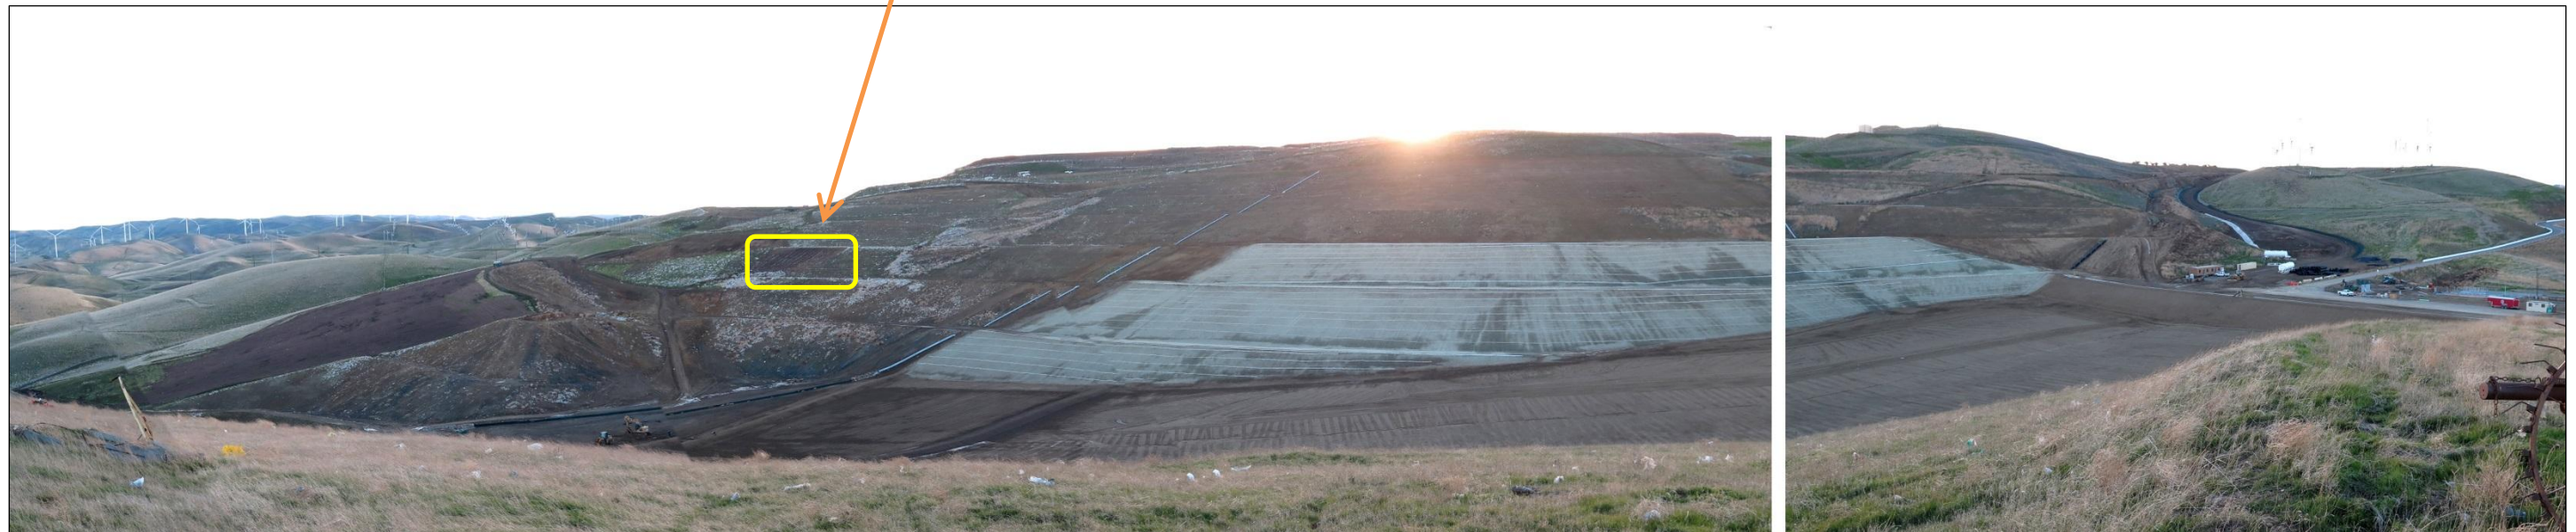
December 14, 2015

Damage repaired, berm replaced

side slope hydroseeded

- The erosion problem at the toe of the Phase 1 lined area has been repaired. Recent wet weather did not cause obvious erosion there or anywhere else on the liner.

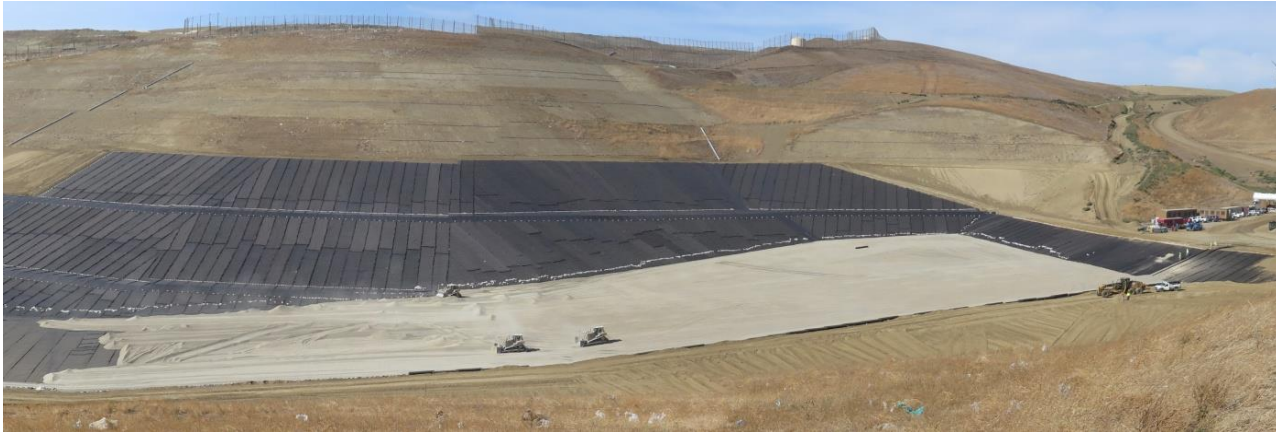
- Drain rock was being placed above the membrane liner. When that is complete, a nonwoven geotextile will be added above that, and the "operations layer" - compacted soil - above that.
