# COMMUNITY MONITOR COMMITTEE

## Altamont Landfill Settlement Agreement

# ALRRF COMMUNITY MONITOR ANNUAL REPORT 2016

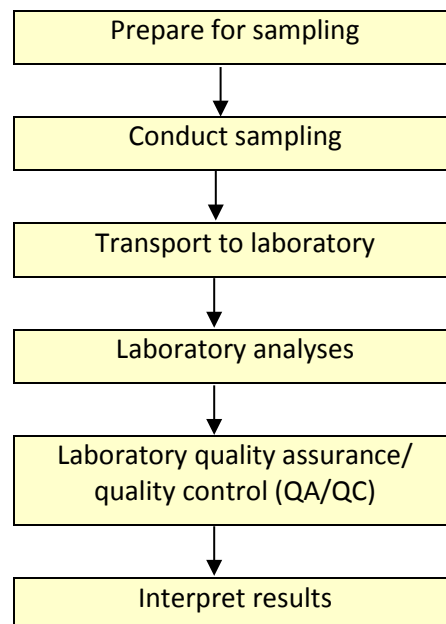
Overall sampling and analysis steps

Here is a generalized flow chart of the process. There are way more steps than shown here.

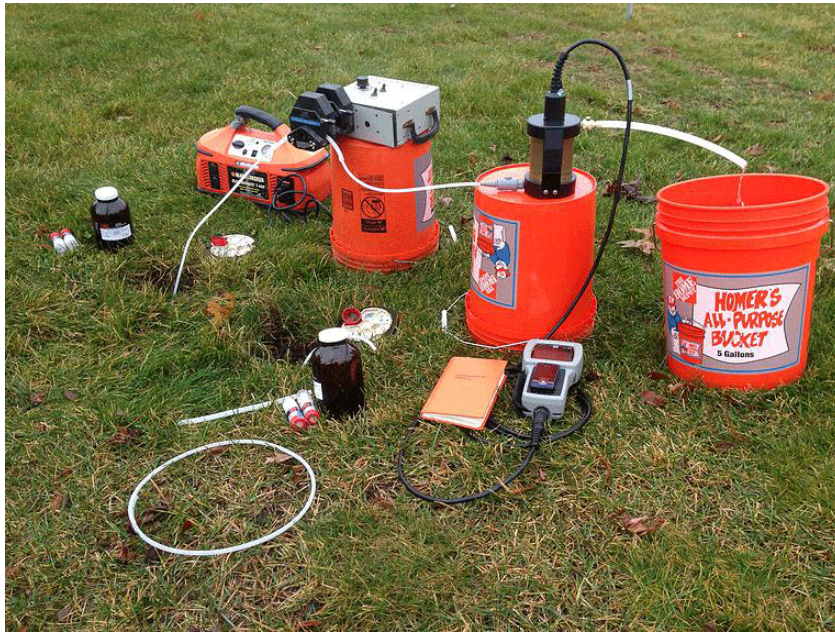
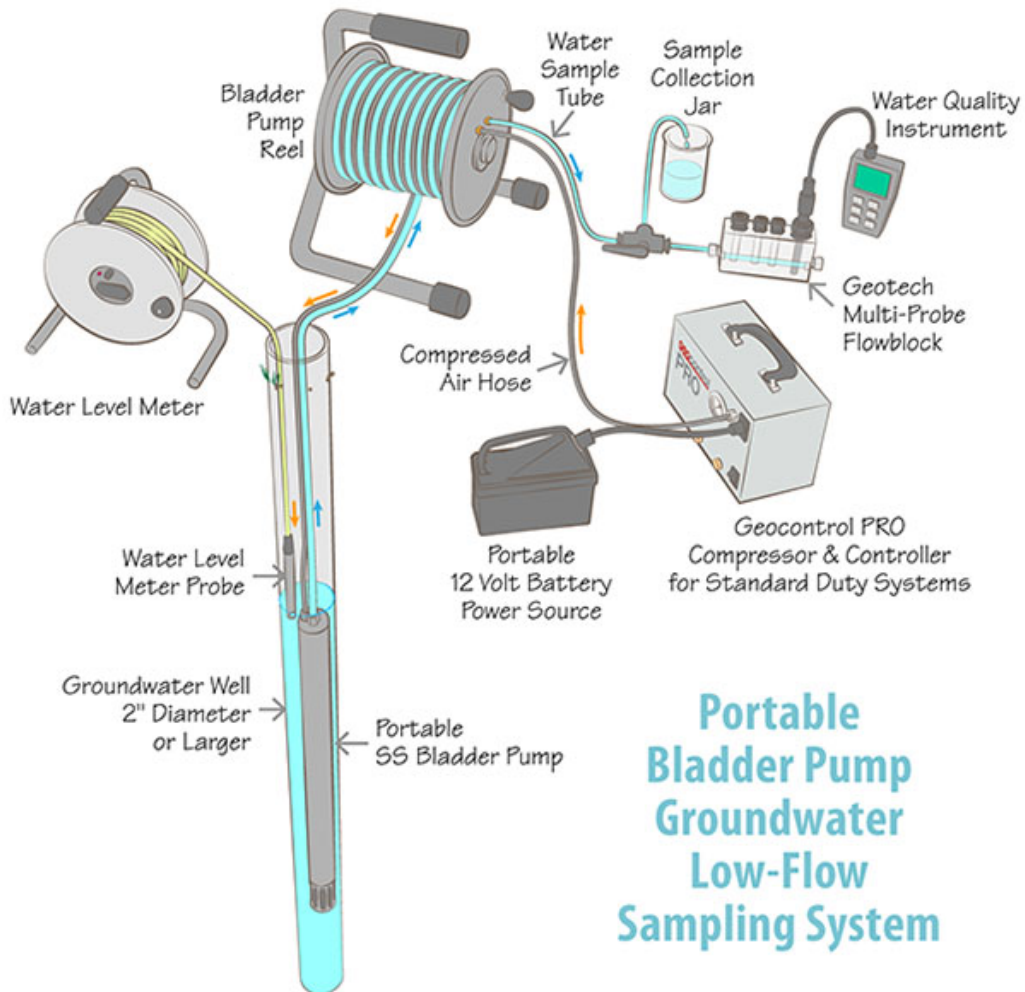
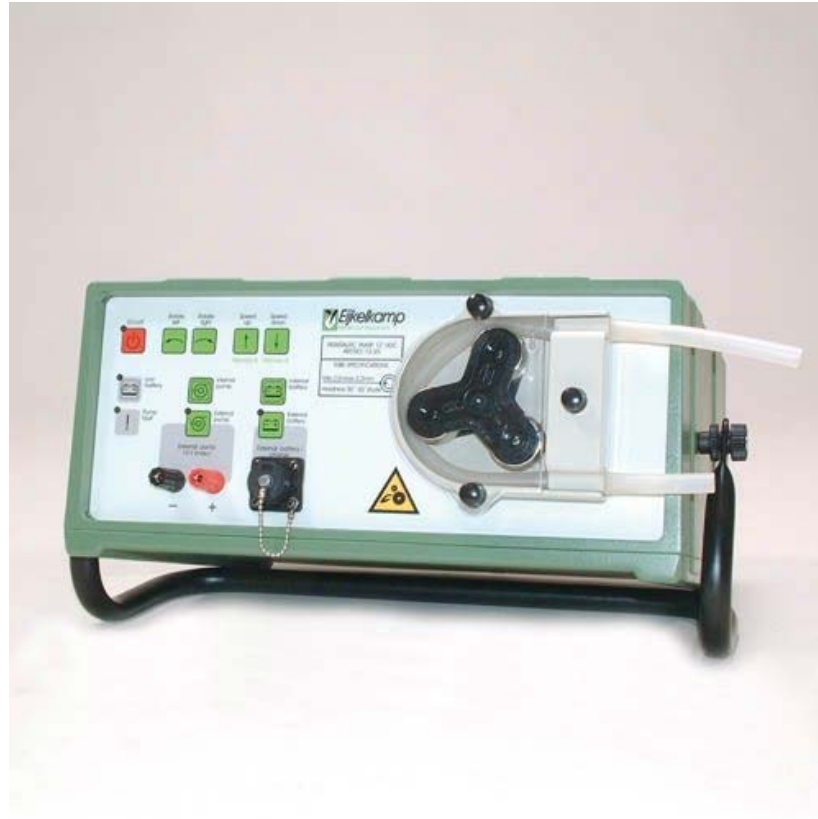
- Setup at sample site
- For each well
  - Purge the well to remove standing water not representative of the groundwater
    - Low-flow purge methods reduces loss of volatiles and stirring up the sediment trap
  - Sample the well
    - Use low-flow techniques for sampling; same reasons
  - Decontaminate equipment
- Surface water
  - Sample
  - Decontaminate equipment

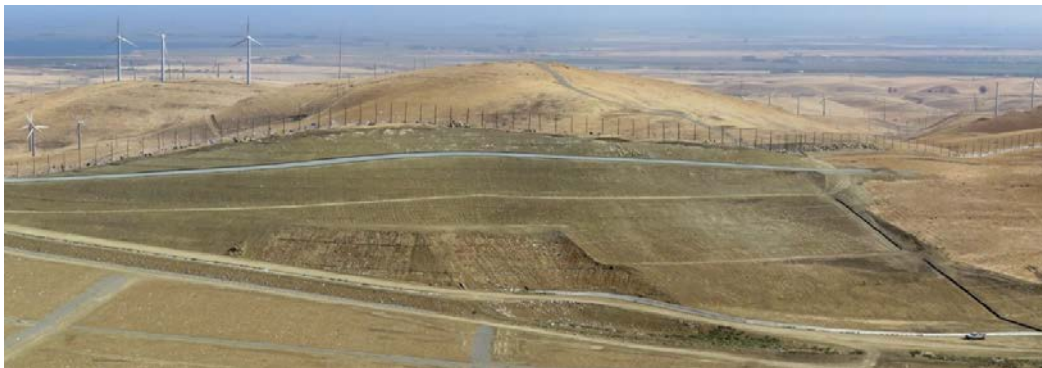
- Phase 2 excavation was complete. The groundwater seeps south of the Phase 1 area were dry.
- Staff reported that the gravel "windows" on the west side of Phase 1, which conduct leachate to the underdrains, will be closed off with black plastic during the upcoming wet season.

Phase 2 excavation, with wattle, benches and downdrain in place.

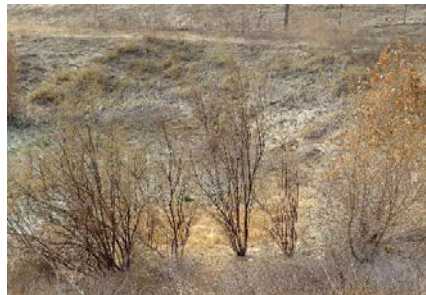
- The suspected tamarisk trees at the truck wash water storage pond were treated by the County pest control agency and appear to be dead.

Ms. Cabanne asked if the possible tamarisk plants, noted in a monthly report, could be harmful to the Conservation Plan Area. Mr. Runyon explained that the County has applied herbicide to those plants, and they are now dead; however, new plants could emerge if seeds were previously produced, and this should be watched for.

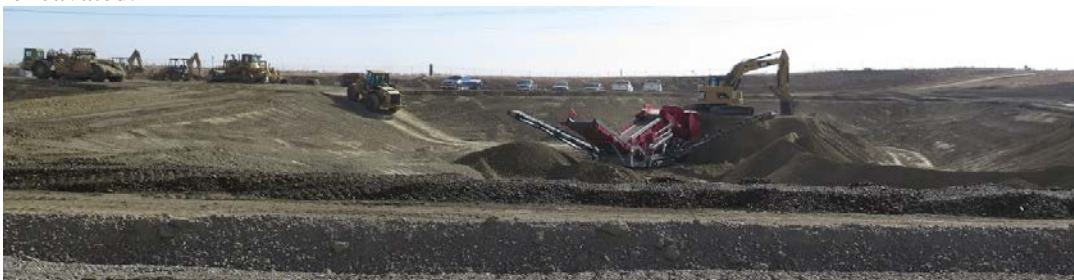
- Construction was observed at the Fill Area 1 leachate ponds, near the southeast corner of Fill Area 1. Clay liner material was being blended and prepared in the south pond; the north pond was being excavated.

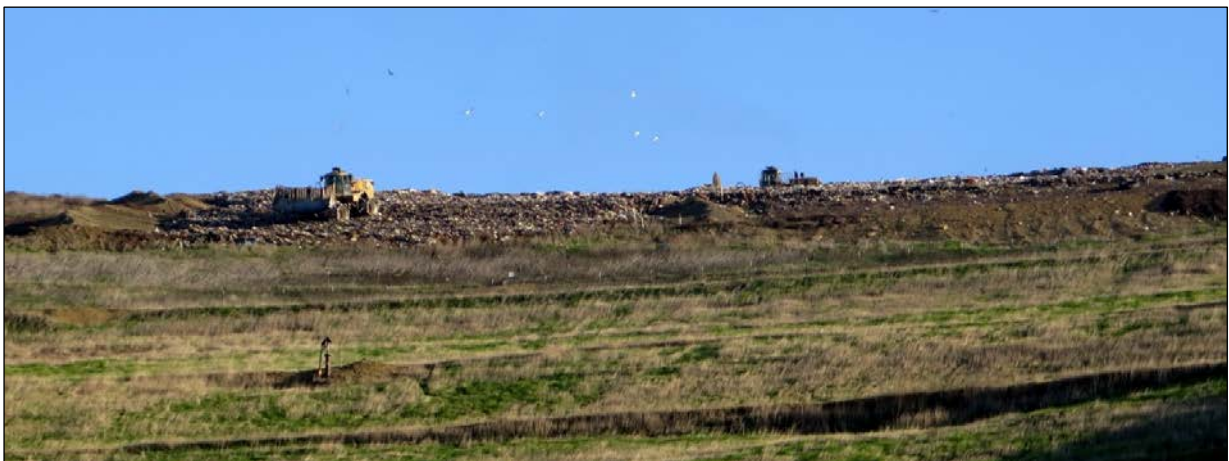
- The entry road between the scales and the active landfill is in good condition, well lit.
- According to ALRRF staff, the Water Board has required that the final-cover demonstration area not straddle both the Class 2 and Class 3 portions of the landfill. Consequently the ALRRF will place it entirely on the Class 3 area, with part of it extending over the steep front (south) face of the landfill. As a first step, the 10-acre test area was being filled to reach its final elevation. The test area is referred to as the "ET" (for evapotranspiration) cover area, because it will use surface vegetation rather than an impervious liner to keep rainwater from reaching the subsurface.

**Steep portion of ET cover area, viewed from below**

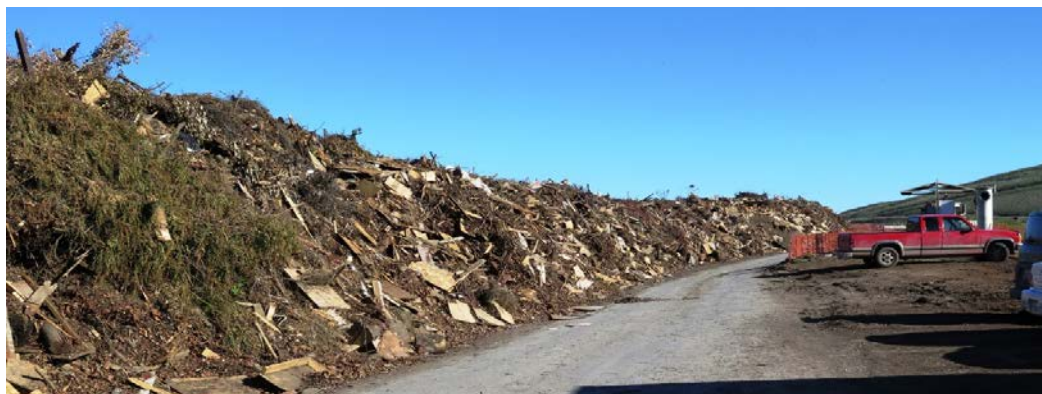
**East edge of Bio-Fuel Systems wood pile**  
(see next page for discussion)

- Attended by K. Runyon; escorted by Sarah Fockler. Announced.  
This visit began with a look at the wood waste stockpile at the adjacent Bio-Fuels System site, which occupies property apparently leased from Waste Management, adjacent to the ALRRF scale house, the LNG plant, and a transfer trailer holding area. The size of the wood waste stockpile has been an issue for some time; Bio-Fuels has a permit to operate from CalRecycle, but the LEA has written Violation notices against Bio-Fuels with every monthly inspection visit since January 2016 for holding wood waste beyond their permitted 7-day limit. In fact the October Violation noted that some piles of wood had been on site since January. In addition, the Water Board issued a violation notice to the ALRRF, dated November 22, indicating that this operation was in violation because the wood pile is significantly larger than, and in a different location than, the description in the ALRRF Waste Discharge Requirements. See photo on previous page.

The root cause of this issue is the lack of a market for wood fuel over the last 12 to 18 months.
- One tipper was available at the working face, which was the ET cover demonstration area. One dozer and one compactor were spreading and compacting refuse, continuing to raise the test area to final grade in preparation for the cover test. The queue of transfer trucks waiting to unload grew from one truck to three during observation, but this did not present a traffic management problem.

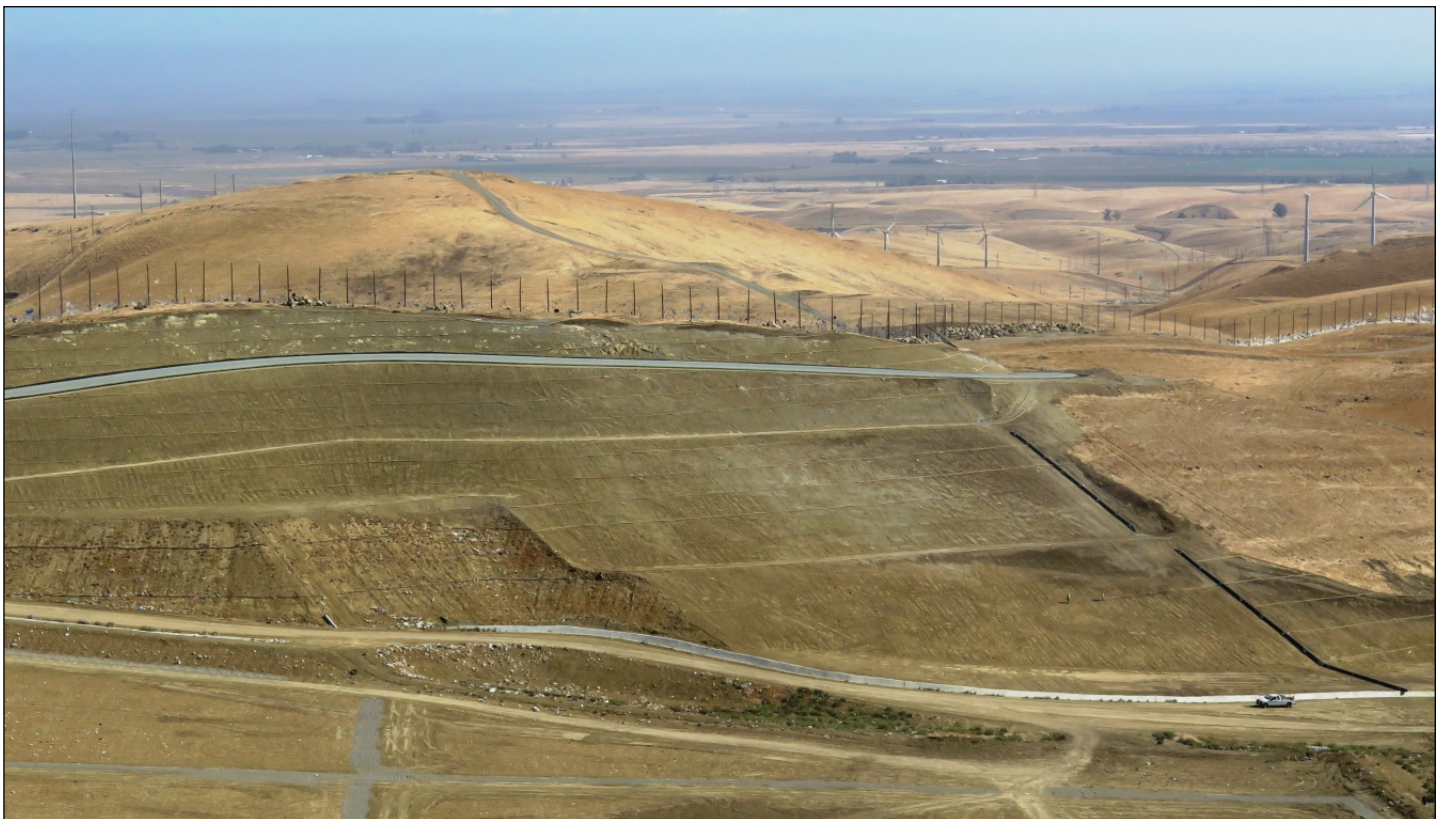
The photo on the cover of this report shows the view looking eastward at the southern portion of the excavation for Fill Area 2, Phase 2. The photo was taken on September 30, 2016.
