COMMUNITY MONITOR COMMITTEE

Altamont Landfill Settlement Agreement

AGENDA

DATE: **Wednesday, April 12, 2017**
TIME: **4:00 p.m.**
PLACE: City of Livermore
Maintenance Services Center
3500 Robertson Park Road

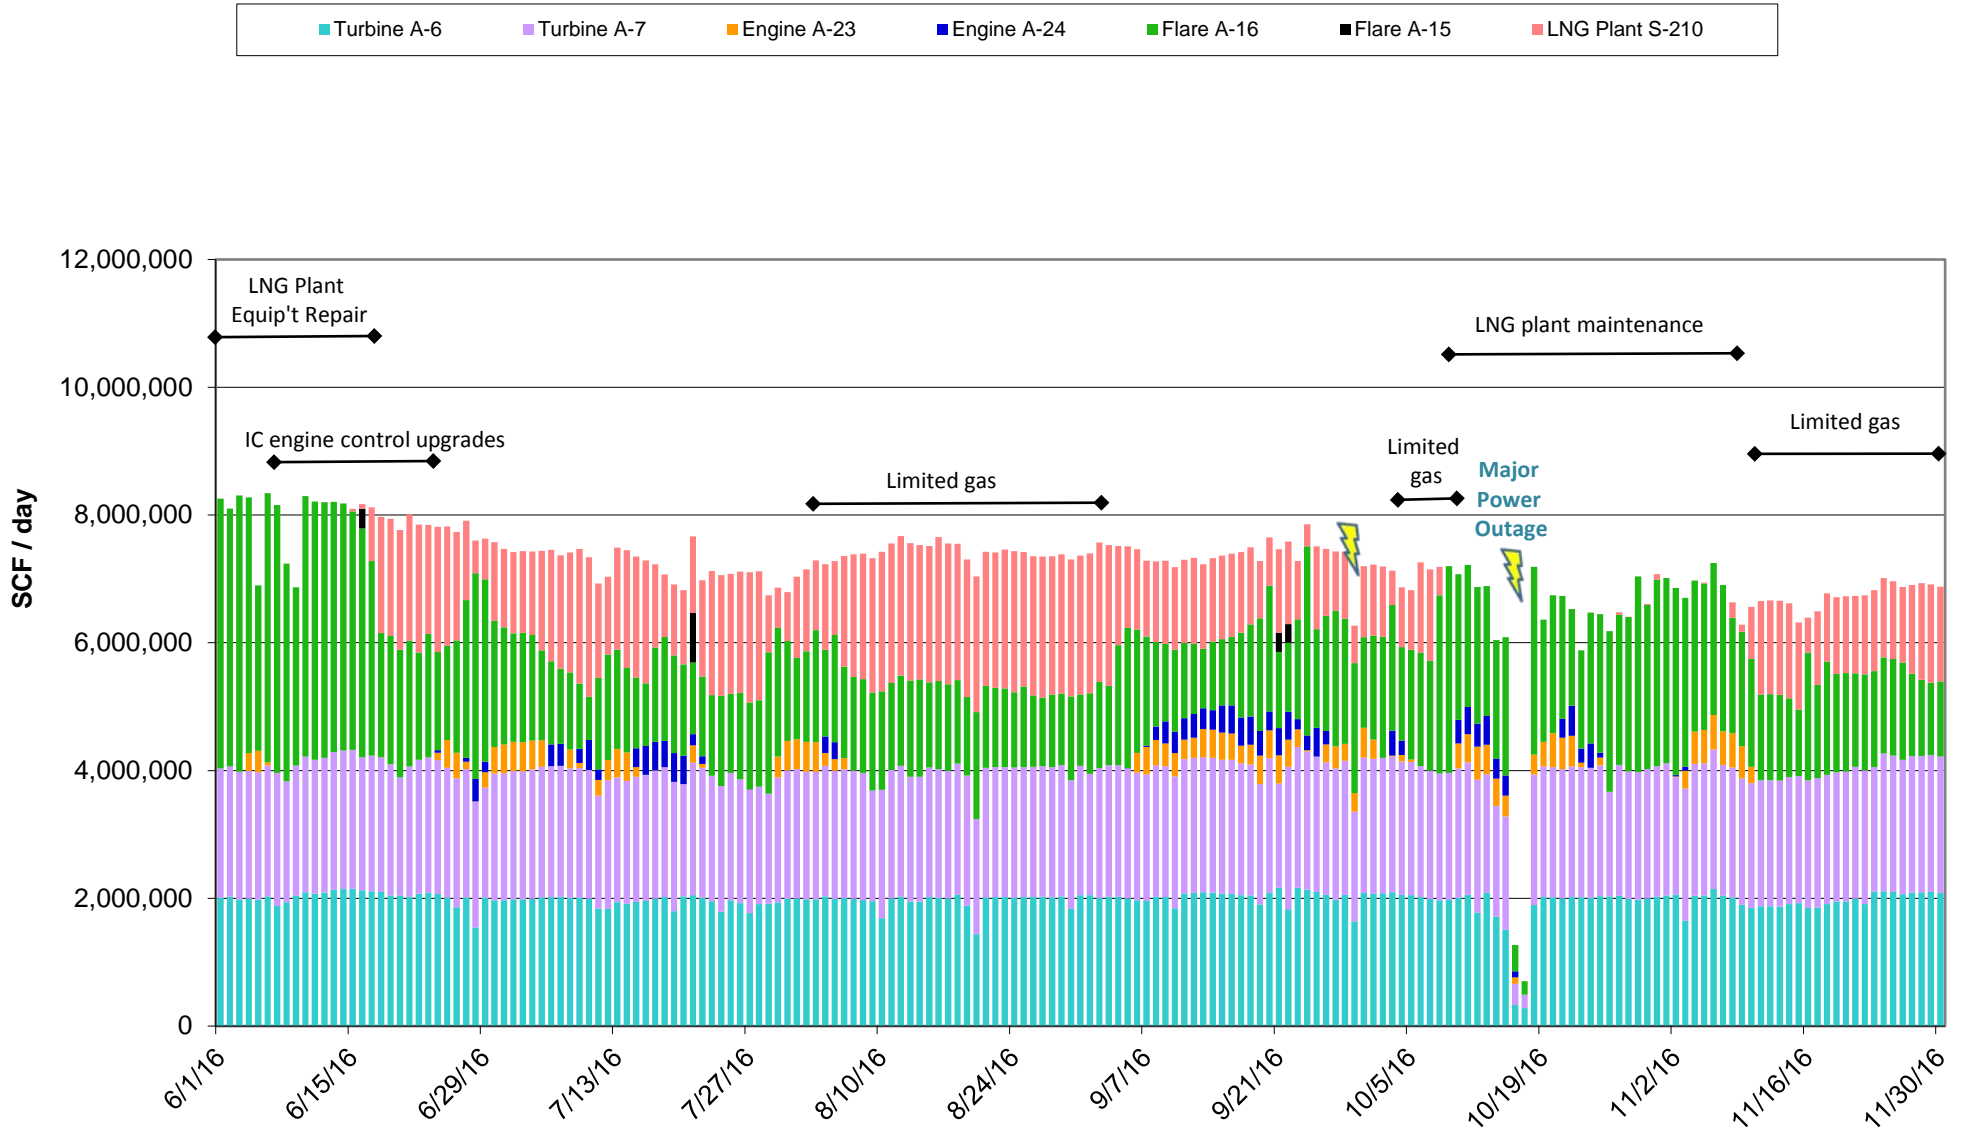
Figure 6.3-1 - ALRRF Daily LFG Flow
(values derived from Title V Report)

Figure 6.4-1 on the following page shows the amounts of landfill gas consumed by each of the combustion systems at the ALRRF. This bar chart illustrates two issues that arose during the reporting period. First, there was a gradual decline in gas production, which should have been relieved when the newly installed wells were first operated in December; the next semiannual report will show the change. Second, in mid-October there was a substantial power outage at a nearby substation that lasted more than a day and affected the electronic controls for all of the gas-consuming equipment, effectively shutting down energy recovery until PG&E could remedy the problem.

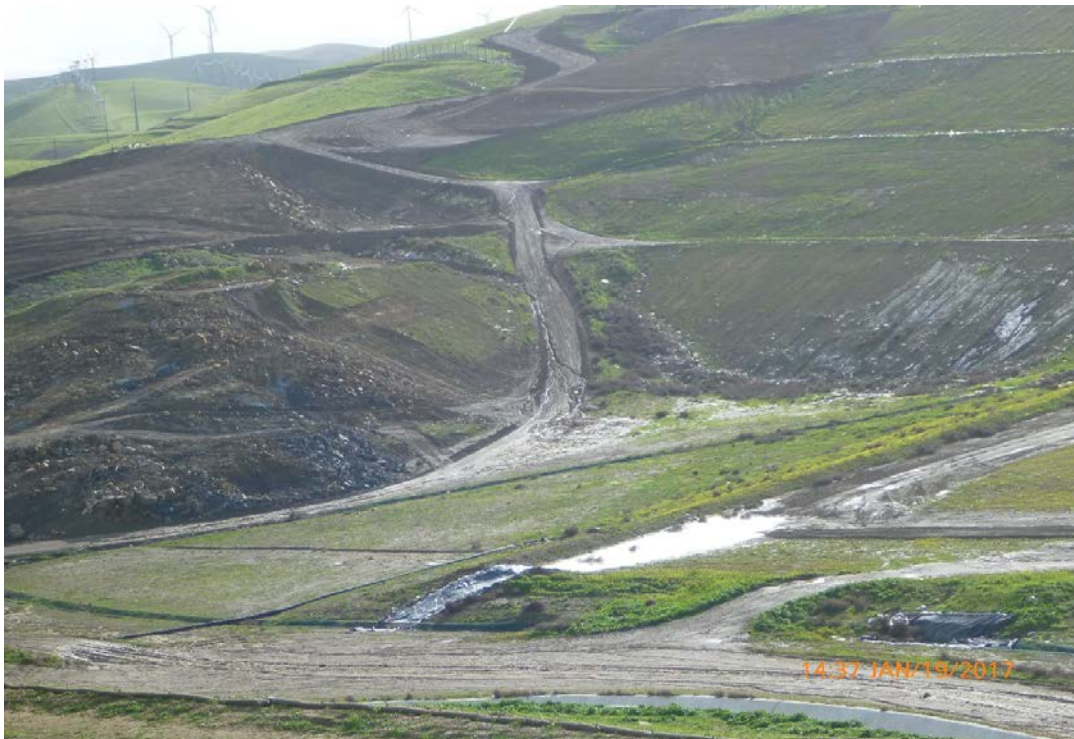
- The Phase 2 excavation was checked for erosion on side slopes. None was seen.
- The stockpile of pallets at the toe of the Phase 1 portion of FA2, noted in the previous inspection, was no longer there.
- In the Phase 1 portion, stormwater collects at a berm that defines the base of the lined area. It then flows to the stormwater system through a channel that has been lined with plastic sheeting to prevent erosion. This configuration appears to be handling the stormwater volume adequately; see the photo below. Also note the groundwater (not leachate) seepage occurring on the lower part of the far side slope. Due to wet weather it is more pronounced than when that slope had first been excavated. As the landfill is further developed across this area in the future, a drain system will be needed beneath the liner to remove that groundwater continuously.

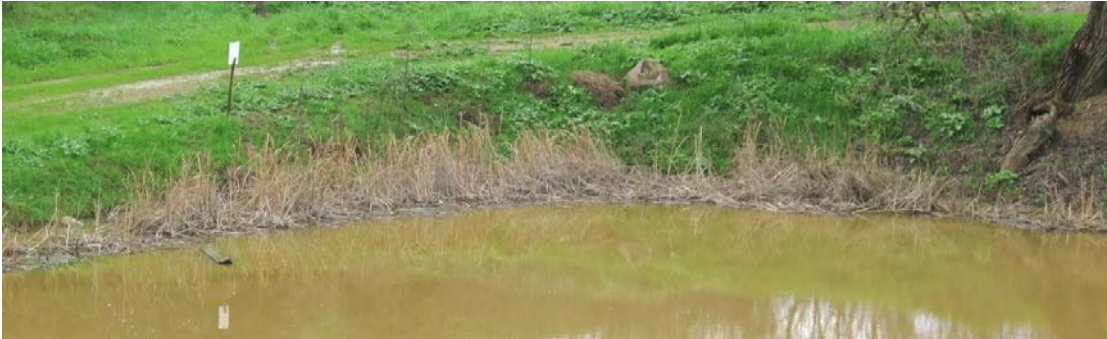
**Basin A - February 10, 2017**Fill Area 2

- Erosion control (wattle, straw rolls) along the toe of the slope north of the turbine plant was overwhelmed by runoff and needs to be repaired.
- The western portion of the east alkali wetland, visible from the east side of Fill Area 1, appeared to be completely full of water.
- Basins A, B and SW-A (which is in Fill Area 2) were directly observed. All appeared to be full, and the water in them was turbid. This is unsurprising, since there had already been almost 3 inches of rain in the past ten days. See photo below.

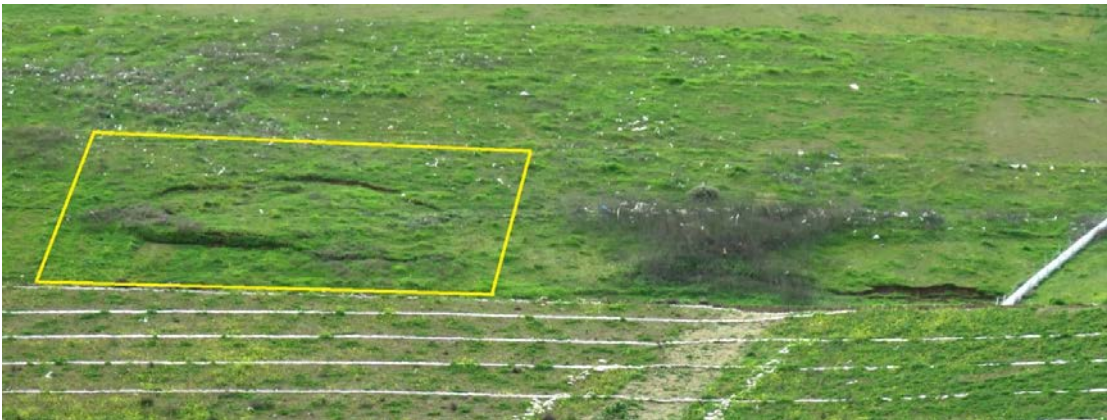
**Landslide Forming above Fill Area 2, Phase 1**Construction of Covered Aerated Static Pile (CASP) Compost Facility

- A small landslide appeared to be forming near the north end of the west slope of Fill Area 1, immediately upslope from the lined Phase 1 area. See photo below.

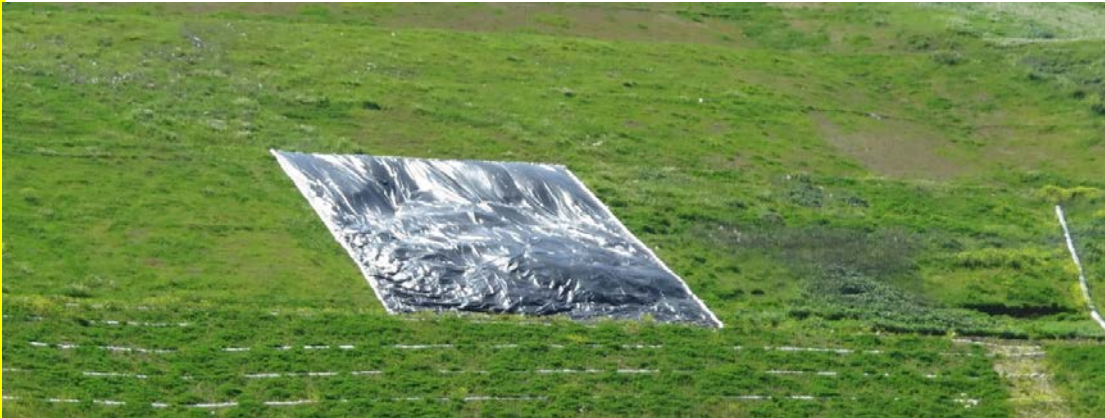
**Landslide Above Fill Area 2, Phase 1**Special Occurrences Log, December 1, 2016 - March 22, 2017

- The small landslide area noted last month above the west side of FA2 continued to slump. It was covered by a large plastic sheet held in place by sandbags. A rough estimate of the area involved is 80 feet x 80 feet, or about 1/8 acre. A second, smaller slide was also seen nearby, partially below a downdrain pipe. This area will be addressed when conditions are dry enough.
