# COMMUNITY MONITOR COMMITTEE

## Altamont Landfill Settlement Agreement

*COMMUNITY MONITOR  
COMMITTEE*  
*Altamont Landfill Settlement Agreement*  
Minutes of April 12, 2017

**ALRRF Community Monitor Monthly Report****April 2017**Stormwater Controls and Best Management Practices

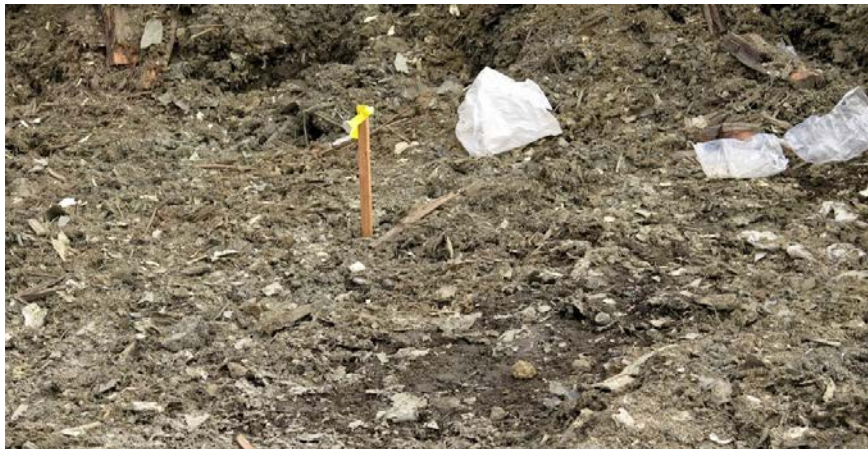
- At the asbestos disposal area, one dozer was spreading soil to cover material that had been brought in earlier in the day.
- Near the northeast corner of the Fill Area 1 top deck, the benzene-contaminated soil was exposed for removal, and the edges of the area had been marked with survey stakes, but removal had not yet begun. Approval by the hazardous waste site that would receive the material was pending review of lab test results. Minor ponding was occurring in this area, which was slightly below grade due to the excavation made to expose the soil. See photo below.

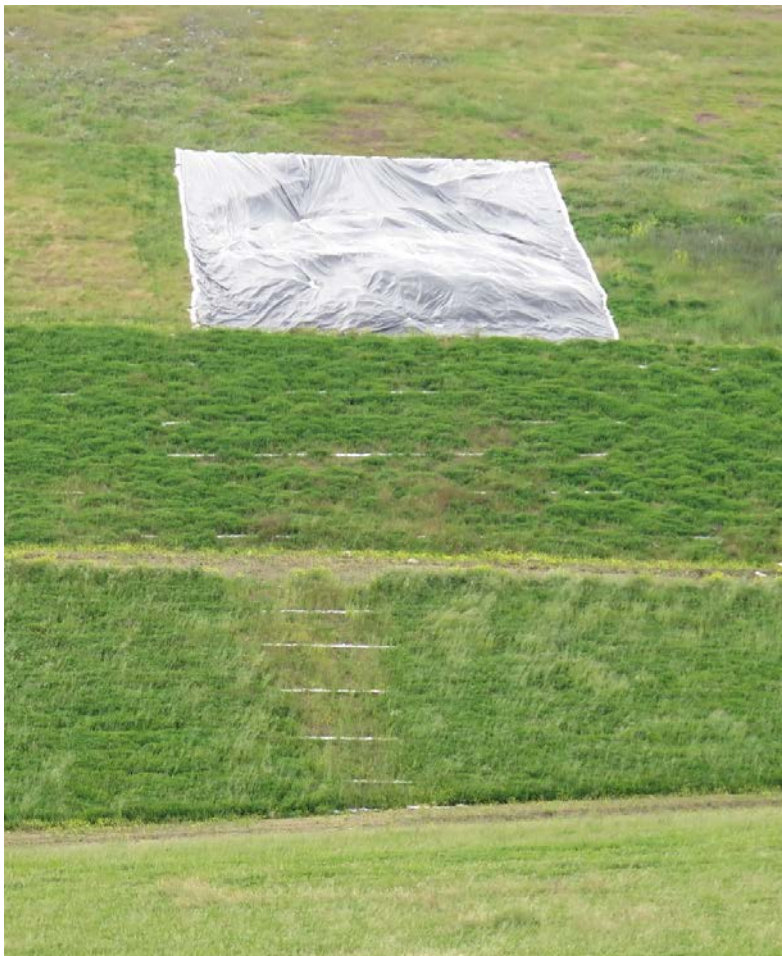
- New groundwater wells are being / have been installed as described in reports to the Central Valley Regional Water Board.
- Windblown litter in Fill Area 2 has been completely cleaned up.
- The small landslide area noted last month above the west side of FA2 appeared unchanged. It was still covered by a large plastic sheet held in place by sandbags. See photo below.

In the April Community Monitor Committee meeting, members asked to be kept informed about the status of the minor landslide that has occurred on the west side of Fill Area 2, in the future Phase 3 area. It has not been repaired, and it does not appear to have moved in at least the last two months. It appears that the wind has begun to pull its black plastic cover out from under the sandbags that are holding it down, but a small crew of workers can replace the cover easily.

- Windblown litter in Fill Area 2 was virtually nonexistent. East of Fill Area 2, only a very minor amount of litter was seen.
- The small landslide area noted last month above the west side of FA2 appeared unchanged. It was still covered by a large plastic sheet held in place by sandbags.

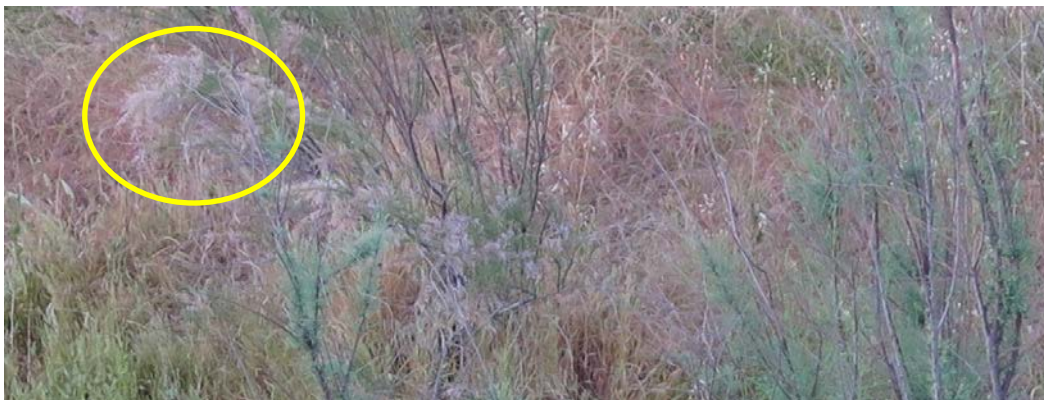
- No water was visible in this small basin. Unfortunately, the tamarisk trees that were treated with herbicide last year have begun to regrow. This invasive plant can damage surface soil by concentrating salt, and it is very hard to control. The plant may have been blooming as well. See photo below. The pinkish-gray tufts at the ends of the dark green branches appear to be flowers from this plant.

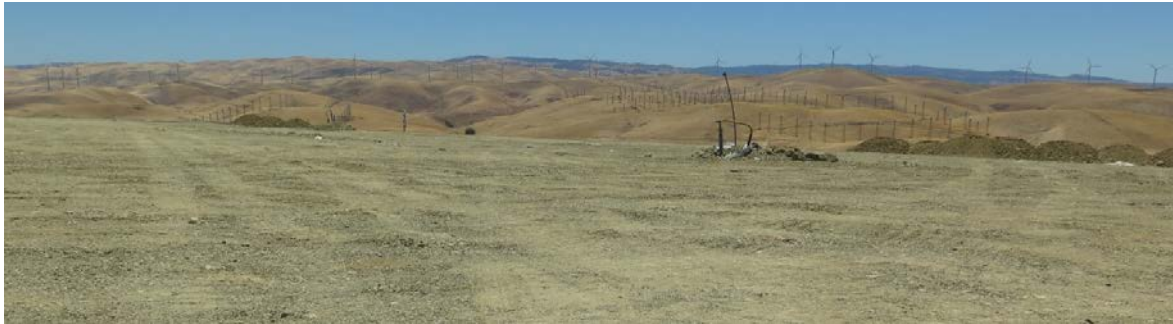
**top deck of ET area**

- The 10-acre test area for evapotranspiration (ET) cover was being covered with soil. The soil was being brought from elsewhere on site. It appeared somewhat coarse. Large rocks were being removed and stockpiled as the soil was being placed. According to staff, the uppermost layer of soil will be less coarse.

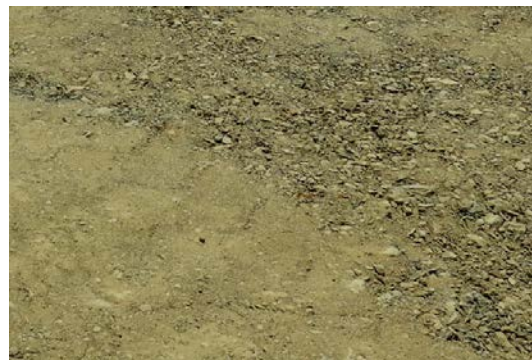
**Close-up of ET cover subsurface soil. Largest fragments are approximately 2 to 3 inches**

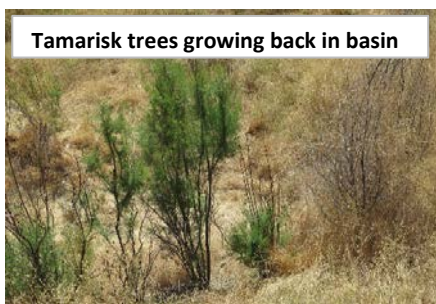
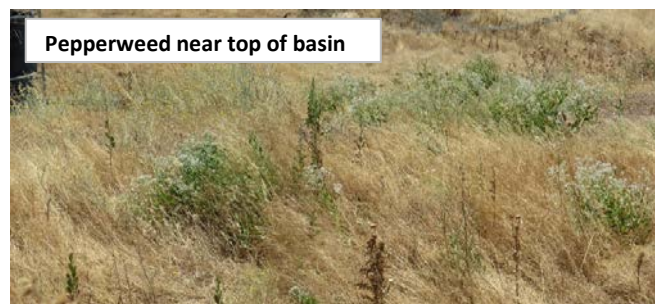
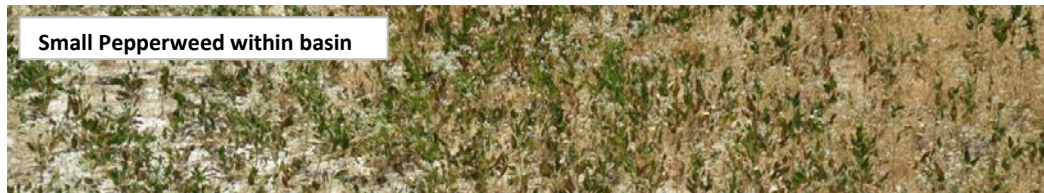
- No water was visible in this small basin. The tamarisk trees that were treated with herbicide last year were still growing but it appears that they have finished blooming and have probably set seed. In addition, small perennial pepperweed was seen in the bottom of the basin, and several pepperweed plants were seen growing near the top of the basin. This plant is highly invasive; see [this link for further information](#).

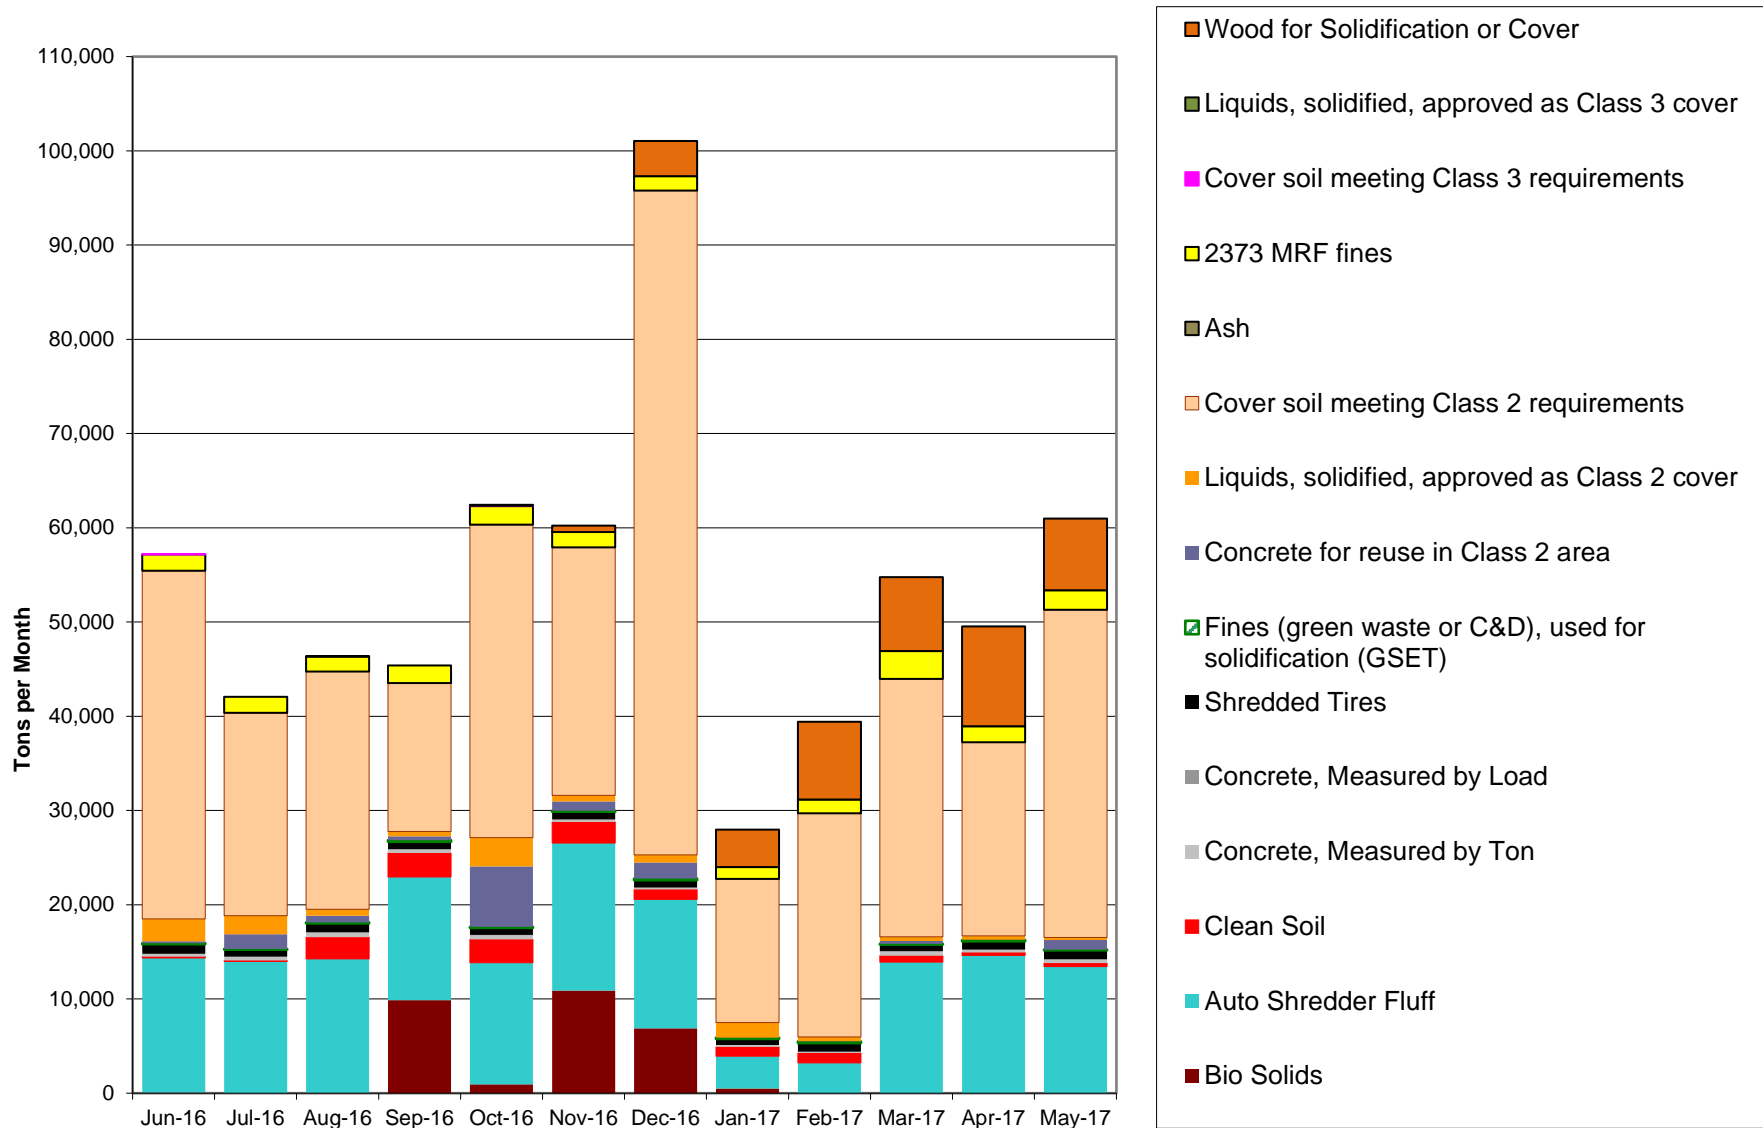
**Figure 6.4-1 Monthly Volumes of Revenue-Generating Cover**

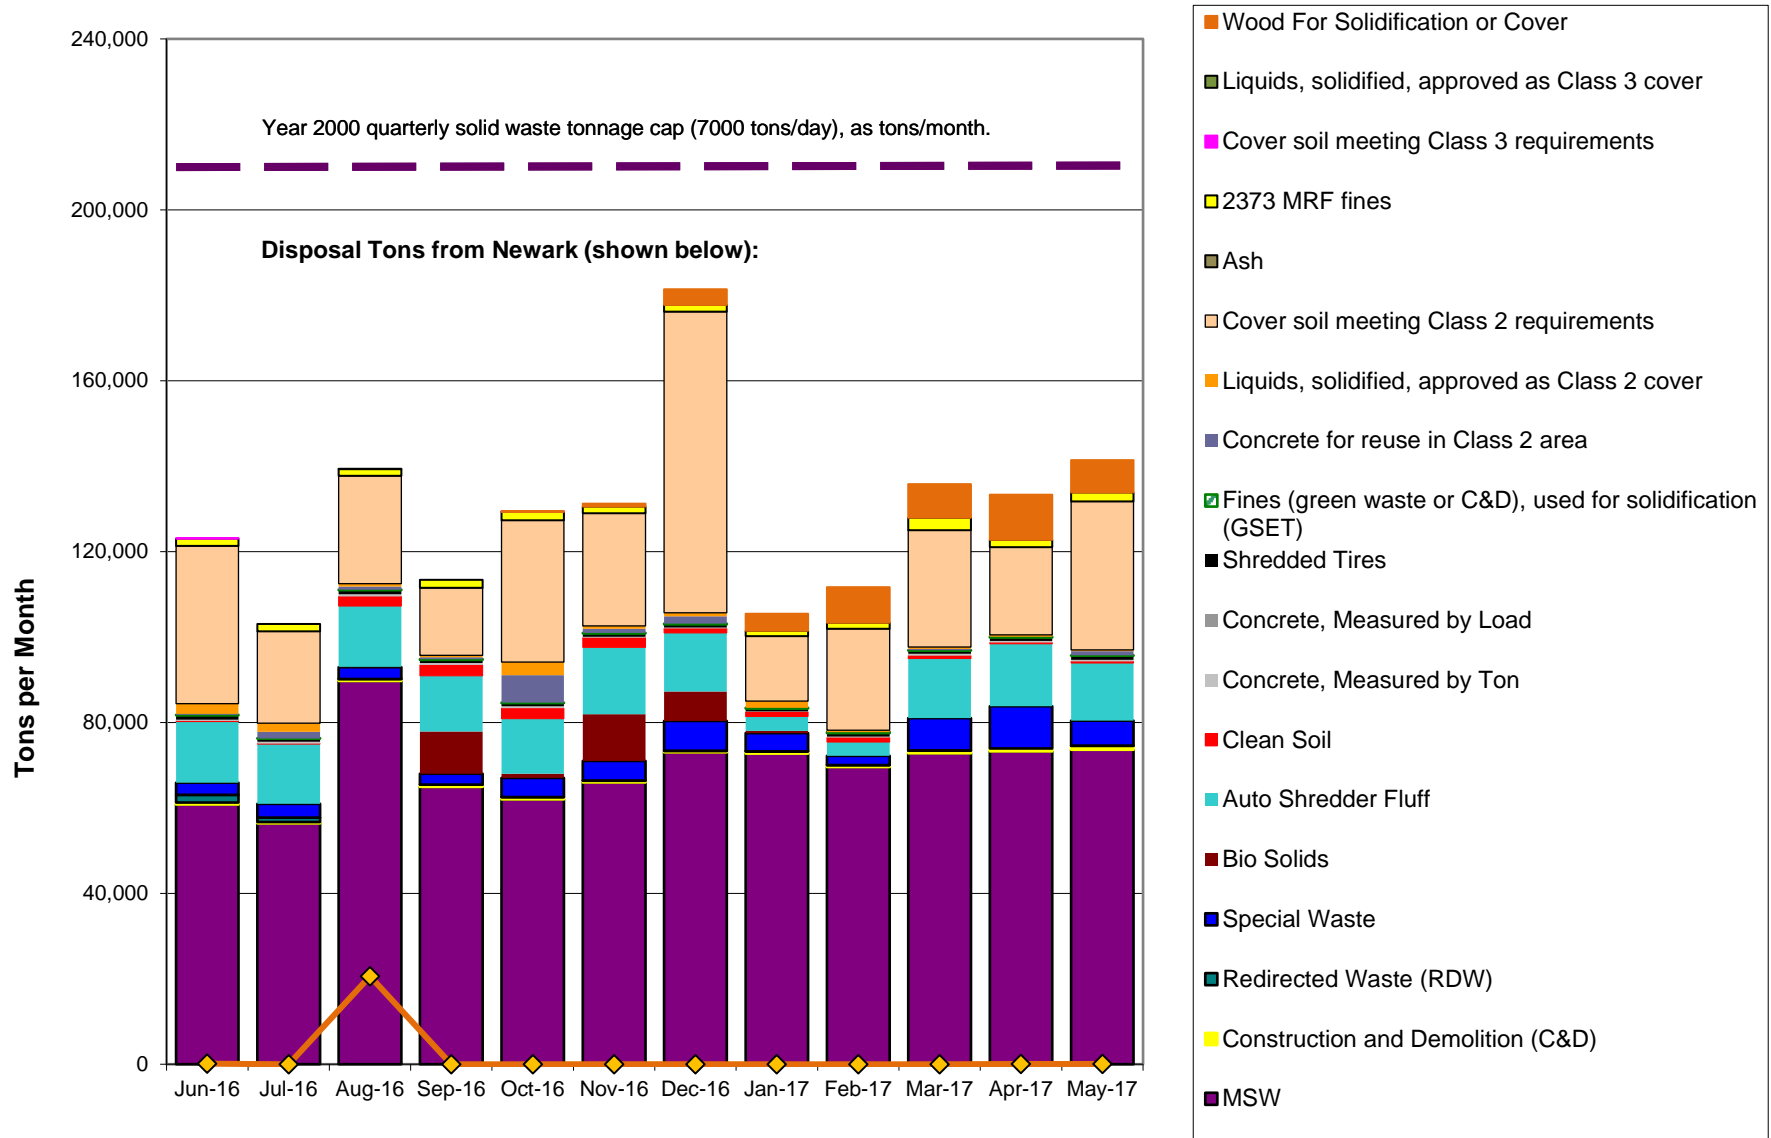
**Figure 6.4-2 Monthly Volumes of Landfilled Materials**
