# COMMUNITY MONITOR COMMITTEE

## Altamont Landfill Settlement Agreement

### AGENDA

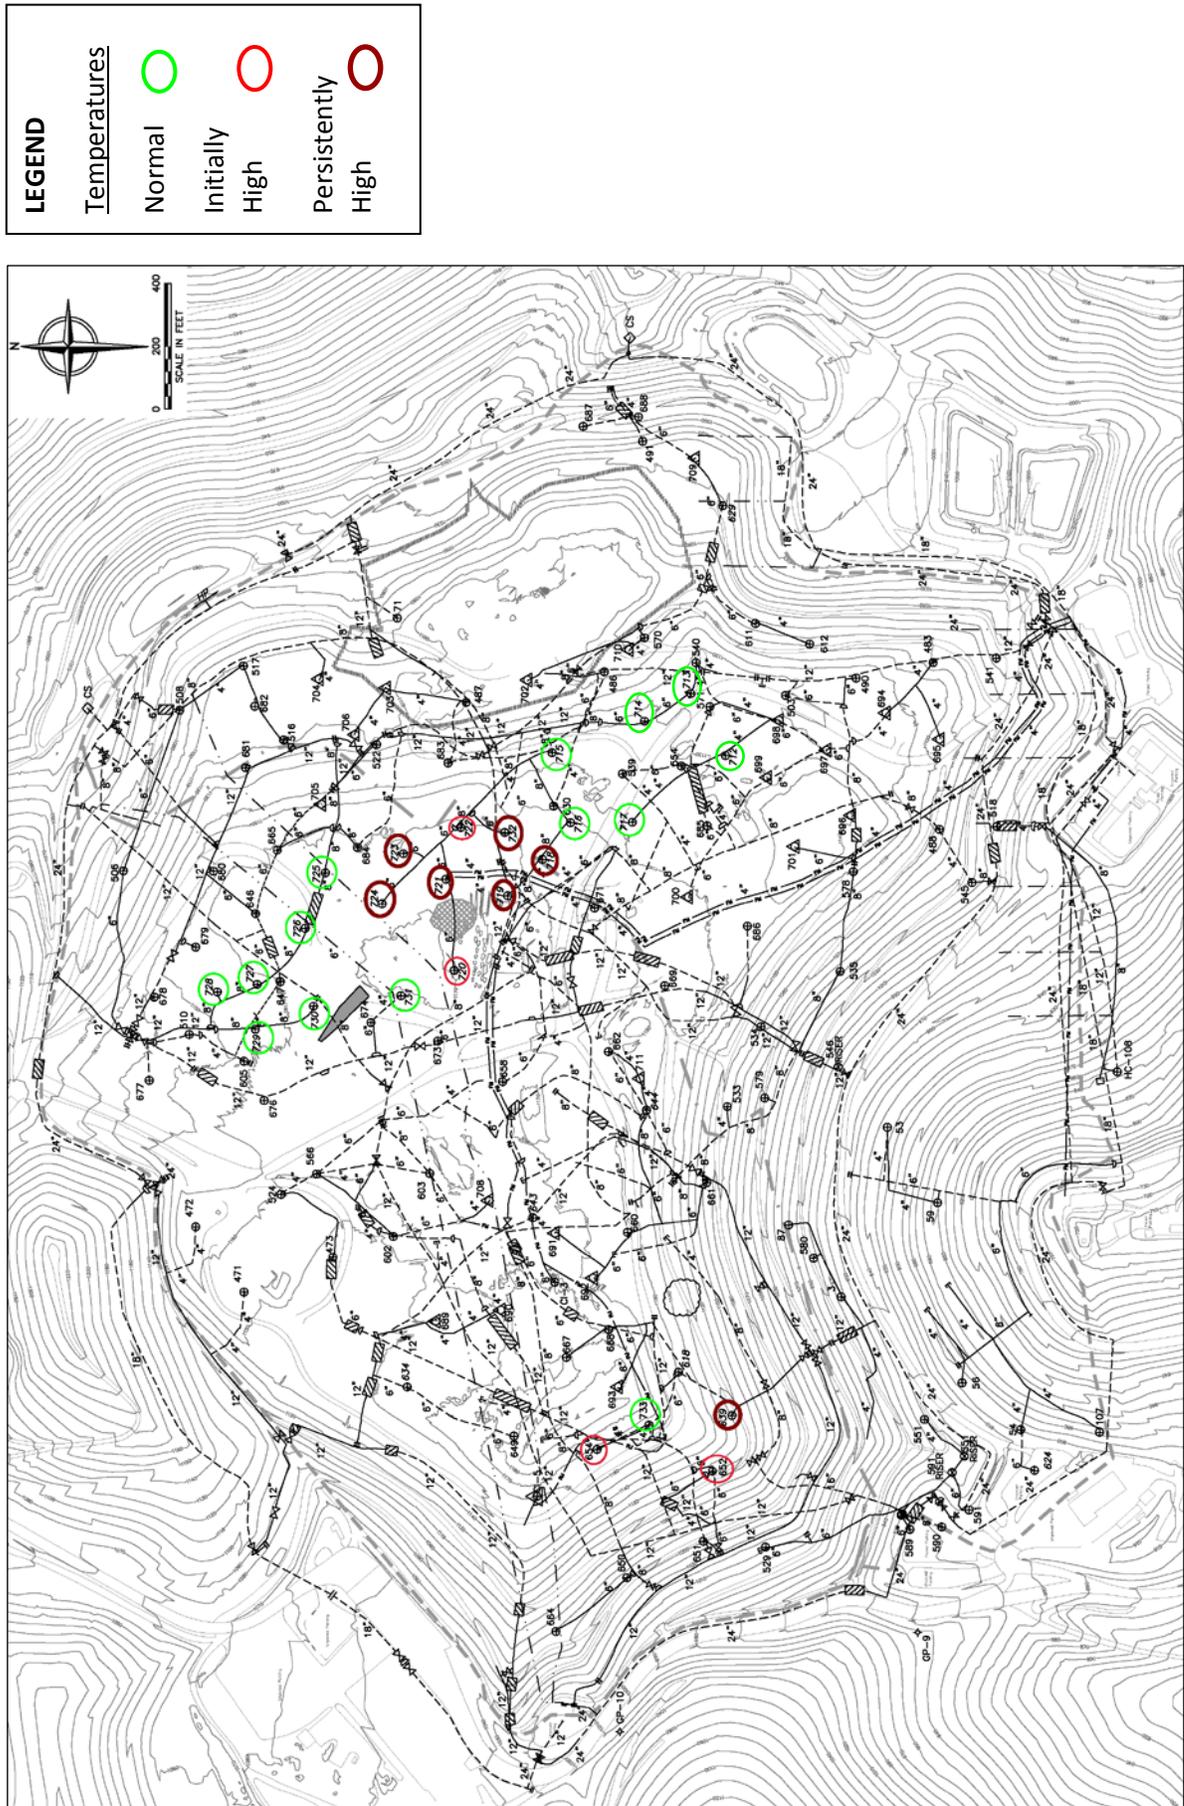
Figure 6.3-1 – Gas Well System and High-Temperature Wells, December 2016 – May 2017

- High Temperature wells - Eight of the newly installed wells, plus three slightly older wells, were found to be operating at atypically high temperatures in this reporting period. All eight of these wells are in close proximity to one another, suggesting that something unusual is going on below the surface. There are no direct indications of subsurface combustion, such as inordinately high carbon monoxide levels (above 1000 ppm), rapid subsidence, or high ground-surface temperatures; but this high-temperature cluster is an unusual occurrence. See the maps in Figures 6.3-1 and 6.3-2; they compare the most recent temperature data with that from over a year before, when the hot area had been the site of several landfill gas condensate<sup>1</sup> injection wells. It is possible that the fluid from those wells is degrading exothermically and raising temperatures of the extracted gas. The high temperature wells have been reported to the BAAQMD, and they are being classified as High Operating Value (HOV) wells because their gas temperature exceeds 131F (55C) at the wellhead. We will continue to track reports on these wells.

In summary, the air emissions report indicates continued sound operation of the landfill gas control systems, presenting no serious new environmental risks. However, the high temperatures at a cluster of newer wells, described above, should continue to be monitored closely due to the increased possibility of subsurface fire. Figure 6.3-1

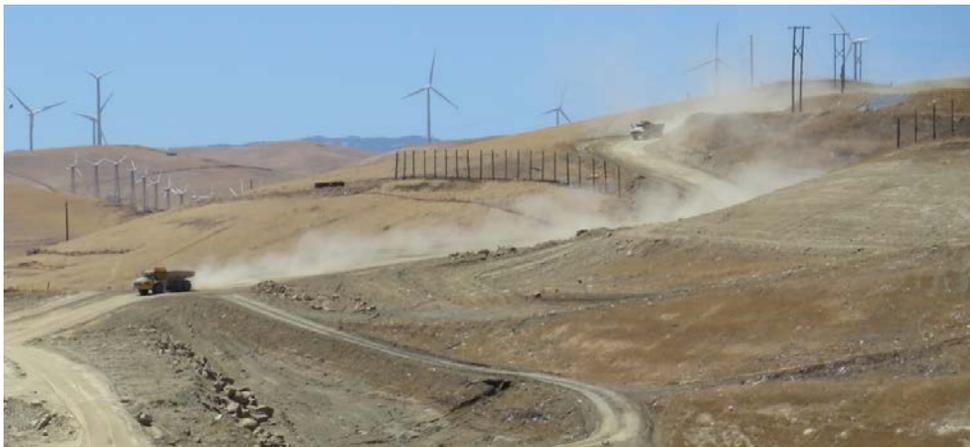
- Bird numbers and activity were much lower than usual, for no apparent reason. The bird cannon did not operate during these observations.
- The 10-acre test area for evapotranspiration (ET) cover was being covered with its compacted-soil layer (to reach a depth of 2 feet). The source of the soil is in Fill Area 2, south of the excavation for Phase 3.

- For fire prevention and weed control, goats were grazing on the hillside south of the turbine plant.
- The haul road for trucks bringing soil to the ET area was very dry and dusty. Trucks hauling soil were raising a considerable amount of dust. More water was needed.

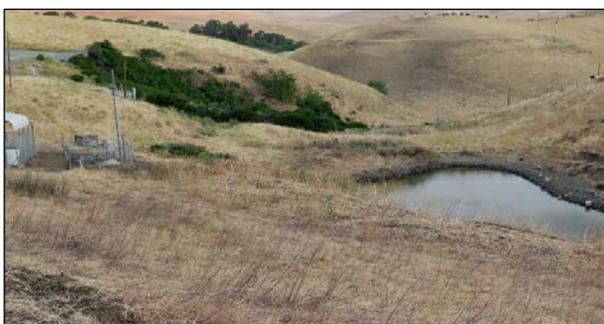
Stock Pond 11, June 2016

- At Stock Pond 11 in the NW corner of the property, more water was present than in 2016, covering a wider area. It appeared to have overtopped the pond and flowed west and north in the Brushy Creek drainage. No erosional damage could be seen from the access road, but there was some evidence of possible efforts to contain or control this flow.

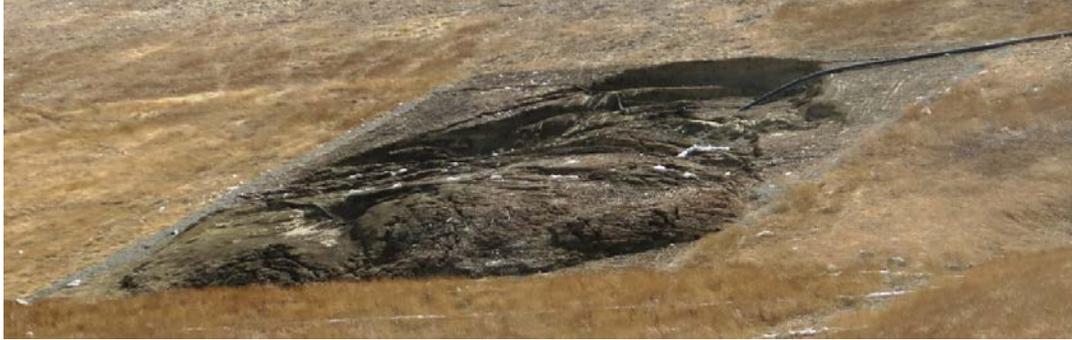
- A portion of the Fill Area 2 access road remained closed for CASP construction work.
- The area appeared to be undisturbed and in good condition, with some windblown litter on the west slopes and in the Phase 1 area.
- The small landslide area above the west side of FA2 had the tarp removed for inspection and repair planning. ALRRF staff mentioned that the slide may have been caused by incomplete compaction of soil fill when the side slopes were constructed.

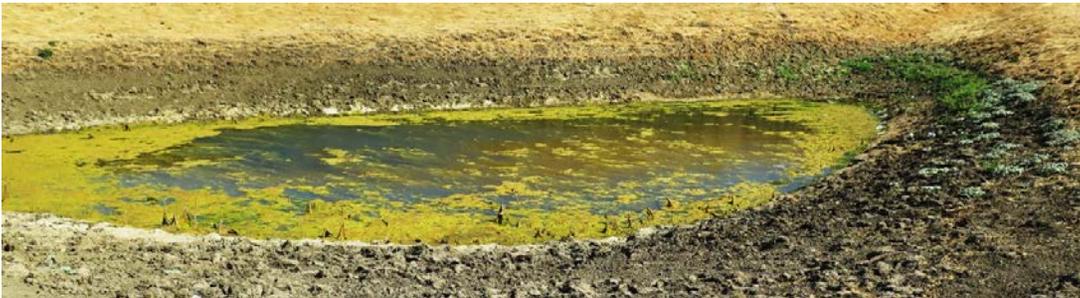
- At Stock Pond 10 near the northern boundary of the property, water was present, and two types of shrub were growing on the northeast-facing slopes (with lowest sun exposure) near the pond. Heavy algal growth was visible within the pond.
