COMMUNITY MONITOR COMMITTEE

Altamont Landfill Settlement Agreement

AGENDA

ALRRF COMMUNITY MONITOR ANNUAL REPORT 2017

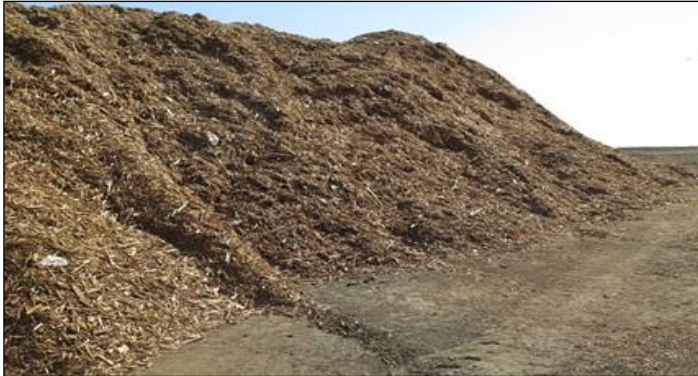
Shredded wood stockpile

- Shredded wood, stockpiled for use as ADC, was closely observed. Very minor amounts of non-wood material, such as small shreds of plastic, were visible in the stockpile. These may have blown onto the pile after delivery; in any case they would not interfere with the material's performance as cover.

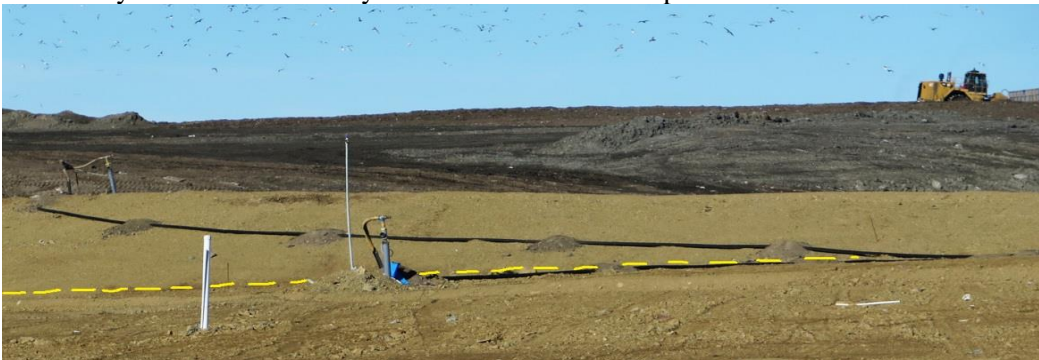
- The 10-acre test area for evapotranspiration (ET) cover appeared to be unchanged from previous site visits, but staff reported that differential settlement has occurred, and this is likely to interfere with preparations for the planned test.
- Soil screening and blending for the ET cover area was continuing, but no additional soil had been placed above the initial layer of cover material, first observed in June.

- At the ET test area, a shallow valley has formed in the upper portion, near a gas well; the bottom of this valley is indicated with a yellow dashed line in the photo below.

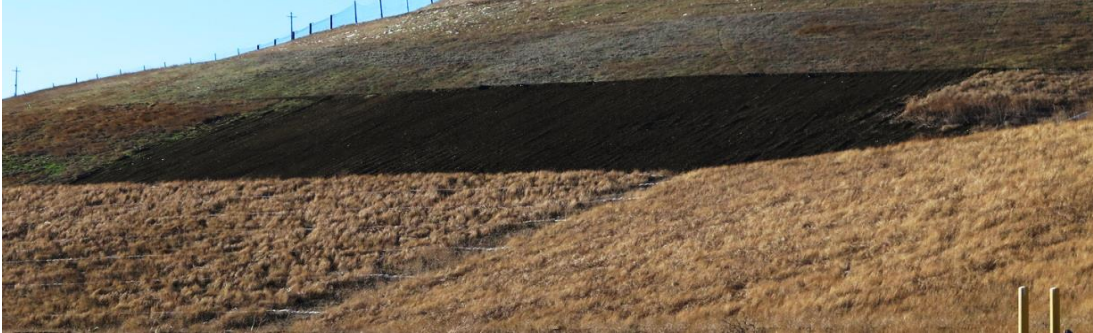
- The Fill Area 2 access road has been reopened, as construction of the CASP site apparently is nearing completion. The alternate route to FA2, a steep dirt road down to the office and unloading area, has had water bars installed to direct runoff to the roadside ditch, to prevent erosion.
- The area appeared to be undisturbed and in good condition, with no windblown litter visible.
- The small landslide area above the west side of FA2 has been repaired and regraded. The repair area is about three times as wide as the obvious portion of the slide had been. The area did not appear to have been hydroseeded. See photo below.

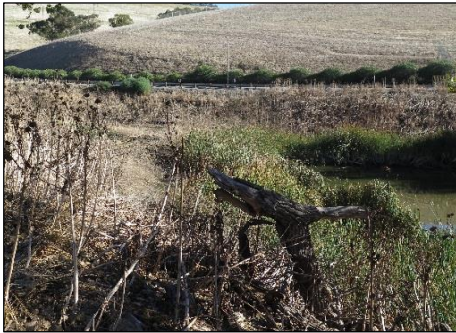
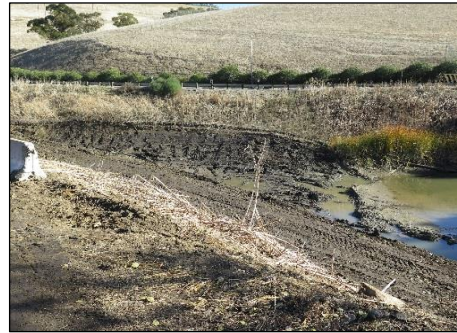
- Basin A was in the process of being excavated. Staff reported that Basins B and C had also been excavated, to increase capacity. Before-and-after photos of the upper end of the basin:

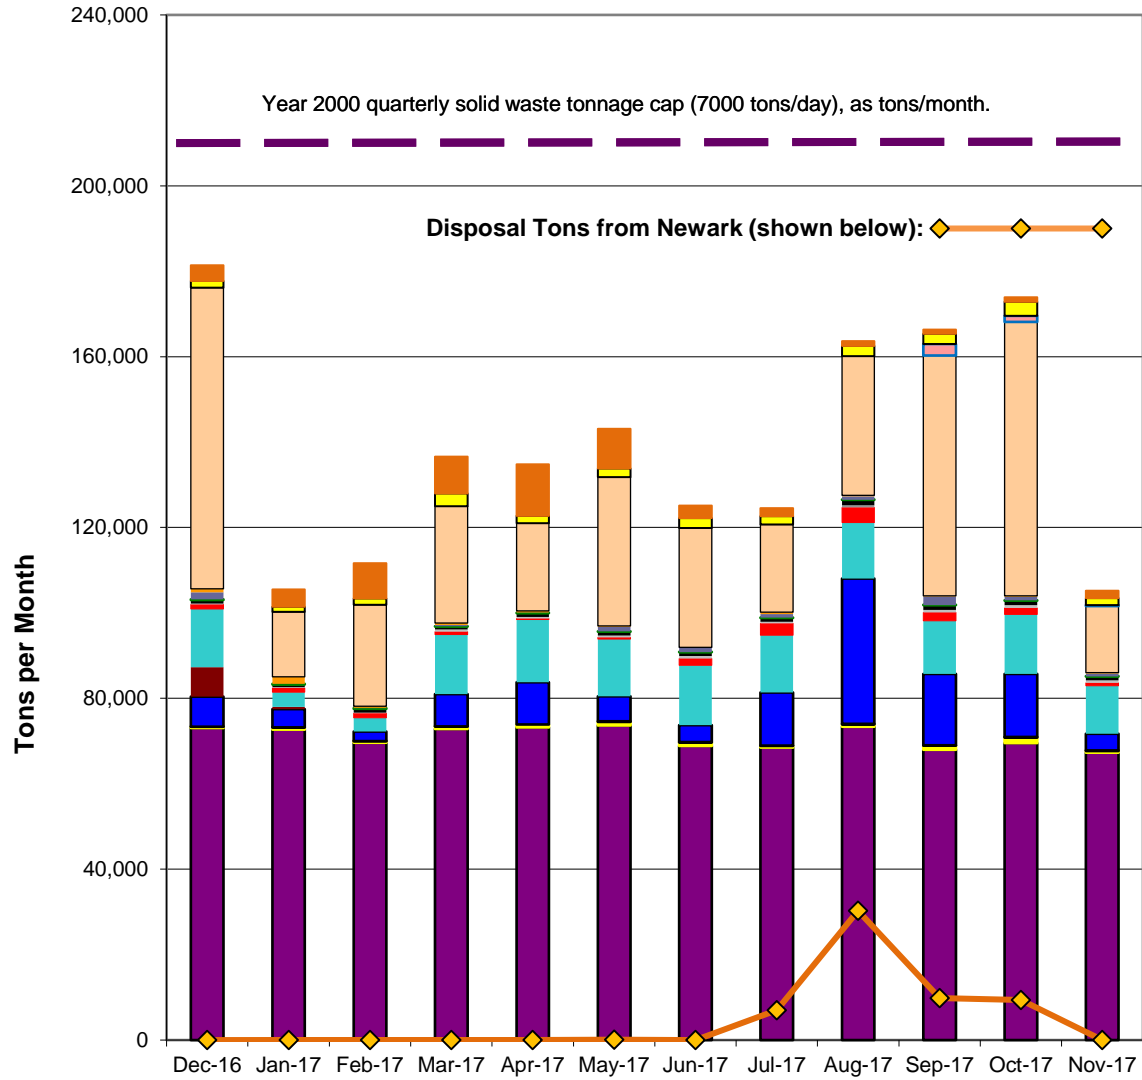
Figure 6.6-2 Monthly Volumes of Landfilled Materials

- Wood For Solidification or Cover
- Liquids, solidified, approved as Class 3 cover
- Cover soil meeting Class 3 requirements
- 2373 MRF fines
- Ash
- Cover soil, Class 2, low-VOC
- Cover soil meeting Class 2 requirements
- Liquids, solidified, approved as Class 2 cover
- Concrete for reuse in Class 2 area
- Fines (green waste or C&D), used for solidification (GSET)
- Shredded Tires
- Concrete, Measured by Load
- Concrete, Measured by Ton
- Clean Soil
- Auto Shredder Fluff
- Bio Solids
- Special Waste
- Redirected Waste (RDW)
- Construction and Demolition (C&D)
- MSW
