COMMUNITY MONITOR COMMITTEE

Altamont Landfill Settlement Agreement

AGENDA

DATE: **Wednesday, April 11, 2018**
TIME: **4:00 p.m.**
PLACE: City of Livermore
Maintenance Services Center
3500 Robertson Park Road

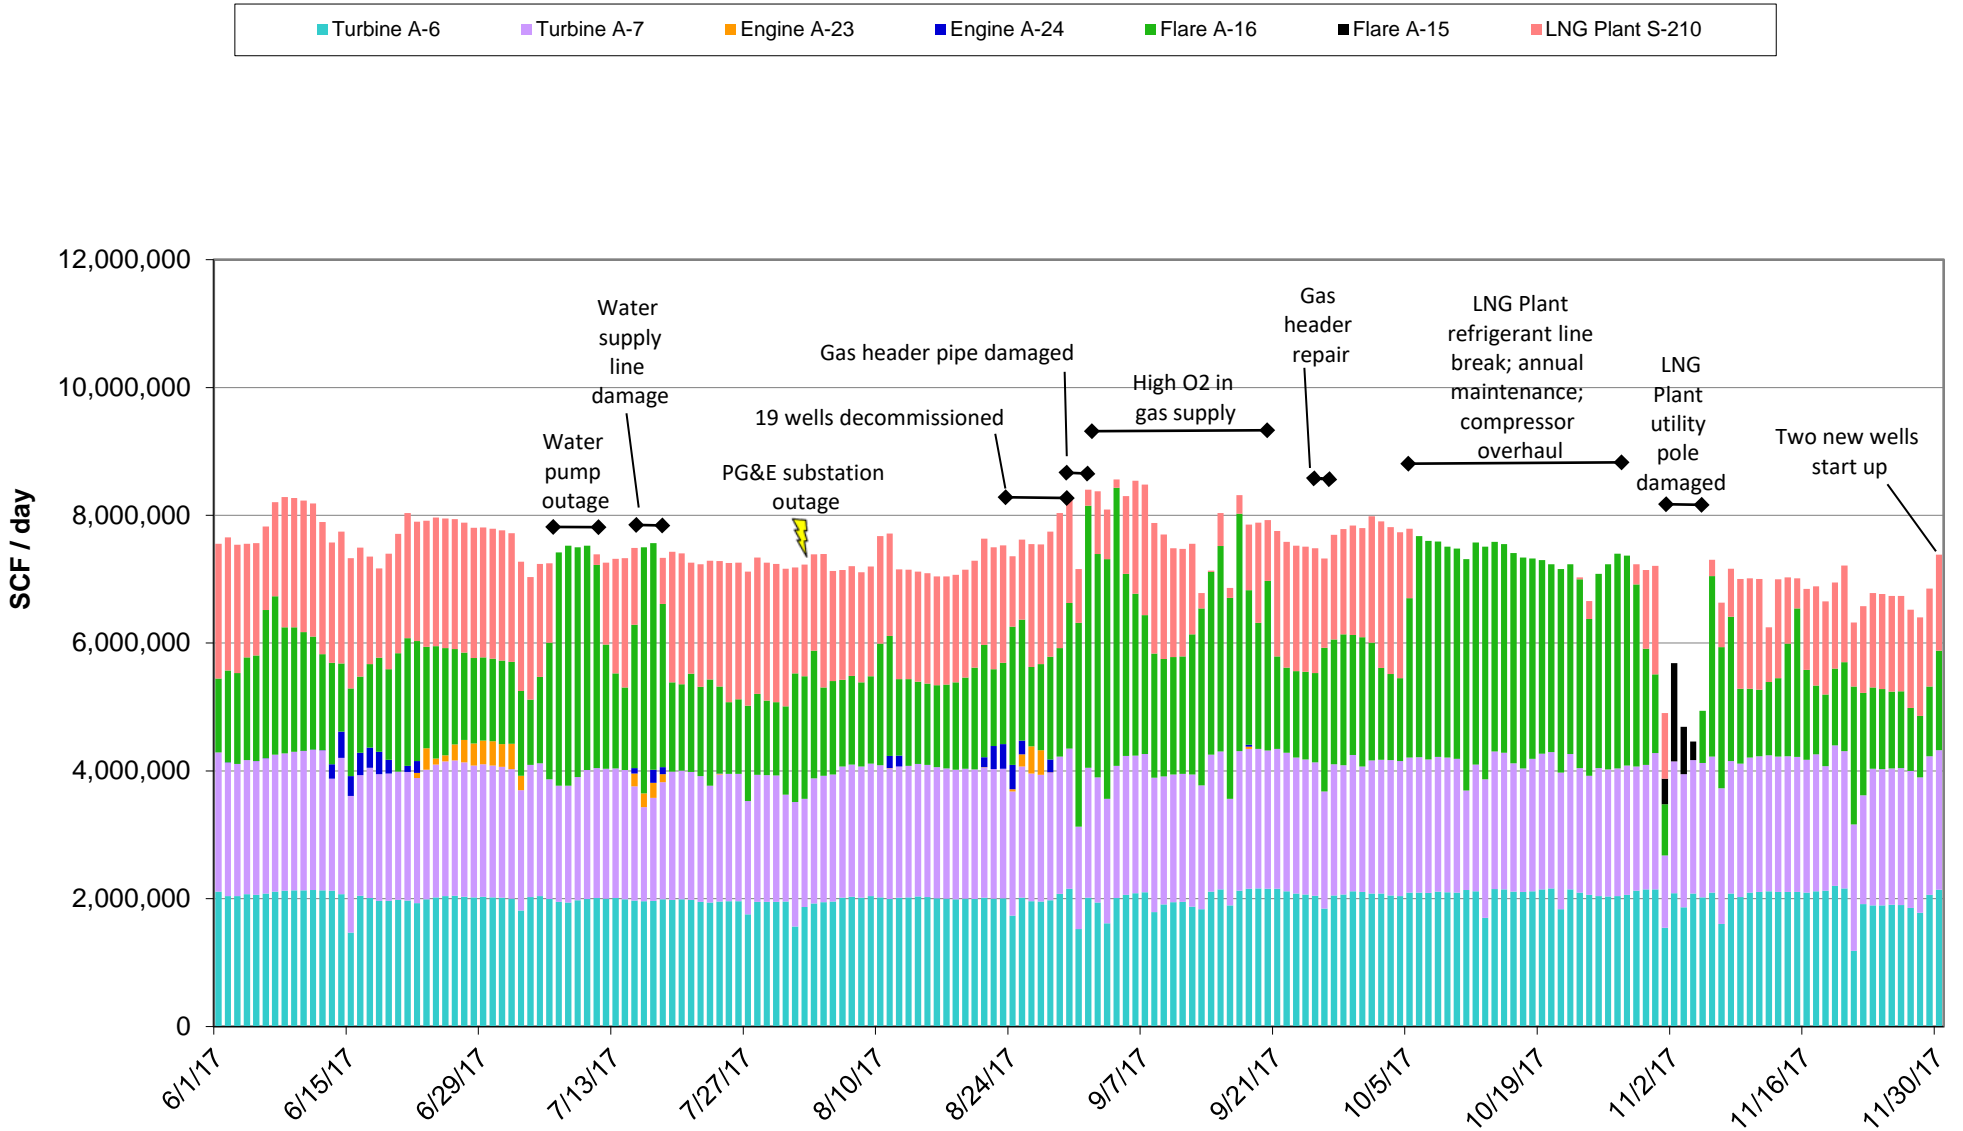
Figure 6.4-1 - ALRRF Daily LFG Flow
(values derived from Title V Report)

- A water pump outage that shut down the LNG plant for several days.
- A water supply line problem, causing a multi-day LNG outage, less than a week later.
- Damage to a large “header pipe” carrying landfill gas to the LNG plant. This interrupted the gas supply intermittently, and it apparently allowed some air to enter the gas stream, creating problems in extracting methane from the landfill gas.
- A break in a refrigerant line within the LNG plant.
- An oil leak in a compressor that required the compressor to be overhauled.
- Damage to a utility pole serving the LNG plant. This forced the shutdown of the LNG plant and the adjacent primary flare, for several consecutive days. During that time, efforts were made to use backup flare A-15 to consume gas, but various problems with that device limited its operation.

In summary, the air emissions report indicates some unique difficulties in operating the landfill gas control systems, but these did not result in substantial new emissions or other environmental harm.

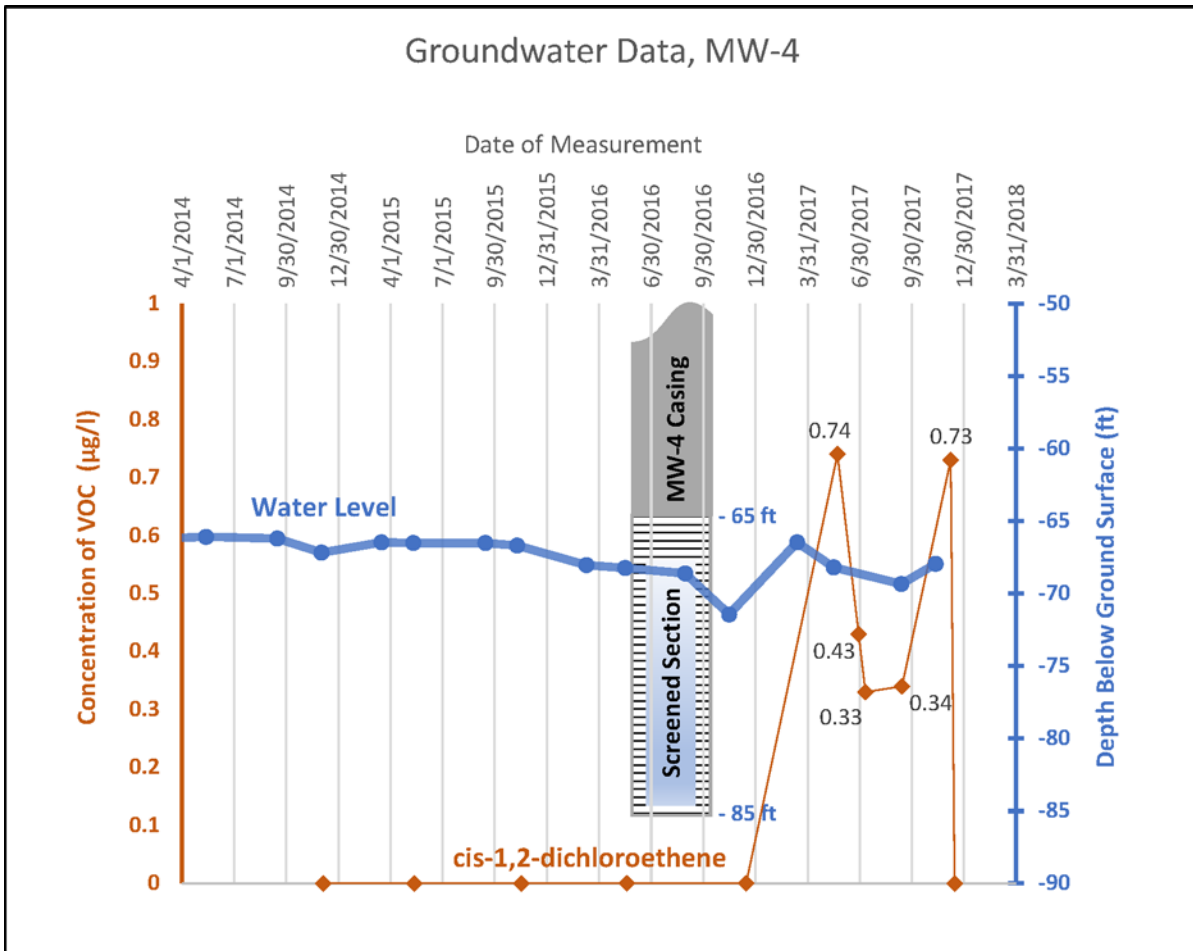
Figure 6.4-2 below shows the concentrations of one of the VOC contaminants measured at MW-4. Also shown, on the same time scale, are the changes in groundwater elevation (using the right-hand axis), juxtaposed with a matching illustration of the screened section of the well.

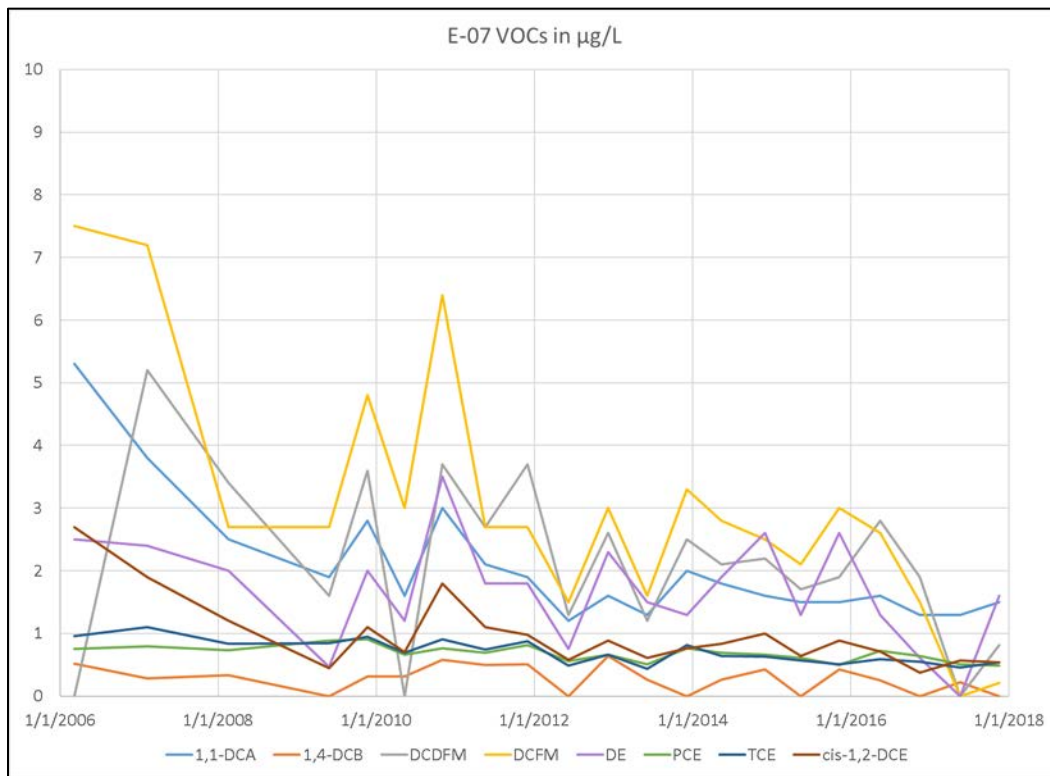
Three VOCs were not detected in E-07 during the May 2017 sampling event, resulting in a downward spike to zero, even though the other 5 VOC concentrations were consistent with their historical trends. For the subsequent November 2017 sampling event, the concentrations of those 3 undetected chemicals returned to values lower than earlier sampling results, further suggesting that the three non-detect results from May could be anomalous. The cause of only 3 of the 8 chemicals being non-detect is unknown but seems peculiar. It may relate to the fact that at room temperature, the three undetected chemicals are vapors, and all of the others are liquids. Dilution from rain events would be expected to affect all chemicals, as occurred in early 2010 and early 2012.

Other than the previously noted detections of 1,1-DCA prior to 2010, Well E-03A does not have detections of VOCs, indicating that in this region, the effect on groundwater is limited to the area immediately adjacent to the landfill.

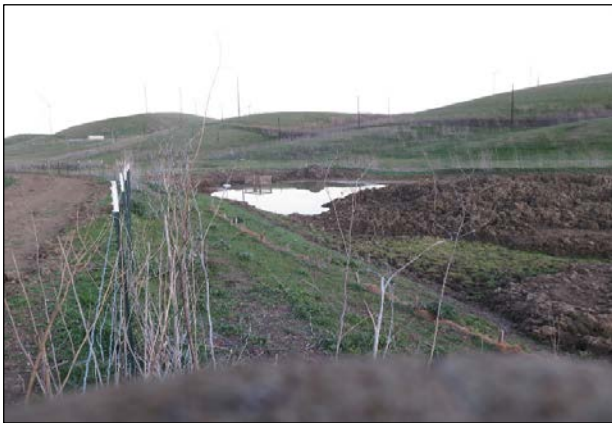
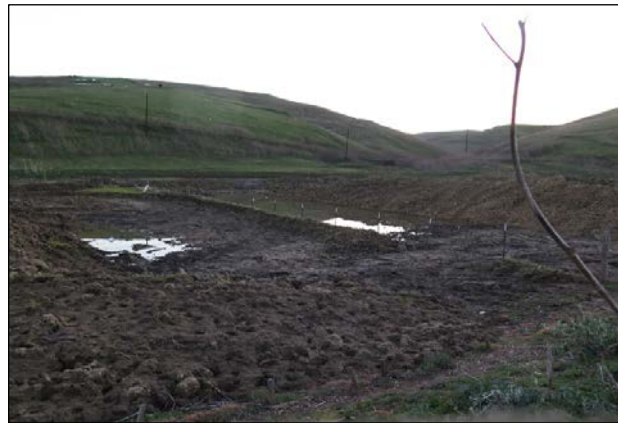
Mitigation Pond Construction

- Due to recent rains, construction at the pond site was suspended. The photos below were taken from the same point along the north side of the pond, facing east (on the left) and southwest (on the right). ALRRF staff reported that soils were too soft to move excavating equipment into and out of the work area.

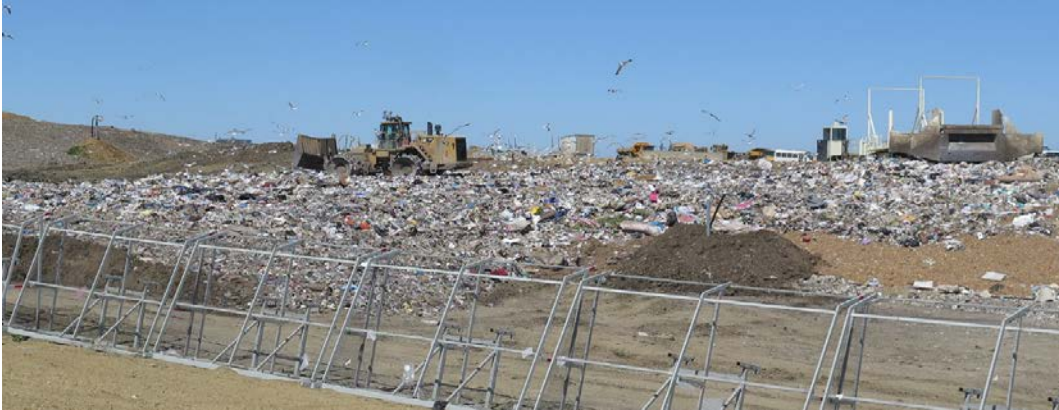
- Attended by K. Runyon, accompanying LEA Arthur Surdilla. Escorted by Audrey Lundin and Enrique Perez. Announced.
- Primary filling activity was on the southeast side of Fill Area 1, in the Class 2 area. Compaction was taking place close to the tippers, with only one dozer, one compactor and one tipper operating.
- The active tippers were diesel fueled. The CNG tippers were stored at the wet weather pad where they could be brought on line if needed. The photo below is a view of the area from the south.

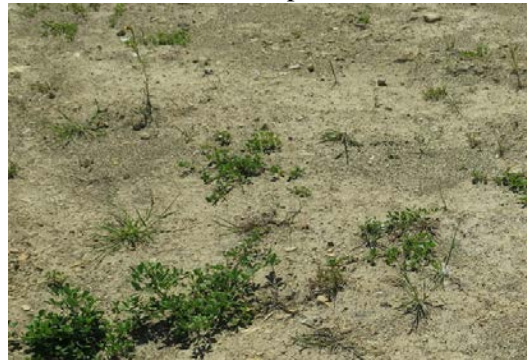
- At the ET cover area, plants have begun to grow in the compacted base layer, sparsely (see photo). When the area is regraded, these plants will be buried. They include some native plants and some weedy species.

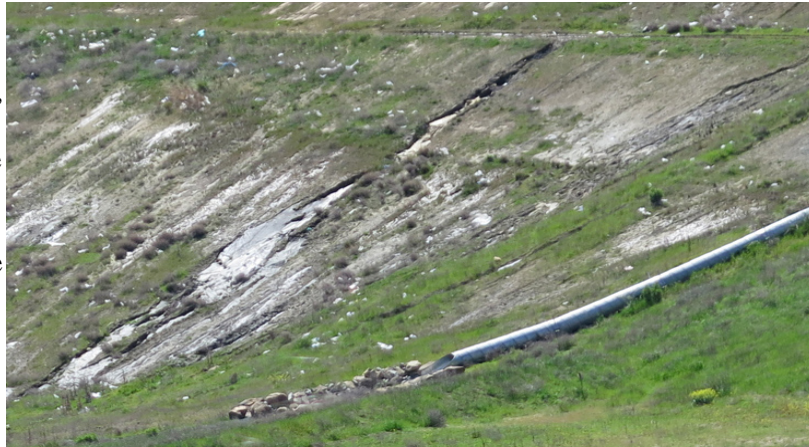
- Area was in good shape, no erosion or earth movement. South of the constructed area, a groundwater seep, seen in prior years, has again become active (see photo). Wind-blown litter was also present in this area because it became too wet to access in recent rains. Cleanup is planned as soon as the area dries out.
