# COMMUNITY MONITOR COMMITTEE

## Altamont Landfill Settlement Agreement

*COMMUNITY MONITOR  
COMMITTEE  
Altamont Landfill Settlement Agreement  
Minutes of April 11, 2018*

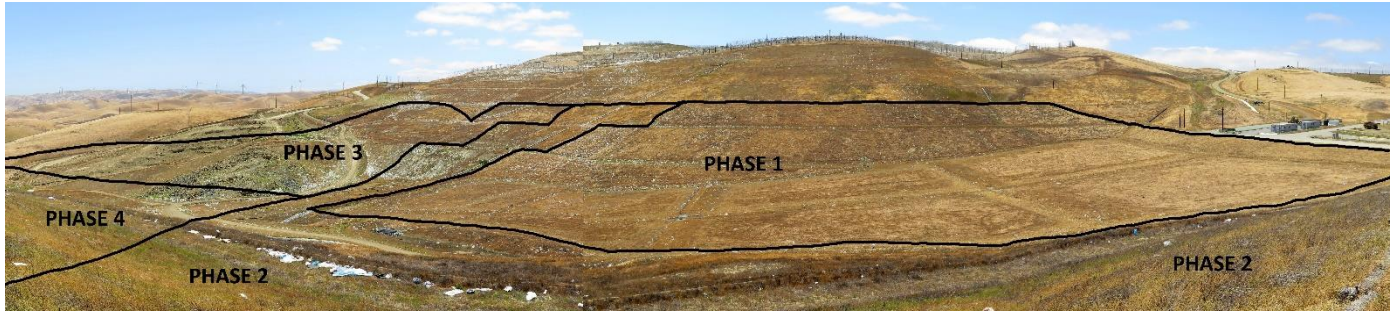
**Figure 6.5-2**  
**Simulation of 2018 Fill Area 2 Footprint, with Phases**

- Phase 1, which is fully constructed, will receive waste beginning in April of 2019
- Construction of modified Phase 2 will begin in 2019
- Excavation of Phases 3 and 4 will begin in 2020.

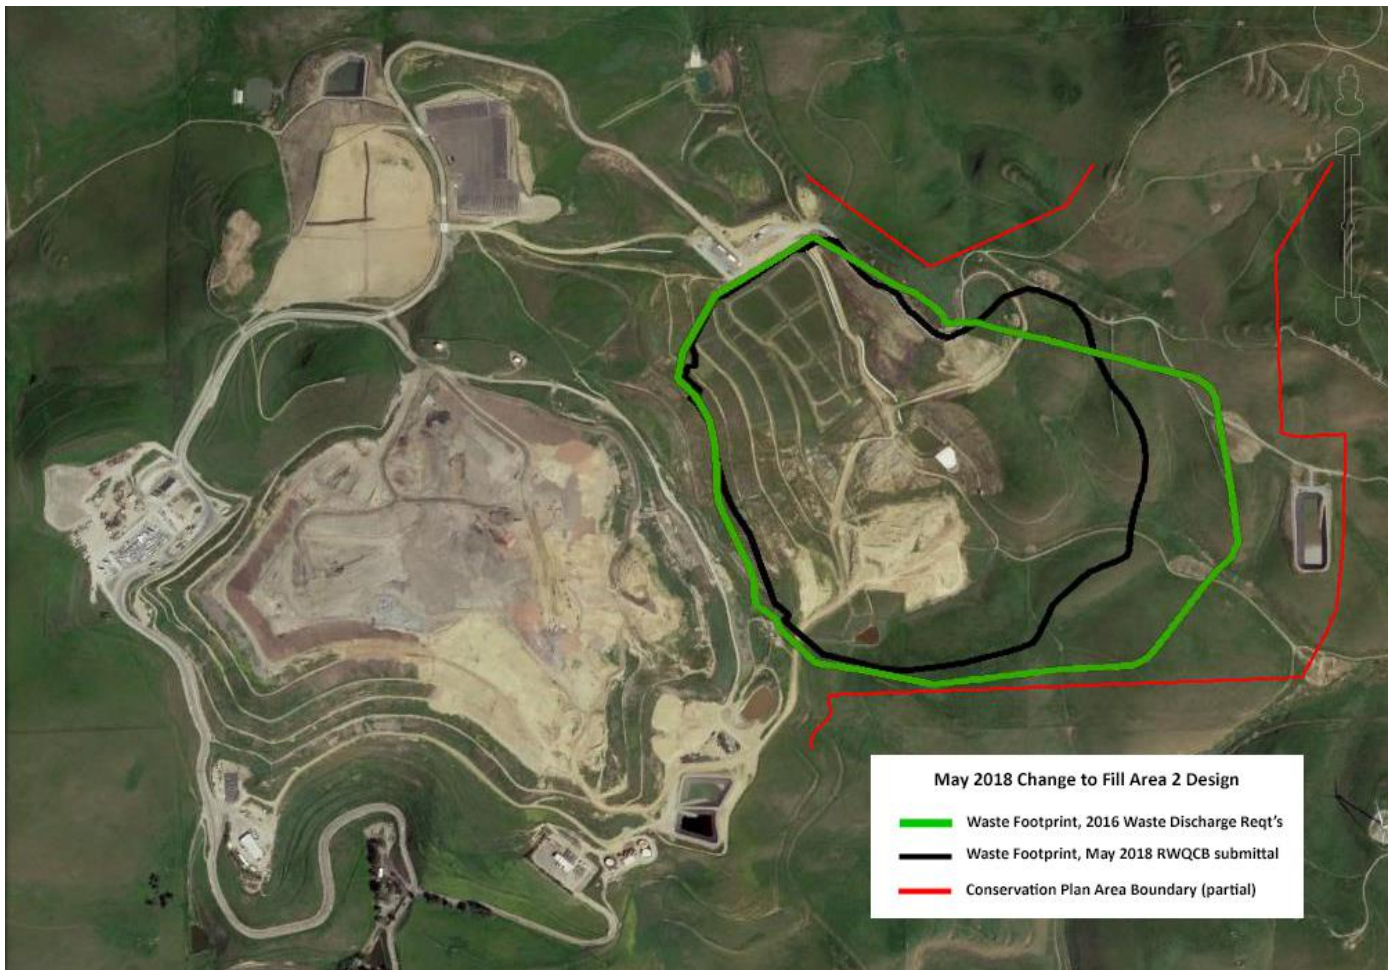
**Figure 6.5-3**  
**Comparison of Fill Area 2 Footprints**

Photo Taken May 31, 2018

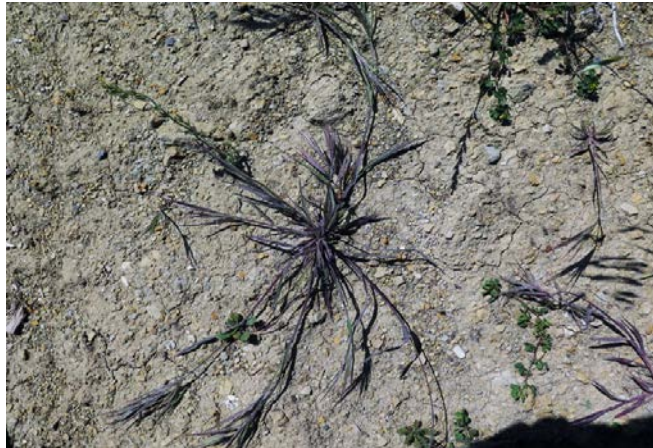
- At the ET cover area, a variety of low-growing plants were growing in thinly scattered patches. These included amsinkia, mustard, bur clover, and non-native grasses. Soil conditions were unchanged, and the top deck continued to exhibit shallow swales in some locations due to differential settlement. There was no plant growth on the soil stockpiled for future use in the ET cover area.

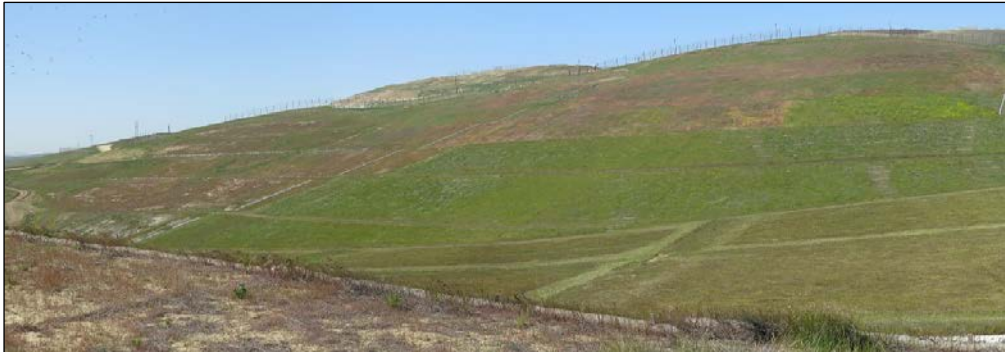
- Due to strong winds, a large group of seagulls that had flown to Fill Area 2 were unable to return to Fill Area 1. They were flying against the wind, in a group, but could not make headway.
- In spite of the wind, Fill Area 2 was almost entirely free of litter. Grasses and other low vegetation covered the entire area.
- No erosion, earth movement, or ponding was seen in Fill Area 2.

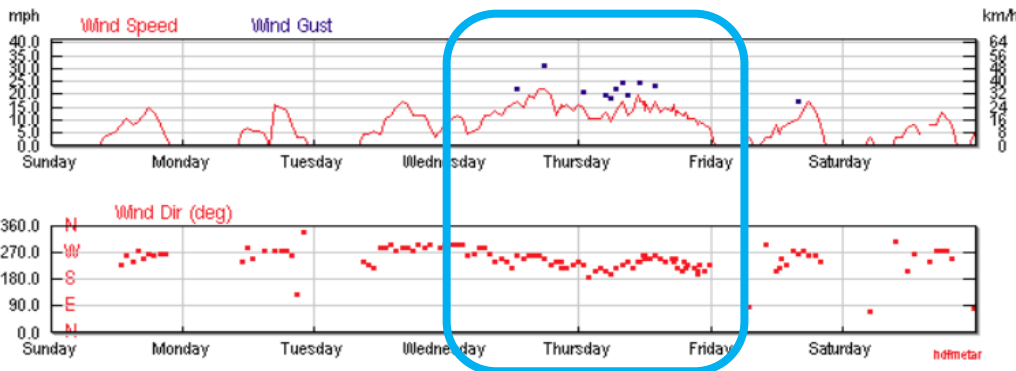
- Attended by K. Runyon, escorted by Audrey Lundin and Enrique Perez. Announced.
- A wind event, which began on May 30 and was continuing during this inspection, caused a large amount of windblown litter to be deposited to the west of Fill Area 1 (active area), into the south portion of Fill Area 2 and the open space farther west. Wind speeds had been 20 - 30 MPH continuously, with gusts up to 50 MPH. During this inspection, ALRRF staff checked the wind speed using a hand held anemometer, which gave a reading of 27 MPH. The chart below is from a location within the City of Livermore, where wind speeds are lower than at the ALRRF.

Source: Wunderground station KLVK, Livermore Municipal Airport

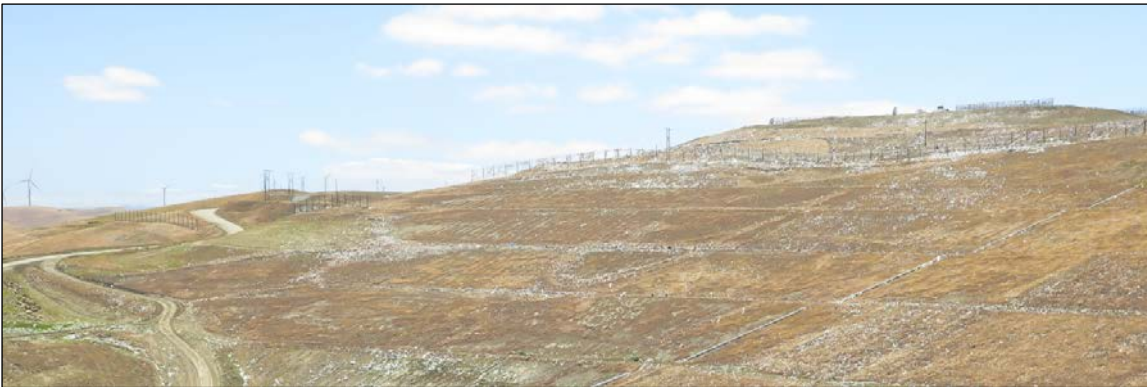
- This photo shows accumulated windblown litter from the recent wind event. Cleanup of this material was hindered by low staffing of the litter control crew. ALRRF was actively hiring replacement workers, but hiring procedures governed by union contracts were causing delays in hiring.

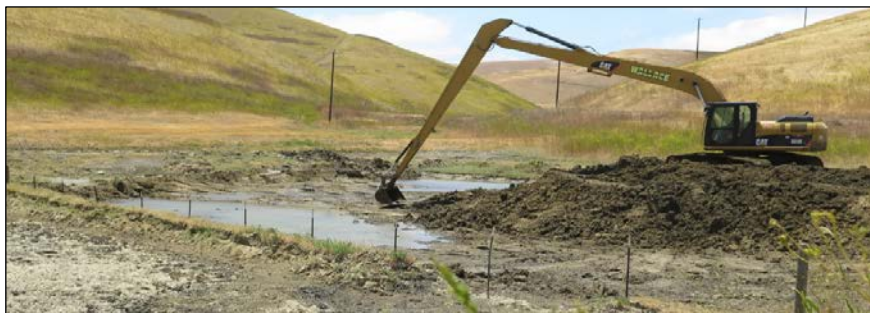
- Excavation (silt removal) had resumed, since wet weather was unlikely in the coming weeks.

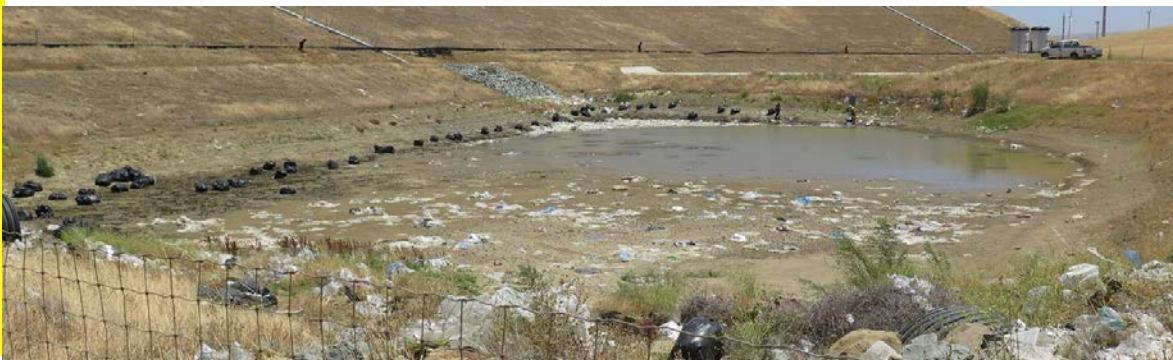
- Two litter crew members were observed cleaning up the interior of the sedimentation basin SB-A, in Fill Area 2, placing litter into black trash bags for later removal.

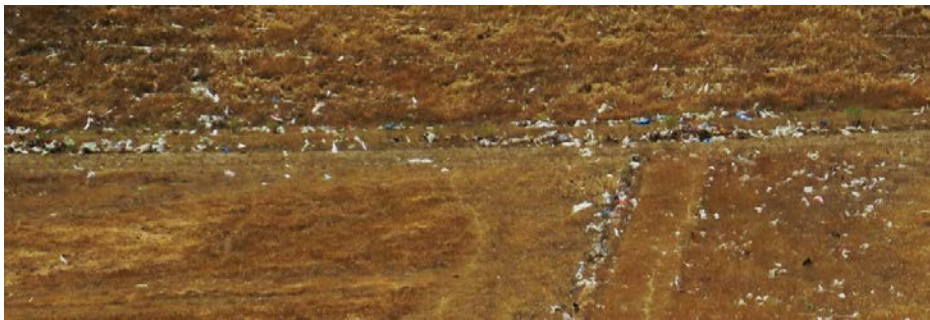
- ❑ There was a substantial amount of windblown litter within, and east of, Fill Area 2.

- ❑ Aside from the litter problem, Fill Area 2 was in good condition, with no erosion damage.

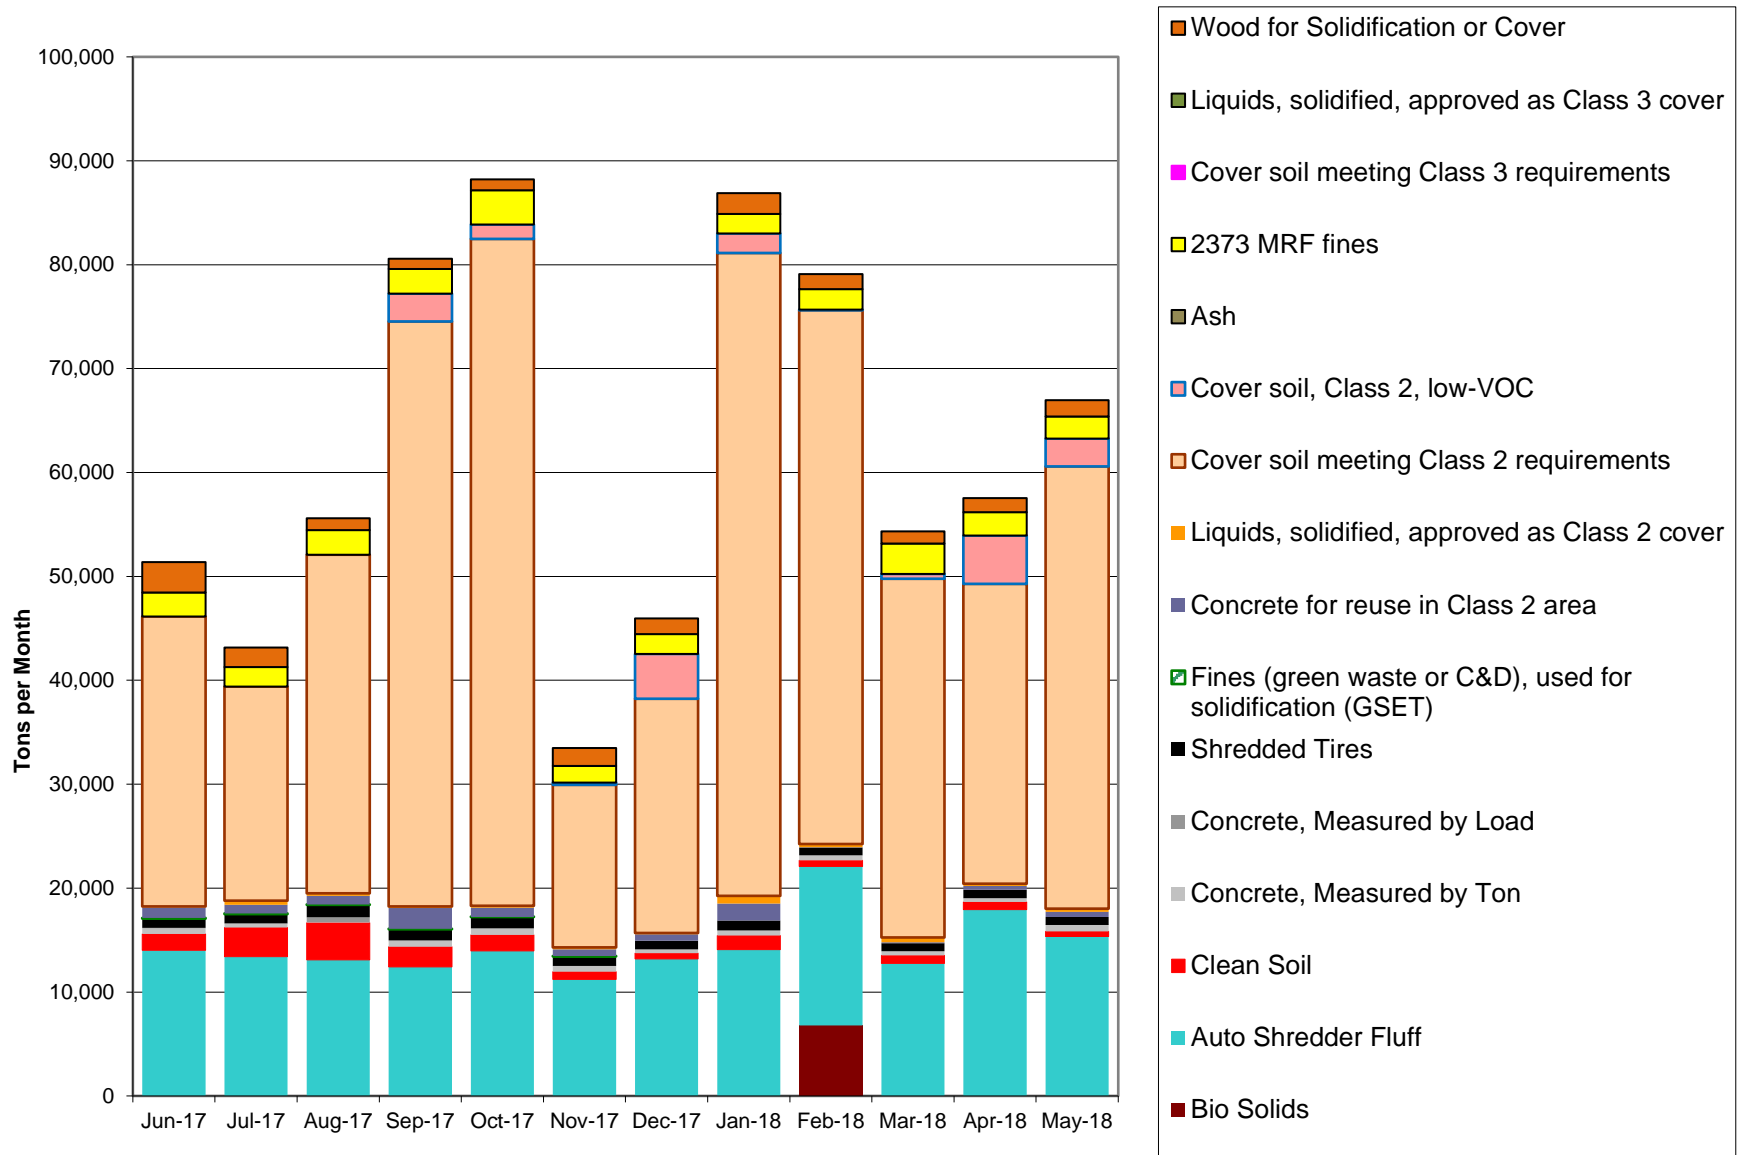
**Figure 6.6-1 Monthly Volumes of Revenue-Generating Cover**

1. High volumes of Class 2 cover soil continue to be brought to the ALRRF, as shown in Figure 6.6-1; and
2. The intermittent seep shown in the photo on page 54 of the packet is a future design issue for the landfill but is not a problem per se.

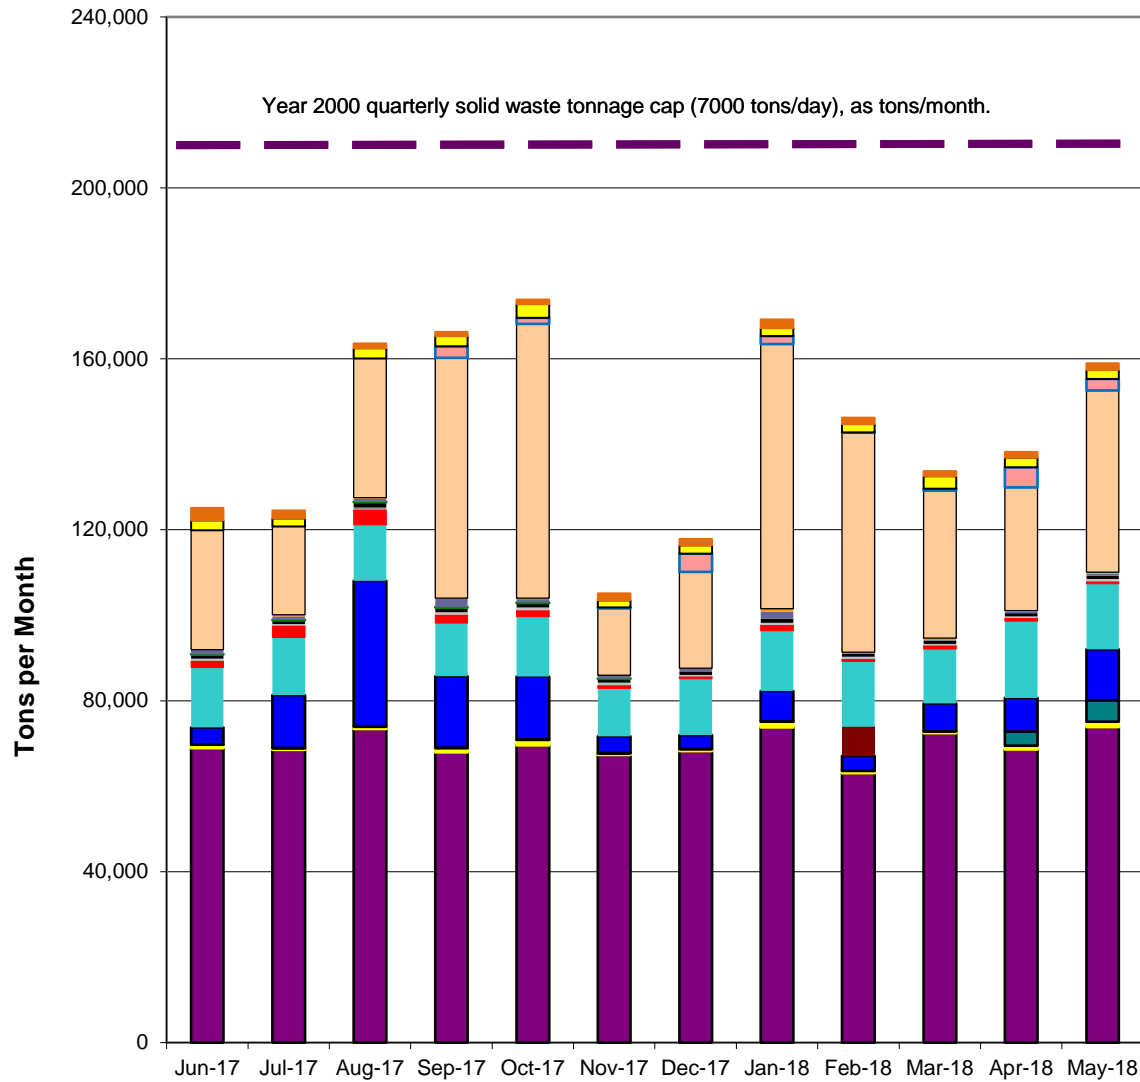
**Figure 6.6-2 Monthly Volumes of Landfilled Materials**

- Wood For Solidification or Cover
- Liquids, solidified, approved as Class 3 cover
- Cover soil meeting Class 3 requirements
- 2373 MRF fines
- Ash
- Cover soil, Class 2, low-VOC
- Cover soil meeting Class 2 requirements
- Liquids, solidified, approved as Class 2 cover
- Concrete for reuse in Class 2 area
- Fines (green waste or C&D), used for solidification (GSET)
- Shredded Tires
- Concrete, Measured by Load
- Concrete, Measured by Ton
- Clean Soil
- Auto Shredder Fluff
- Bio Solids
- Special Waste
- Redirected Waste (RDW)
- Construction and Demolition (C&D)
- MSW
