COMMUNITY MONITOR COMMITTEE

Altamont Landfill Settlement Agreement

AGENDA

DATE: **Wednesday, October 10, 2018**
TIME: **4:00 p.m.**
PLACE: City of Livermore
Maintenance Services Center
3500 Robertson Park Road

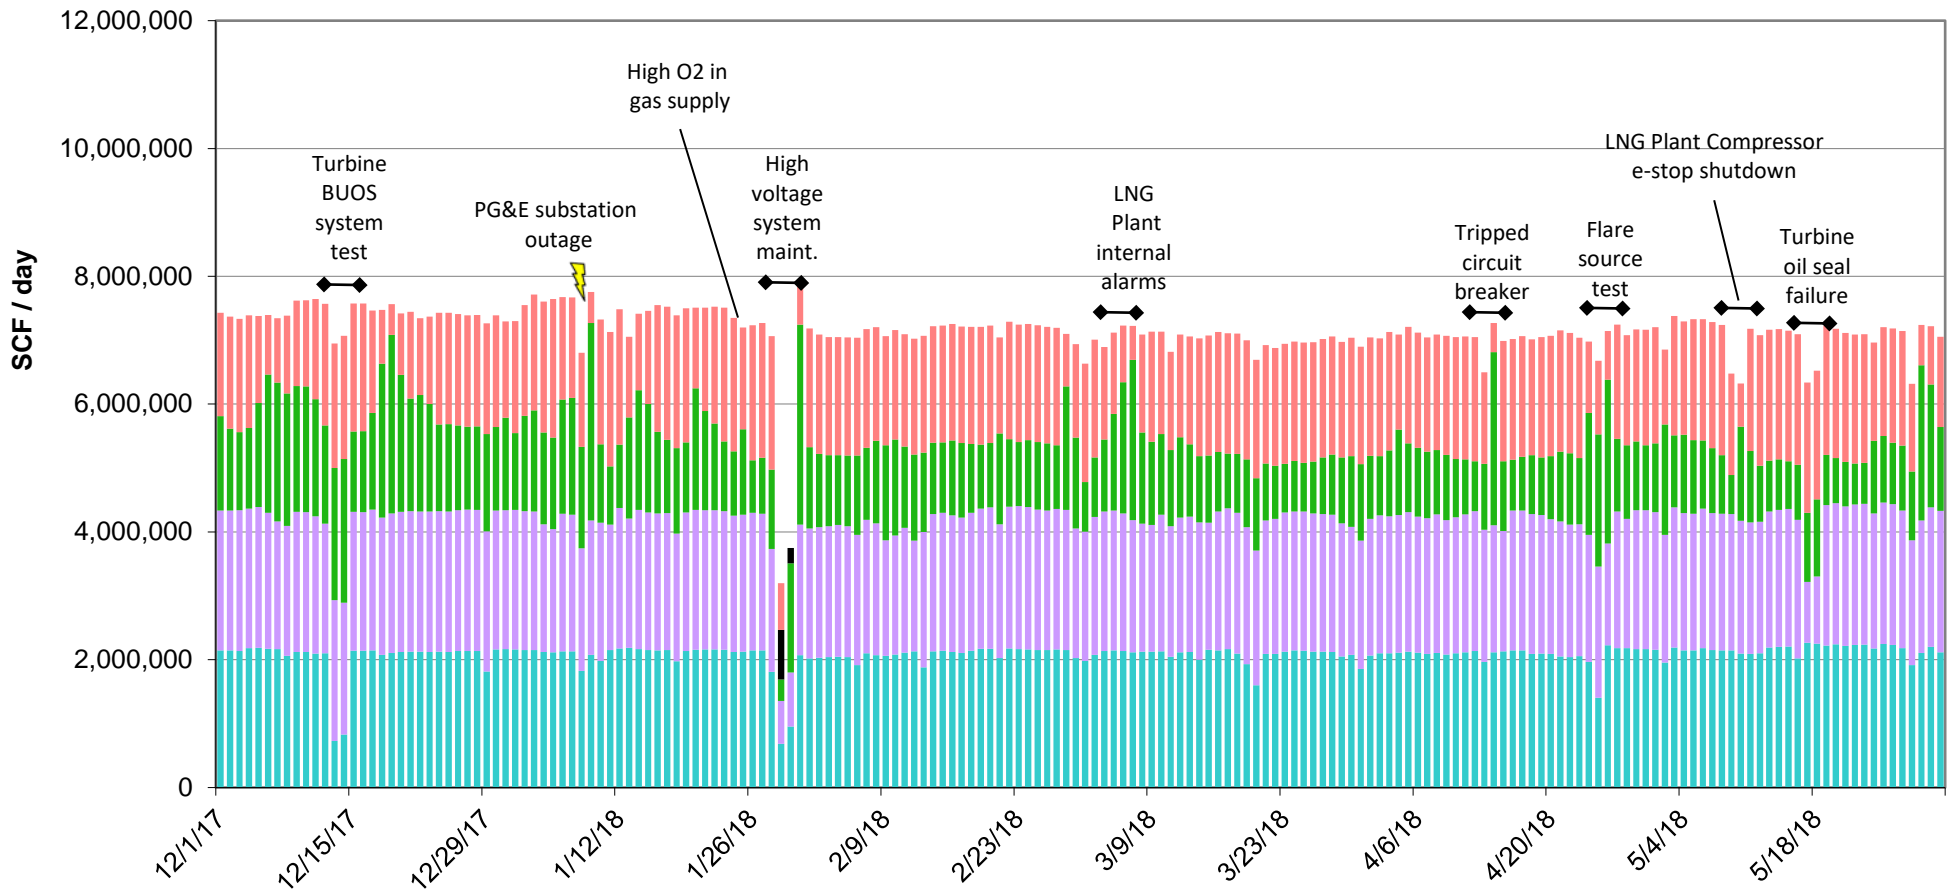
Figure 6.4-2 shows the amounts of landfill gas consumed by each of the gas-consuming devices at the ALRRF. As shown in the figure, the gas system ran smoothly for most of the six-month reporting period. There was a major interruption in electrical power due to high-voltage system maintenance in late January, but all other issues were minor.

Engines A-23 and A-24 were not operated and are being decommissioned

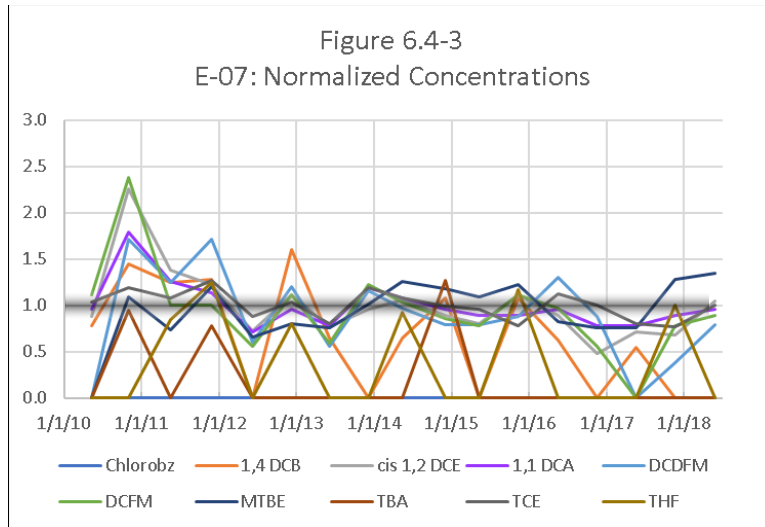
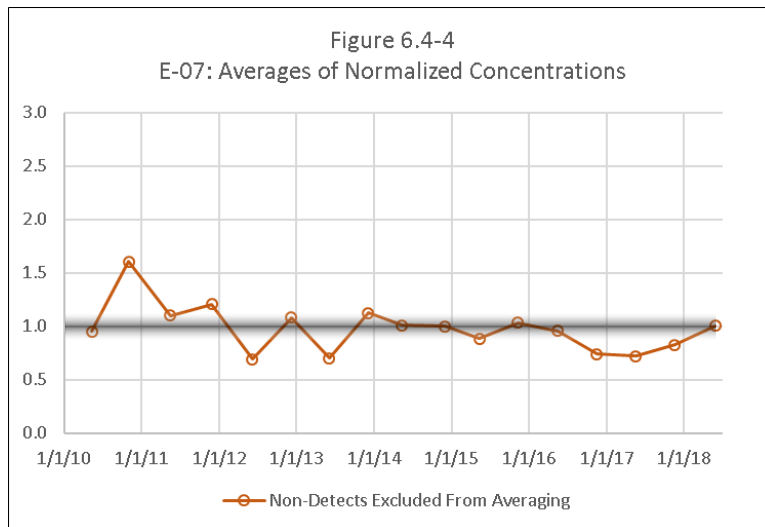
The Community Monitor team has continued to review the trends in data from monitoring wells where VOCs have been detected, to evaluate the ALRRF's position that VOC concentrations have been decreasing. We have taken the further step of graphing the data over time for each contaminant in each well. We have normalized the concentration data (dividing each data point by the average for that substance at that well, with non-detects excluded) in order to pool all of the VOC data at a well and look for trends. In general, we see a level or diminishing trend that is obvious from the shapes of the graphs; see Figures 6.4-3 and 6.4-4, below.

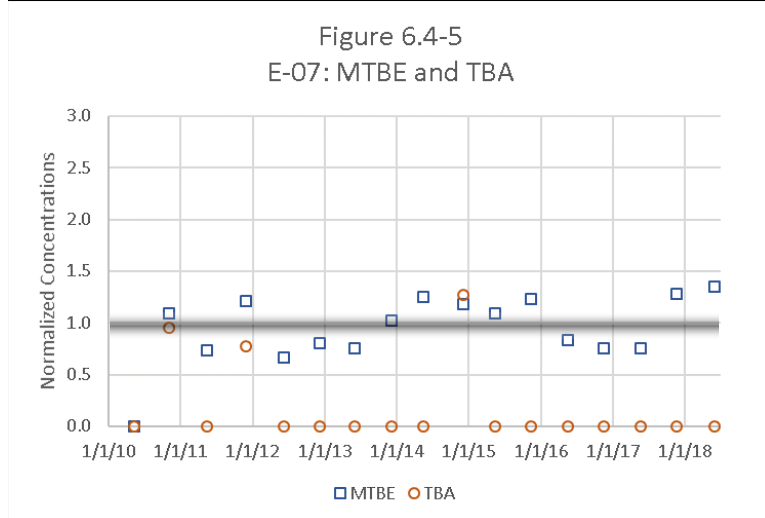
However, it became apparent during this analysis that methyl tert-butyl ether (MTBE) is not declining; see below.

The MTBE concentrations are very small in E-05, E-07 and E-20B, typically around 0.4 parts per billion; and they vary $\pm 20\%$, but they are not declining. MTBE has also been found at MW-4A, but there are too few data points to indicate a trend. Since this substance is such a fast-moving groundwater contaminant, we will continue to watch these data very carefully.

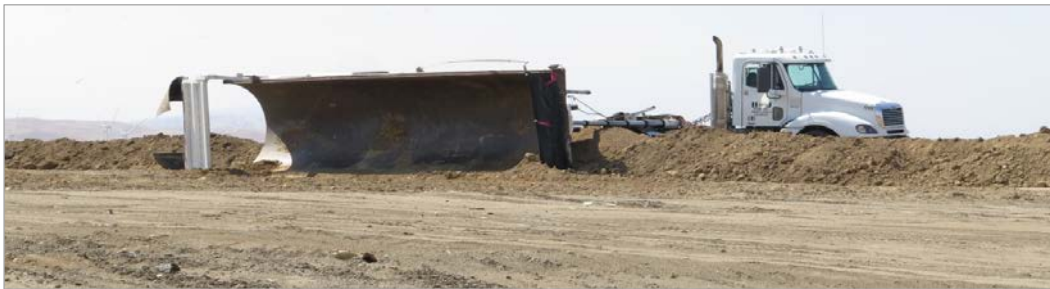
- In the Class 2 soil receiving area, an overturned truck was seen, apparently awaiting a tow truck.

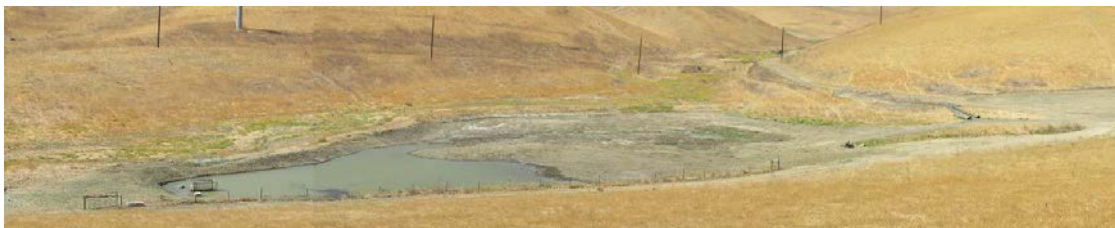
- Excavation and grading work is complete. The pond configuration appeared to be exactly the same as the original, with deeper water at the east end and two small "islands" near the center.

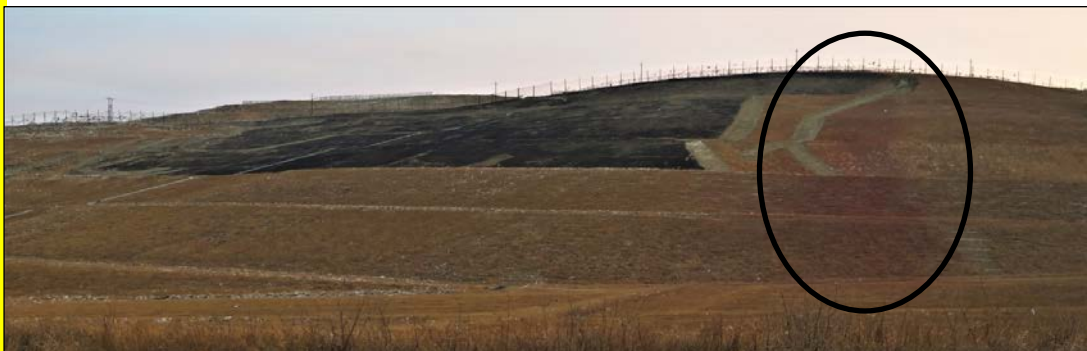
- A fire had occurred since the last Community Monitor site visit, originating east of Fill Area 2 but burning downslope, toward Fill Area 2, due to winds from the west. Site staff and local fire agencies responded, containing the fire before it reached the lined portion of Fill Area 2. The response included an air drop of fire retardant, along the northern boundary of Fill Area 2, as shown in the photo below as a red stain on the right side of the burned area:

Due to the rapid response the fire was successfully contained and extinguished. ALRRF staff believe that the fire was caused by a piece of metal-coated plastic film blowing into the high voltage power lines that run between Fill Areas 1 and 2, providing power to the CASP operation. Fill Area 1 was not directly affected by this fire.

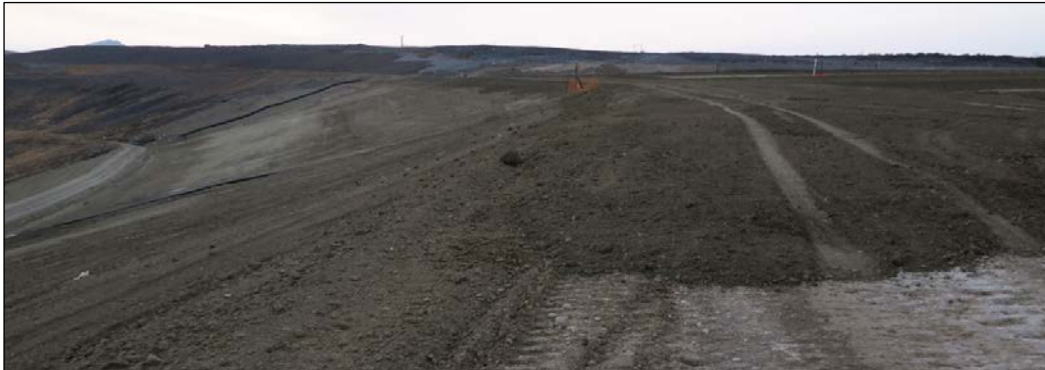
- Work is being done on the ET Cover area to correct the grades affected by differential settlement and apply additional soil; see photo below.

- No vegetation or litter was seen on the ET Cover test area during this site visit.
- The soil that was being added to the ET Cover test area was looser and more granular (less rocky) than the base layer of soil that was applied and compacted in 2017. This is consistent with design.

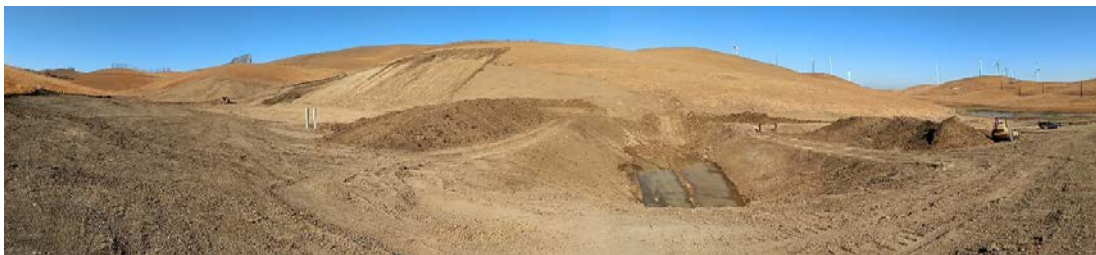
- The stormwater Best Management Practices recommended for the forthcoming water year (July 2018 - June 2019) were discussed with ALRRF staff. The recommended measures are being sized and ordered but are not yet on site for installation.
- Downslope of Fill Area 2 and above the mitigation pond, construction of the enlarged detention basin SB-H was well under way - see photo below. The Water Board had not yet approved the removal and replacement of monitoring wells that are within the basin, so those wells were being protected by large diameter pipes placed vertically above the wellheads.
