# COMMUNITY MONITOR COMMITTEE

## Altamont Landfill Settlement Agreement

# ALRRF COMMUNITY MONITOR ANNUAL REPORT 2018

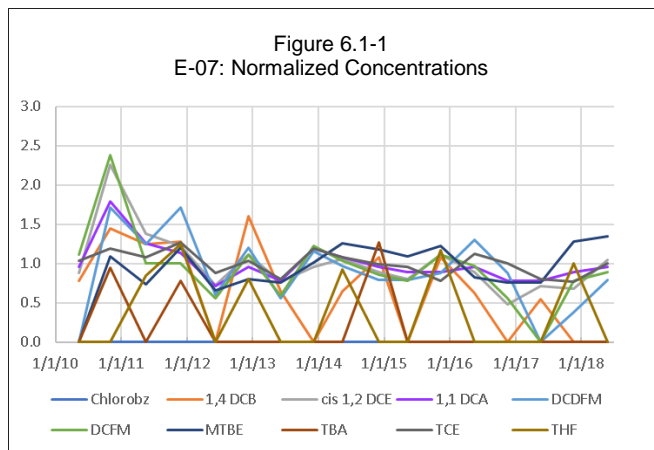
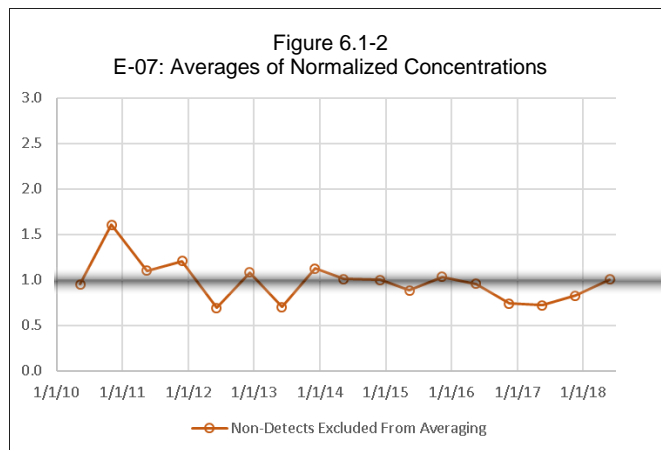
The Community Monitor team has continued to review the trends in data from monitoring wells where VOCs have been detected, to evaluate the ALRRF's position that VOC concentrations have been decreasing. We have taken the further step of graphing the data over time for each contaminant in each well. We have normalized the concentration data (dividing each data point by the average for that substance at that well, with non-detects excluded) in order to pool all of the VOC data at a well and look for trends. In general, we see a level or diminishing trend that is obvious from the shapes of the graphs; see Figures 6.1-1 and 6.1-2, below.

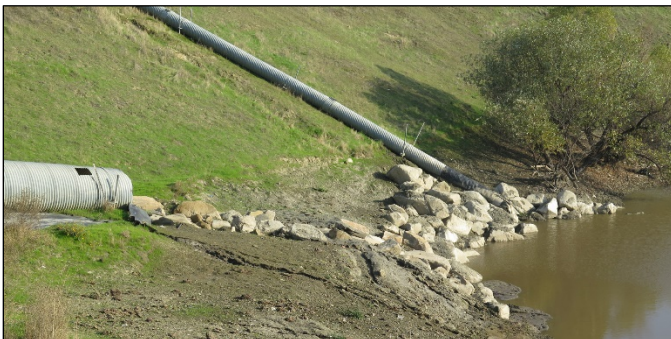
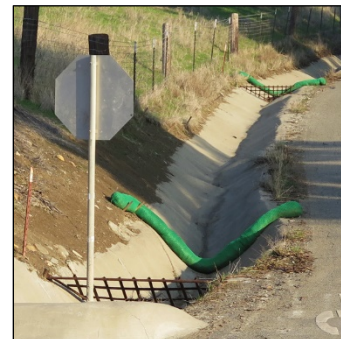
ALRRF has implemented these measures. This was verified during the December 13 site inspection. The photos below show riprap at the Basin C inlet and green Filtrexx check dams in a concrete V-ditch.

- Riprap below stormwater basin inlets, to reduce erosion.
- Special “Filtrexx” check dams in drainage ditches to reduce metals and COD by removing pollutants.
- Using a different Basin C sampling point to prevent cross-contamination from off-site stormwater.

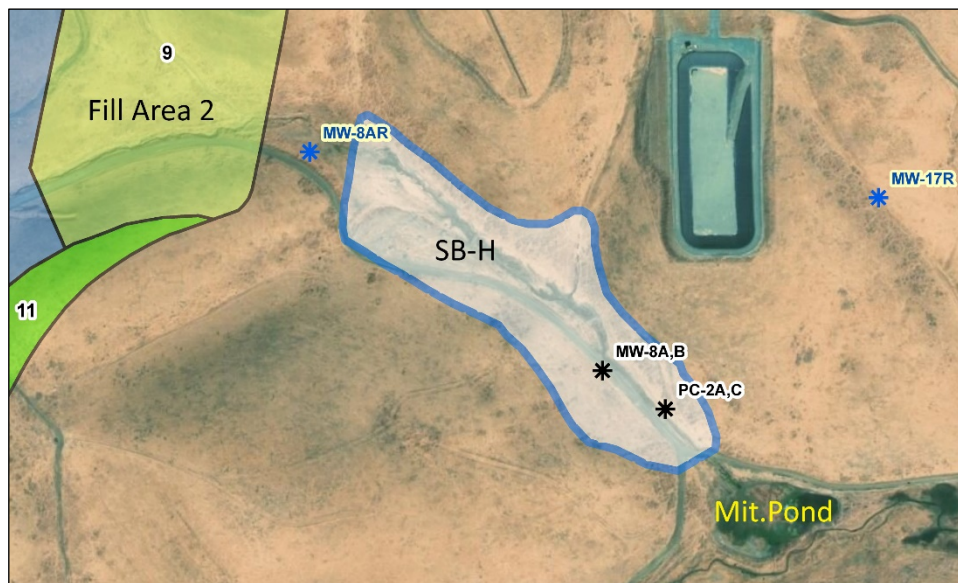
The MW-8 and PC-2 well pairs are situated within the new sedimentation basin SB-H between FA2 and the wetland mitigation pond, as shown in Figure 6.6-1 below. They have been protected during construction of SB-H. The ALRRF now faces the challenges of (a) raising these wellheads so that the wells can continue to be sampled while the sedimentation basin is handling storm water, and (b) preventing storm water from infiltrating at the wells.

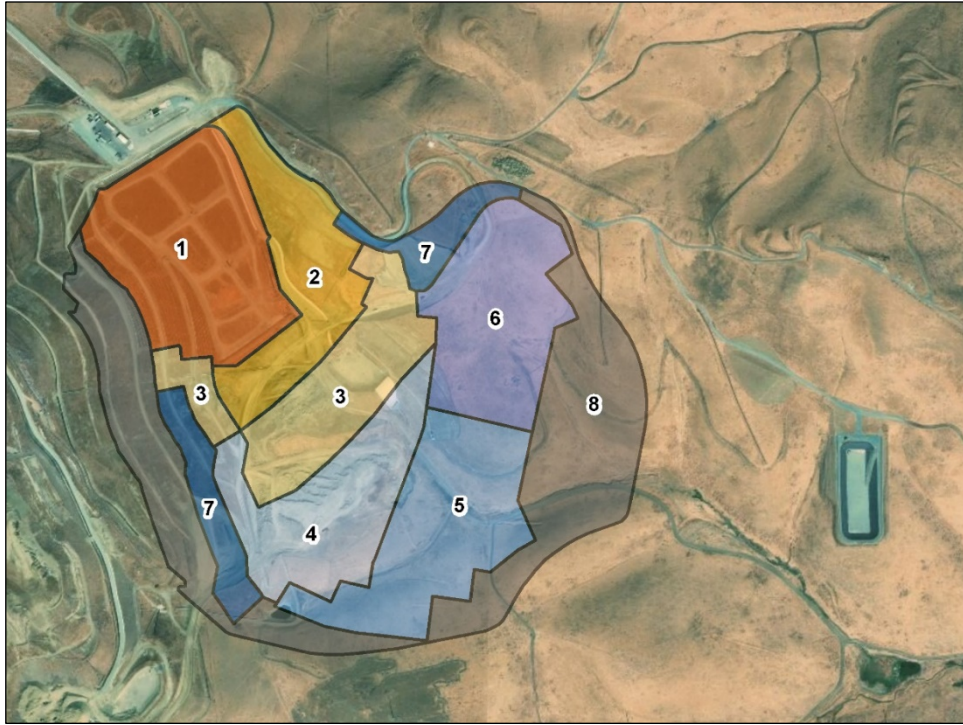
Figure 6.6-2  
From July 17, 2018 Submittal to Water Board

Preliminary drawings for the cuts and fills in each Phase indicated that the footprint of refuse in FA2 will advance as shown on Figure 6.6-2, below. In a letter dated August 31, ALRRF submitted a *Revised Plan for Fill Area 2 Monitoring Locations* showing the progression of FA2 fill activity, the dates of replacement of monitoring wells at the edges of refuse, and the locations of those wells. The revised progression is shown in Figure 6.6-3, below.

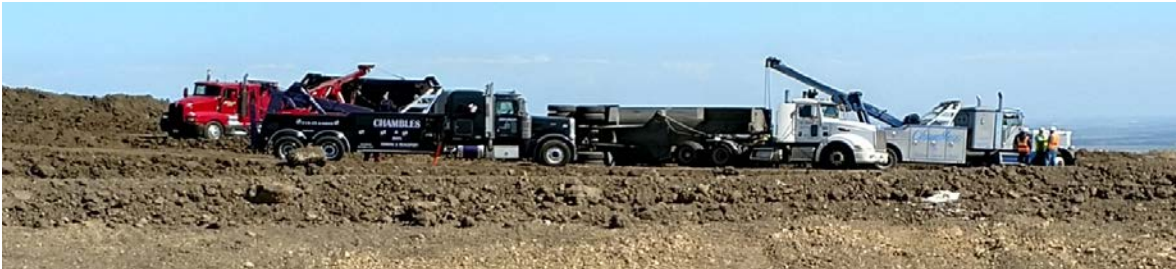
- Attended by K. Runyon, accompanying LEA Arthur Surdilla. Escorted by Audrey Lundin and Brenda Perez. Unannounced.
- Active area for transfer trailer unloading was in the Class 3 portion of the site (southeast). Two tippers, one dozer and one compactor were operating during these observations. There was no queue of transfer trucks waiting to unload.
- Bird cannons were operating. Bird population was normal for this time of year.
- The public disposal area, in the Class 2 portion of Fill Area 1, was receiving a load of MRF fines, for Alternative Daily Cover, during these observations.
- We observed that two end dump trailers had fallen over while unloading, in the same general area. They were being serviced by three large capacity wreckers, and a mechanic was working on one of the trailers.

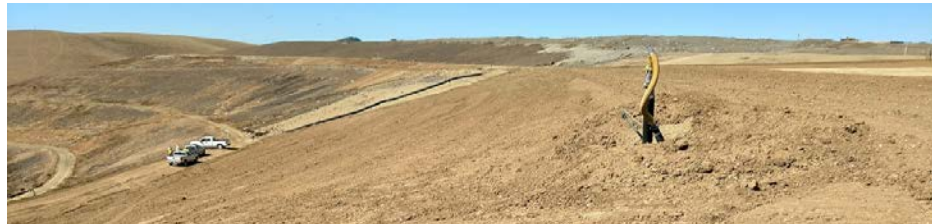
- The C&D bunker was nearly 100% full, and virtually all of that material was scrap lumber. No prohibited materials were seen. No scrap metal items such as appliances were evident.
- The 10-acre ET Cover Test Area was in the process of receiving the top ("vegetative") layer of cover soil on both the side slope portion and the top deck. Grading appeared to be uniform and reasonably smooth.

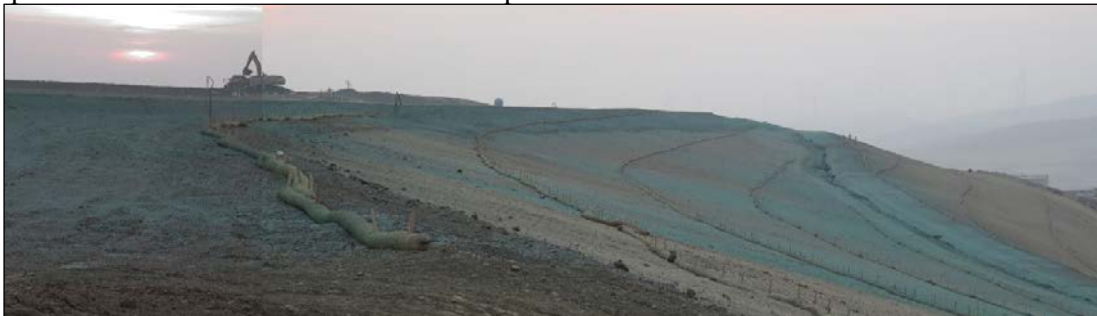
ET Cover Test Area

- The entire area was covered with hydroseed, as planned. Unsurprisingly, no germination was evident. The fiber matrix in the hydroseed appeared to be adequately thick and firm. The sloped portion of the area had wattle installed to prevent erosion.

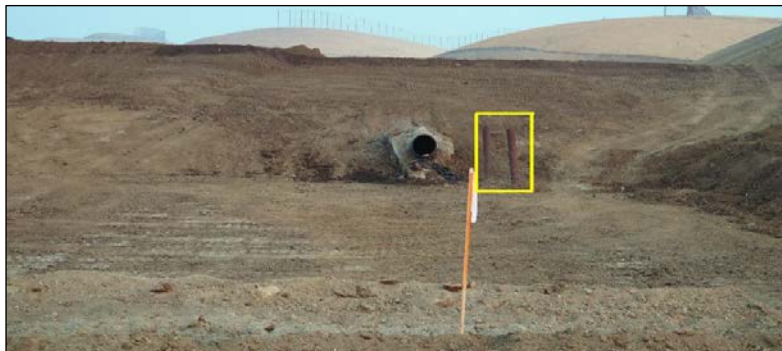
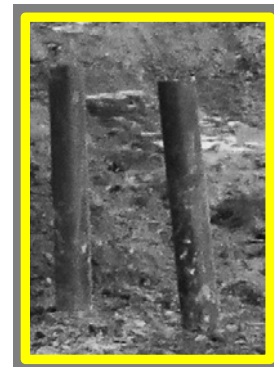
Mitigation Pond Reconstruction; SB-H Installation

- ❑ Enroute to the mitigation pond, near the northeast corner of the property, stock pond 6 was nearly full of water, and the nearby stock pond was dry. Both of these are normal conditions.
- ❑ The mitigation pond has not yet been planted. It appeared unchanged from the previous site visit. The lower (eastern) portion of the pond was wet; the upper part had green plants but was dry.
- ❑ At sedimentation basin SB-H, excavation and grading work had continued, and it appeared that final grading was under way. Hydroseeding of side slopes had not yet occurred.
- ❑ The lowest portion of SB-H appeared nearly complete except for erosion protection at the inlet. Two riser pipes were protecting the monitoring wells there (see photos below). When decommissioning of those wells is approved by the Water Board, further excavation work will likely be needed there.

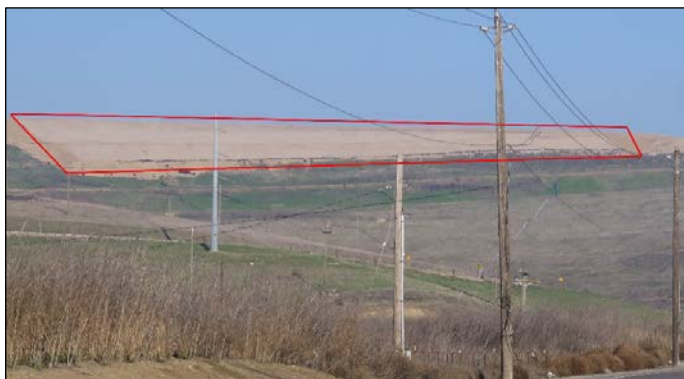
- ❑ The area remains covered with hydroseed, and the sloped section is clearly visible from Altamont Pass Road. Instrument clusters have been installed to gather weather data and measure moisture below the cover (photos below). Recent rains do not appear to have cause the hydroseed to germinate except in a few low spots that collect and hold nearby runoff.

ET cover (sloped part) seen from Altamont Pass Rd.

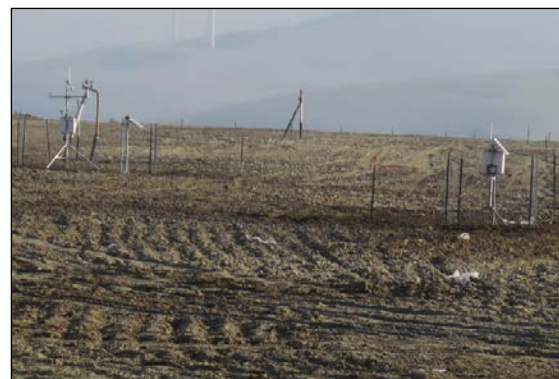
ET cover area instruments

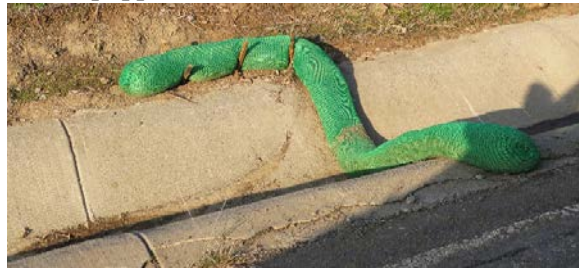
- Ditches in many areas were fitted with Filtrexx wattle to reduce silt and other contaminants (iron, VOCs) in stormwater.
- Near the scale house, Filtrexx wattle had been placed along the upslope edges of all ditches so that runoff would pass through wattle just before entering a ditch.

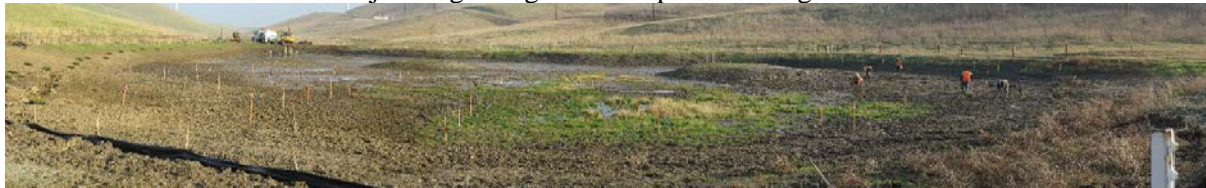
Mitigation Pond Reconstruction

- A contractor's crew was just beginning to install plants during these observations.

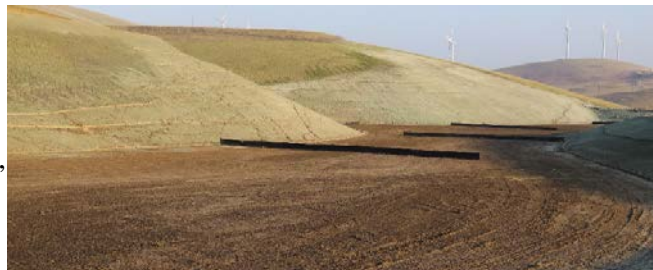
- Preparation of the stormwater basin SB-H, upstream of the mitigation pond, appeared complete.
- The monitoring wells within this basin remain accessible for future monitoring, as required by the Central Valley Regional Water Quality Control Board.

View toward mitigation pond

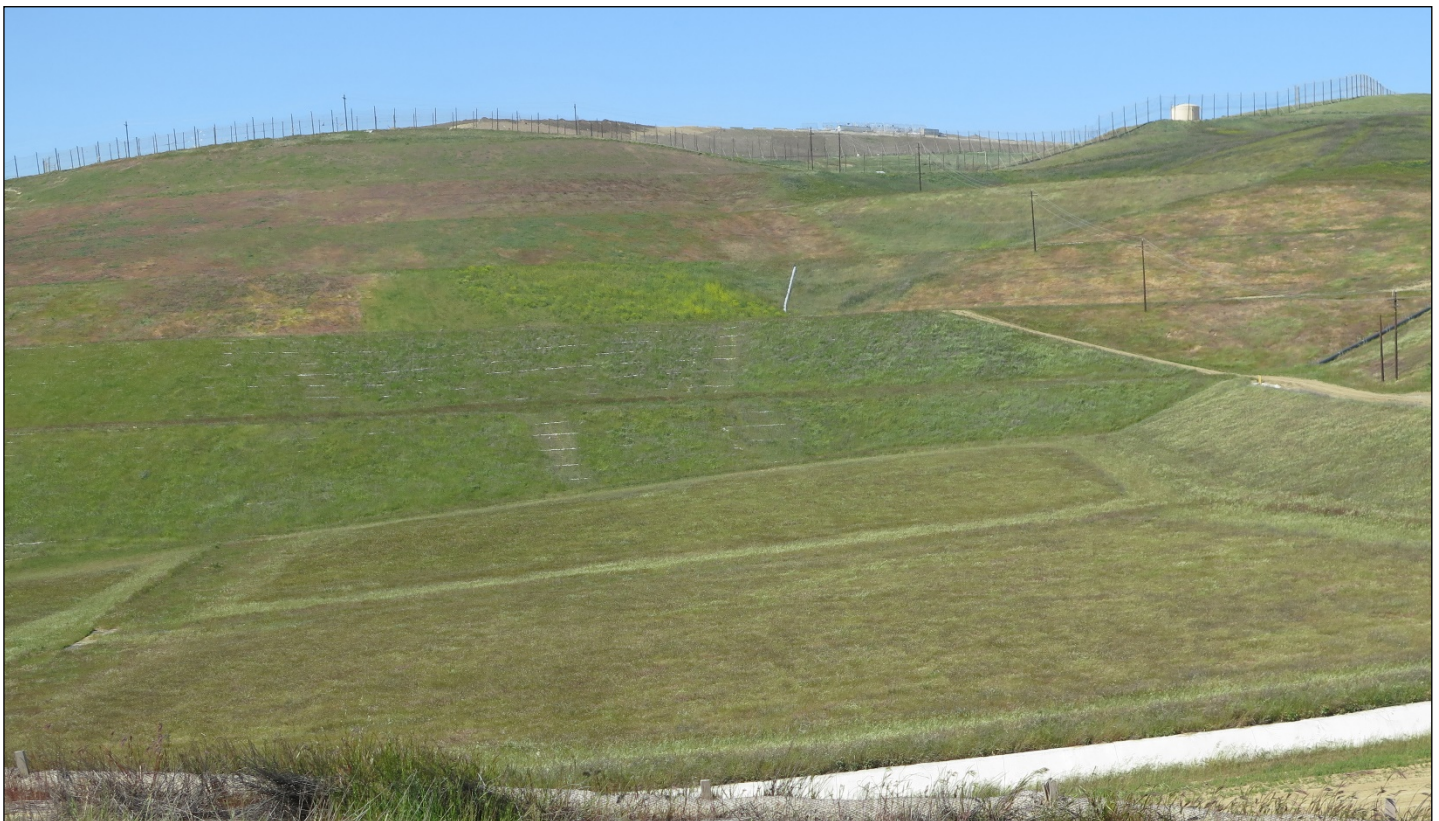
The photo on the cover of this report shows the Phase 1 portion of Fill Area 2, viewed from the roadway on the hill immediately to the east. The photo was taken on April 26, 2018.
