# COMMUNITY MONITOR COMMITTEE

## Altamont Landfill Settlement Agreement

### AGENDA

# ALRRF COMMUNITY MONITOR ANNUAL REPORT 2018

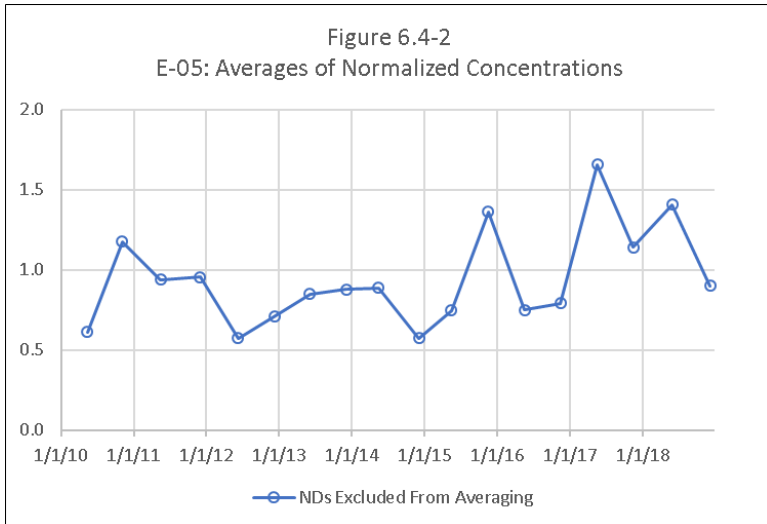
At Well E-05, at the toe of Fill Area 1, the data vary too widely to provide a clear trend.

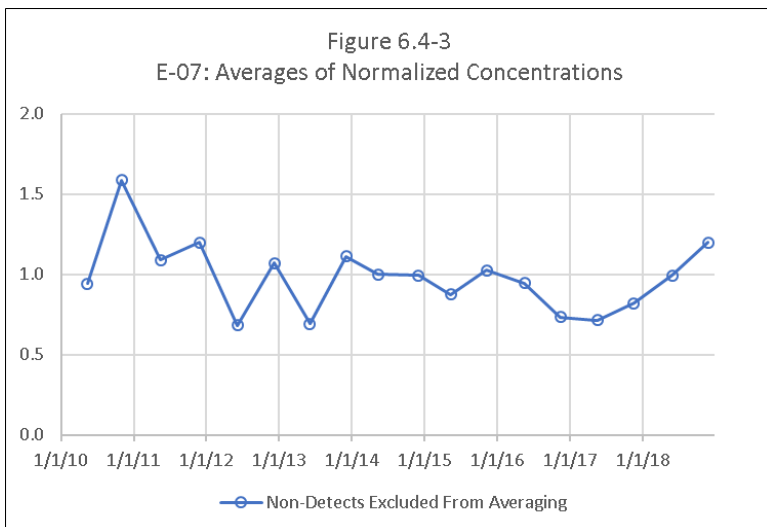
At well E-07, in the same location but sampling at a greater depth, the most recent VOC data appears to present an upward trend.

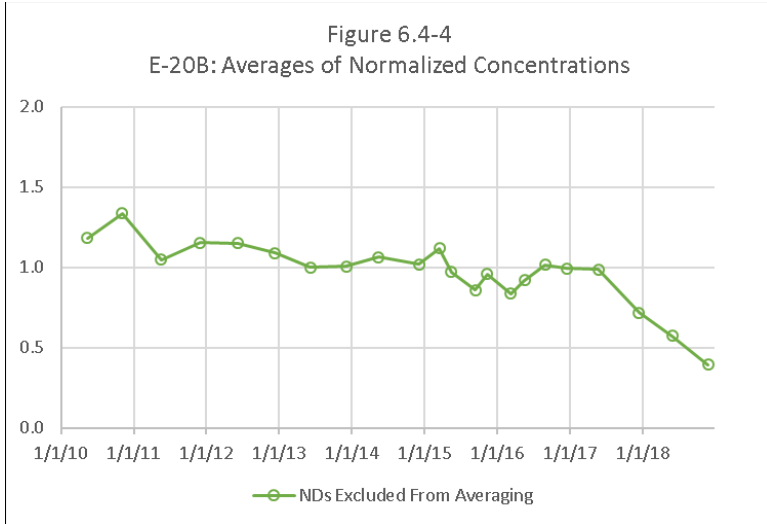
At well E-20B on the east side of Fill Area 1, the average across all VOC's shows a clear decline in the past 18 months. Aggressive landfill gas extraction near this well may be the reason for this change.

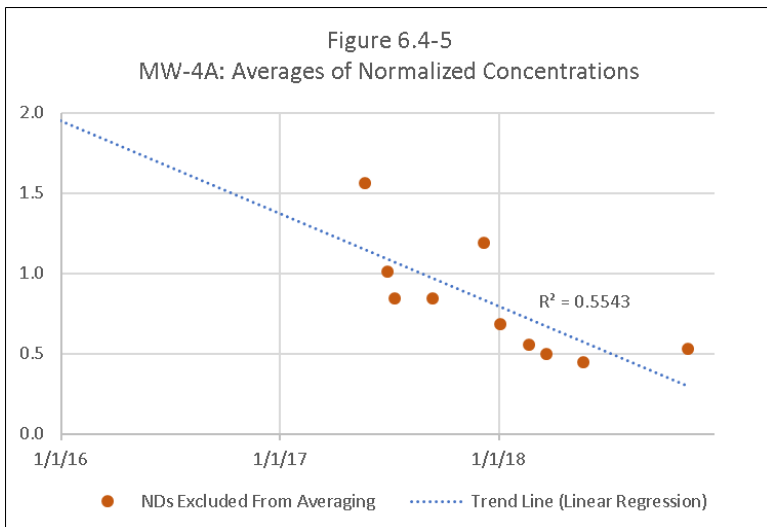
At well MW-4A, at the northeast corner of Fill Area 1, although the data cover a shorter time span there appears to be a downward trend in average VOC concentrations.

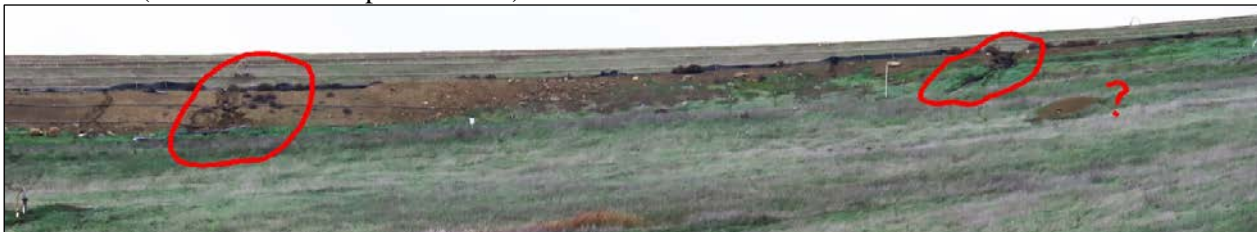
- ❑ On the steep south face of Fill Area 1, below the ET Cover Test Area and above the closed portion of Unit 1, two substantial erosion gullies were seen from the Admin area parking lot. They are marked with red circles in the photo below. Within the closed area, a small mound of soil was also seen (marked "?" in the photo below).

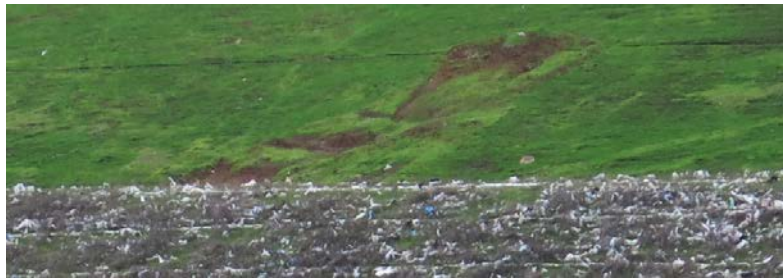
- Basins A and B were not full. The water in these basins was quite turbid, probably due to runoff from rainfall the previous day. Basin C was not observed. The northwest runoff area was observed in order to note the locations of rock check dams and wattle.
- In Fill Area 2, a small area of exposed soil may have been due to a minor landslide or disturbance from heavy equipment. See photo at right.

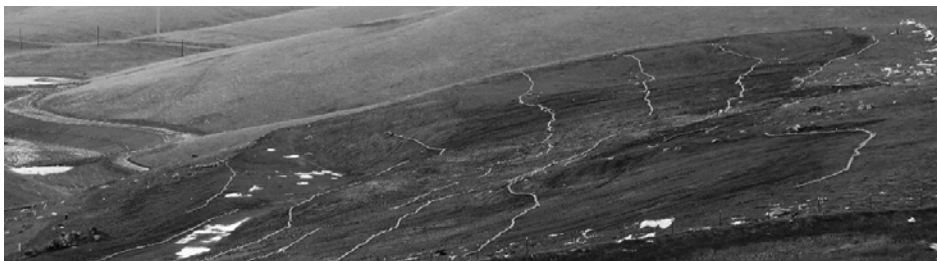
- South of Fill Area 2, the west side of the canyon had stormwater controls (primarily wattle) that had been damaged by cattle and appeared to be less than fully effective. Erosional damage was minor because hydroseeded plants were germinating and helping to hold soil in place. Photo below.

- ALRRF staff explained that the damage to wattle seen in our January inspection was caused by cattle grazing in the area. The wattle had not yet been repaired due to wet conditions / difficult access. This did not appear to be causing serious erosional problems.

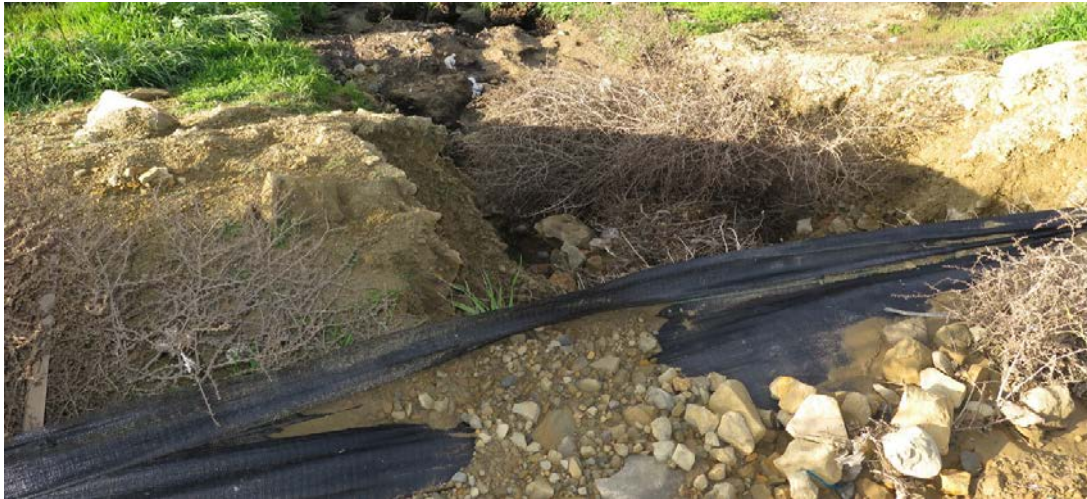
- On the steep south face of Fill Area 1, below the ET Cover Test Area and above the closed portion of Unit 1, the erosion gullies seen on January 17 from the Admin area parking lot were closely observed. It was clear from the erosional patterns at the top of this gully that a large volume of water was traveling at high velocity on the bench road and simply overwhelmed the silt fence along the edge of that road, at the low point of the road. See photo below.

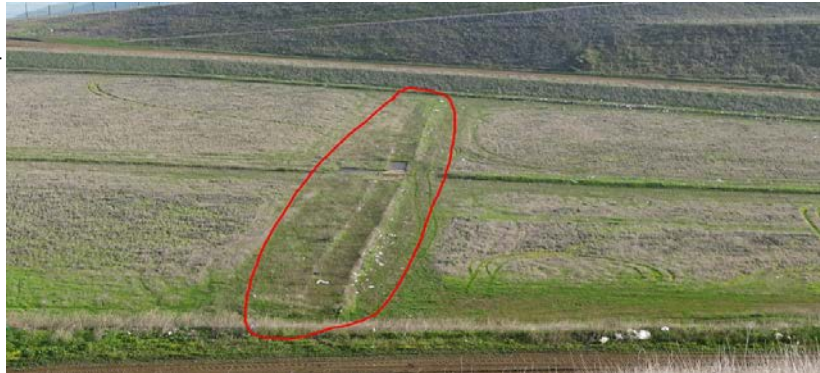
- In FA2 Phase 1, the ALRRF will need to remove a protective soil cover from the gravel "windows" that will direct leachate from waste into the leachate collection system. The photo to the right shows one set of these windows, marked with a red circle. This view of Fill Area 2 is from the west.

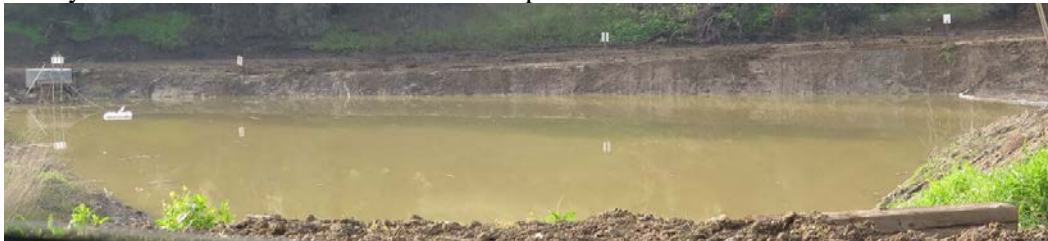
- All stormwater basins were partially or completely full. The water in these basins was quite turbid, probably due to runoff from recent rains. See photo of Basin A below.

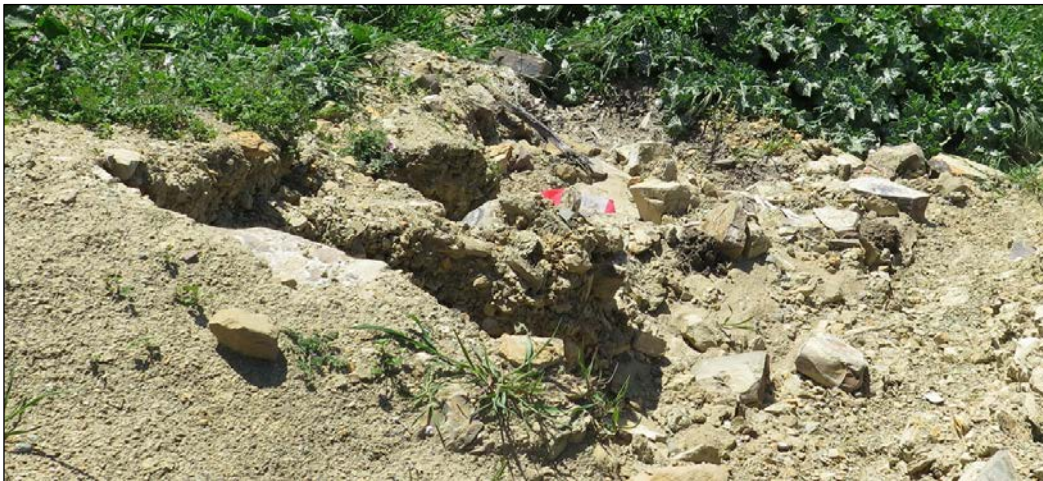
- The erosion gullies on the steep south face of Fill Area 1, first noted in the January visit, did not appear to have been repaired. Some filling of eroded areas in a nearby roadway had been done, but the continuing wet weather had damaged that also.

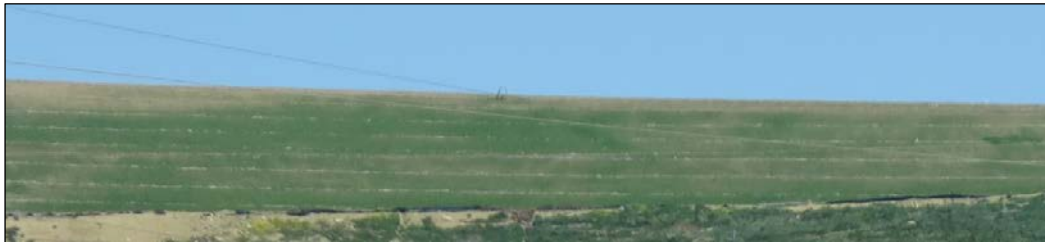
- The base of the sloping portion of the test area was closely inspected. There was no sign of erosion in the Test Area. Herbaceous plants, mostly hydroseeded species but also some local native and invasive plants, were growing. Growth was most vigorous near the base of the slope, where precipitation can accumulate. The photo below was taken from Altamont Pass Road.

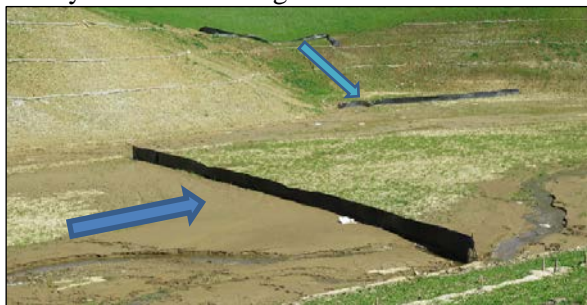
- Basin SB-H, which was installed to protect the mitigation pond from silt originating in Fill Area 2, has performed well in its first rainy season. Although the flow from a side canyon (top center of photo) damaged the silt fence at that canyon outlet, sediment remained in the basin and did not visibly impact the pond.

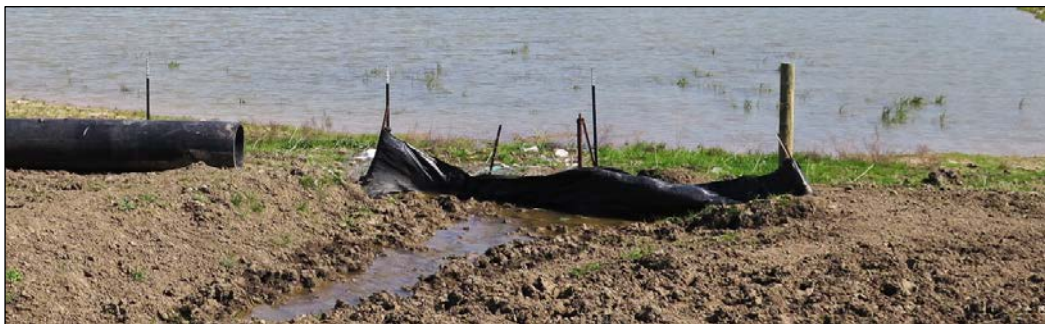
- The mitigation pond was full, with some vegetation evident in the water. Six waterfowl (Mallard and Bufflehead) were using the pond. At the pond inlet, shown below, the soil in the photo was not transported from upstream but was exposed by cattle trampling the area. Water flowing to the pond was only slightly turbid.

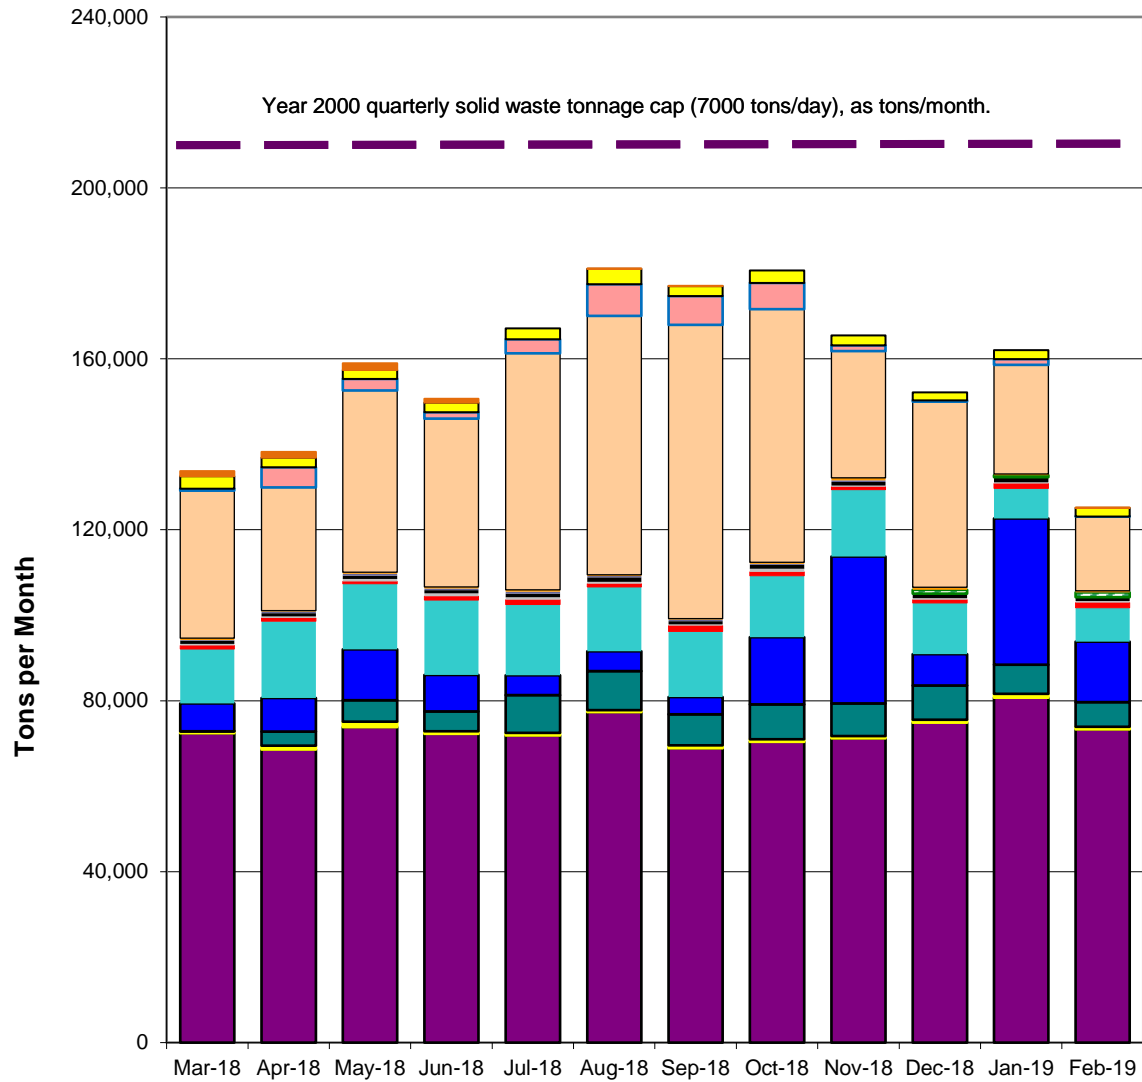
**Figure 6.6-2 Monthly Volumes of Landfilled Materials**

- Wood For Solidification or Cover
- 2373 MRF fines
- Ash
- Cover soil, Class 2, low-VOC
- Cover soil meeting Class 2 requirements
- Liquids, solidified, approved as Class 2 cover
- Concrete for reuse in Class 2 area
- Overs from composting
- Shredded Tires
- Concrete, Measured by Load
- Concrete, Measured by Ton
- Clean Soil
- Auto Shredder Fluff
- Bio Solids
- Special Waste
- Redirected Waste (RDW)
- Construction and Demolition (C&D)
- MSW
