COMMUNITY MONITOR COMMITTEE

Altamont Landfill Settlement Agreement

AGENDA

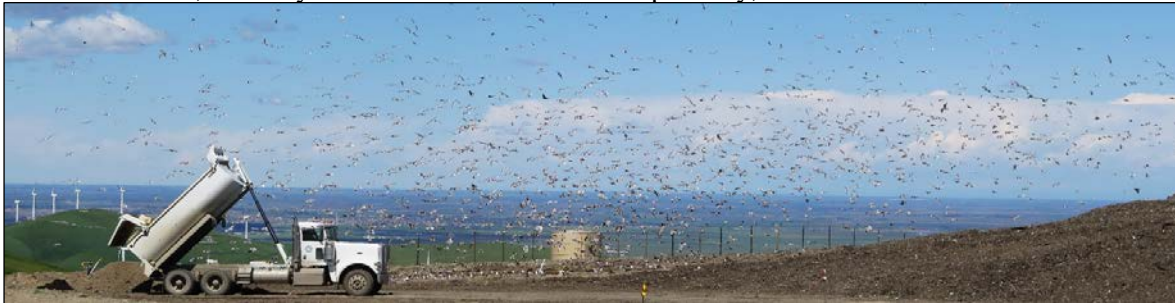
- Several hundred gulls were on site near the working face. Bird "screamers" were being used to harass the birds, and they were effective when fired repeatedly, as shown below.

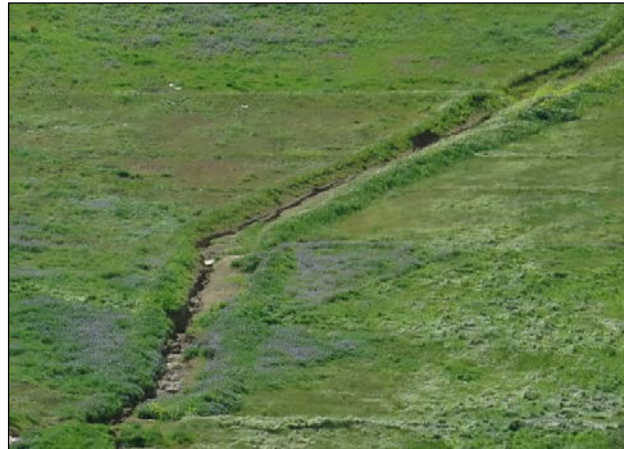
- The erosion gullies on the steep south face of Fill Area 1, first noted in the January visit, did not appear to have been repaired. In addition, an erosion gully was seen in a firebreak created in August 2018, on the slope west of Fill Area 2. (See photo at right.) There is no refuse beneath the ground there.

- The erosion gully first observed in April, in a firebreak on the slope east of Fill Area 1, had not yet been repaired.
- Also, the erosion gullies on the lower south face of the closed portion of Fill Area 1 were still awaiting repair. The access road to those areas had been graded recently to improve access.

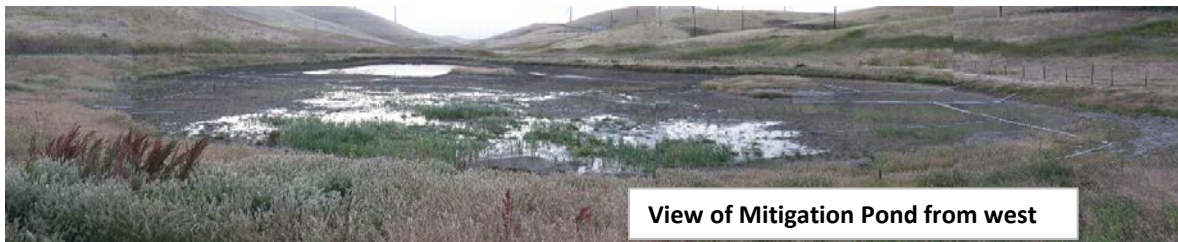
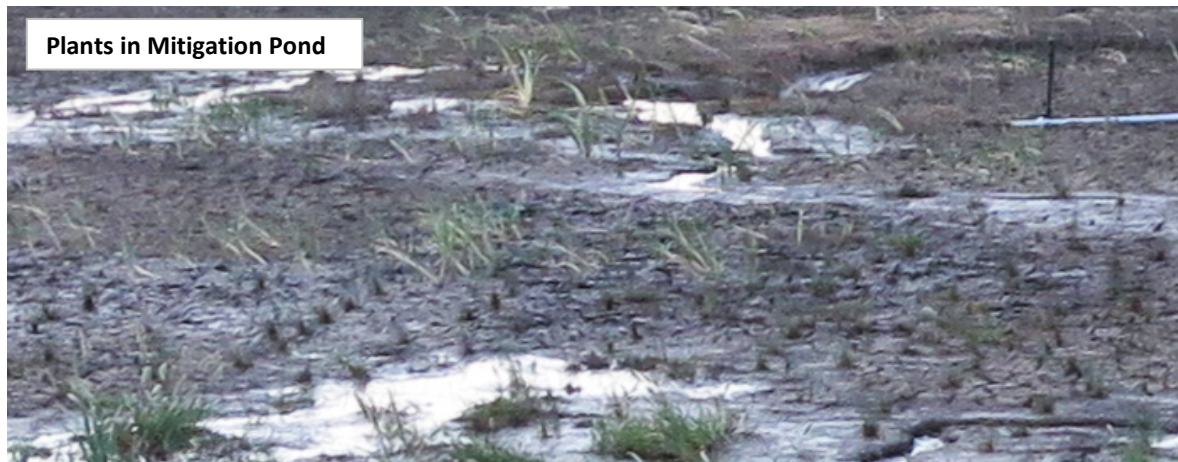
- The pond had drained down after the May rains, and the plantings from late 2018 appeared to be largely intact; see photos below, noting the uniform rows of small rushes that were planted in 2018. Local wetland plants appeared to be moving into the pond from the inlet area.

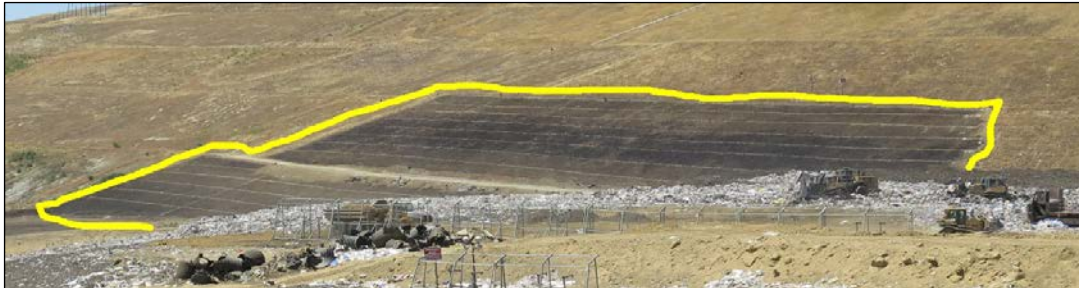
- This area was supporting a great deal of activity in a relatively small space. Activities included: Refuse disposal from transfer trailers, using tippers, and other self-unloading vehicles. Moving cover soil from a central stockpile to the working face, with excavator and haul truck.
 - If winds had been stronger, watering or other dust control measures would have been needed. Receipt of other cover material, such as auto shredder fluff, chopped tires, MRF fines.
- Two dozers, one compactor and one tipper were active. There was no queue of transfer trailers or other vehicles waiting to find space to unload.
- Along the west side slope near the south end of Fill Area 2, there was evidence of a recent grass fire. This was described in the Special Occurrences Log (see previous page). A photo is below, with the burned area outlined in yellow.

- May 23: A large trash compactor fell off of the rolloff truck that had brought it to the site.
- Jun 9: Before sunrise on this Sunday morning, a fire started in refuse near the toe of Fill Area 2 and spread to the dried grass on the adjacent hillside. It moved rapidly but was stopped by the combined efforts of site personnel, Alameda County Fire, and CalFire. ALRRF staff's estimate of the area burned was 3 acres. The fire was fully extinguished several hours after it had begun. There was no damage to the liner material in the burned area.

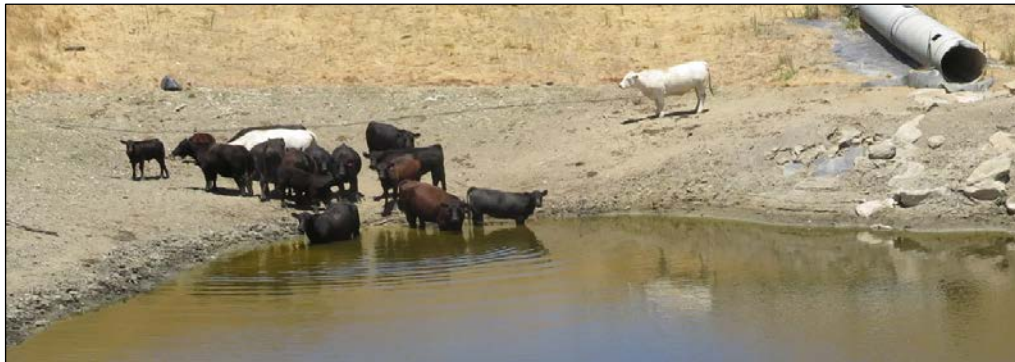
- Basin C was observed this month. The water level was quite low. Cattle were clustered along the north side of the pond, in and out of the water:

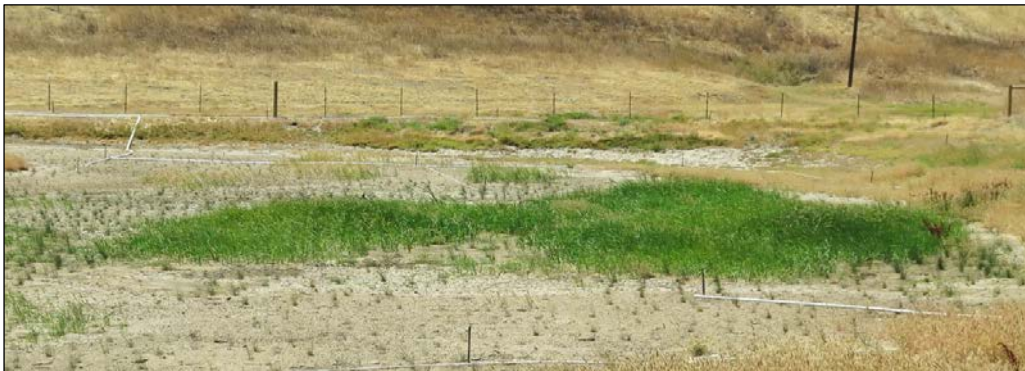
- It appeared that grasses and other unintended vegetation was beginning to grow in the pond, especially near the inlet, where water from upslope would have been delivering seeds and moisture. The inlet is at the right-hand edge of this photo:

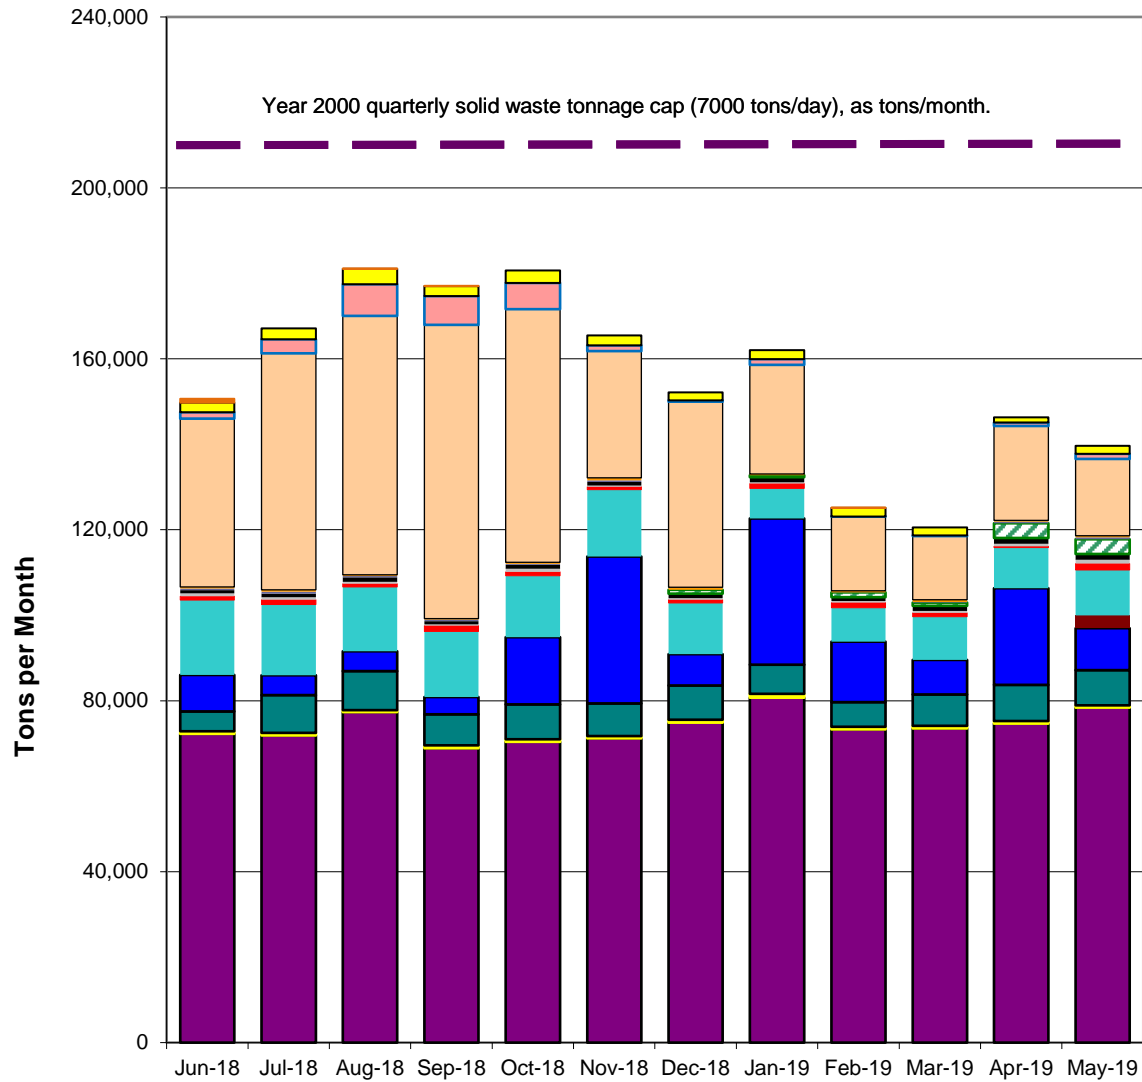
Figure 6.5-2 Monthly Volumes of Landfilled Materials

- Wood For Solidification or Cover
- 2373 MRF fines
- Ash
- Cover soil, Class 2, low-VOC
- Cover soil meeting Class 2 requirements
- Liquids, solidified, approved as Class 2 cover
- Concrete for reuse in Class 2 area
- Overs from composting
- Shredded Tires
- Concrete, Measured by Load
- Concrete, Measured by Ton
- Clean Soil
- Auto Shredder Fluff
- Bio Solids
- Special Waste
- Redirected Waste (RDW)
- Construction and Demolition (C&D)
- MSW
