# COMMUNITY MONITOR COMMITTEE

## Altamont Landfill Settlement Agreement

## ALRRF Community Monitor Monthly Report

# ALRRF COMMUNITY MONITOR ANNUAL REPORT 2019

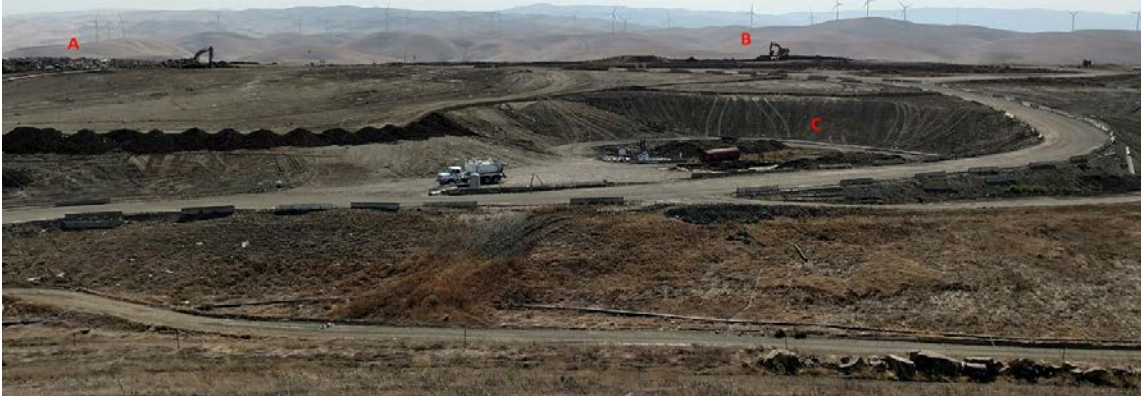
- As seen in the photo below, activity in Fill Area 1 was limited to three functions:

A (upper left): Preparing a winter pad to handle disposal operations during wet weather;  
 B (upper right): Reclaiming stockpiled soil for use as daily and/or intermediate cover; and  
 C (below B): Operating the solidification basin.

- The blue solidification basin, which handles materials that will be disposed in the Class 2 area after solidification, contained mud (or soft soil) partially wrapped in heavy plastic film, which is removed prior to mixing in the basin, according to ALRRF staff.

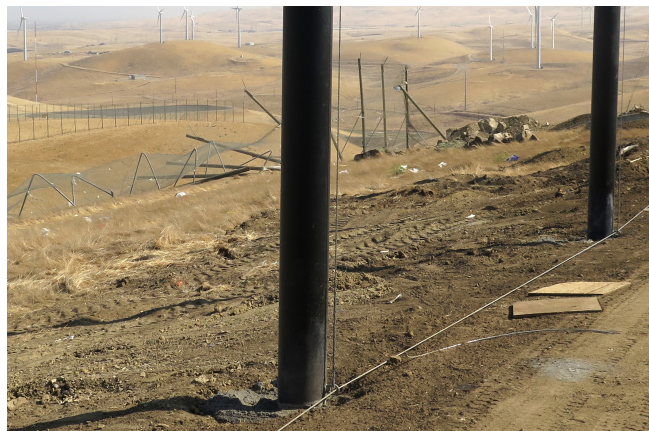
- The area east of Fill Area 2 was checked for windblown litter, from the east edge of FA2 to the east property line. Windblown litter was much lighter than noted on the previous Community Monitor site visit. However, there was litter along the property line fences and in the valley immediately east of Fill Area 2, where some sections of tall litter fence had failed and were being replaced. The LEA noted windblown litter as an Area of Concern in his inspection report.

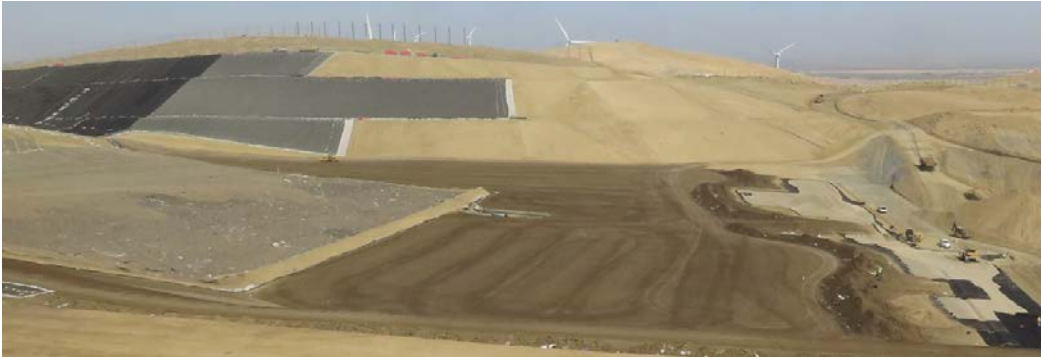
- Construction of Phases 2 and 2B was continuing, downslope of Phase 1 and on adjoining side slopes. The layers of the liner were being installed in sequence, as shown below. The dark brown layer at the right-hand side of the photo is the operations layer where refuse will be placed.

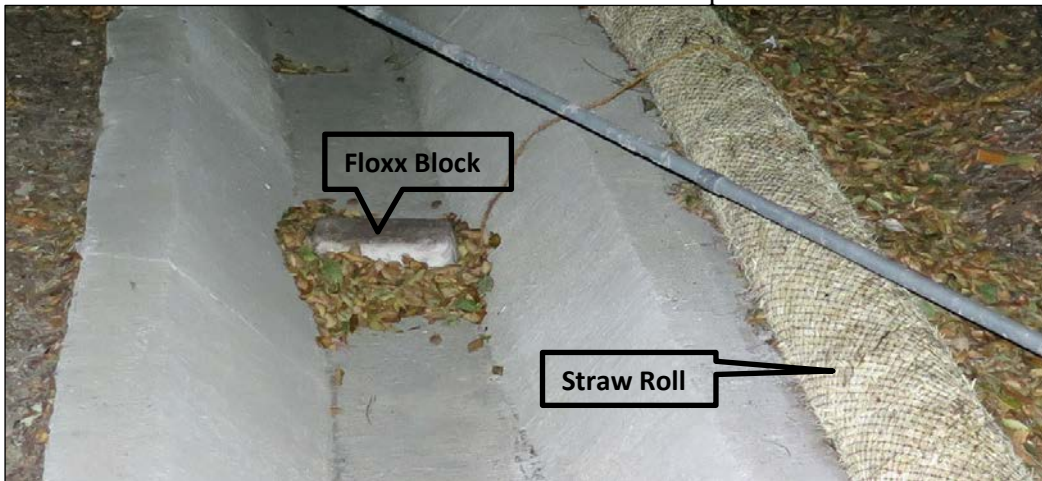
- Straw rolls at the edge of ditches and on slopes to trap suspended solids.
  - Adsorbent wattle ("Filtrex") installed across drainage ditches to remove VOC's and metals.

- "Floxx blocks", tethered brick-shaped objects that release flocculant into stormwater channels.
 The flocculant is delivered to stormwater basins where it causes suspended solids to clump together and settle out, reducing Total Suspended Solids within the basin and in its discharge. A Floxx block and the straw roll material are shown in the photo below.

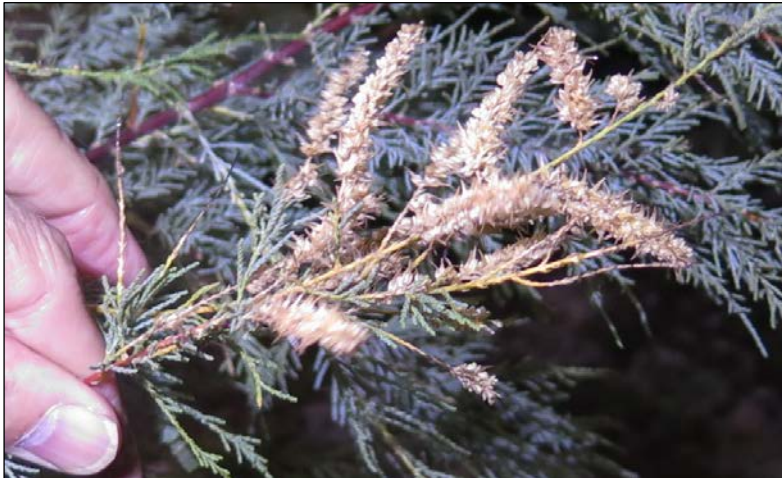
- For this inspection, our group walked to the basin inlet and examined the plants there closely. Many were willows, which are native and provide valuable habitat for insects, birds and other animals. However, a number of young tamarisk as well as several mature tamarisk were present around the west side (the in-basin side) of the SB-G inlet; and the mature plants had bloomed and set seed, as shown in the photo below. Tamarisk seed spreads by wind and by water, and by spreading roots. The plant survives well in dry and alkaline areas, which are present in the Conservation Plan Area. From aerial photos visible in Google Earth, it is clear that Tamarisk was not present in SB-G two years ago. The presence and spread of this plant should continue to be monitored. It is present elsewhere in eastern Alameda and Contra Costa counties, so it may emerge anywhere on the ALRRF property at any time.

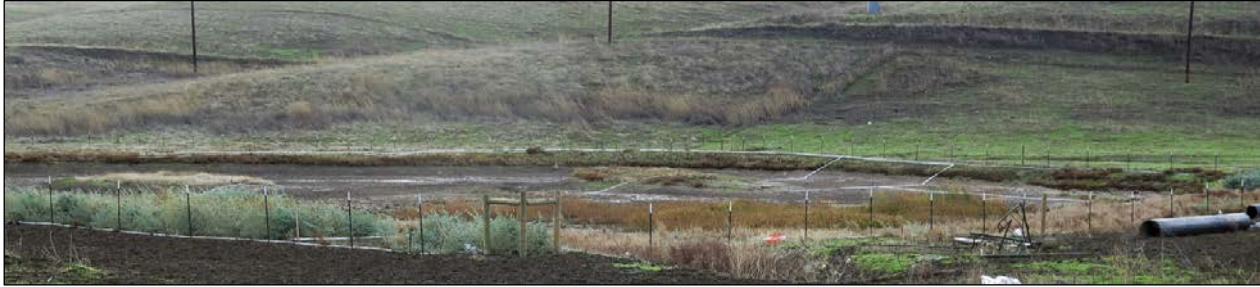
- As shown above, the upper portion of the pond was not yet holding water, but recent rains had irrigated the area and grasses were growing in the surrounding uplands.
- The irrigation system remained in place, although the water supply trucks were no longer on site.
- The inlet (west) side of the pond had been regraded and the lower portion of the area between SB-H and the pond inlet appeared to be bare soil.
- Noticed a tall blue survey stake midway along the north side of the pond, with a matching stake on the opposite side. Might be markers for habitat survey work.

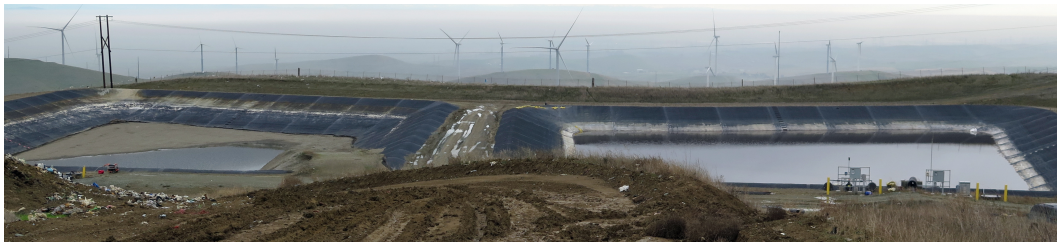
- Shallow ponding was visible in flat areas near roadways and in heavy equipment tire ruts. No erosional problems were seen. Ditches and drains were clear.  
The leachate and underdrain ponds were in good condition. The south pond (LSI-1) contained a modest amount of leachate and underdrain liquid, combined. The north pond (LSI-2) was emptied in late October and had since accumulated a small amount of rain water. In the photo below, taken from a high point to the west of the ponds, LSI-2 is on the left.

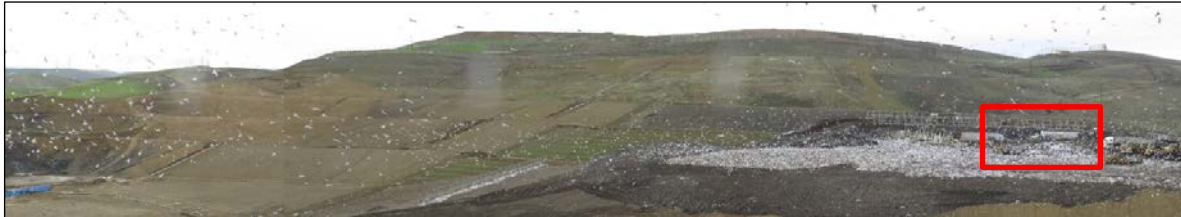
- Filling was taking place in the north end of Phase 1, with two tippers, two compactors, and two dozers working. The working area had portable litter fences nearby along the east and west sides. During these observations, winds were light, but there was a noticeable amount of litter to the northwest of Fill Area 2 on the slope below (east of) the CASP operation. That litter was probably blown there by southeast winds that occurred during recent storms.
- The number of birds at Fill Area 2 was very large, probably several thousand. See photos below.

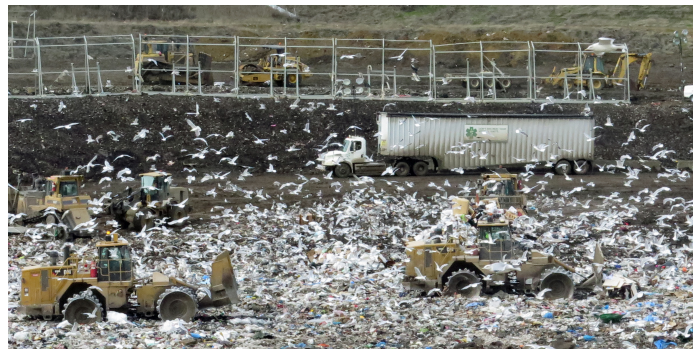
The photo to the right is a close-up of the area shown in the red box above.

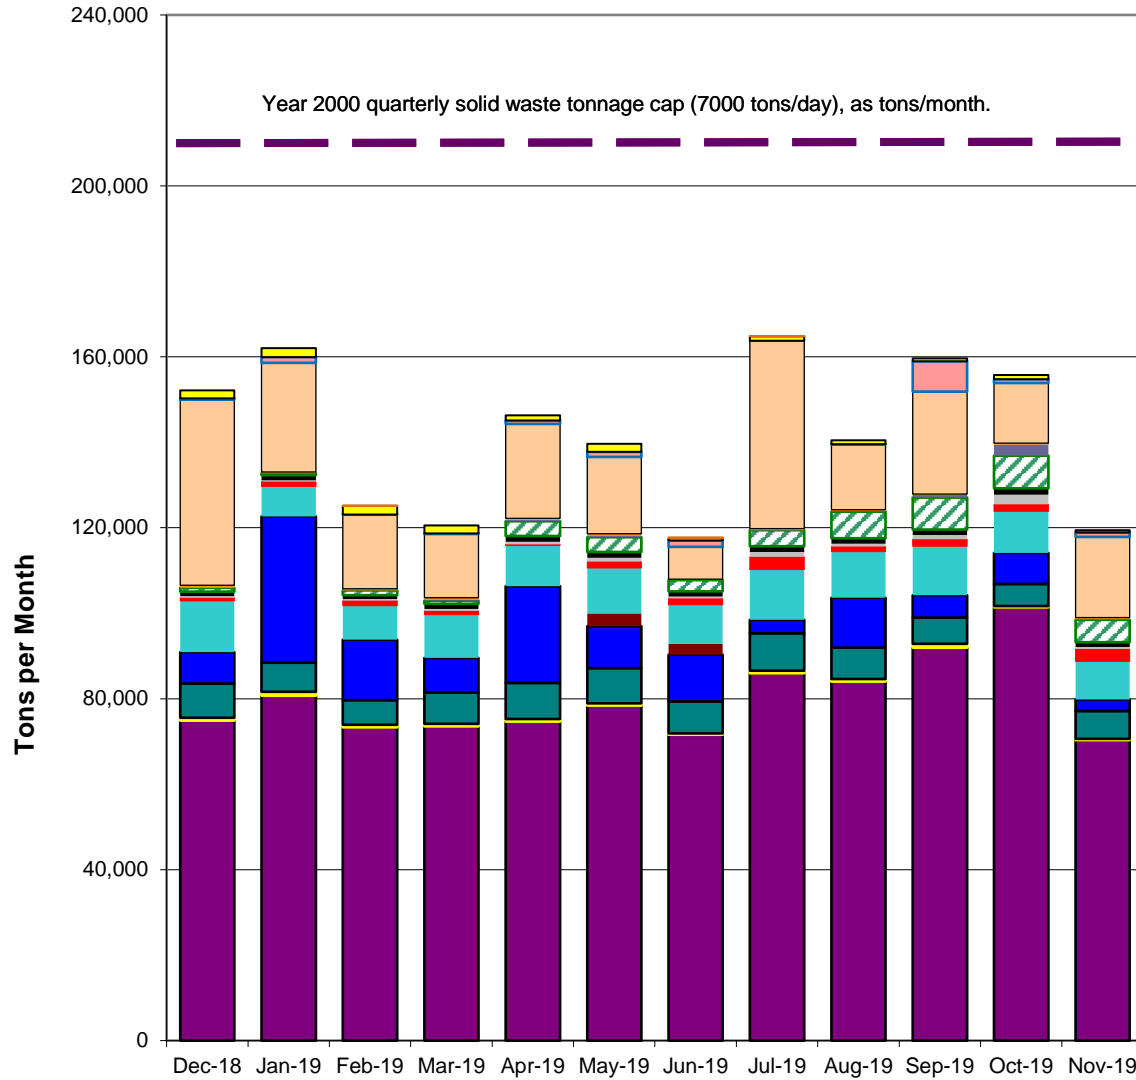
**Figure 6.6-2 Monthly Volumes of Landfilled Materials**

- Wood For Solidification or Cover
- 2373 MRF fines
- Ash
- Cover soil, Class 2, low-VOC
- Cover soil meeting Class 2 requirements
- Liquids, solidified, approved as Class 2 cover
- Concrete for reuse in Class 2 area
- Overs from composting
- Shredded Tires
- Concrete, Measured by Load
- Concrete, Measured by Ton
- Clean Soil
- Auto Shredder Fluff
- Bio Solids
- Special Waste
- Redirected Waste (RDW)
- Construction and Demolition (C&D)
- MSW

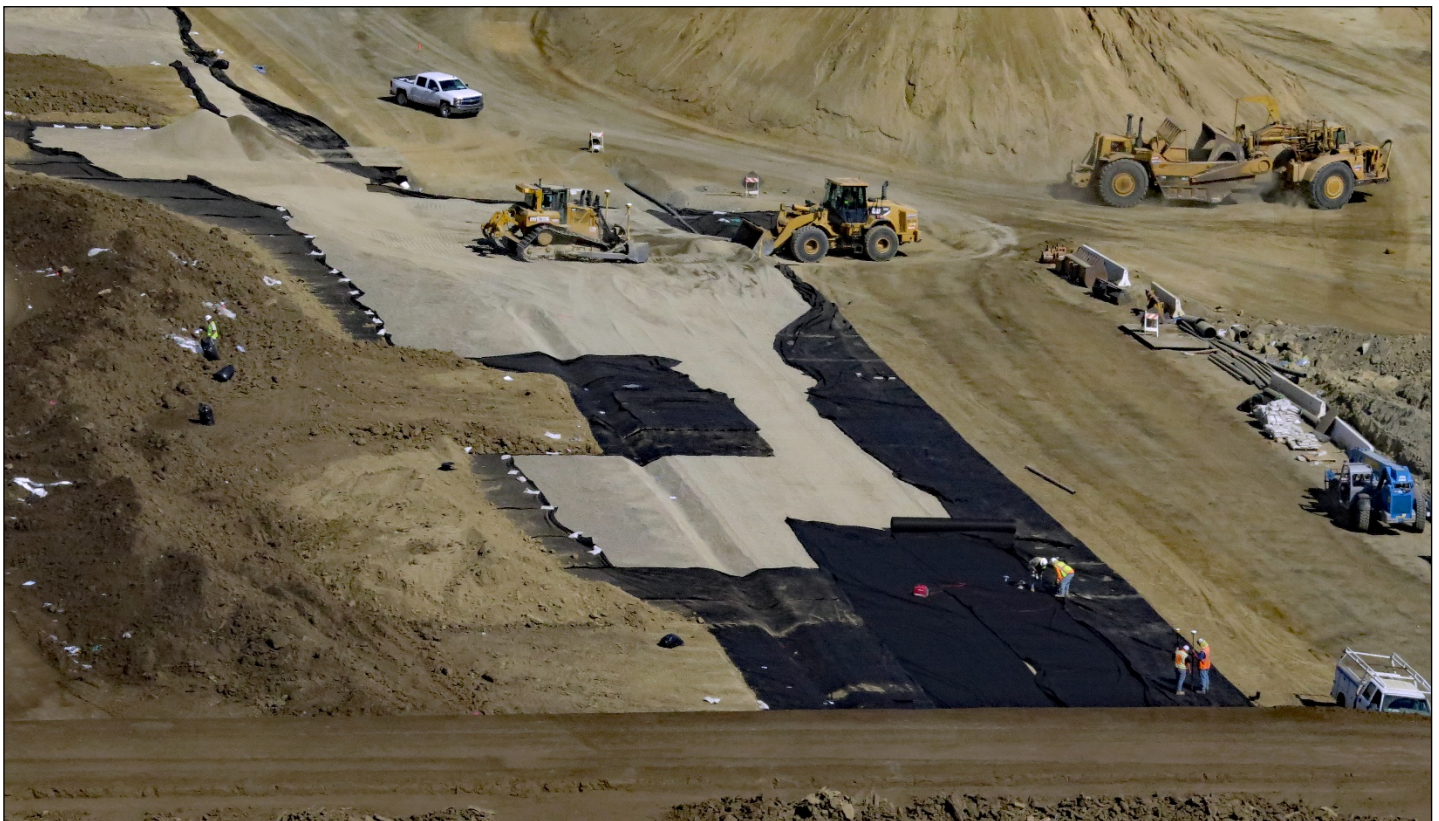
The photo on the cover of this report shows construction of the liner for the Phase 2/2B portion of Fill Area 2, viewed from the hill immediately to the west. The photo was taken on October 11, 2019.

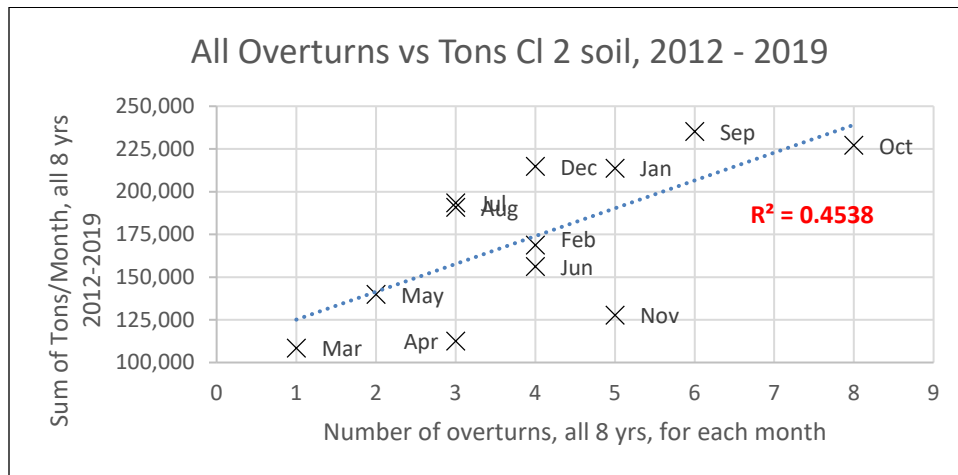
We used the sum total of tonnage each month as a proxy for the number of loads and compared that to the number of overturns – for all types of loads – in a given month. To reduce the effect of year-to-year variation, we made this comparison using the sums of tonnage and overturns for all eight years. For example, the number of January overturns for all 8 years is 5, and the amount of Class 2 soil received in all eight Januaries is 213,621 tons. Graphing these pairs for all 12 months and calculating the best-fit straight line gives the result shown in Figure 2-1 below.

In the figure above, the  $R^2$  value, known as the coefficient of determination, indicates the extent to which the number of overturns correlates with the number of tons.  $R^2 = 1$  would indicate a perfect correlation; the data points would all be in a straight line. An  $R^2$  value of 0.45 indicates a moderate correlation. There appears to be a relationship between these two factors, but other factors are probably also having an effect.

This suggests that the ALRRF should consider making a greater effort to prevent overturns during months when Class 2 soil deliveries are at their peak. While this may seem like an obvious result, it is interesting to note that when the same analysis was run for the treated auto shredder waste tonnage, there was no relationship between that tonnage and the overturns per month. It may be that in the busiest months, the unloading areas are more congested, some drivers are inexperienced, some drivers are more hasty, and some are distracted by other traffic. There also may be trucks coming to the site with mechanical problems, as older equipment is placed in service to move more material.
