COMMUNITY MONITOR COMMITTEE

Altamont Landfill Settlement Agreement

AGENDA

ALRRF COMMUNITY MONITOR ANNUAL REPORT 2019

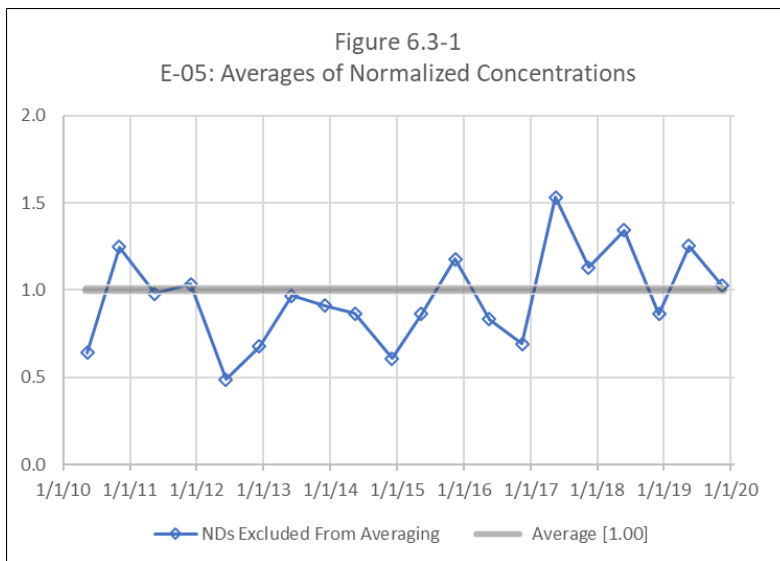
We continued to review the trends in data from monitoring wells where VOCs have been detected and continued graphing the data over time for each contaminant in each such well. We have normalized the concentration data (dividing each data point by the average for that substance at that well, with non-detects excluded) in order to pool all of the VOC data at a well and look for trends. We offer the following updated observations well-by-well, and the general observation that for most of these wells normalized concentration trends were close to at or below the average (i.e. 1.0), with the exception of MW-4A for which VOCs were not detected.

At Well E-05, at the toe of Fill Area 1, as noted previously, the data vary too widely to provide a clear trend. The November 2019 sample showed average concentrations.

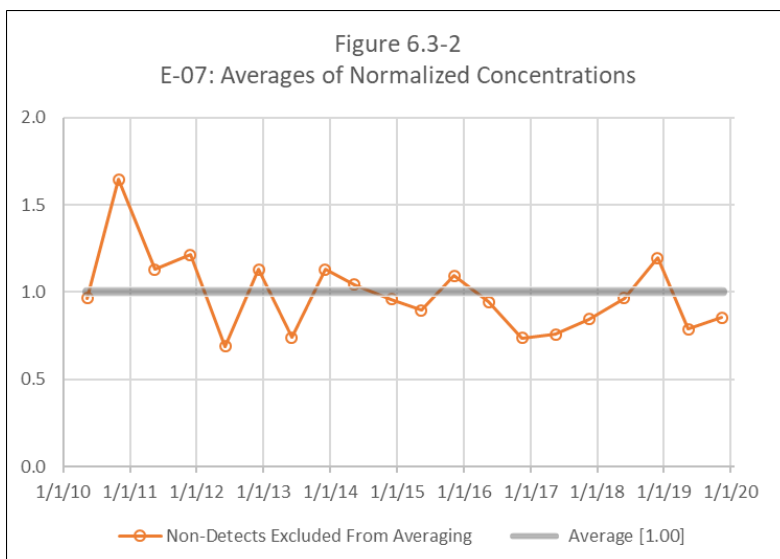
At well E-07, in the same location but sampling at a greater depth, the most recent VOC data appeared to present an upward trend until the March 2019 sample. The November 2019 sample was similar, in showing less than average concentrations.

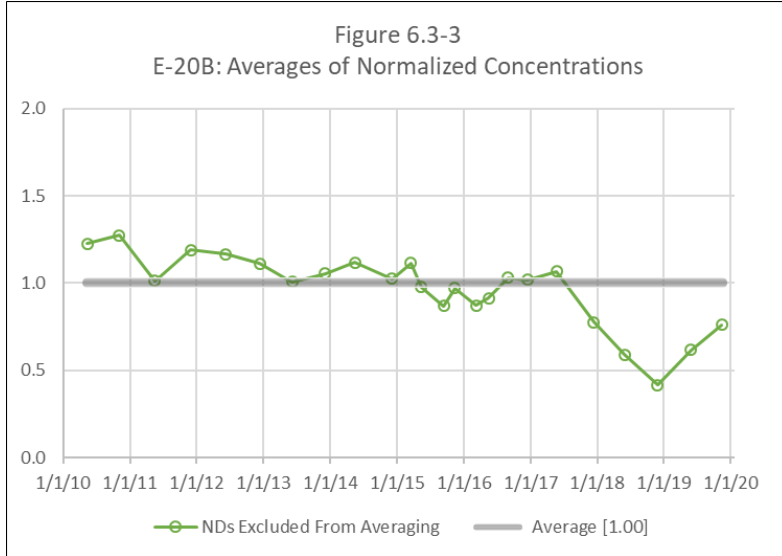
At well E-20B on the east side of Fill Area 1, the average across all VOC's was showing a clear decline in 2017 – 2018, but the most recent samples (2019) show a slight increase. This should continue to be tracked.

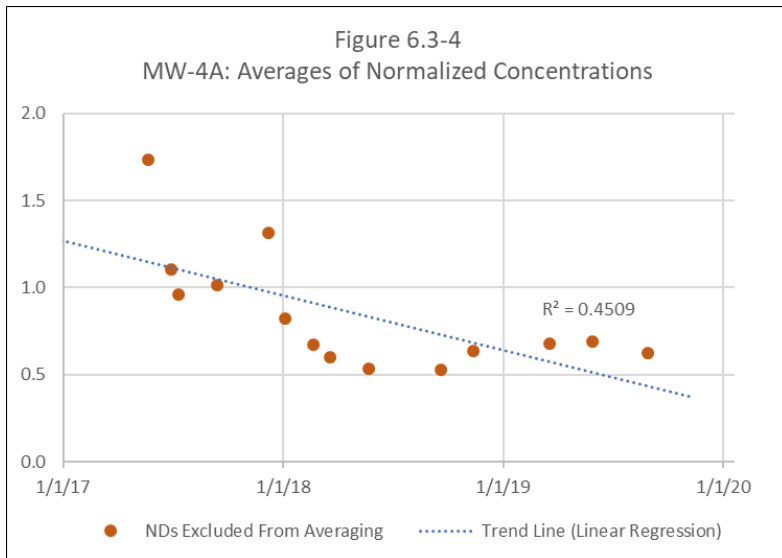
At well MW-4A, at the northeast corner of Fill Area 1, the first two 2019 samples appeared to have weakened the downward trend in average VOC concentrations. The November 2019 sample had no detections and therefore it appears that the downward trend continues.

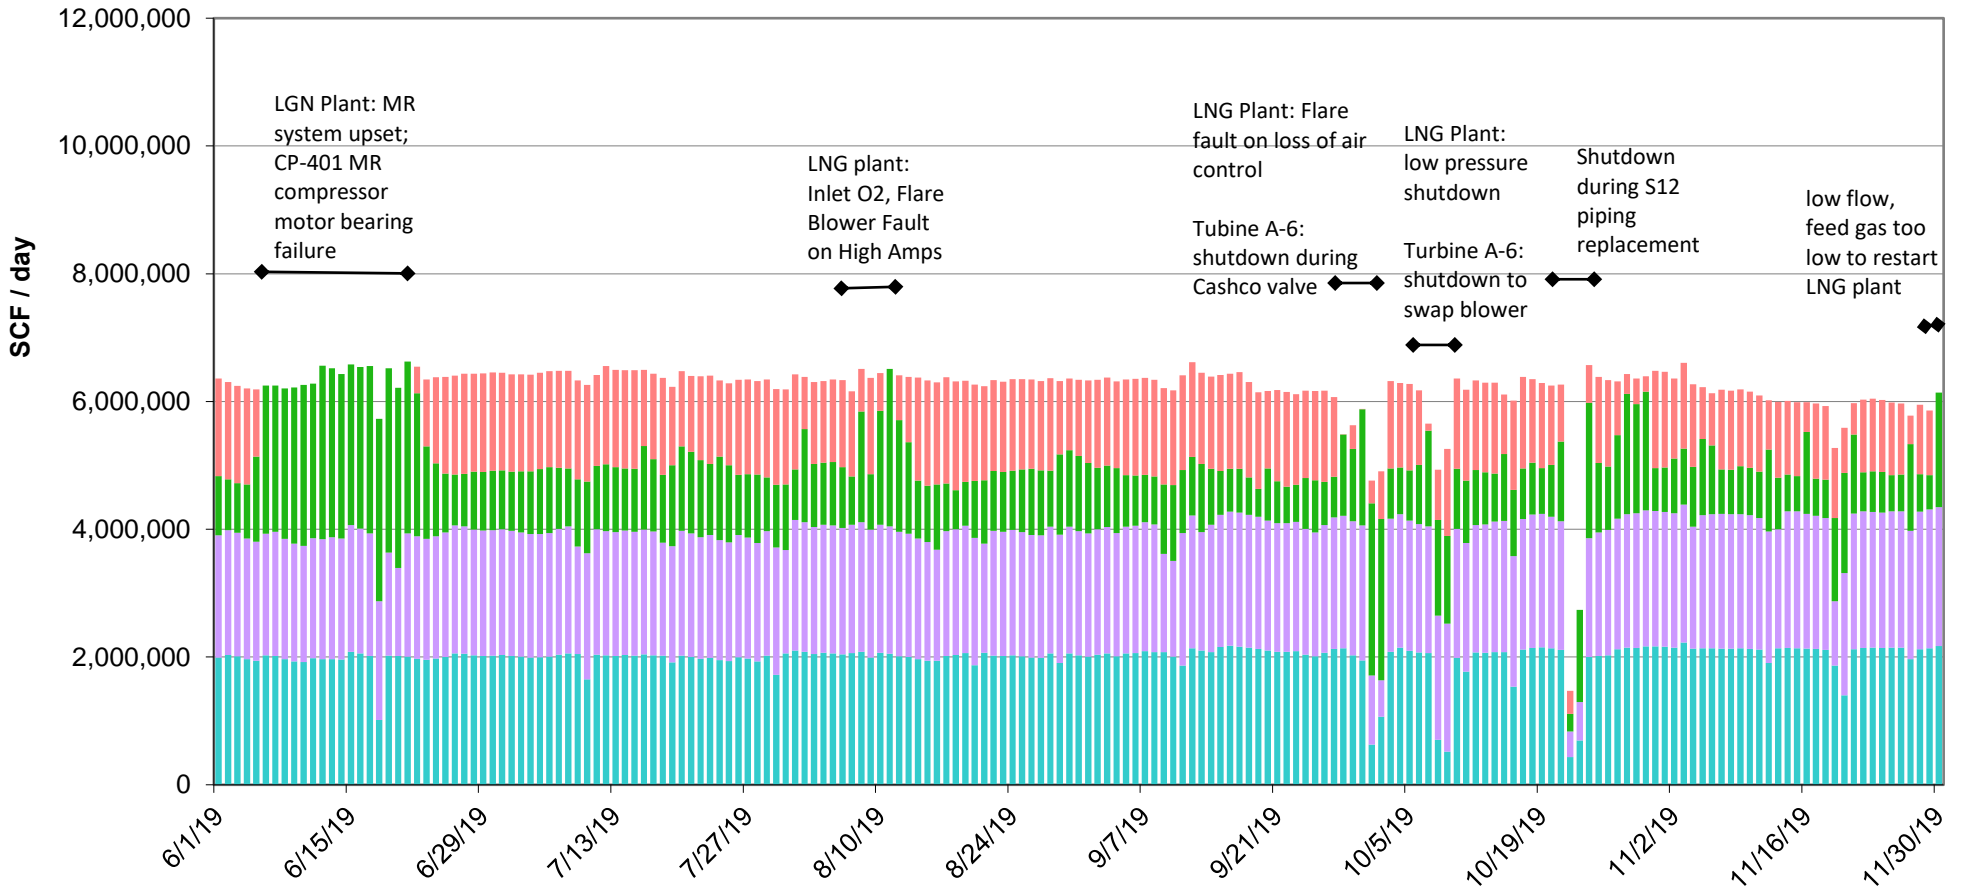
Figure 6.3-7 - ALRRF Daily LFG Flow
 (values derived from Title V Report)

Figure 6.3-7, taken from the December 20, 2019 report, shows the amounts of landfill gas consumed by each of the gas-consuming devices at the ALRRF. As shown in the figure, the gas system ran smoothly for most of the six-month reporting period. There were down times for each of the two turbines, a unique event in June where the LNG plant was down for over 14 days due to a motor bearing failure, and a unique incident in October that involved an almost complete shutdown for 2 days to complete piping replacement. Other unplanned interruptions were few, and brief, and were confined to a single gas control device at any given time.

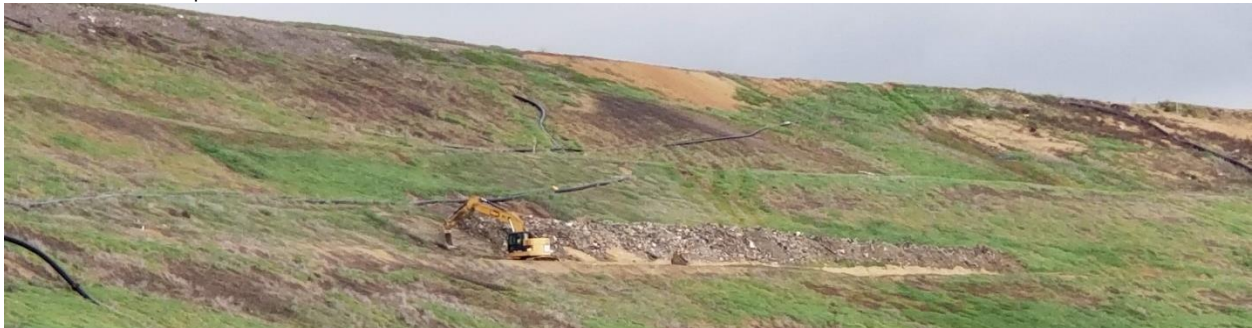
- At the Fill Area 1 solidification basins, the yellow basin (cover material production) was active and had a pile of absorbent material next to it. The blue basin (blending for Class 2 disposal) was active and had visible liquid.
- Leachate seeps were observed in three areas. Excavators were working to contain seeps during the site visit. Mr. Rocha indicated these were mostly contained. The photo below shows a seep and excavator on the south face of Fill Area 1.

- Erosion previously observed on the access road to the top of Fill Area 1. Mr. Rocha reported they would continue to monitor the erosion-prone areas and repair when weather permits.
- Minimal activity was taking place on top of Fill Area 1, only piles of inert debris were observed on the top deck of Fill Area 1.

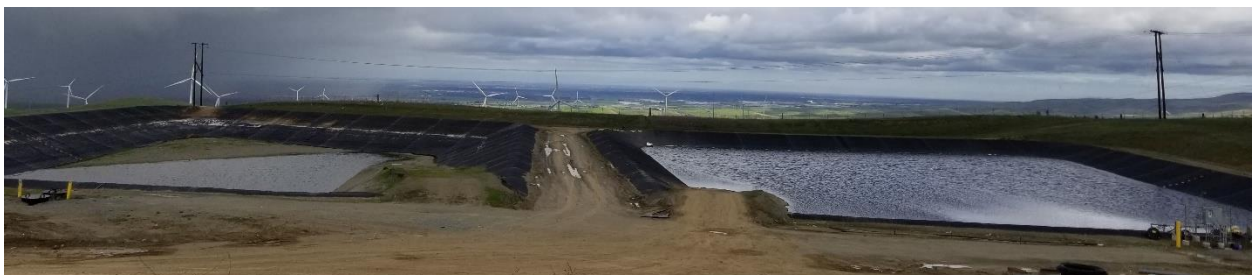
- Construction was in progress at the east access road to connect a leachate line from Fill Area 2 to LSI 1. The east access road was blocked for through access.
- Leachate ponds were in good condition. LSI-2 was nearly drained and contained subdrain water. CASP water had been pumped out of LSI-2.

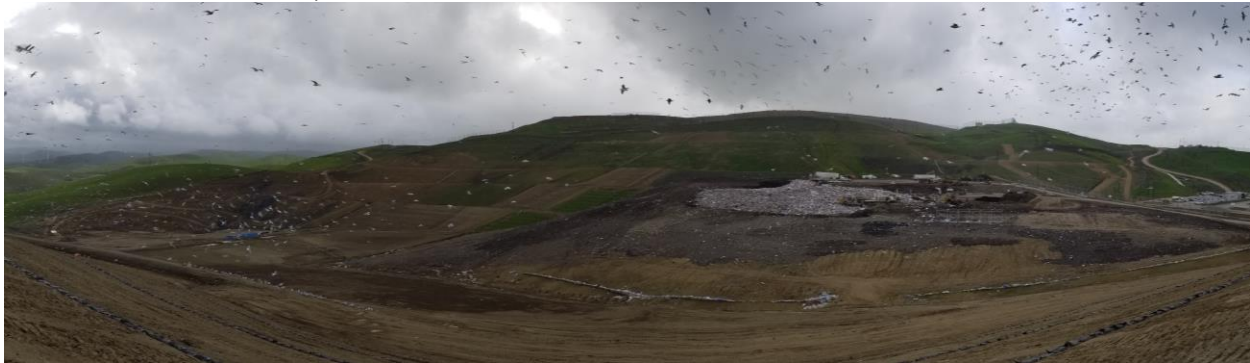
- Several hundred seagulls were present in Fill Area 2. Bird screamer and cannon were used by ALRRF to scatter birds from the active face of this area.
- One dozer, one wheel loader and two compactors were handling incoming refuse, with one tipper operating during the observation period.
- Soil and ADC stockpiles were present on top of Fill Area 2. Thin cover was noted within portions of Fill Area 2.
- Windblown litter was present in this area.

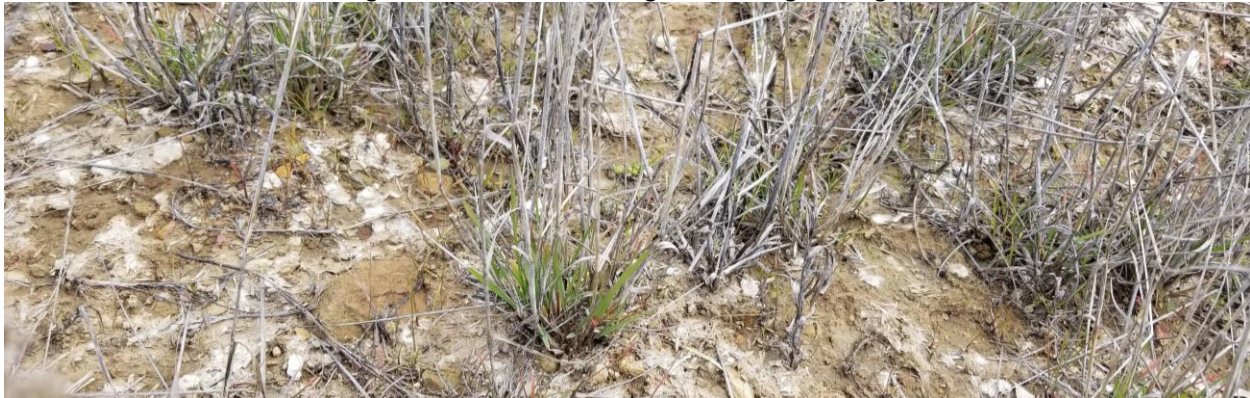
- This area was examined on foot on the south face of Fill Area 1.
- The ET cover area was in good condition. New grass was growing on the cover.

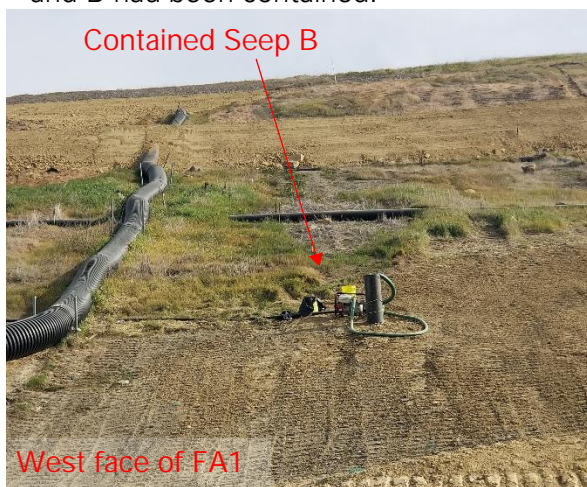
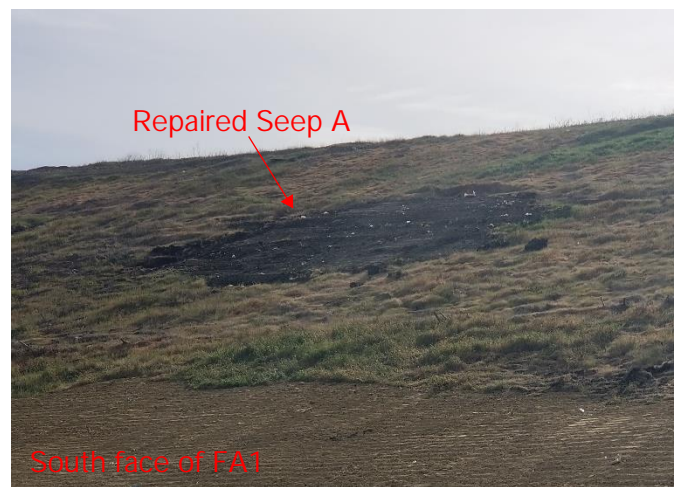
- Leachate seeps were observed. The excavators were working to contain Seep C. Seeps A and B had been contained.

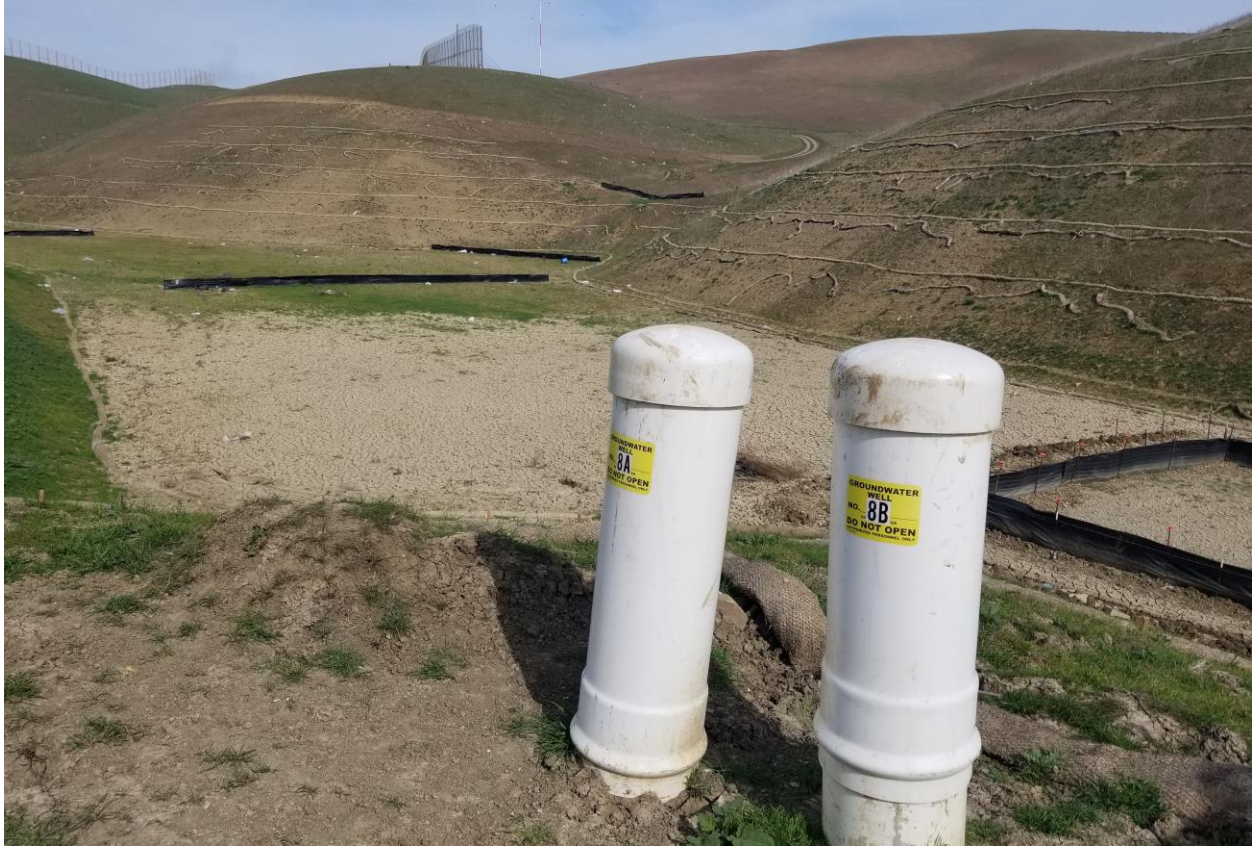
- Basin H was completely dry during this site visit. Monitoring wells MW-8A and MW-8B were observed. These wells were in good condition.

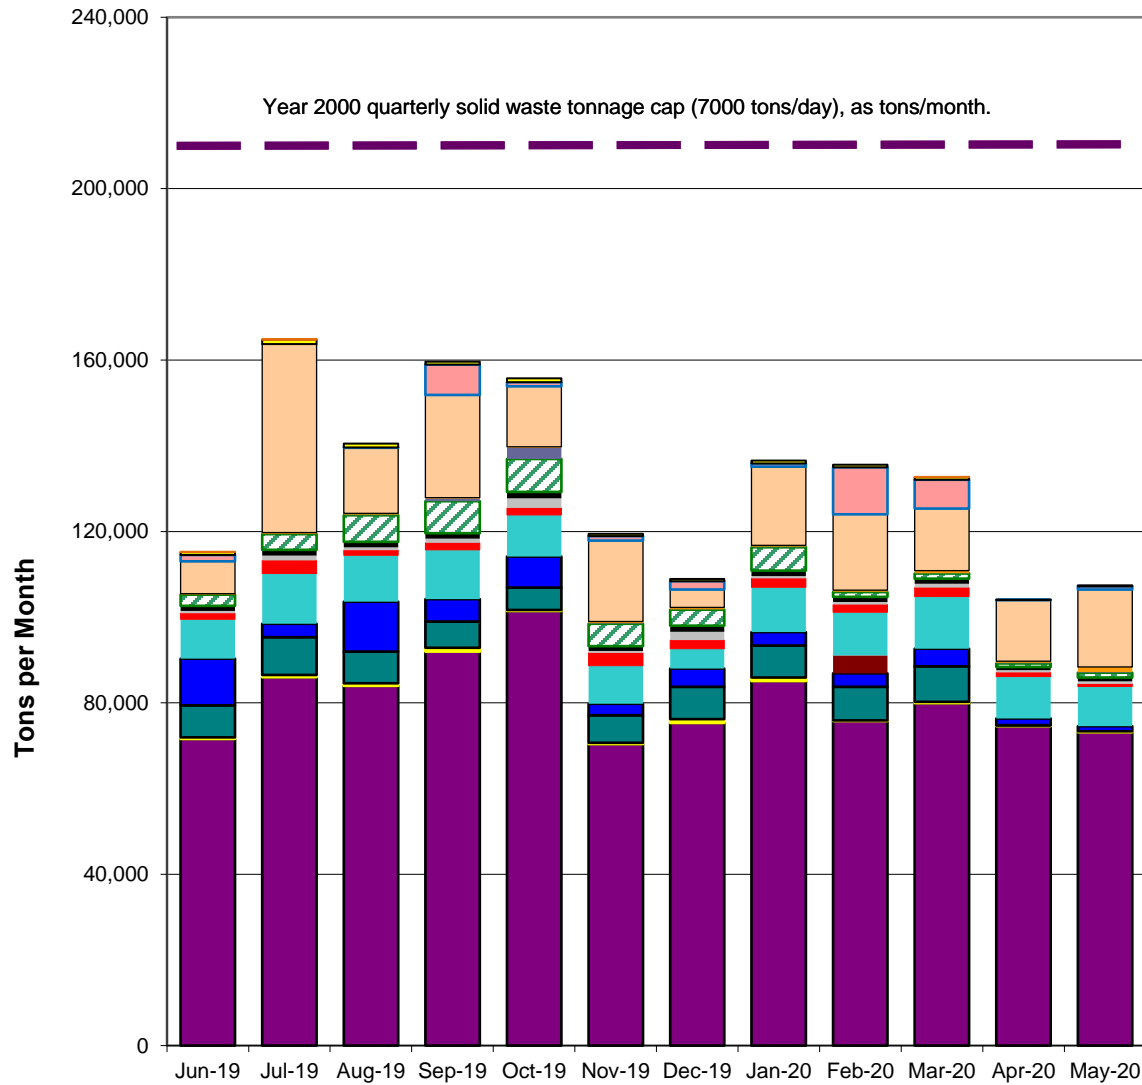
Figure 6.5-2 Monthly Volumes of Landfilled Materials

- Wood For Solidification or Cover
- 2373 MRF fines
- Ash
- Cover soil, Class 2, low-VOC
- Cover soil meeting Class 2 requirements
- Liquids, solidified, approved as Class 2 cover
- Concrete for reuse in Class 2 area
- Overs from composting
- Shredded Tires
- Concrete, Measured by Load
- Concrete, Measured by Ton
- Clean Soil
- Auto Shredder Fluff
- Bio Solids
- Special Waste
- Redirected Waste (RDW)
- Construction and Demolition (C&D)
- MSW

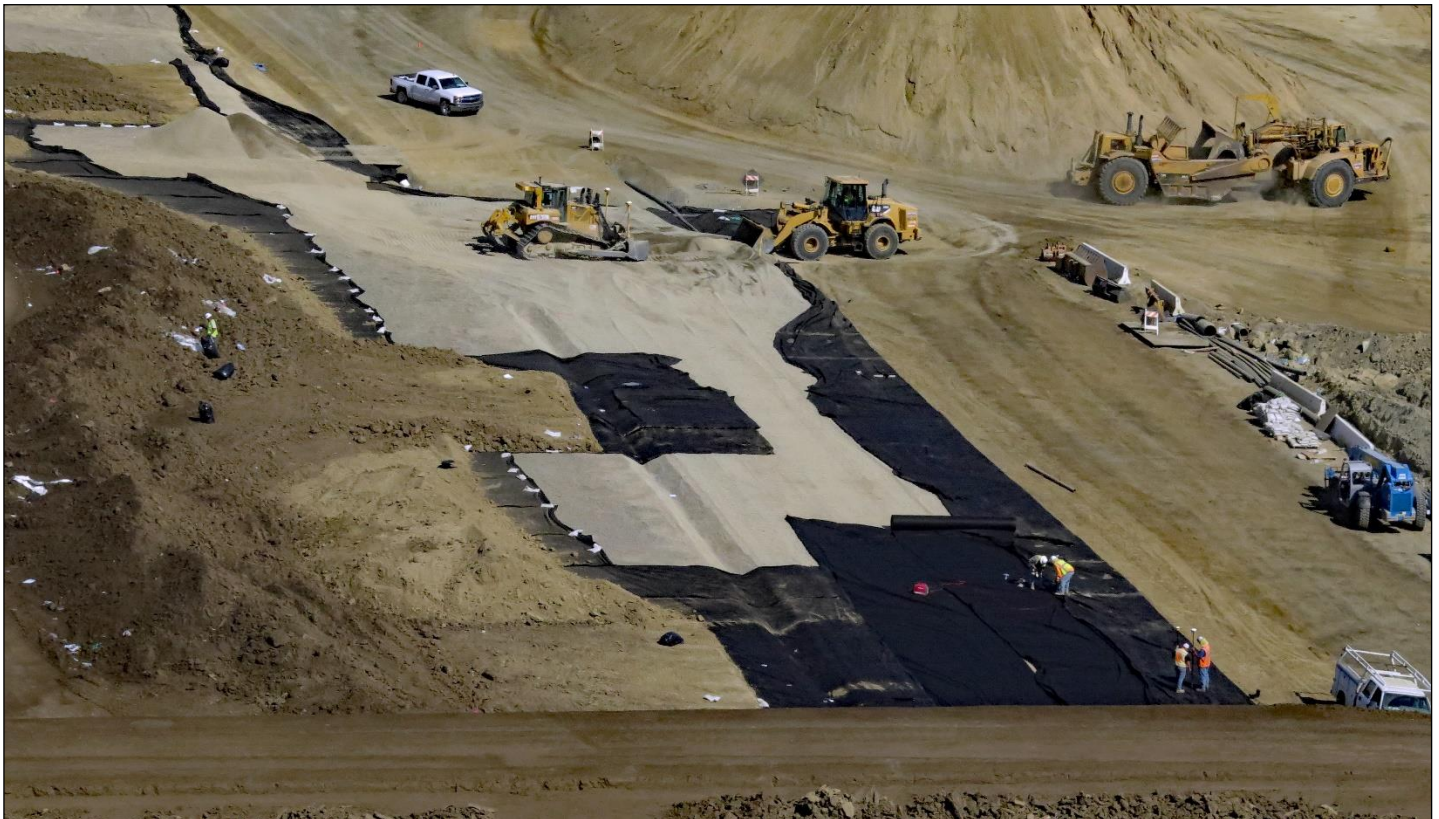
The photo on the cover of this report shows construction of the liner for the Phase 2/2B portion of Fill Area 2, viewed from the hill immediately to the west. The photo was taken on October 11, 2019.

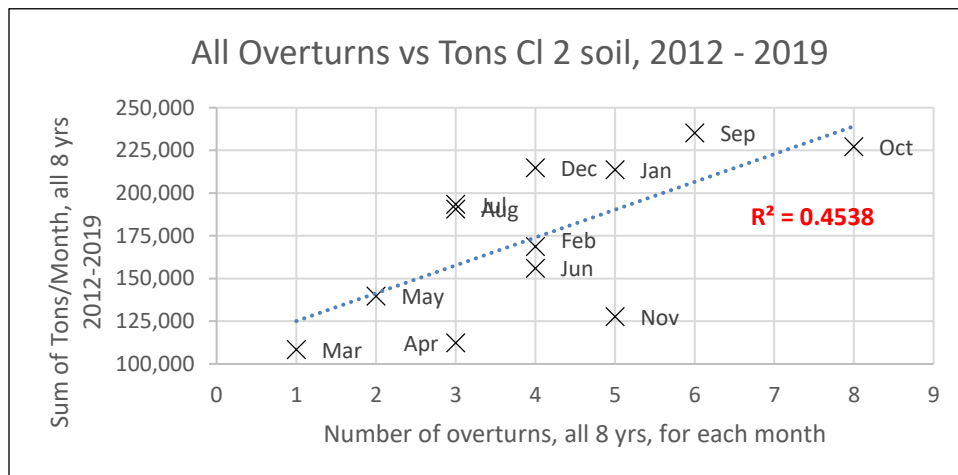
We used the sum total of tonnage each month as a proxy for the number of loads and compared that to the number of overturns – for all types of loads – in a given month. To reduce the effect of year-to-year variation, we made this comparison using the sums of tonnage and overturns for all eight years. For example, the number of January overturns for all 8 years is 5, and the amount of Class 2 soil received in all eight Januaries is 213,621 tons. Graphing these pairs for all 12 months and calculating the best-fit straight line gives the result shown in Figure 2-1 below.

In the figure above, the R² value, known as the coefficient of determination, indicates the extent to which the number of overturns correlates with the number of tons. R² = 1 would indicate a perfect correlation; the data points would all be in a straight line. An R² value of 0.45 indicates a moderate correlation. There appears to be a relationship between these two factors, but other factors are probably also having an effect.

This suggests that the ALRRF should consider making a greater effort to prevent overturns during months when Class 2 soil deliveries are at their peak. While this may seem like an obvious result, it is interesting to note that when the same analysis was run for the treated auto shredder waste tonnage, there was no relationship between that tonnage and the overturns per month. It may be that in the busiest months, the unloading areas are more congested, some drivers are inexperienced, some drivers are more hasty, and some are distracted by other traffic. There also may be trucks coming to the site with mechanical problems, as older equipment is placed in service to move more material.

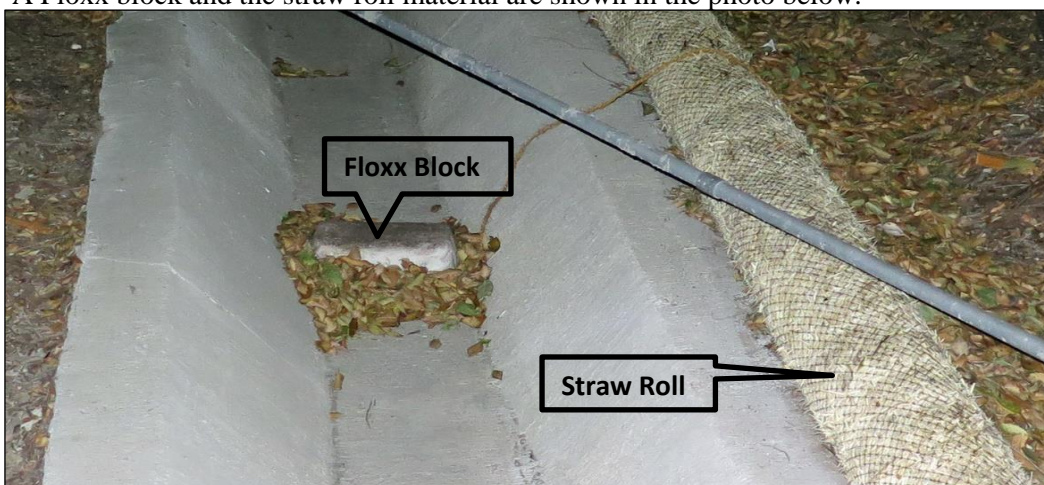
- Straw rolls at the edge of ditches and on slopes to trap suspended solids.
 - Adsorbent wattle ("Filtrex") installed across drainage ditches to remove VOC's and metals.

- "Floxx blocks", tethered brick-shaped objects that release flocculant into stormwater channels.
 The flocculant is delivered to stormwater basins where it causes suspended solids to clump together and settle out, reducing Total Suspended Solids within the basin and in its discharge. A Floxx block and the straw roll material are shown in the photo below.

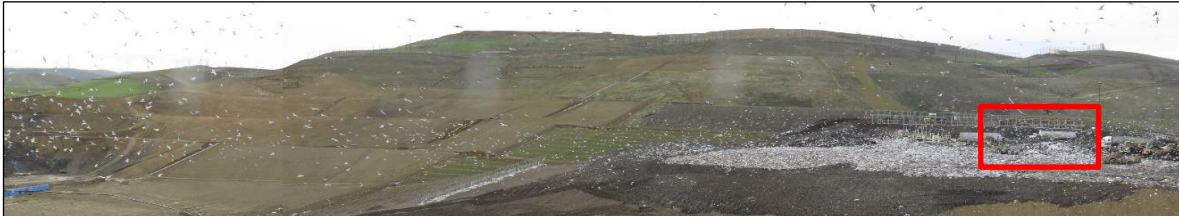
- Filling was taking place in the north end of Phase 1, with two tippers, two compactors, and two dozers working. The working area had portable litter fences nearby along the east and west sides. During these observations, winds were light, but there was a noticeable amount of litter to the northwest of Fill Area 2 on the slope below (east of) the CASP operation. That litter was probably blown there by southeast winds that occurred during recent storms.
- The number of birds at Fill Area 2 was very large, probably several thousand. See photos below.

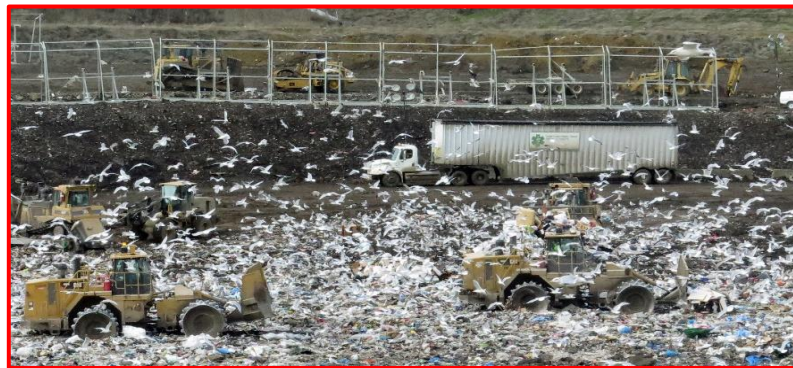
The photo to the right is a close-up of the area shown in the red box above.
