Inspection Report

789 Home Inspection Drive
Fairfax VA 22033

VA Home Inspect, LLC

Date: 8/15/2015	Time: 09:00 AM	Report ID: 789 Home Inspection Drive - Savvy Buyer
Property: 789 Home Inspection Drive Fairfax VA 22033	Customer: Ms. Savvy Home-Investor	Real Estate Professional:

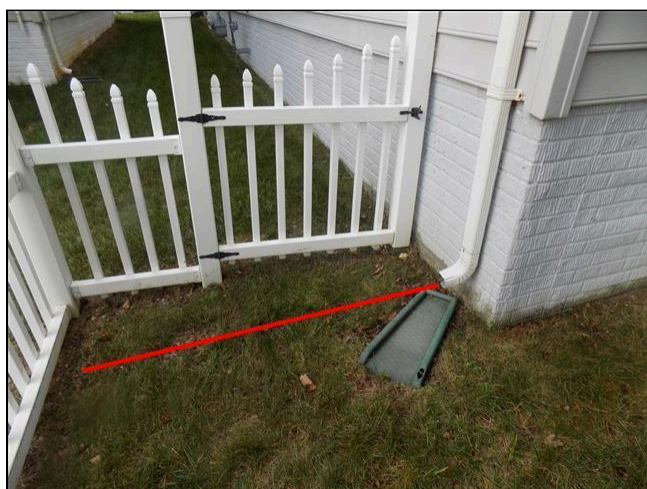
1.3 Item 1 (Picture)

1.3 The downspout here should have an extension and the extension should be buried beneath the surface to help prevent trip hazards. The buried downspout extension should extend to at least 6-12 feet away from the house to help prevent moisture penetration. Install downspouts here and bury and extend. Consult with a qualified contractor, have her or him assess the entire system and repair as needed.

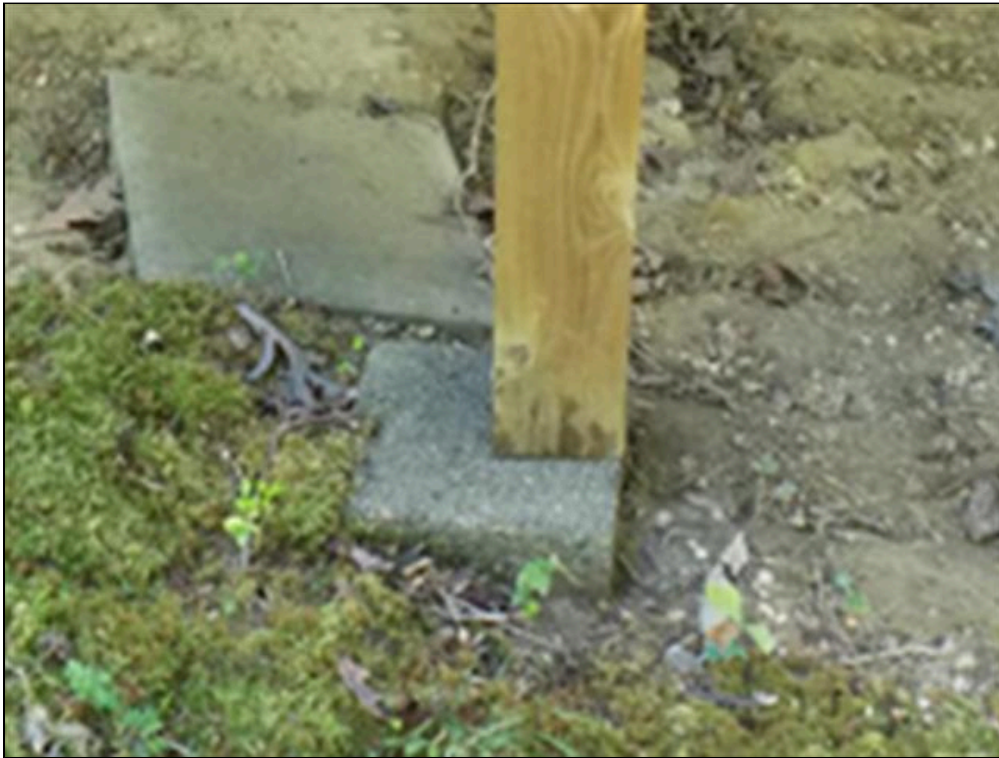
2.3 Item 1 (Picture)

2.3 The deck and stair support posts are resting on what appear to be surface-level concrete blocks. This method of support may not provide adequate stability, especially over time as soil shifts or settles. Proper footings for deck posts typically require the posts to be anchored in concrete below the frost line to prevent movement and ensure long-term structural stability. Repair. Structural hazard. Consult with a qualified contractor to evaluate the stability and structural integrity of the support posts and footings.

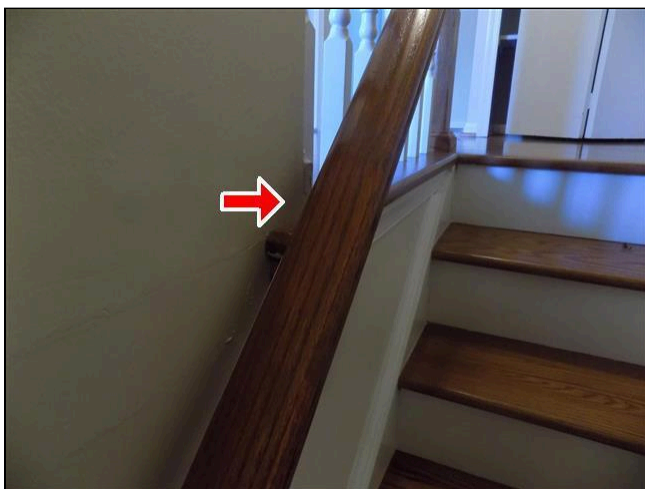
4.3 Item 1 (Picture)

4.3 (1) This handrail is missing a 1.5 inch clearance from the wall to handrail. This needs to be corrected to allow for easy grip and help reduce the risk of injury. Safety hazard. Consult with a qualified contractor, have her or him assess the entire system and repair as needed.

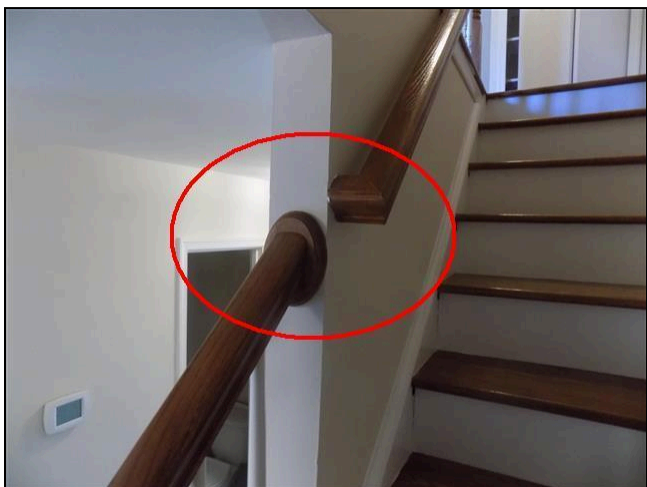
4.3 Item 2 (Picture)

(2) This handrail is not continuous. Handrails for stairways shall be continuous for the full length of the flight, from a point directly above the top riser of the flight to a point directly above lowest riser of the flight. Safety hazard. Consult with a qualified contractor, have her or him assess the entire system and repair as needed.

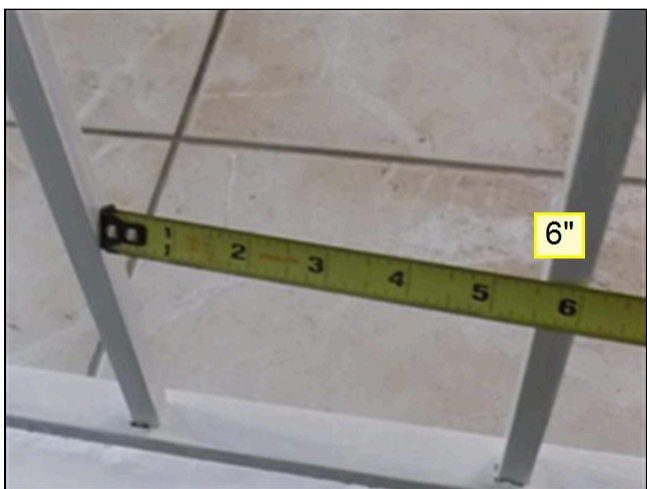
4.3 Item 3 (Picture)

(3) The railing spindles should be only 4" wide, any wider is a safety hazard as people or pets could get stuck or fall through. Re-set spindles to those that are only 4" wide from each other. The spindles throughout the house are 6" wide. Replace. Consult with a qualified contractor, have him or her assess the entire system and repair as needed.

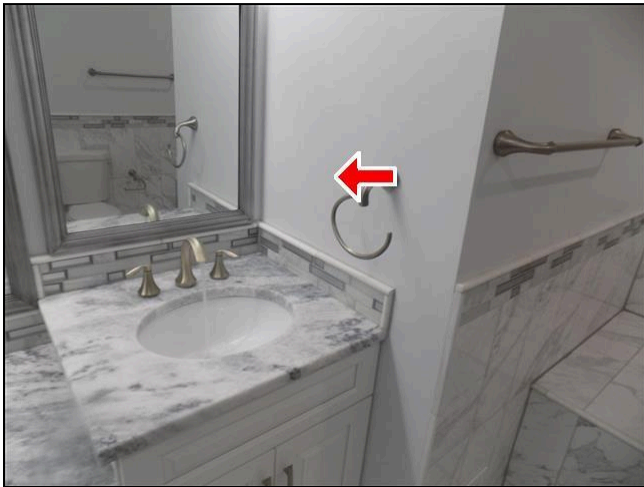
6.1 Item 1 (Picture)

6.1 No outlet within 3' of primary BA sink. Safety hazard. Install a GFCI protected electrical outlet at this side of this sink. Every bathroom must have a GFCI electrical outlet within 3 feet of the edge of every sink. Repair. Consult with a qualified contractor, have her or him assess the entire system and repair as needed.

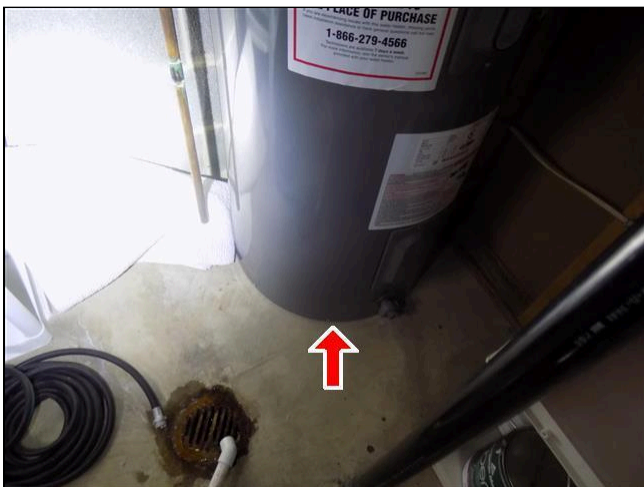
6.2 Item 1 (Picture)

6.2 (1) It is recommended that the water heater have a pan underneath of it to collect water in case of leaking. There was no pan present underneath the water heater at the time of inspection. Install pan underneath water heater. Consult with a qualified contractor, have her or him assess the entire system and repair as needed.

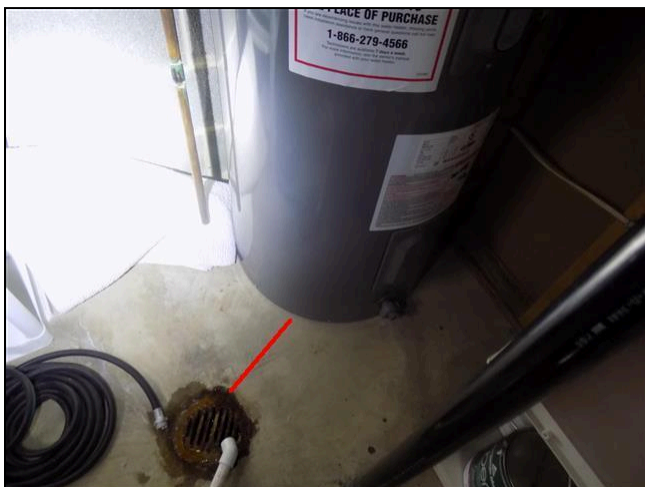
6.2 Item 2 (Picture)

(2) The water heater drain pan (when installed) should have a PVC pipe connecting to it that dumps off to a floor drain, or sump pump, etc. It currently does not have a pipe leading to a drain. Install pipe leading to a drain. Consult with a qualified contractor, have him or her assess the entire system and repair as needed.

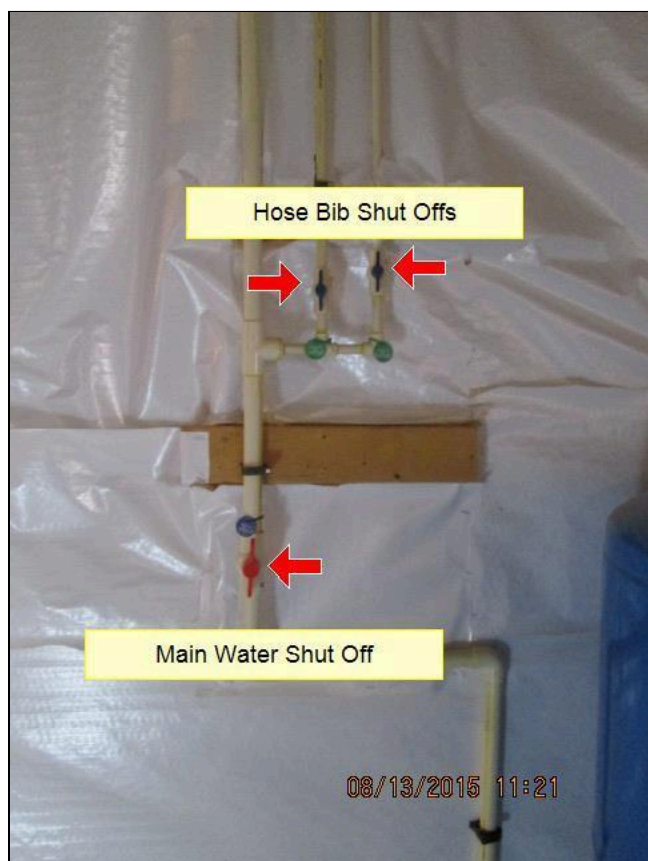
6.3 Item 1 (Picture)

6.3 (1) Main water shutoff valve located in utility room.

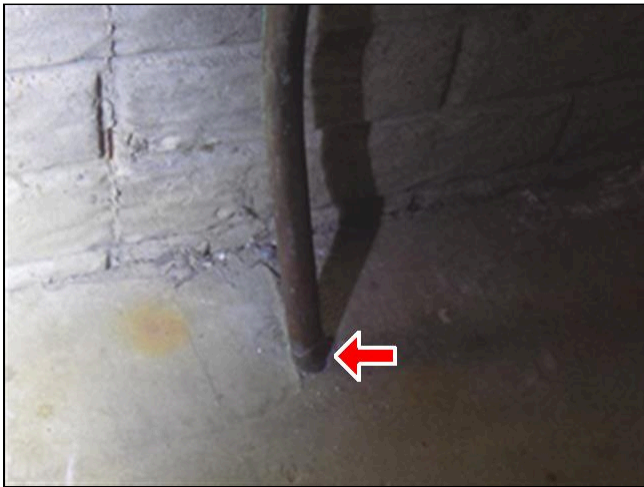
6.3 Item 2 (Picture)

(2) The main water pipe does not appear to be insulated underground. Although underground pipes are generally protected from extreme temperatures, lack of insulation can still pose a risk in particularly cold climates or during severe weather conditions, potentially leading to freezing and subsequent damage. It is recommended to install appropriate insulation around the underground main water pipe to provide additional

protection and ensure long-term durability and functionality.

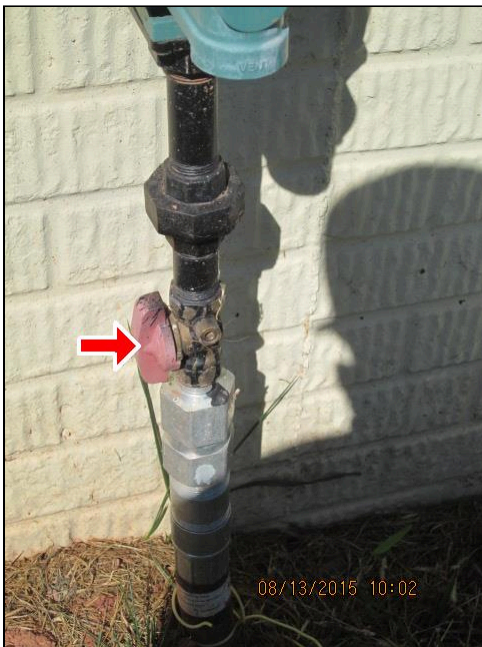
6.5 Item 1 (Picture)

6.5 The main fuel shut off is at gas meter outside

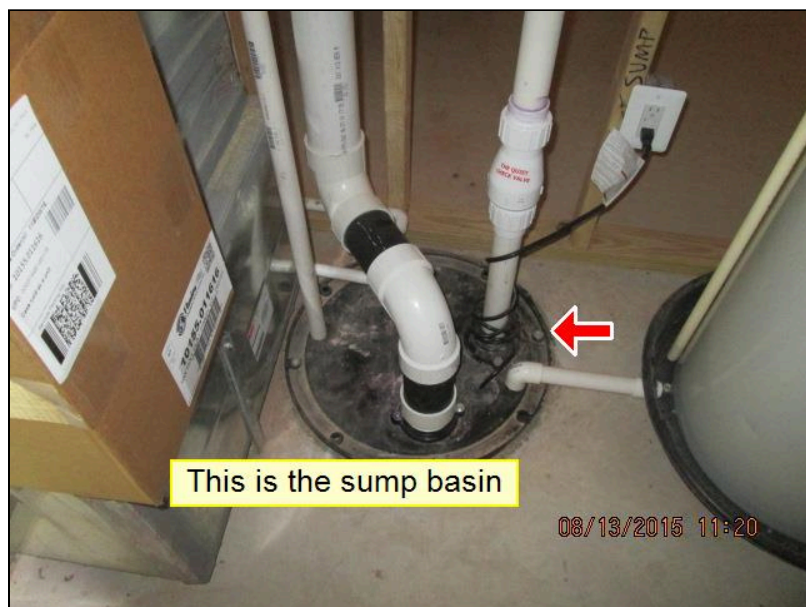
6.6 Item 1 (Picture)

6.6 (1) It is recommended to install a battery backup system to ensure the sump pump continues to function in the event of a power outage, which often occurs during heavy rains or storms-precisely when the pump is most needed. Consult with a qualified contractor, have her or him assess the entire system and repair as needed.

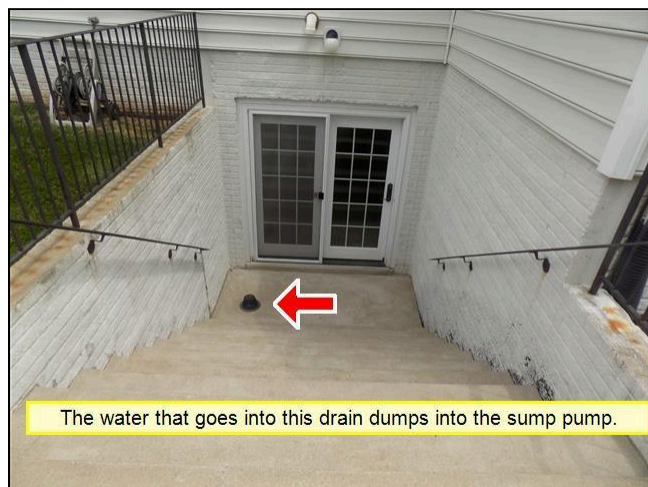
6.6 Item 2 (Picture)

(2) The sump basin in the basement is connected to the drain located at the bottom of the exterior stairs. Water from this drain flows into the sump basin pit inside the house. Every time it rains, the sump pump must activate to manage the water. It's crucial to take preventive measures to ensure the pump doesn't fail, such as installing a battery backup system, scheduling regular maintenance, and having a secondary backup pump in place.

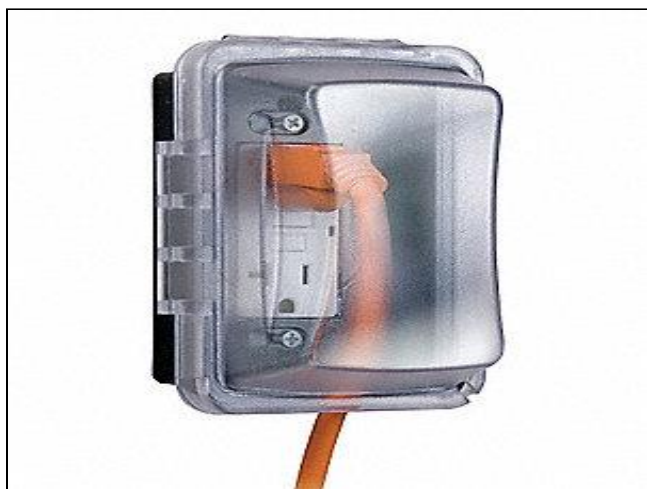
7.3 Item 1 (Picture)

7.3 Recommend installing plastic "in-use" covers, at electrical outlet (s), outside as needed to help keep exterior outlets dry and protect occupants from electrical shock. Safety hazard. Consult with a qualified contractor, have him or her assess the entire system and repair as needed.

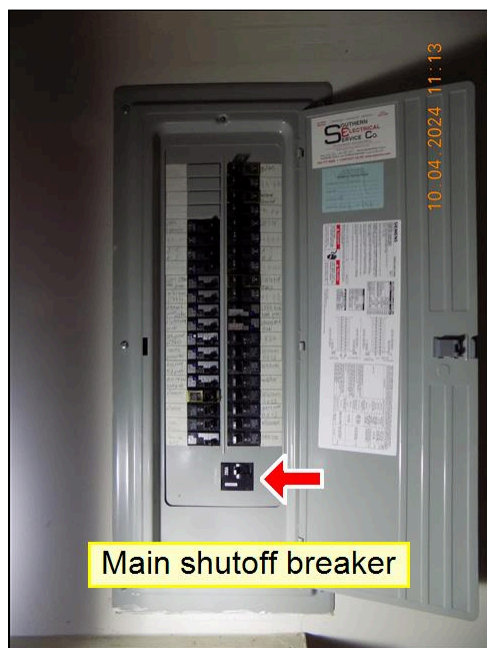
7.6 Item 1 (Picture)

7.6 Electrical panel located in utility room.

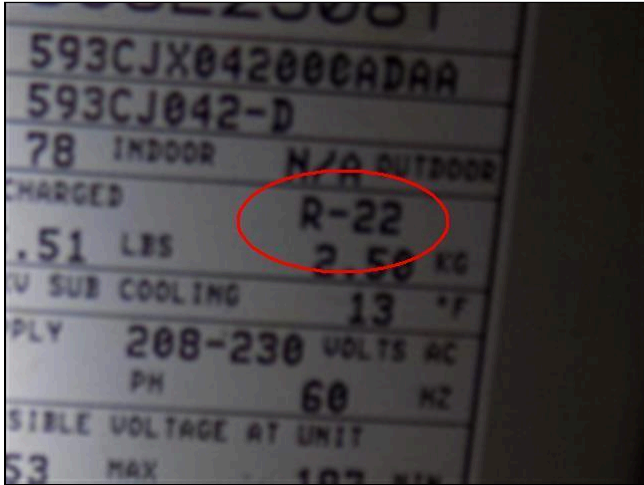
8.8 Item 1 (Picture)

8.8 The air conditioning system in this home utilizes R-22 refrigerant. As of January 1, 2020, the production and importation of R-22 refrigerant have been banned in the United States due to its ozone-depleting properties. This phase-out may affect the cost and availability of future repairs or necessary refrigerant recharges. It is recommended to consider the potential impacts of the R-22 phase-out when planning for long-term maintenance or system replacement. Also, there will be a point where R22 refrigerant will no longer be available, and this unit might not be capable to convert to a newer refrigerant.

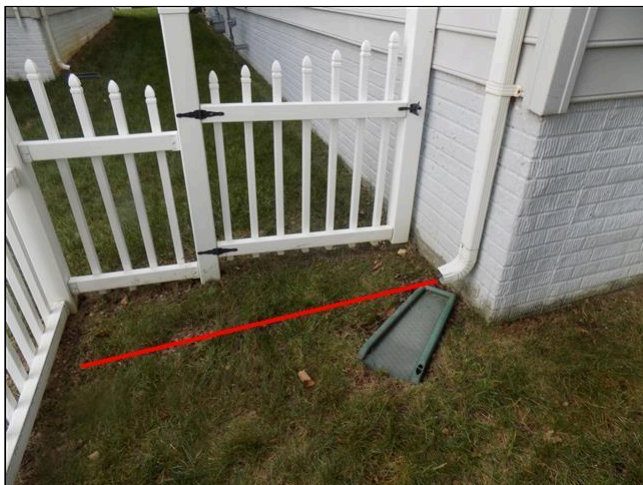
Item 1 - Item 1 (Picture)

- 1 The downspout here should have an extension and the extension should be buried beneath the surface to help prevent trip hazards. The buried downspout extension should extend to at least 6-12 feet away from the house to help prevent moisture penetration. Install downspouts here and bury and extend. Consult with a qualified contractor, have her or him assess the entire system and repair as needed.

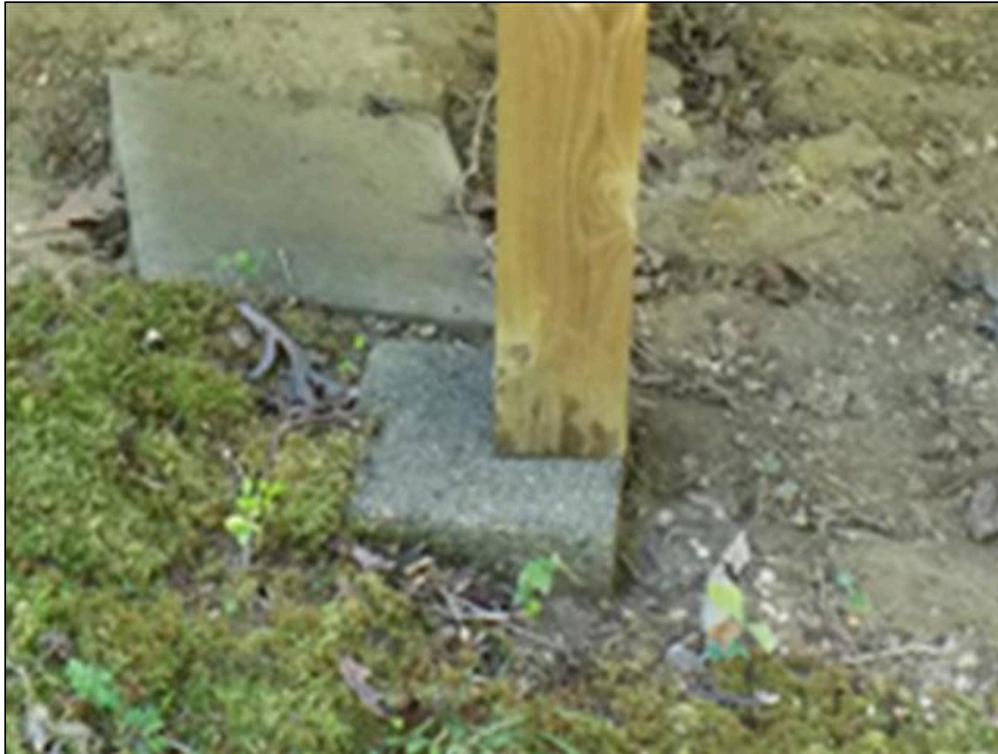
Item 2 - Item 1 (Picture)

- 2 The deck and stair support posts are resting on what appear to be surface-level concrete blocks. This method of support may not provide adequate stability, especially over time as soil shifts or settles. Proper footings for deck posts typically require the posts to be anchored in concrete below the frost line to prevent movement and ensure long-term structural stability. Repair. Structural hazard. Consult with a qualified contractor to evaluate the stability and structural integrity of the support posts and footings.

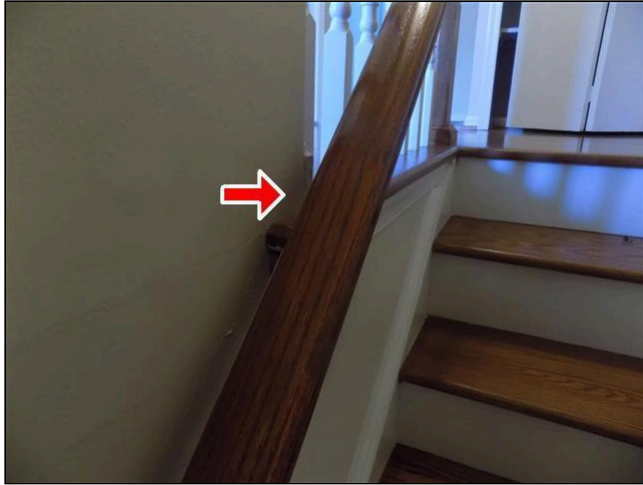
Item 3 - Item 1 (Picture)

- 3 (1) This handrail is missing a 1.5 inch clearance from the wall to handrail. This needs to be corrected to allow for easy grip and help reduce the risk of injury. Safety hazard. Consult with a qualified contractor, have her or him assess the entire system and repair as needed.

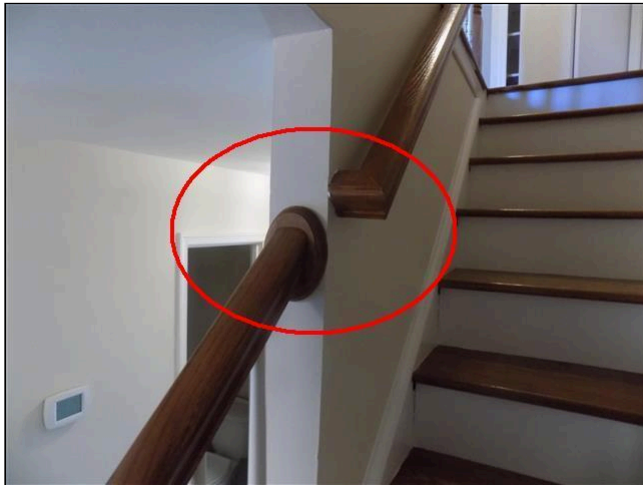
Item 4 - Item 1 (Picture)

- 4** (2) This handrail is not continuous. Handrails for stairways shall be continuous for the full length of the flight, from a point directly above the top riser of the flight to a point directly above lowest riser of the flight. Safety hazard. Consult with a qualified contractor, have her or him assess the entire system and repair as needed.

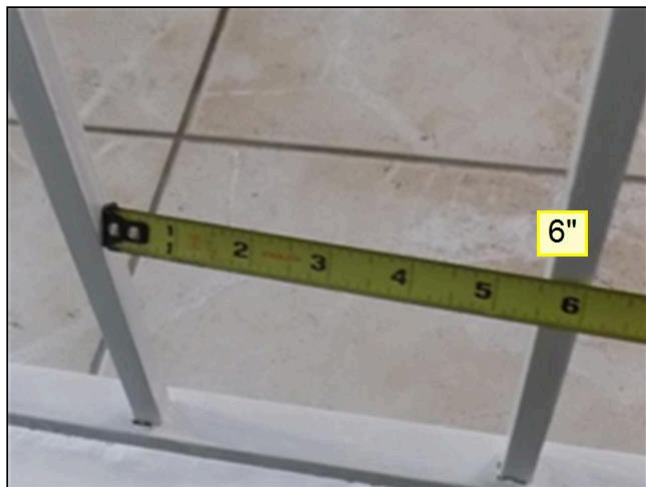
Item 5 - Item 1 (Picture)

- 5** (3) The railing spindles should be only 4" wide, any wider is a safety hazard as people or pets could get stuck or fall through. Re-set spindles to those that are only 4" wide from each other. The spindles throughout the house are 6" wide. Replace. Consult with a qualified contractor, have him or her assess the entire system and repair as needed.

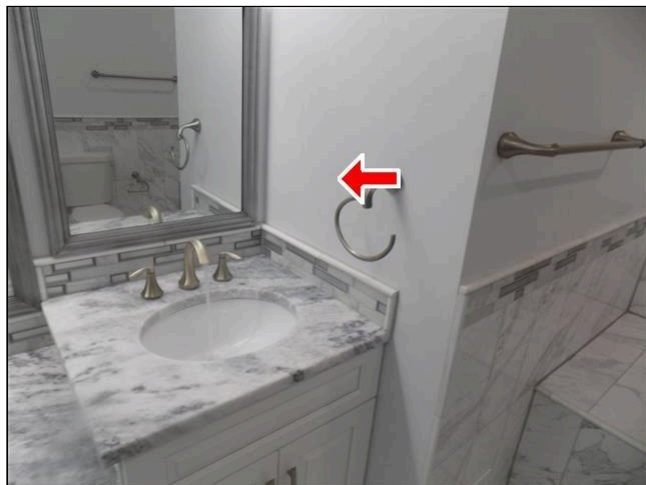
Item 6 - Item 1 (Picture)

- 6 No outlet within 3' of primary BA sink. Safety hazard. Install a GFCI protected electrical outlet at this side of this sink. Every bathroom must have a GFCI electrical outlet within 3 feet of the edge of every sink. Repair. Consult with a qualified contractor, have her or him assess the entire system and repair as needed.

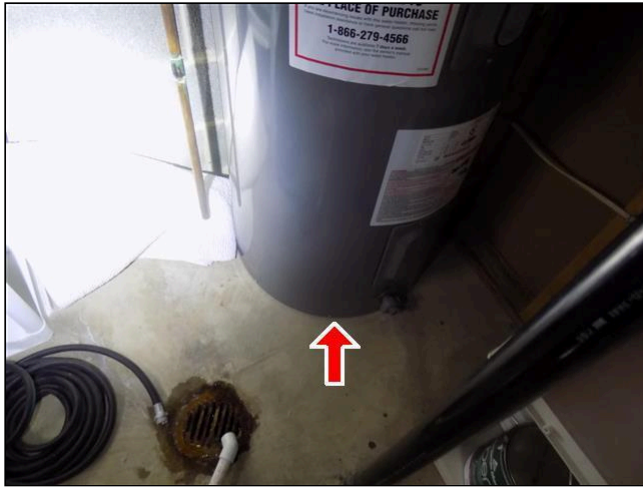
Item 7 - Item 1 (Picture)

- 7 (1) It is recommended that the water heater have a pan underneath of it to collect water in case of leaking. There was no pan present underneath the water heater at the time of inspection. Install pan underneath water heater. Consult with a qualified contractor, have her or him assess the entire system and repair as needed.

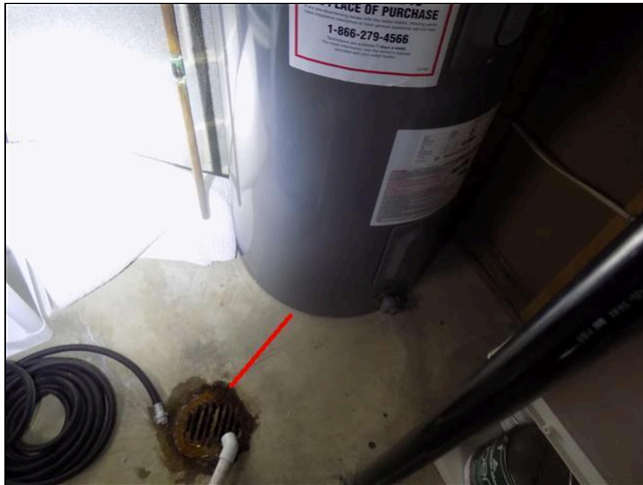
Item 8 - Item 1 (Picture)

- 8 (2) The water heater drain pan (when installed) should have a PVC pipe connecting to it that dumps off to a floor drain, or sump pump, etc. It currently does not have a pipe leading to a drain. Install pipe leading to a drain. Consult with a qualified contractor, have him or her assess the entire system and repair as needed.

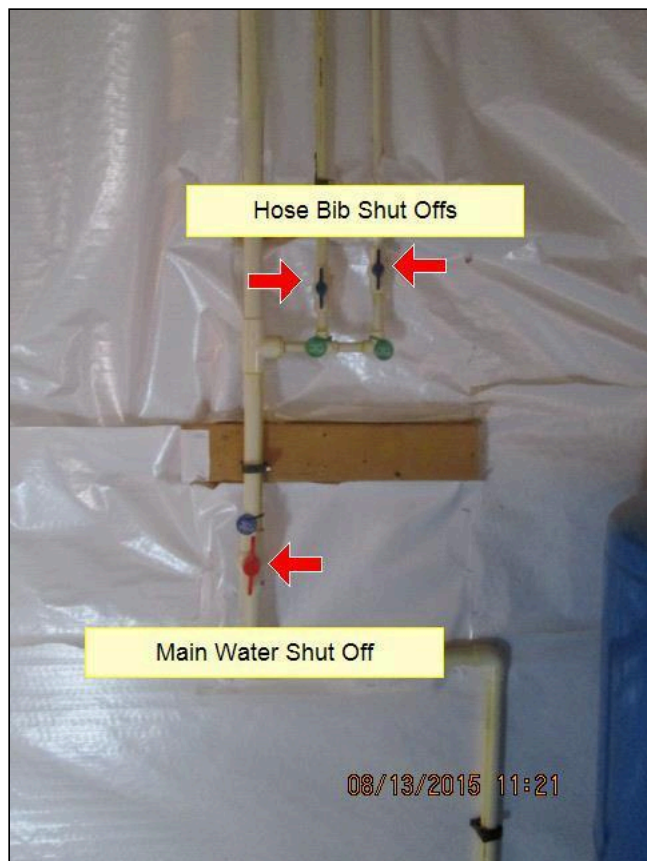
Item 9 - Item 1 (Picture)

- 9 (1) Main water shutoff valve located in utility room.

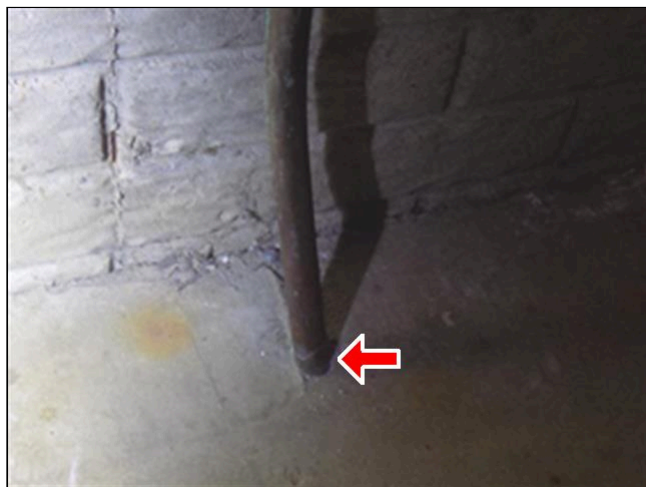
Item 10 - Item 1 (Picture)

- 10** (2) The main water pipe does not appear to be insulated underground. Although underground pipes are generally protected from extreme temperatures, lack of insulation can still pose a risk in particularly cold climates or during severe weather conditions, potentially leading to freezing and subsequent damage. It is recommended to install appropriate insulation around the underground main water pipe to provide additional protection and ensure long-term durability and functionality.

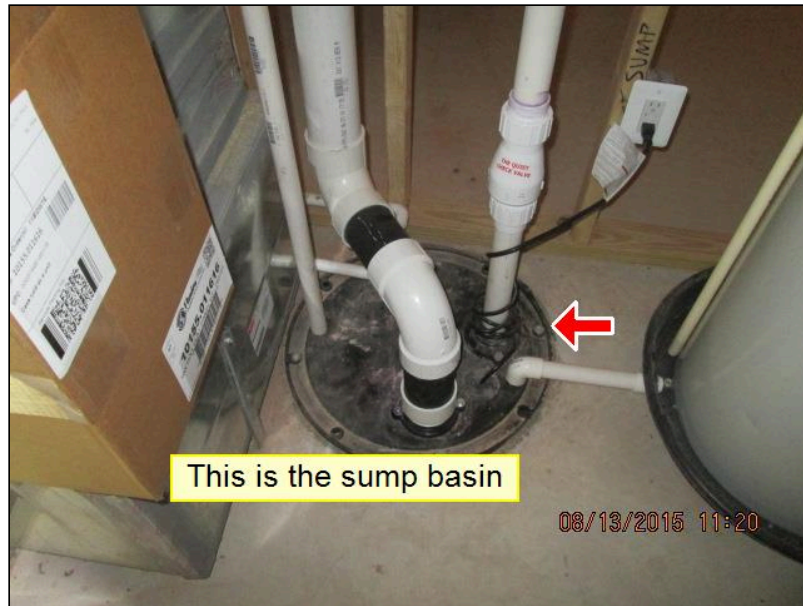
Item 11 - Item 1 (Picture)

- 11** (1) It is recommended to install a battery backup system to ensure the sump pump continues to function in the event of a power outage, which often occurs during heavy rains or storms-precisely when the pump is most needed. Consult with a qualified contractor, have her or him assess the entire system and repair as needed.

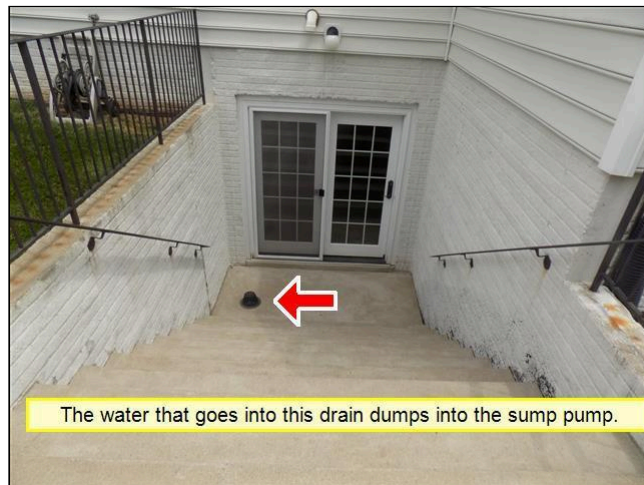
Item 12 - Item 1 (Picture)

- 12** (2) The sump basin in the basement is connected to the drain located at the bottom of the exterior stairs. Water from this drain flows into the sump basin pit inside the house. Every time it rains, the sump pump must activate to manage the water. It's crucial to take preventive measures to ensure the pump doesn't fail, such as installing a battery backup system, scheduling regular maintenance, and having a secondary backup pump in place.

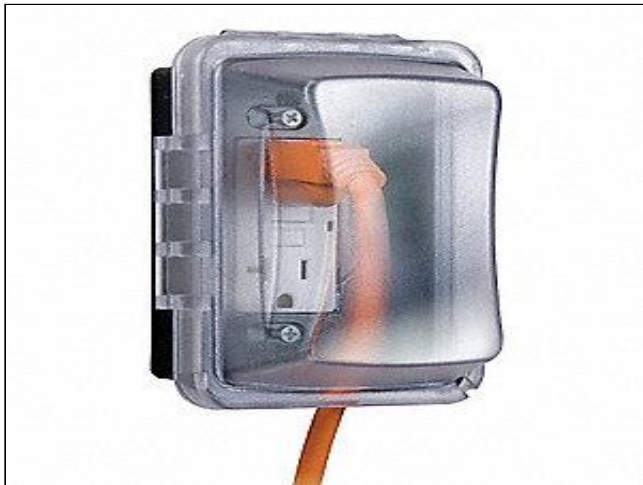
Item 14 - Item 1 (Picture)

- 14** Recommend installing plastic "in-use" covers, at electrical outlet (s), outside as needed to help keep exterior outlets dry and protect occupants from electrical shock. Safety hazard. Consult with a qualified contractor, have him or her assess the entire system and repair as needed.

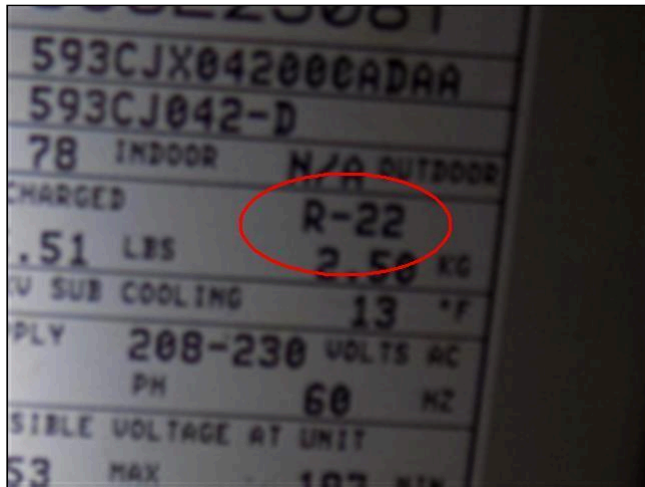
Item 17 - Item 1 (Picture)

- 17** The air conditioning system in this home utilizes R-22 refrigerant. As of January 1, 2020, the production and importation of R-22 refrigerant have been banned in the United States due to its ozone-depleting properties. This phase-out may affect the cost and availability of future repairs or necessary refrigerant recharges. It is recommended to consider the potential impacts of the R-22 phase-out when planning for long-term maintenance or system replacement. Also, there will be a point where R22 refrigerant will no longer be available, and this unit might not be capable to convert to a newer refrigerant.
