THE SECRETARY
OF THE INTERIOR'S
STANDARDS FOR
REHABILITATION &

ILLUSTRATED
GUIDELINES ON
SUSTAINABILITY
FOR
REHABILITATING
HISTORIC
BUILDINGS

U.S. Department of the Interior
National Park Service
Technical Preservation Services

2011

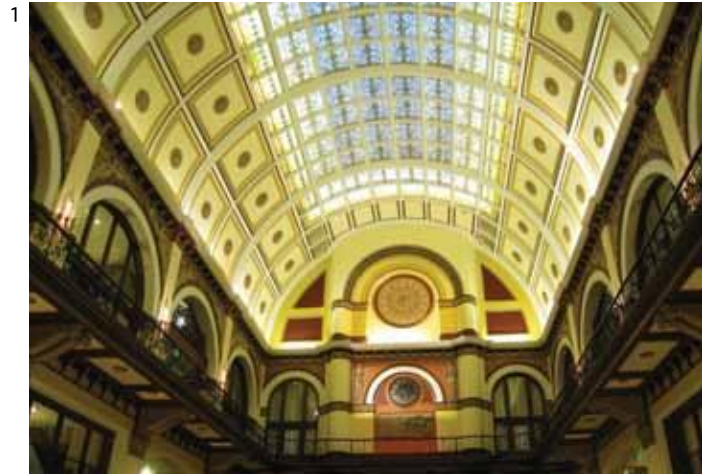
[1] Stained glass skylight provides natural light in a historic train station.

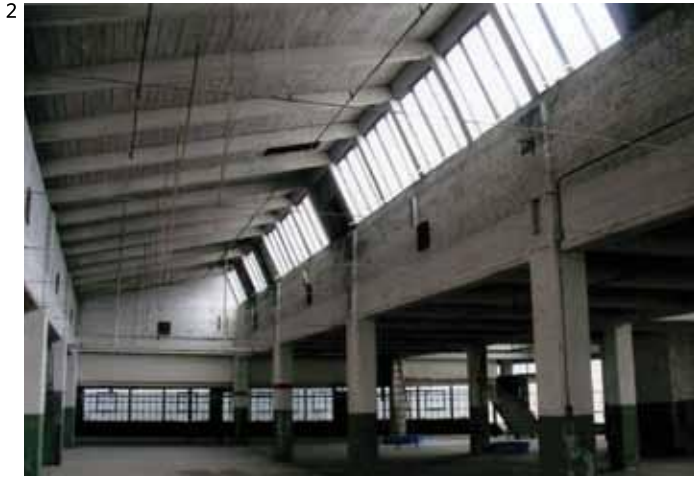
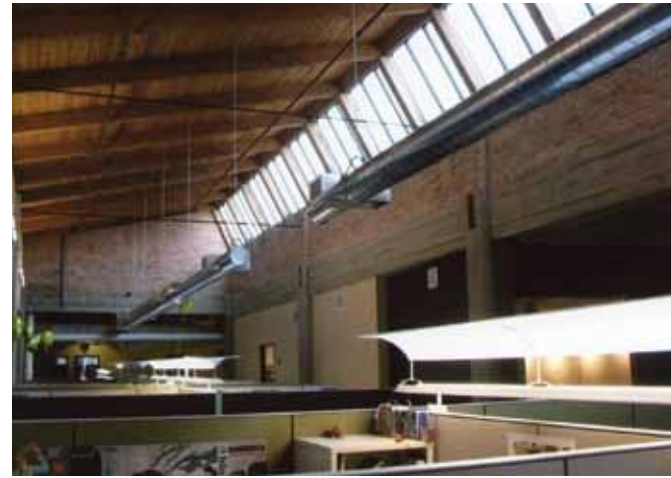
[2-3] Clerestory windows provide natural light in a historic industrial building: Before and after rehabilitation.

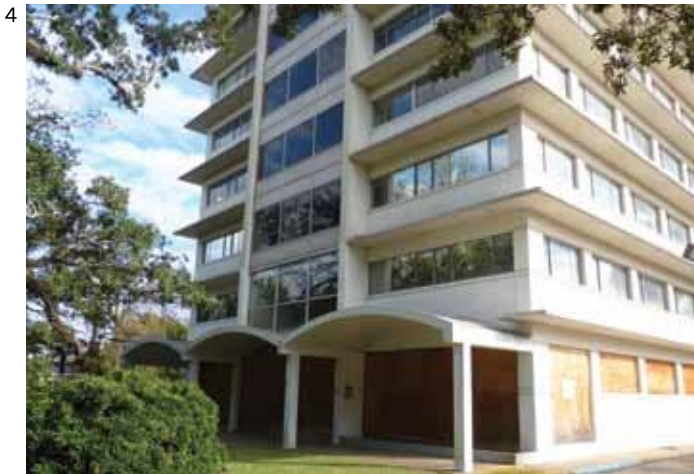
[4] Covered walkways and horizontal sun screens are distinctive and sustainable features in some mid-century modern office buildings.

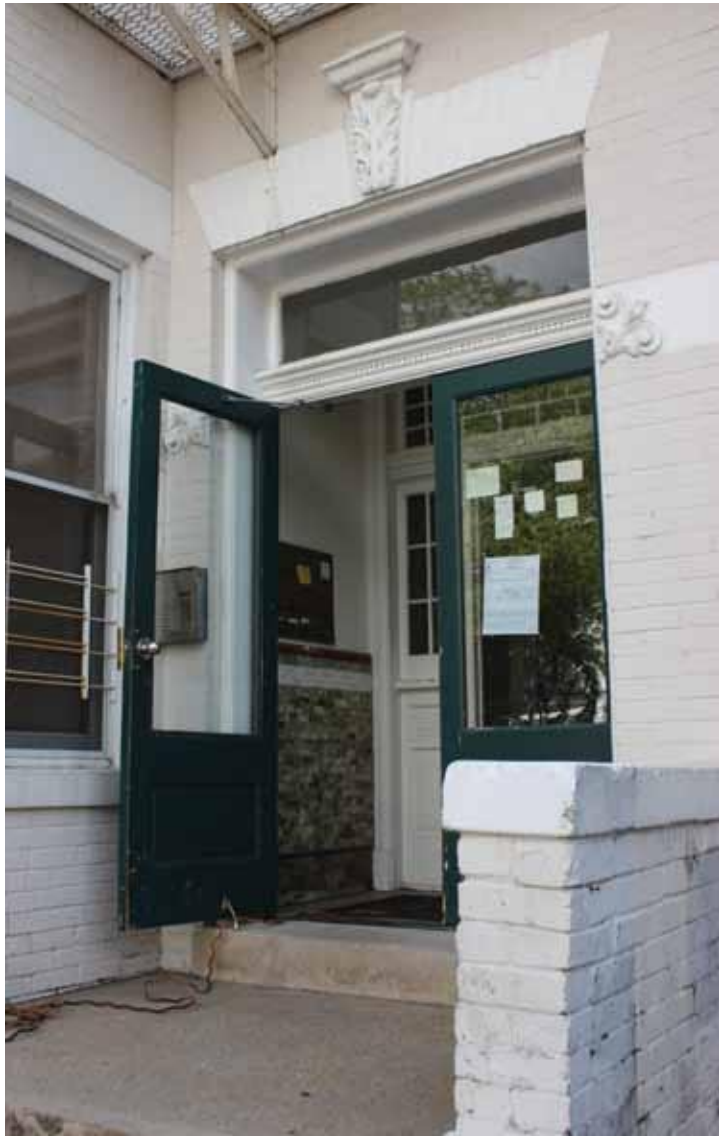
11

[11] A vestibule helps retain interior conditioned air in the living space in this historic row house.

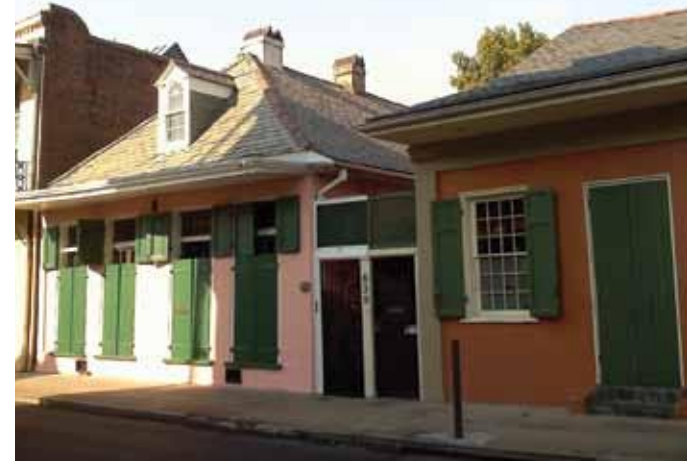
10

[10] Wood shutters provide natural light when open and keep interiors cool when closed in historic residential buildings.

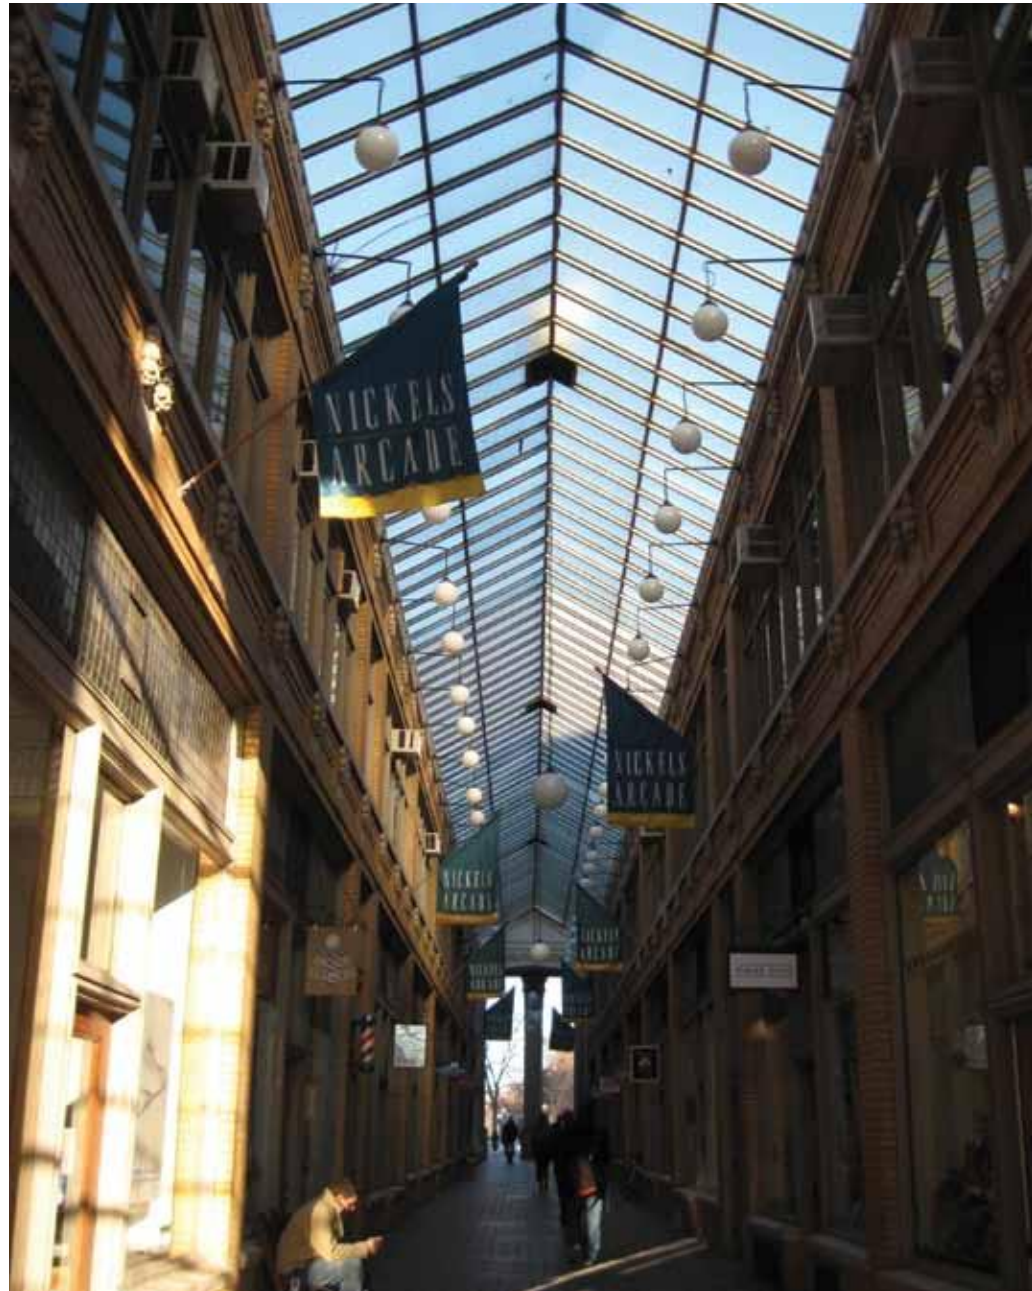
[15] Glass skylight illuminates historic shopping arcade.

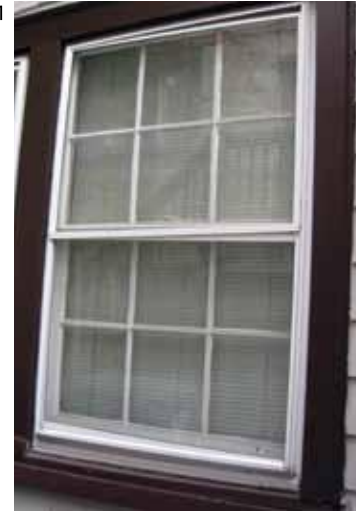
31

Not Recommended: [31-32] Ill-fitting exterior aluminum storm windows viewed from both inside and outside are clearly not energy efficient.

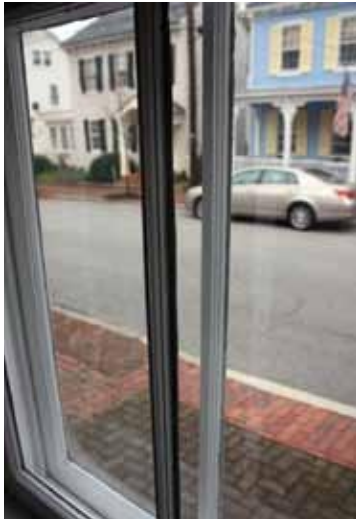
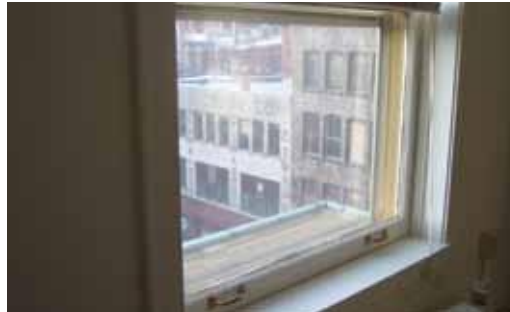
Recommended: [28-29] These exterior storm windows match the pane configuration of the historic interior windows in a residence and in a multi-story hotel building.

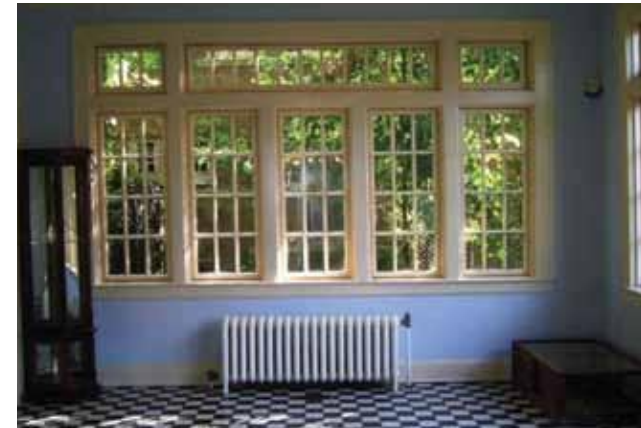
60

Recommended: [60] Original radiators that are still functional and efficient were retained in the rehabilitation of this historic house.

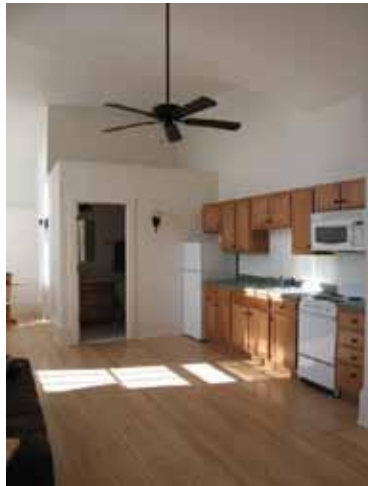
58

Recommended: [58] Ceiling fans enhance the efficiency of HVAC systems in historic buildings.

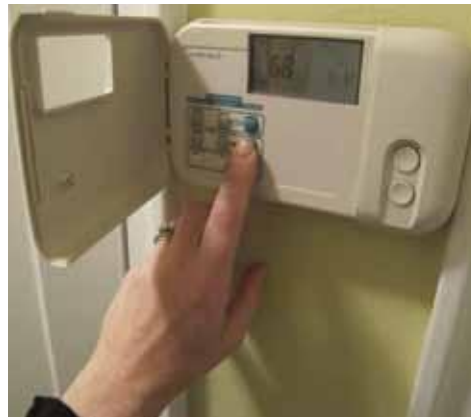
59

Recommended: [59] Installing a programmable thermostat can help existing systems to operate more efficiently.

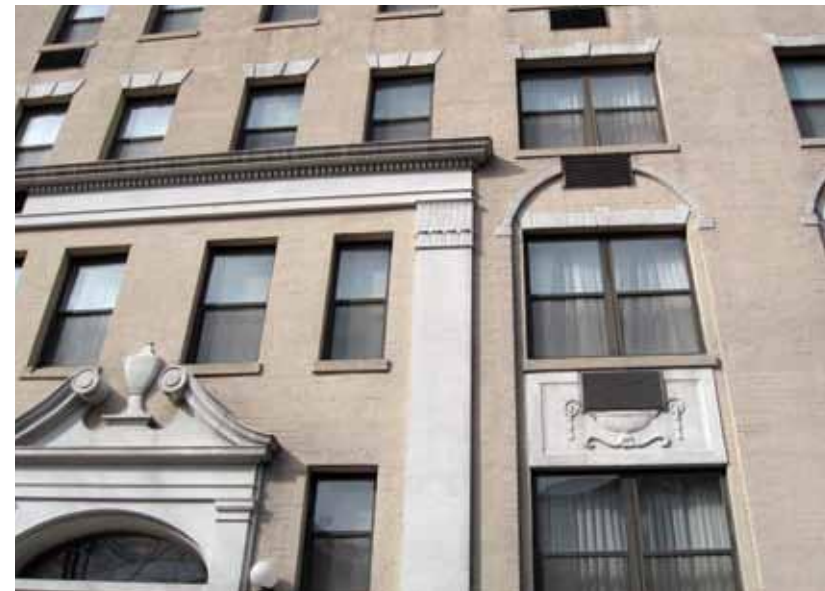
61

Not Recommended: [61] The cuts made in the brick and the decorative stone trim to install through-the-wall air conditioners have not only destroyed building material, but have also negatively impacted the character of this historic apartment building.

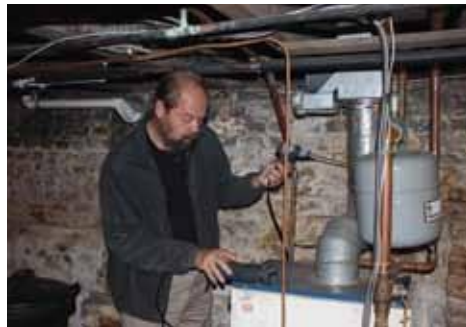
67

Recommended:[67] A professional energy auditor analyzes the performance of an existing furnace to ensure it is operating efficiently.

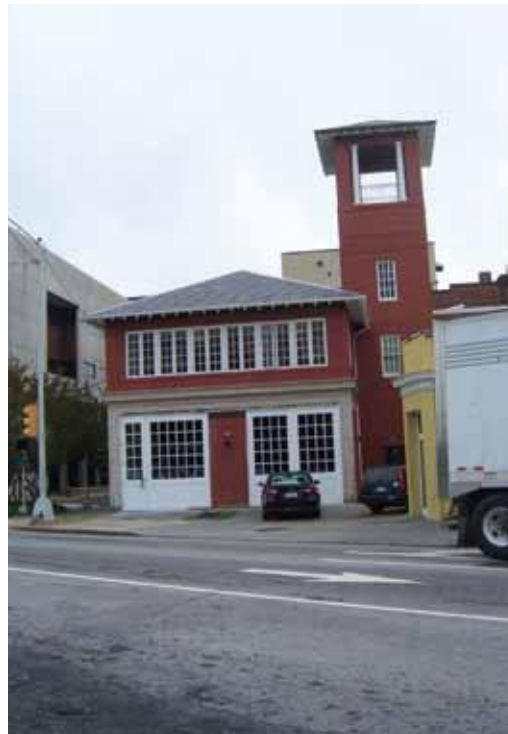
68

[68-69] A geothermal system, evidenced by a panel in the sidewalk, was installed on the site of this historic firehouse during rehabilitation.

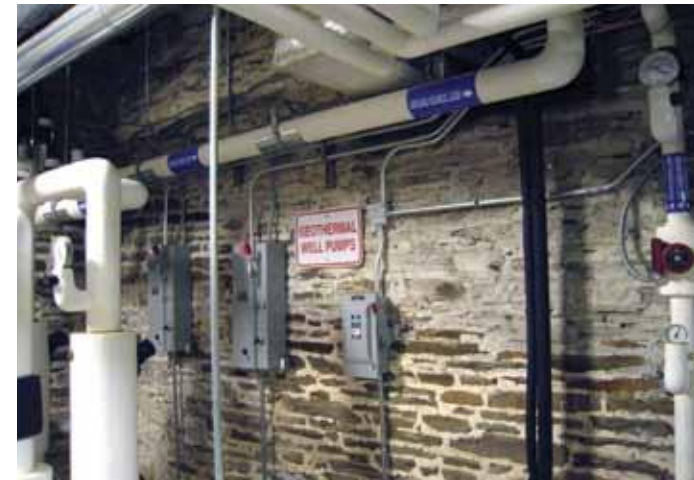
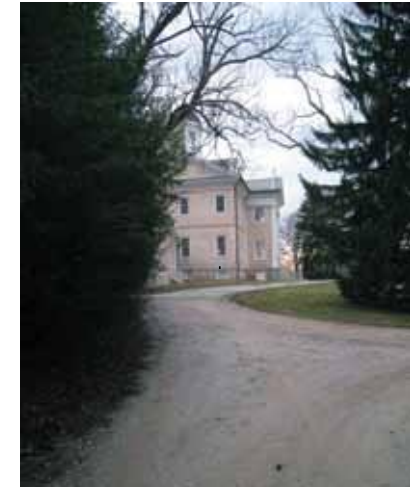
Recommended: [70-71] A geothermal system was installed on the property of this historic mansion, but only after an archeological investigation was conducted of the grounds.

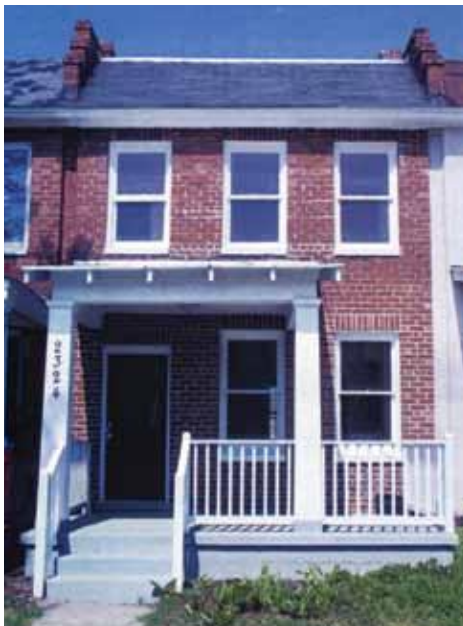
73

Recommended: [72-73] Solar panels were installed appropriately on the rear portion of the roof on this historic row house that are not visible from the primary elevation.

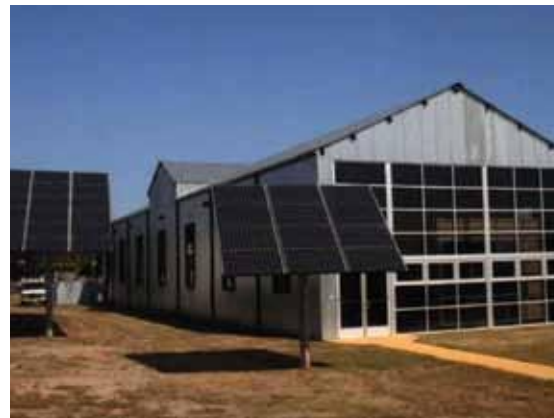
74

Recommended: [74] Free-standing solar panels have been installed here that are visible but appropriately located at the rear of the property and compatible with the character of this industrial site.

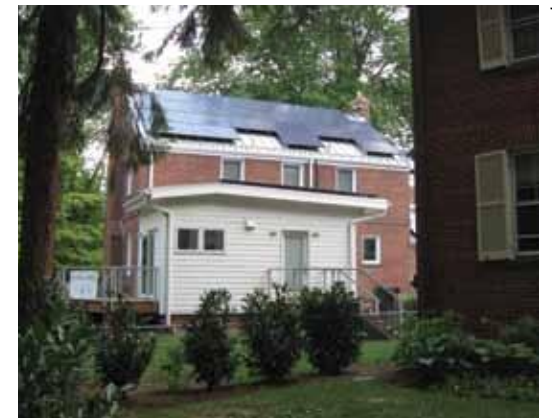
75

Not Recommended: [75] Solar roof panels have been installed at the rear, but because the house is situated on a corner, they are highly visible and negatively impact the character of the historic property.

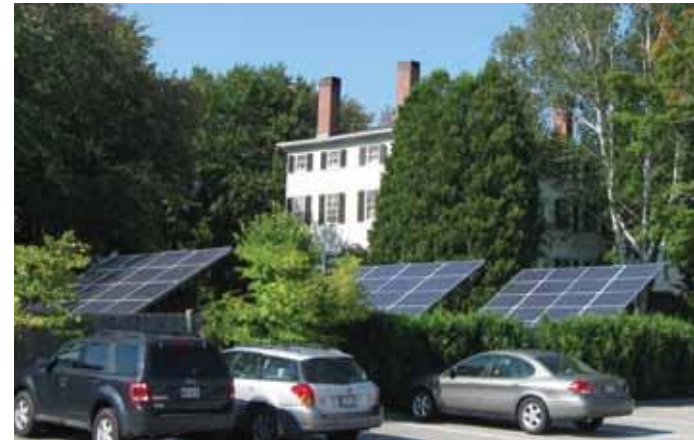
79

Not Recommended: [79] Although installing solar panels behind a rear parking lot might be a suitable location in many cases, here the panels negatively impact the historic property on which they are located.

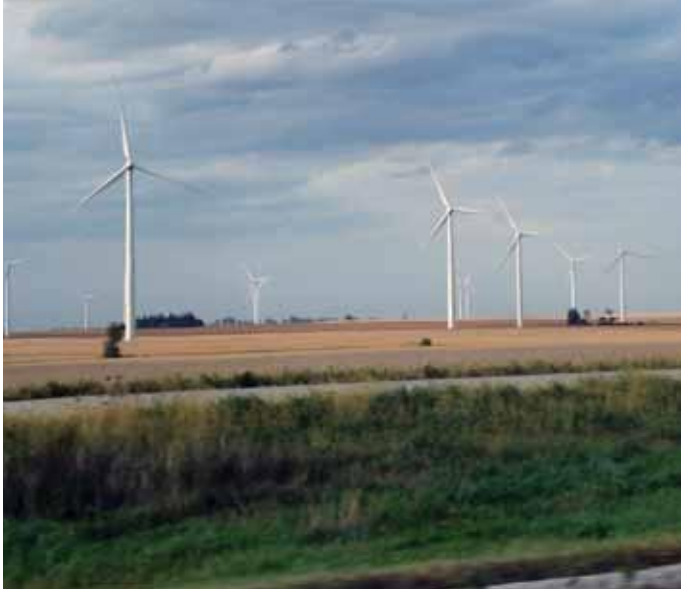
80

Recommended: [80] It is often best to install wind-powered equipment in off-site, rural locations to avoid negatively impacting a historic building and its site.

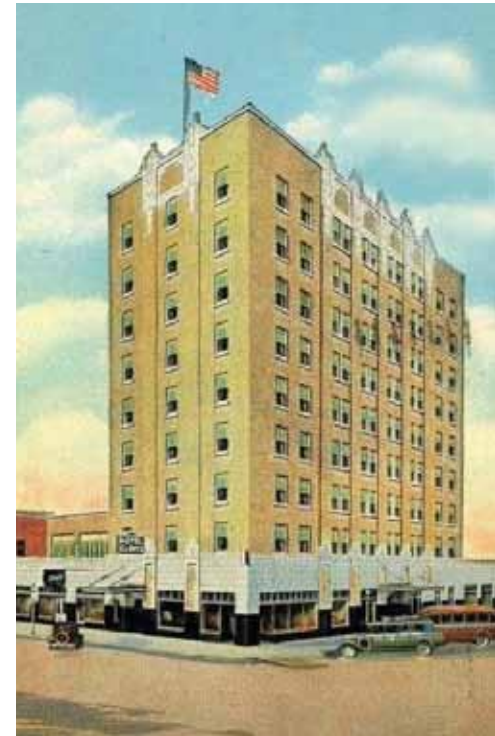
Not Recommended:
 [83-84] This historic hotel is a prominent and highly visible local landmark, and the wind turbines proposed to be added on the roof would negatively impact its historic character.

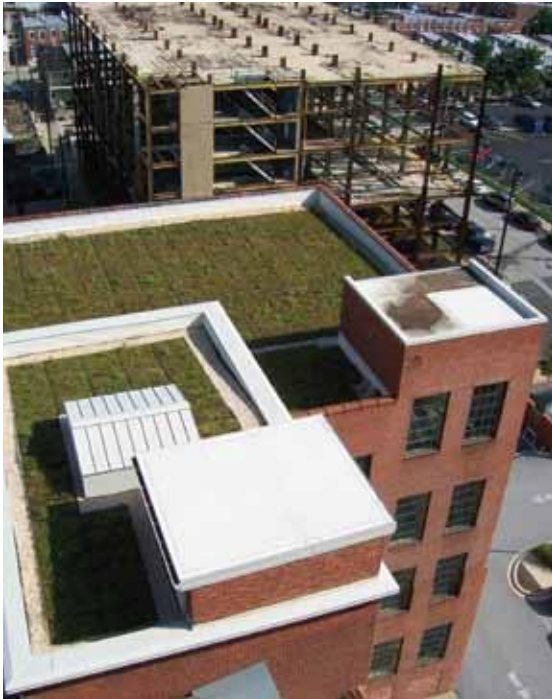
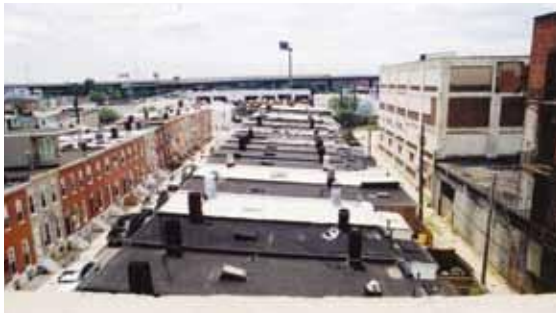
Recommended: [85-86] A cool or green roof is best installed on a flat roof where it cannot be seen from the public right of way and will not negatively impact the character of the historic building.

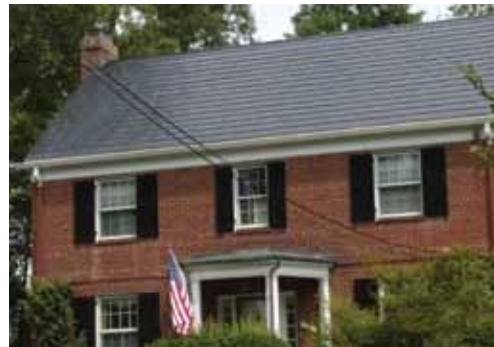
87

Not Recommended: [87] Historic roofing materials in good condition should be retained rather than replaced with another material perceived as more sustainable, such as, in this case, solar roofing shingles.

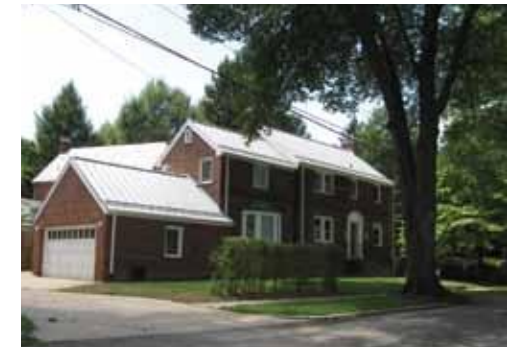
88

Not Recommended: [88] This new, cool white metal roof is not an appropriate material or color for this historic mid-20th century house.

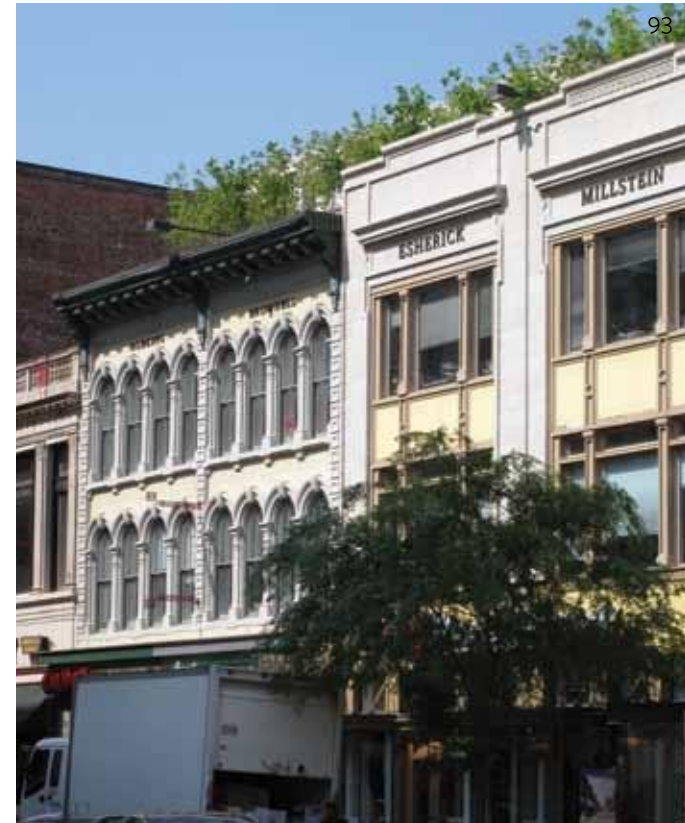
93

Not Recommended: [93] The vegetation on these green roofs has grown too tall and negatively impacts the character of these historic commercial buildings.

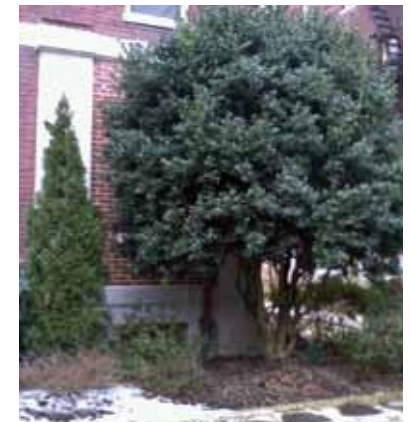
97

Not Recommended: [97] This tree, which was planted too close to the building, has caused the masonry wall to retain moisture that damaged the mortar and required that the brick be repointed in this area.

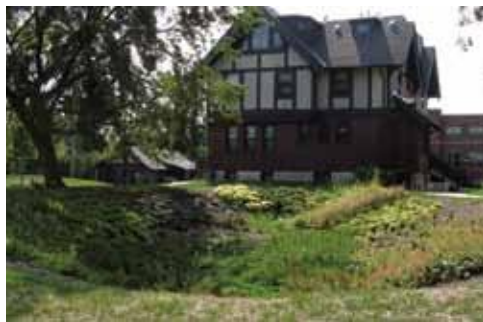
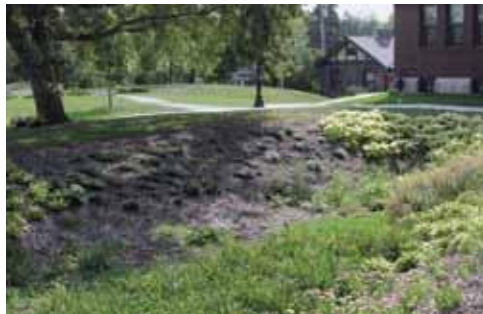
Recommended: [98-100] Rain gardens and rain-water collection tanks are features that may be added to a historic property to improve storm-water management and increase on-site water use.

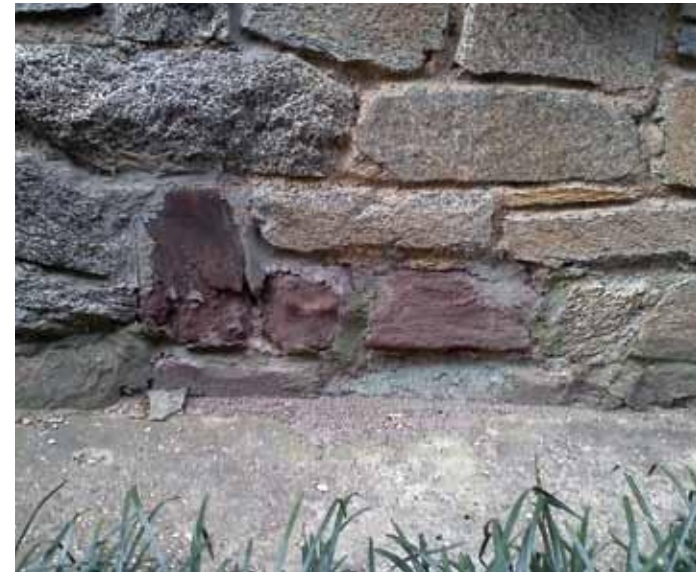
101

Not Recommended: [101] Splash back from the impermeable concrete paving next to the foundation is damaging these stones.

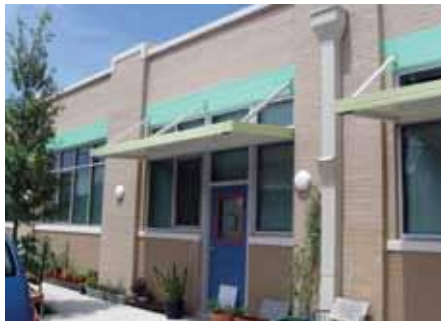
107

Recommended: [107] Traditional canopies compatible with the industrial character of this former factory building were installed when it was converted for residential use.

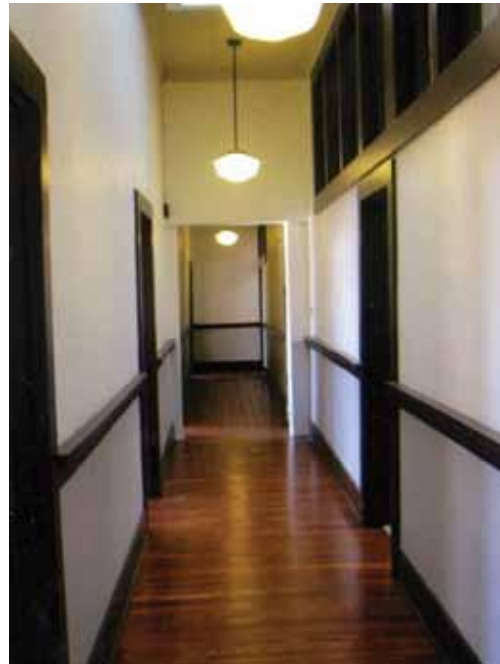
108

[108-109] The original, partially-glazed doors and office partitions, as well as skylights, that let natural light into the corridors were retained as part of the rehabilitation of this early-20th century building.
