UNDERSTANDING LITTLE TRAVERSE LAKE WATERSHED RESPONSES DURING RAIN EVENTS MARCH - APRIL 2026

This supplemental report is intended to provide a summary of watershed responses observed during April 2026 as well as historical documentation of watershed impacts that were experienced by property owners. This summary is intended as a supplement to a previous report: “Understanding Little Traverse Lake Watershed Responses to Rain Events Fall 2024 – Spring 2025 & Fall 2025 – Winter 2026”, which provides additional data, background and relevant discussion related to watershed responses leading up to April 2026. That report is referenced as the “February 2026 report” and covered watershed responses Fall 2024-Spring 2025 with the inclusion of a supplemental “March 2026 report” covering Fall 2025-Winter 2026 watershed responses.

David Skjaerlund, PhD April 2026

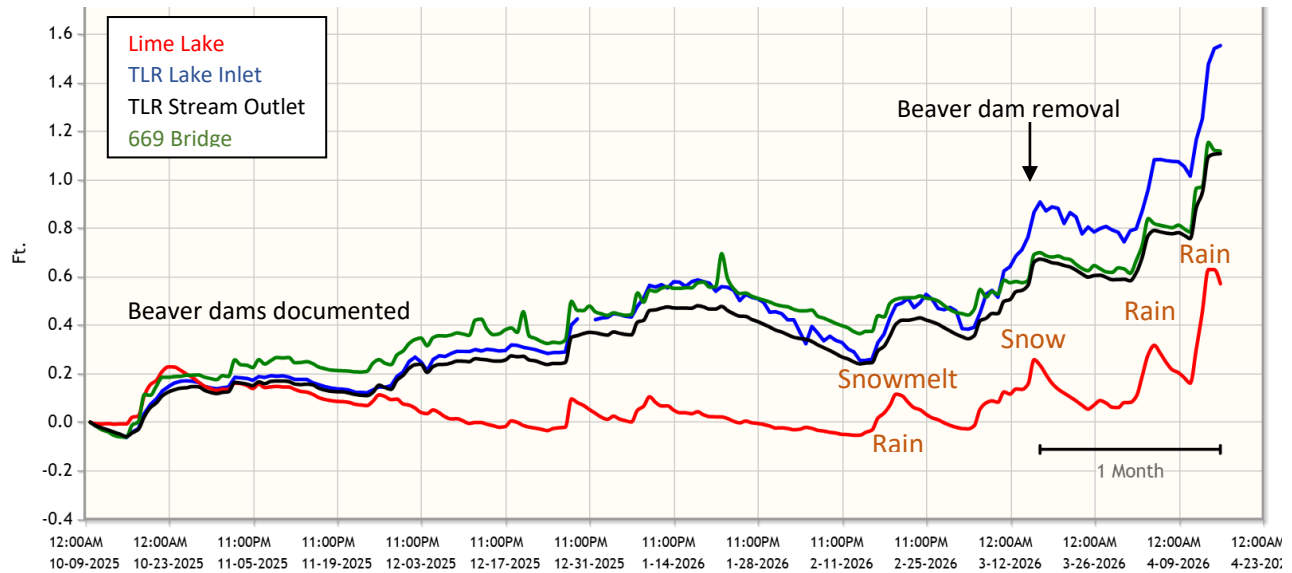
AN OVERVIEW OF WATERSHED RESPONSES FALL 2026 – SPRING 2026

The combination of precipitation events raised the water level across all four measurement points in the watershed. Lime Lake rose and properties were impacted with high water levels. Shalda Creek levels elevated with water rising to the bottom of 669 Bridge. LTL levels reached one of the highest levels observed, approaching 595.45 at the TLR Lake Inlet. Extensive shoreline breaching was observed with extensive flooding that impacted properties, including accessory buildings, foundational crawl spaces and some basement spaces (see images towards the end). Septic systems of properties in lower areas have the potential for impacts as well. Levels were one inch lower in 2014 during the last extensive flooding with both beaver dams and significant rain events.

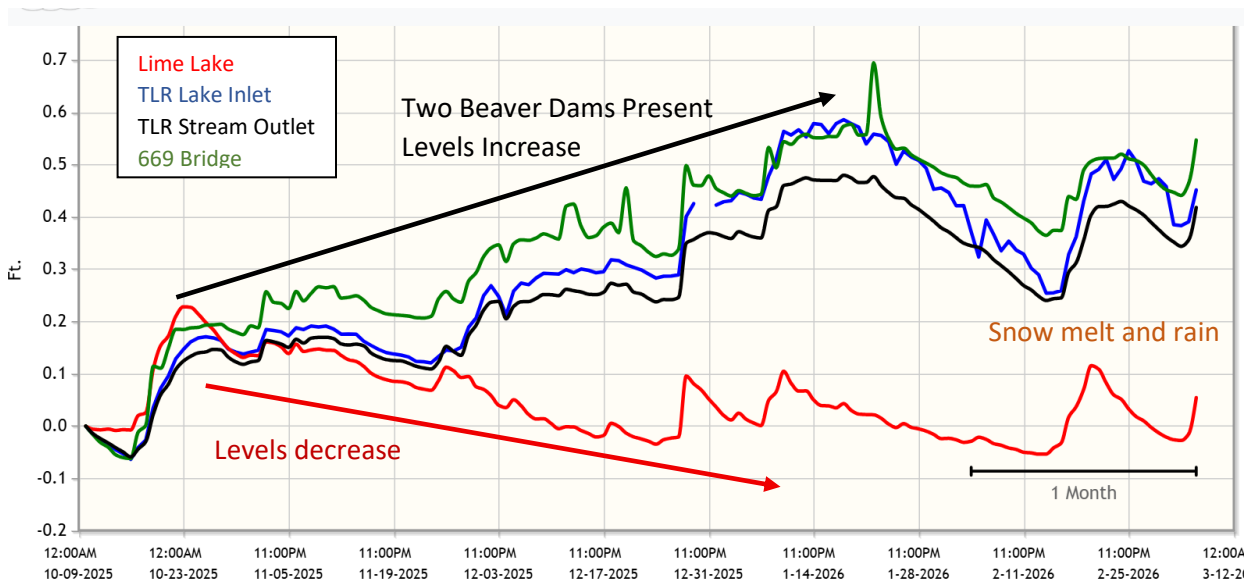
CLOSER LOOK AT WATERSHED CONDITIONS PRIOR TO SPRING PRECIPITATION EVENTS

As discussed in more detail in the previous March 2026 supplemental report, two beaver dams (Tweener Dam and Fish Camp Dam) were discovered in Fall 2025 and were pulled the morning of March 14, 2026. During the winter, Shalda Creek levels at CR 669 Bridge and at TLR Stream Outlet as well as LTL levels as measured at TLR Lake Inlet

all continued to increase over winter while Lime Lake lowered back to lower pre-fall levels. On January 25, 2026, Shalda Creek level at 669 Bridge was 0.5' (6.6") higher, Shalda Creek level at TLR Stream Outlet was 0.5 (6.0") higher, and LTL level (TLR Lake Inlet) was 0.6' (7.2") higher – as compared to October 10, 2025 levels. Lime Lake had lowered back to the same level (0" difference).

Prior to the start of the spring precipitation events (24" snow storm plus 6.0" rain events), watershed levels on March 6, in comparison to October 10, 2025, were the same (0" difference) for Lime Lake while LTL (TLR Lake Inlet), Shalda Creek at TLR Stream Outlet, and Shalda Creek at 669 Bridge were 0.5' (6.0"), 0.4' (4.8") and 0.5 (6") higher respectively. Shalda Creek and Little Traverse Lake was roughly 6" higher at the start of the rain events in comparison to Lime Lake, relative to the watershed's lower levels on October 10, 2025. The bathtub had increased and remained full over the winter instead of draining due to the presence of beaver dams. Thus, LTL and Shalda Creek levels were already elevated heading into spring rain events. Having additional bathtub capacity to absorb spring rain events minimizes the extent of high water levels and related flooding. Beaver dam maintenance in Shald Creek, especially with it's gradual slope, is essential for watershed management to ensure natural flow conditions without restrictions or elevating water levels unnecessarily. The previous February 2026 report provides additional documentation of a beaver dam downstream 669 Fall 2024-Spring 2025 creating the same watershed scenario – rising water levels through out winter that then were higher at time of significant spring rains. The Fall 2024-Spring 2025 scenario has been repeated again in Fall 2025-Spring 2026, and more.

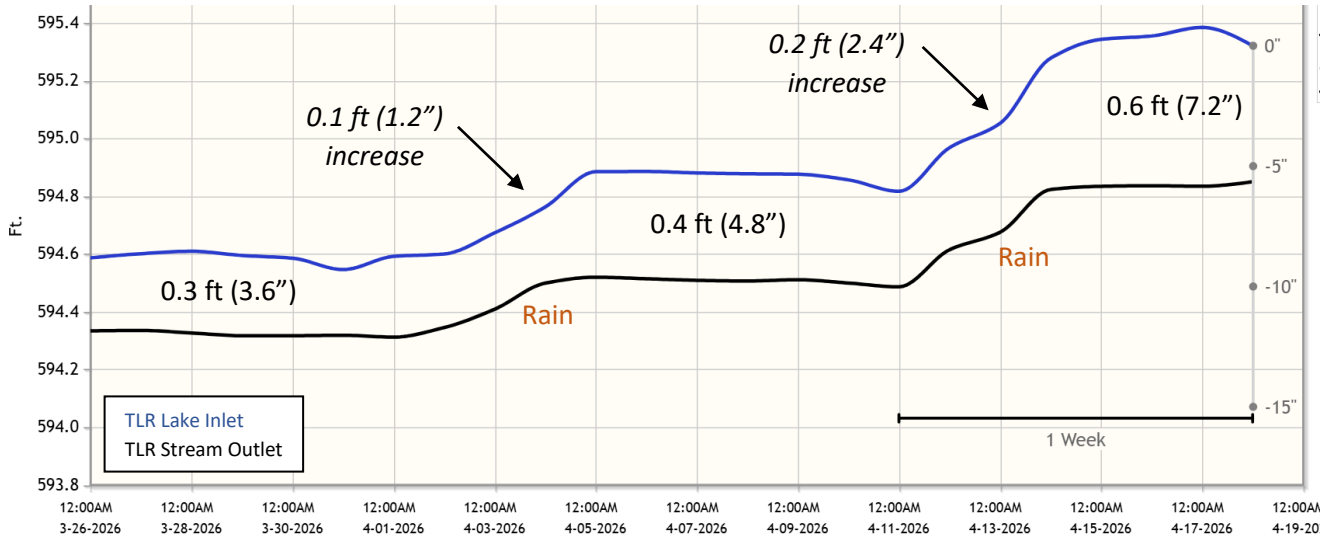
CHANGES IN CULVERT INLET-OUTLET DIFFERENTIAL WITH RAIN EVENTS APRIL 2026

Water levels are measured on the eastern TLR Lake Inlet side and the western TLR Stream Outlet side of the TLR culvert. The difference between the two is known as the culvert inlet-outlet differential. As LTL water levels (TLR Lake inlet) increase, the culvert inlet-outlet level increases proportionally in a linear fashion. The culvert inlet-outlet differential nearly doubles as water levels increase from 594.7 (0.35') to 595.5 (0.65'). The culvert inlet-outlet differential increased approximately 2" above 595.0, which is considered flood stage with significant shoreline breach of water. At this level, the additional 2" creates even more water problems. This is another reason why it is important to keep LTL levels as low as possible before heading into spring rains, allowing the

bathtub capacity to absorb the rain events before reaching high water levels. Thus, the culvert inlet-outlet differential does not become as much of a factor if levels are kept below 595.0 or even below 594.7.

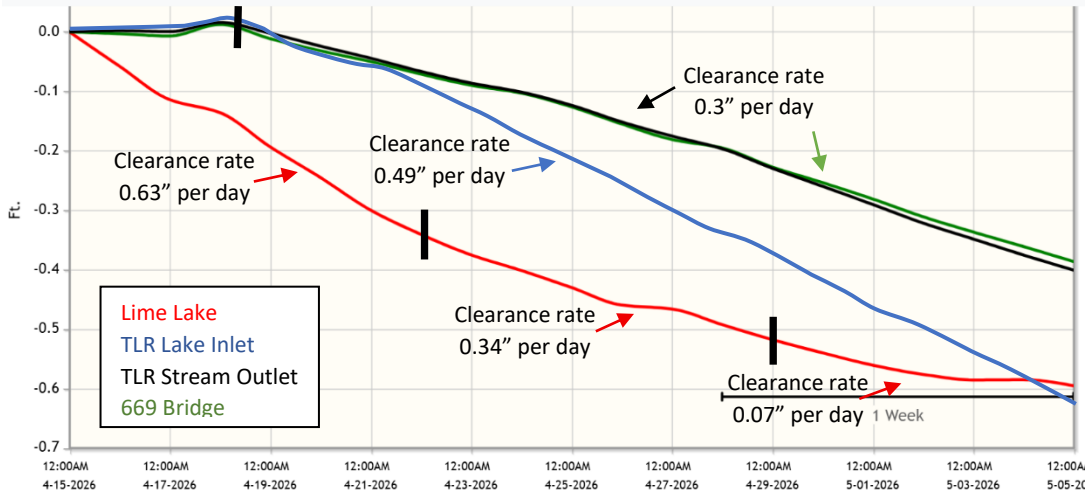
WATERSHED CLEARANCE RESPONSES AND CLEARANCE RATES AFTER APRIL 2026 RAIN EVENTS

Water levels did not continue to increase after rains ended early April 15. As observed across Michigan’s lower peninsula, flood waters do not recede quickly. With the watershed elevated and saturated with standing water in many places, it takes time to clear water from the watershed. After the end of rain, Lime Lake levels began to decrease as water was cleared through the Shetland Creek outlet. Between April 15 and May 5, Lime Lake levels dropped 0.6’ (7.2”) while LTL levels decreased 0.68’ (8.16”) at TLR Lake Inlet. LTL levels were dropping while also clearing out all the inflow of water from the watershed, including all the water from Lime Lake. During this time, Shalda Creek dropped 0.42’ (5.0”) at both 669 Bridge and TLR Stream Outlet, a smaller decline due to significant water standing in the Shalda Conifer Swamp and associated bottlenecks. All levels returning to March 15 levels.

Water levels plateaued initially (four days) in Shalda Creek at 669 Bridge and at Shalda Creek TLR Stream Outlet as well as for LTL at TLR Lake Inlet. Water must first be cleared out from the elevated levels of Shalda Creek and the surrounding areas downstream. Shortly thereafter, water levels began to decrease for Shalda Creek at both locations as well as LTL levels at TLR Lake Inlet as water is cleared from Shalda Conifer Swamp. The rate of decrease in LTL levels accelerated with additional decline in Shalda Creek, the slowing of watershed inflow, and a proportional decrease in the culvert inlet-outlet differential with lowering water levels. The culvert inlet-outlet differential decreased 3” as water levels decreased from 595.45 to 594.85. After the initial plateau, the clearance rates for LTL (0.49” per day) matched or exceeded the rates observed for Lime Lake (maximum clearance rate observed: 0.63” per day for first week). This pattern is consistent for what was observed April 2025 after rain events ended (LTL levels reached 595.1) that was described at length in the February 2026 report.

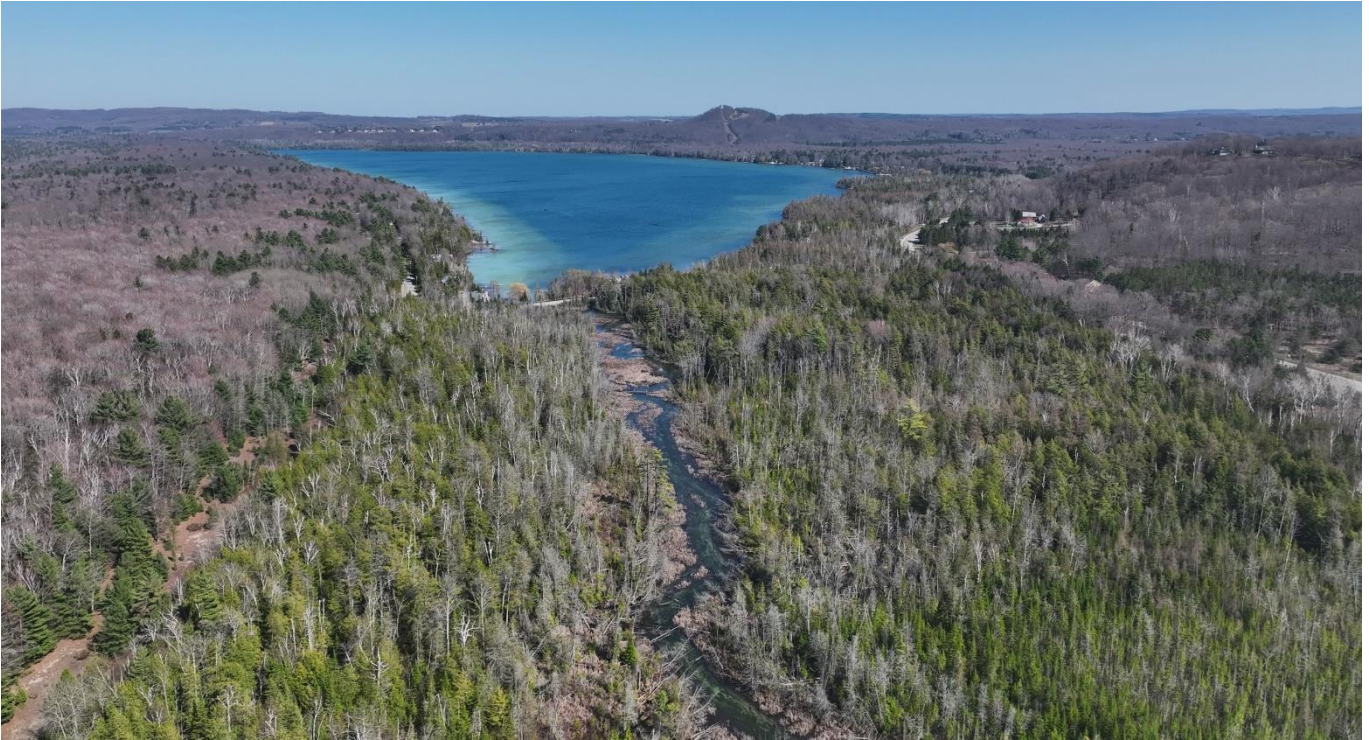
Eastward view from 669 Bridge, Little Traverse Lake and headwaters of Shalda Creek

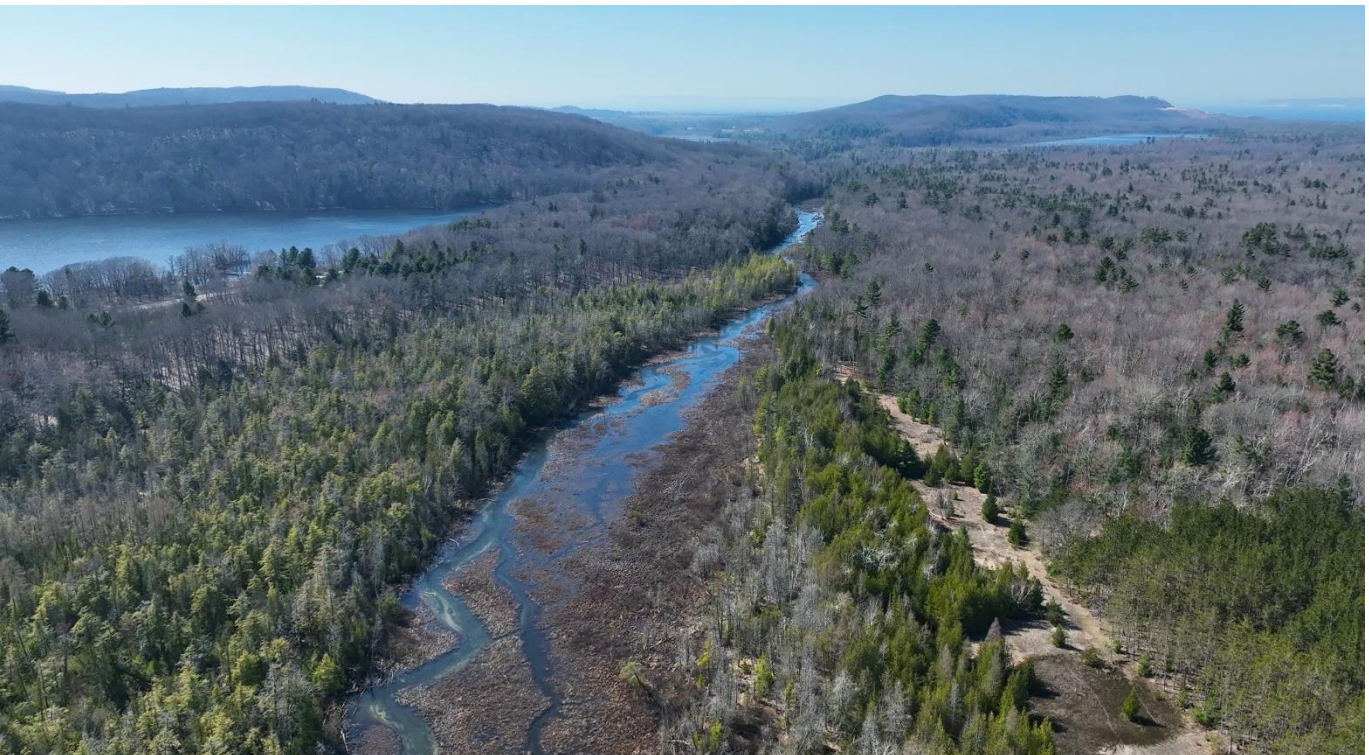
Westward view from 669 Bridge, Shalda Conifer Swamp

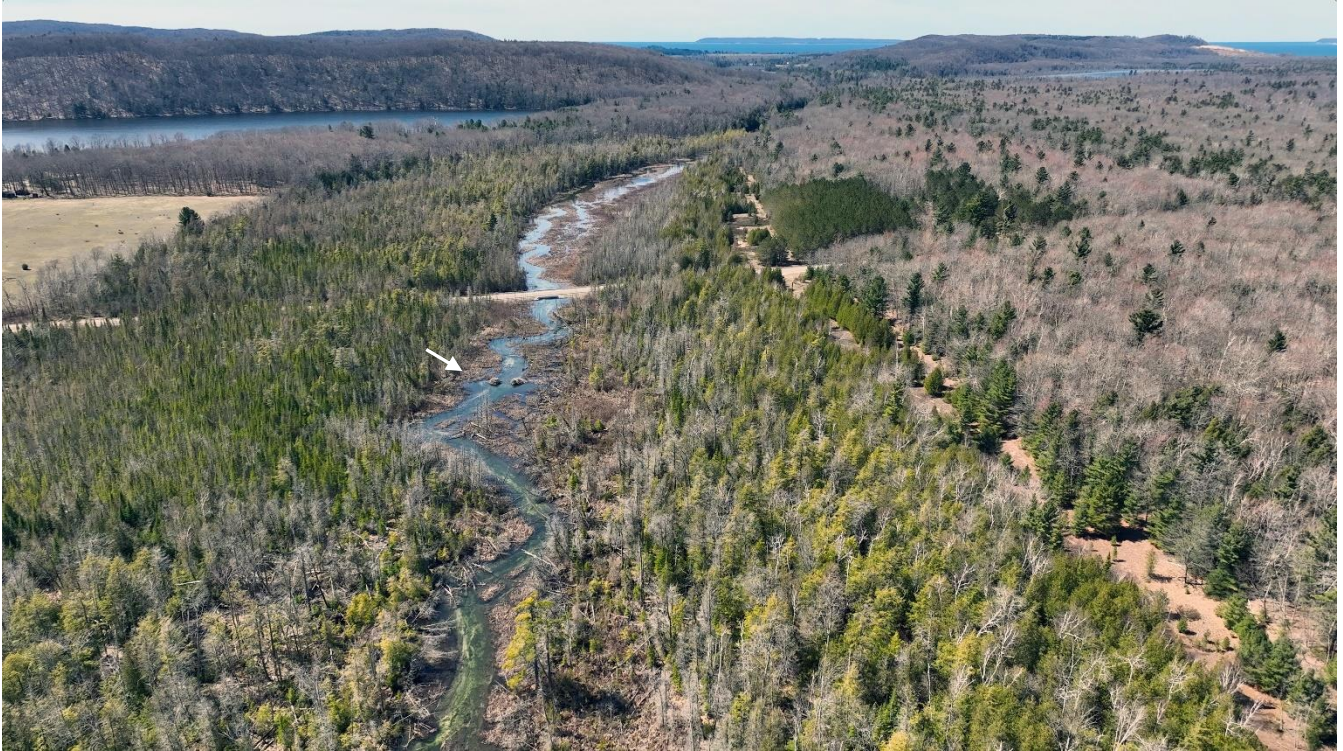
Westward view of the central portion, 669 Bridge, and Tweener Dam

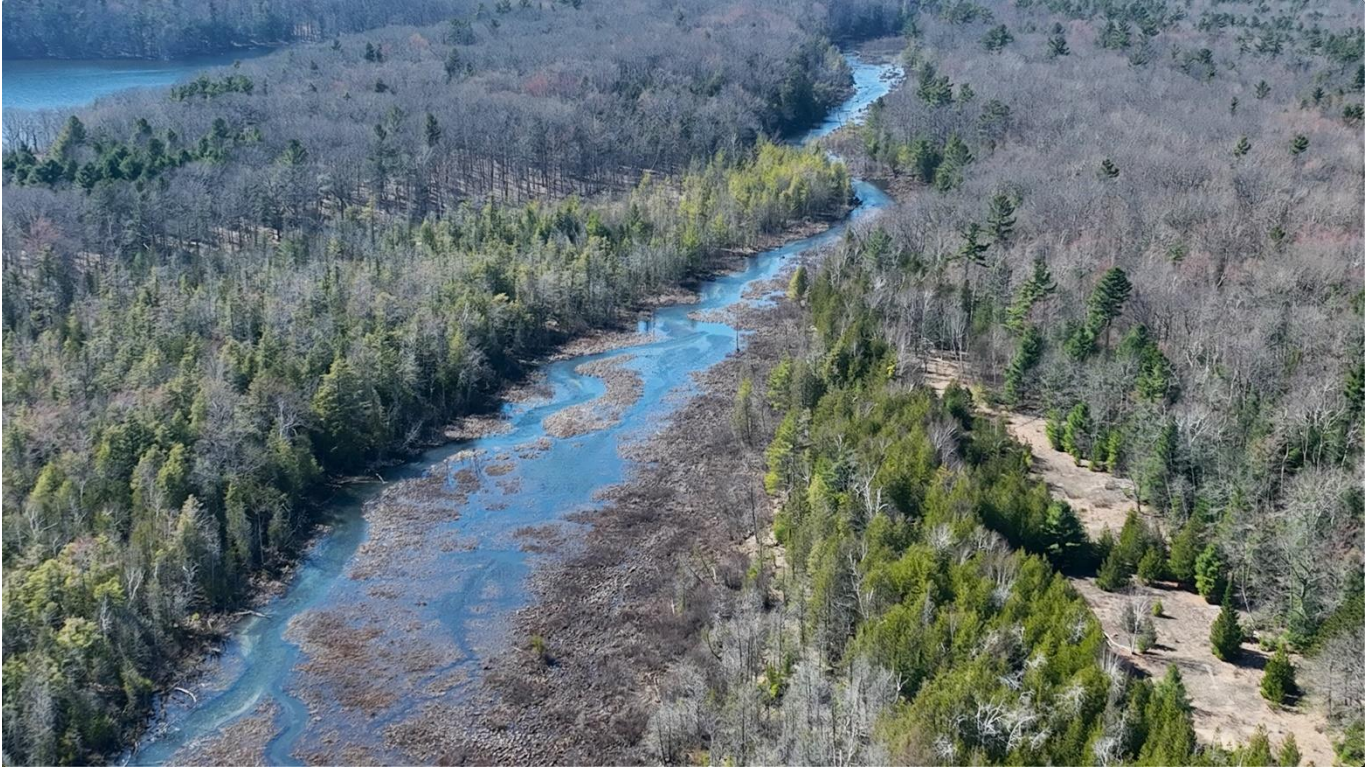
Shalda Conifer Swamp and the first narrowing upstream of 669 Dam, low gradual slope

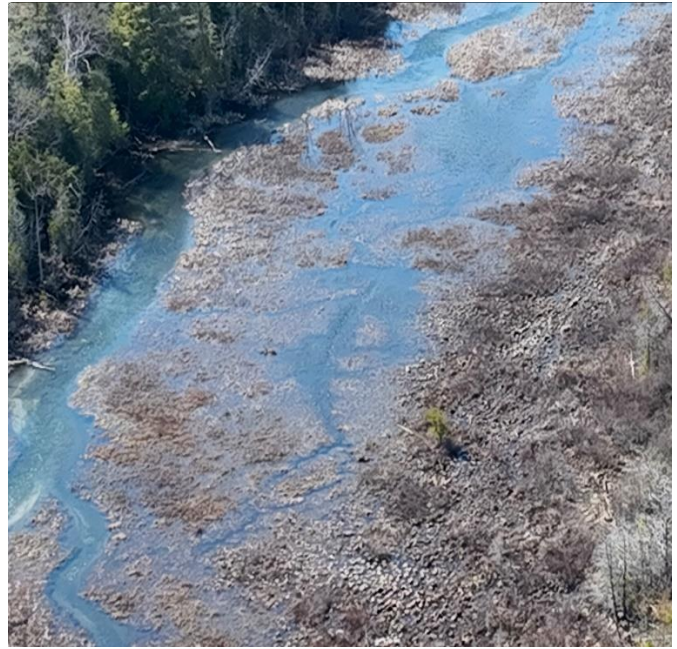
Standing water in watershed, slow gradual slope

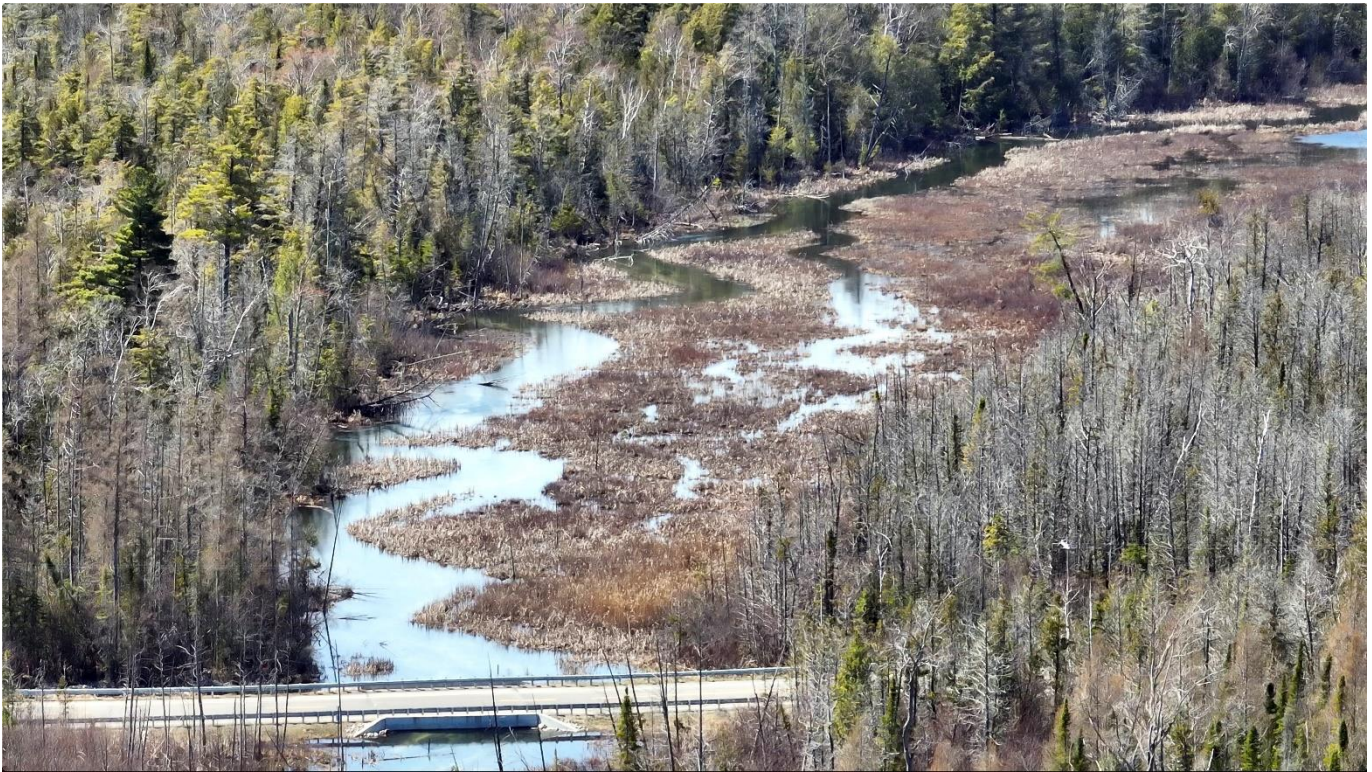
Westward view downstream of 669 Bridge, note the flat gradual slope and standing water

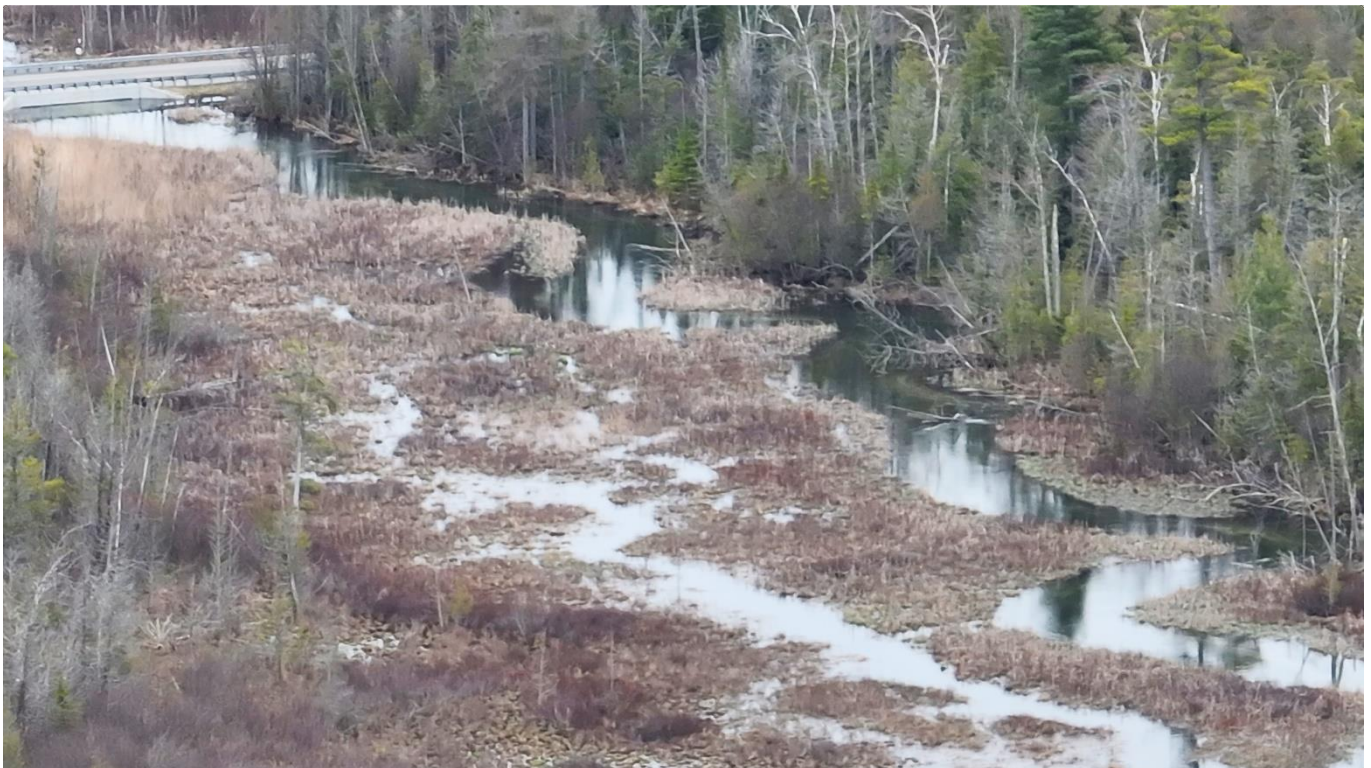
Eastward view downstream of 669 Bridge, note the flat gradual slope and standing water up to 669 Bridge

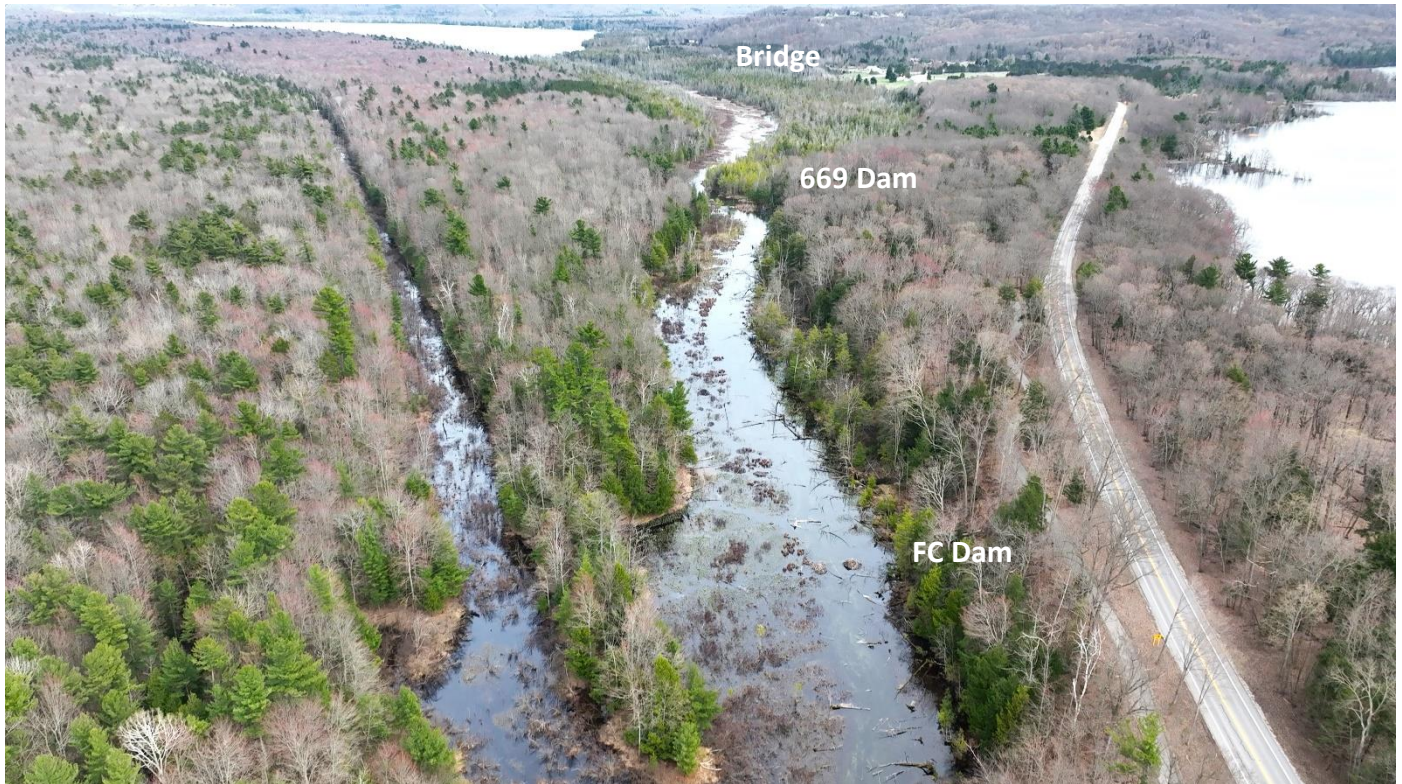
Eastward view towards LTL from Y intersection of Shalda Creek (right) and Juniper Drain (left)
Locations of Bridge ("B"), 669 Dam ("669") and Fish Camp Dam ("FC" noted)

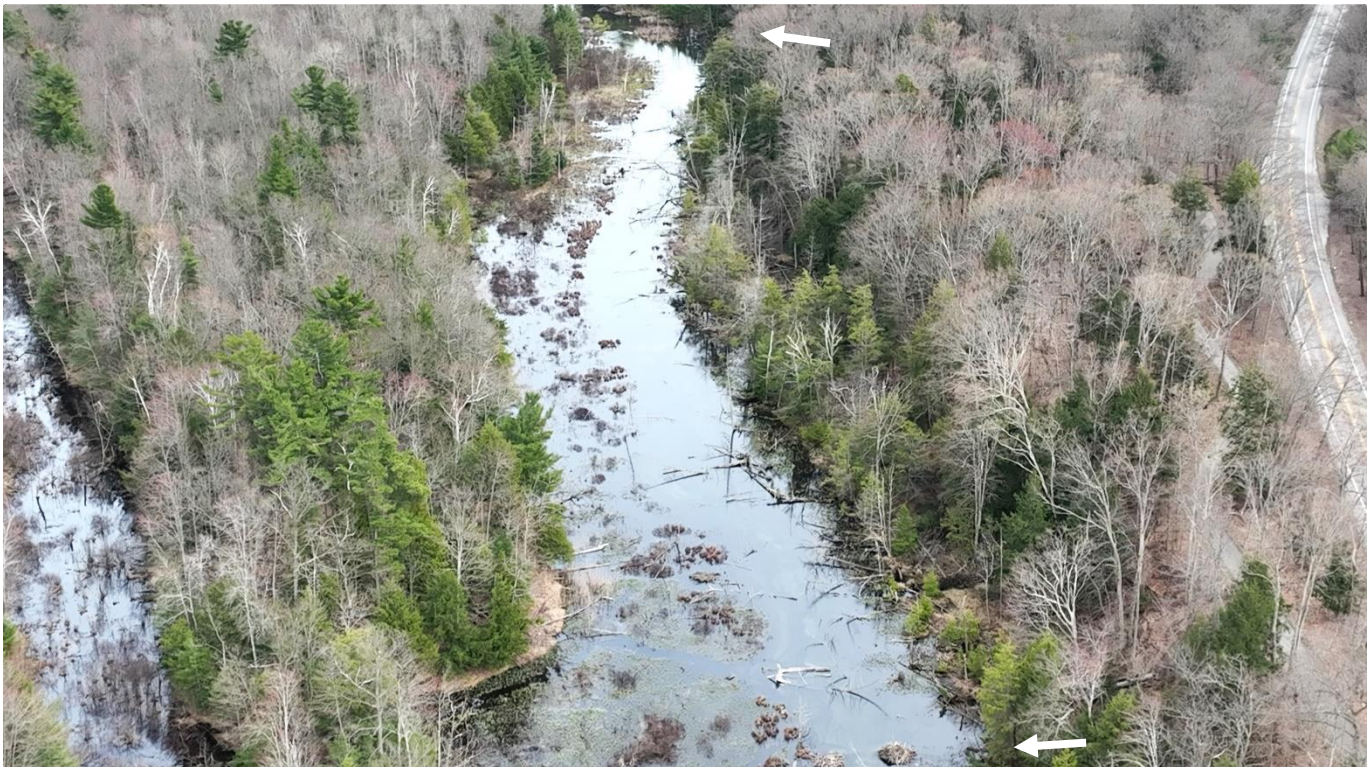
Closer view of section between Fish Camp Dam (bottom downstream) and 669 Dam (top, upstream)

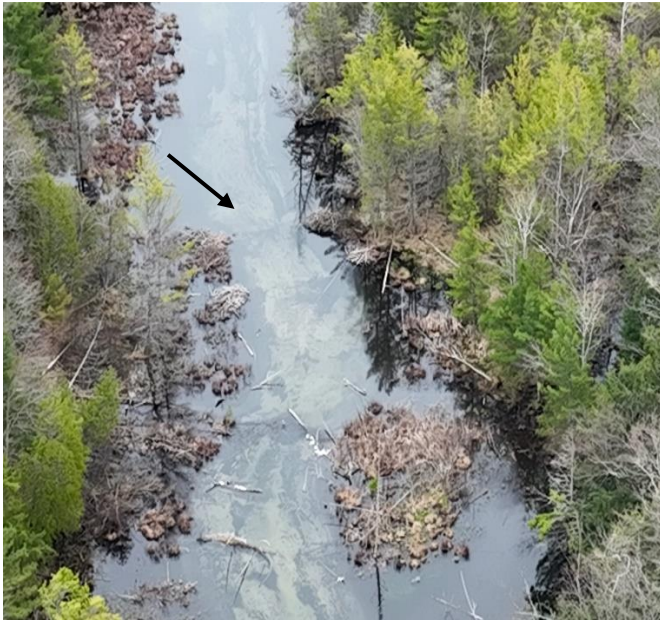
Closer view of 669 Dam area

Observation note: At these high flood water levels, the beaver dam areas have become overwhelmed with water. Potential beaver dams are not a restricting factor at this floodwater stage with dams removed March 14, 2026 and flood water submerging the adjoining wetland areas around the dam debris piles (from prior removals) that are observed in the photos. The presence of dams at Tweener Dam and 669 Dam are not as subject to being overwhelmed due to narrower stream width.

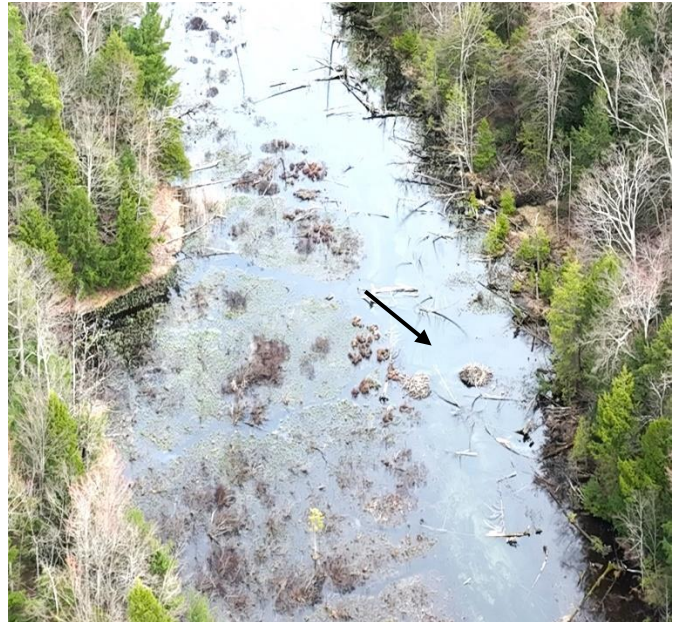
Closer view of Fish Camp Dam area

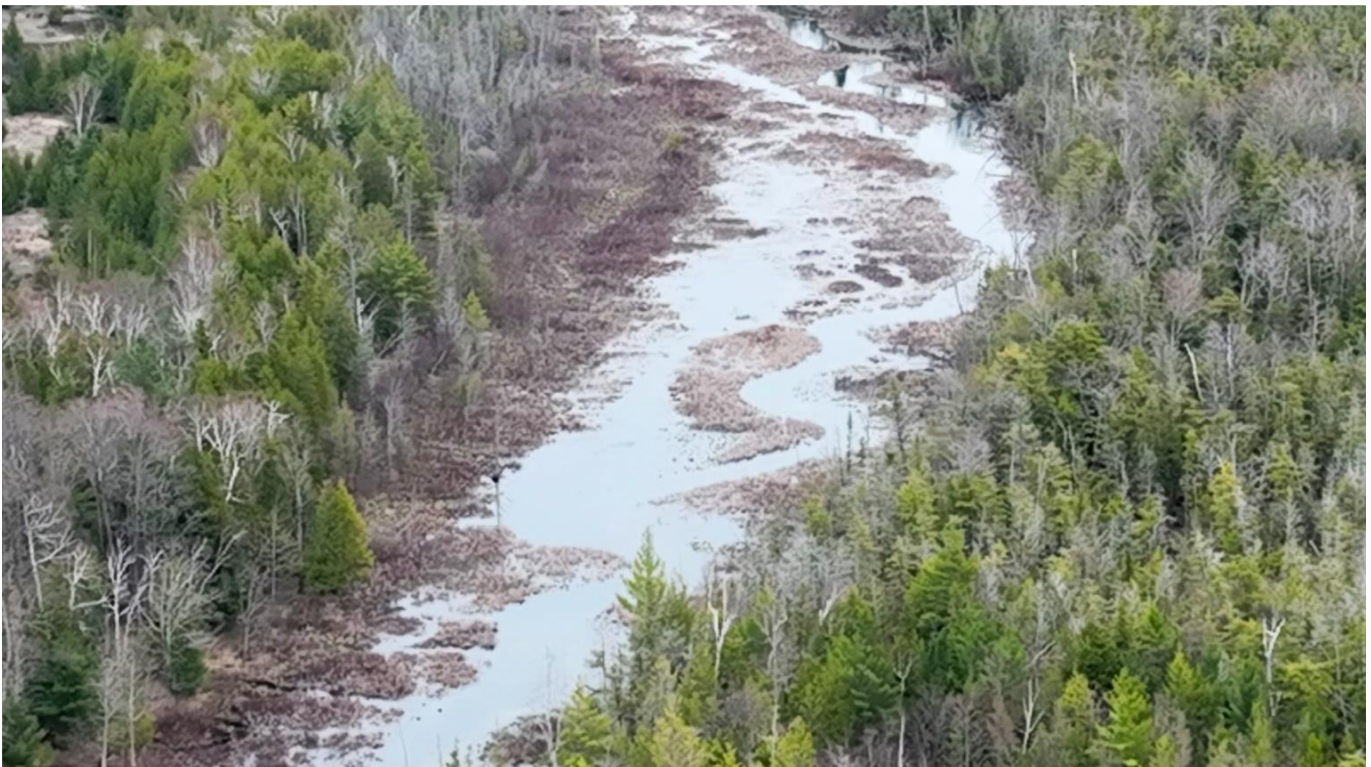
Westward view of Shalda Creek as it approaches 669 Dam downstream

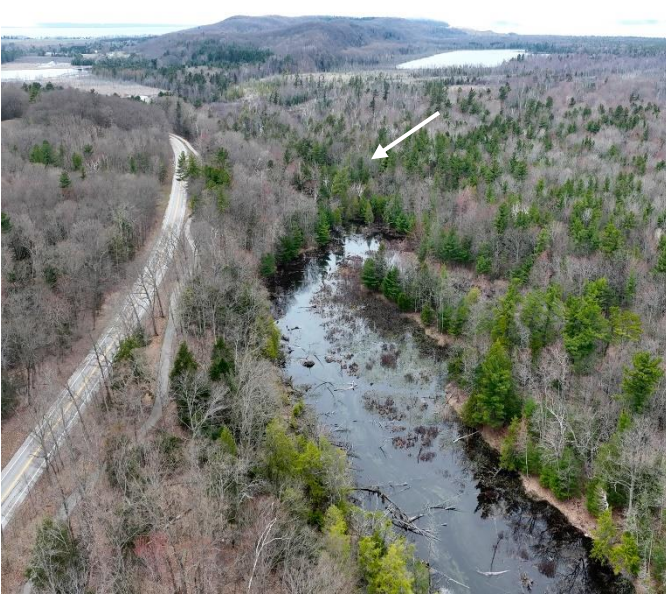
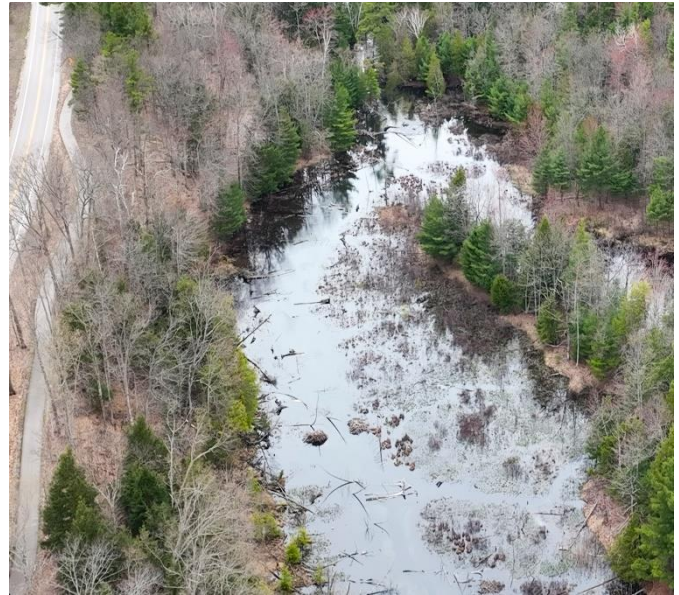
Westward view of “Hardwoods Bottleneck” downstream of Y intersection

Shalda Creek on left, Juniper Drain on right

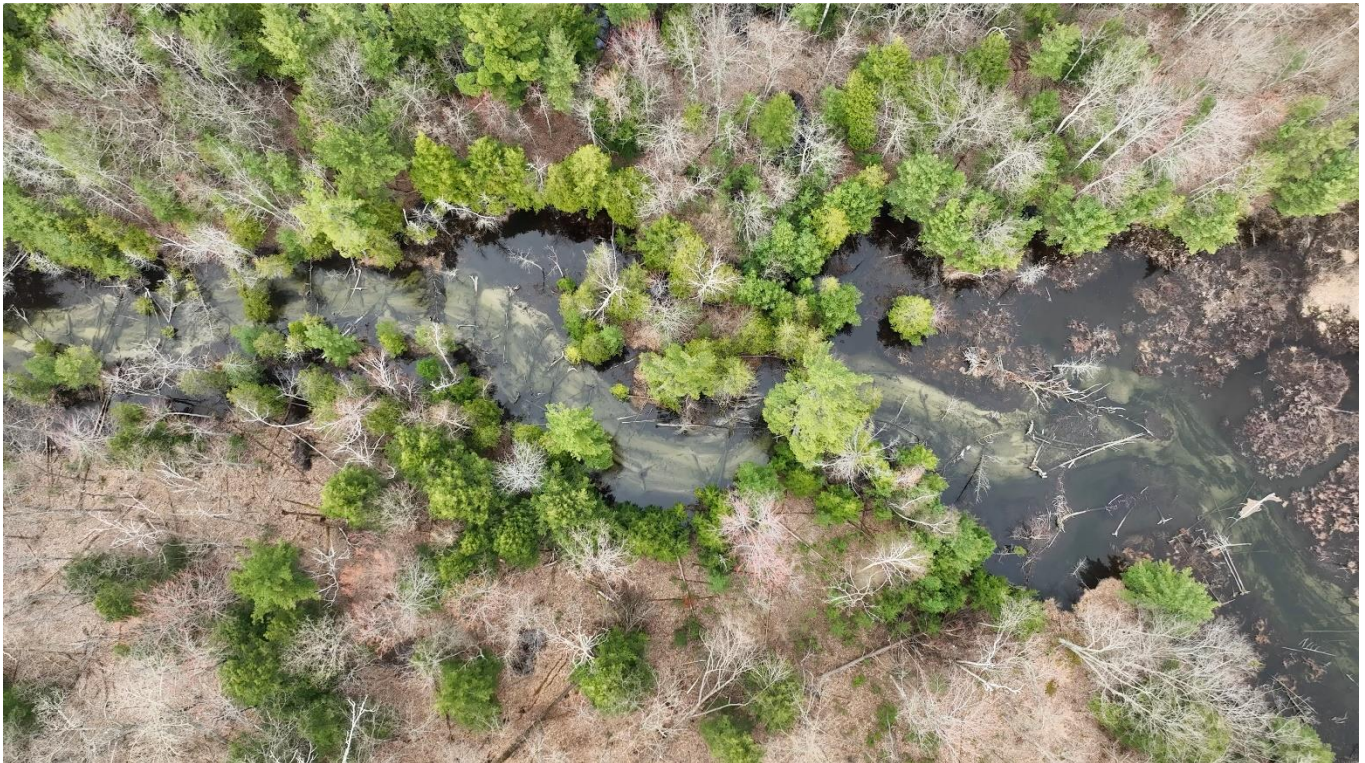
Closer view of “Hardwoods Bottleneck” downstream of Y intersection

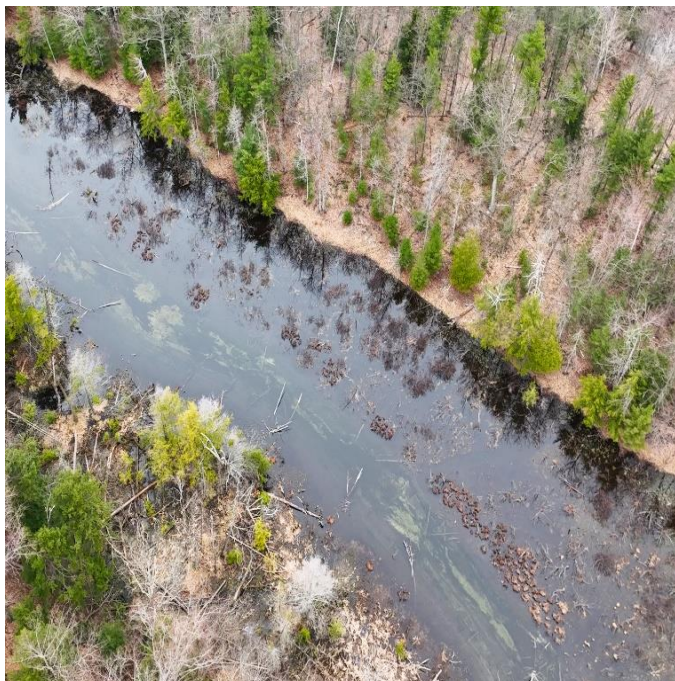
Section between 669 Dam and Fish Camp Dam
Note reflections of trees in water surface

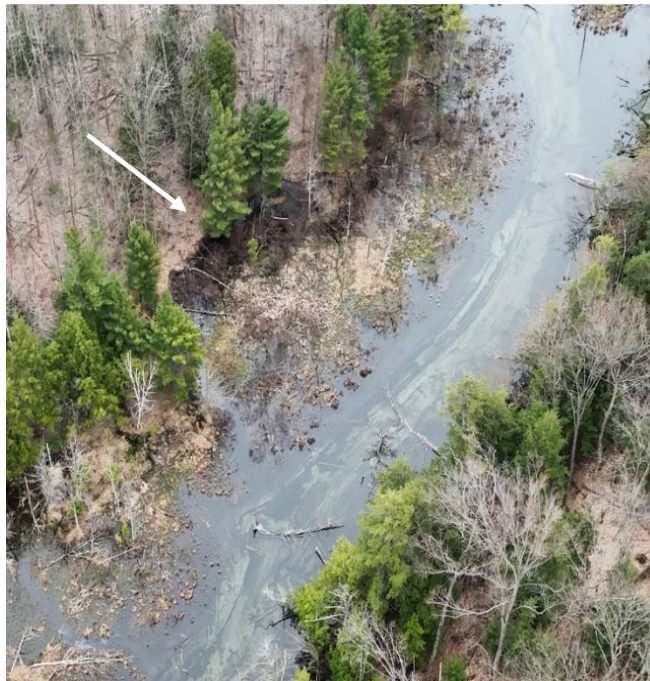
Section of bank collapsing into stream
with all the ground saturation

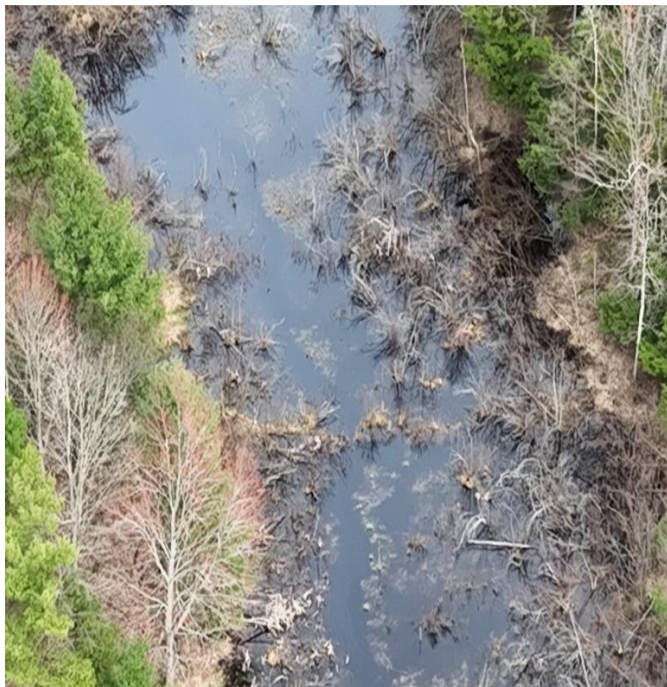
Water in Juniper Drain

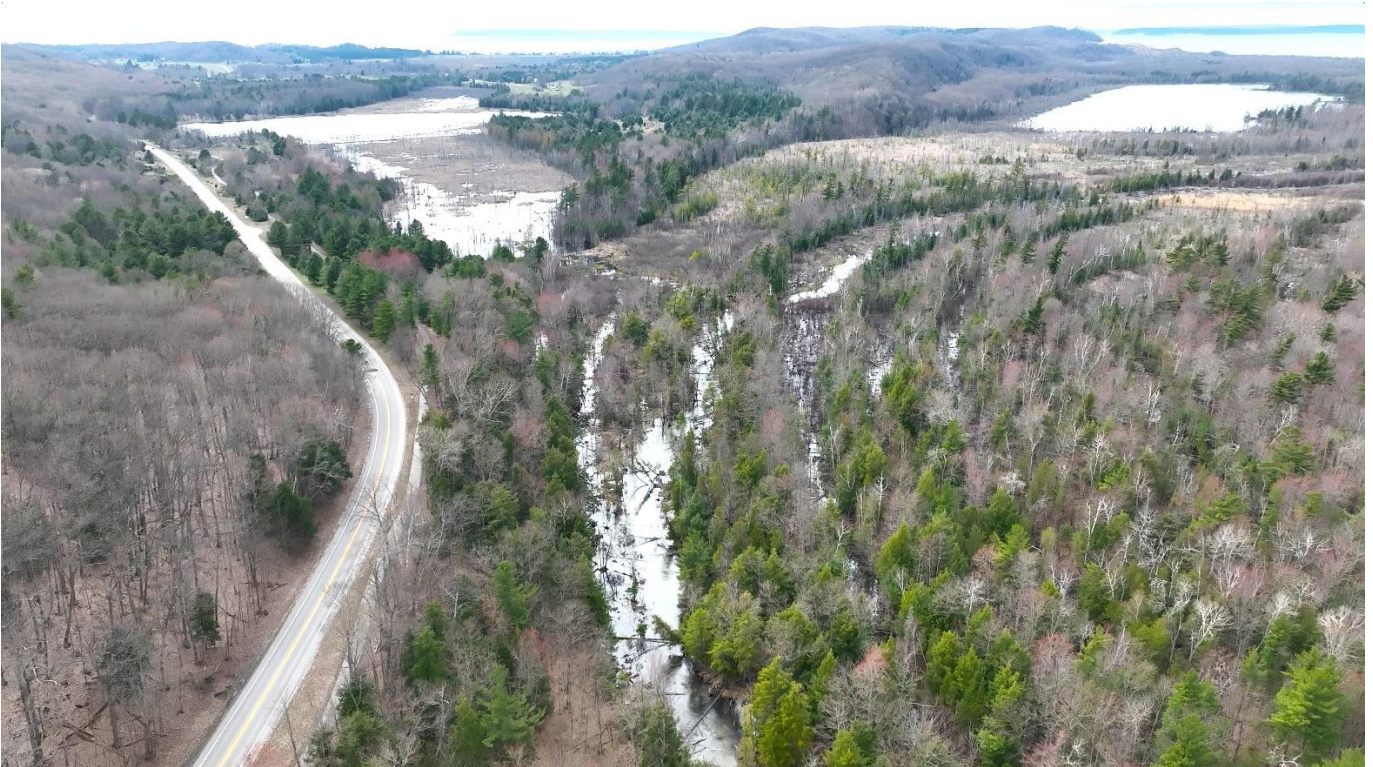
Westward view beyond Hardwoods Bottleneck, standing water in glacial formations, Narada Lake outlet

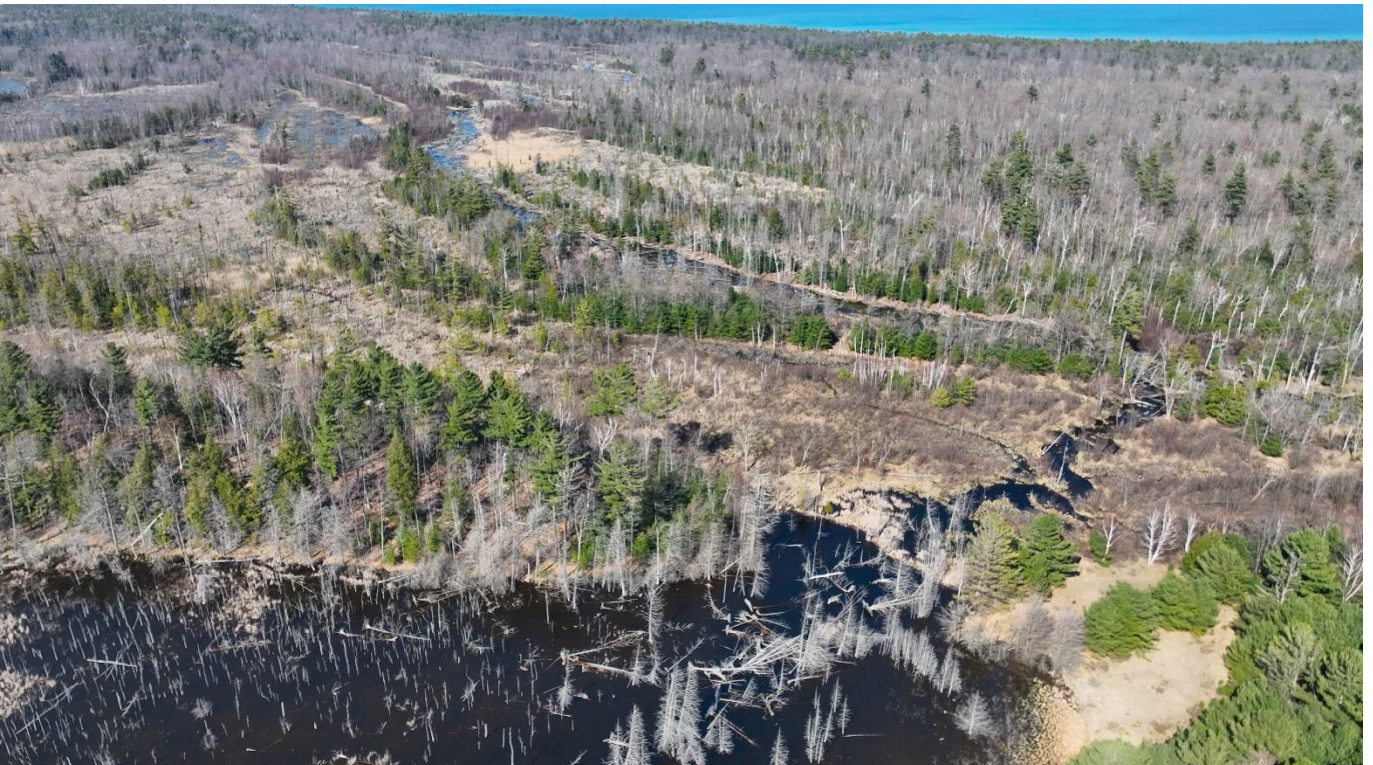
Northward view of Shalda Creek flowing towards Lake Michigan
Narada Lake beaver dam and stream outlet in foreground

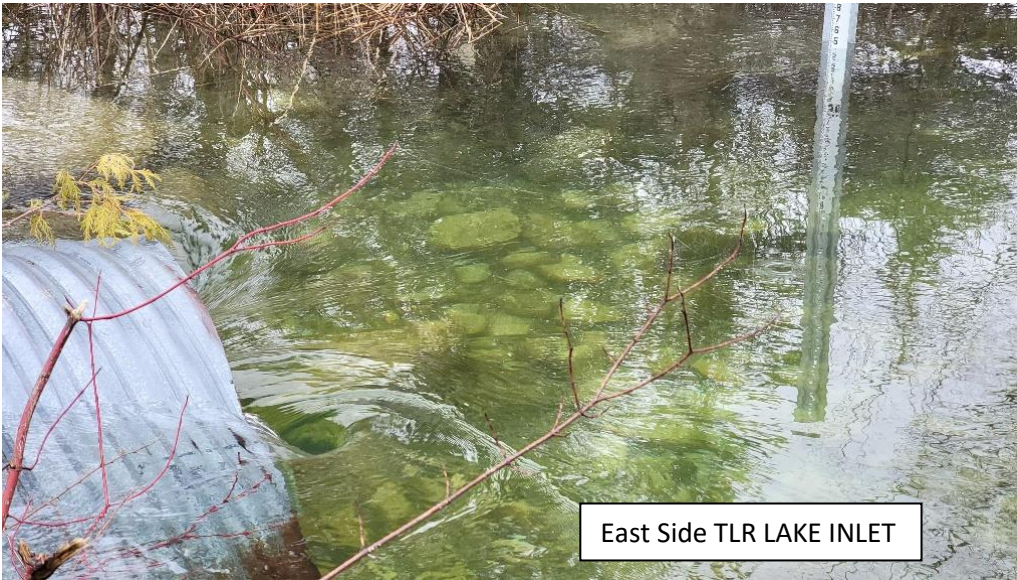
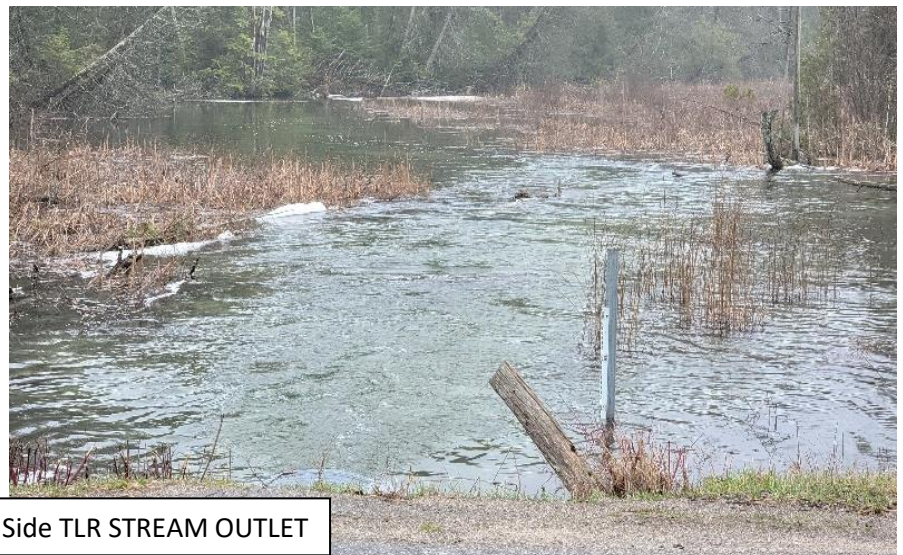
TRAVERSE LAKE ROAD CULVERT

On April 15, 2026, water levels measured at the east side TLR Lake Inlet measuring stick was 595.45 with a 6" air gap from top of culvert. The culvert opening had surrounding water creating an inlet eddy. The water level on the west side TLR Stream Outlet was 594.75 with a 1" air gap. The inlet-outlet differential was 0.7 or 8.4".

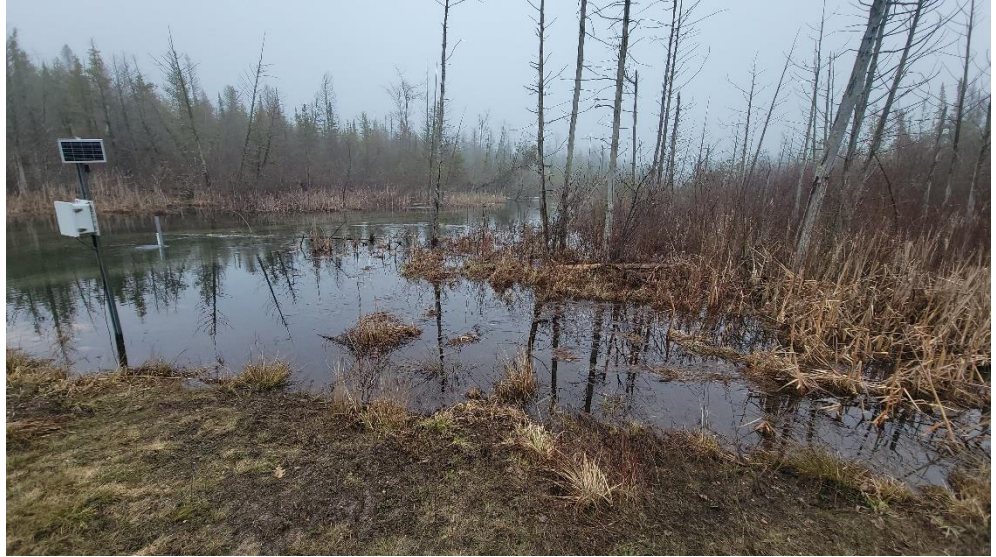
SHALDA CREEK AT CR 669

On April 15, the Shalda Creek water level on the measuring stick at CR 669 Bridge was 594.9. Water was up to the bottom of the bridge with no air gap. Debris was being collected and not passing under. The surrounding water shed areas were saturated with standing water way beyond the banks of Shalda Creek. A difference in surface elevation between the bridge section and the road has appeared over winter.
