IMPROVING TRAVERSE LAKE ROAD SIGHT DISTANCE

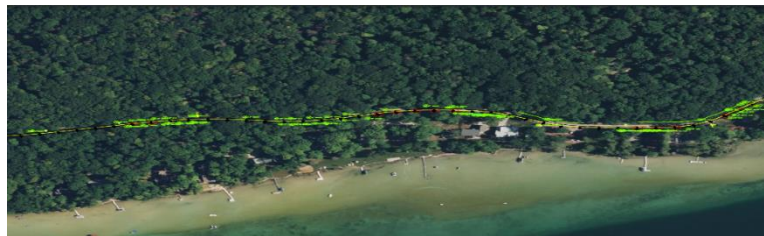
A survey was completed of Traverse Lake Road to identify potential sight distance concerns and mapped obstacles alongside the roadway. This help identify areas critical to improving sight distance. Efforts were then taken by Leelanau County Road Commission and property owners to remove vegetation that reduce sight distance and were a contributing factor to road safety concerns.

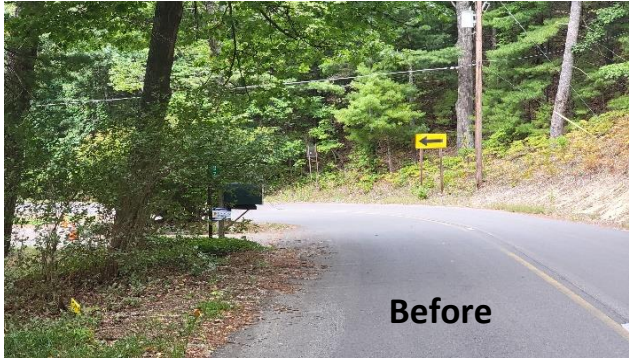
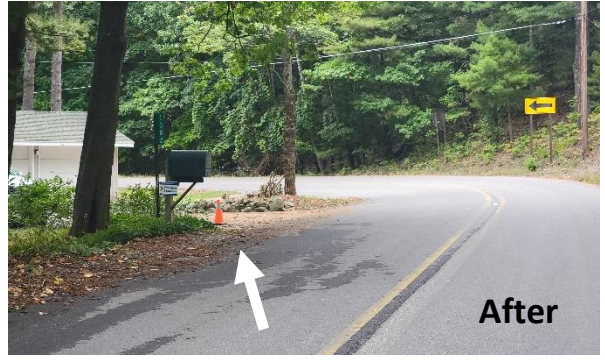
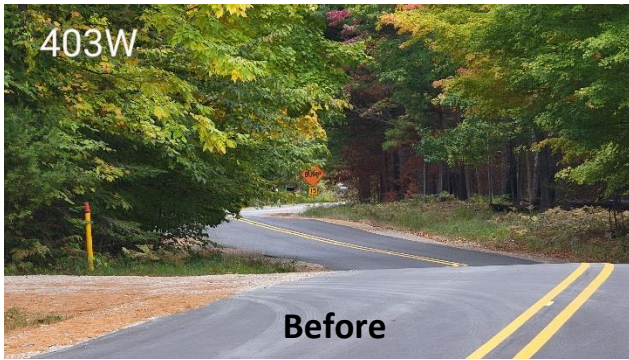
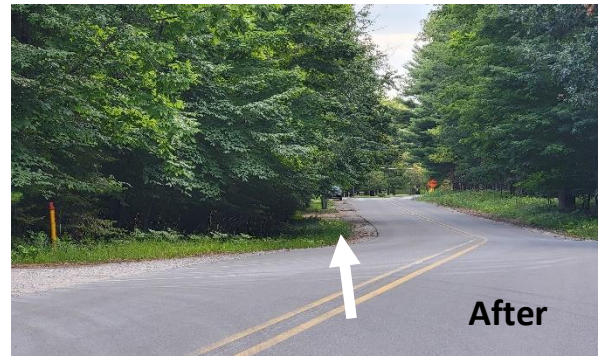
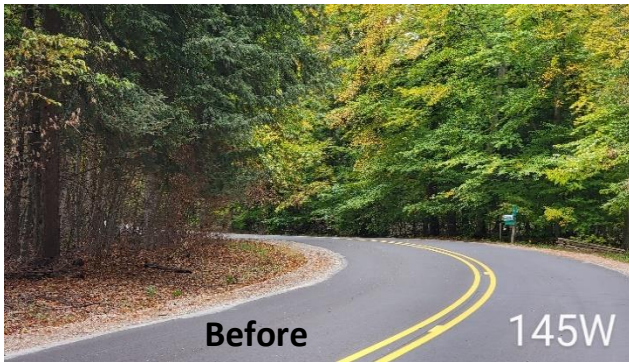
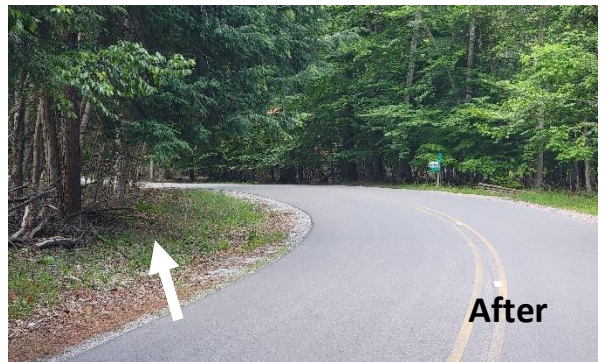
Following are visual examples of sight distance improvements along Traverse Lake Road:

Enhanced vehicle visibility

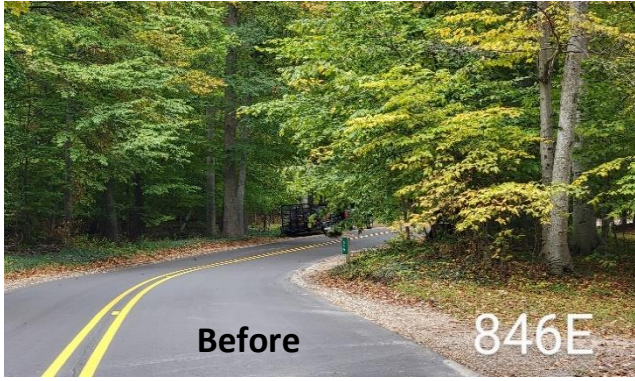
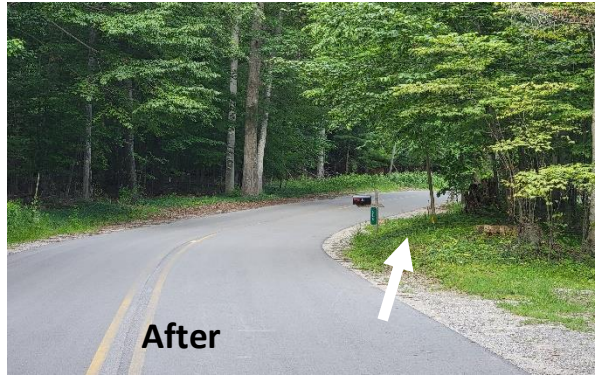
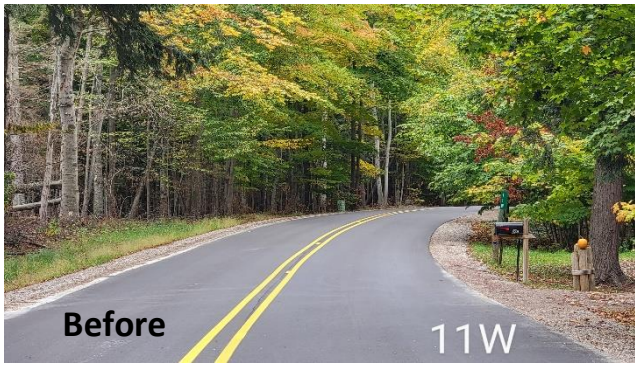
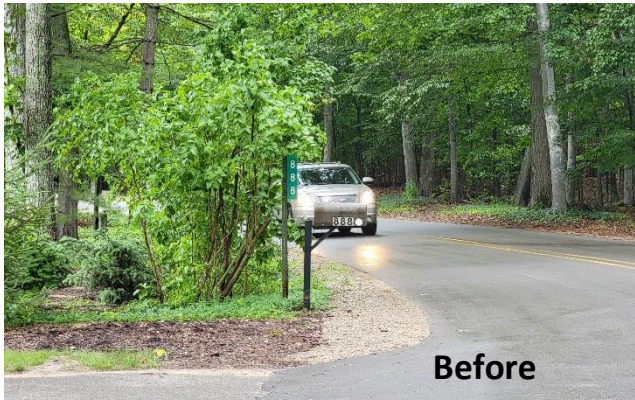
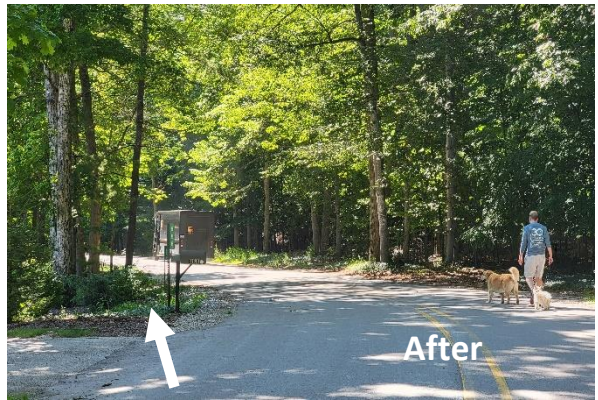
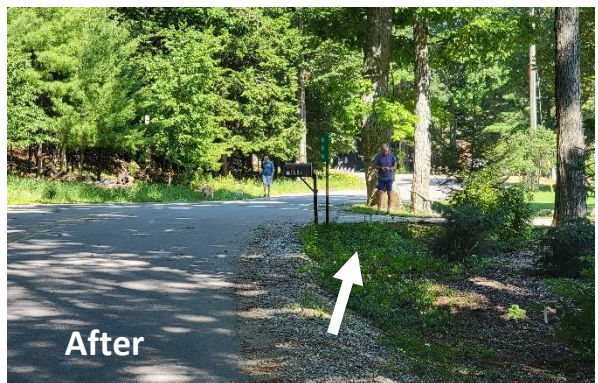
Enhanced pedestrian visibility

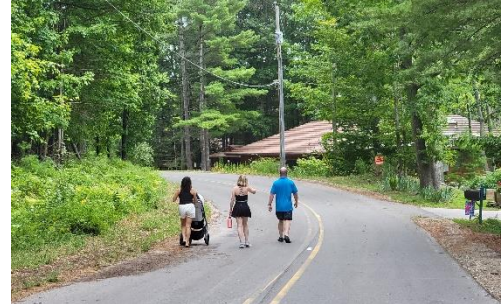
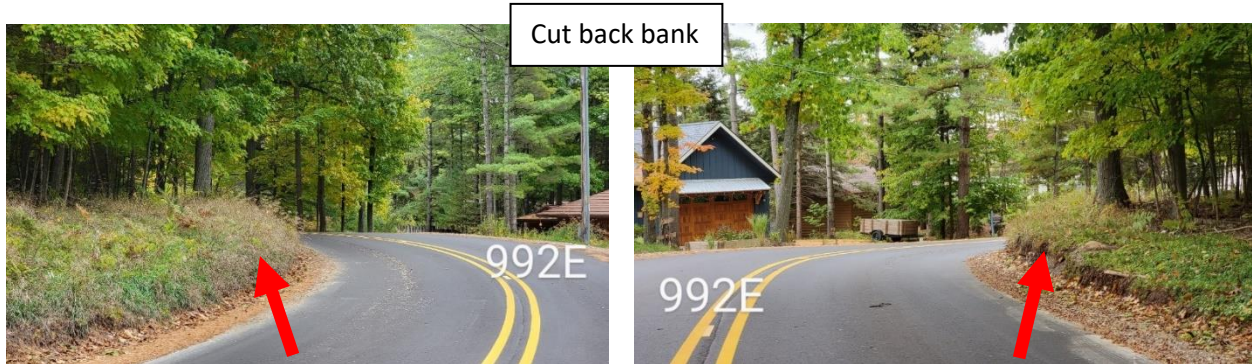
Cutting back of berm at middle curve

Sight distance can be improved at the middle curve by cutting back the dirt bank. This is a minor earth project that can be easily accomplished by the Leelanau County Road Commission. Sight distance is also important for the families that frequently cross the road just to the west of this curve. The result would be increased visibility at this curve and thus an improvement in road safety for all users.

The improvement of sight distance along Traverse Lake Road has been significant, with significant benefits to enhancing road safety for both vehicular and non-vehicular users. Two areas remain where sight distance can easily be improved: 1) removal of berm at the curve across from 992 E Traverse Lake Road; 2) annual mowing of cattails at the sharp curve at the west end of TLR with the addition of bike lanes to road pavement width around the curve for additional safety.

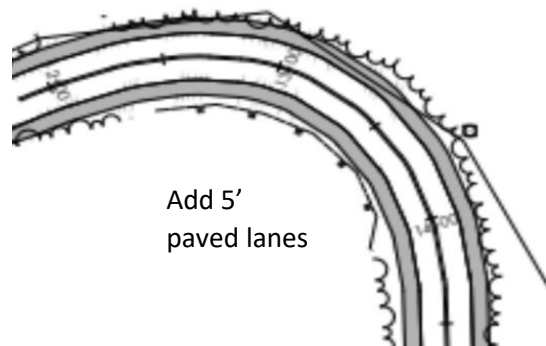
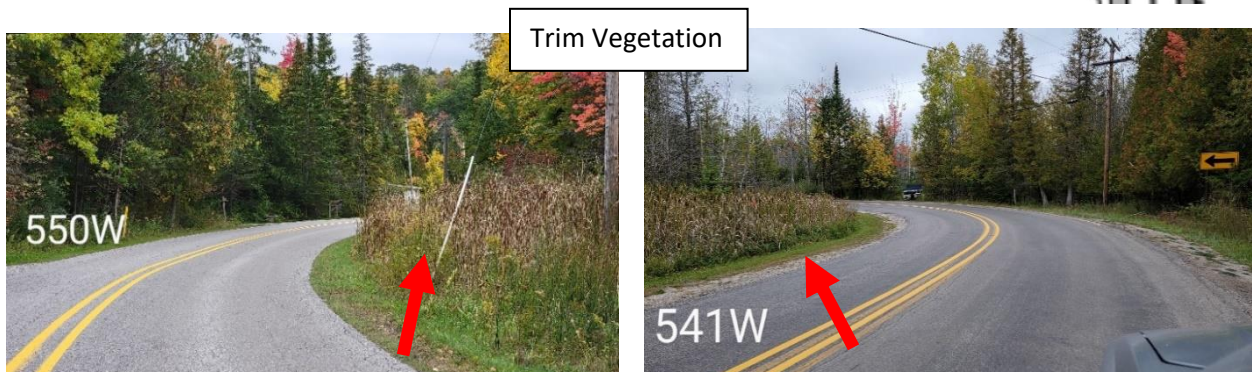
Improvements at west end curve

Sight distance and road safety can be improved at the west end curve by two actions: (1) Cutting down of vegetation to increase visibility around the curve; and (2) Increasing road width during scheduled road reconstruction by adding 5' bike lanes to provide more clearance space when cars meet non-vehicular users.
