## **Case Study: Garden City, Texas** **Produced Water Spill in Cotton Field**

**Location:** Near Garden City, Texas

**Release Type:** Brine produced water spill loaded with hydrocarbons

**Treatment Method:** In-situ application of microbial and biosurfactant solution (no dig & haul)

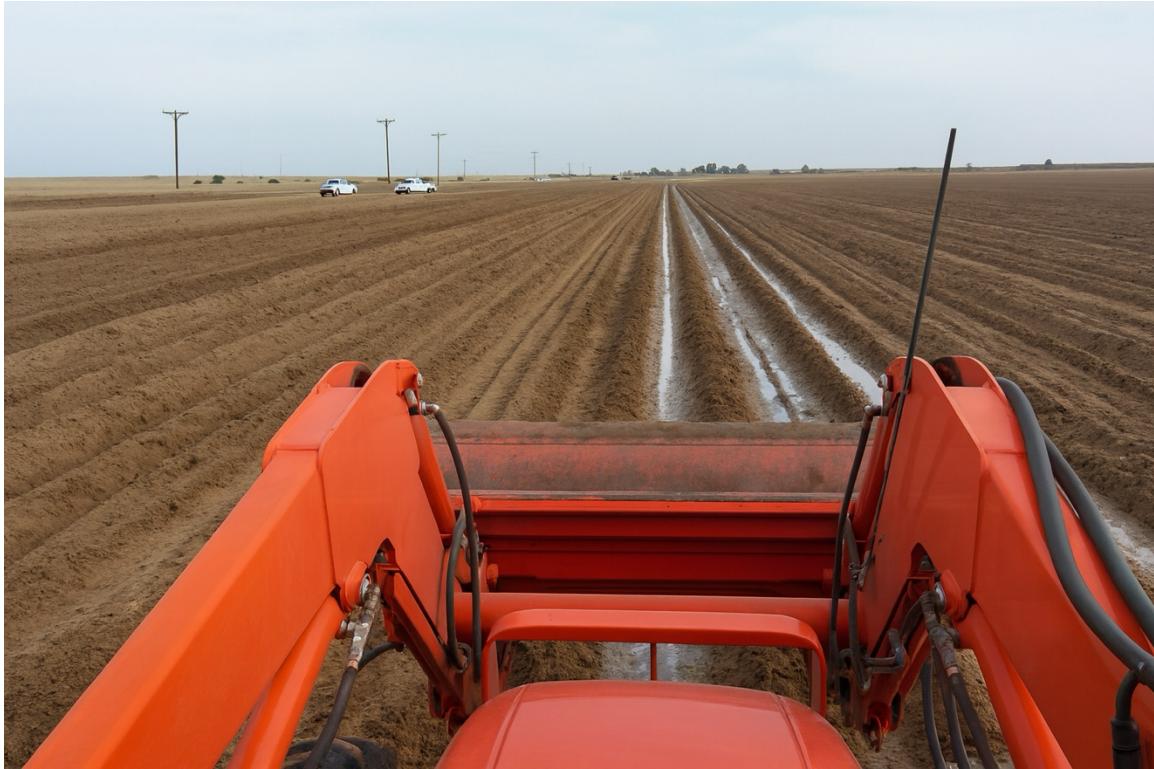
**Before Photo (Garden City – Spill in Cotton Rows)**

A produced-water line failed in an actively farmed cotton field near Garden City, Texas. The line released high-salinity brine produced water containing residual hydrocarbons, directly into the furrows. Within days, the spill path was clearly visible as a discolored strip running across the field. Cotton plants along the release area were stressed, stunted, or dead, while adjacent unaffected rows continued to grow normally.

Garden City, Texas – Produced-water spill in an active cotton field. Note dead and stressed cotton rows along the release path before treatment.

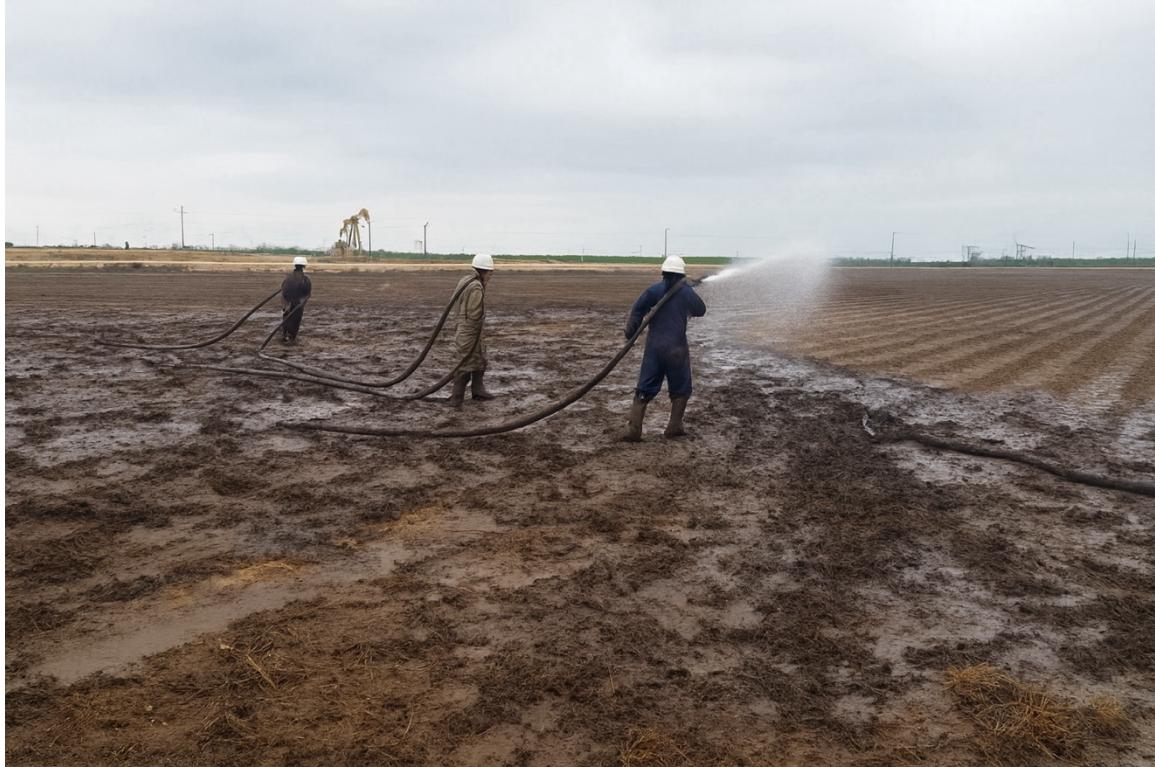
### **Applying Bio Solution - (Garden City – Spill in Cotton Rows)**

Garden City, Texas – A produced-water spill occurred in an active cotton field. The solution is being actively sprayed onto the contaminated area.

The treatment was applied using low-pressure spray equipment to maximize spray volume, as the soil was soft and the contamination area was large.

- The affected rows were sprayed along the visible spill path and slightly beyond it to ensure thorough coverage.
- Application rates were designed to provide sufficient microbial and biosurfactant loading to match the observed contaminant levels without over-saturating the soil.

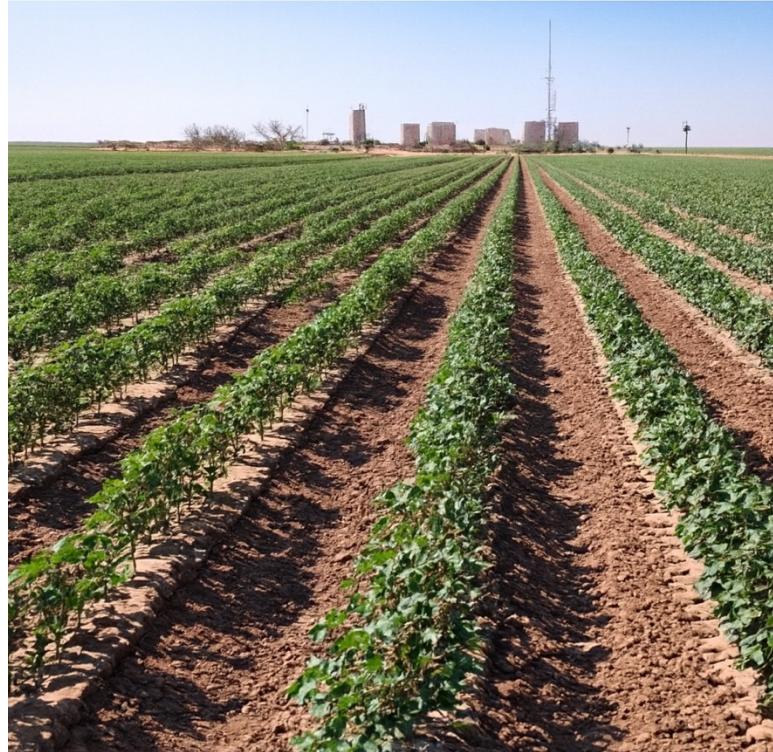
**After Photo (Garden City – Restored Field)**

The following growing season, the area of the previous spill, which had dead and stunted cotton rows, was covered with uniform, healthy vegetation. From the fence line, the spill zone no longer stood out from the rest of the field.

Exact location after in-situ microbial treatment. Vegetation has recovered, and the field has returned to productive cotton farming. No excavation or soil replacement was required.
