UP AND UP HOME INSPECTIONS

RESIDENTIAL REPORT

1234 Main St.
Madison, AL 35756

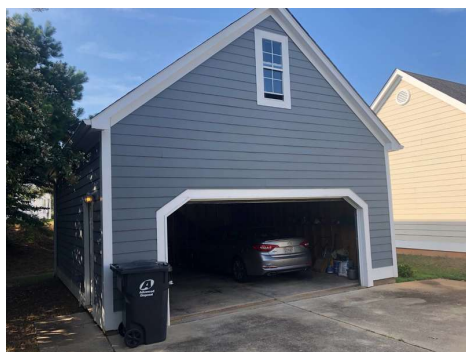
Detached Structures Not Inspected

The property included one or more detached structure (structures not attached to the home) which were not included as part of a General Home Inspection and were not inspected. The Inspector disclaims any responsibility for providing any information as to their condition.

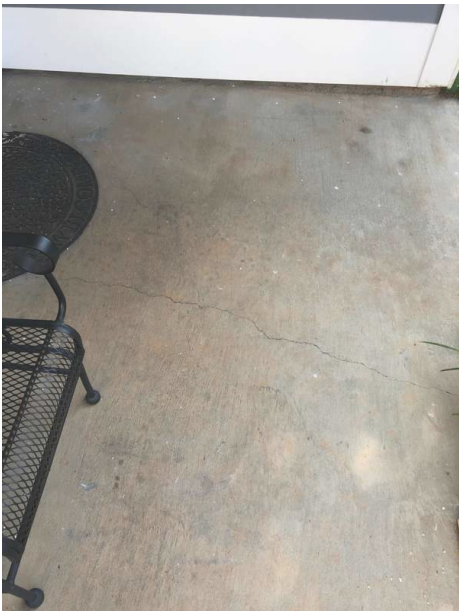
Vegetation, Grading, Drainage & Retaining Walls: Directing Water Away From Foundation Should Be A Continuous Priority

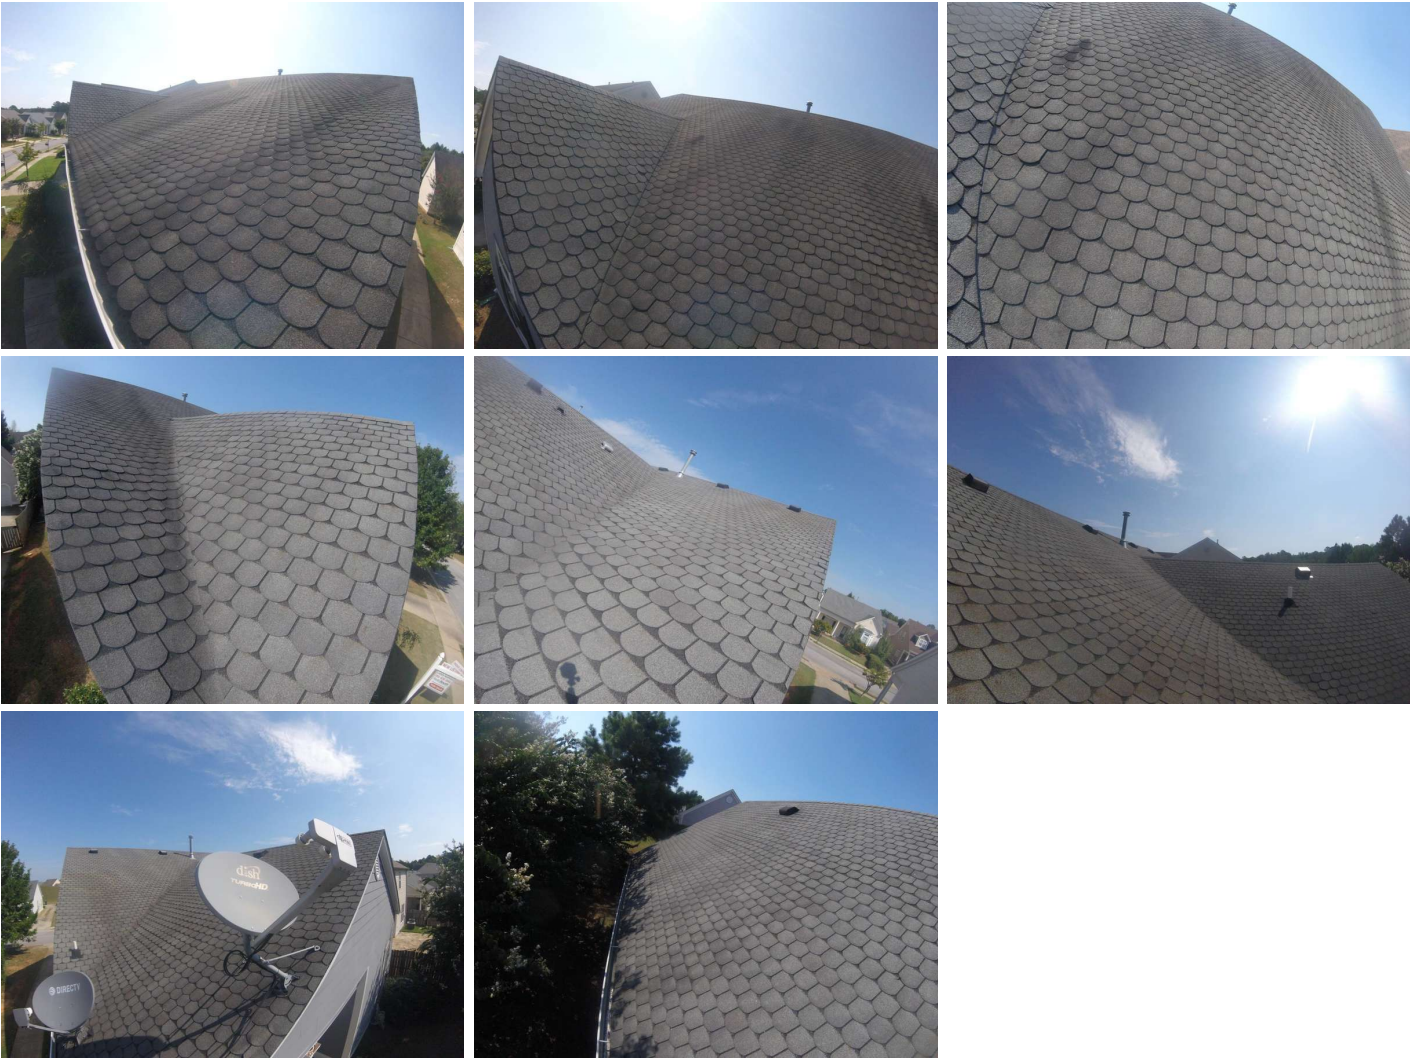
Coverings: Asphalt Shingles

Granular coverage was very good and consistent throughout the roof. The roof covering appears to be in very good condition. Any isolated observations will be addressed later in this section.

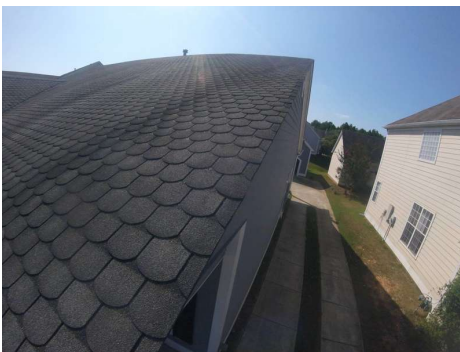
**Flashings: General Flashing Description**

Flashing is a general term used to describe sheet metal fabricated into shapes and used to protect areas of the roof from moisture intrusion. Inspection typically includes inspection for condition and proper installation of flashing in the following locations: - roof penetrations such as vents, electrical masts, chimneys, mechanical equipment, patio cover attachment points, and around skylights; - junctions at which roofs meet walls; - roof edges; - areas at which roofs change slope; - areas at which roof-covering materials change; and - areas at which different roof planes meet (such as valleys). Chimney flashings are covered in next section

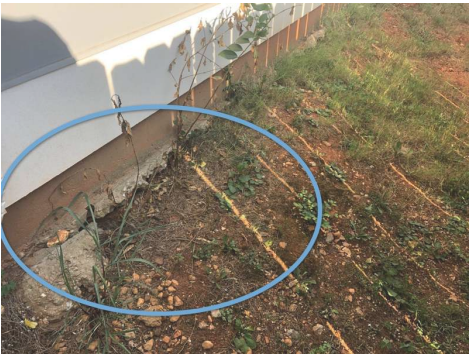
4.1.1 Foundation

FOUNDATION IN BEING COMPROMISED BY WATER INTRUSION

Taking steps to keep any further soil erosion is recommended.

Contact a qualified handyman.

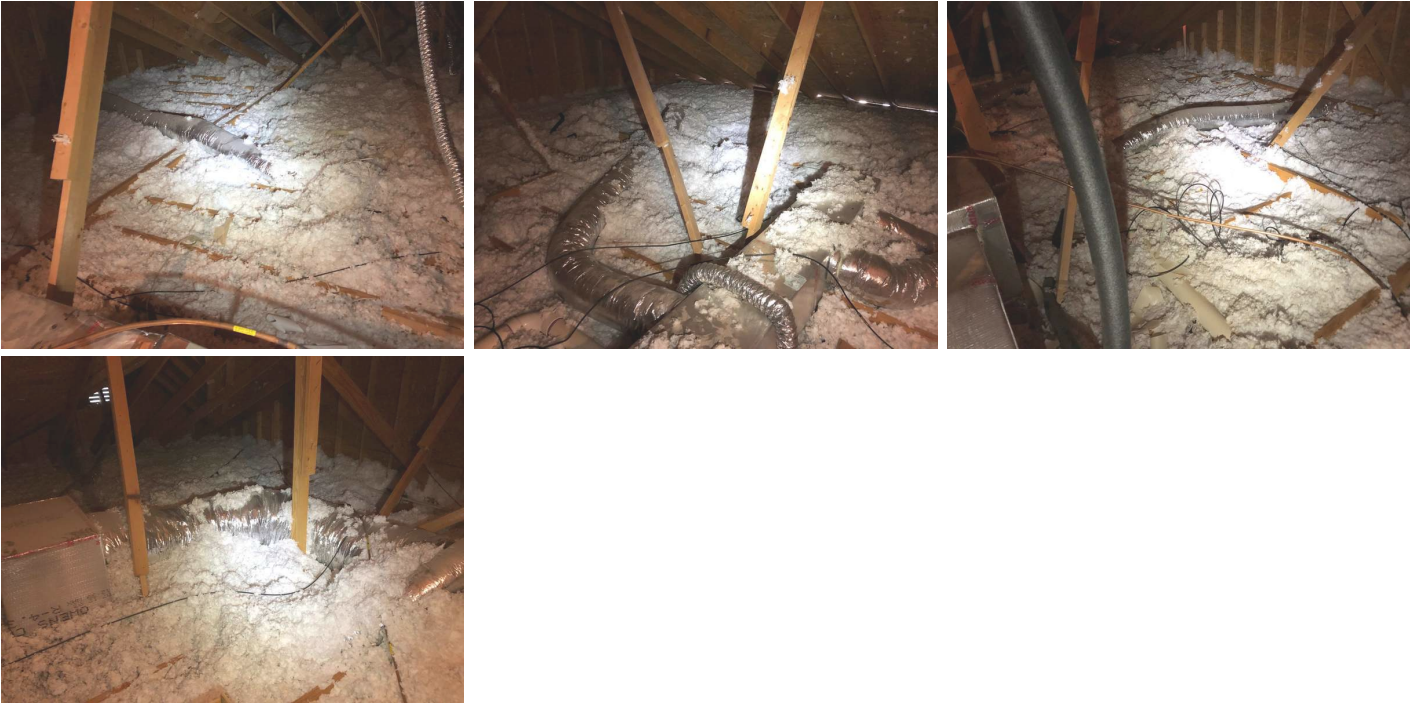
Attic /Floor Insulation: Insulation Type In Attic
Loose-fill

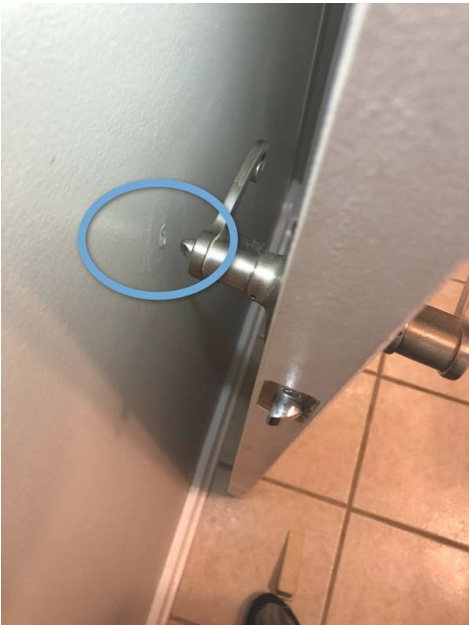
7.1.1 Doors

DOOR STOPS MISSING IN SOME AREAS

Recommend Adding.

Contact a handyman or DIY project

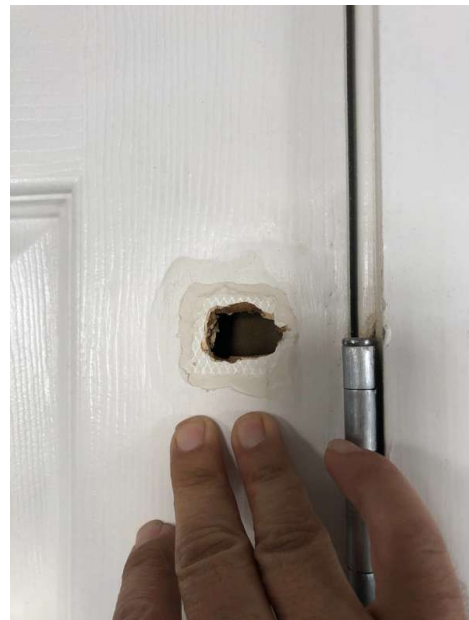
7.1.2 Doors

DOOR DAMAGED BY DOOR STOP

Recommend covering area.

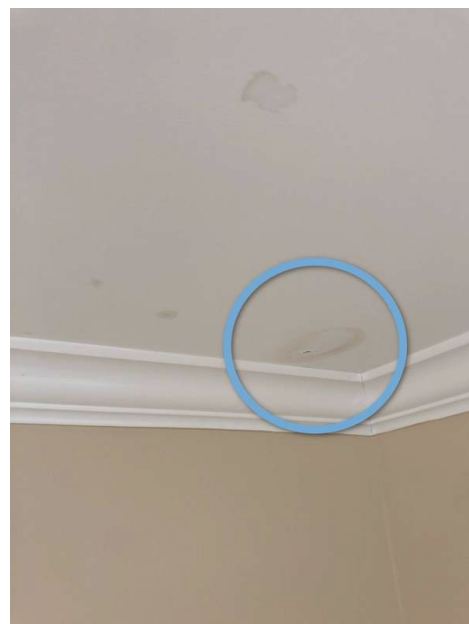
7.5.1 Ceilings

STAIN/REPAIRS ON CEILING (INACTIVE MOISTURE)

There is an inactive stain on ceiling in kitchen. Monitor. If active moisture is noted, the source of staining should be determined and repaired.

Recommend monitoring.

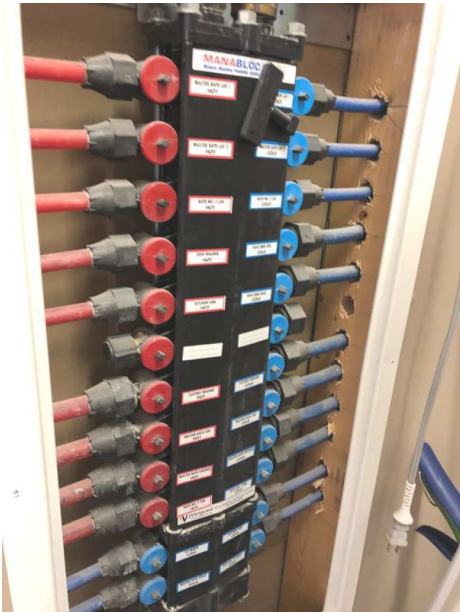
Hot Water Systems, Controls, Flues & Vents: Manufacture Date
2003

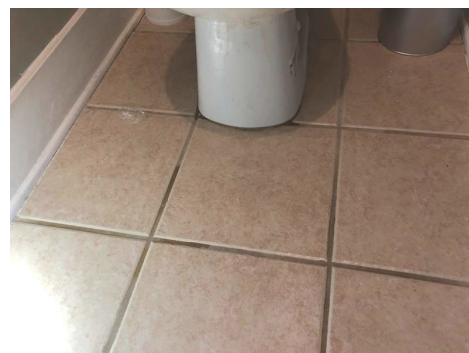
9.3.1 Water Supply, Distribution Systems & Fixtures

**SOME MOISTURE AROUND MASTER BATHROOM COMMODE**

Monitor. If moisture continues or becomes worse, changing the wax ring may be needed.

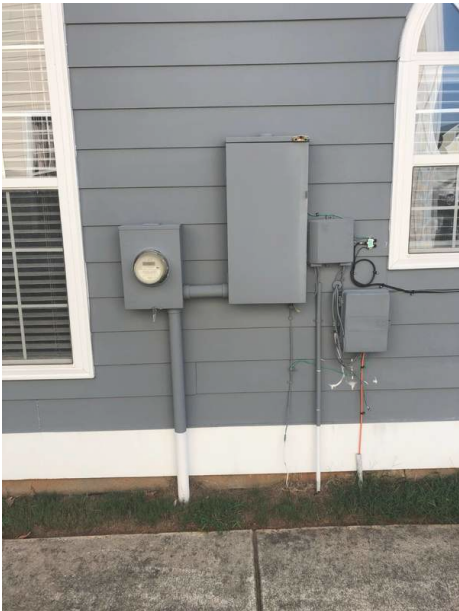
Main & Subpanels, Service & Grounding, Main Overcurrent Device: Main Panel Location
Right End Of House

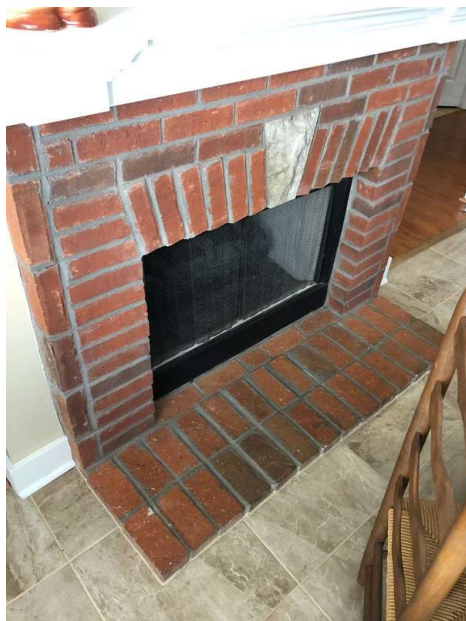
Fireplace : Non-Vented Fireplace

Carbon Monoxide detection protection is recommended in any rooms in which combustion occurs. Unless Otherwise stated, a carbon monoxide detector was not installed in the room with the fireplace.

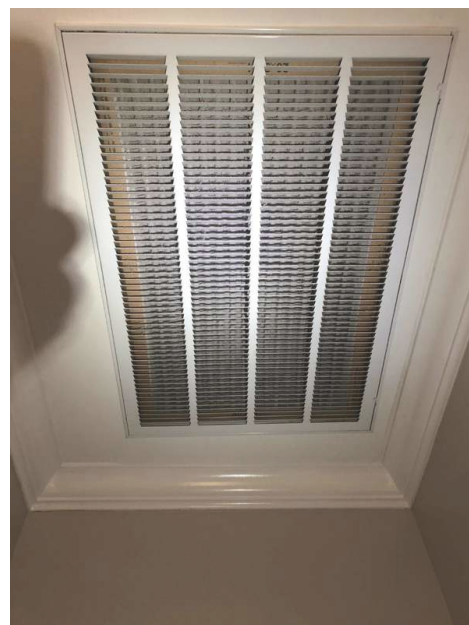
11.2.1 Heat/Cool Unit

The filter is dirty and needs to be replaced. Recommend change every 6 months.

Contact a handyman or DIY project

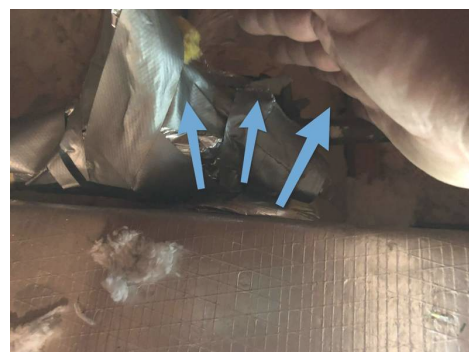
11.4.1 Distribution Systems

DUCT LEAKING

Air supply duct was slightly leaking air. Recommend a qualified HVAC technician repair.

Contact a qualified HVAC professional.

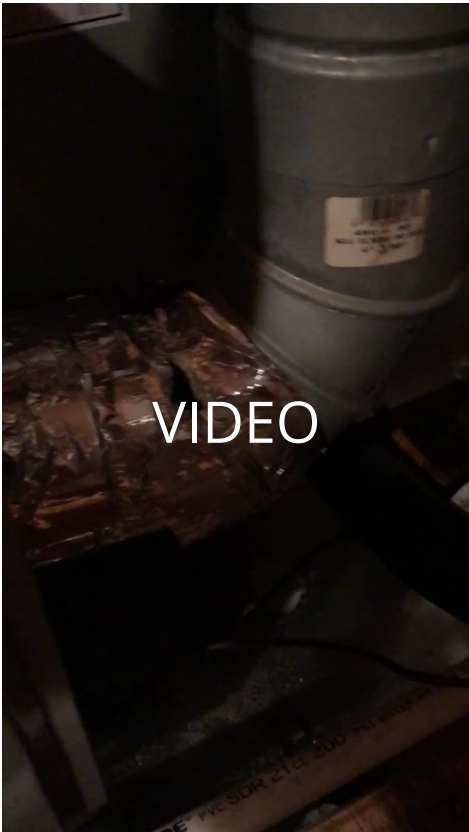
11.6.1 Vents & Flues (Gas Units)

FLUE WAS LOOSE AT THE UNIT

Exhaust flue was not properly connected. This is a safety issue.
Fumes should be removed from the attic properly. Recommend a qualified HVAC contractor evaluate and repair.

Recommendation
Contact a qualified HVAC professional.
