Clark Fork River Operable Unit Milltown Reservoir/Clark Fork River Superfund Site Powell, Deer Lodge, and Granite Counties

Geomorphology and Hydrology of Reach A

Final Report: Geomorphology and Hydrology of Reach A

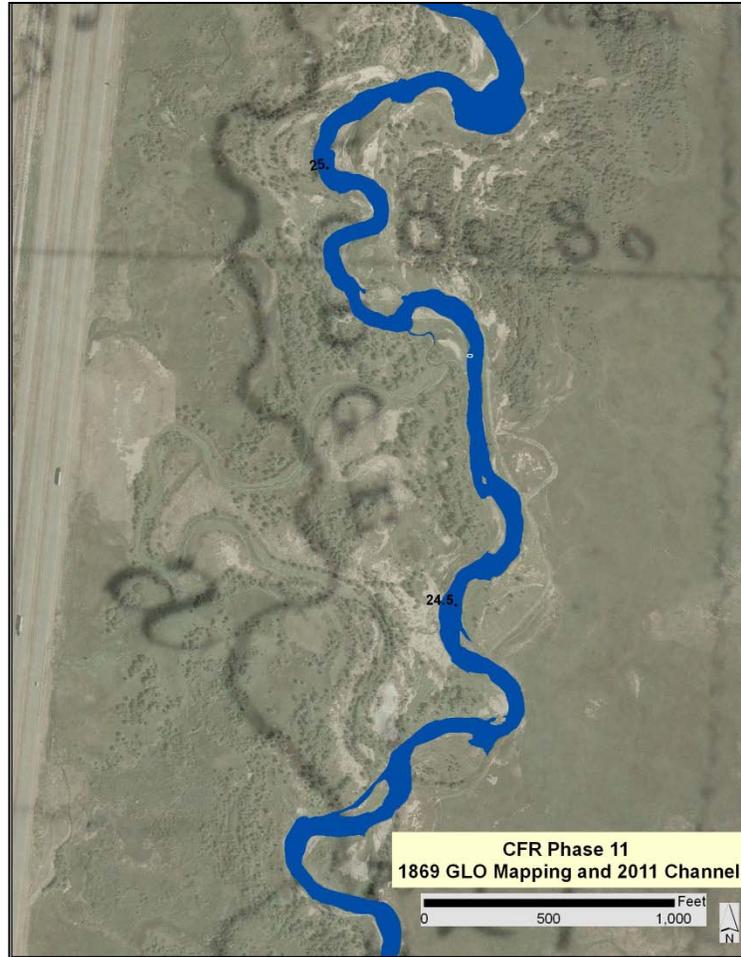
Figure 2-3. Example of deviation between 1869 GLO map and modern channel (blue), including a section line crossing, Phase 11.

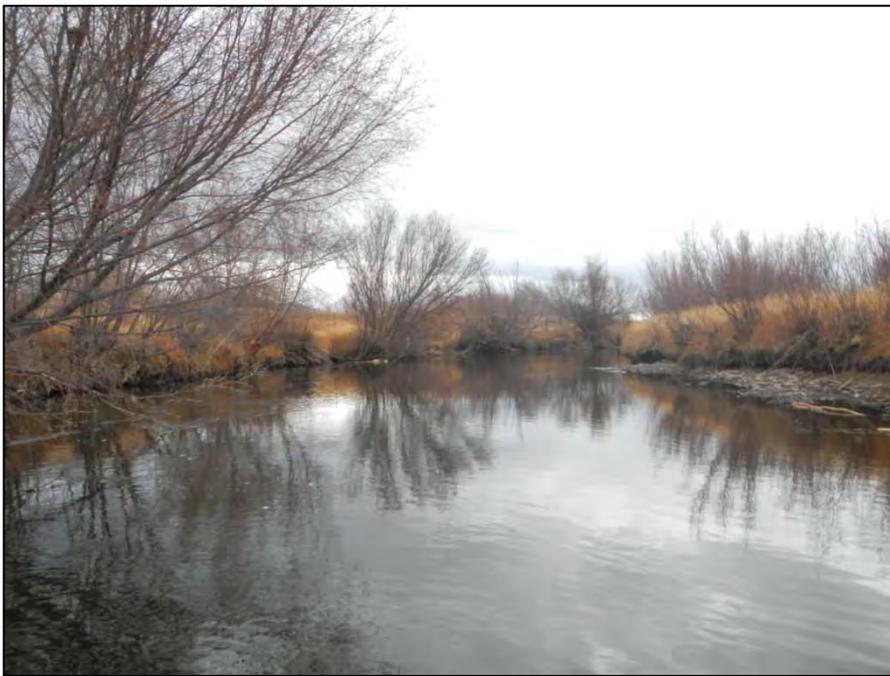
Figure 2-29. View downstream of locally entrenched channel segment, Subreach A1, Phase 3, RM 5.5.

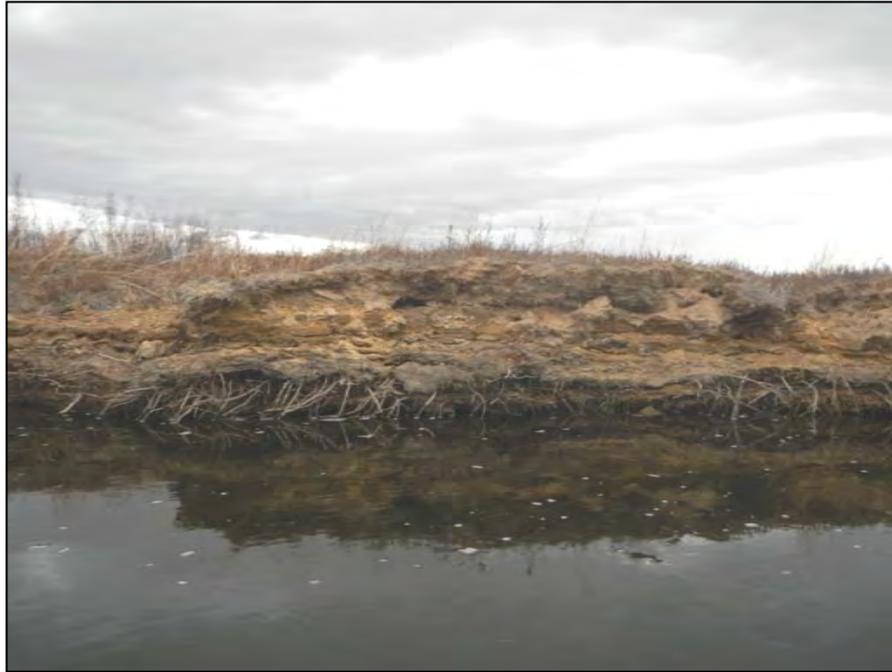
Figure 2-30. Right bank tailings deposit, Subreach A1, Phase 3, RM 6.15.

Extensive tailings deposits were observed in the upper banks in Phase 3. Coarse toe material in the banks increases in the downstream direction, and although floodplain connectivity is good, there are isolated areas of high banks and entrenchment (Figure 2-29). This likely reflects areas where especially thick tailings deposits (such as natural levees) now comprise the active bank. Figure 2-30 shows variable bank heights and tailings thicknesses that demonstrate that variability. The historic floodplain below tailings deposits commonly supports mid-bank woody vegetation, or lower bank root remnants (Figure 2-30). Mid-bank woody vegetation tends to be of moderate density. Bank trampling by cattle was noted as extensive in Phase 3, and this trampling locally occurs where tailings comprise the bank. Gravel riffle crests are common; riffle crest density was also noted as high—the riffle crest density of almost 13 riffles per mile is the highest of all of the inventoried phase segments. Gravel/cobble toes are commonly discontinuous and upwardly convex, indicating exposure of buried gravel bars (Figure 2-31).

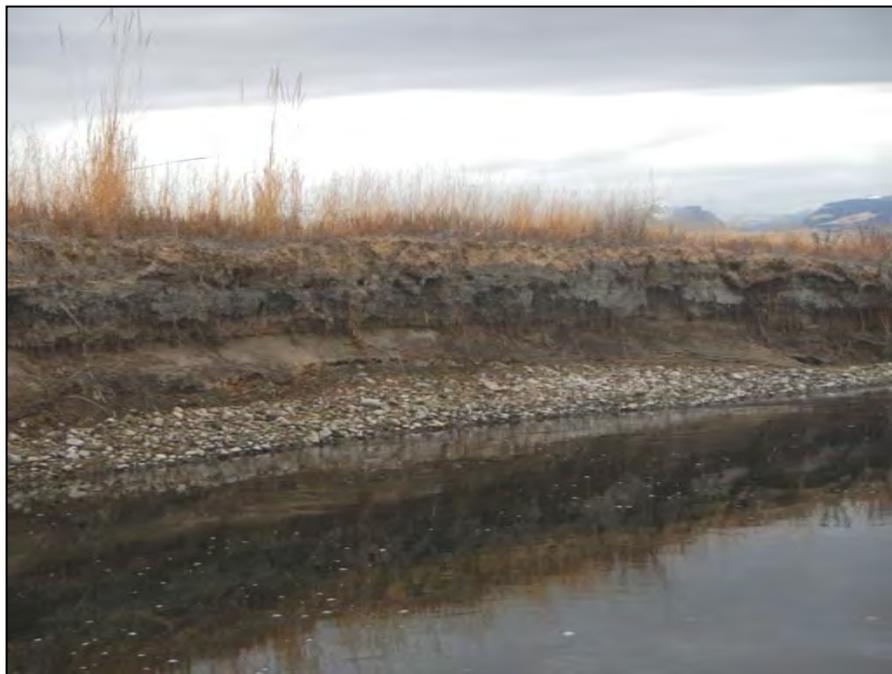
Figure 2-31. Coarse cobble bank toe with convex surface, Subreach A1, Phase 3, RM 6.0.

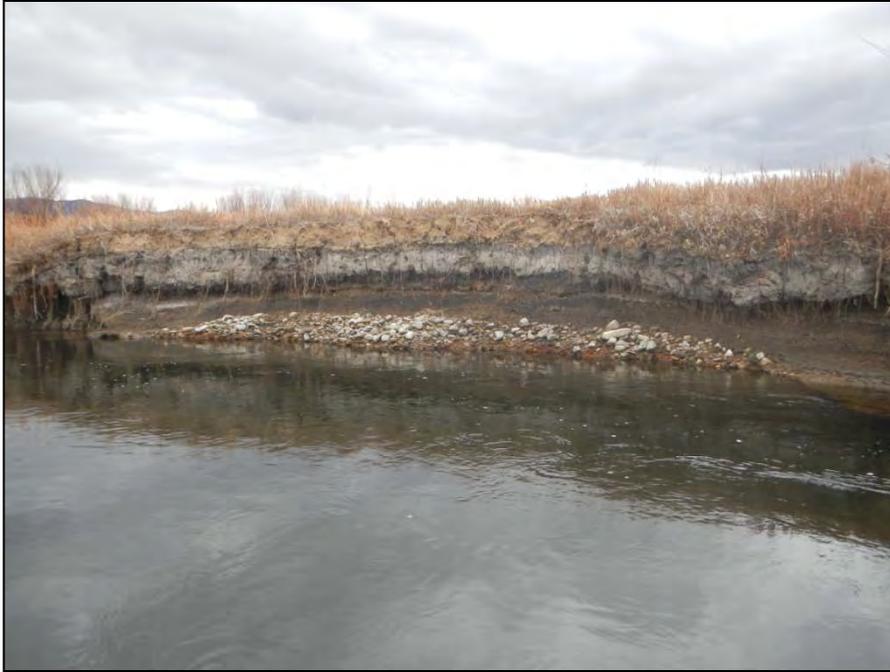
Figure 2-33. High right bank showing coarse bar deposit in toe with overlying historic floodplain deposits and tailings cap; inundation modeling indicates lack of floodplain connectivity at this location, Subreach A1, Phase 4, RM 7.1.

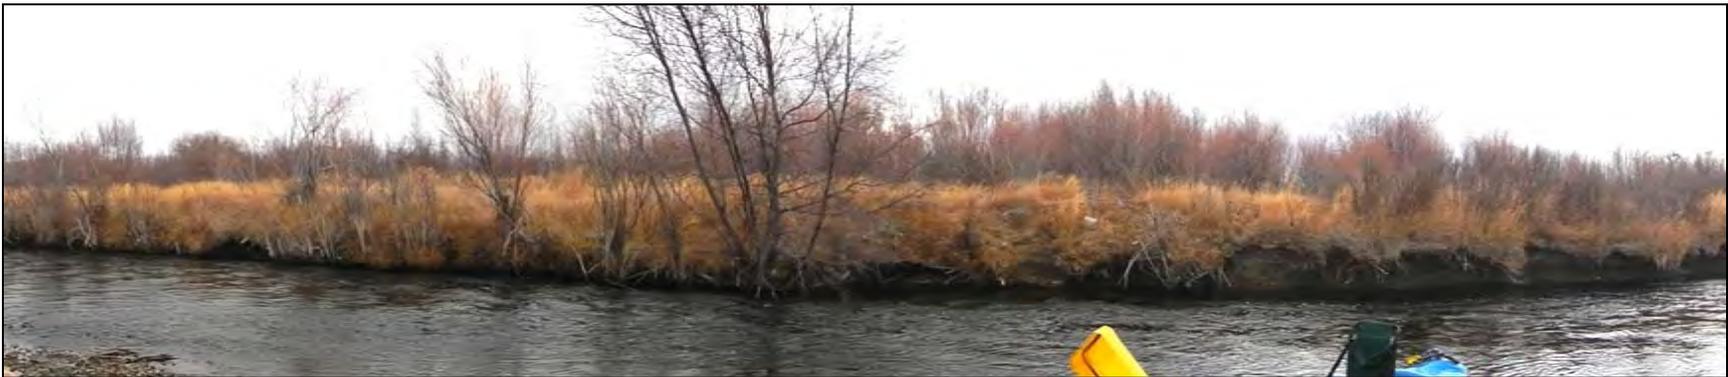
Figure 2-35. Panorama showing role of mid-bank woody vegetation in providing bank stability (left), versus low stability (right); Subreach A1, Phase 4, RM 7.6.

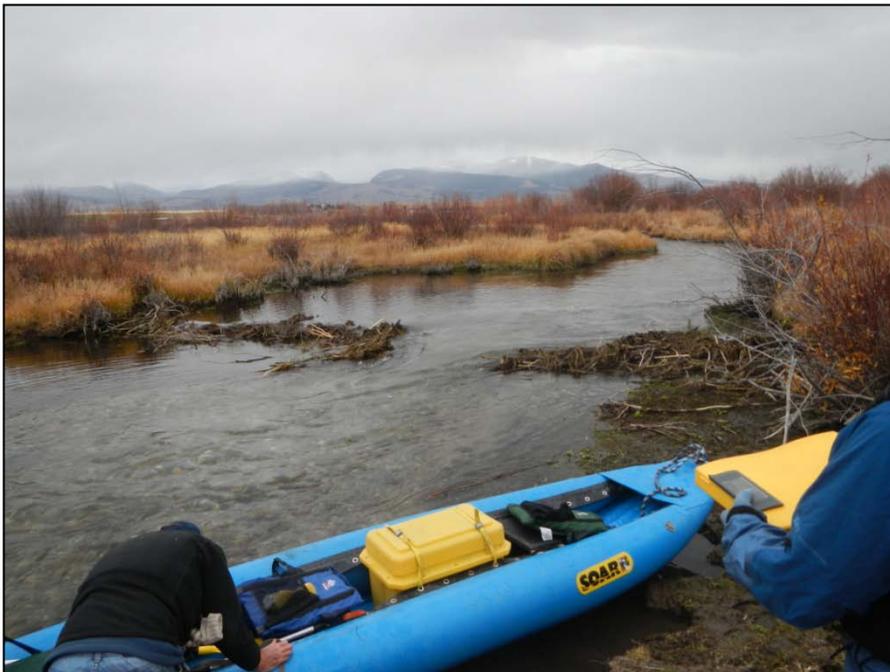
Figure 2-37. Mouth of Lost Creek, Subreach A1, Phase 4, RM 6.75.

Lost Creek enters Phase 4 at RM 6.75. On the day of the field inventory (11/1/12), Lost Creek was contributing 65 cfs (Figure 2-37). The mouth and lower end of Lost Creek were stable and effectively reinforced by floodplain vegetation. A breached beaver dam was present at the mouth of the creek.

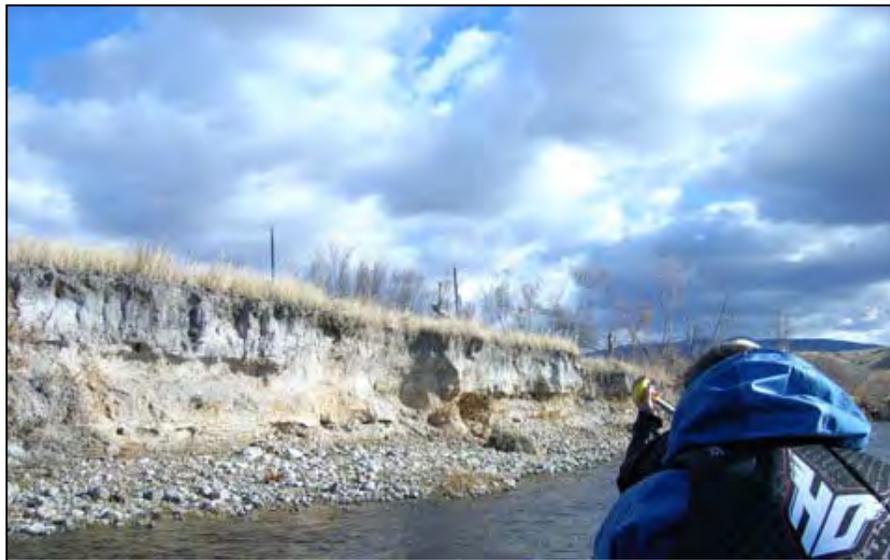
Figure 2-38. View downstream of left bank terrace exposure, Subreach A2, Phase 7, RM 14.25.

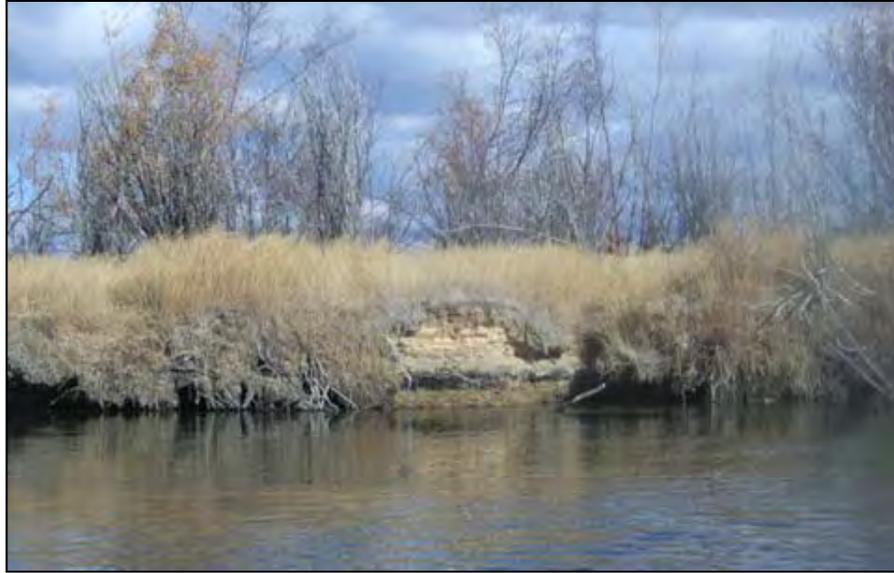
Figure 2-40. Left bank exposure of tailings where overhanging material has failed, Subreach A3, Phase 8, RM 15.1.

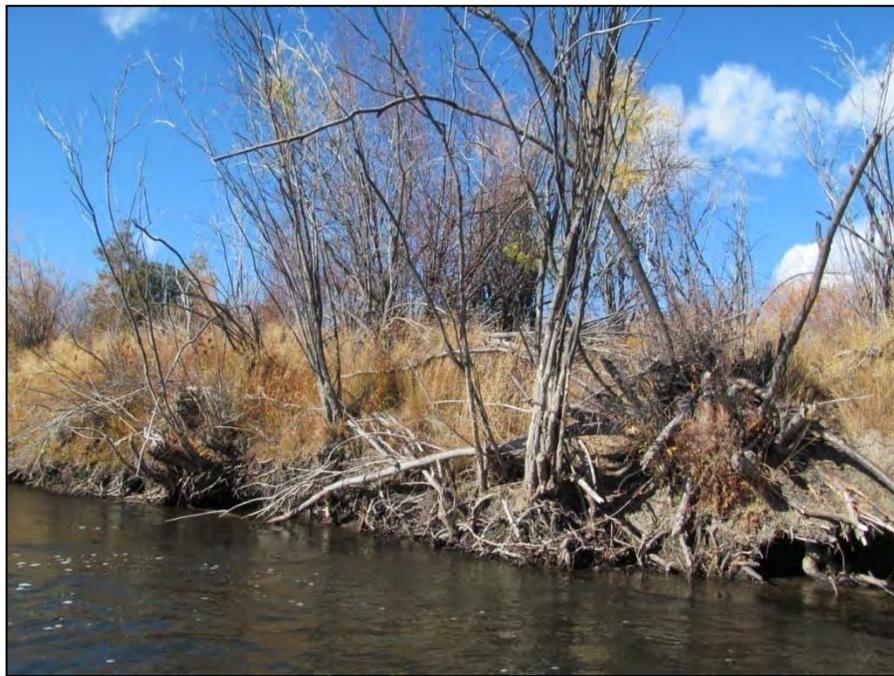
Figure 2-41. View upstream of left bank vegetation reinforcement, Subreach A3, Phase 8, RM 16.85.

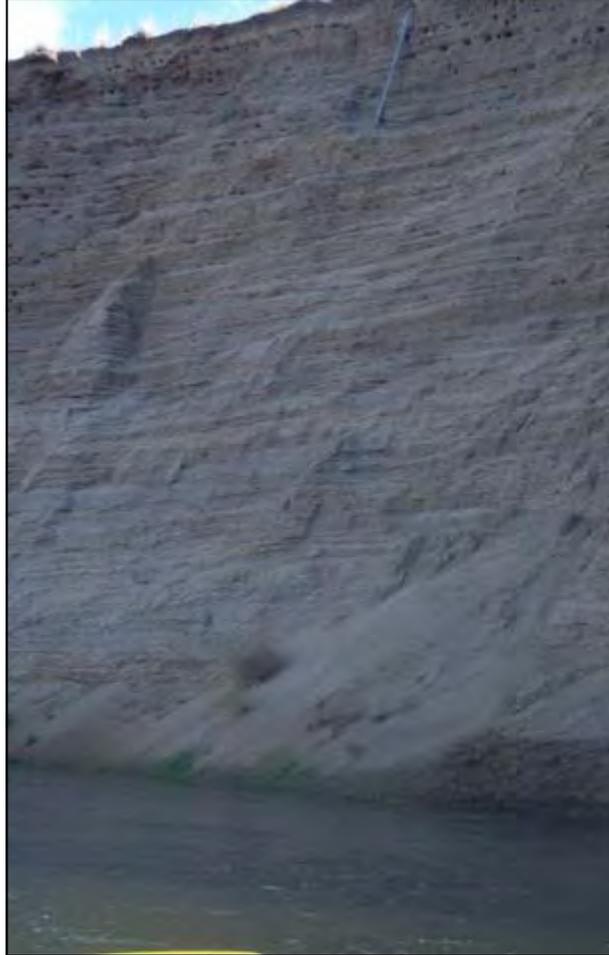
Figure 2-44. High sandy terrace deposits on right valley wall, Subreach A3, Phase 8, RM 16.

On the east side of the valley in Phase 8, terraces and colluvial deposits tend to be very fine-grained and erodible relative to exposures on the west side of the corridor. These units are actively contributing sand and finer material to the river (Figure 2-44). These high surfaces are draped by younger, similarly fine-grained terrace and colluvial units (Figure 2-45).

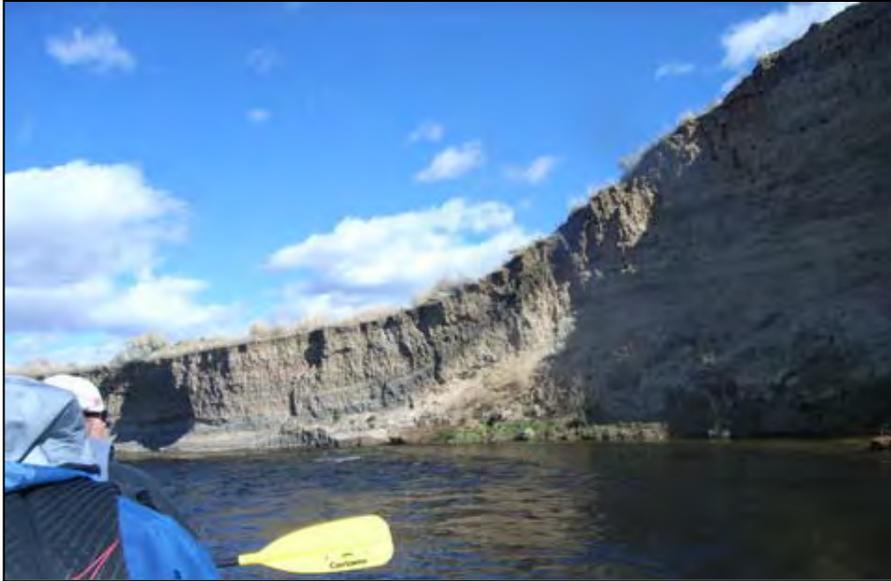
Figure 2-45. View downstream showing intersection of high valley wall sediments (mapped as Tertiary) and younger draping terrace (left), Subreach A3, Phase 8, RM 16.1.

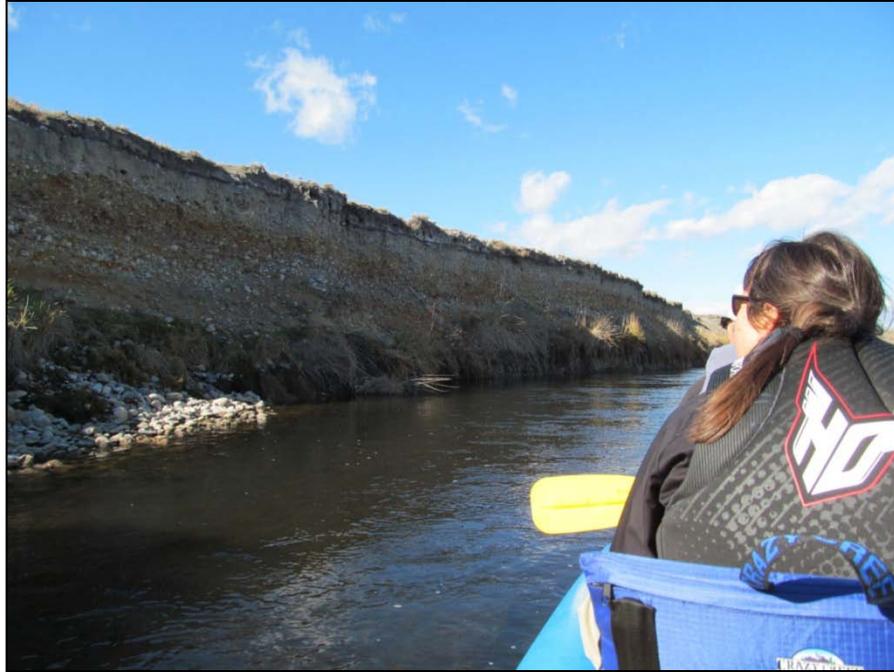
Figure 2-46. View downstream of left bank glacial outwash exposure, Subreach A3, Phase 9, RM 17.9.

At the Phase 8/9 boundary, the river crosses to the west side of the valley, where it flows against coarse glacial outwash deposits (Figure 2-46). These units are derived primarily from Flint Creek Range glacial outwash, and are distinctively coarse grained and more stable than the high exposures on the east side of the valley, which are derived from Tertiary volcanics, coarse granites, and associated alluvial fans. These stable terrace margins also support deep pools, in contrast to those on the east valley wall. Downstream of the Orofino Creek alluvial fan at RM 17.75, the high left bank terrace is irrigated, and significant seepage was noted at the toe (Figure 2-47).

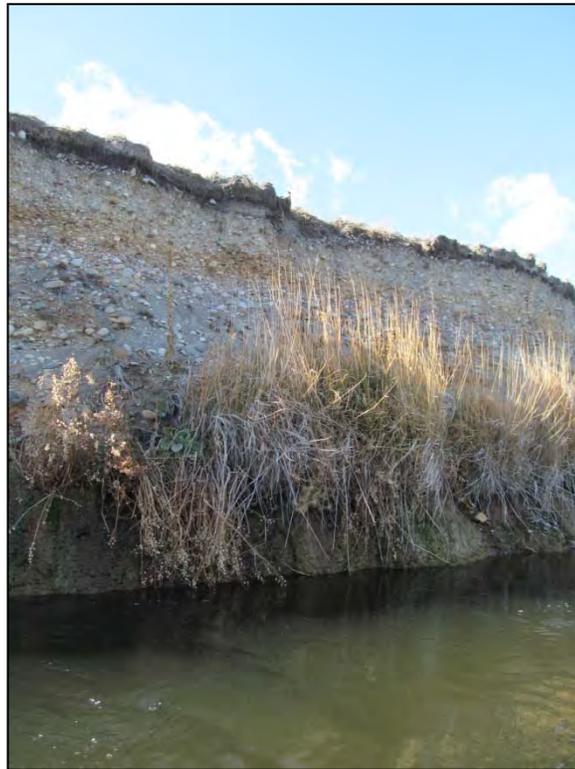
Figure 2-47. Outwash terrace, Subreach A3, Phase 9, RM 17.9.

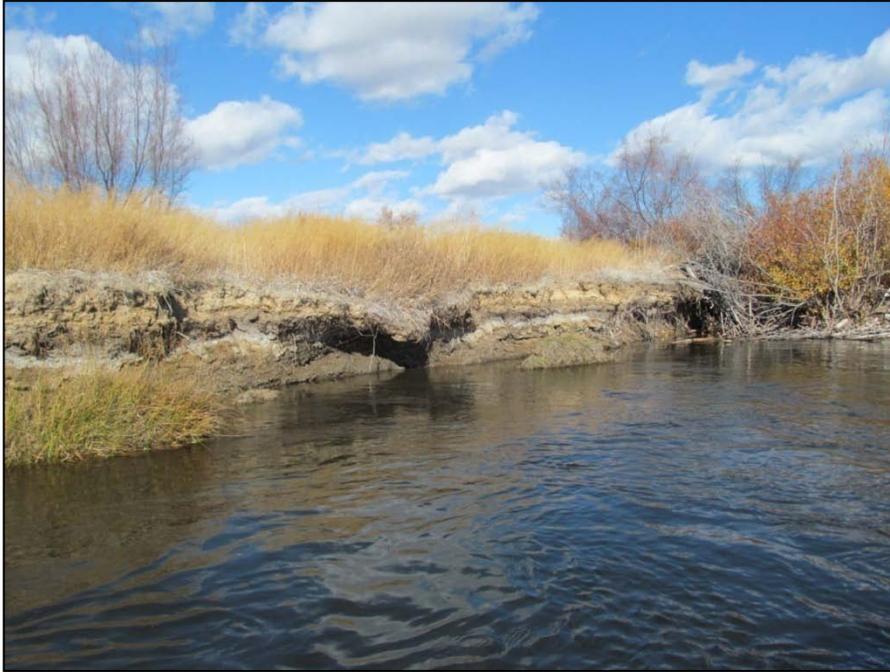
Figure 2-48. Topple failure of overhanging tailings horizon, Subreach A3, Phase 9, RM 17.4.

Where not against the high terrace, bank heights in Phase 9 were noted as consistently low, with laminated tailings ranging from less than a foot to over 2 feet thick. Migration rates in Phase 9 are relatively high, with an average rate of 0.9 ft/yr for all banks that show in excess of 20 ft of movement since 1950. One bioengineered bank treatment was mapped in Phase 9 at RM 19.7 (Figure 2-48 through 2-50).

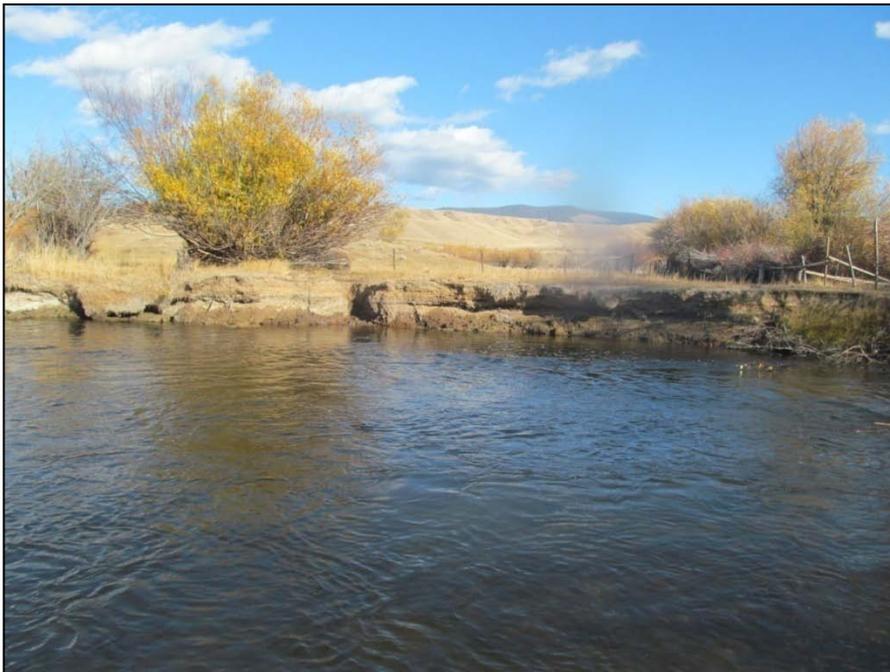
Figure 2-49. View downstream of right bank showing low bank height and tailings cap, Subreach A3, Phase 9, RM 19.05.

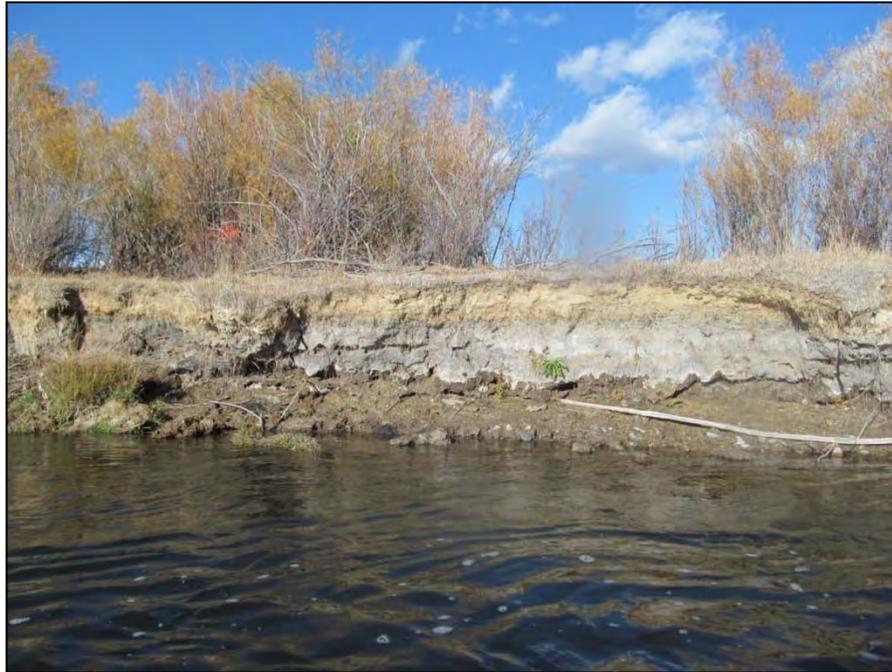
Figure 2-50. Typical bank stratigraphy showing historic floodplain unit (gray) and overlying tailings, Subreach A3, Phase 9, RM 19.5.

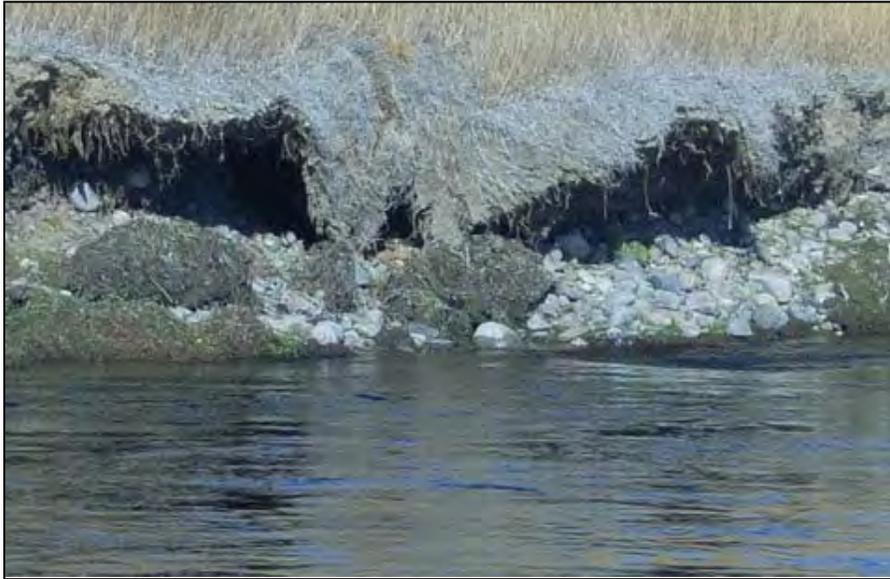
Figure 2-55. Bank undercutting and upper bank topple failure, Subreach A4, Phase 11, RM 24.15.

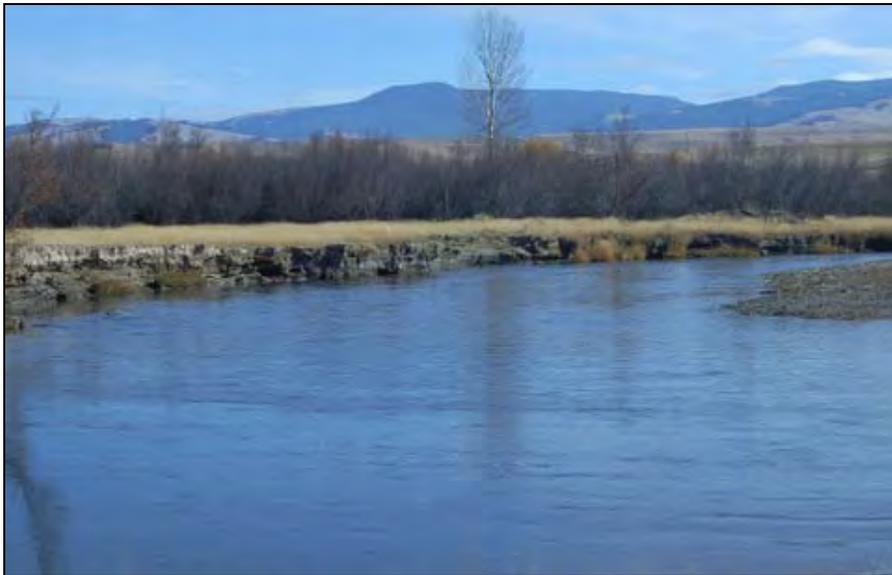
Figure 2-56. View downstream of typical cutbank erosion, Subreach A4, Phase 11, RM 24.8.

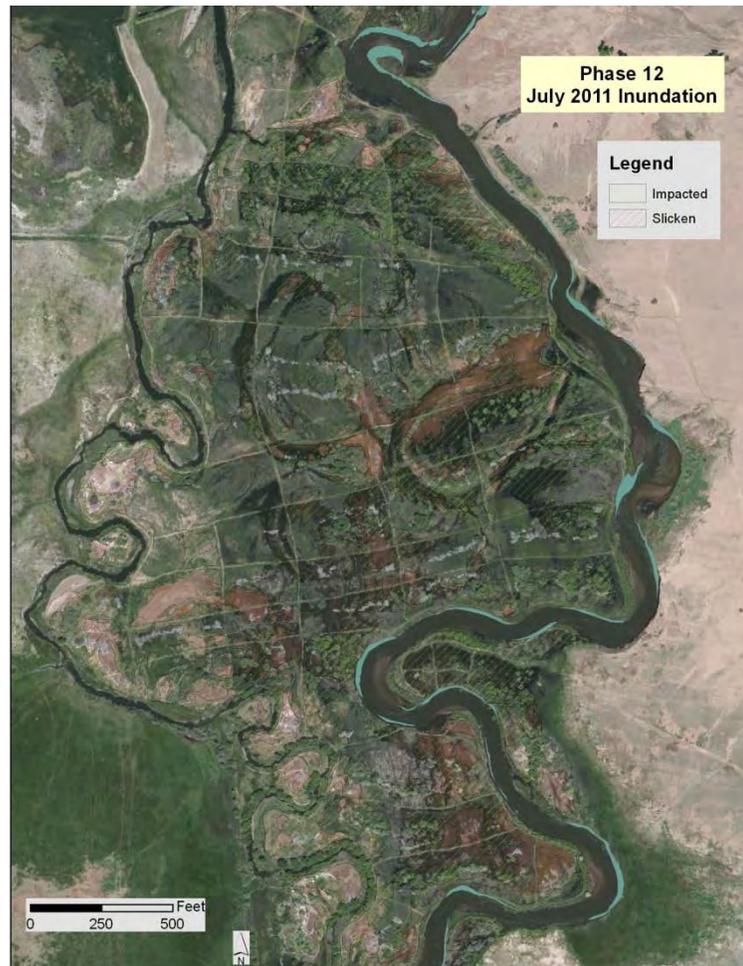
Figure 2-58. July 2011 inundation, Reach 12; note secondary channel west of main thread.

On the far west side of the valley, a secondary channel is a prominent, low elevation feature that has been mapped as an avulsion hazard (Figure 2-58; Appendix D, Figure D-7). This channel was mapped as a 40-ft wide slough in 1869. This channel has a meandering planform with tailings in several meander cores. The channel does not currently flow as a perennial side channel; the upper end is dry under baseflow conditions, along its course which is over a mile long, it gains flow from the west, likely including groundwater seepage and irrigation return flows, to create a persistently wetted channel on the lower several thousand feet of channel (Figure 2-58). This prominent feature in Phase 12 should be carefully considered in terms of both contaminant characterization and potential side channel/wetland restoration.

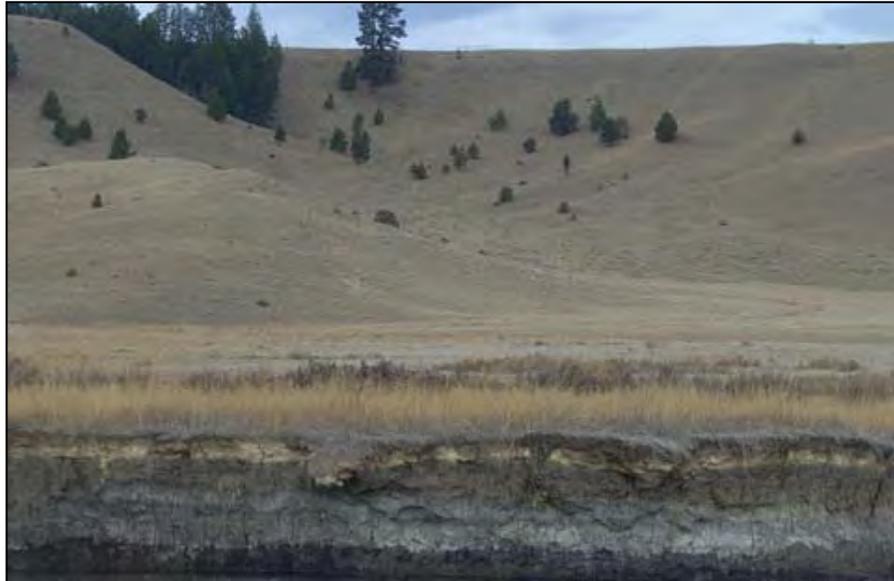
Figure 2-61. Relatively thin tailings cap, Subreach A6, Phase 17, RM 35.4.

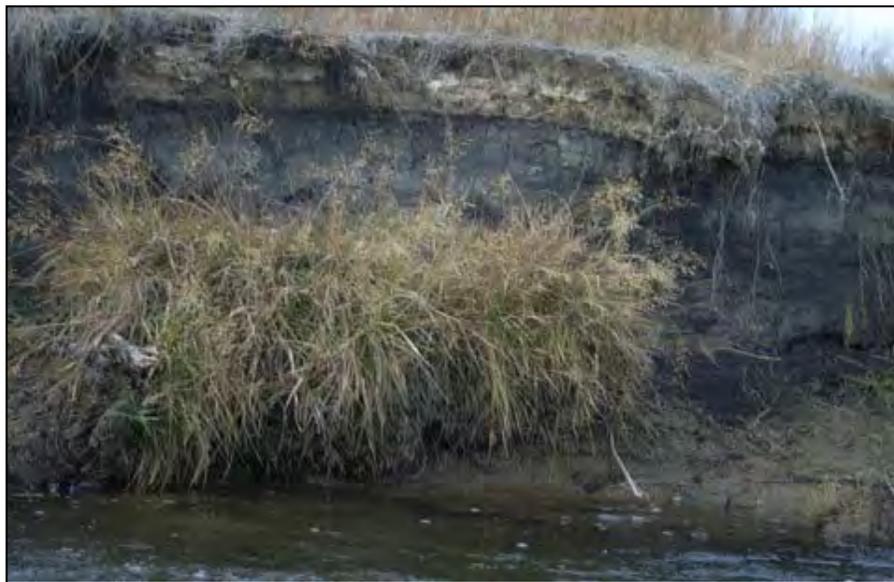
Figure 2-65. Typical bank stratigraphy, Subreach A7, Phase 19, RM 38.6.

In Phases 18 through 20, exposed tailings thicknesses continue to be highly variable although distinct tailings layers are still distinguishable this far down the corridor (Figure 2-65 and Figure 2-66). Bank failures tend to be topple collapses of upper bank fine sediment over a retreating toe (Figure 2-67 through Figure 2-69). There are long stretches in Phase 18 with minimal erosion, and entrenchment varies through the subreach. Bedform complexity is minimal; bed material is coarse and supports long, largely embedded run habitats.

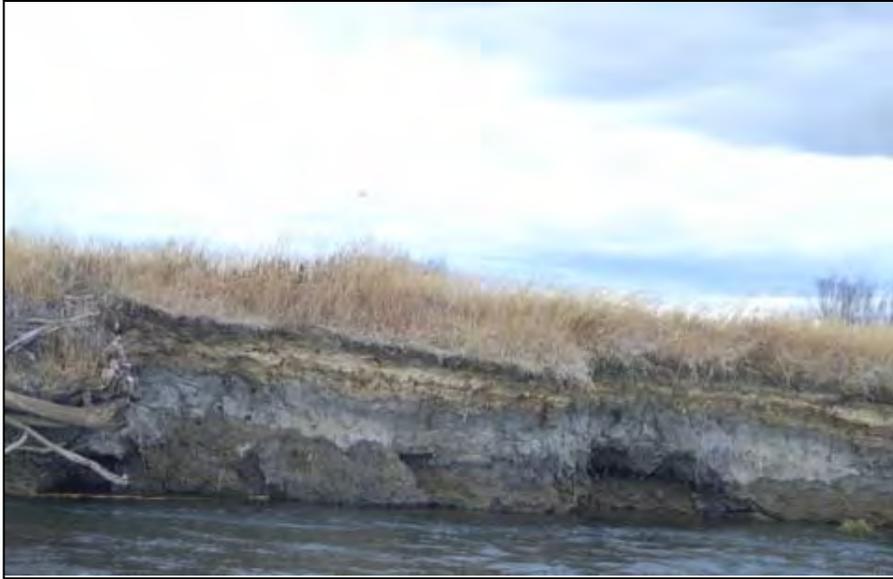
Figure 2-66. Bank stratigraphy, Subreach A7, Phase 19, RM 39.1.

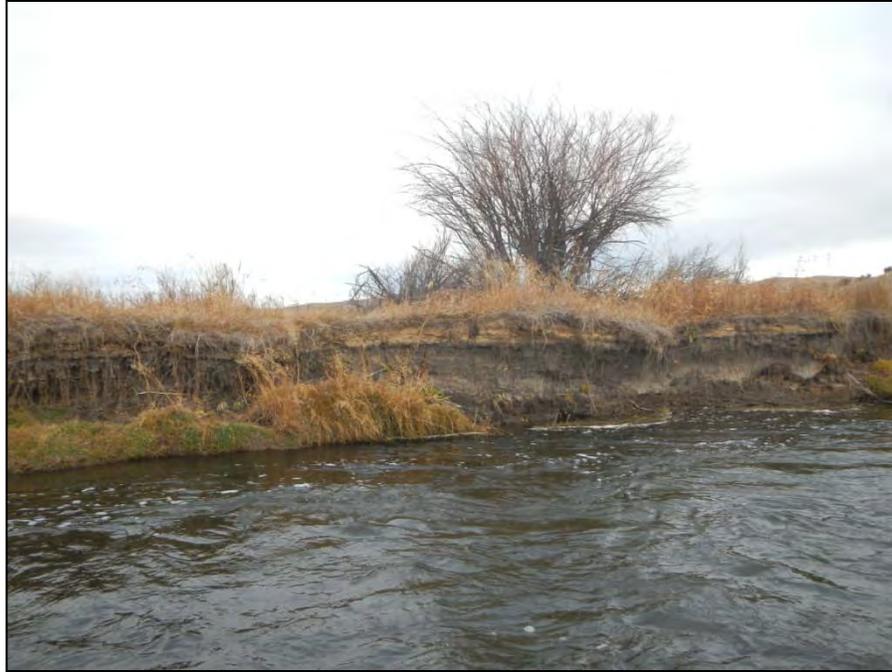
Figure 2-68. Left bank erosion, Subreach A7, Phase 20, RM 40.9.

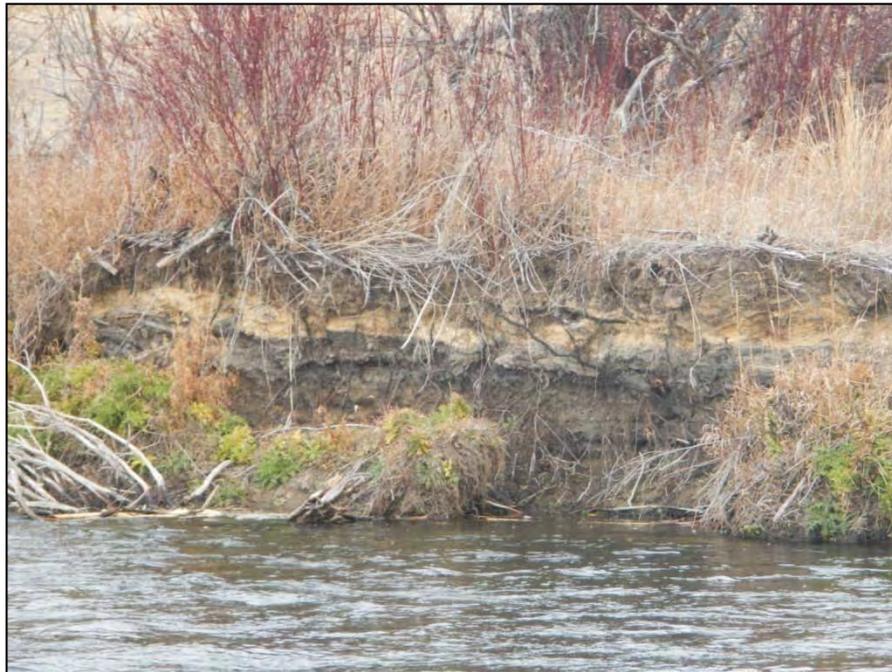
Figure 2-69. Right bank erosion showing deposition over tailings, Subreach A7, Phase 20, RM 40.95.

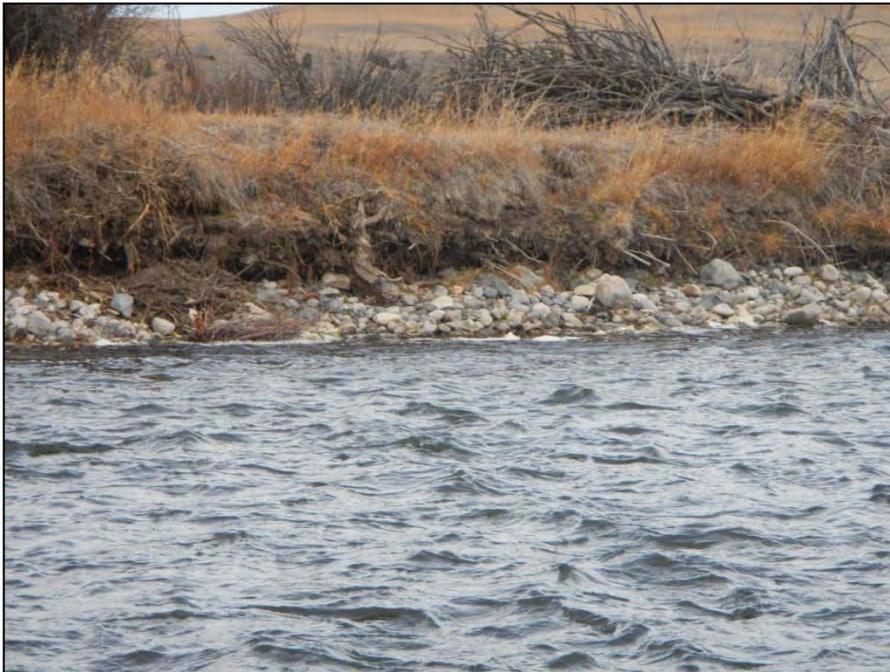
Figure 2-70. Cobble toe in left bank, Subreach A7, Phase 20, RM 41.5.

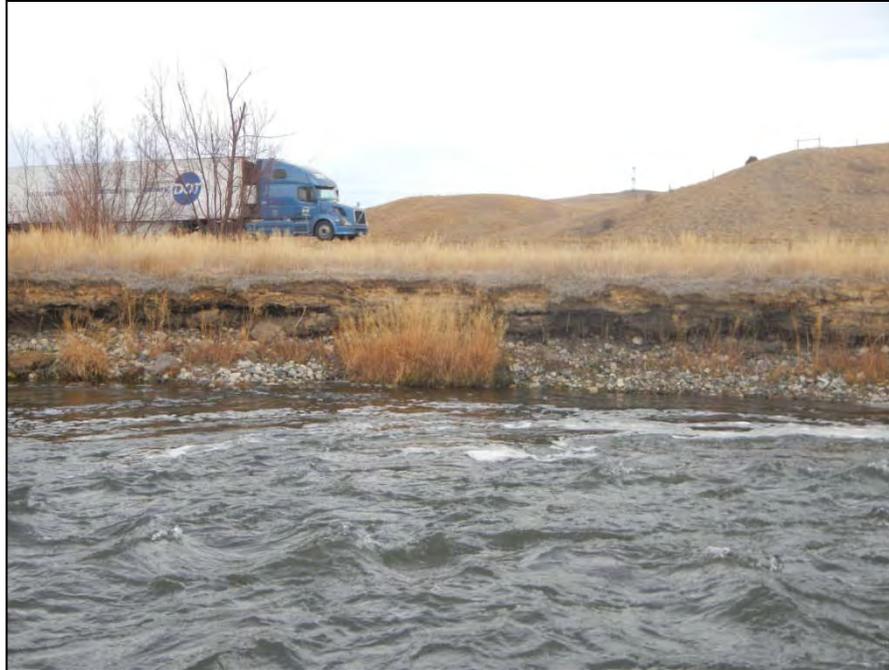
Figure 2-71. Right bank erosion adjacent to I-90, Subreach A7, Phase 21, RM 41.75.

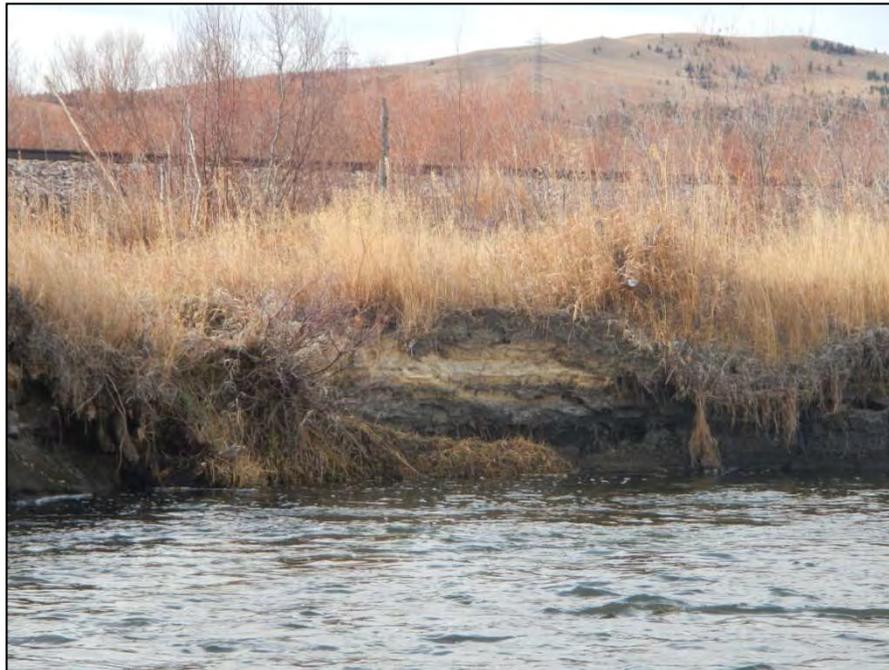
Figure 2-72. Left bank upper collapse exposing tailings, Subreach A7, Phase 21, RM 42.9.

Similar to upstream areas, tailings in Subreach A7 are commonly obscured by overhanging grassed topbank layers that drape into the channel (Figure 2-72). These overhanging upper bank features commonly form notably symmetrical failure patterns (Figure 2-73).

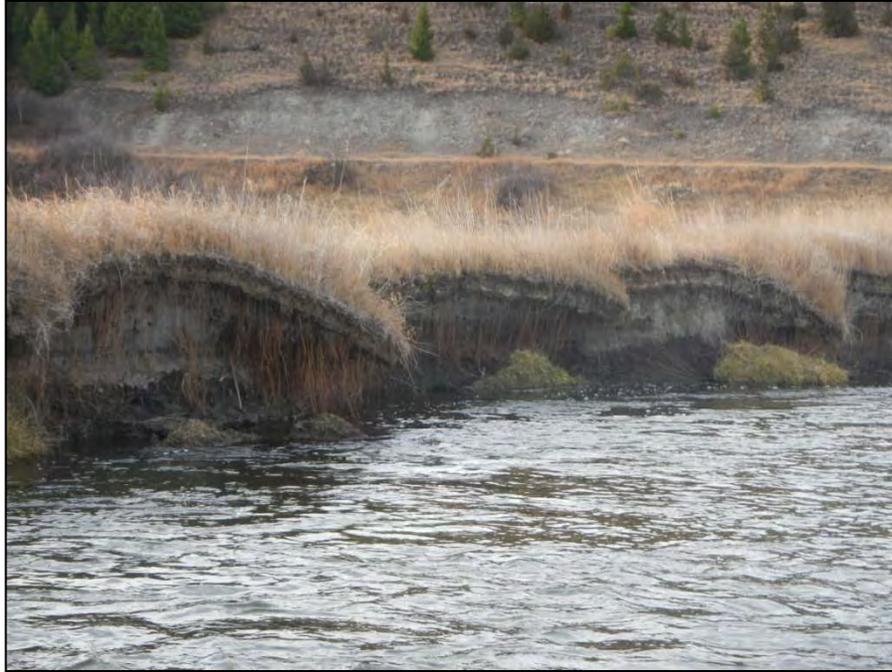
Figure 2-73. Symmetrical topbank overhang and collapse, Subreach A7, Phase 21, RM 43.65.

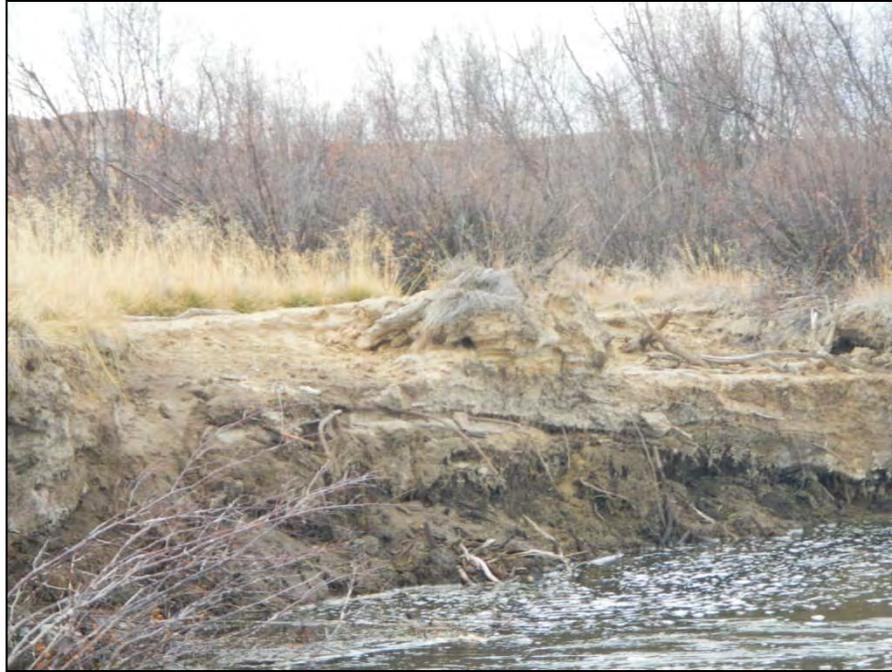
Figure 2-74. Slickens in old meander cutoff, Subreach A7, Phase 22, RM 43.9.

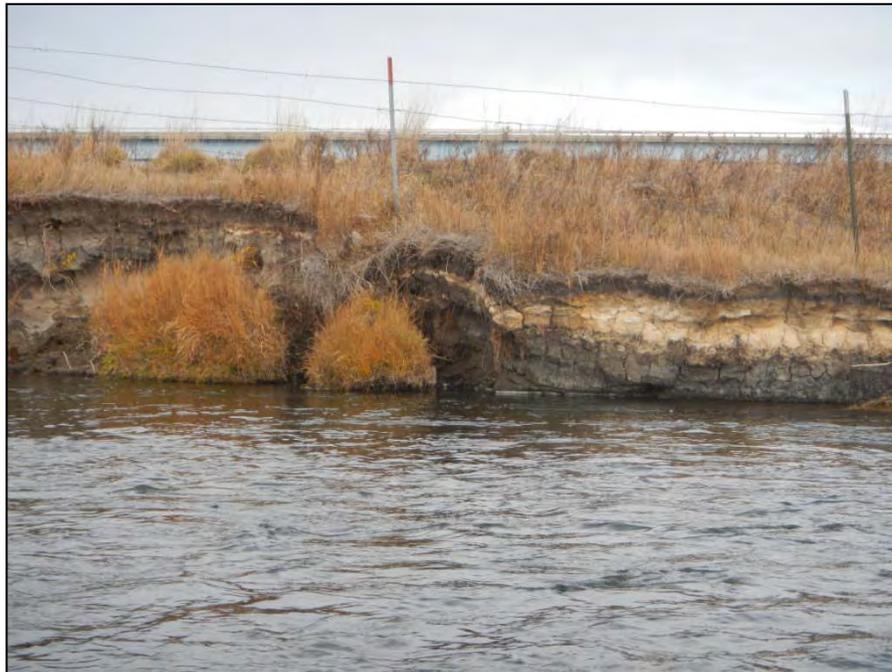
Figure 2-75. Right bank erosion showing topographic control on tailings deposition, Subreach A7, Phase 22, RM 45.0.

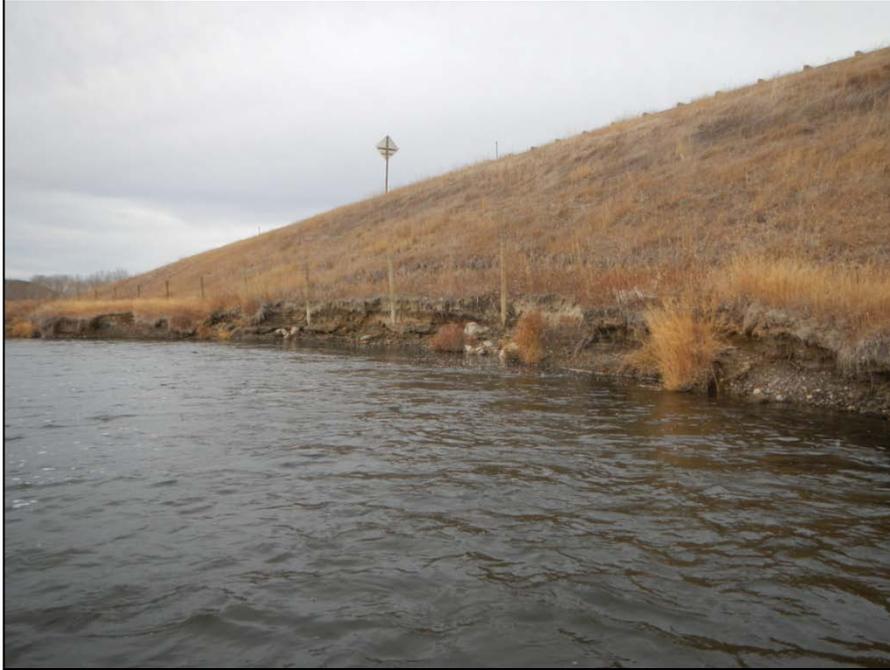
Figure 2-76. View downstream of erosion into I-90 embankment, Subreach A7, Phase 22, RM 42.25.

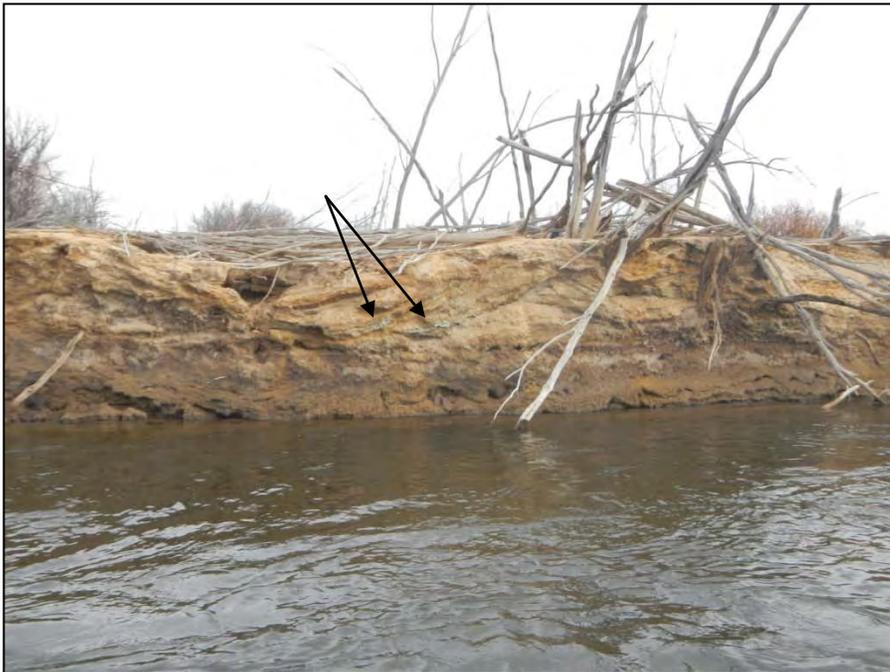
Figure 2-77. Slickens deposit at mouth of Little Blackfoot River, Subreach A7, Phase 33, RM 45.5; note green staining in middle of photo (arrows).
