What Trucking Owners and Managers should know –

Single Vehicle Crash:

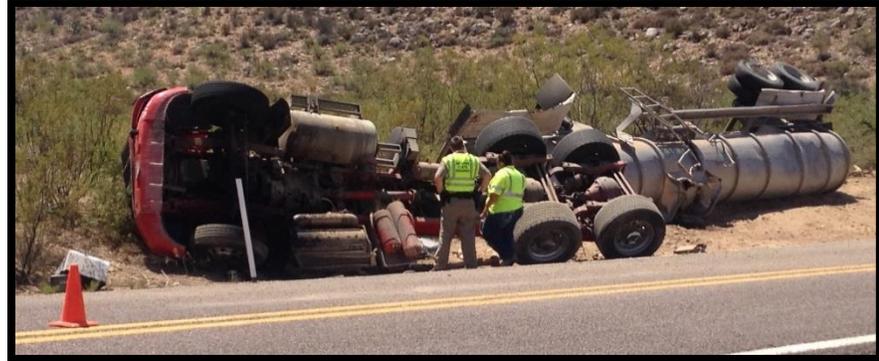
Figure 1: July 2018 rollover on Arizona SR 97

In July 2018, a semi-truck hauling an acid load rolled over on a curve going eastbound on Arizona highway SR 97. In speaking with the Arizona Department of Transport official at the site, he noted that too many experienced drivers are

involved in rollover crashes on the curves on SR 97. “They are just going too fast around these curves,” he lamented. This comment prompted an analysis of the curves on SR 97 with a detailed look at the curves where the rollover occurred, and to estimate the threshold speed at which a trailer would rollover and pull the tractor over as well.

After measuring the height of the center of the tank and adjusting for the weight of the undercarriage, the static roll threshold (SRT) for this trailer fully loaded, was estimated to be 0.49g. The compliance effects, springs, tires, undercarriage etc. were estimated to be 0.11g and lowering the roll threshold to 0.38g. Using the radius of the curve, it was calculated that the threshold speed at which a tip over would likely occur was 39 mph. Unfortunately, an actual rollover speed was not available from the GPS tracking system and was not recovered from the electronic control module (ECM) in the tractor.

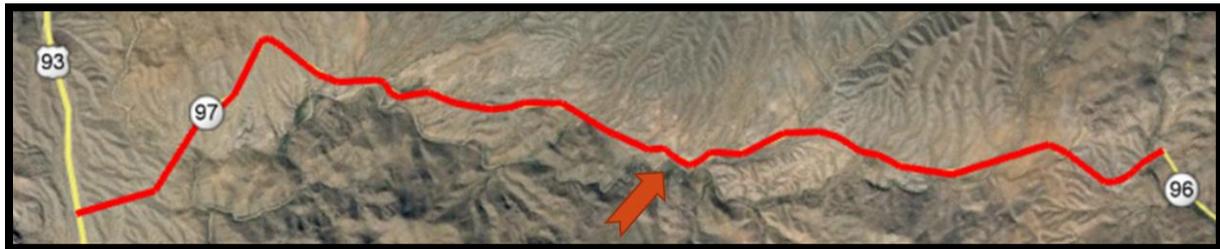
Figure 2: Curves along SR 97

State Route 97 (SR 97) is a 10.91-mile-long (17.56 km) state highway in Arizona. It runs from US 93 to SR 96 southeast of the town of Bagdad. The road was built by the late 1930s and improved during the late 1940s. Established as a state route in 1962, SR 97 was paved in the early 1970s. It is a two lane highway with virtually no shoulders on either side.

There were 15 curves identified along SR 97 that could pose a problem for semi-truck drivers. Several rollover accidents including the one in July occurred on curves #9 and #10.

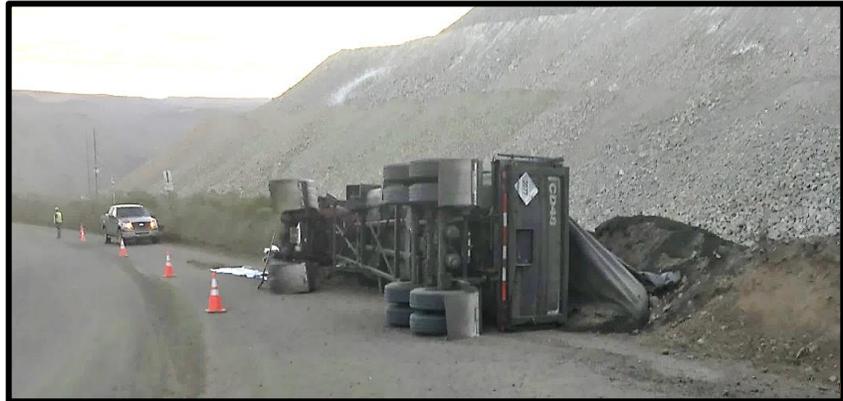
During the study, there was an opportunity to validate the tip over threshold calculations. In September 2018, a rollover occurred on a curve in an active mine property. The truck was loaded with approximately 30 tons of ore concentrate. The

height to the C of G of the load was measured and after adjusting for the weight of the undercarriage the SRT was estimated to be 0.46g. The compliance effects of springs, tires, undercarriage etc., that lower the tip over threshold, were estimated to be 0.11g and so lowering the rollover threshold to 0.35g. Using the radius of curvature of the curve, the tip over threshold speed at the crash site was determined to be **29 to 33 mph**. Later, the owner of the truck provided a readout from its GPS tracking system and the recorded speed, just 100 feet before the rollover, location was **34 mph**.
