**MANDATORY****SEL-71-07****TITLE**

POWER PLANT - TRANSMITTAL OF LYCOMING SERVICE BULLETIN NO. 632A IDENTIFICATION OF CONNECTING RODS WITH NON-CONFORMING SMALL END BUSHINGS

This service letter transmits Lycoming Service Bulletin No. 632A, Identification of Connecting Rods with Non-Conforming Small End Bushings. The Lycoming service bulletin has instructions to inspect engine serial numbers, connecting rod and connecting rod bushing part numbers, remove the cylinders and complete a connecting rod bushing press-out procedure. If a connecting rod, or connecting rod bushing is suspect, they must be replaced.

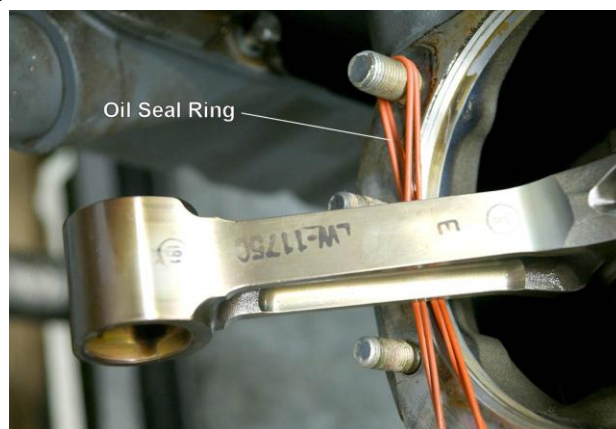
**Figure 2**  
**Oil Seal Ring Installed on the Crankcase Studs**

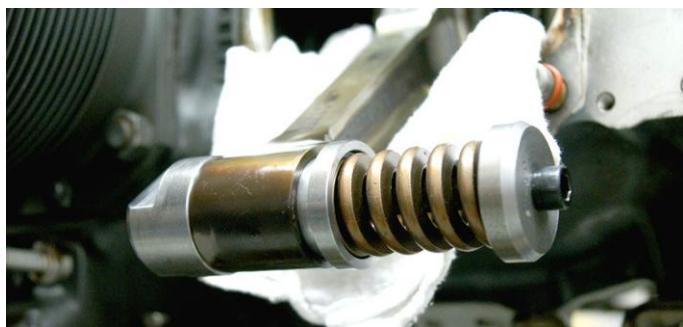
**Figure 5**

### **ST-531 Installed in the Connecting Rod**

4. Install the tool in the piston end of the connecting rod (Figure 5) and reinstall the bottom section.
5. Hold the bottom section of the ST-531 and turn the bolt head until finger-tight (Figure 6).
