Topcon Sokkia announces an update to the SHC5000/6000 RAM Clip Mount Kit

Part Number 1015317-01

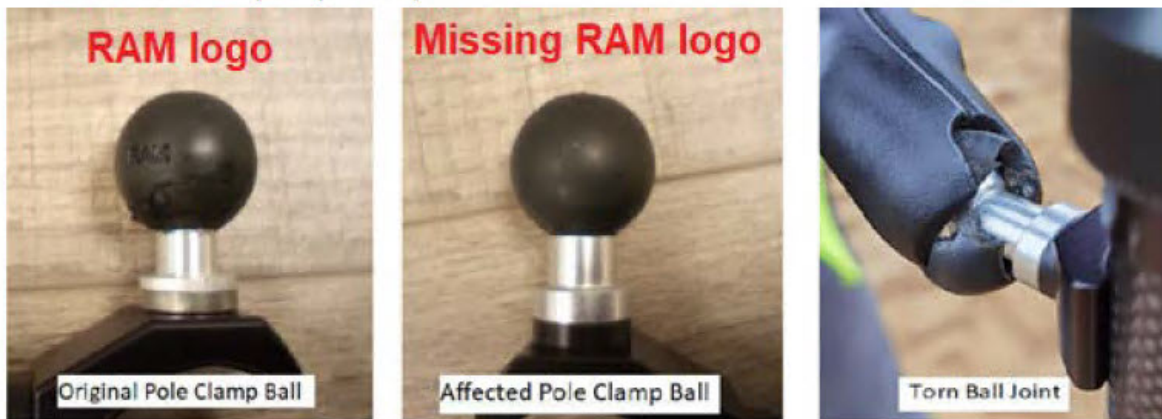
A change made by the supplier to the mounting ball used in the FC/SHC5000/6000 ram clip mount kit may result in an early failure of the ball joint when the clamp is not loosened to adjust the mount. This strain can cause a crack in the rubber ball and failure to support the tablet. The issue has been resolved. There is a potential for product to be out in the field that may cause a premature failure.

How to identify a defective Pole Clamp with Ball:

The affected product can be identified by its matte finish and the absence of the "RAM" logo imprinted on the ball. (See photos)

The FC/SHC5000/6000 Ram Clip Mount Kit contains three parts, The Pole Clamp with Ball, Arm and Mount. *Please only return the defective Pole Clamp with Ball P/N 1059582-01 for replacement.*

Please inspect the pole clamp with ball and contact Topcon customer service for an RMA to replace. Replacements may not be available immediately and will be shipped on a first come-first served basis. The replacement program will end January 31, 2023.
