Web Presentation

Sample Report

Property Address: 8686 Anywhere Dr., Ft. Worth, TX 76179

SharpSight Home Inspections

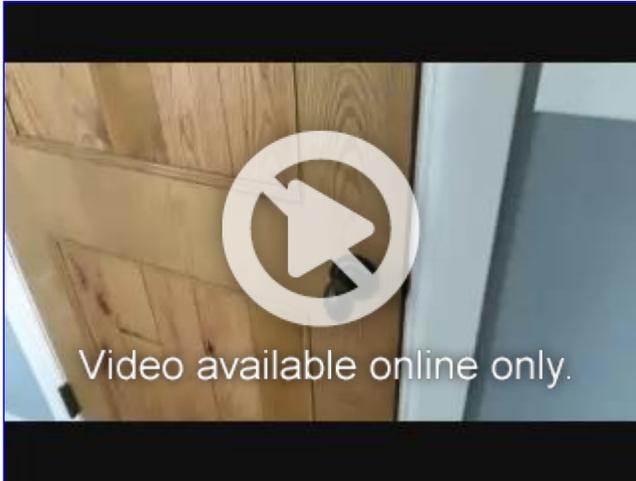
A. Item 1(Video)

The visible areas of the concrete foundation do not reveal any obvious signs of shift or damage; however, I have included photos and videos that reflect cracking in walls and ceilings, doors that do not function properly and framing members that appear to have minimal separation. These items suggest the foundation has shifted sometime in the past.

I recommend obtaining and reviewing all documentation provided by the foundation contractor and the final report by the structural engineer. Perhaps the foundation company offered a transferrable warranty.

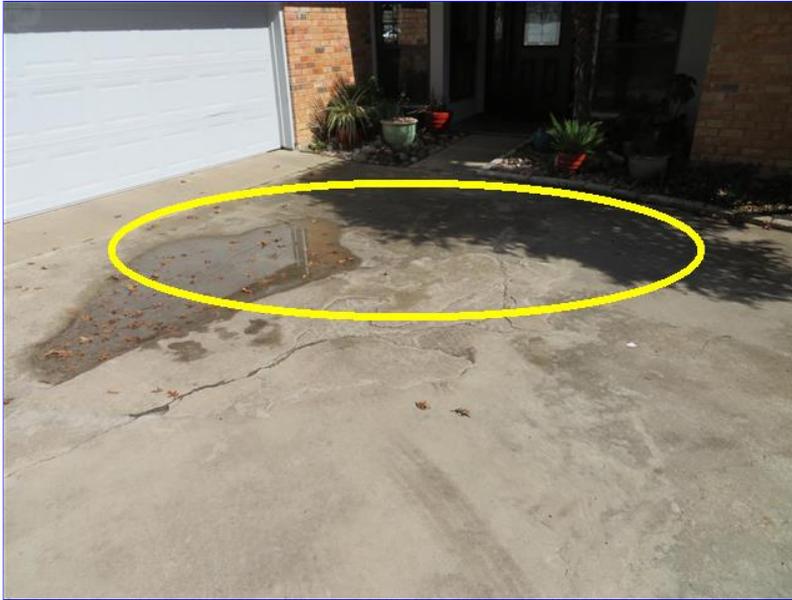
B. Item 1(Picture)

(1) The grading located at the front of the home (driveway) is inverted or in other words the grading is angled back towards the home. Improper grading can allow water penetration that can cause subsequent damage including mold growth. Also, improper grading/draining can cause subsequent damage to the foundation. Grading should be pitched so that water runs away from the home. I recommend further review and correction by a qualified contractor.

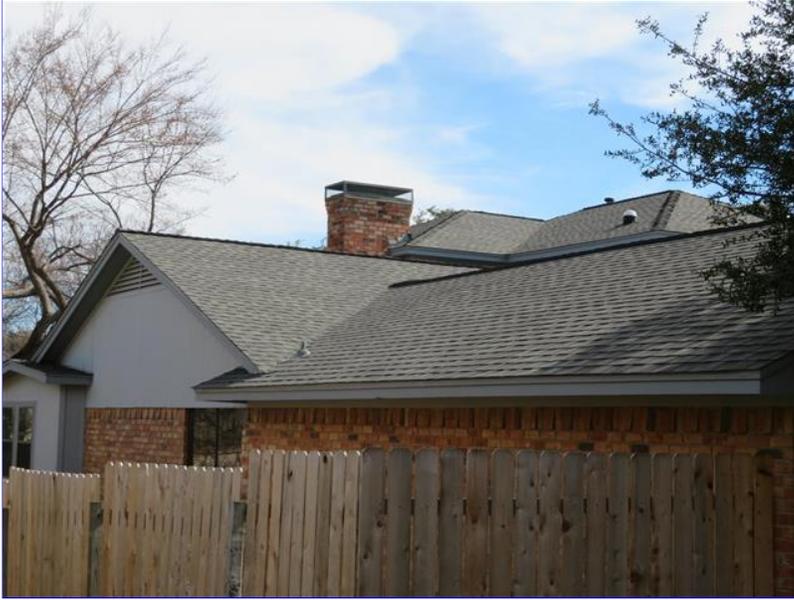
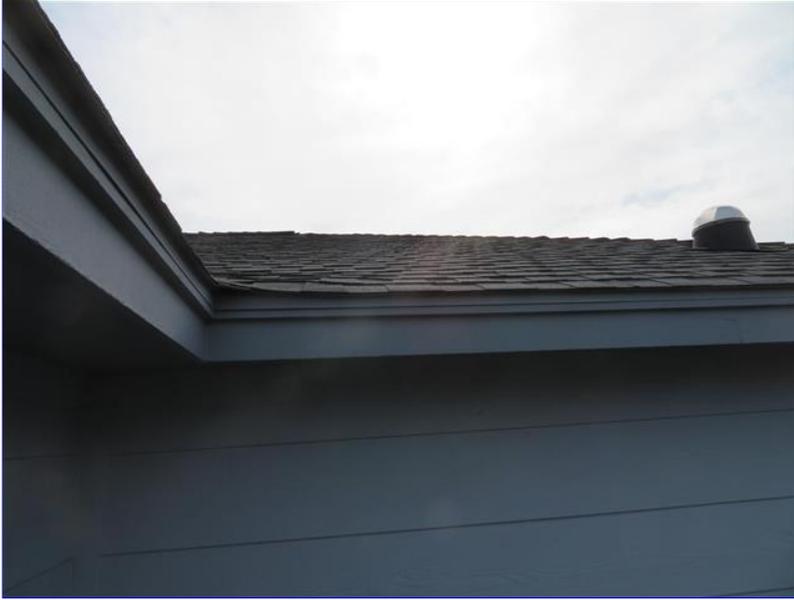
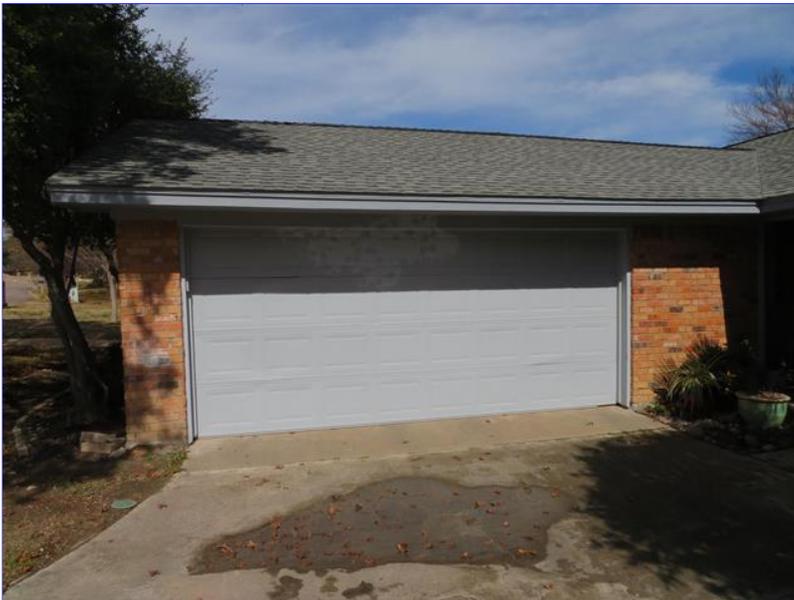
(3) There are no gutters installed on the home. Gutters and drain lines properly direct rain water away from the structure. Pooling rain water can lead to moisture intrusion, mold growth, soil erosion and wood rot. I recommend further review and correction by a qualified guttering contractor.

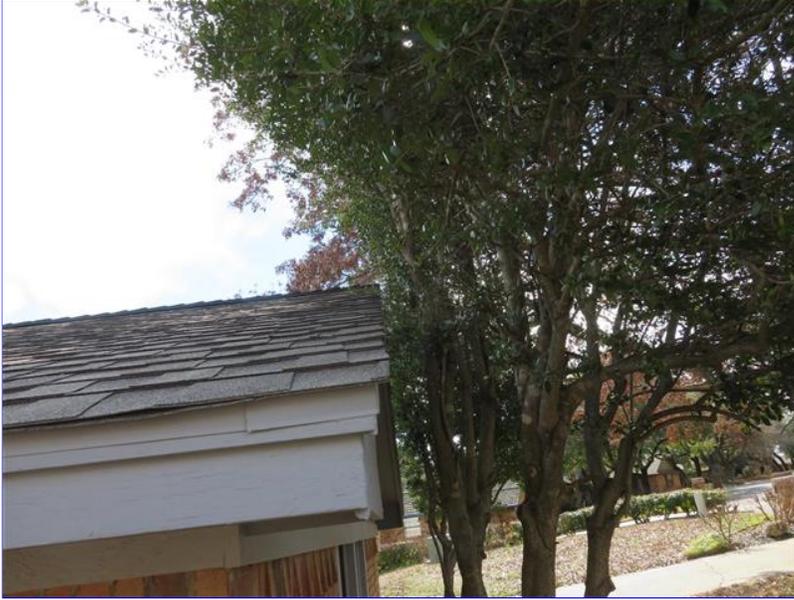
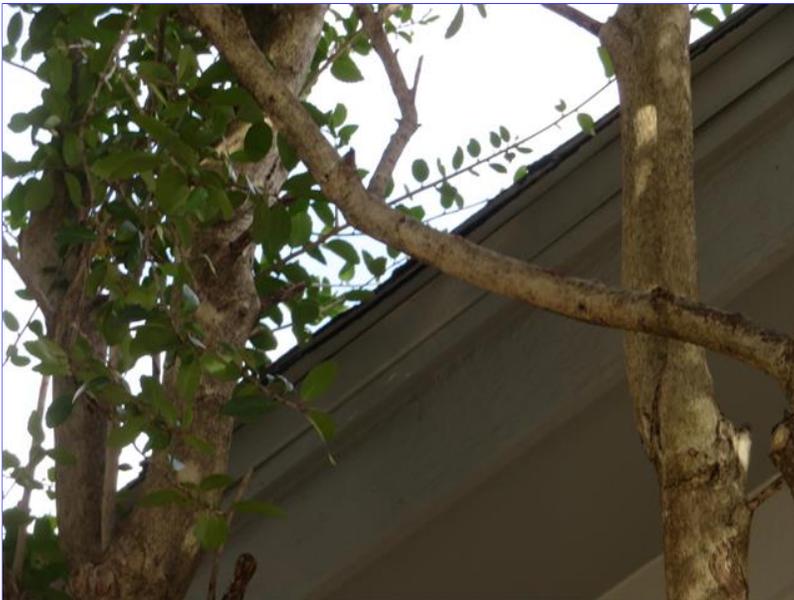
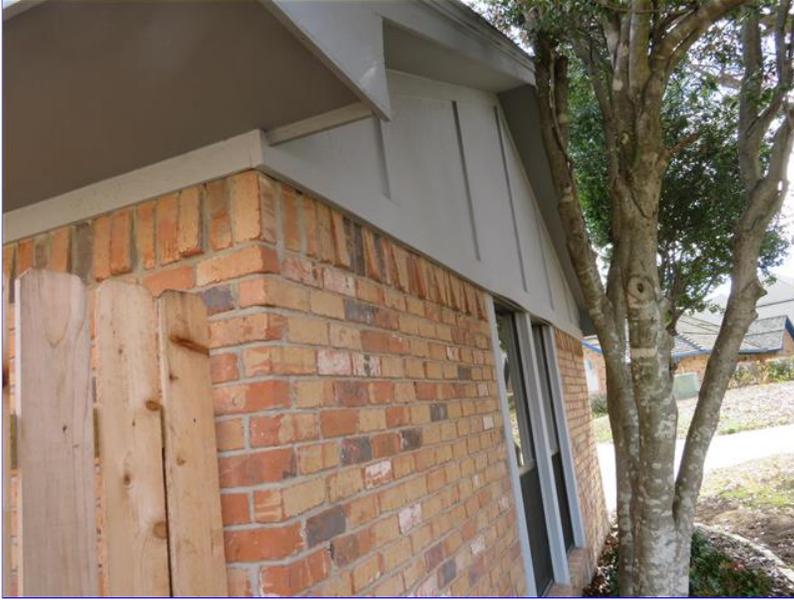
(1) There are tree limbs scraping the roof covering above the garage. Tree limbs scraping on the roof's surface will cause damage to the shingles and can also cause damage to the siding of the home. I recommend a qualified handyman trim the tree limbs a minimum of 6 feet away from the home.

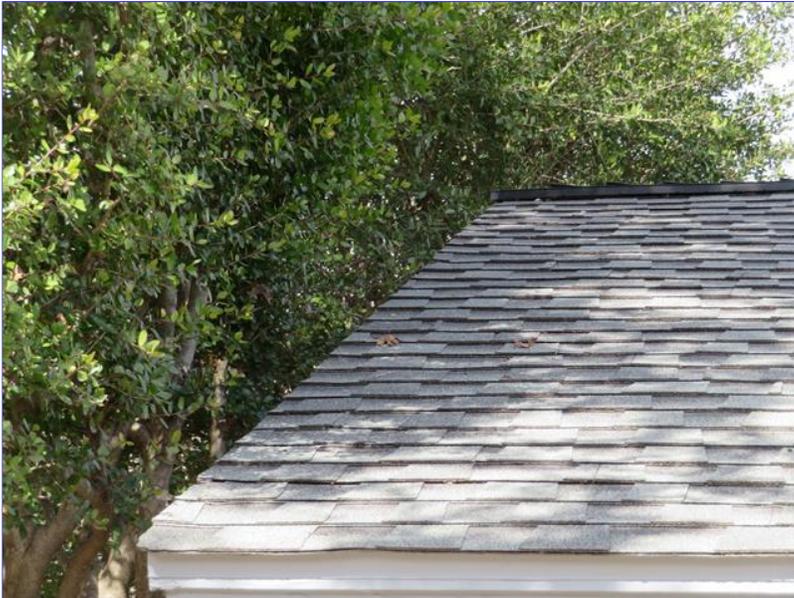
C. Item 4(Picture)

(2) The roof covering is not new; however, it appears to be functioning as intended.

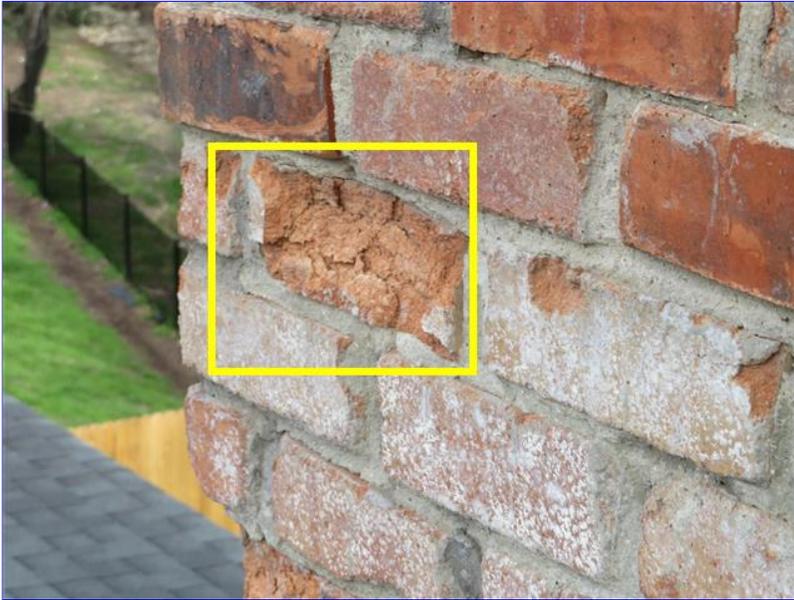
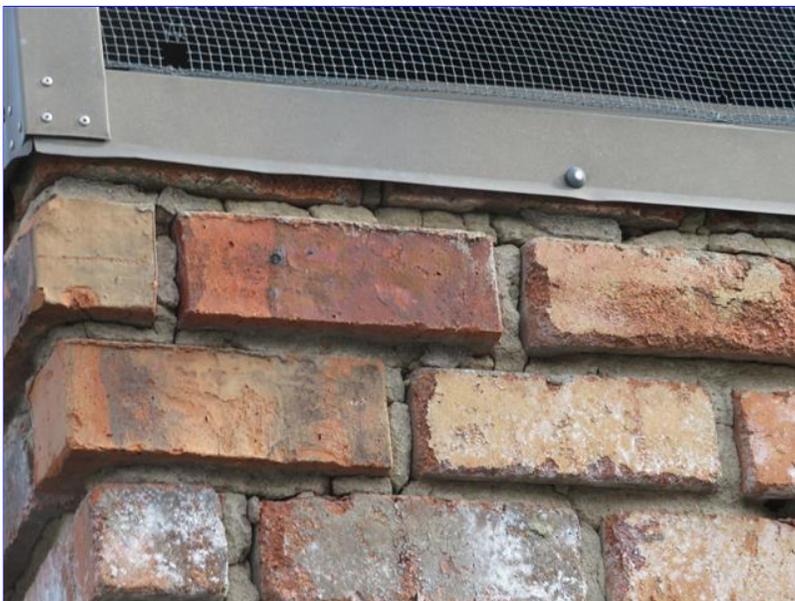
(2) The face of a few of the bricks surrounding the chimney have fallen away. Also, the mortar between some of the brickwork is deteriorated and could benefit from re-pointing (adding additional mortar). The bricks appear to be deteriorating due to age. Damaged brickwork and mortar could allow water penetration that could cause subsequent damage. I recommend further review and correction by a qualified contractor.

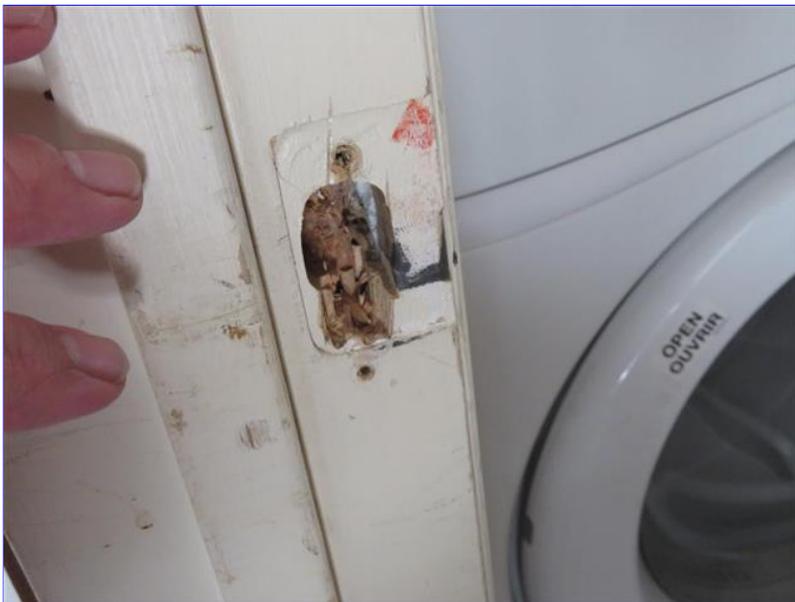
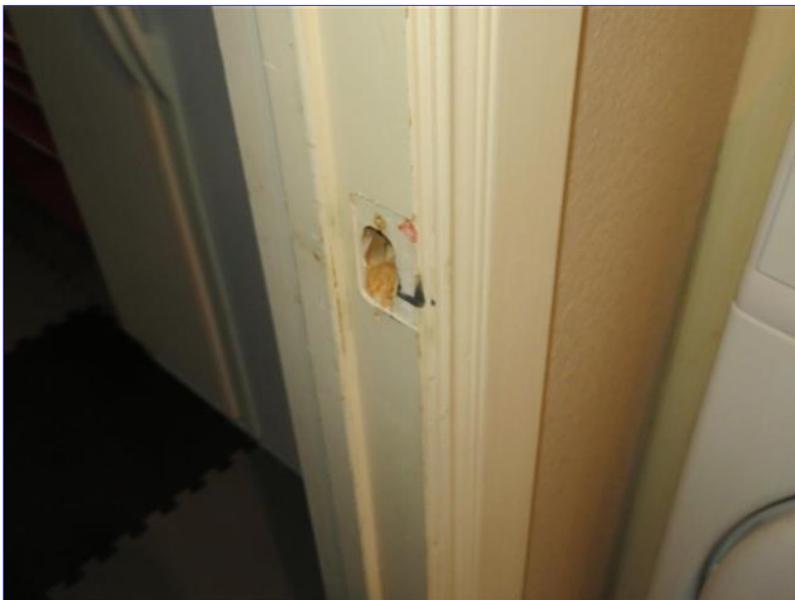
(1) The door leading to the garage and the door leading into the downstairs master suite are missing strike plates. A strike plate is a metal plate with a hole (or holes) cut out of it. The door strike is fastened, usually by screws, onto the frame of a doorway, and it is carefully aligned with the lockset in order to give the latch a place to sink into when the door closes. A missing strike plate could allow the door frame to become damaged. I recommend further review and correction by a qualified handyman.

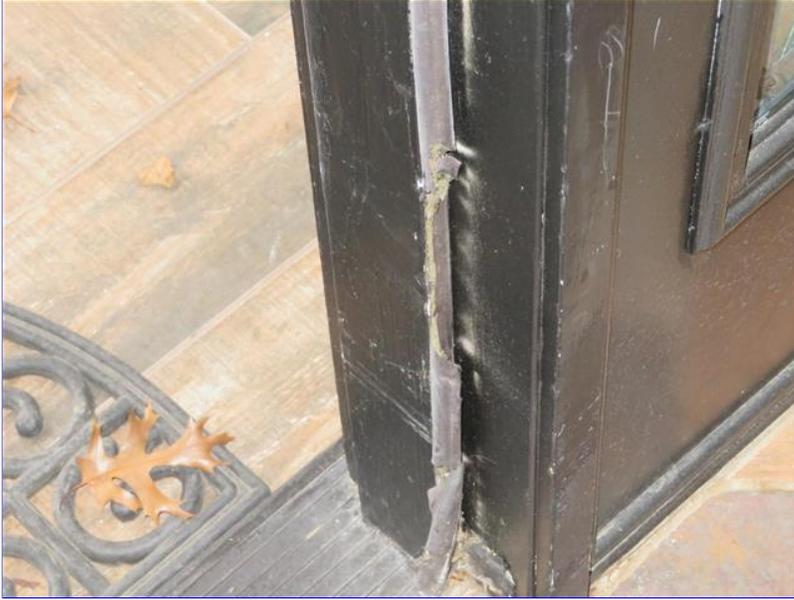
(2) The weather stripping around the front door is damaged. Damaged weather stripping allows conditioned air to escape the home causing AC units and furnaces to consume additional energy to maintain a set temperature. I recommend further review and correction by a qualified handyman or contractor.

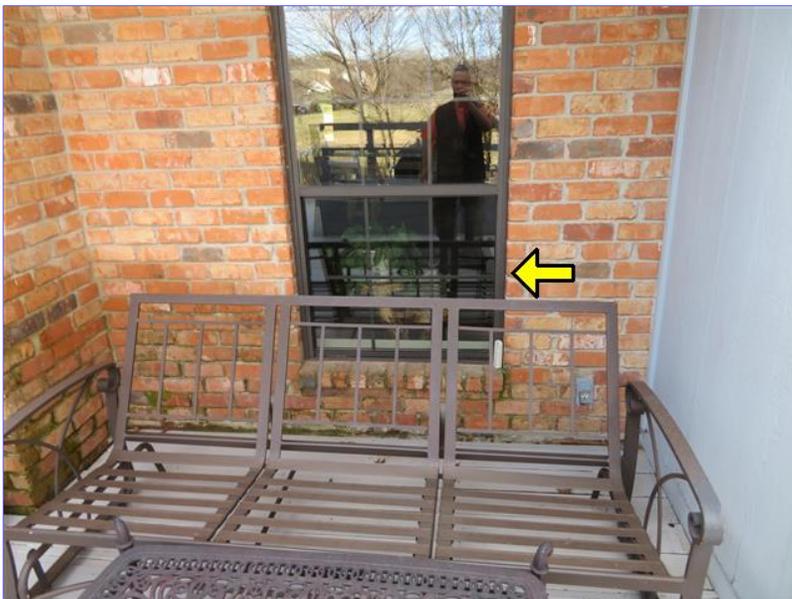
H. Item 1(Picture)

(1) The window screen on the back side of the home is missing Missing window screens are a nuisance and limit the homeowners' ability to ventilate the home without offering access to pests and insects. I recommend further review and correction by a qualified window contractor or handyman.

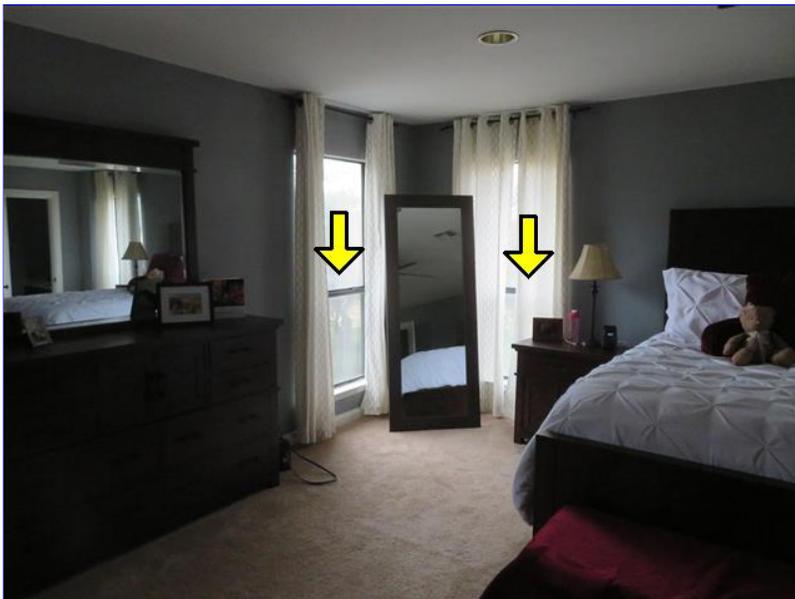
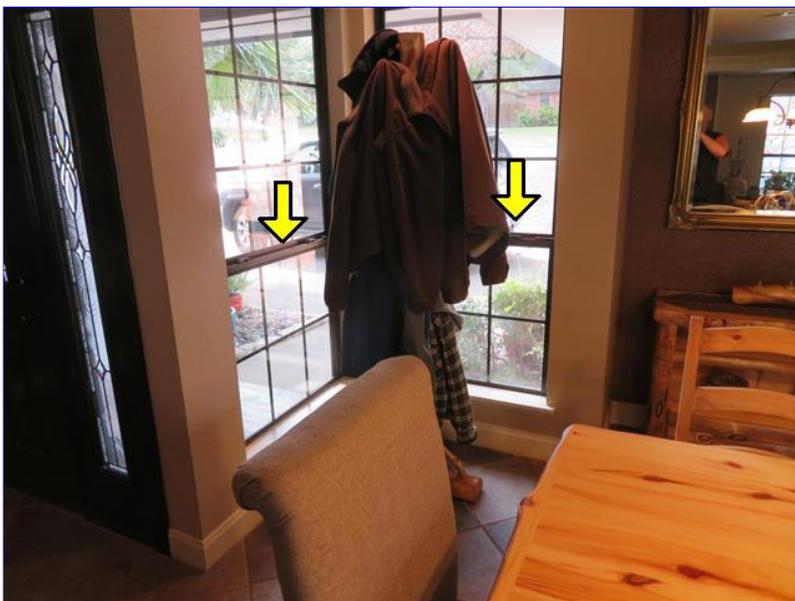
H. Item 2(Picture)

(2) Two windows in the upstairs master bedroom and two downstairs in the dining area would not remain

in the open position. Windows that are inoperable are a nuisance. Windows that will fall after opening are a safety concern. I recommend further review and correction by a qualified window contractor.

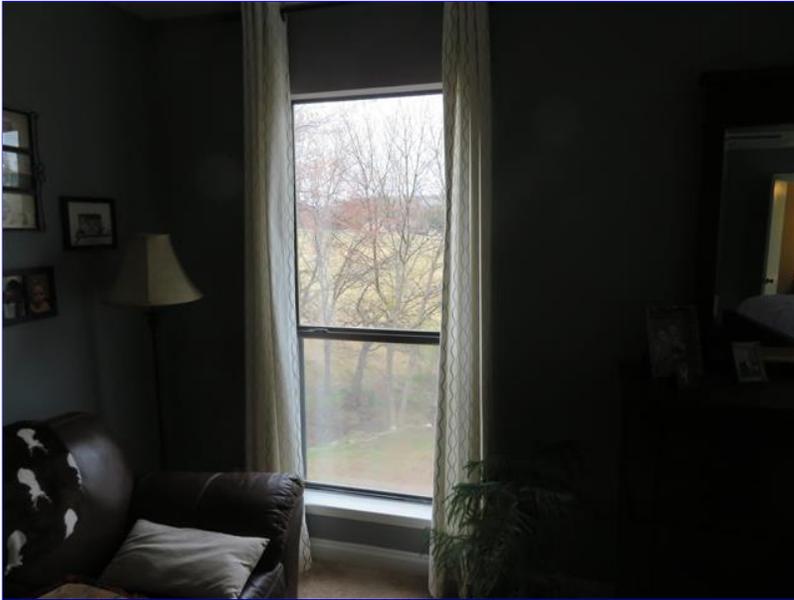
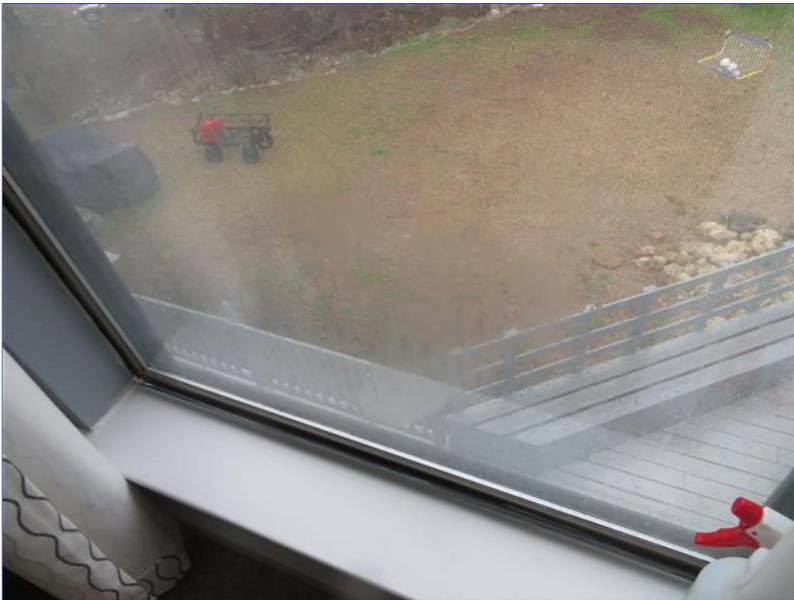
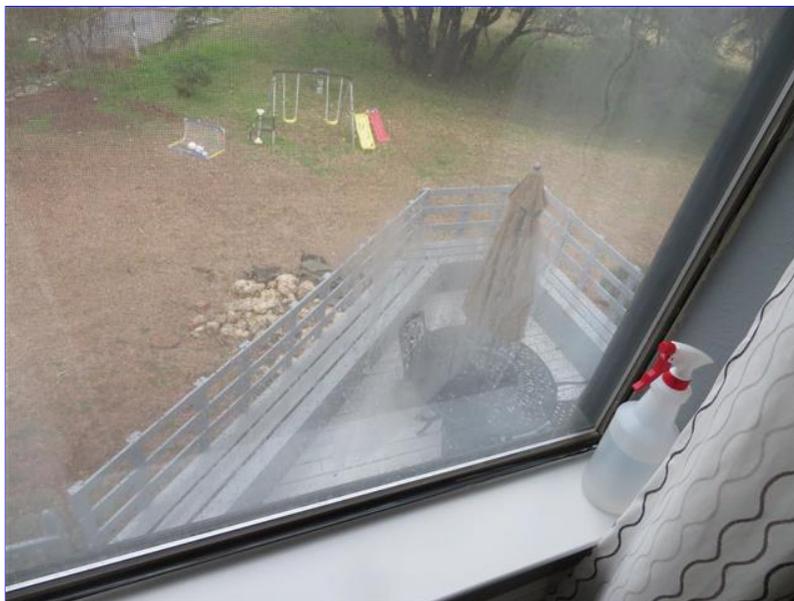
(3) The window located in the upstairs master suite has lost its seal allowing moisture to penetrate between the glass panes. Ineffective seals allow warm air to escape in the winter and cool air to escape in the summer, thus making furnaces and air conditioning units work harder and use more energy. I recommend further review and correction by a qualified window contractor.

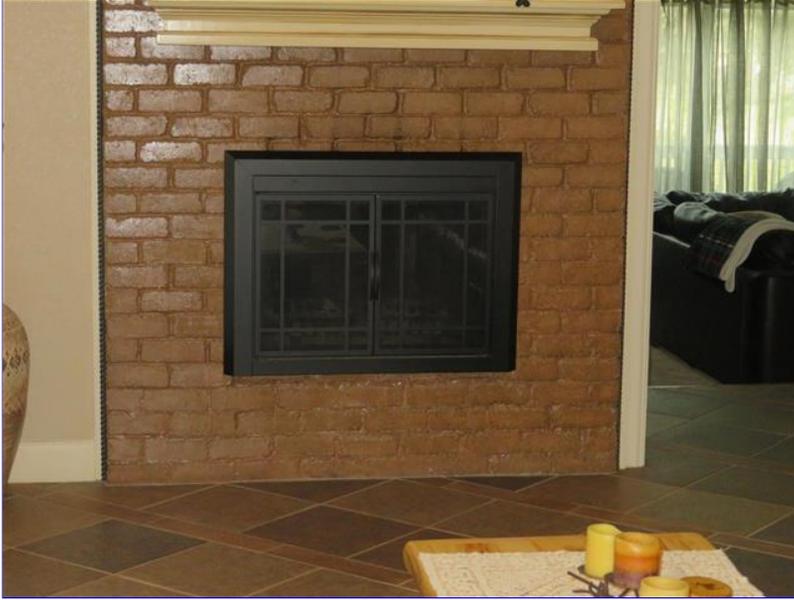
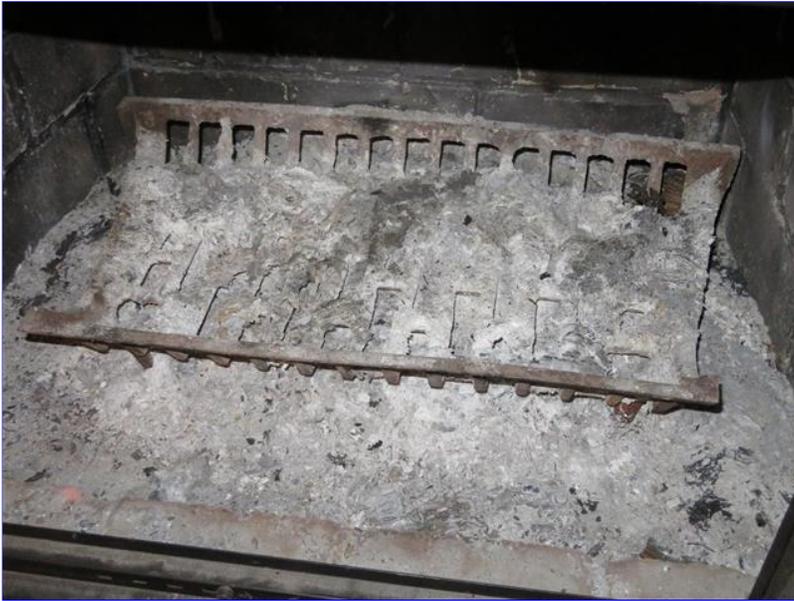
(1) The fireplace was full of ash during the inspection and the base of the fireplace was not visible for inspection. No obvious defects were observed; however, due to the inherent dangers posed by an improperly maintained fireplace and the limited nature of a general home inspection, I recommend a qualified fireplace contractor service the fireplace then review the safety and functionality of the fireplace, including a chimney inspection, prior to first use.

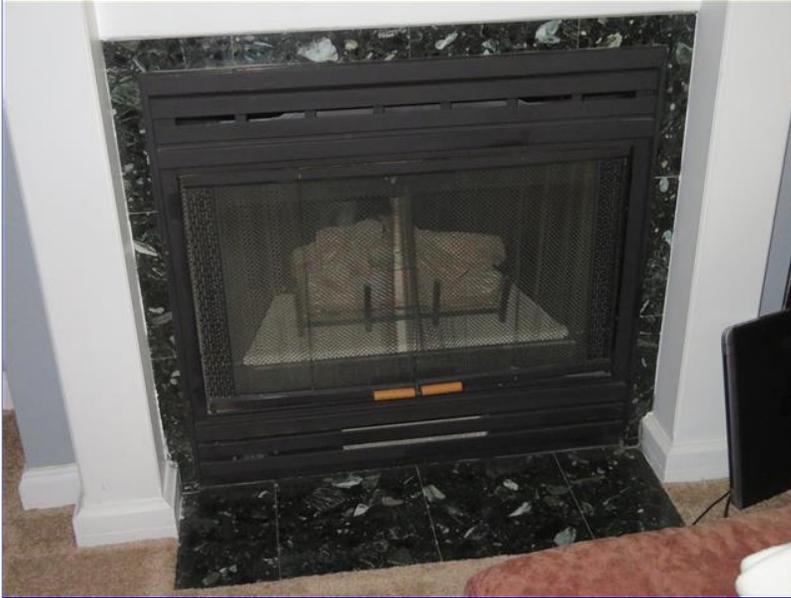
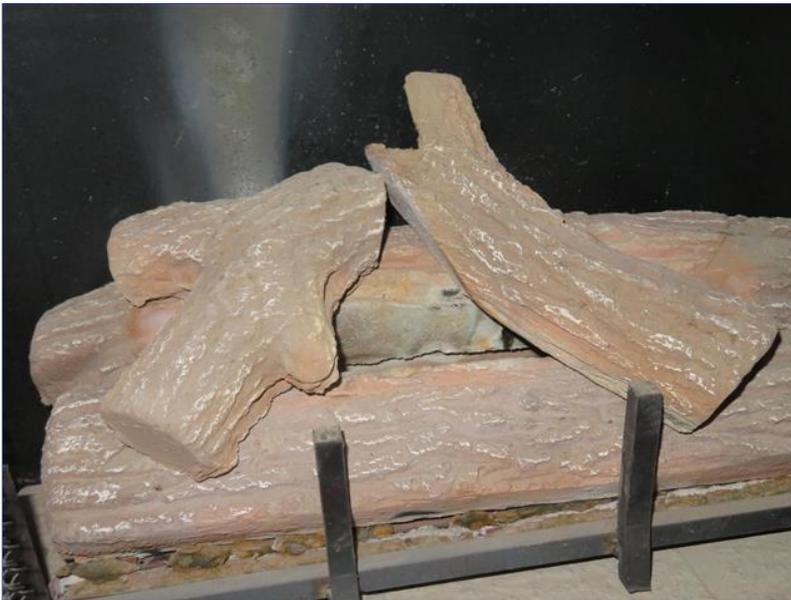
J. Item 5(Picture)

(2) The gas fireplace did not operate during the inspection. Inoperable gas fireplaces are a nuisance and a safety concern. Additionally, the unit is dirty/dusty and has not been serviced in some time. All major gas fireplace manufacturers recommend an annual inspection and cleaning. Dust, dirt, and spiders can all infect and clog up the orifices and burner ports of your gas fireplace causing the unit to burn inefficiently or, worse yet, not at all. Loose or dirty wire connections also affect the operation of the unit. Gaskets wear out and can allow poisonous carbon monoxide to be dispersed into your home. An annual inspection, cleaning and adjustment of your gas fireplace is suggested to correct and prevent these problems. I recommend the unit be further reviewed and serviced by a qualified fireplace contractor.

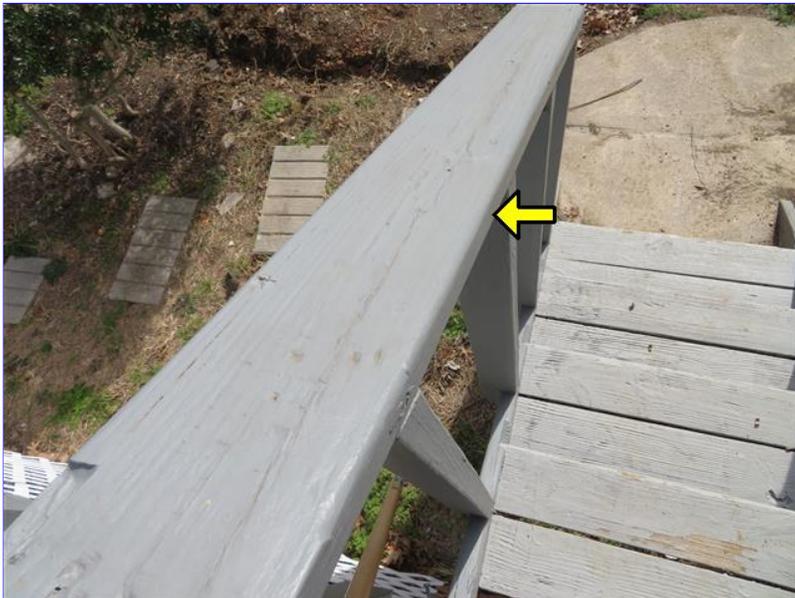
K. Item 17(Picture)

(3) The handrails on the back deck steps are lacking a graspable handrail. Graspable handrails are recommended in any area with more than three steps in order to prevent or interrupt trip, slip, and fall hazards. I recommend further review and correction by a qualified carpenter or handyman.

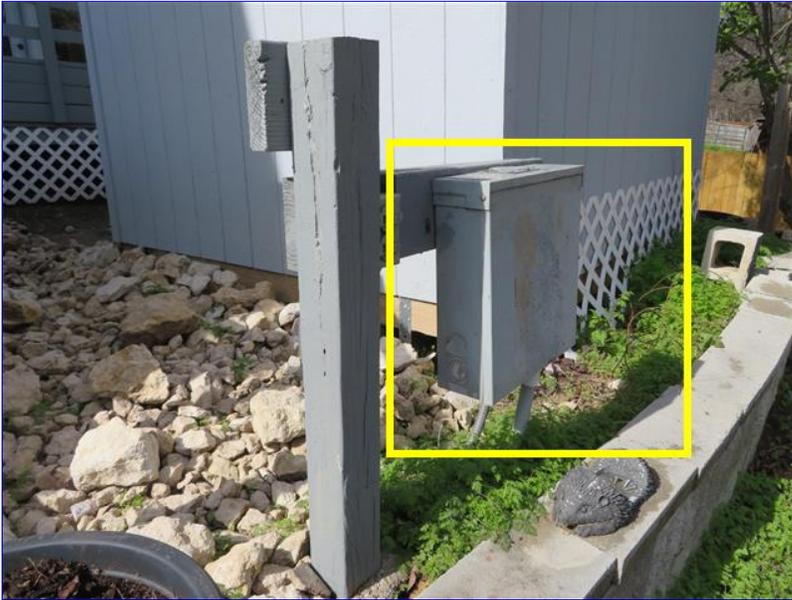
A. Item 1(Picture)

(1) The sub-electrical panel in the backyard is a Federal Pacific brand box. Federal Pacific Electric was a manufacturer of electrical breaker panels in many homes built during the 60's and 70's. Research has shown the breakers designed for use in the boxes have a high fail rate, which has led to hundreds of house fires nationwide. The problem is, they may appear to work fine for years, but can fail at any given time without notice.

Local building codes have outlawed installing the panels in new homes. Most codes do not even allow adding breakers to the existing boxes, instead requiring an additional breaker box for higher amperage circuits such as appliances. Many title companies are even requiring that they be replaced prior to sale.

Additionally, the sub-panel box is rusted, has loose conduit and is missing knockouts. For safety reasons I recommend further review and replacement of the distribution panel by a qualified electrical contractor.

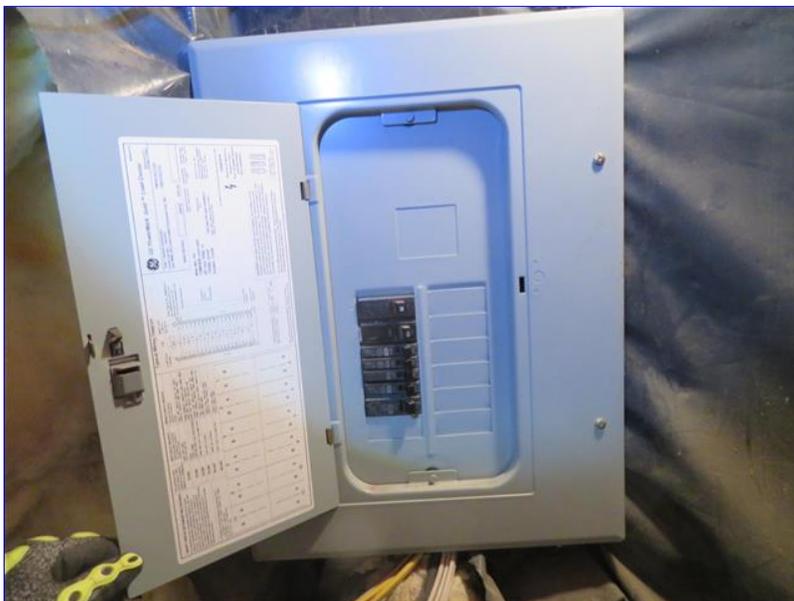
A. Item 8(Picture)

(3) There is a sub-electrical panel located in the first level attic.

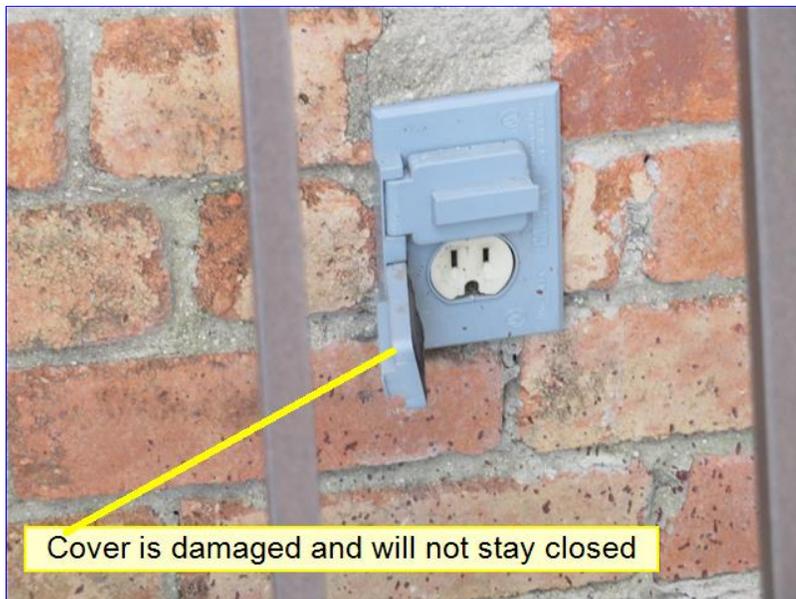
B. Item 1(Picture)

(1) The water resistant cover on an electrical receptacle at the back deck is damaged and will not remain closed. For safety reasons exterior electrical receptacles should have properly working water resistant covers. I recommend further review and correction by a qualified electrical contractor.

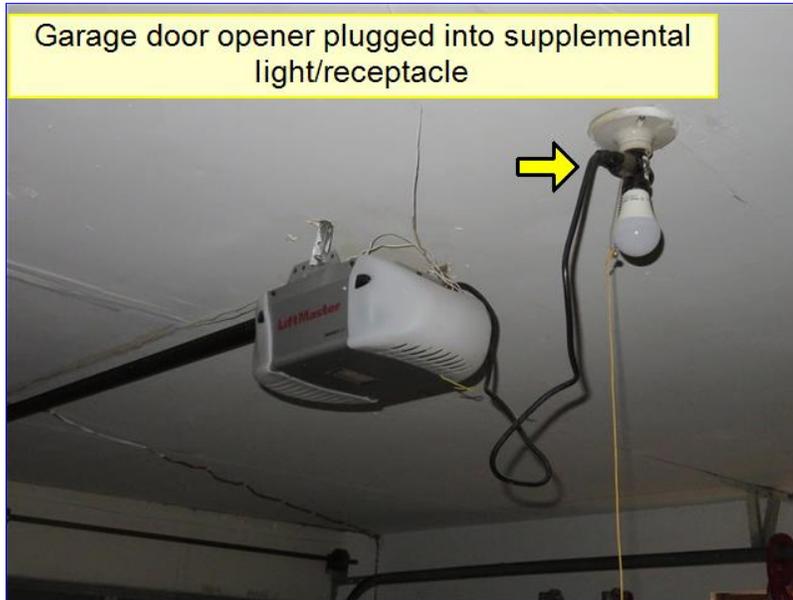
B. Item 6(Picture)

(4) The garage door opener is plugged into an electrical receptacle added to the light fixture. Typically, power to a garage door operating unit is supplied through a dedicated plug and circuit. I recommend further review and correction by a qualified electrical contractor.

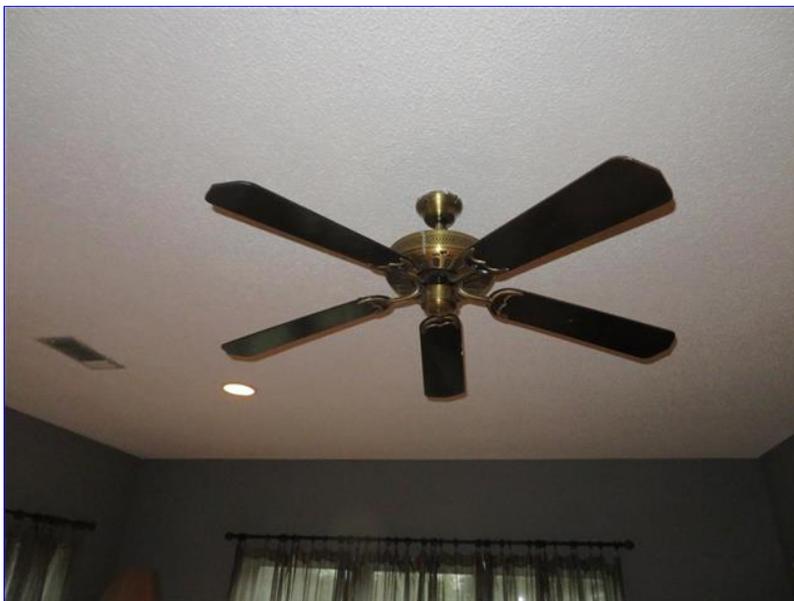
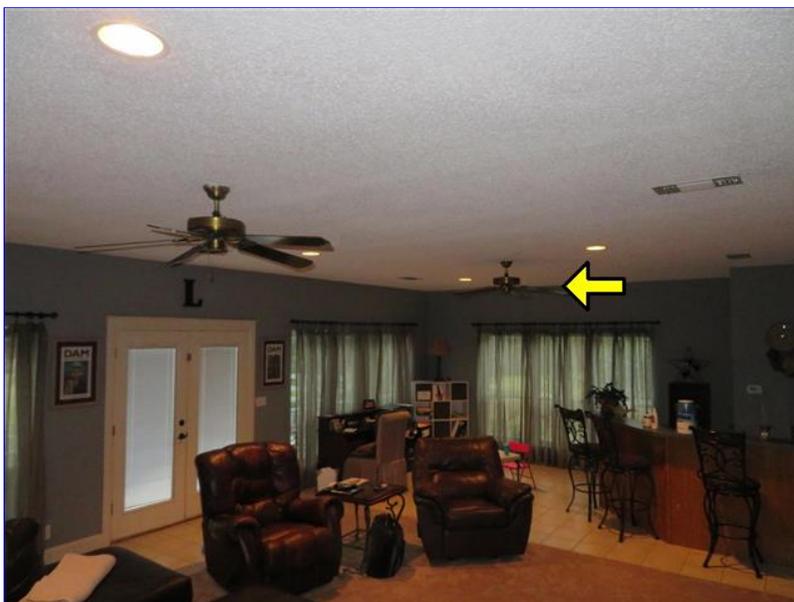
(5) A ceiling fan in the den was inoperable during the inspection. Inoperable ceiling fans are a nuisance and any inoperable electrical component is a safety concern. I recommend further review and correction by a qualified electrical contractor.

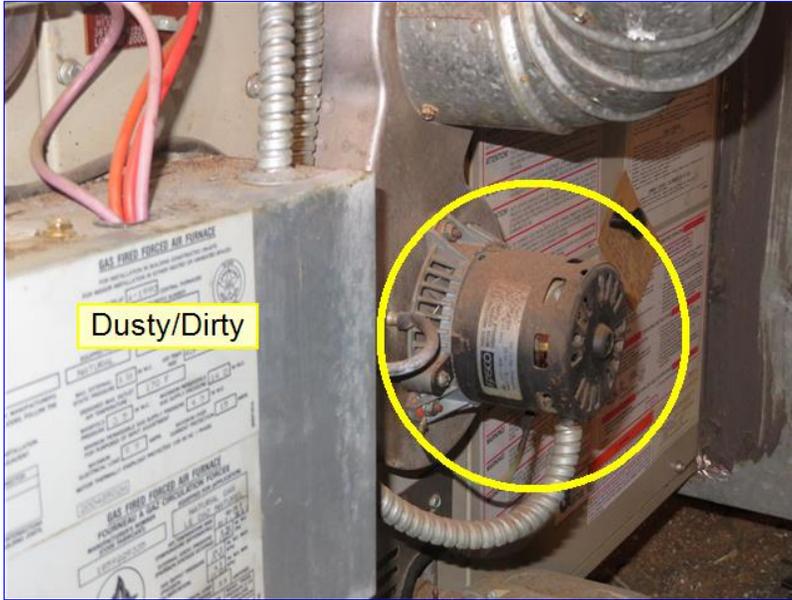
A. Item 6(Picture)

(2) The furnace located in the lower attic operated as desired during the inspection; however, it is dusty/ dirty and does not appear to have been serviced in some time. Furnace maintenance is an important part of the efficient operation of a warm-air heating system and should never be neglected. Dust and dirt limit the performance of the furnace causing it to consume additional energy to maintain a set temperature. Maintaining a furnace includes cleaning and/or replacing the air filter on a regular basis. Furnaces should be periodically serviced by a qualified technician and a maintenance schedule should be posted near the furnace that includes dates of service, maintenance comments, repairs performed, etc. I recommend this unit be further reviewed, serviced and certified by a qualified HVAC contractor.

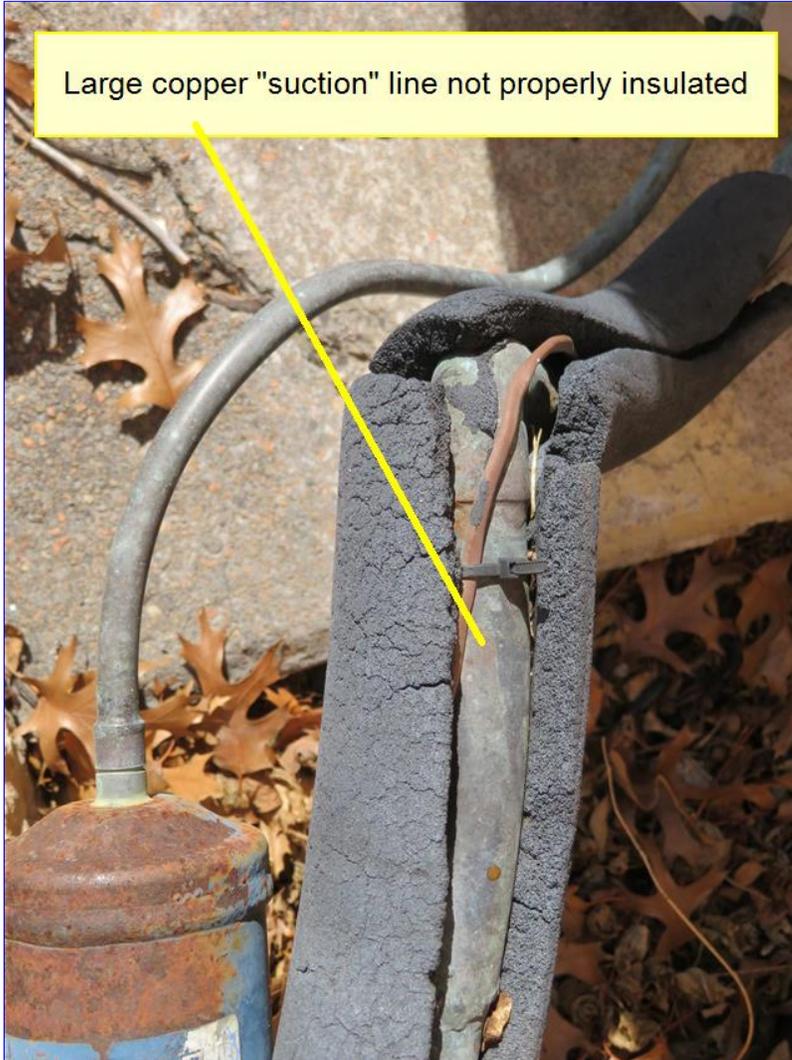
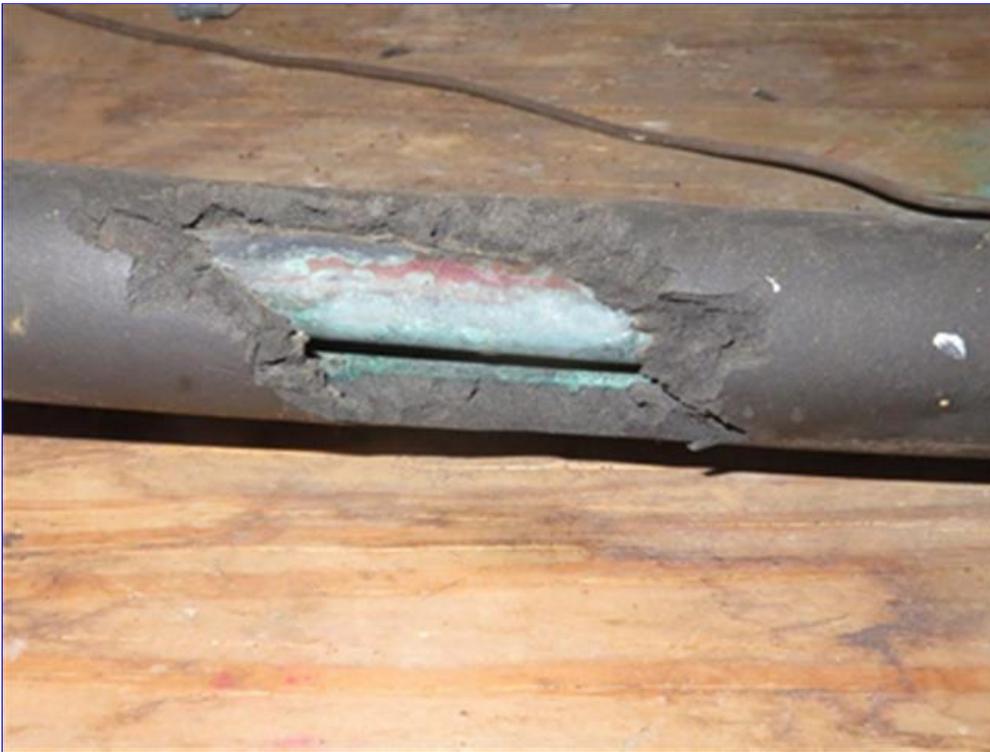
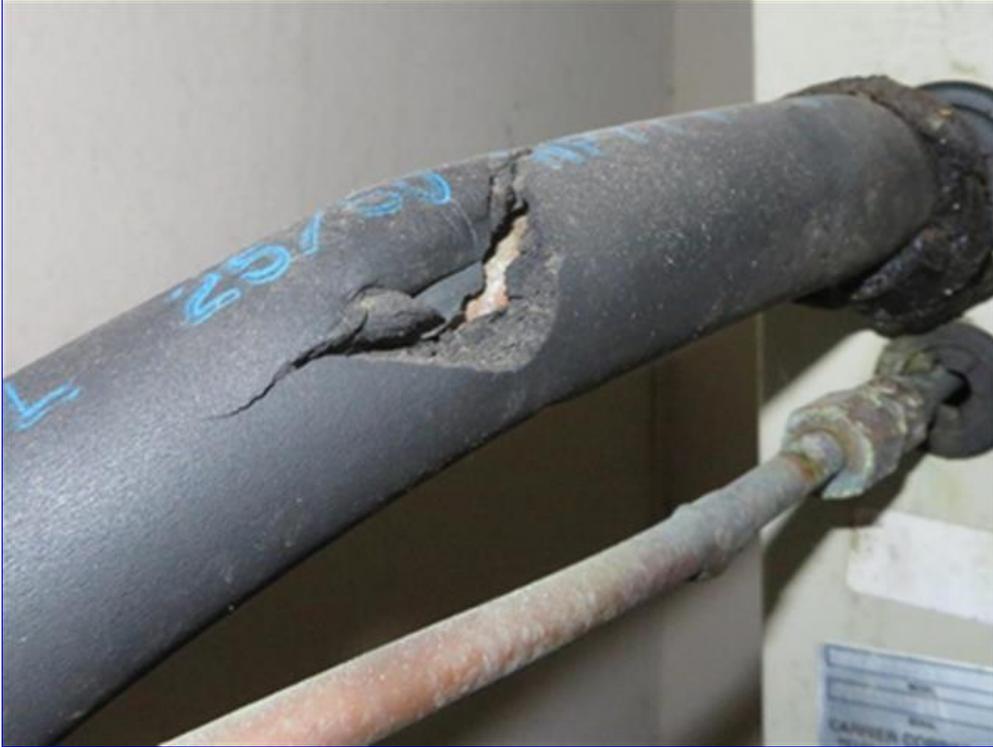
There are three AC units servicing the home all appear to be aged and may be operating beyond their normal life expectancy. I was unable to operate the AC units because the outside air temperature was below 60 degrees. Operating AC units when the outside temperature is below 60 degrees can cause damage. Additionally, the insulation surrounding the suction lines on all the AC units is damaged and in some areas missing. The last compressor unit has its piping buried under soil. Damaged or missing foam insulation on the suction line causes the AC unit to consume additional energy to maintain the set temperature. The lack of proper insulation on the suction lines indicates the units have not been serviced in some time. I recommend further review and correction by a qualified HAVC contractor.

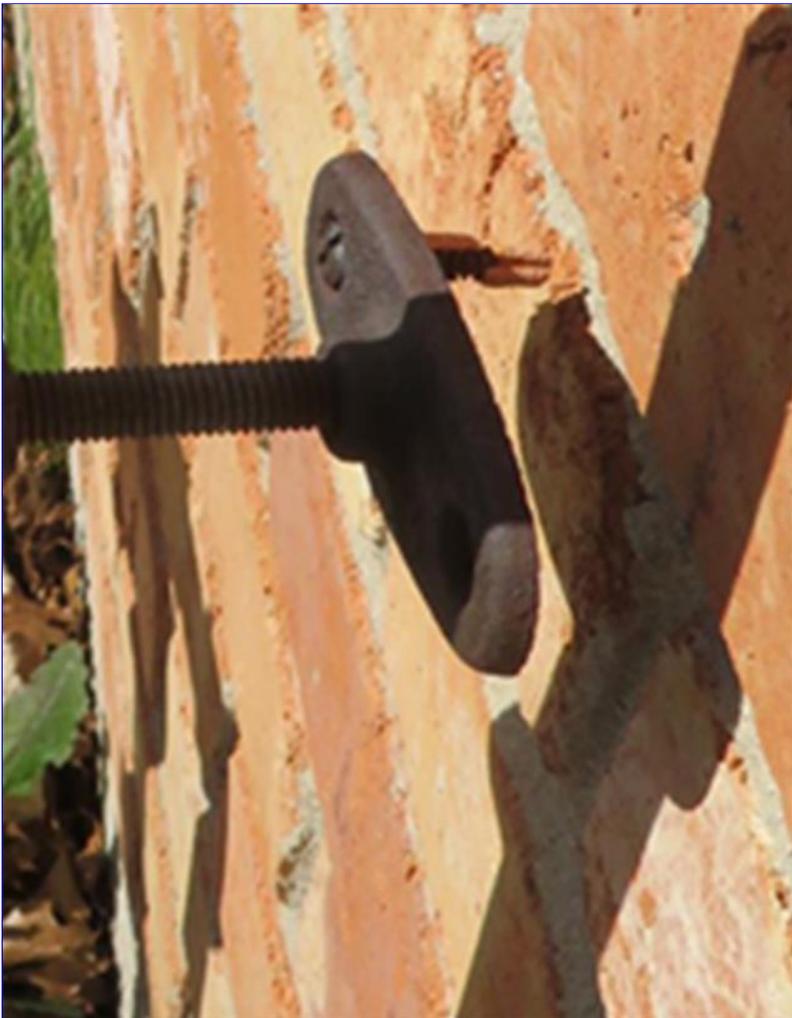
A. Item 2(Picture)

A bracket that should be supporting the main gas line entering the home is unattached. Improperly supported gas supply lines can become damaged and leak natural gas. For safety reasons I recommend further review and correction by a qualified plumbing contractor.

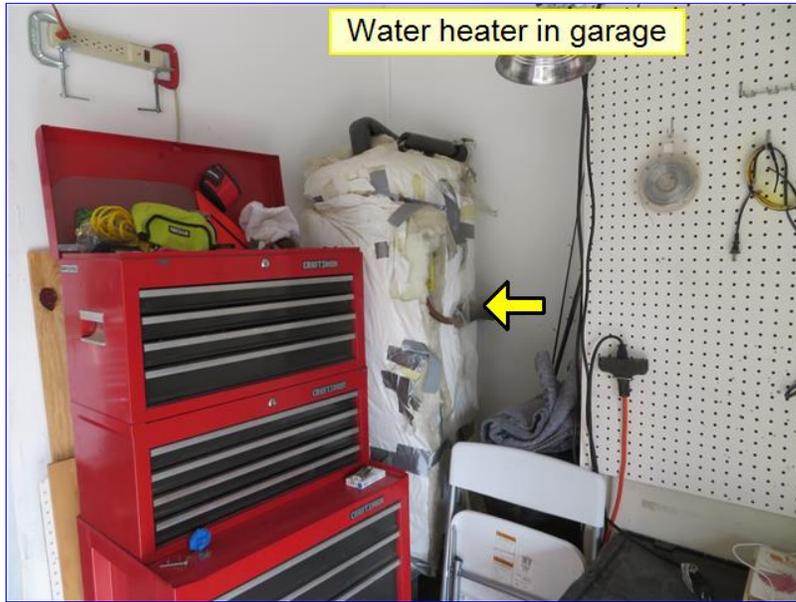
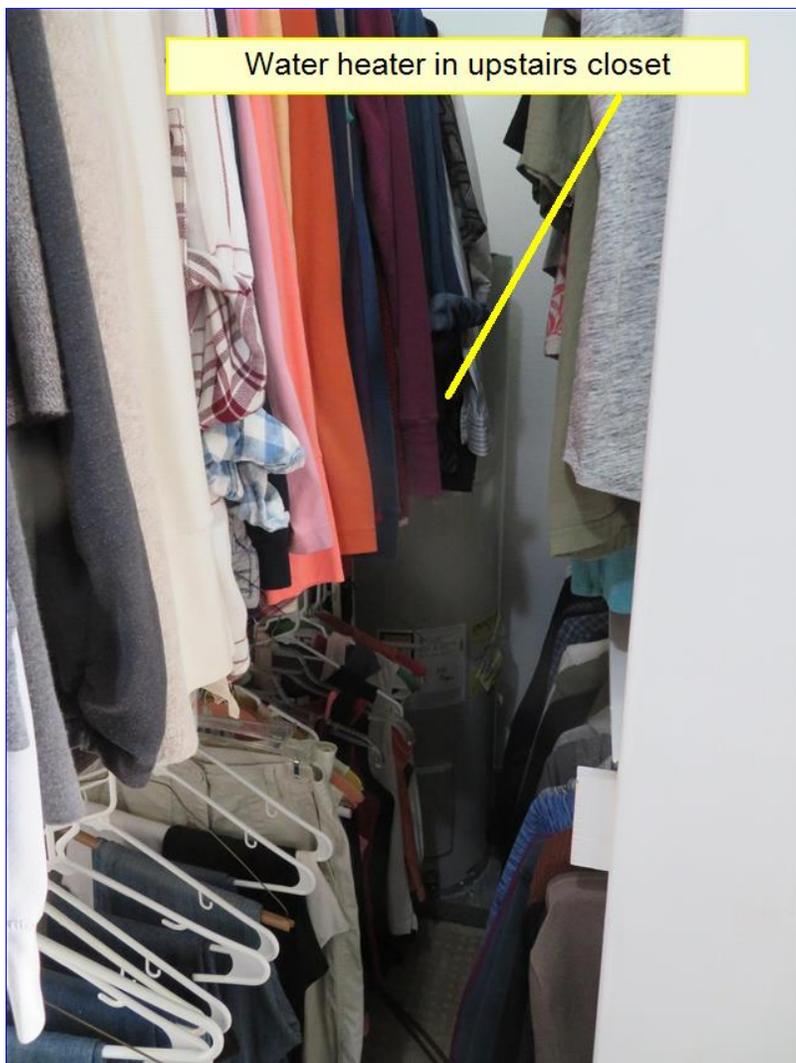
The water heaters do not have a "Thermal Expansion tank" installed to prevent a possible leak at the T&P or "pop-off" valve. Recent changes in code require one when a new water heater is installed. This change is not retroactive on older previously installed electric water heaters such as this one. There were no leaks or drips at the T&P valve during inspection. If either water heater does begin to drip or leak, then a thermal expansion tank may be needed.
