Geotechnical and Geoenvironmental Report

Site: Tenby Road, St Clears

Prepared For: Draycott Group

REPORT TITLE : **Geotechnical and Geoenvironmental Report: Proposed Development, Tenby Road, St Clears**

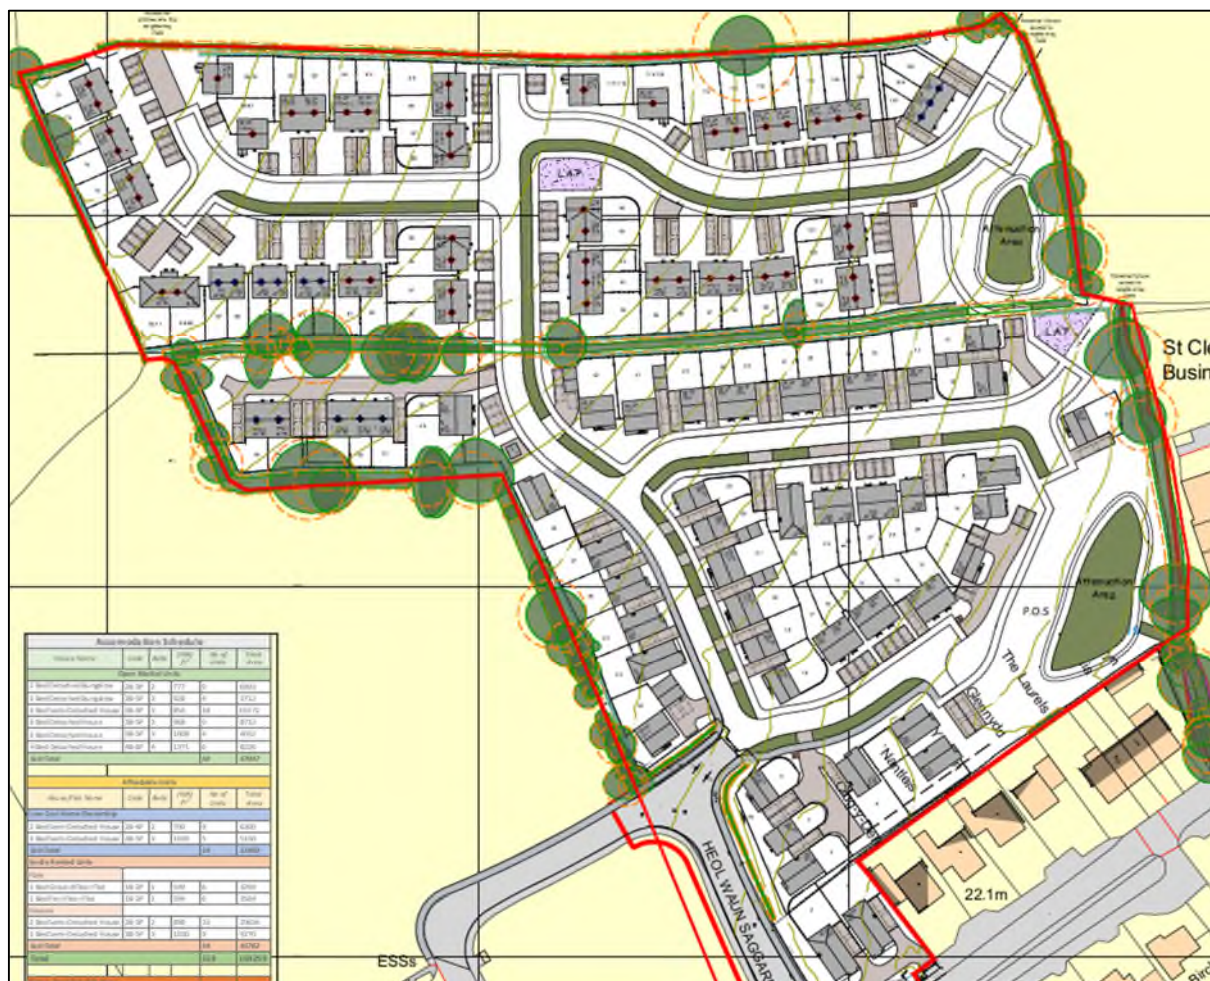
Figure 1.1 Proposed Site Layout (Red Boundary)

Draycott Group (the Client) is proposing a residential development off Tenby Road, St Clears. The development comprises 188 residential dwellings with associated car parking, gardens and areas of soft landscaping. The proposed layout is presented below in **Figure 1.1**.
