CLEAR SIGHT INSPECTION LLC

RESIDENTIAL REPORT

SAMPLE REPORT

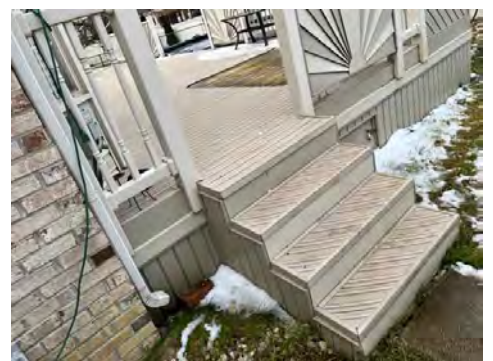
Staircase had no handrails. This is a safety hazard. Recommend a qualified handyman install a handrail.

Contact a qualified handyman.

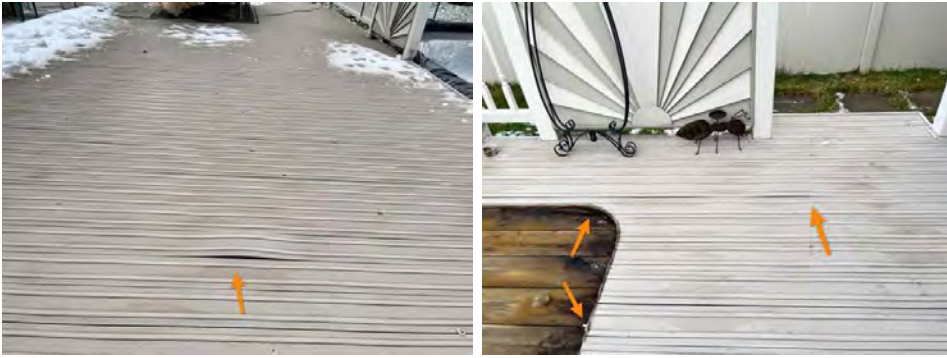
1.1.2 Decks, Balconies, Porches & Steps

TRIPPING HAZARD

Tripping Hazard was observed on deck steps at time of inspection. Recommend Handyman/Deck Contractor evaluate/remove.

Contact a qualified professional.

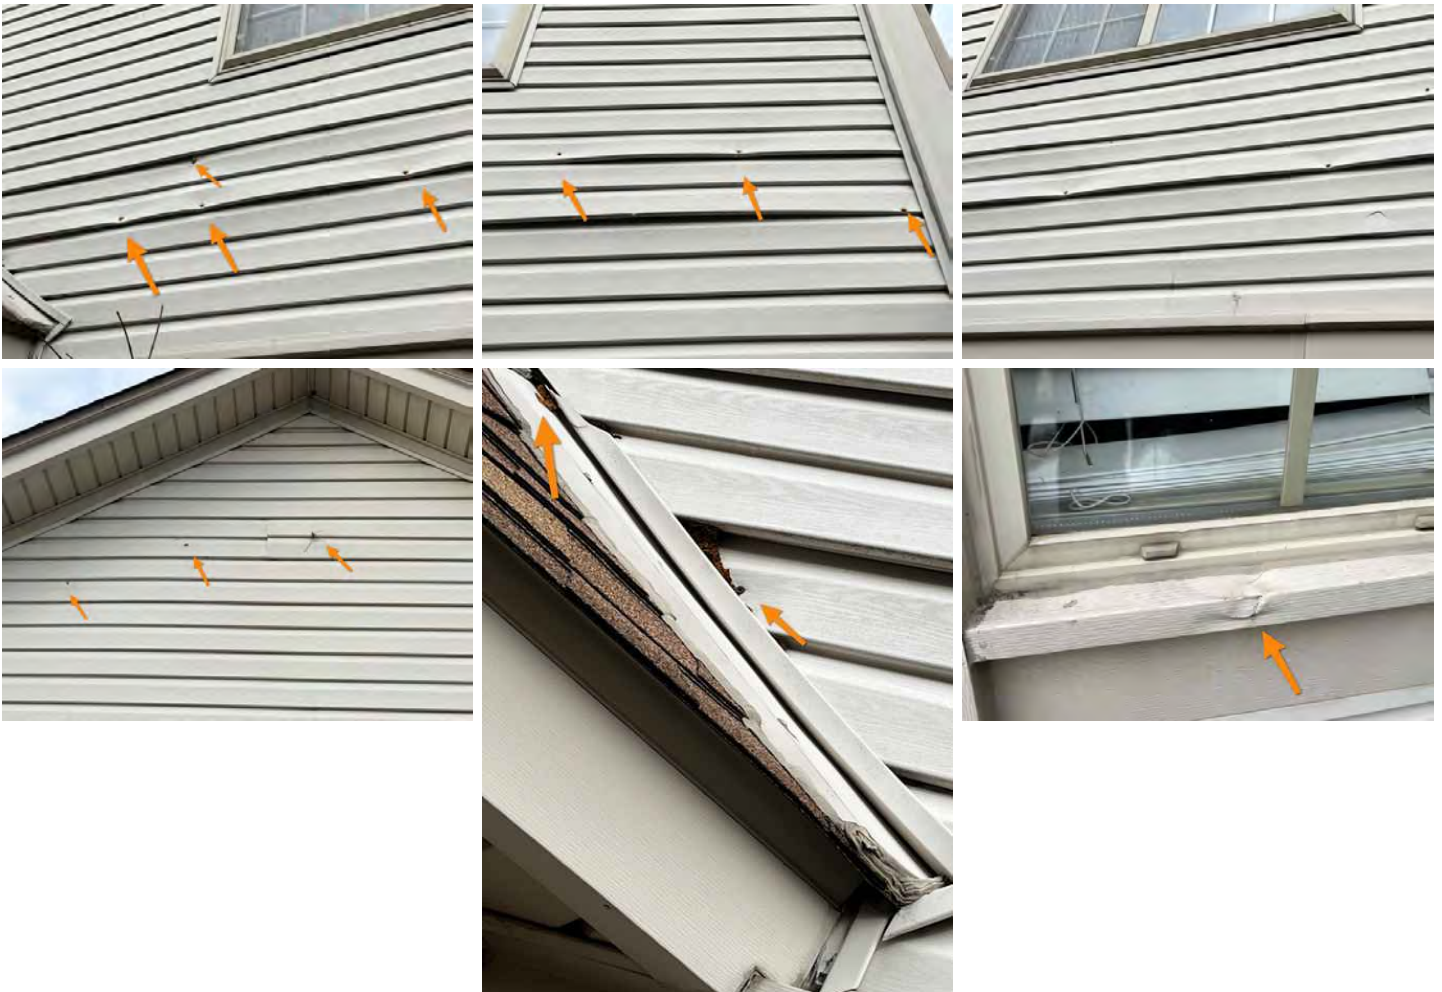
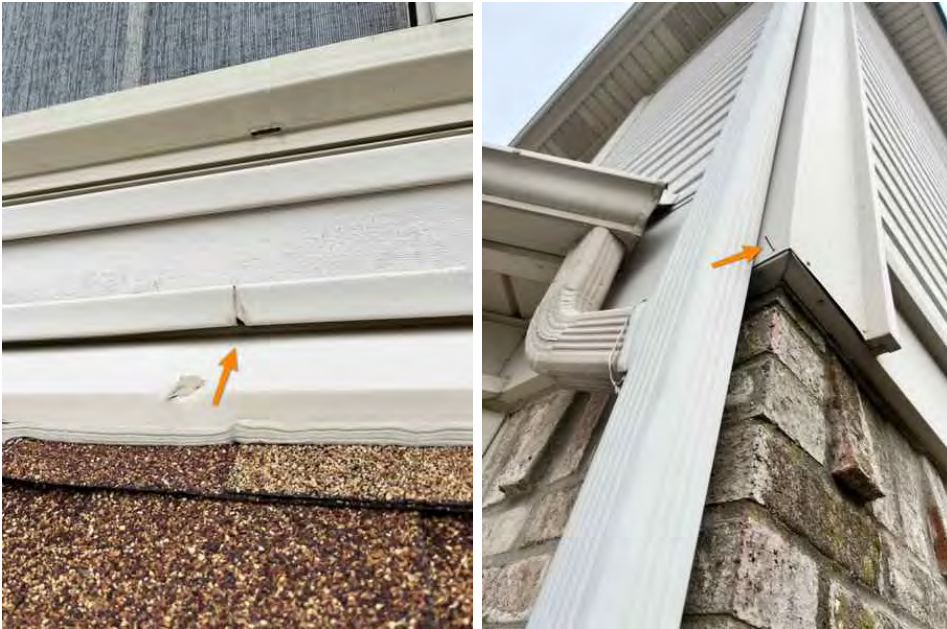
1.2.1 Siding, Flashing & Trim

DAMAGED

Damage was observed to siding at time of inspection. Recommend siding contractor evaluate/repair as this could lead to moisture intrusion.

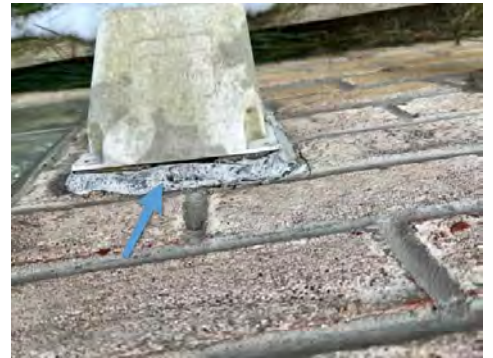
1.2.2 Siding, Flashing & Trim

Dryer vent cover was damaged / resealed at time of inspection. Recommend handyman or qualified contractor evaluate/repair

Contact a qualified handyman.

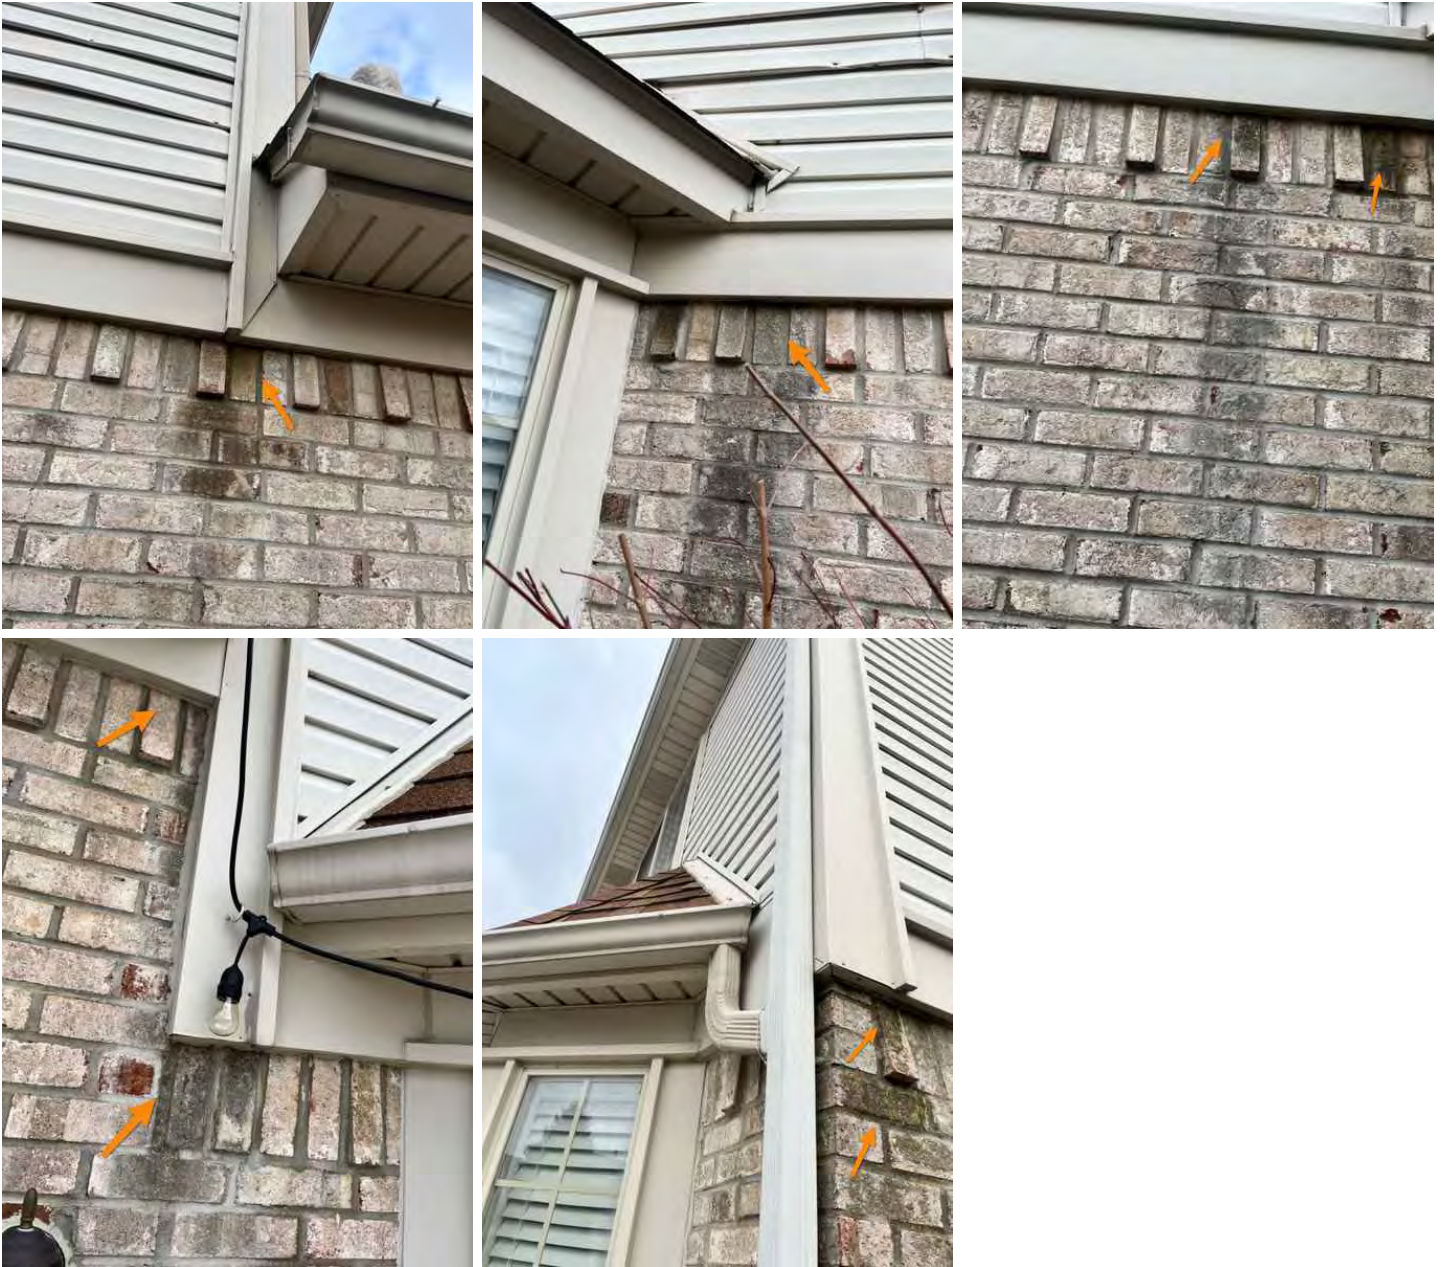
1.2.3 Siding, Flashing & Trim

BRICK WATER STAINS

Water stains running down the wall. This is signs of moisture intrusion underneath the siding. Further evaluation/recommendation from a siding contractor is recommended.

Contact a qualified siding specialist.

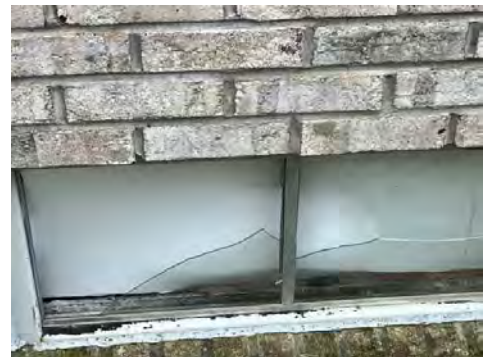
1.3.1 Exterior Doors/Windows

WINDOW CRACKED/BROKEN

Basement Window was observed to be cracked/broken at time of inspection. Recommend window repair contractor evaluate/repair

Contact a qualified professional.

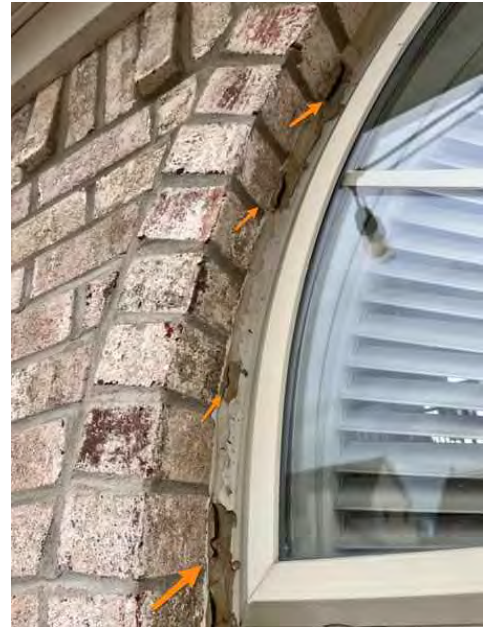
1.3.2 Exterior Doors/Windows

WINDOW CAULKING

Caulking is advised around exterior windows to prevent leaks. Caulk the window where it meets the exterior siding. If the window is surrounded by wood trim, use a high-grade polyurethane caulk to seal all gaps between the trim and the siding (and the trim and the window). Recommend qualified professional evaluate/repair

Contact a qualified professional.

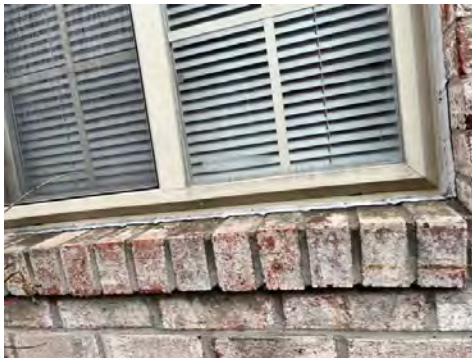
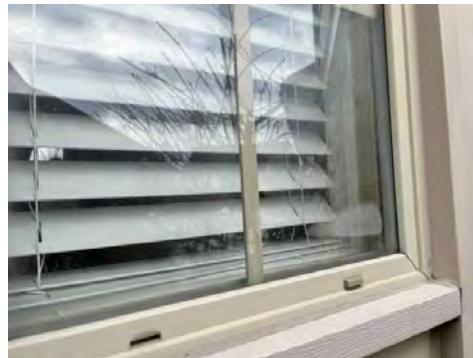
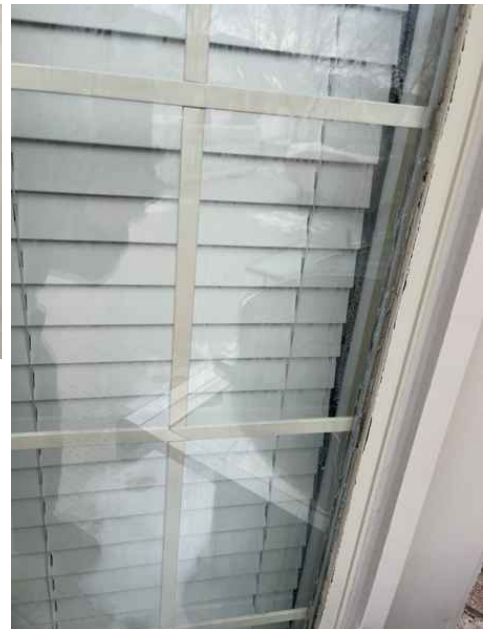
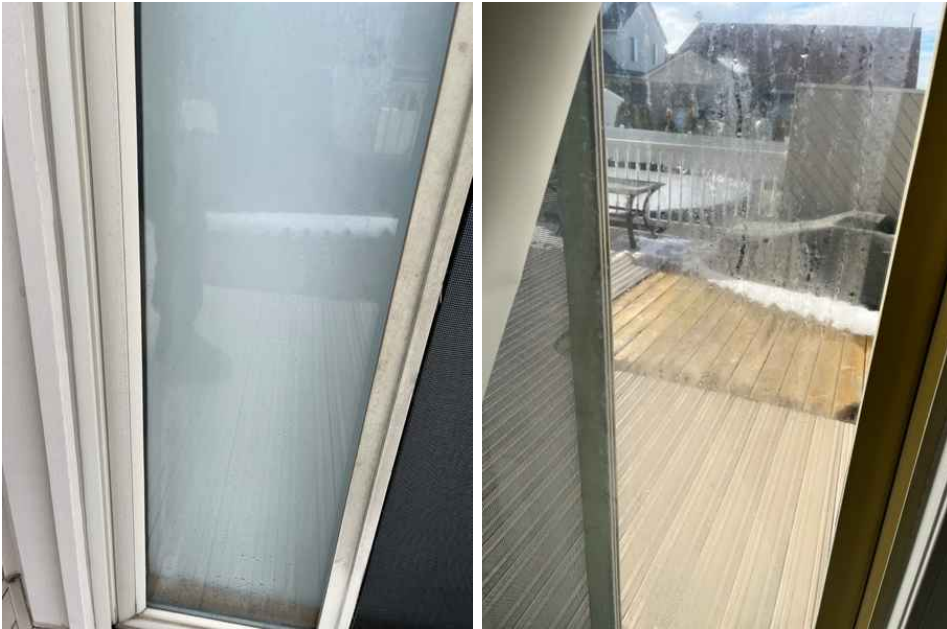
1.3.3 Exterior Doors/Windows

WINDOW FAILED SEAL

Observed condensation between the window panes, which indicates a failed seal. Recommend qualified window contractor evaluate & replace.

Contact a qualified window repair/installation contractor.

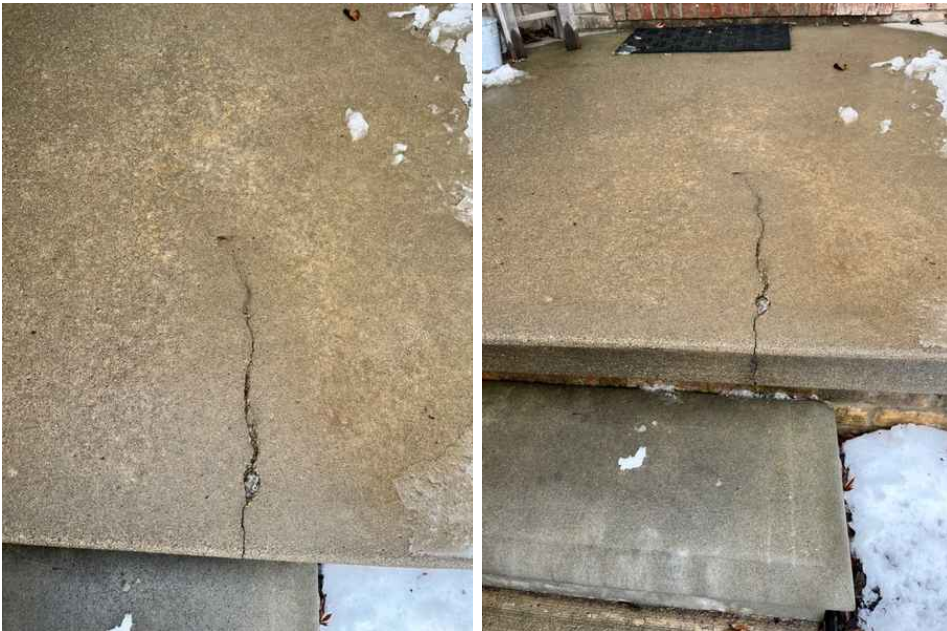
1.4.1 Driveways & Patios

PATIO CRACKING - MAJOR

Significant settling & cracking observed. Further deterioration could result. Recommend concrete contractor evaluate & repair.

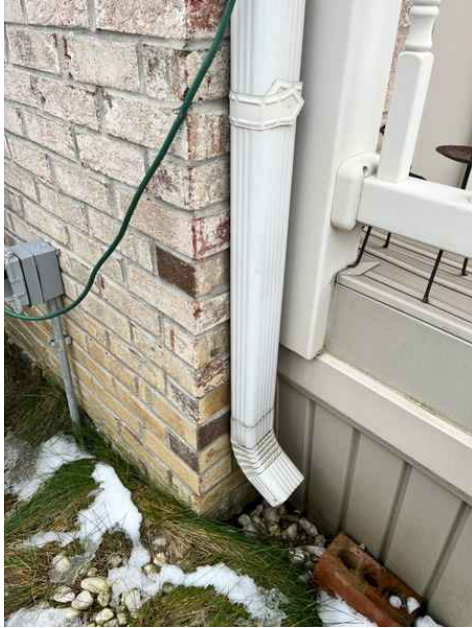
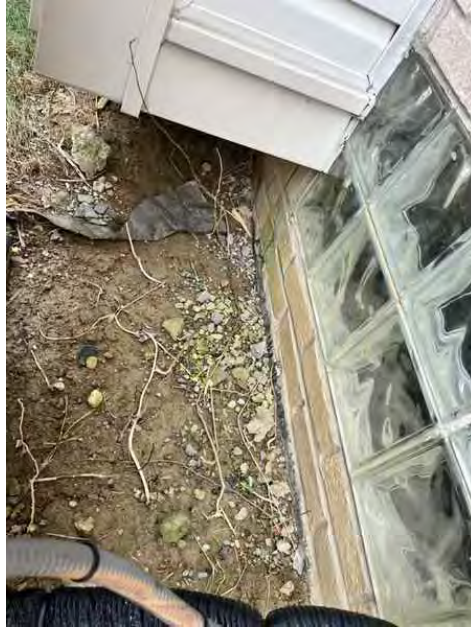
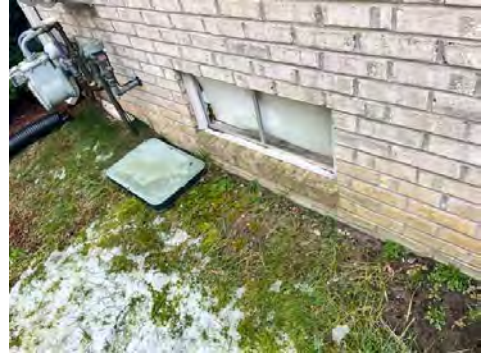
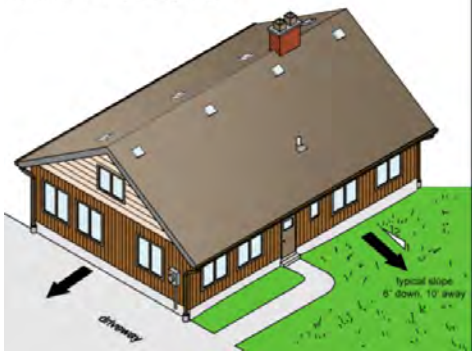
1.7.1 Vegetation, Grading, Drainage & Retaining Walls

NEGATIVE GRADING

Grading is sloping towards the home in some areas. This could lead to water intrusion and foundation issues. Recommend qualified landscaper or foundation contractor regrade so water flows away from home.

Contact a qualified landscaping contractor

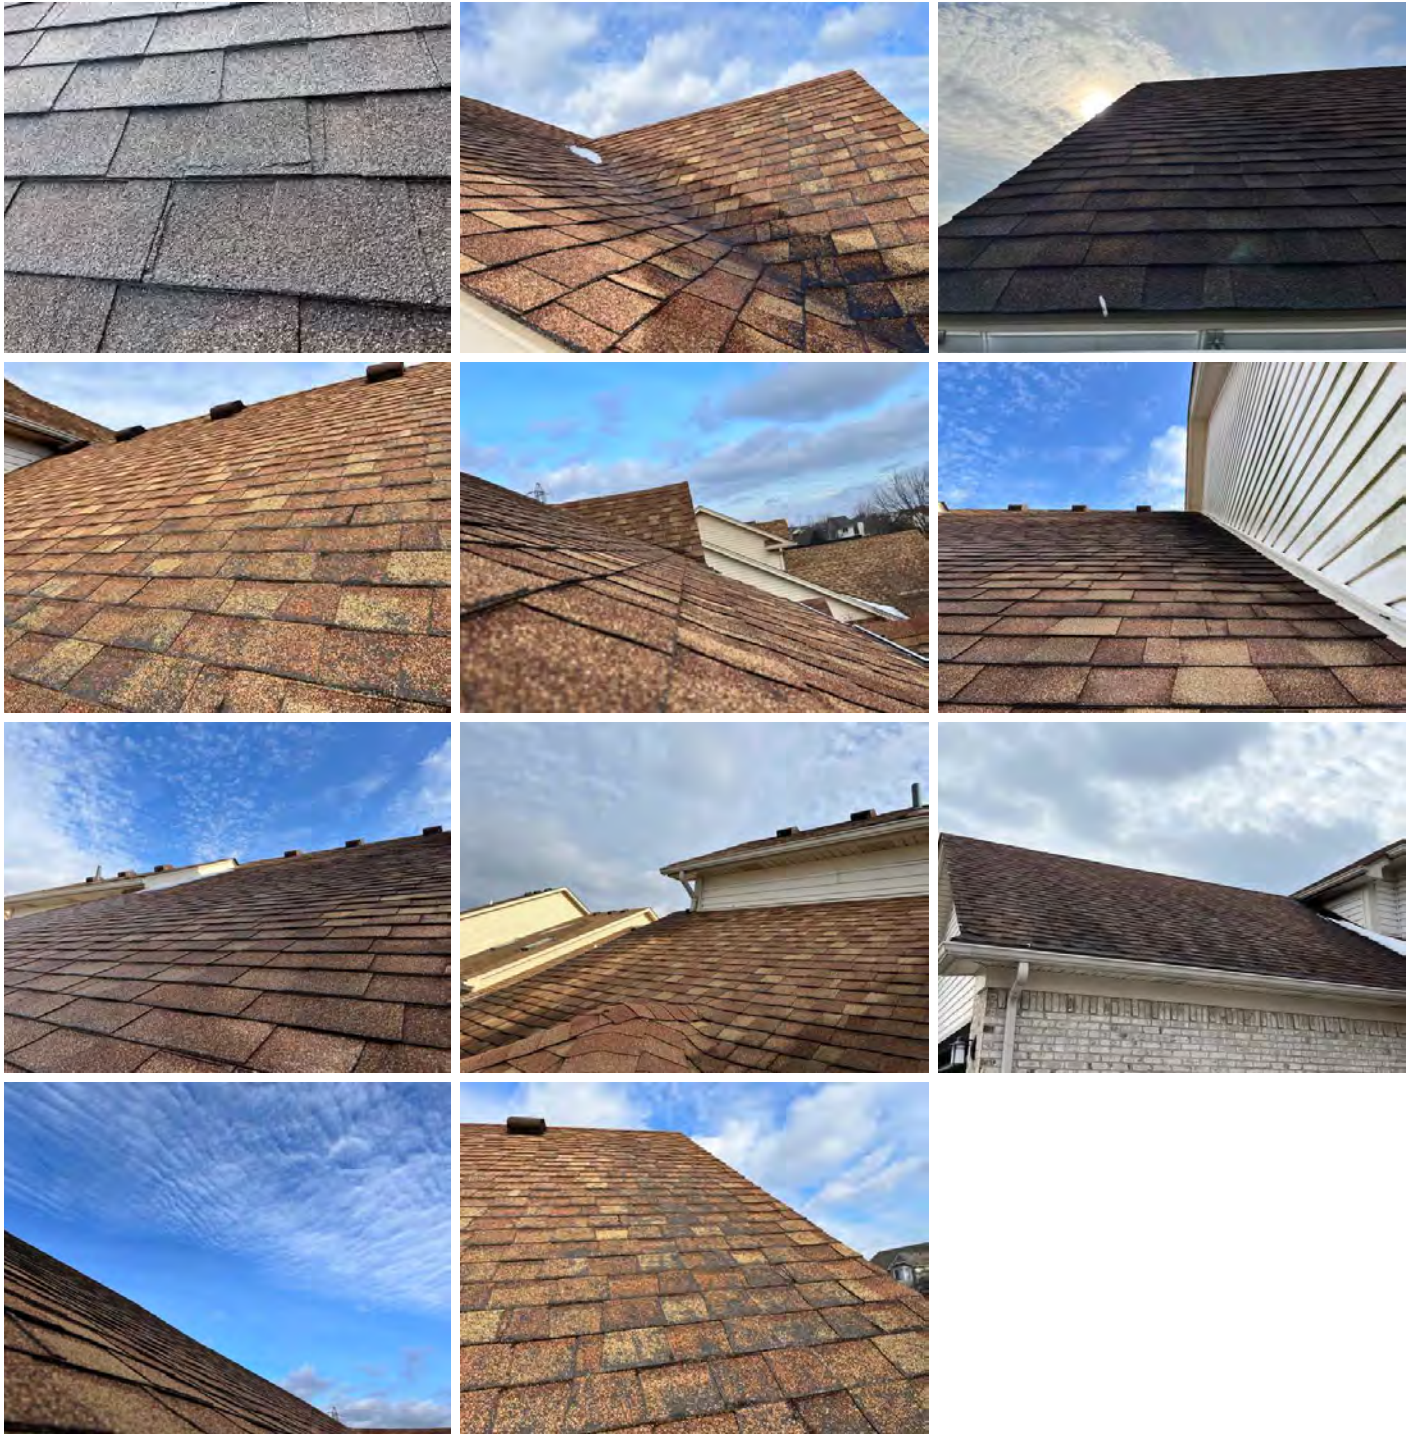
Coverings: Shingles

Three tab shingles near the end of its service life. Most asphalt shingles have a lifespan of 15 to 20 years depending on the weather and ventilation.

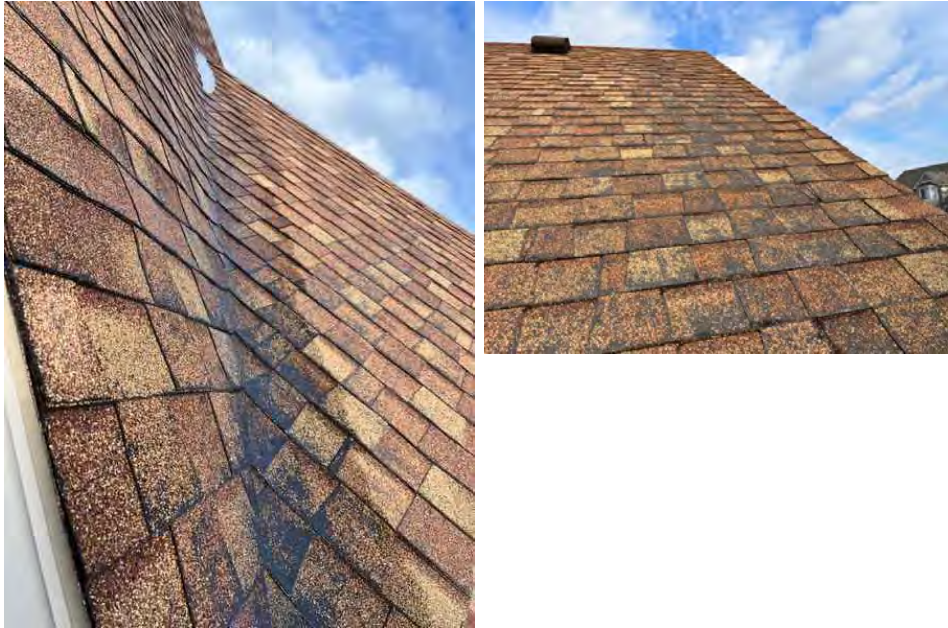
Asphalt shingle mineral granule loss on an asphalt shingle roof due to normal aging. Recommend Roofing Contractor evaluate/repair.

Contact a qualified roofing professional.

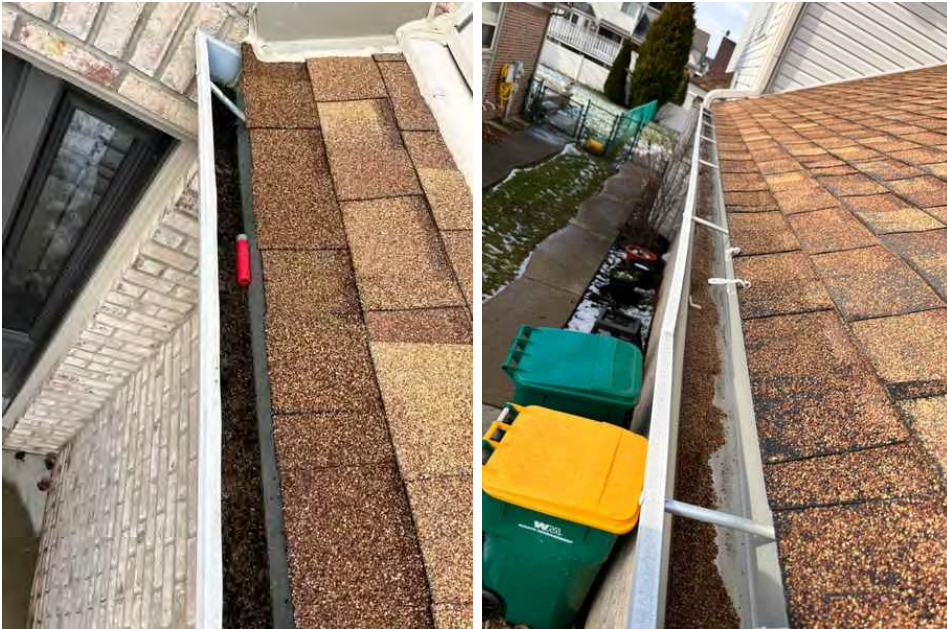
2.3.1 Roof Drainage Systems

DEBRIS

Debris has accumulated in the gutters. Recommend cleaning to facilitate water flow.

Contact a handyman or DIY project

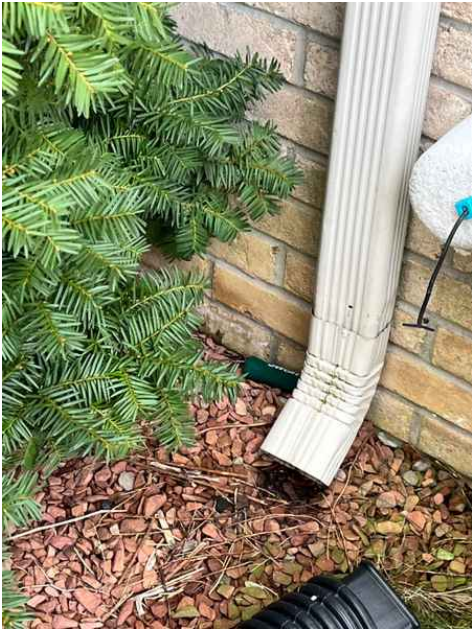
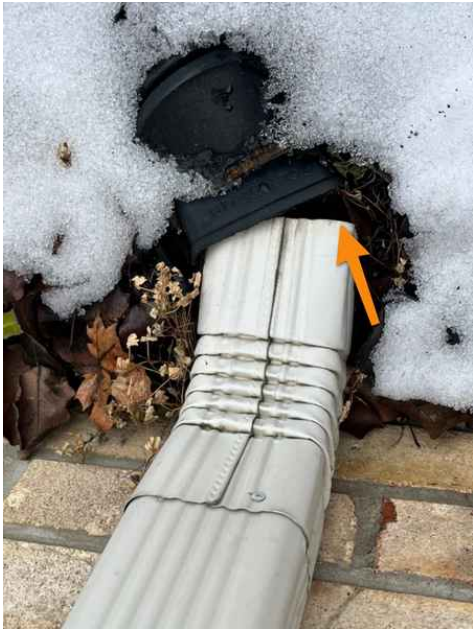
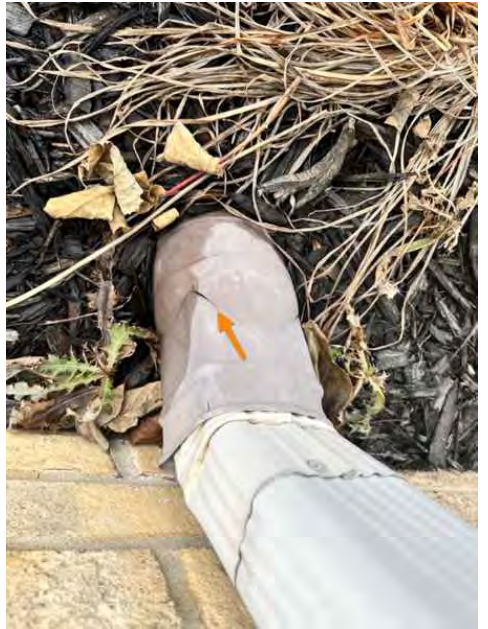
2.3.2 Roof Drainage Systems

DOWNSPOUT LOOSE

Downspout strap was observed to be missing at time of inspection. Recommend gutter contractor/handyman evaluate/repair

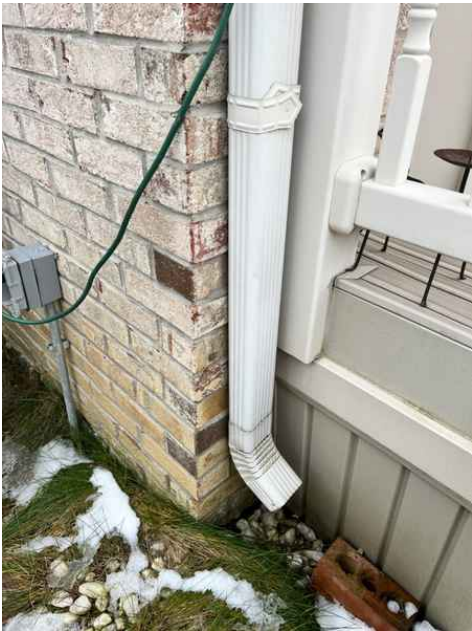
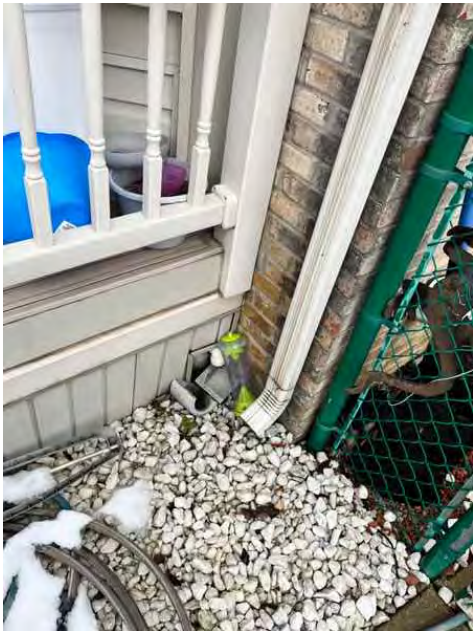
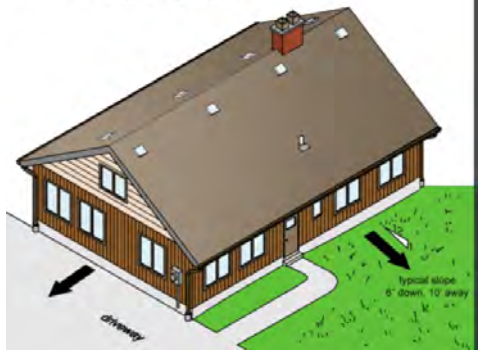
One or more downspouts drain too close to the home's foundation. This can result in excessive moisture in the soil at the foundation, which can lead to foundation/structural movement. Recommend a qualified contractor adjust downspout extensions to drain at least 6 feet from the foundation.

Contact a handyman or DIY project

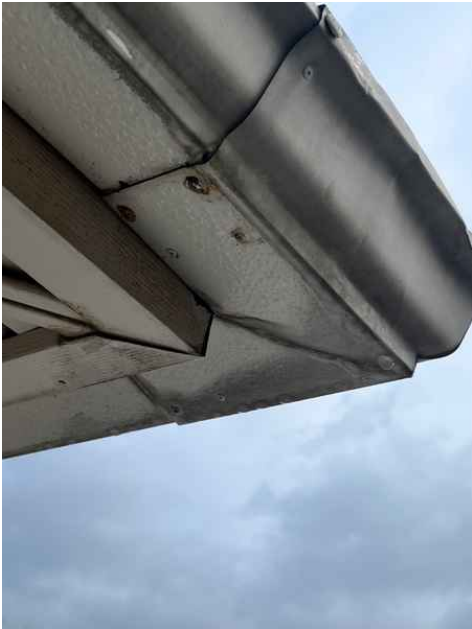
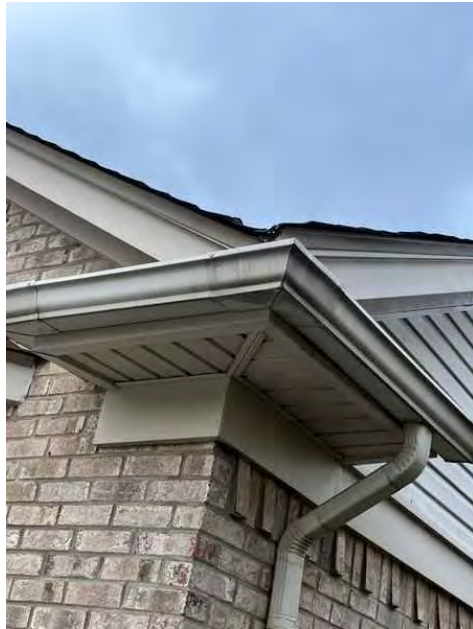
2.3.4 Roof Drainage Systems

GUTTER LEAKAGE

Gutters were observed to be leaking in one or more areas. This can result in excessive moisture in the soil at the foundation, which can lead to foundation/structural movement. Recommend a qualified contractor evaluate and repair gutters to proper functionality.

Contact a qualified general contractor.

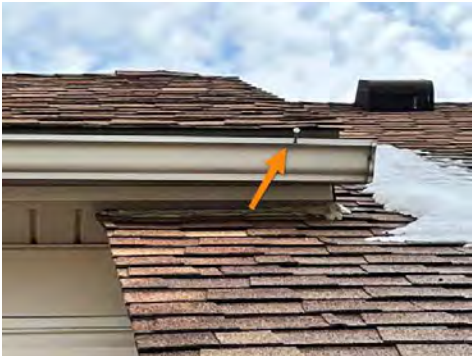
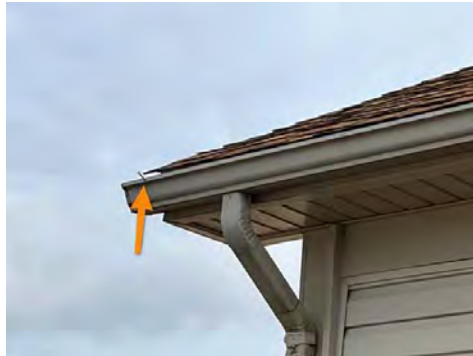
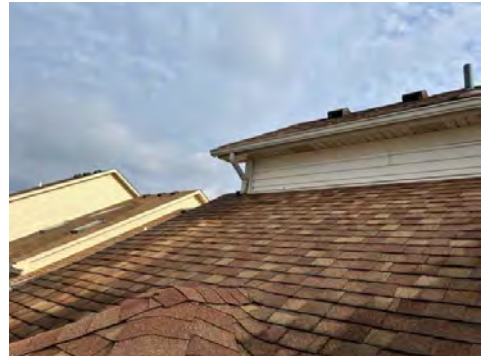
2.3.5 Roof Drainage Systems

GUTTER LOOSE

The gutter(s) is loose and needs to be re-fastened to fascia and pitched properly.

Contact a qualified gutter contractor

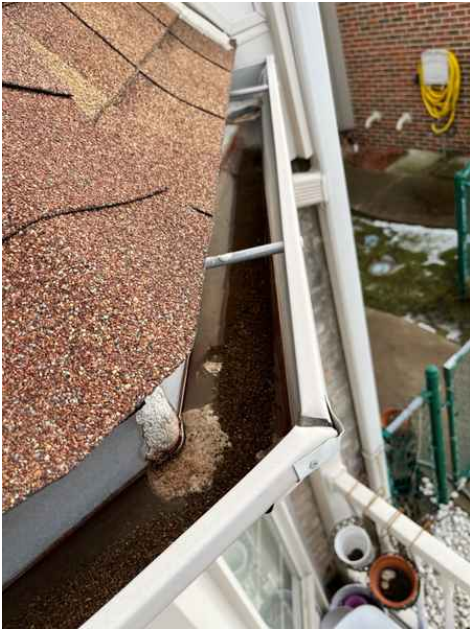
2.3.6 Roof Drainage Systems

STANDING WATER

Standing water was observed in gutters at time of inspection. Reason for standing water being present in your gutters is because of clogs or poor gutter pitching. Recommend qualified professional evaluate/repair

Contact a qualified professional.

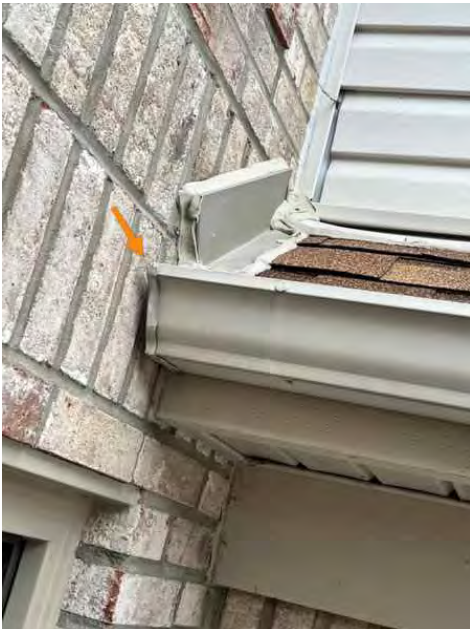
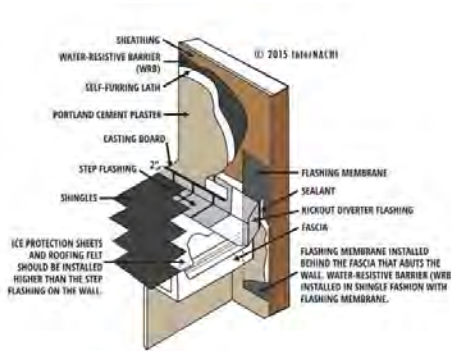
2.4.1 Flashings

KICKOUT FLASHING

Kickout flashing was observed to be missing in multiple areas at time of inspection. **Kickout flashing**, also known as diverter **flashing**, is a special type of **flashing** that diverts rainwater away from the cladding and into the gutter. When installed properly, they provide excellent protection against the penetration of water into the building envelope. Recommend roofing contractor evaluate/advise

Contact a qualified roofing professional.

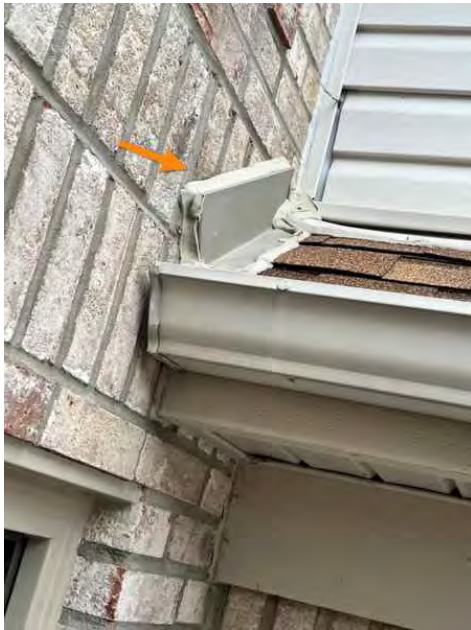
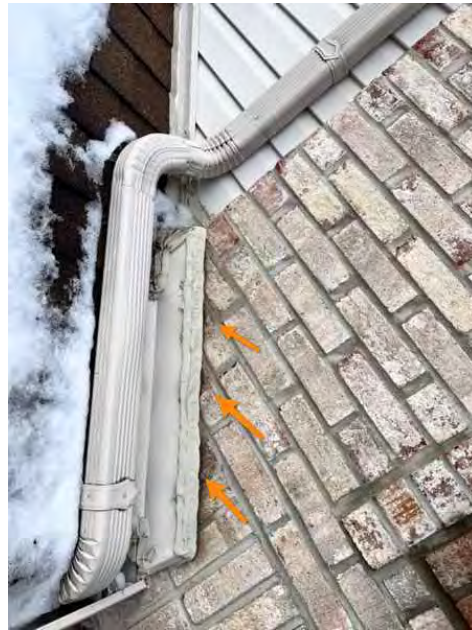
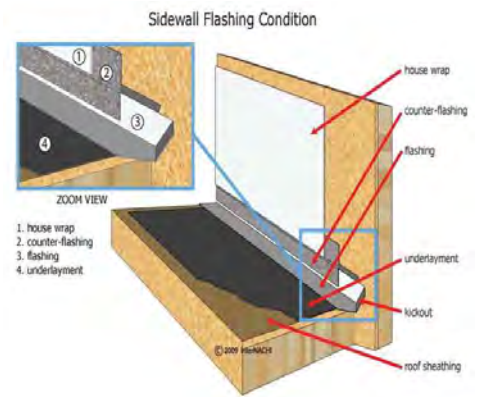
2.4.2 Flashings

MISSING COUNTER FLASHING

Counter flashing is designed to prevent moisture from behind the vertical flange of head wall or side wall flashing. Counter flashing is especially important where walls are brick.

Contact a qualified professional.

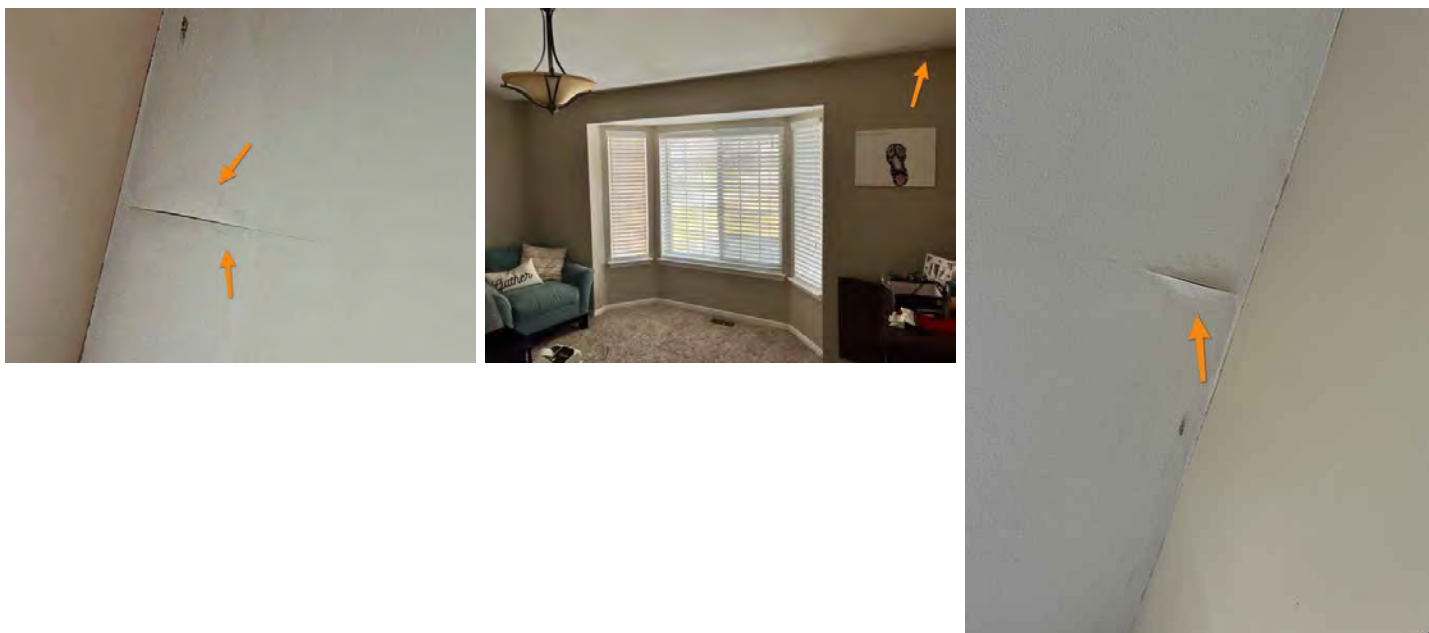
MOISTURE DAMAGE

Stains on the walls visible at the time of the inspection appeared to be the result of moisture intrusion. The source of moisture may have been corrected. Recommend further examination by a qualified contractor to provide confirmation.

Contact a qualified professional.

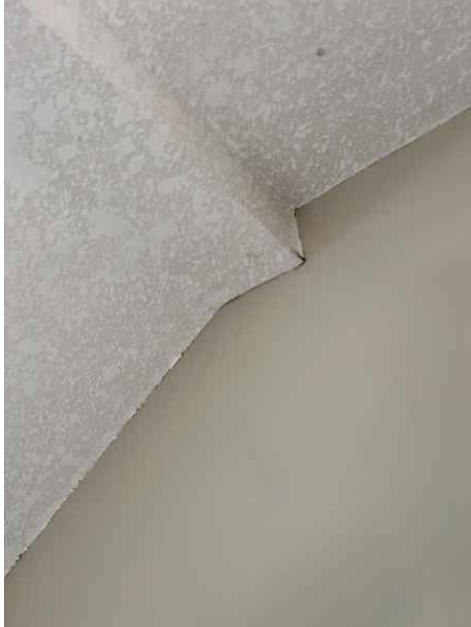
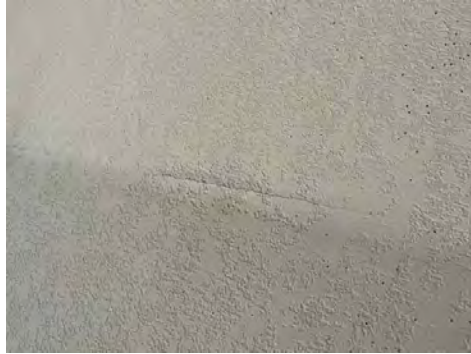
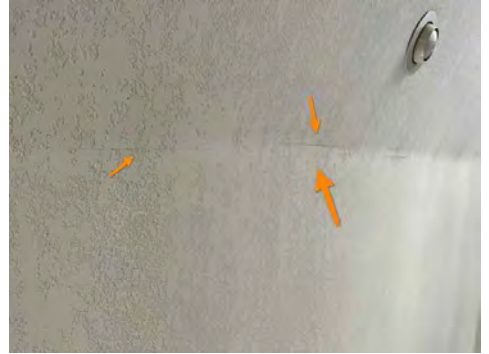
4.4.2 Walls, Ceilings

PAINT CRACKING

Wall paint was cracking in one or more areas. Recommend a qualified painter evaluate and apply a new coat.

Contact a qualified painting contractor.

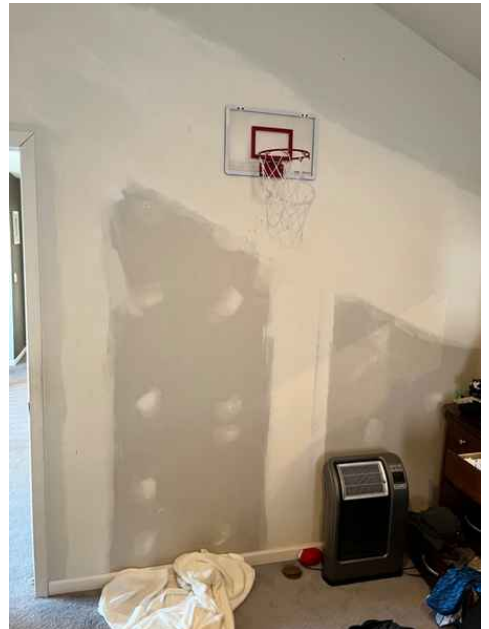
4.4.3 Walls, Ceilings

Sub-standard drywall patching observed at time of inspection. Recommend handyman/drywall contractor re-patching.

Contact a qualified general contractor.

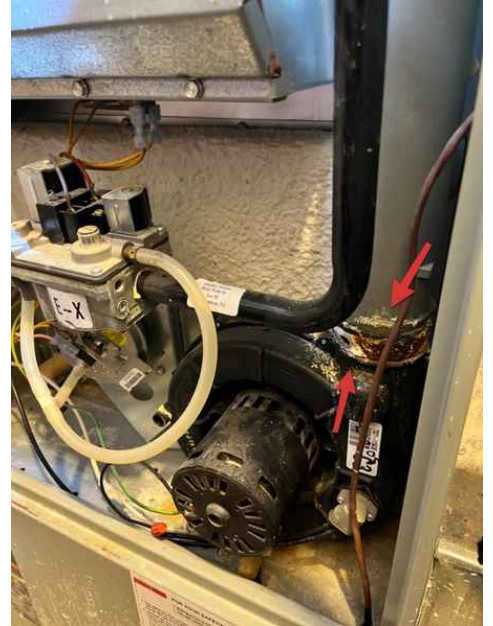
CORROSION

Furnace was corroded in one or more areas. This could be the result of improper venting, which the source would need to be identified. Recommend a HVAC contractor evaluate and repair.

Contact a qualified HVAC professional.

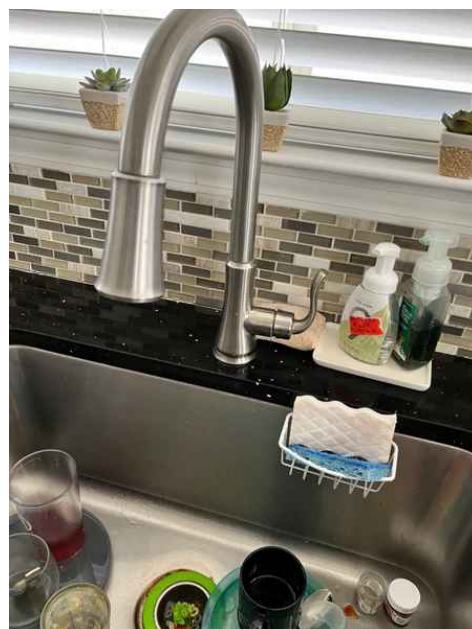
LEAKING FIXTURE

Fixture was observed leaking at time of inspection. Recommend plumbing contractor/handyman evaluate/repair

Contact a qualified professional.

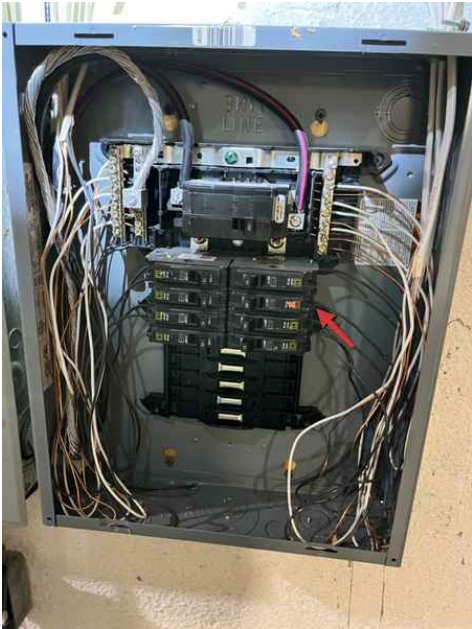
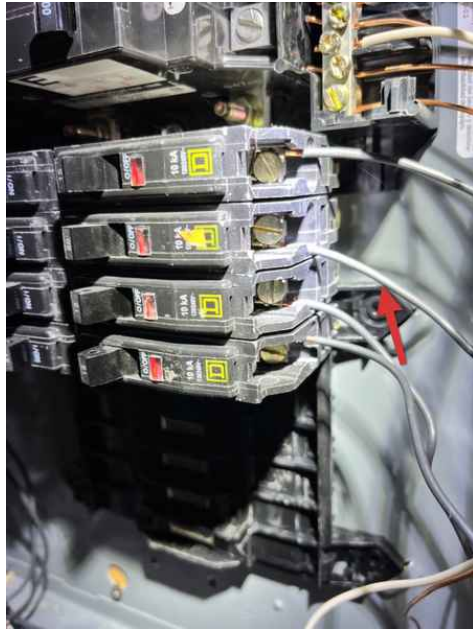
Sub panel Circuit breaker was incorrectly wired / installed. 20A Breaker on a 14 AW.... This Is a safety and fire hazard. This indicates that work was probably not performed by a licensed electrician and poses a safety hazard. Recommend that a licensed electrician check the entire panel and repair and replace as need.

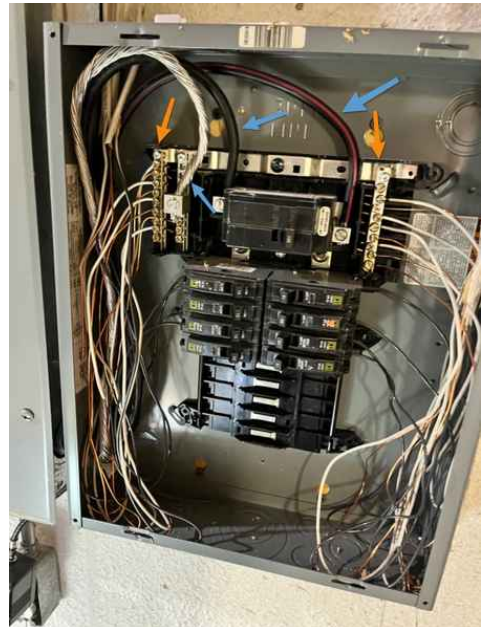
8.1.2 Panelboards & Breakers

SUBPANEL NOT SUPPLIED WITH 4 CONDUCTORS

I observed that the subpanel was not supplied with 4 conductors/wire

Blue arrows represent 3 wires. Sub panels are required to have 4 wire and have grounds and neutrals on separate bus bars. Orange arrows represent the bus bars. In a sub panel naturals and grounds can not share the same bus bar. Recommend a licensed electrician for further evaluation and repair.

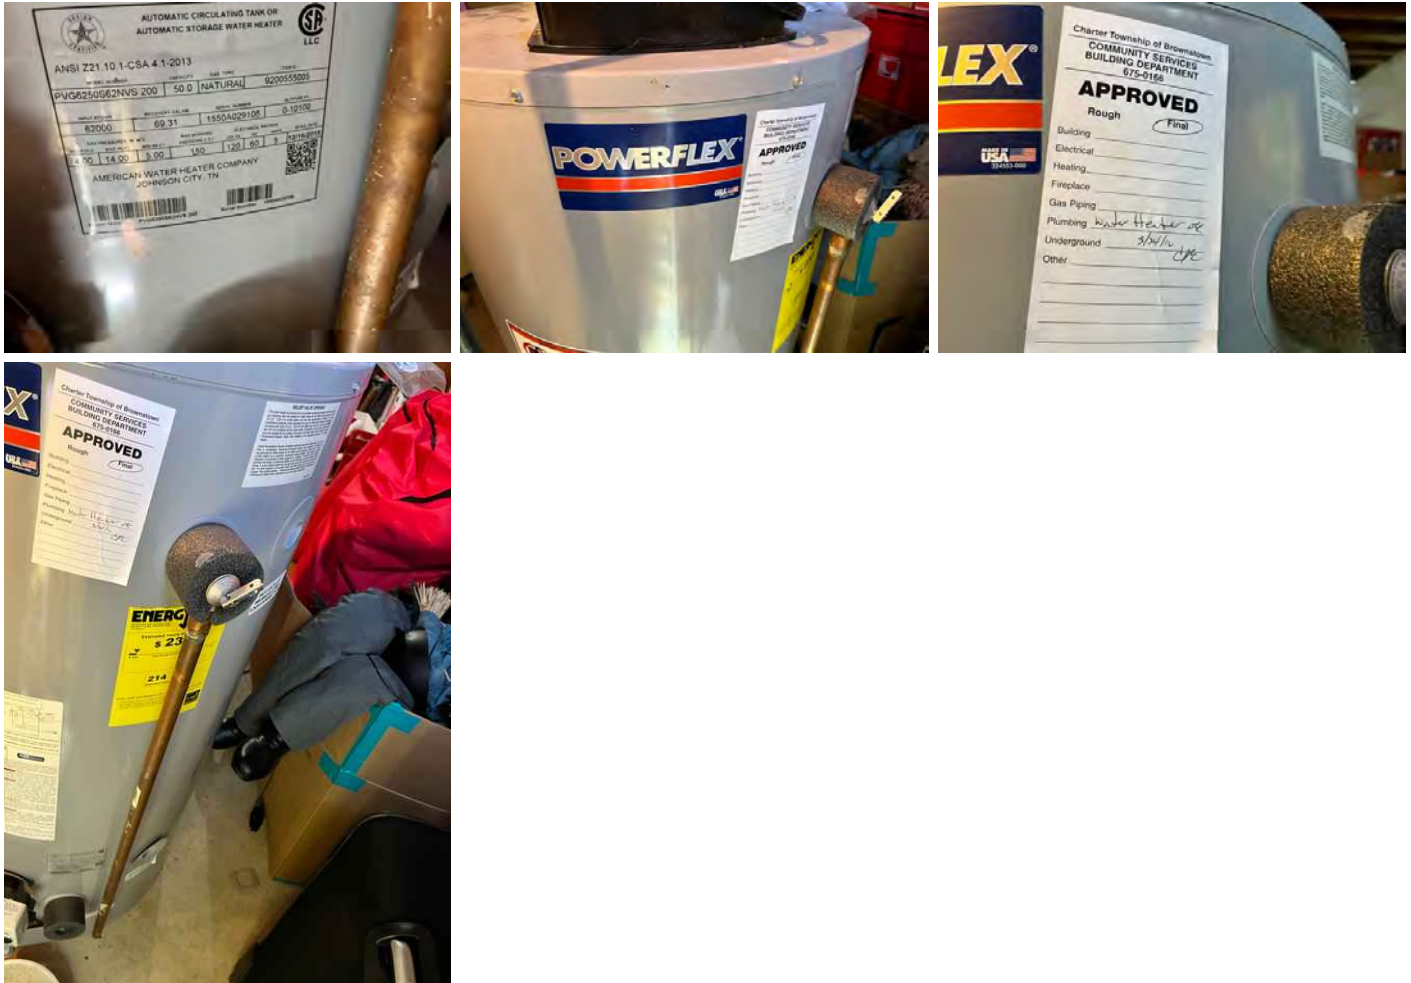
Hot Water Heater, Controls, Flues & Vents: Capacity

50 5 yrs old gallons

I recommend flushing & servicing your water heater tank annually for optimal performance. Water temperature should be set to at least 120 degrees F to kill microbes and no higher than 130 degrees F to prevent scalding.

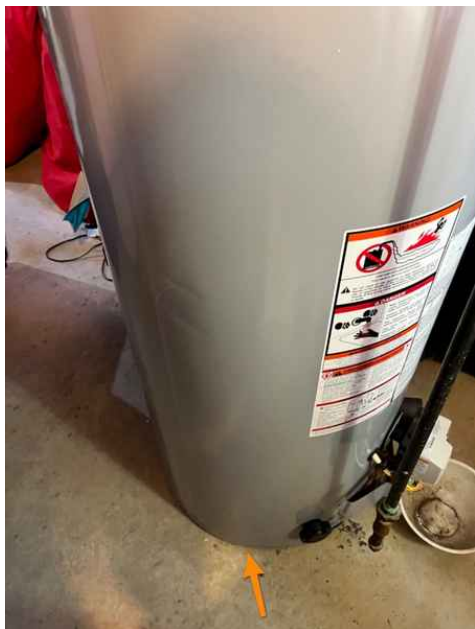
No drip pan was present. Recommend installation by a qualified plumber/handyman. Drip pans are required when tank type water heaters are installed in places where a leak could cause damage.

Contact a qualified professional.

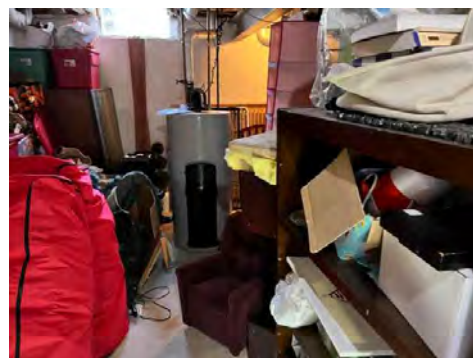
10.3.2 Hot Water Heater, Controls, Flues & Vents

COMBUSTIBLE MATERIAL NEAR

Combustible material near hot water tank. This is a safety hazard.

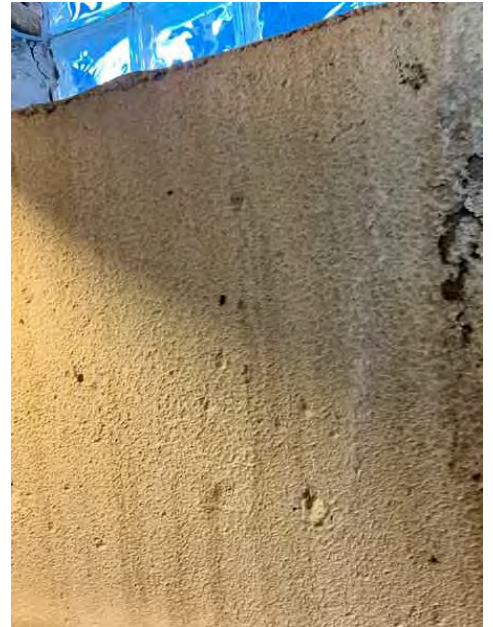
12.1.2 Foundation

WATER INTRUSION

Water intrusion was evident on the surface of the floor slab or in the basement/crawlspace. This can compromise the soil's ability to stabilize the structure and could cause damage. Recommend a qualified contractor identify the source of moisture and remedy.
