CLEAR SIGHT INSPECTION LLC

RESIDENTIAL REPORT

SAMPLE REPORT

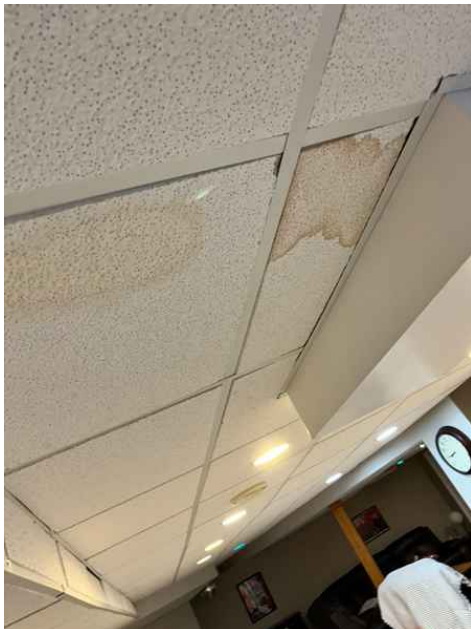
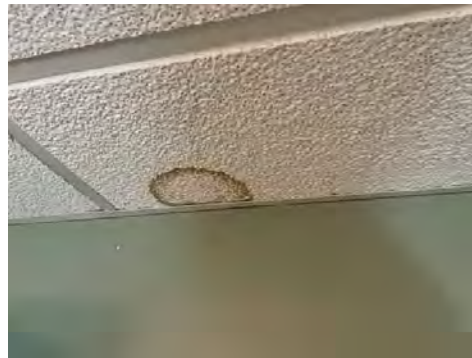
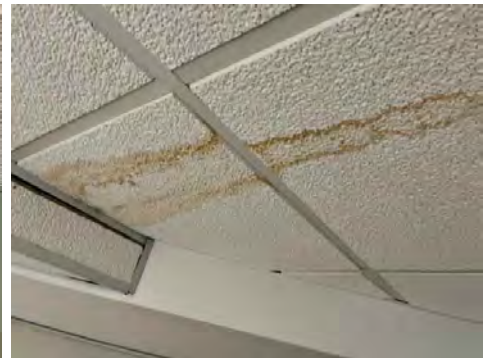
12.6.1 Crawlspace/Basement Ceiling

Ceiling structure showed signs of water intrusion, which could lead to more serious damage. Suspect it is coming from Condensation from the ducts in the summertime.

Recommend a qualified contractor identify source or moisture and remedy.

Contact a qualified HVAC professional.
