**PRESERVATION ASSESSMENT OF THE
OLD SHILOH PRESBYTERIAN CHURCH CEMETERY,
CLEVELAND COUNTY, NC AND
CHEROKEE COUNTY, SC**

Chicora Research Contribution 526

June 15, 2010

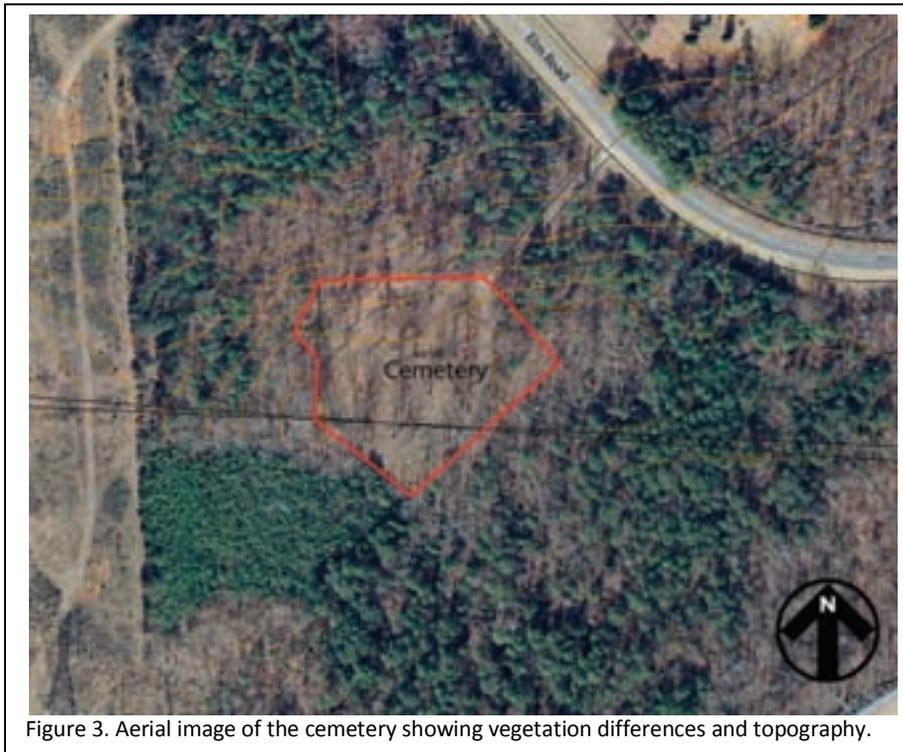
Figure 3. Aerial image of the cemetery showing vegetation differences and topography.

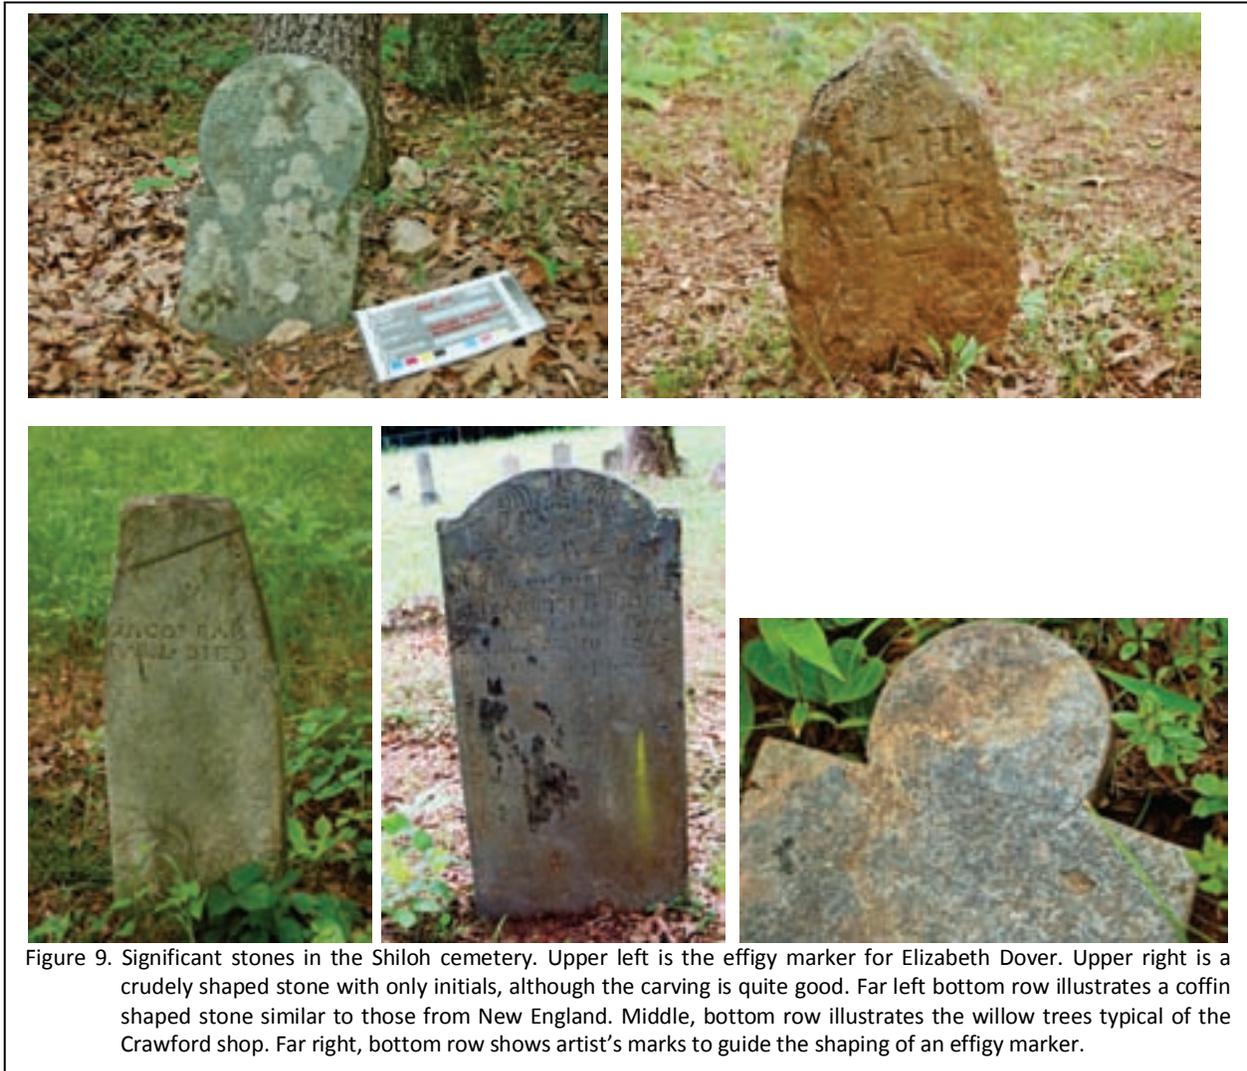
Figure 9. Significant stones in the Shiloh cemetery. Upper left is the effigy marker for Elizabeth Dover. Upper right is a crudely shaped stone with only initials, although the carving is quite good. Far left bottom row illustrates a coffin shaped stone similar to those from New England. Middle, bottom row illustrates the willow trees typical of the Crawford shop. Far right, bottom row shows artist's marks to guide the shaping of an effigy marker.

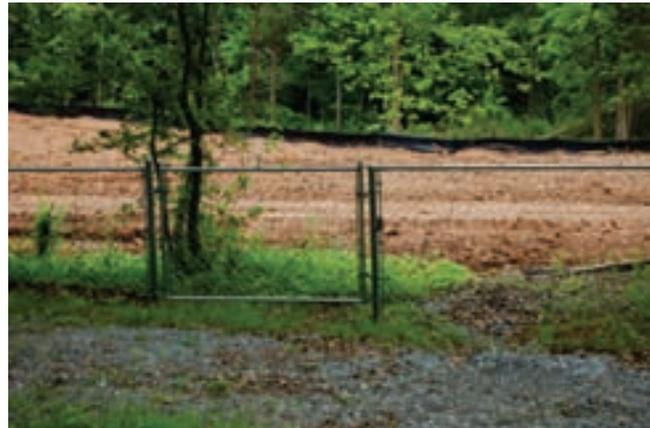
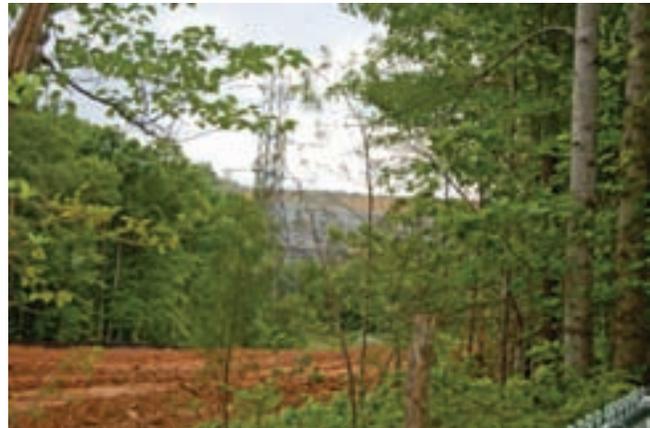
Figure 10. Visual intrusion caused by the 230-kV line between the Southern Power Cleveland County Generating Facility and a Duke Power substation.

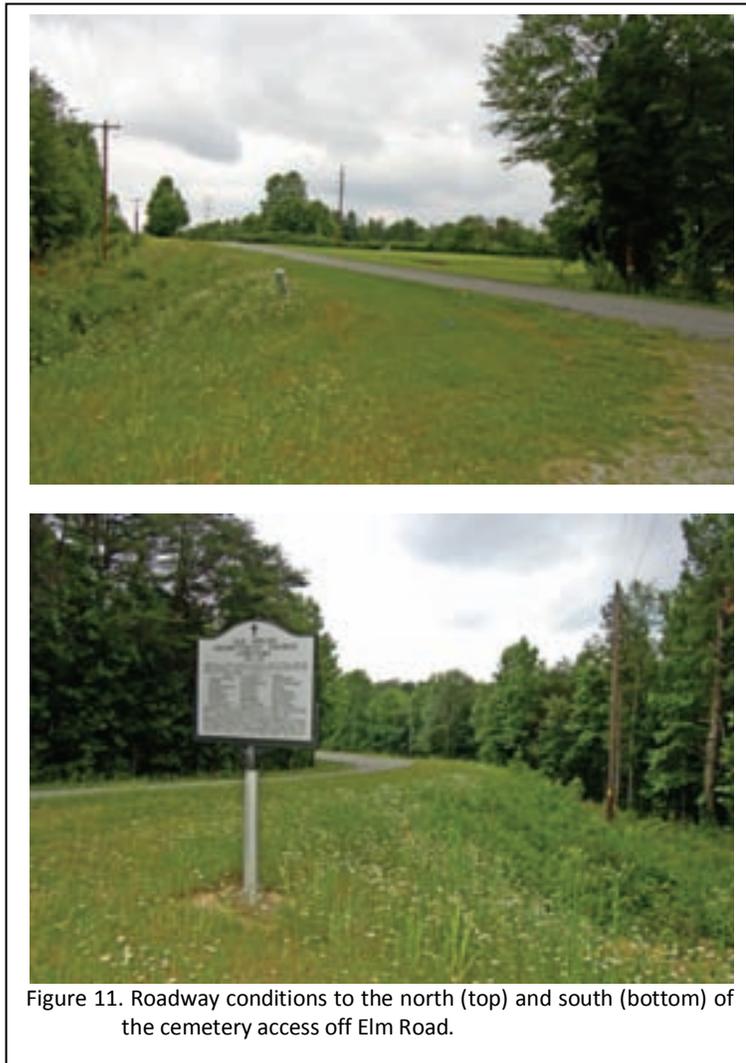
Figure 11. Roadway conditions to the north (top) and south (bottom) of the cemetery access off Elm Road.

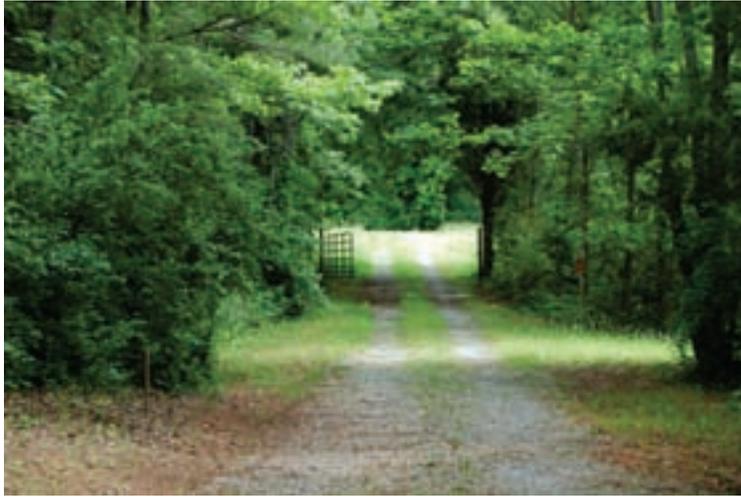
Figure 12. View on the cemetery access road looking northeast to the access gate and Elm Road.

allows a car to park safely in order to secure the gate after visitation is complete. While the access drive does have about a 7% slope, this does not seem excessive (Figure 12).

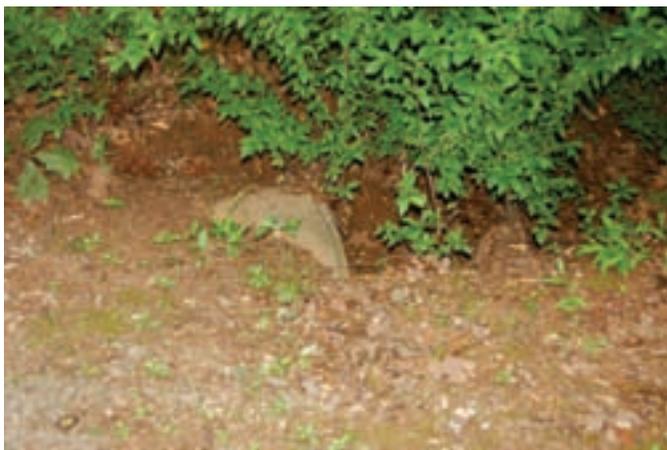
The one-lane gravel access road is adequately maintained, exhibiting no erosion, potholes, or other damaged areas. This road does cross a small depression just beyond the cemetery that is crossed using a 2 foot concrete pipe. The pipe appears to be adequate in size and structurally sound at this time. The ditch associated with the pipe, however, has not been cleaned and the pipe is partially clogged. This ditch requires cleaning and

Figure 13. Pipe under the gravel access road. The associated ditch requires maintenance and the crossing should be marked.

periodic maintenance. In addition, the drop-off at the pipe is not marked and may present a traffic hazard. It should be marked with yellow reflective signage.

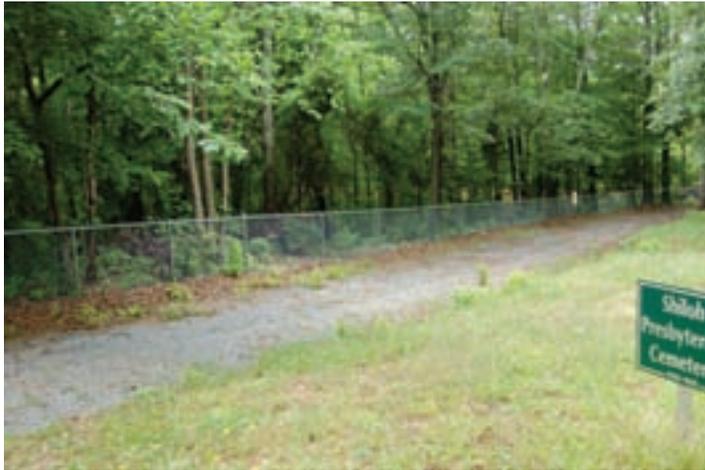
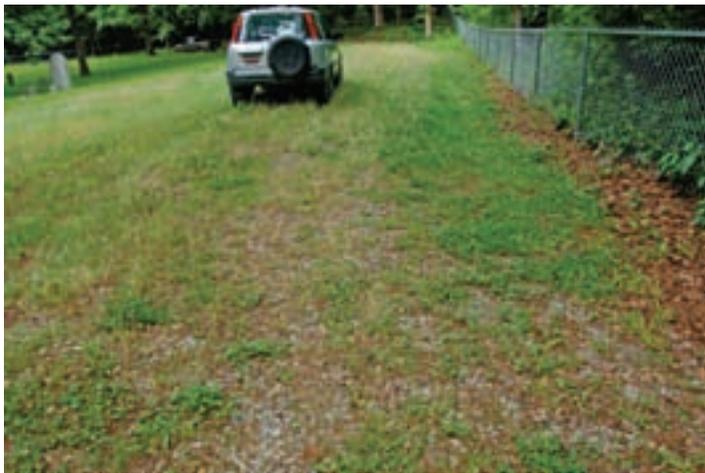
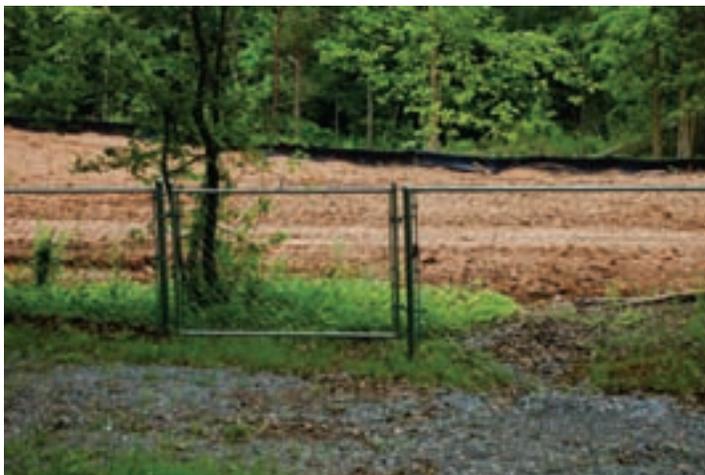
Figure 14. Gravel road around the cemetery. Top view shows the road in good condition. Middle view shows the road largely overtaken by grass. Bottom view shows erosion at the south end of the road.

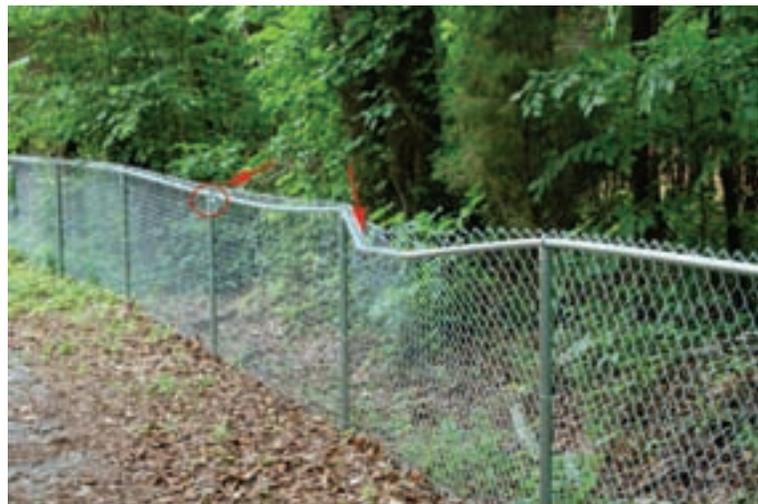
Figure 15. Damaged fence section showing dislodged top cap and severely bent top rail. This requires immediate replacement.

Damage to the fence should be repaired immediately.

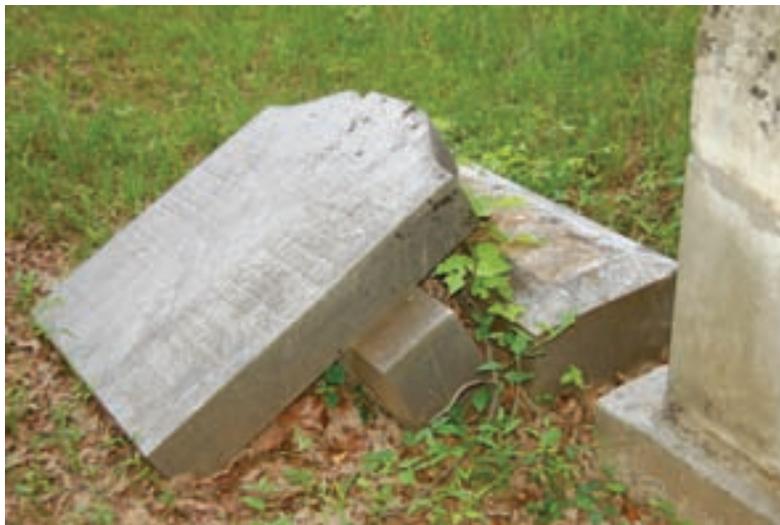
There has been no effort to track vandalism in the cemetery, although evidence of damage that is likely vandalism related is present in the cemetery. The vandalism, however, does not appear recent and it does not seem that the cemetery has been especially targeted. It is likely the efforts put into maintenance by the caregivers, combined with the locked gate at the road entrance, are reducing the threat posed by vandalism.

Figure 17. Probable vandalism. Stones such as this are generally too large and heavy to topple without outside intervention.

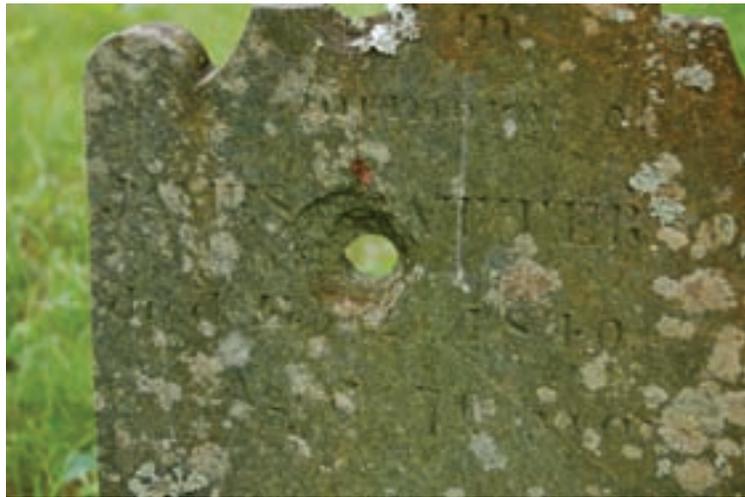
The vast majority of hunters is responsible and law abiding. A very small minority are regrettably rogues. There is at least one stone in the cemetery that evidences a bullet hole. Whether this was a miss or intentional can't be determined, but caregivers should be alert to this issue.

Figure 18. Bullet-damaged stone.

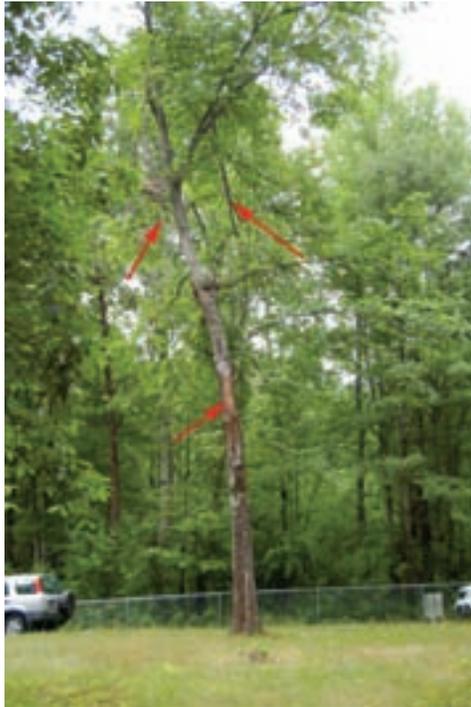
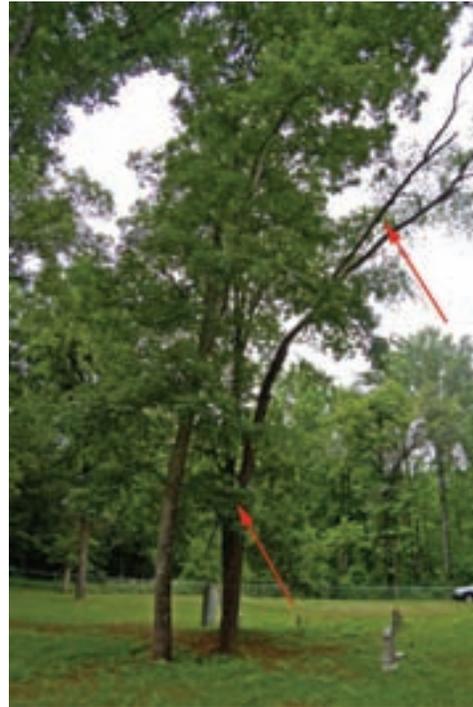
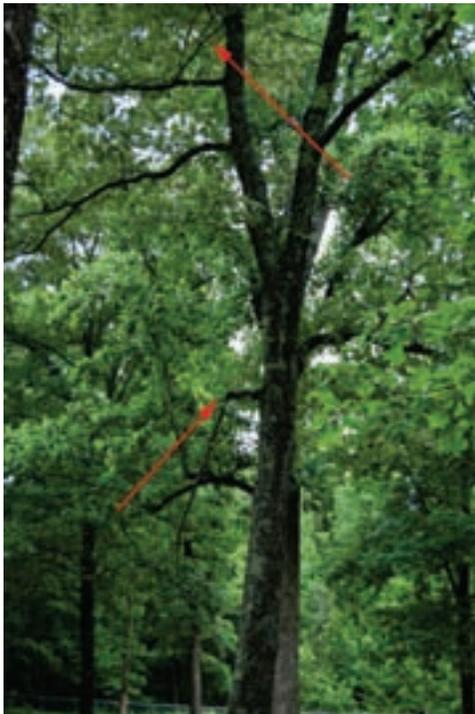
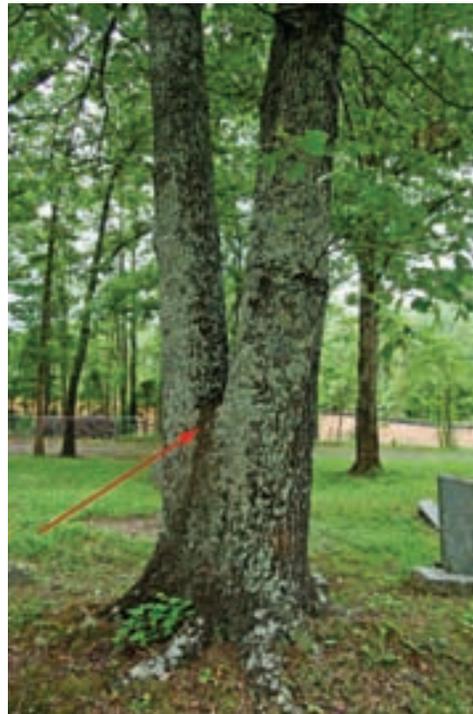
Figure 19. Tree problems. Upper left shows damaged tree with dead wood. This tree should be removed and replaced. Upper right shows a weak double leader with dead and damaged limbs. This tree should be removed, allowing nearby tree more room for growth. Lower left shows tree requiring pruning to remove dead wood and crossed branches. Lower right illustrates another weak double leader.

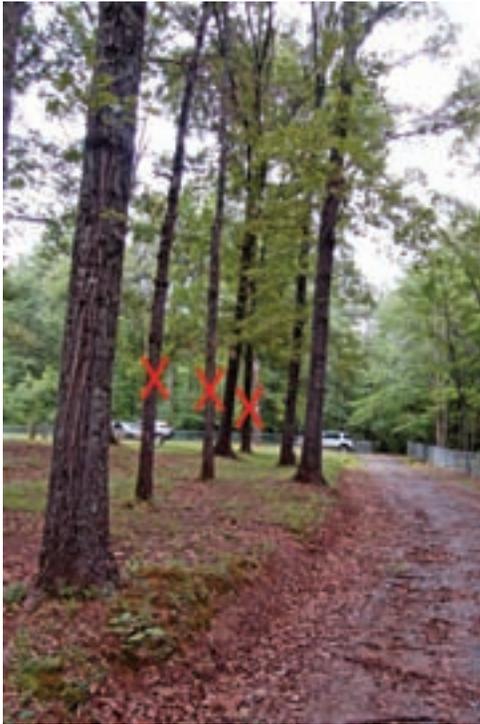
Figure 20. Cluster of small trees at the east edge of the cemetery should be thinned to allow the healthier trees room to grow.

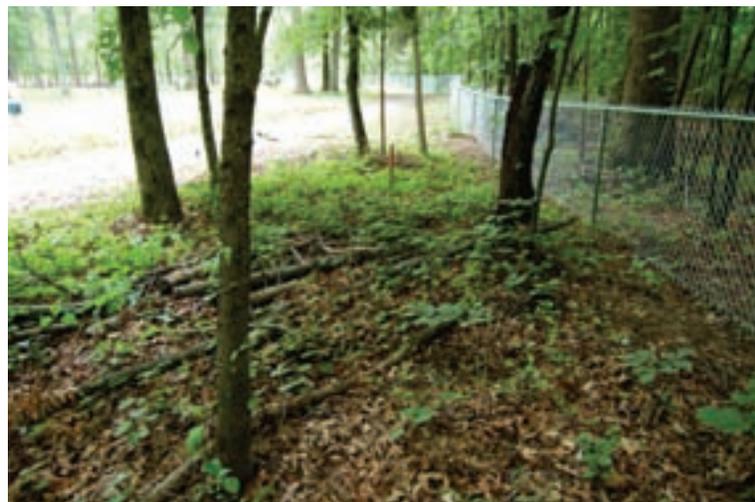
Figure 21. Example of debris pile that should be put through a chipper to create mulch. Similar piles just beyond the fence should also be chipped and stored for cemetery mulch.

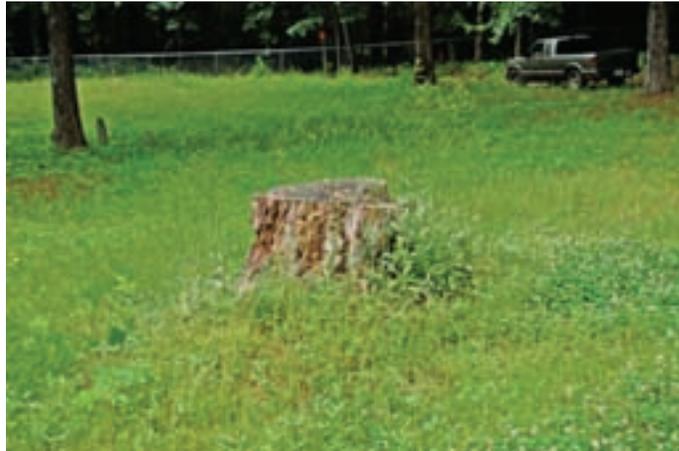
Figure 22. Example of a stump that should be cut closer to the ground.

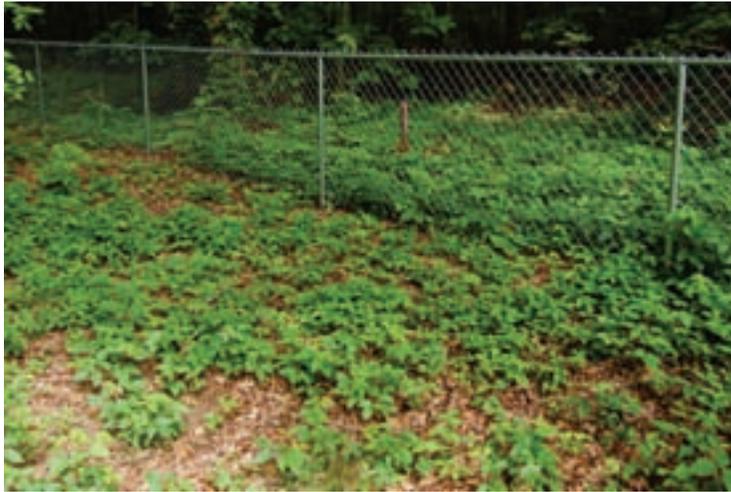
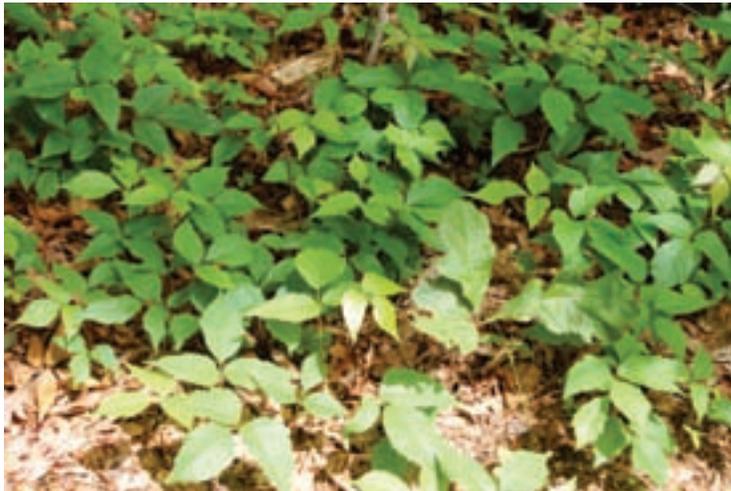
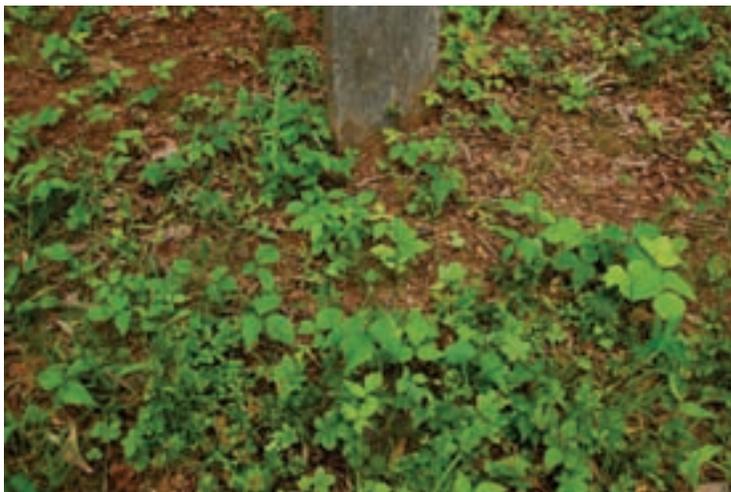
Figure 23. Poison ivy found in the cemetery.

One of the most significant landscape related issues is the need to eliminate the poison ivy that is overtaking the cemetery, as well as to reduce the strain maintenance is having on volunteer efforts. We recommend a program of chemical control using the herbicide Garlon 4 (triclopyr) followed by mulching. In addition, we recommend the removal of some diseased or weakened trees.

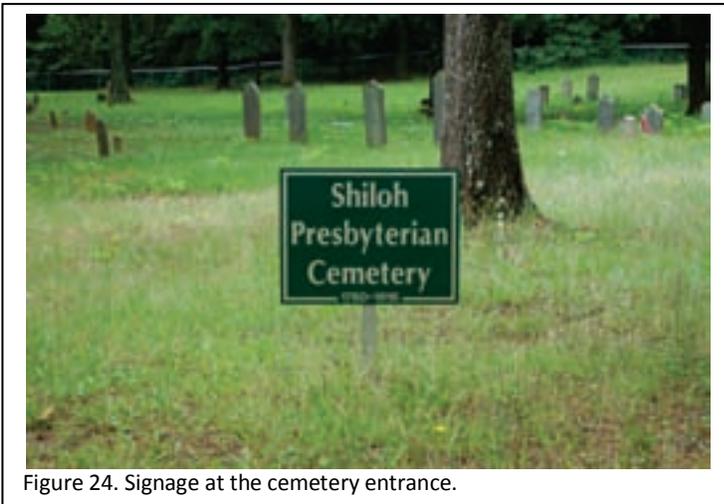
The cemetery lacks effective signage. During our assessment the only signage we observed was a sign at the entrance of the cemetery (Figure 24) providing the cemetery name and dates of operation, but no other details or information. There

Figure 24. Signage at the cemetery entrance.

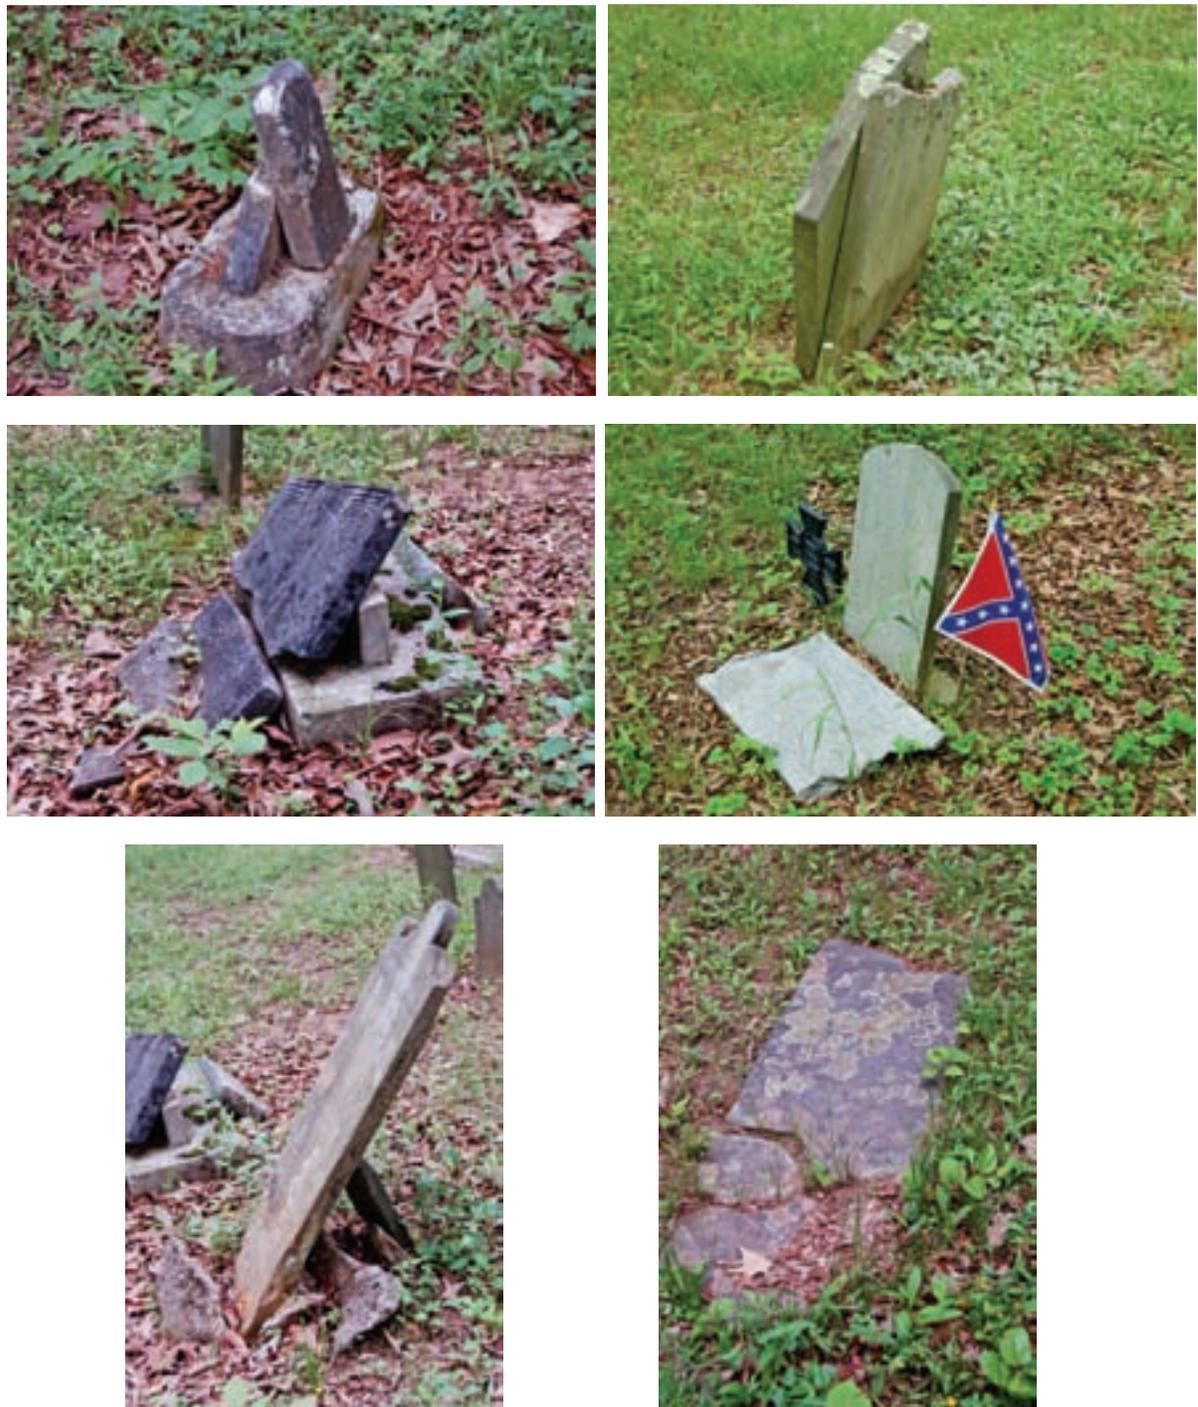
Figure 25. Examples of broken stones at the Old Shiloh Presbyterian Church Cemetery. Top and middle rows illustrate a variety of stone breaks. Bottom left illustrates a broken stone propped up. Should the stone fall it will certainly break again, increasing repair costs. The stone at the bottom right lying on the ground is subject to mower and pedestrian damage.

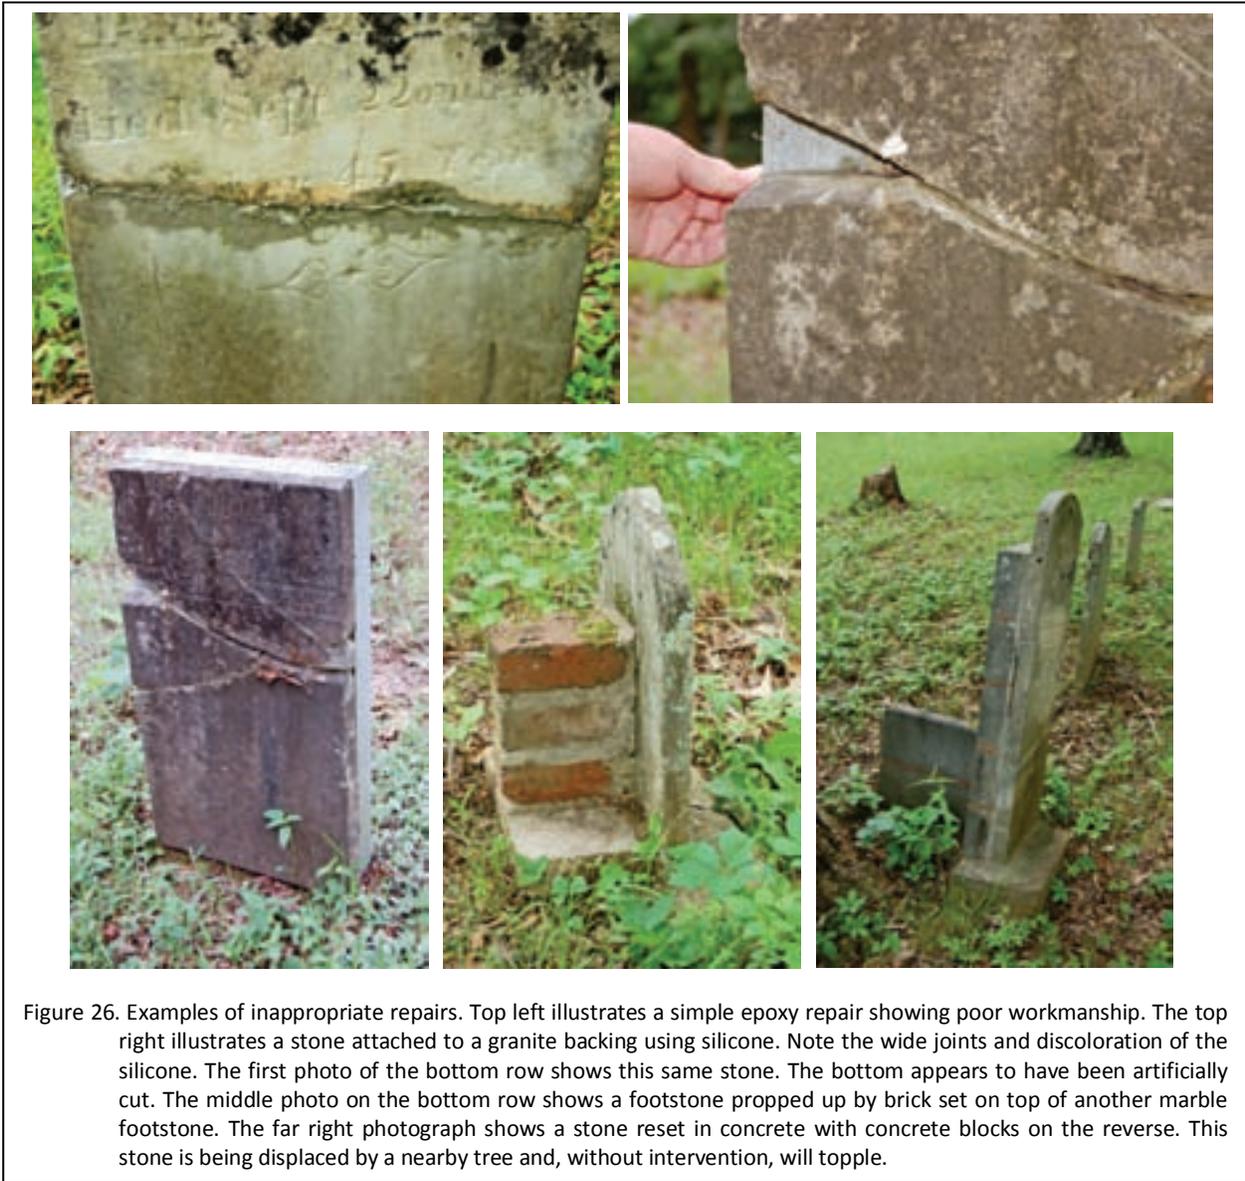
There are additional stones, likely repaired by a commercial monument company. The stones are backed by granite and attached using what appears to be a silicone adhesive. These repairs are also inappropriate. The backing stone, being a

Figure 26. Examples of inappropriate repairs. Top left illustrates a simple epoxy repair showing poor workmanship. The top right illustrates a stone attached to a granite backing using silicone. Note the wide joints and discoloration of the silicone. The first photo of the bottom row shows this same stone. The bottom appears to have been artificially cut. The middle photo on the bottom row shows a footstone propped up by brick set on top of another marble footstone. The far right photograph shows a stone reset in concrete with concrete blocks on the reverse. This stone is being displaced by a nearby tree and, without intervention, will topple.

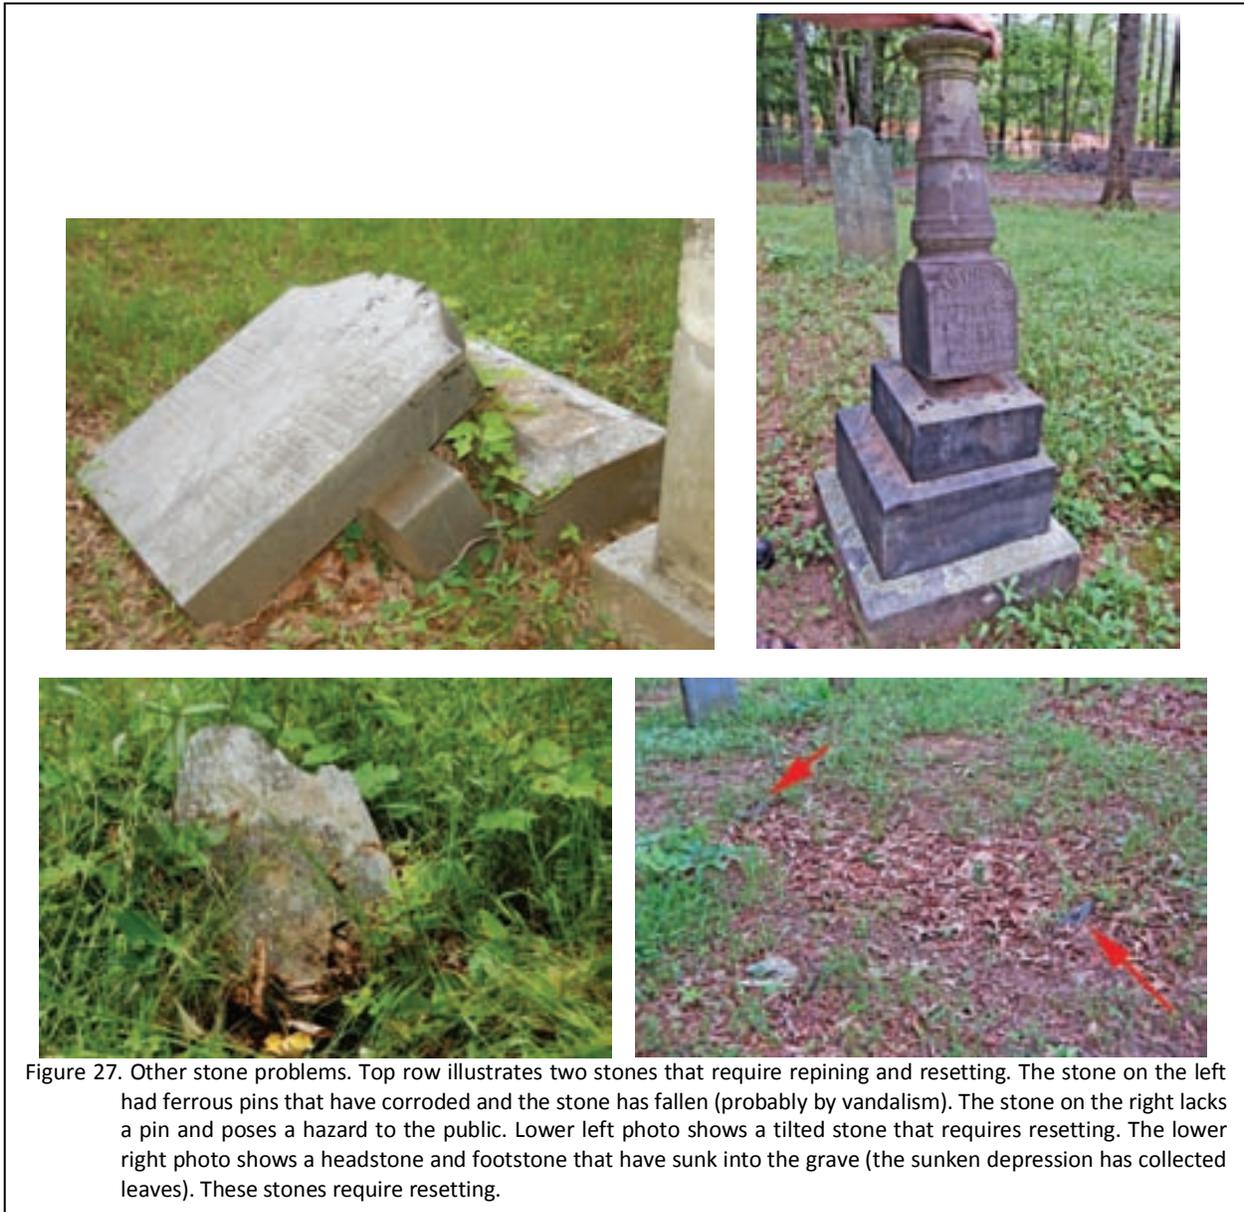
Where ferrous pins were used, the stones often exhibit corrosion attacking the pins and eventually causing sufficient damage that the stone topples. At times the stone itself is affected by a

Figure 27. Other stone problems. Top row illustrates two stones that require repining and resetting. The stone on the left had ferrous pins that have corroded and the stone has fallen (probably by vandalism). The stone on the right lacks a pin and poses a hazard to the public. Lower left photo shows a tilted stone that requires resetting. The lower right photo shows a headstone and footstone that have sunk into the grave (the sunken depression has collected leaves). These stones require resetting.

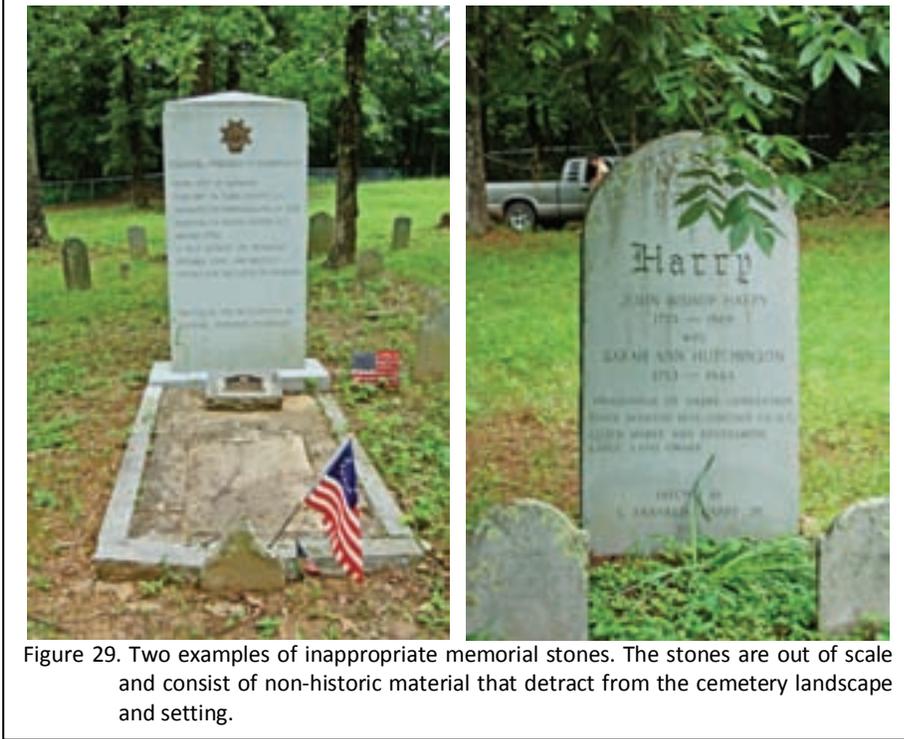
The monuments are out of scale with the rest of the cemetery, being entirely too large and

dominating the landscape. They are made of inappropriate, non-historic material. This cemetery does not contain granite monuments, except for these two examples.

Figure 29. Two examples of inappropriate memorial stones. The stones are out of scale and consist of non-historic material that detract from the cemetery landscape and setting.

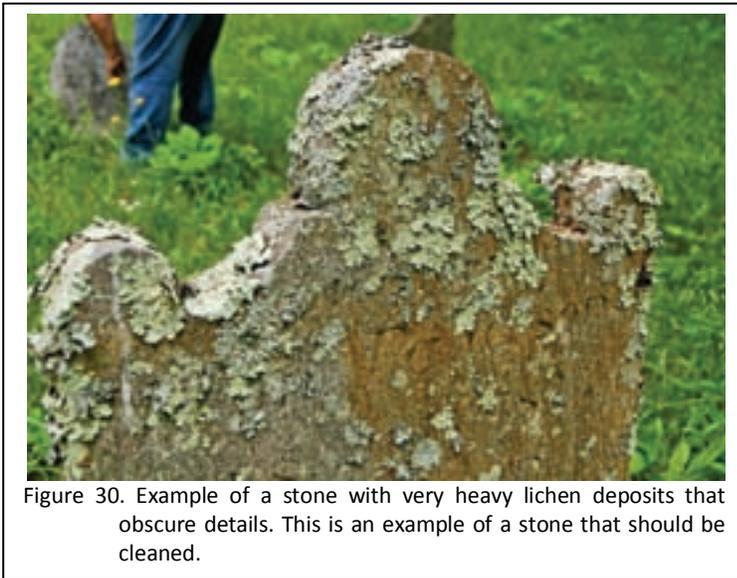
Figure 30. Example of a stone with very heavy lichen deposits that obscure details. This is an example of a stone that should be cleaned.

We recommend that a stone-by-stone assessment be conducted at Old Shiloh Presbyterian Church Cemetery. This will identify all monuments in need of treatment, determine their priority for treatment, and provide costs for that work to be accomplished. This is a critical planning function.
