The Oakridge Village II Association Reserve Policy (Updated: April, 2026) provides the essential requirements and descriptions of the Reserve Study and a proposed 20 year Reserve Fund plan. As required by the Colorado Common Interest Ownership Act ("CCIOA"), the Home Owner's Association (hereafter referred to as "Association" or "Oakridge Village II Association") which holds common interest elements (common area spaces, landscaping, buildings, etc.) is required to form, publish and periodically update a Reserve Study and funding plan specific to the Association's common element sustaining needs. Specifically, the Reserve Study should quantify the Association's "common elements" (turf-landscape, irrigation, arbor/shrubs, drainage/culverts) that require periodic expenditures for their upkeep, replacement, or necessary augmentation. Such expenditures are separate from those that might normally be managed with the Association's Operating funds.

### Physical Analysis of Oakridge Village II: Property Description

## Reserve Study and Funding Plan for Oakridge Village II Association, Inc. (2026)

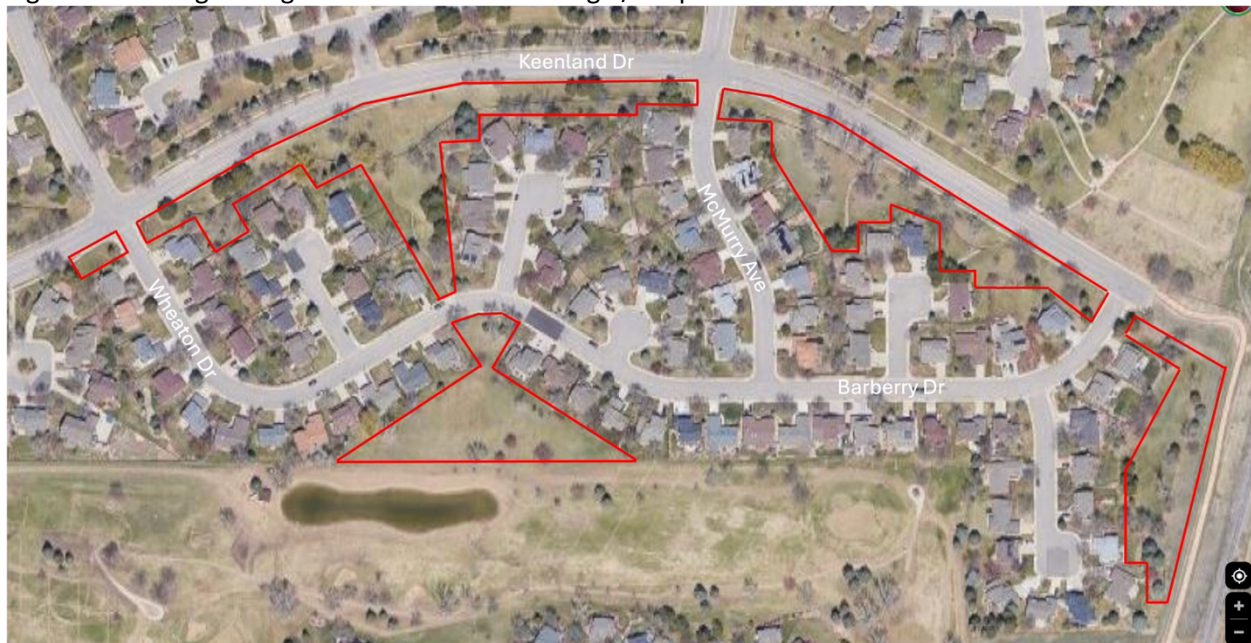
Figure 1. Oakridge Village II Association Ariel Image / Map

The red lines of the aerial image below (Fig. 1) indicate the approximate boundaries of the Oakridge Village II Association common areas.
