# Inspection Report

## Sample Report

123 Sample Street  
Charleston SC 29401

## Cardinal Home Inspections

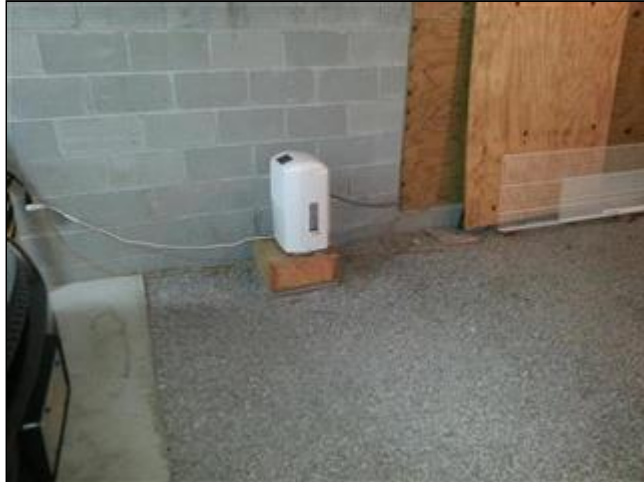
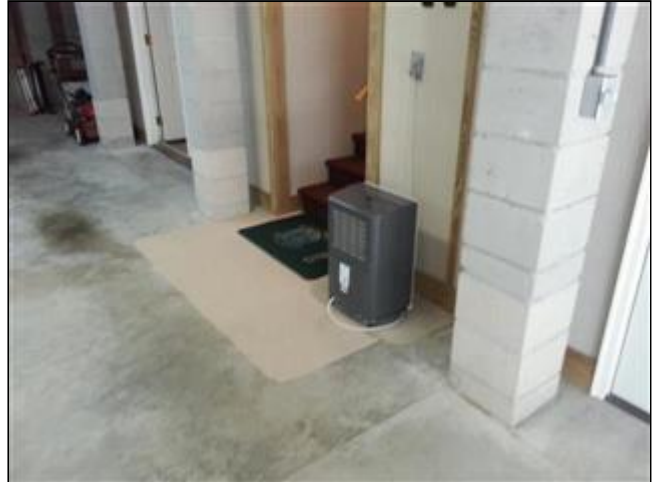
2.3 Item 1(Picture)

Portable dehumidifiers are present in the garage to reduce moisture levels. Recommend continue utilizing as necessary.

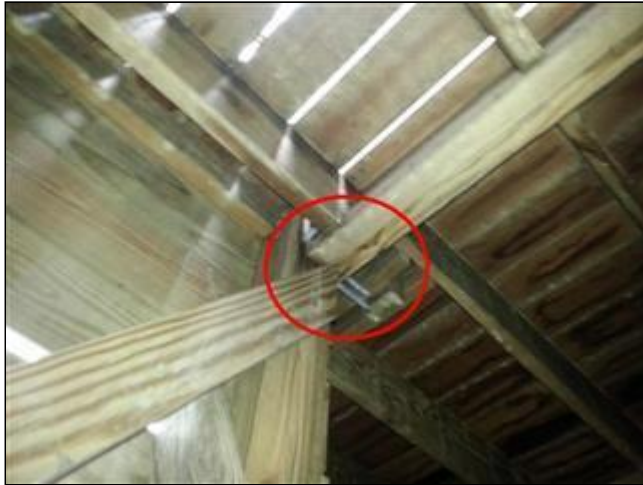
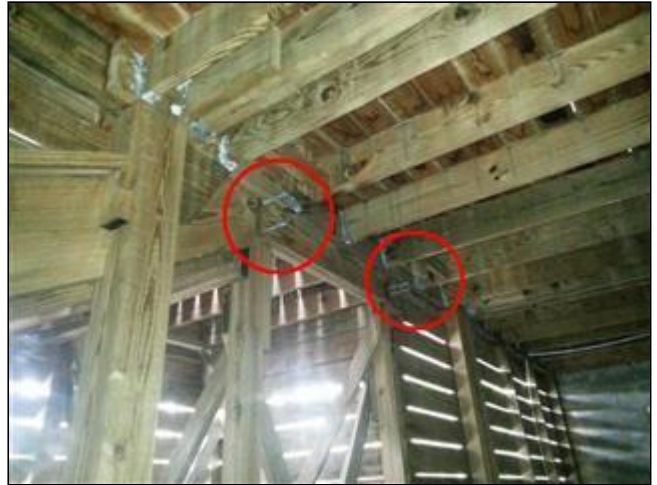
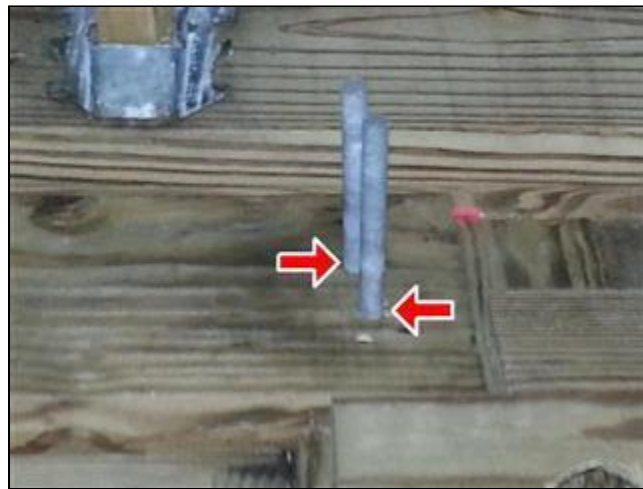
2.4 Item 1(Picture)

Connecting bolts located under the rear lower level porch steps are missing nuts and washers.

Connecting bolts located under the rear lower level porch steps are missing nuts and washers.

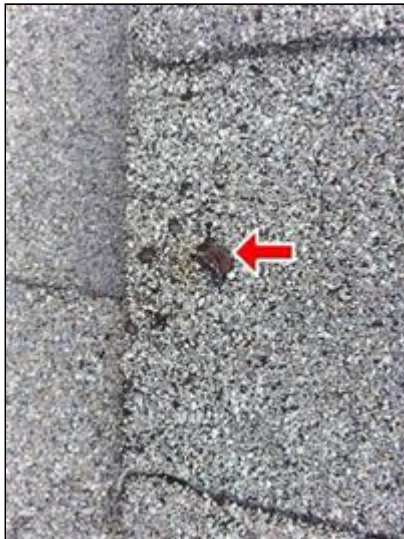
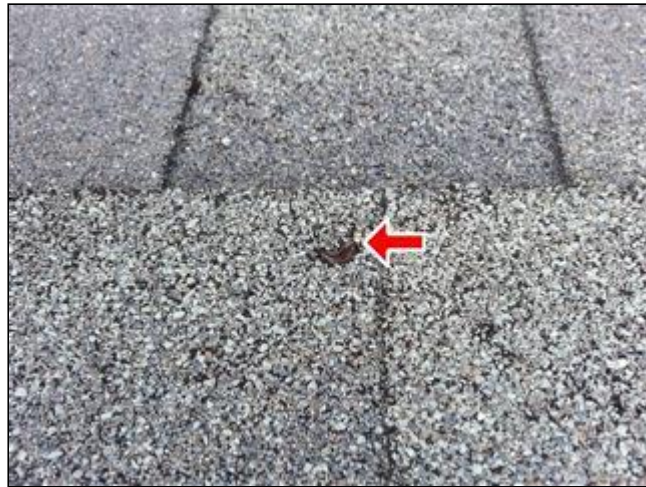
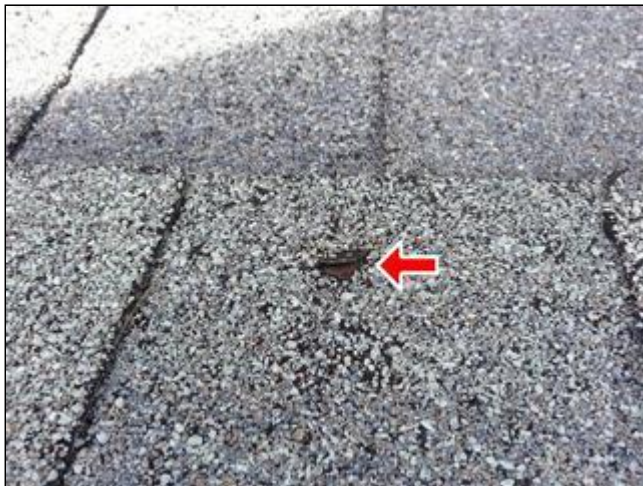
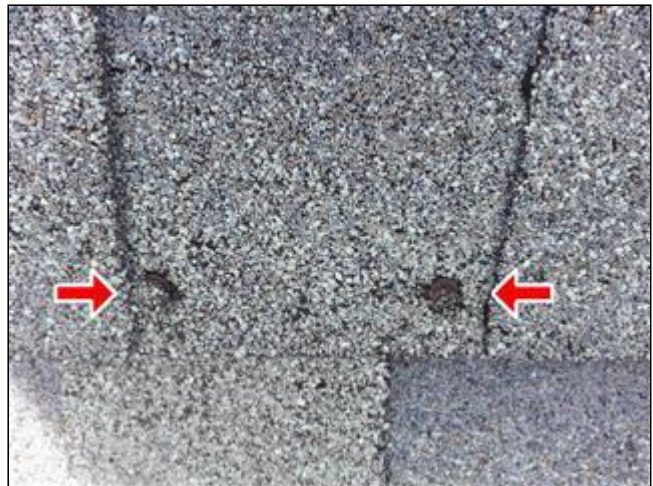
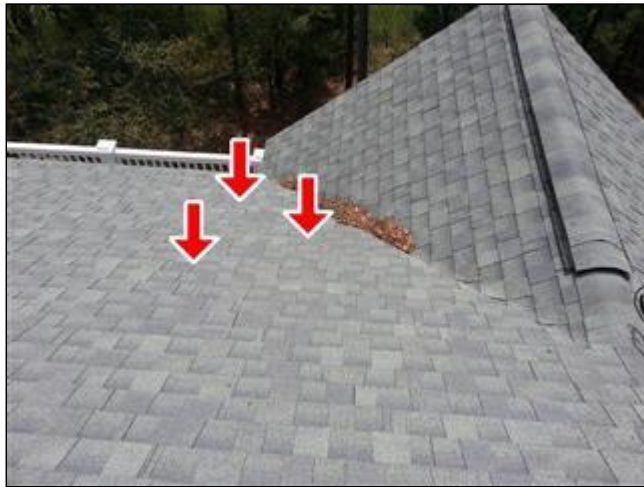
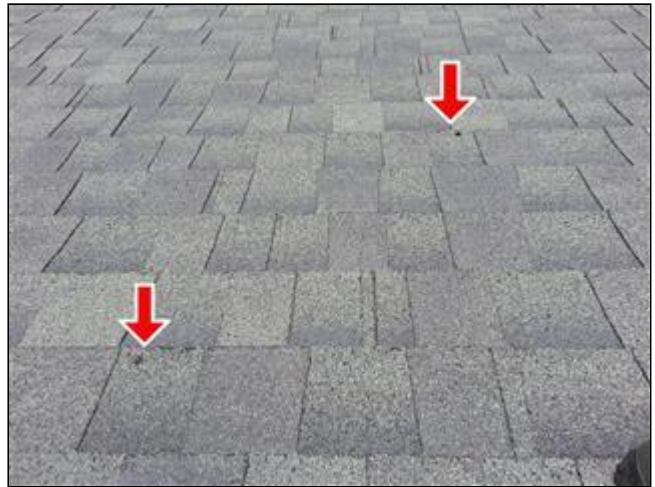
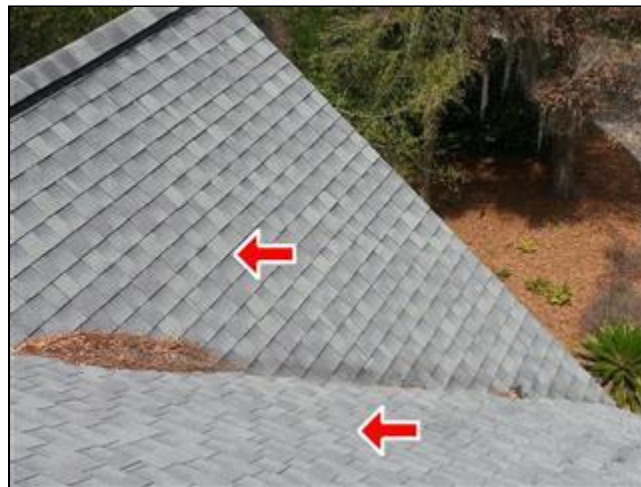
3.0 Item 1(Picture)

The roof shingles reveal multiple locations where nail heads are exposed (too many to list). These areas are prone to leaking due to expansion and contraction. Recommend all areas be corrected by a licensed tradesman to prevent potential leaks.

The roof shingles reveal multiple locations where nail heads are exposed (too many to list). These areas are prone to leaking due to expansion and contraction. Recommend all areas be corrected by a licensed tradesman to prevent potential leaks.

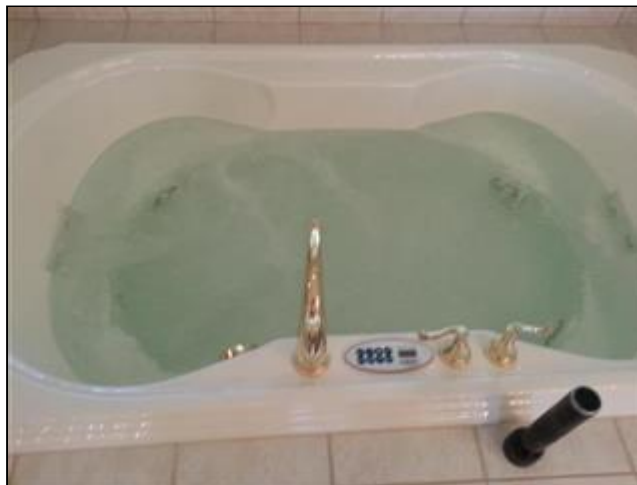
4.3 Item 1(Picture)

(1) View of Jacuzzi in operation.

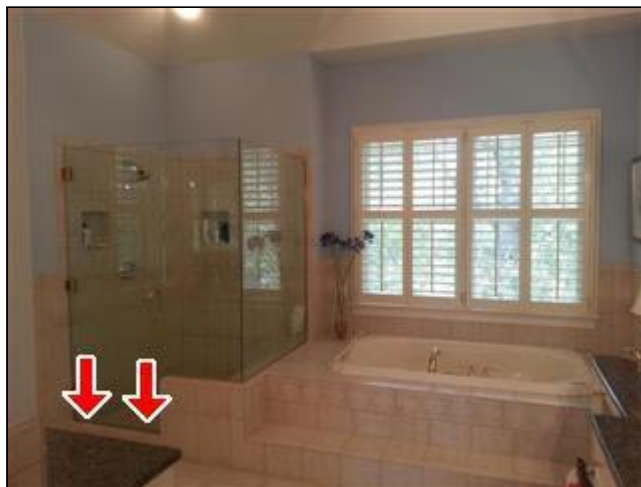
4.3 Item 2(Picture)

(2) The tile grout located in the master bathroom shower reveals gaps in areas due to typical wear. Recommend top coat with grout and grout sealer to prevent potential leaks.

(2) The tile grout located in the master bathroom shower reveals gaps in areas due to typical wear. Recommend top coat with grout and grout sealer to prevent potential leaks.

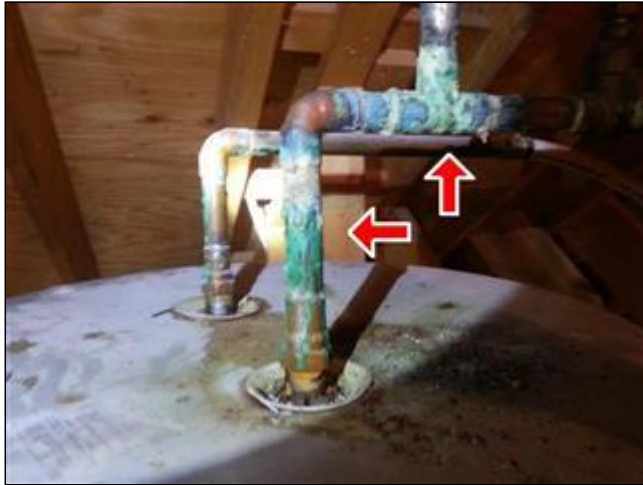
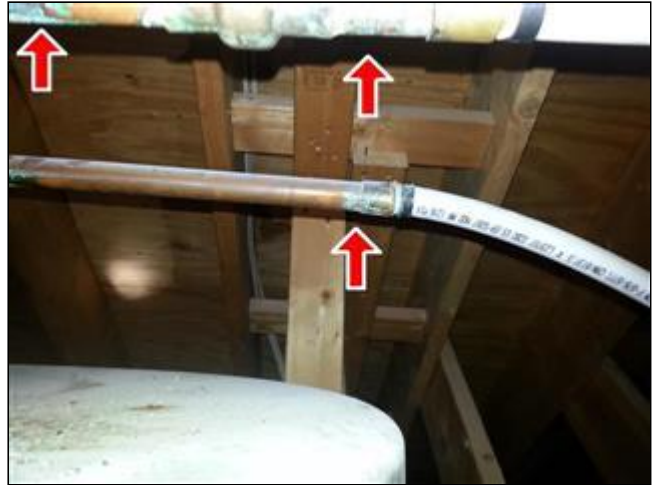
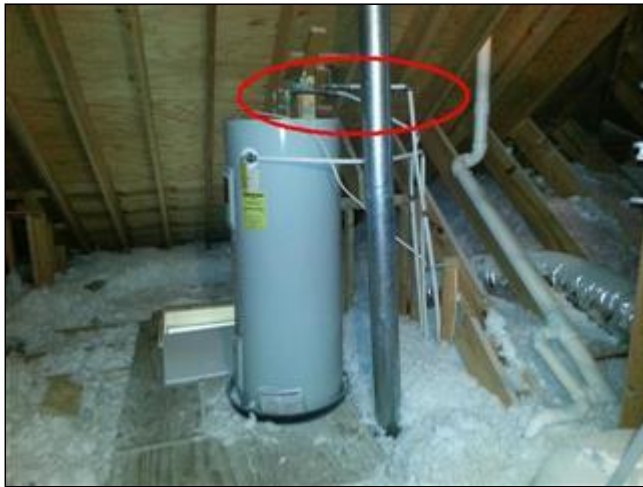
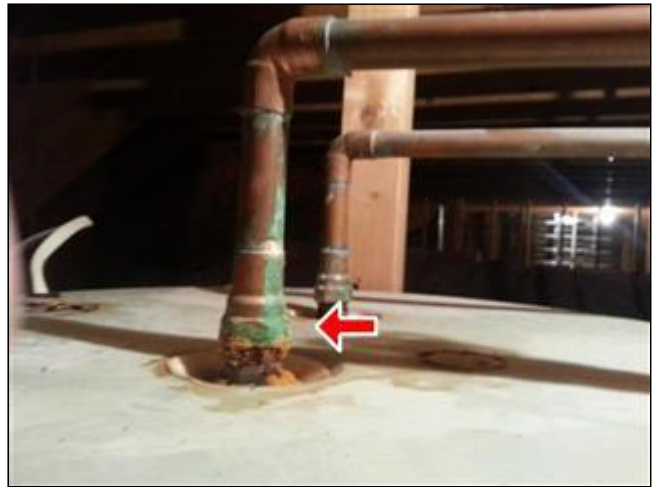
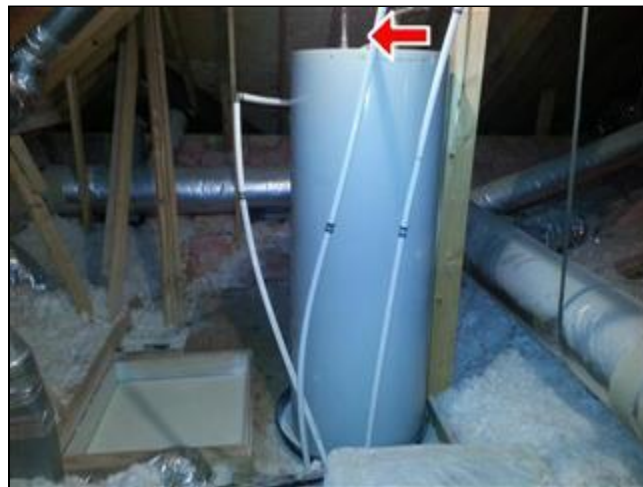
4.4 Item 1(Picture)

Pipes and pipe connections are rusted and corroded at the top of both water heaters (revealing pin hole leaks). Recommend replaced deteriorated pipes.

Pipes and pipe connections are rusted and corroded at the top of both water heaters (revealing pin hole leaks). Recommend replaced deteriorated pipes.

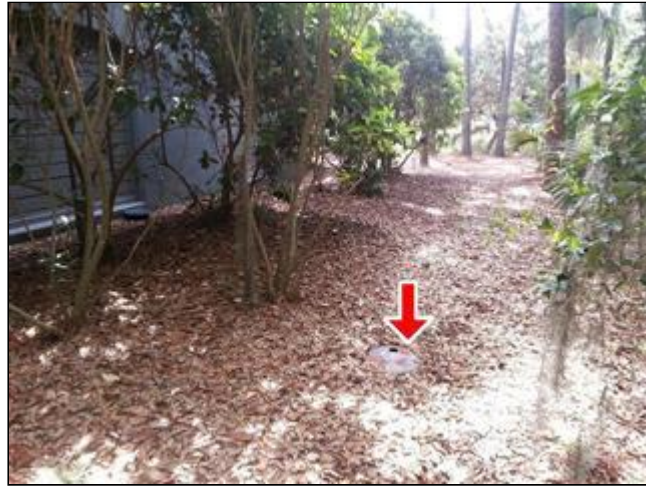
4.6 Item 2(Picture)

Gas shut off location (see photo).

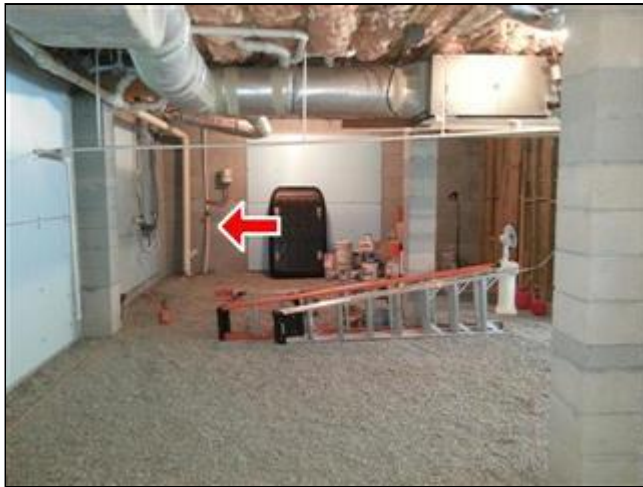
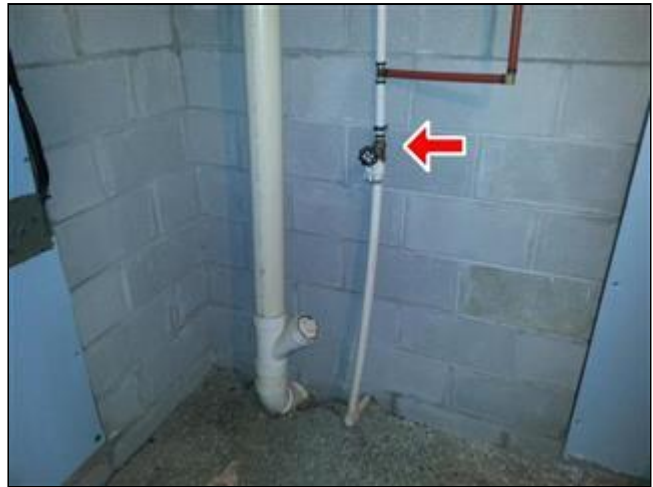
4.7 Item 1(Picture)

Water shut-off device location (see photo).

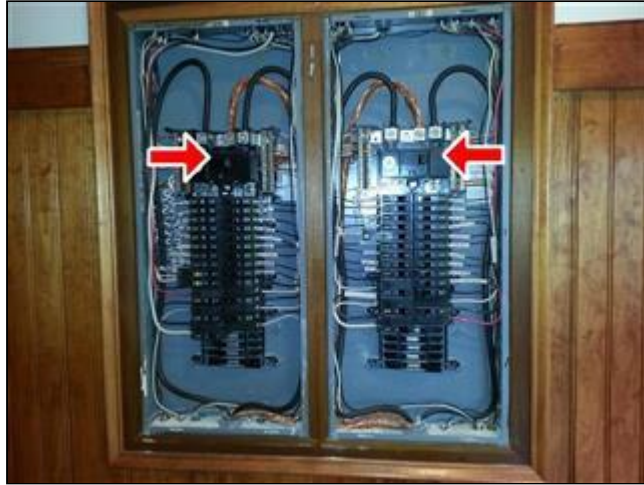
5.8 Item 1(Picture)

Main panel box and disconnects are located in the Den/Study (for your information).

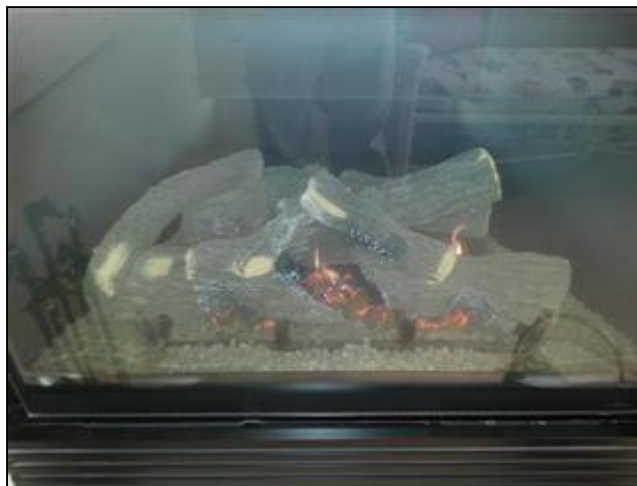
6.8 Item 1(Picture)

View of gas logs in operation.

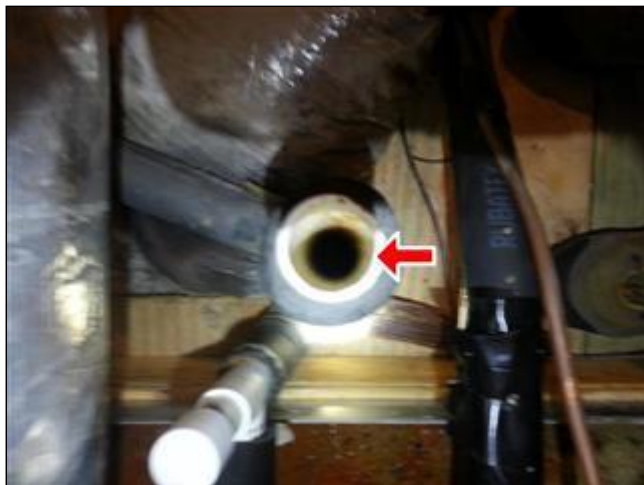
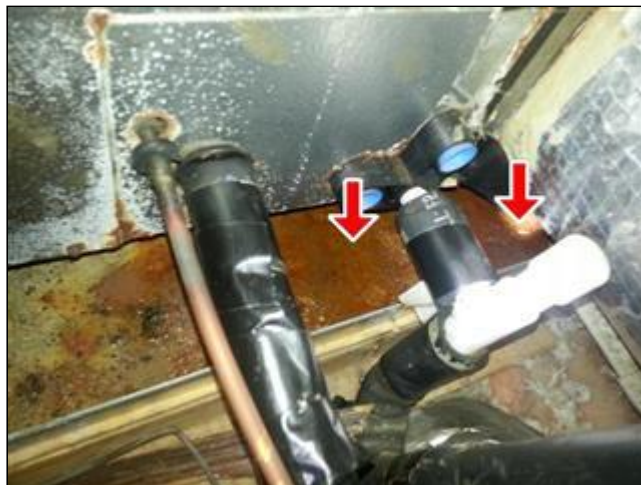
7.0 Item 1(Picture)

The condensation drain lines are partially clogged at both air handlers located in the attic. The unit located on the right side of the home is beginning to leak into the pan. Recommend repair.

The condensation drain lines are partially clogged at both air handlers located in the attic. The unit located on the right side of the home is beginning to leak into the pan. Recommend repair.

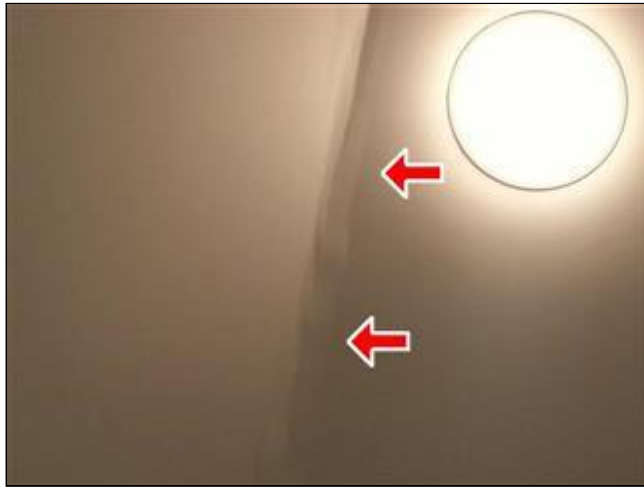
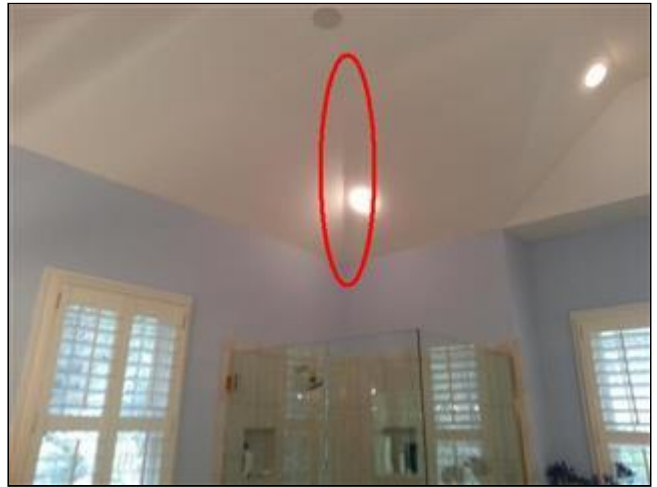
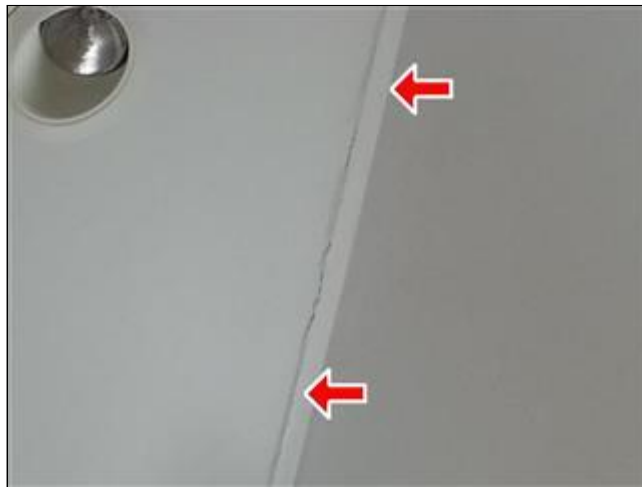
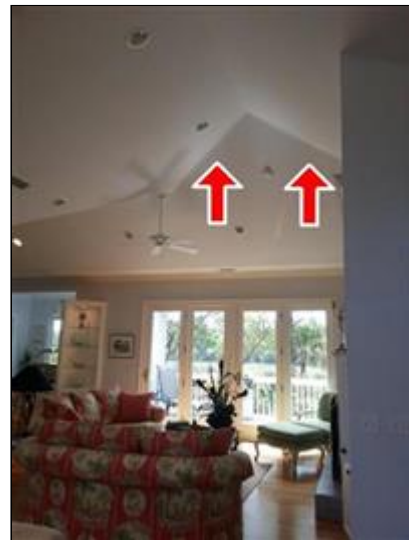
8.0 Item 1(Picture)

Ceilings in the master bathroom and upstairs family room are in need of cosmetic repairs due to cosmetic cracks at some of the drywall joints caused by typical shrinkage.

Ceilings in the master bathroom and upstairs family room are in need of cosmetic repairs due to cosmetic cracks at some of the drywall joints caused by typical shrinkage.

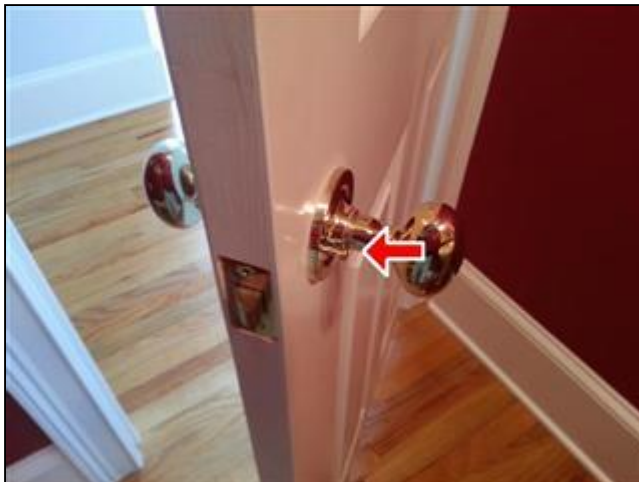
8.4 Item 1(Picture)

Privacy lock is not functional at the upstairs half bath.

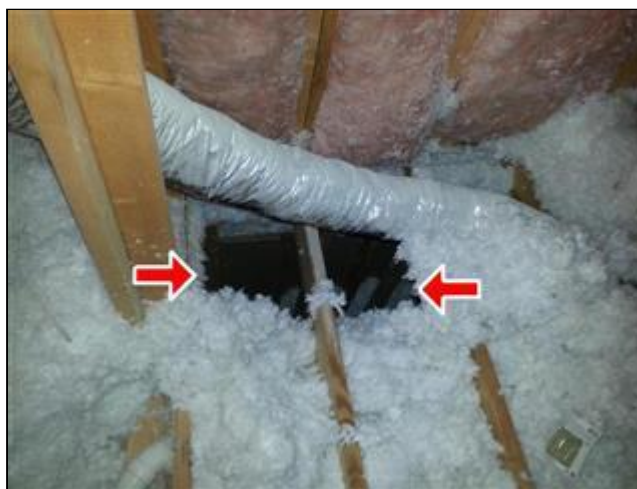
9.0 Item 1(Picture)

Recommend installing insulation over ceiling opening above the non vented fireplaces to prevent energy loss.

Recommend installing insulation over ceiling opening above the non vented fireplaces to prevent energy loss.
