Inspection Report

Property Address:
123 Your New Home
Mt. Pleasant SC 29464

Cardinal Home Inspections, LLC

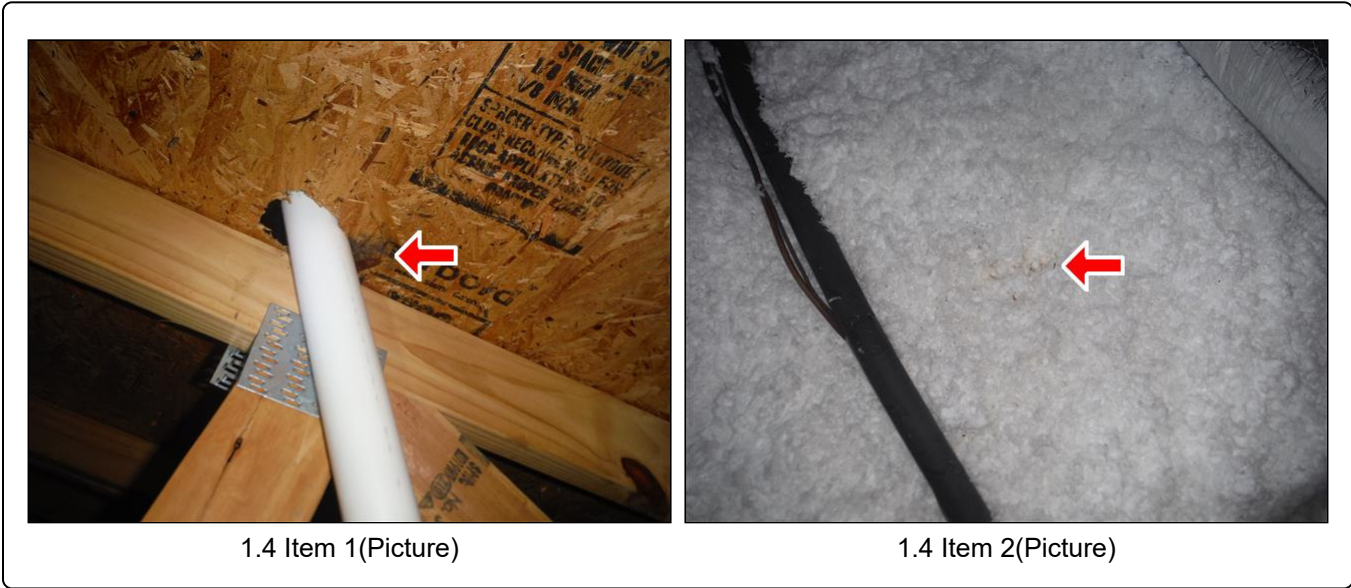
1.4 Item 1(Picture)

Small leak is active at one plumbing vent stack located at the rear of the home. Recommend repair or replace both of the plumbing vent flashings due to aged condition.

Small leak is active at one plumbing vent stack located at the rear of the home. Recommend repair or replace both of the plumbing vent flashings due to aged condition.

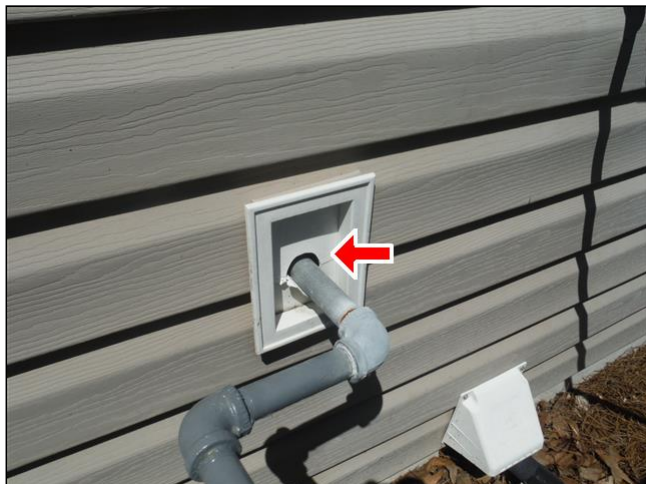
2.0 Item 1(Picture)

Exterior wall penetrations need caulking to prevent pest or moisture entry.

Exterior wall penetrations need caulking to prevent pest or moisture entry.

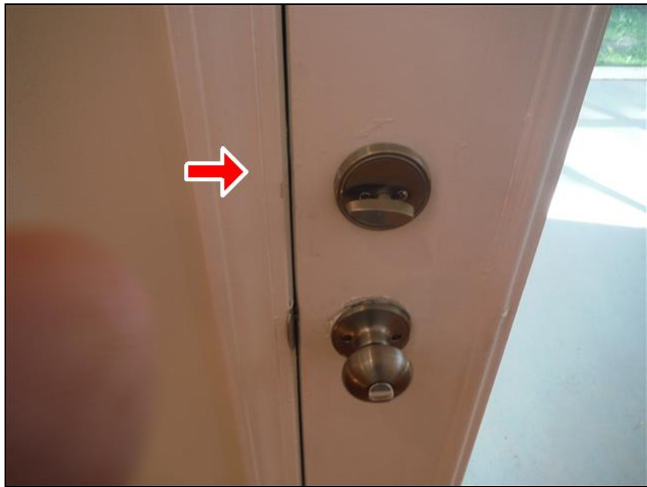
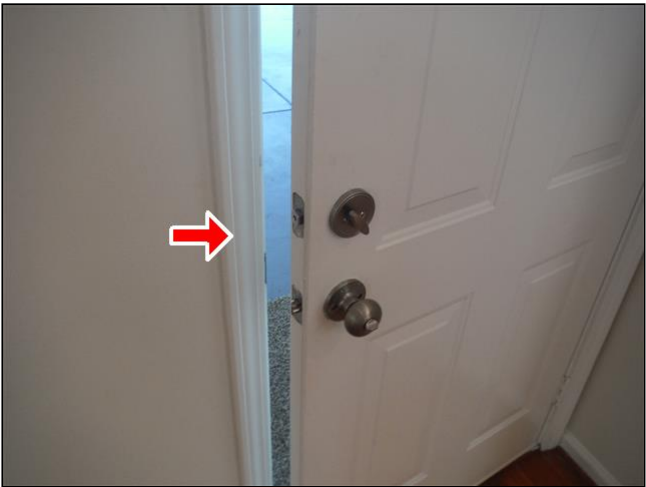
2.2 Item 1(Picture)

(1) Exterior doors to the screened porch and garage do not latch properly at the deadbolt latch and need adjustments.

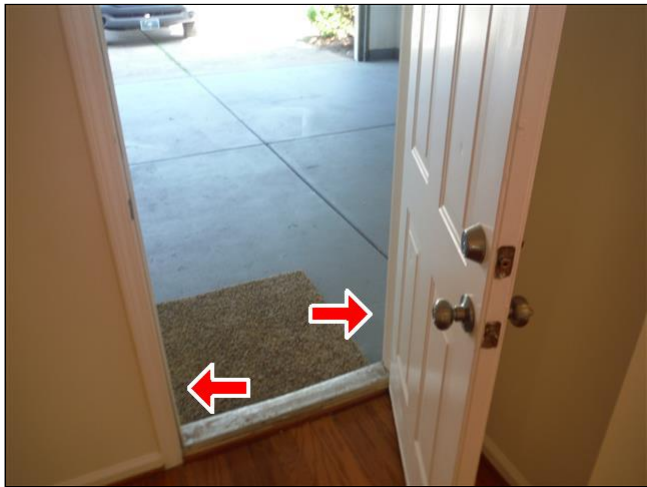
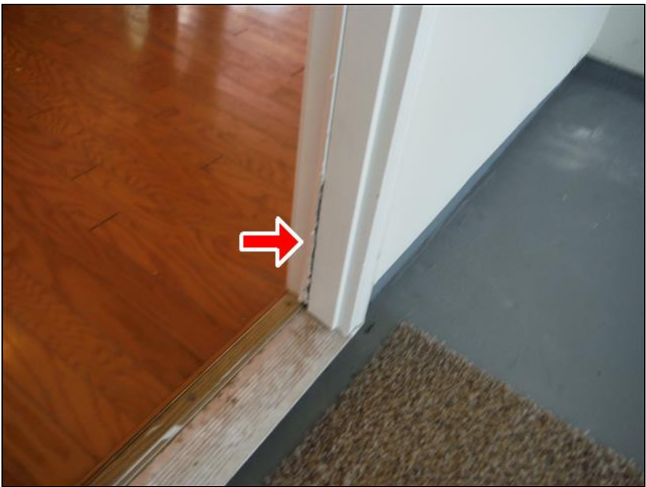
2.2 Item 3(Picture)

(2) Weather stripping is damaged on the door to the garage and needs replaced.

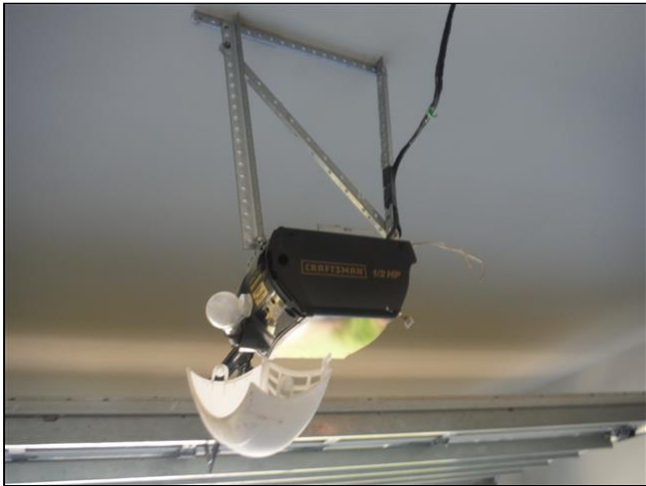
2.3 Item 1(Picture)

The automatic opener for the garage door does not work and needs repair or replace.

The automatic opener for the garage door does not work and needs repair or replace.

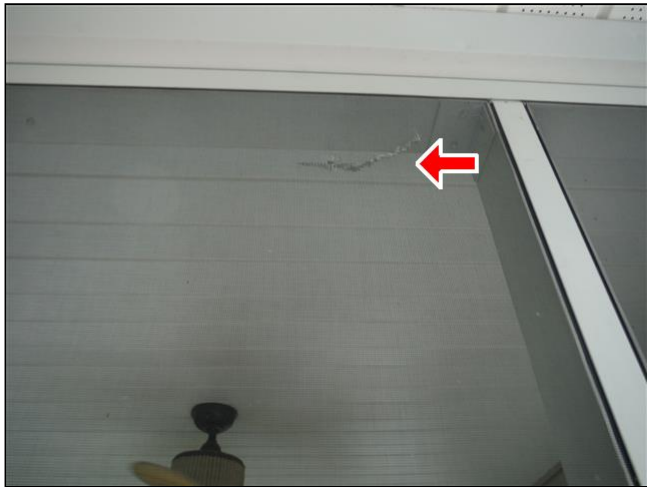
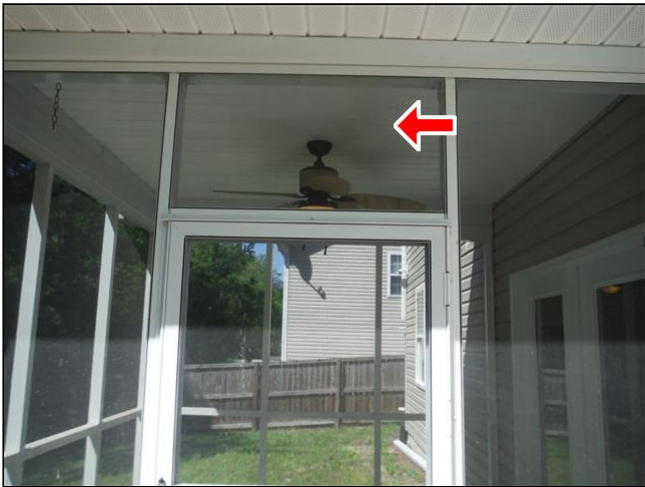
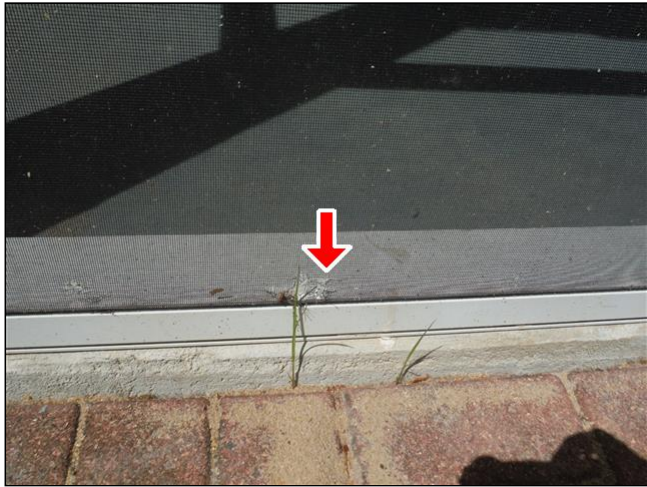
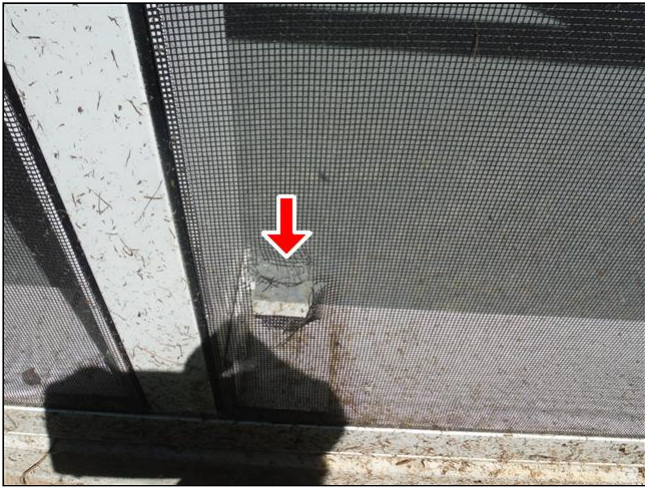
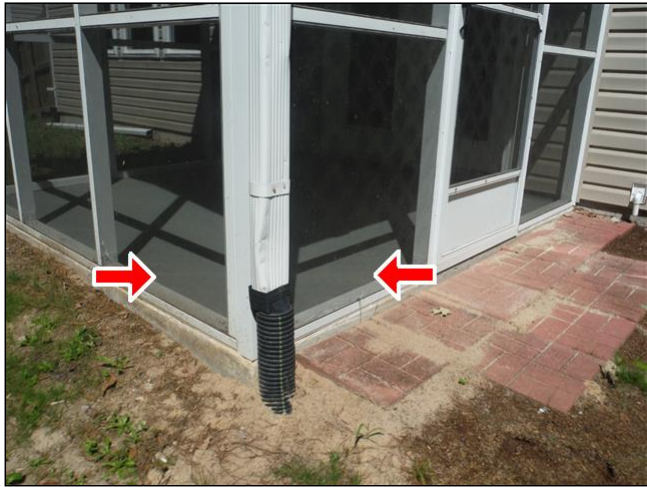
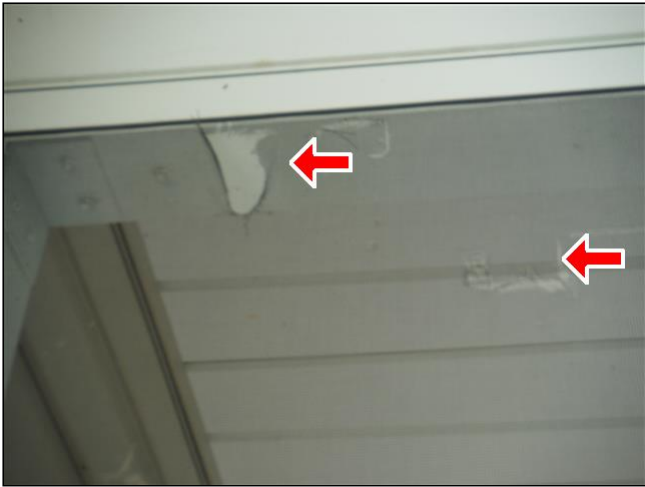
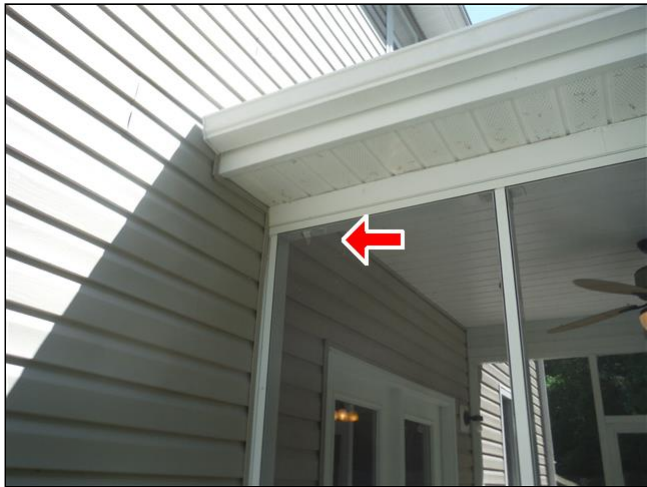
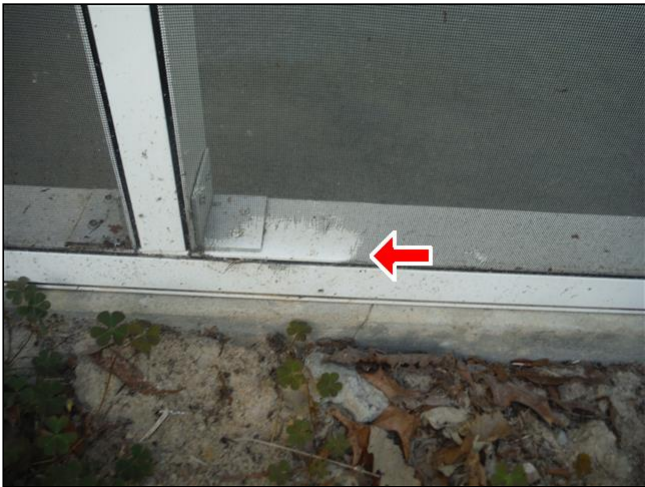
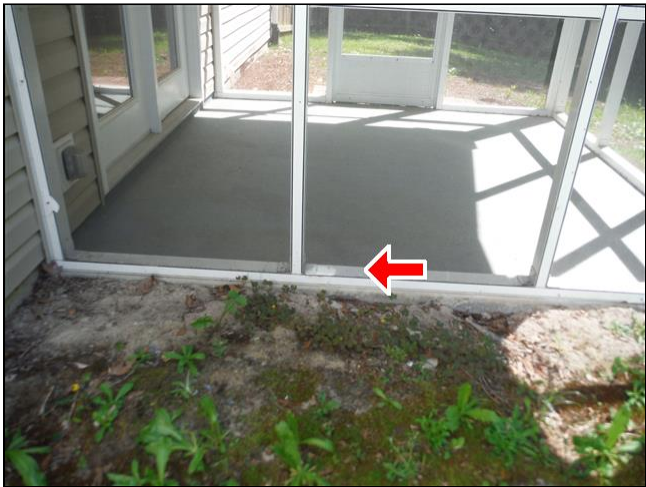
2.4 Item 1(Picture)

Screens are damaged and five placed and need repair or replaced on the rear porch.

Screens are damaged and five placed and need repair or replaced on the rear porch.

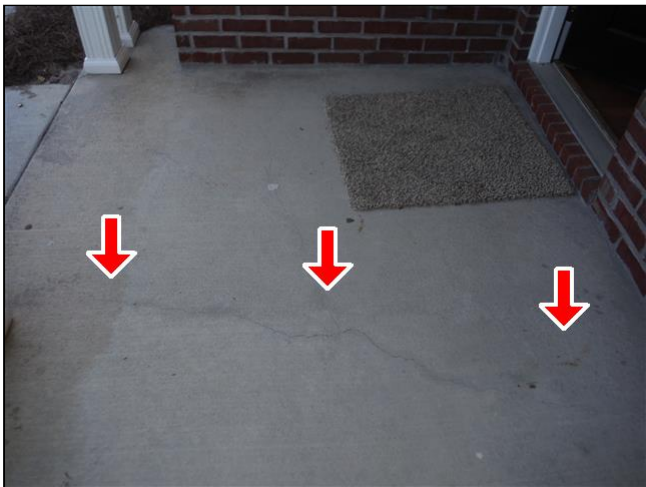
2.5 Item 1(Picture)

The concrete stoop located at the front porch reveals hairline cosmetic cracks. No repair is needed.

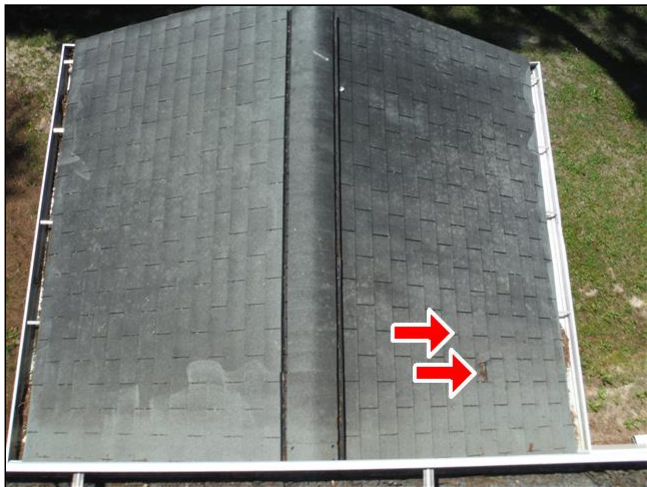
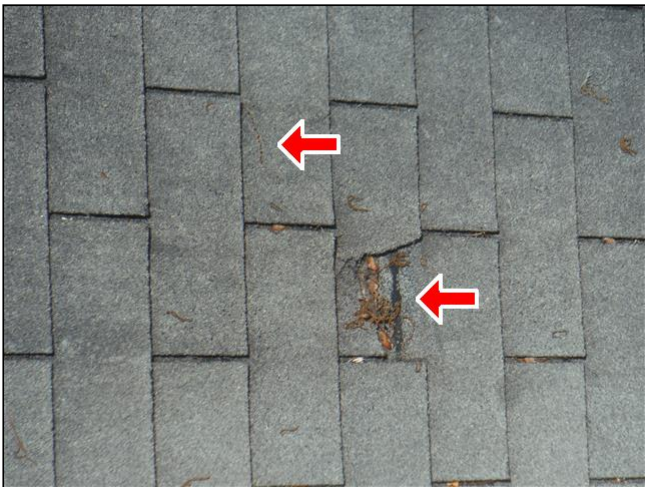
3.0 Item 1(Picture)

Two damaged shingles need replaced above the screened porch at the rear of the home.

Two damaged shingles need replaced above the screened porch at the rear of the home.

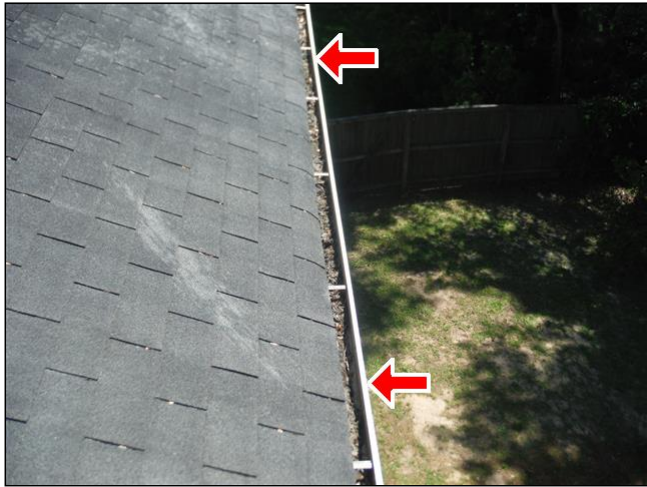
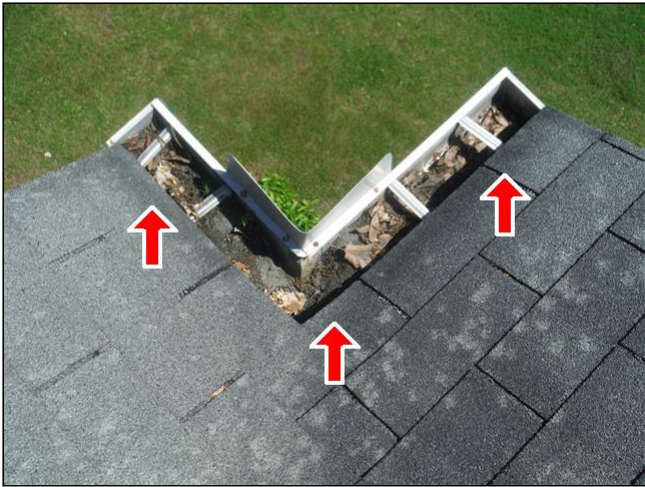
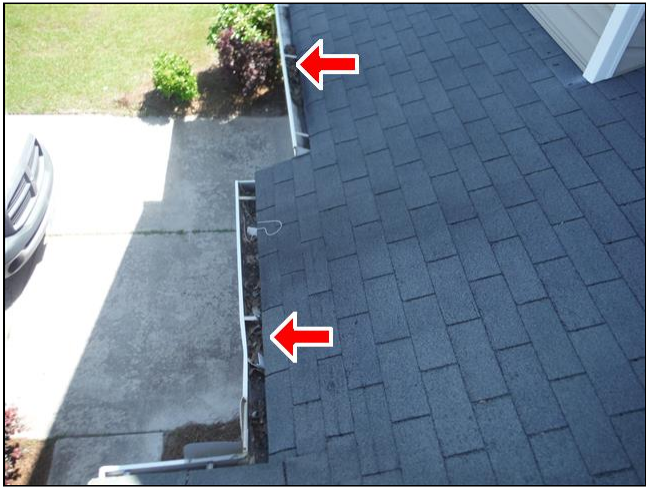
3.3 Item 1(Picture)

(1) Recommend removing debris from gutters to prevent clogging which can lead to soffit and fascia damage.

(1) Recommend removing debris from gutters to prevent clogging which can lead to soffit and fascia damage.

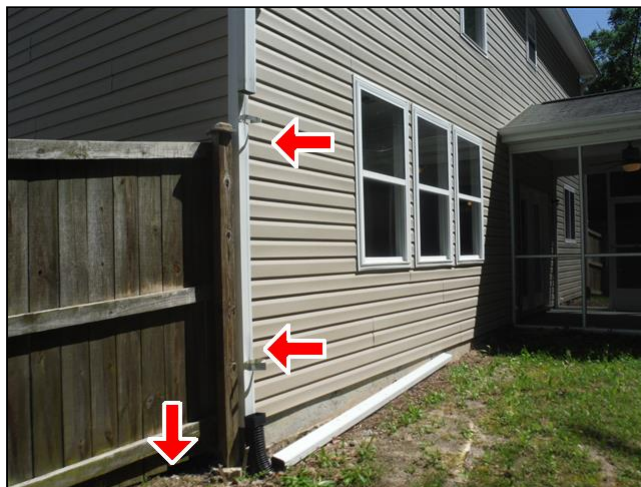
3.3 Item 4(Picture)

(2) Downspout located at the right rear corner of the home is detached and needs repair. Dirt bank at this location is eroding and needs backfilled.

(2) Downspout located at the right rear corner of the home is detached and needs repair. Dirt bank at this location is eroding and needs backfilled.

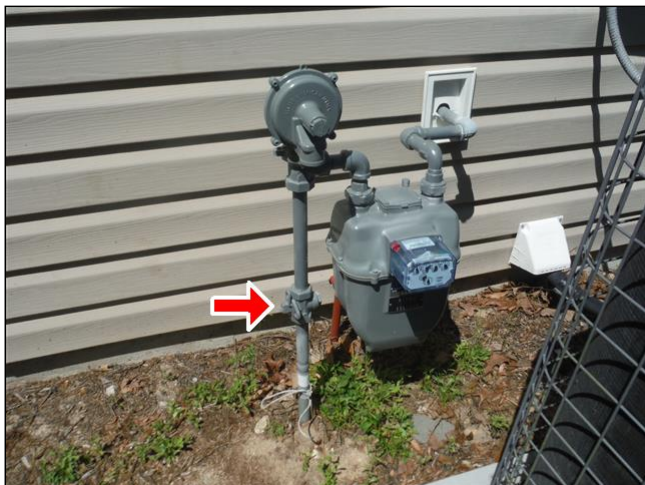
4.6 Item 1(Picture)

Gas shut off location (see photo).

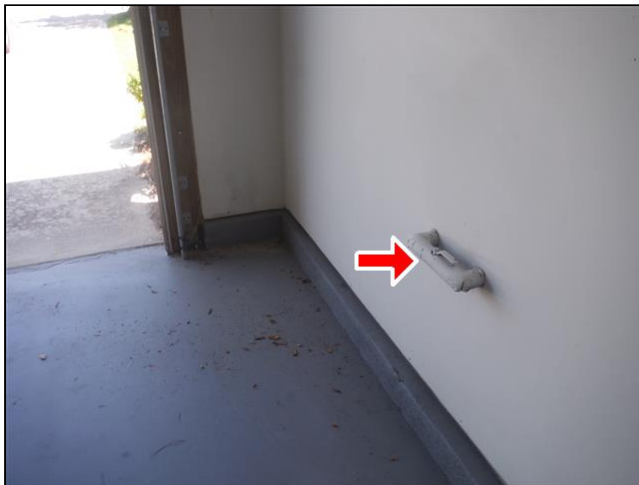
4.7 Item 1(Picture)

Water shut-off device location (see photo).

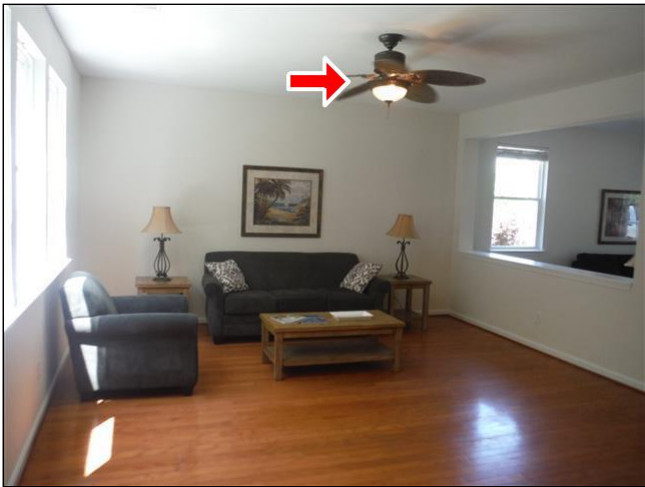
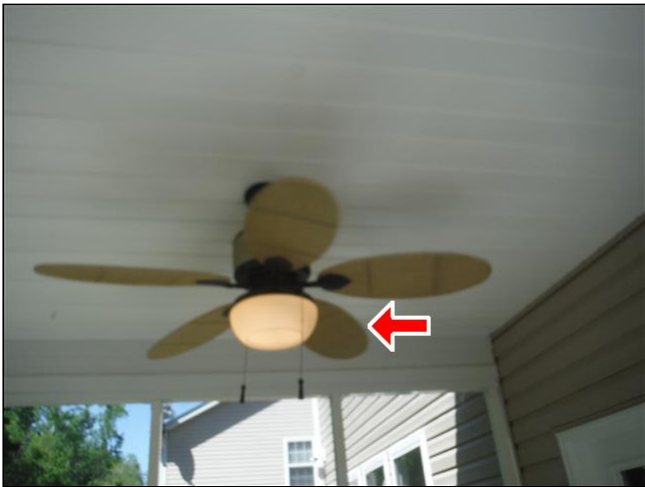
5.4 Item 1(Picture)

(1) Ceiling fans in the family room and on the screened porch have a wobble and need adjustments.

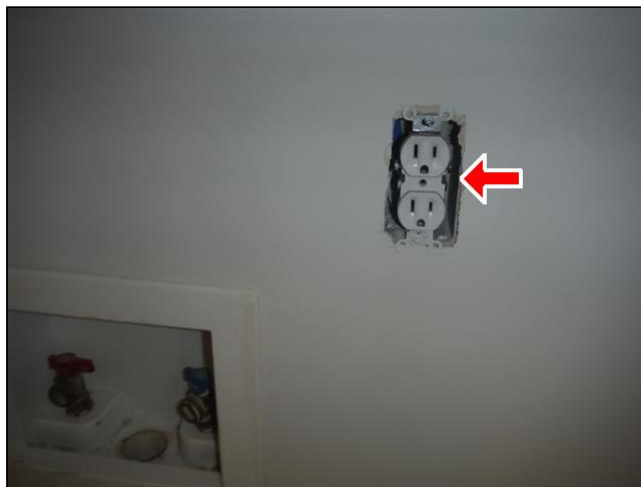
5.4 Item 4(Picture)

(2) Outlet located in the laundry room needs a coverplate where missing.

(2) Outlet located in the laundry room needs a coverplate where missing.

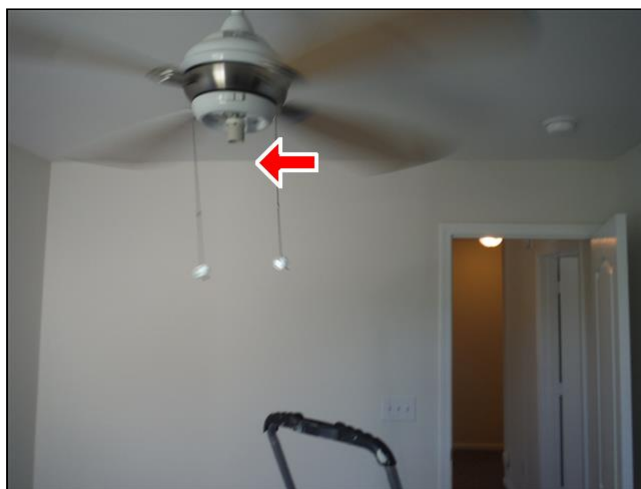
5.4 Item 5(Picture)

(3) Ceiling fan located in the upstairs right middle bedroom is missing a light bulb and light cover.

(3) Ceiling fan located in the upstairs right middle bedroom is missing a light bulb and light cover.

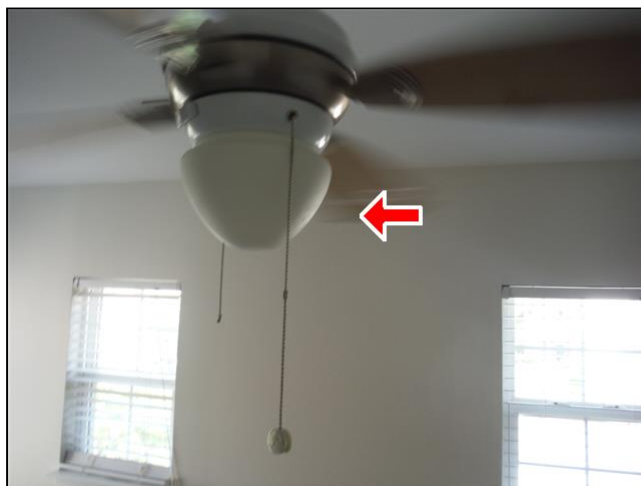
5.4 Item 6(Picture)

(4) Ceiling fan located in the front bedroom needs the light bulb replaced.

(4) Ceiling fan located in the front bedroom needs the light bulb replaced.

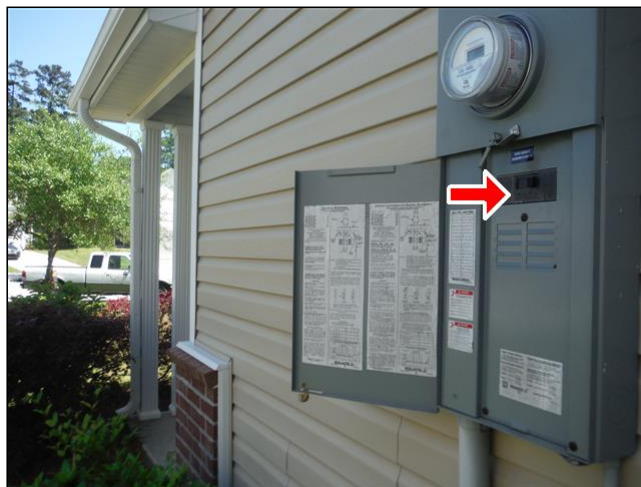
5.8 Item 1(Picture)

Main panel box is located in the garage. However, the main disconnect (shut-off) is outside at the meter base panel (for your information).

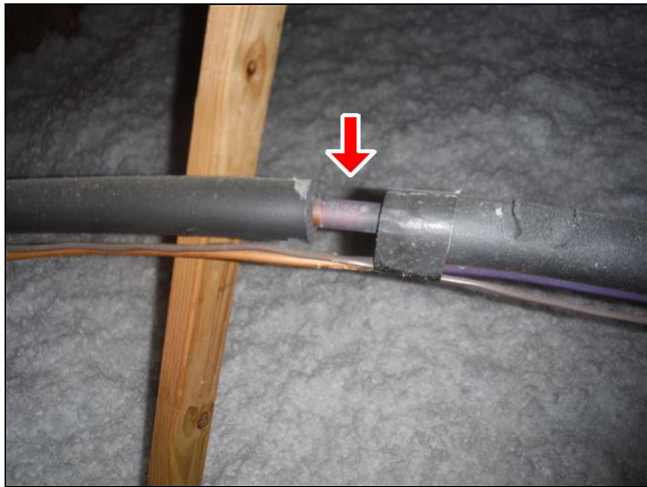
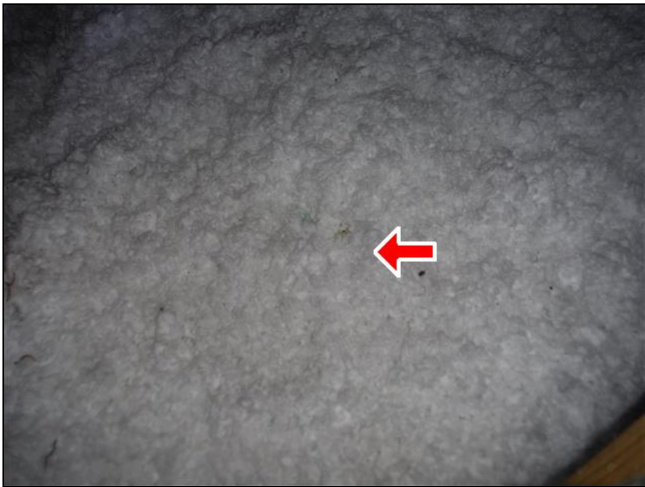
7.2 Item 1(Picture)

Suction line located in the attic needs repair where the foam sleeve has separated above the master bathroom to prevent condensation from dripping onto the ceiling.

Suction line located in the attic needs repair where the foam sleeve has separated above the master bathroom to prevent condensation from dripping onto the ceiling.

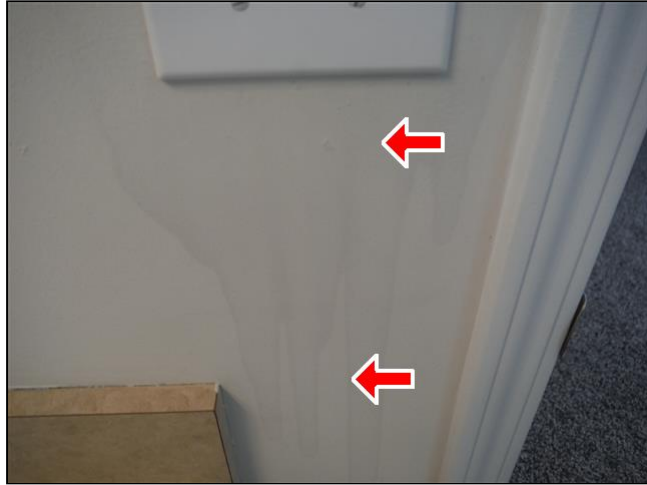
8.1 Item 1(Picture)

(1) Wall is stained under the light switch in the master bathroom (cosmetic).

(1) Wall is stained under the light switch in the master bathroom (cosmetic).

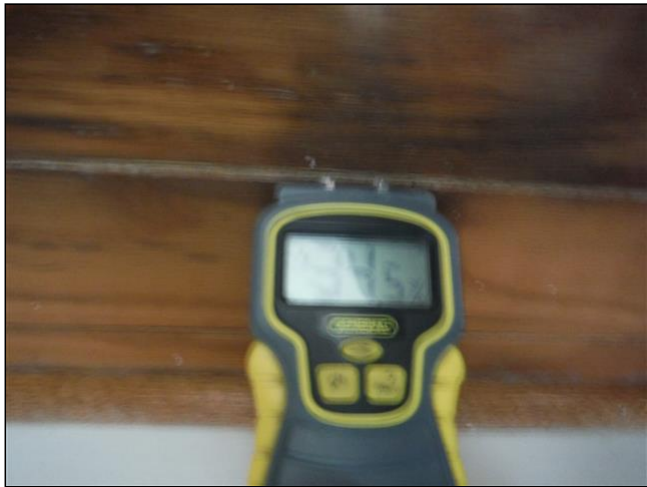
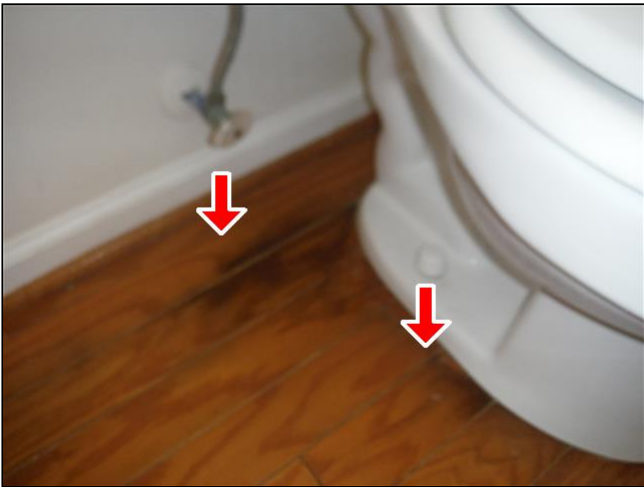
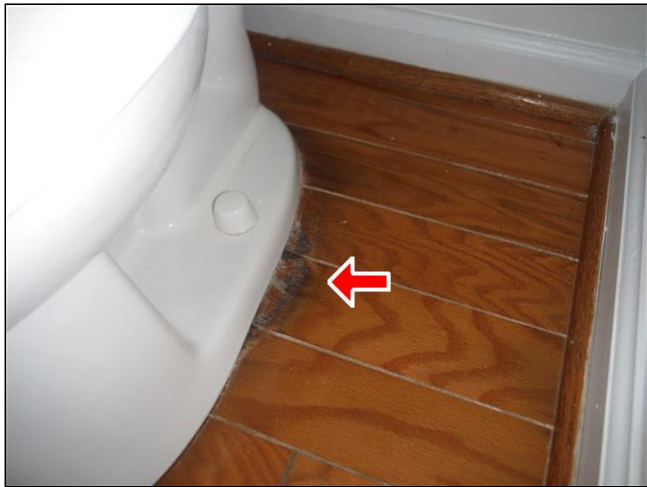
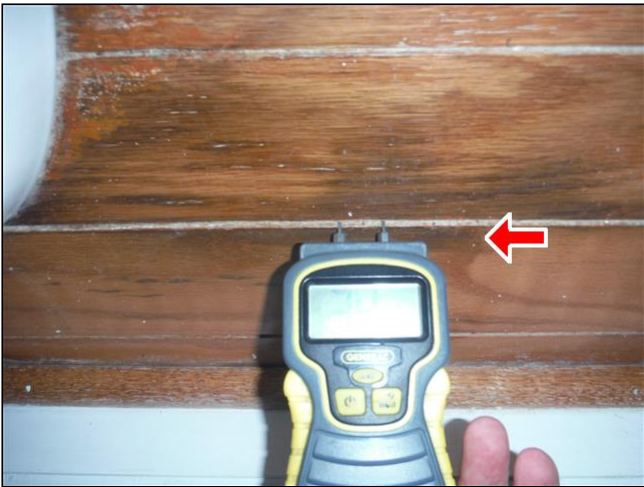
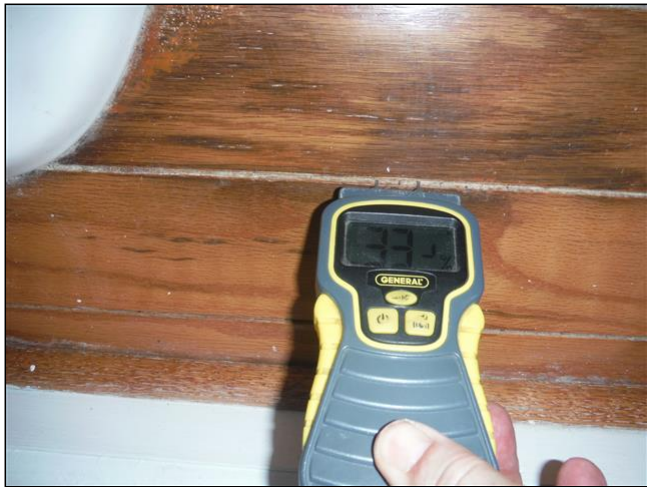
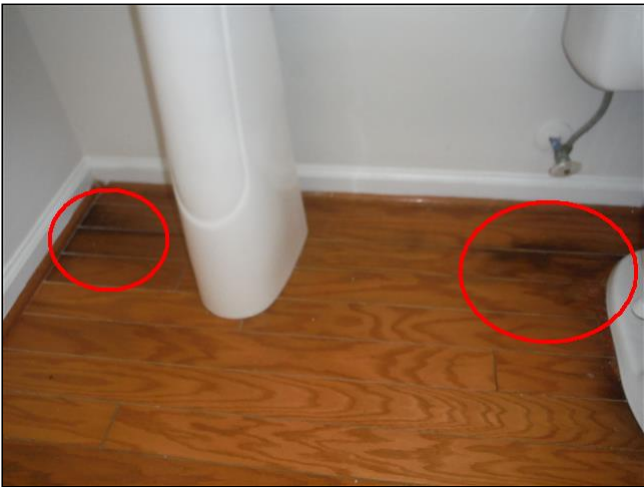
8.2 Item 1(Picture)

(1) Wood flooring located in the downstairs half bathroom is deteriorated around the toilet and stained under the sink. Areas were tested with a moisture meter and readings indicate moisture is active. Repair will involve removing the existing wood flooring and applying a deep penetrating concrete sealer on the slab, installing a new floor covering, and replacing the wax seal on the toilet.

(1) Wood flooring located in the downstairs half bathroom is deteriorated around the toilet and stained under the sink. Areas were tested with a moisture meter and readings indicate moisture is active. Repair will involve

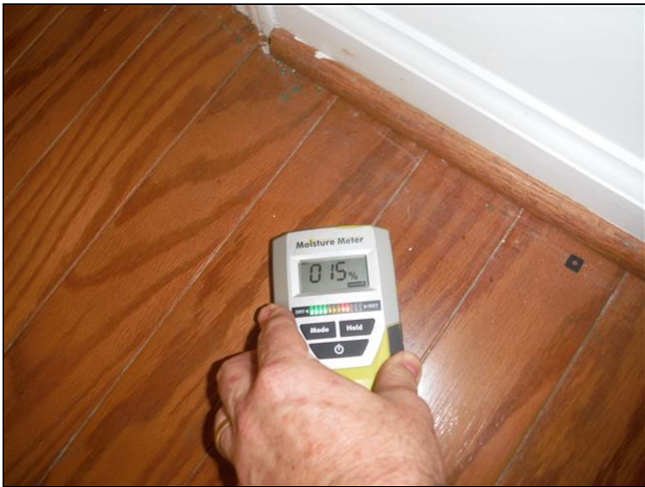
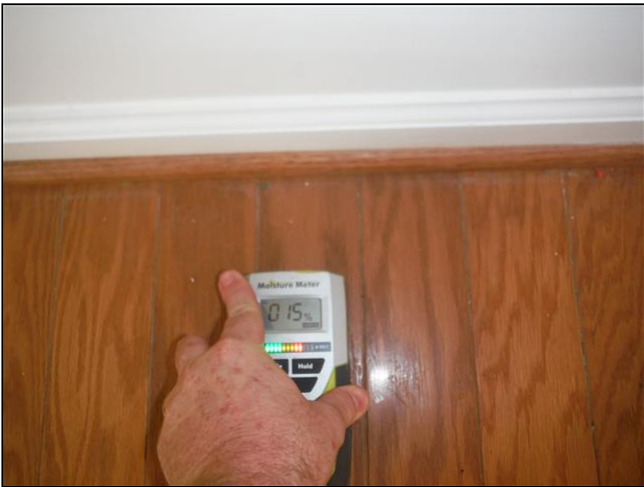
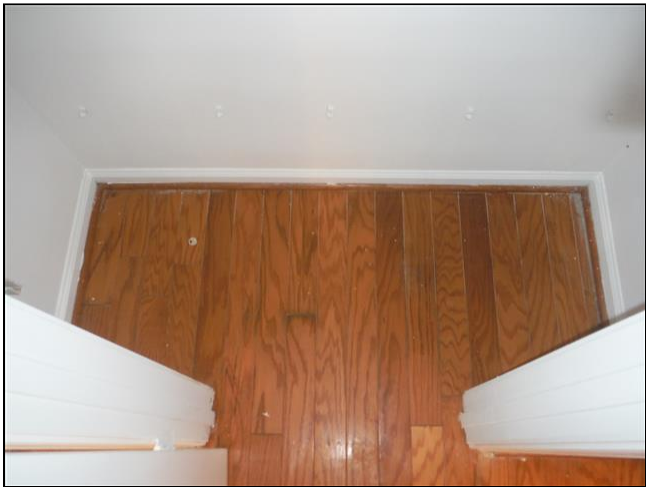
8.2 Item 7(Picture)

(2) Wood flooring is stained in the dining area and in the kitchen pantry closet. Moisture readings are elevated but within an acceptable range. No repairs are needed at this time.

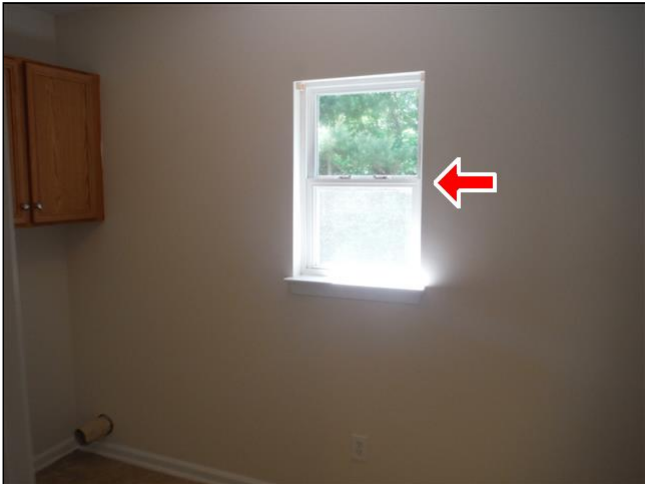
8.3 Item 1(Picture)

Two windows are beginning to show signs of damaged seals. Locations are the laundry room and in the master bedroom.

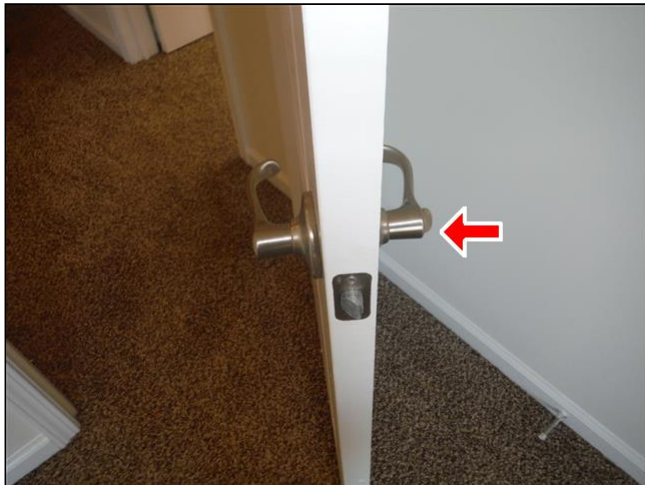
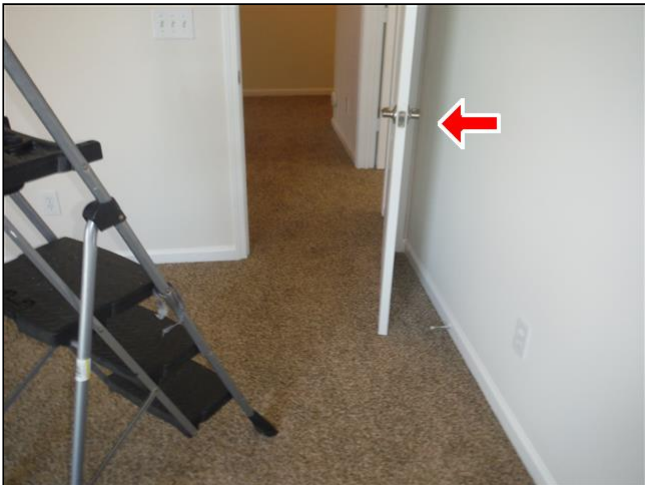
8.4 Item 1(Picture)

(1) The door knob for the upstairs right middle bedroom does not lock properly and needs repair.

(1) The door knob for the upstairs right middle bedroom does not lock properly and needs repair.

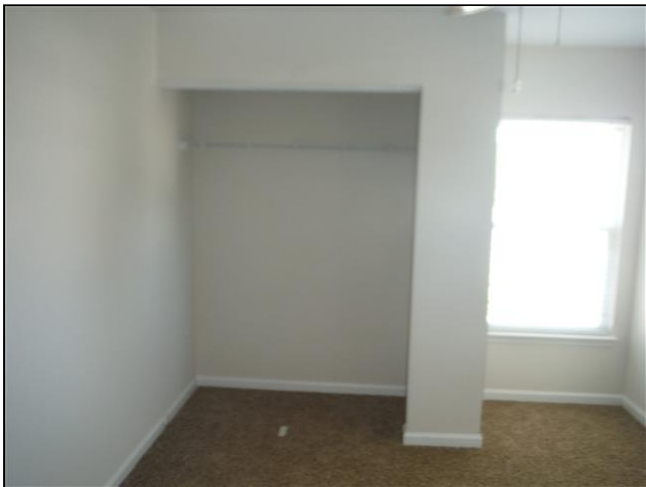
8.4 Item 3(Picture)

(2) Closet doors are missing at the upstairs front right bedroom.

(2) Closet doors are missing at the upstairs front right bedroom.

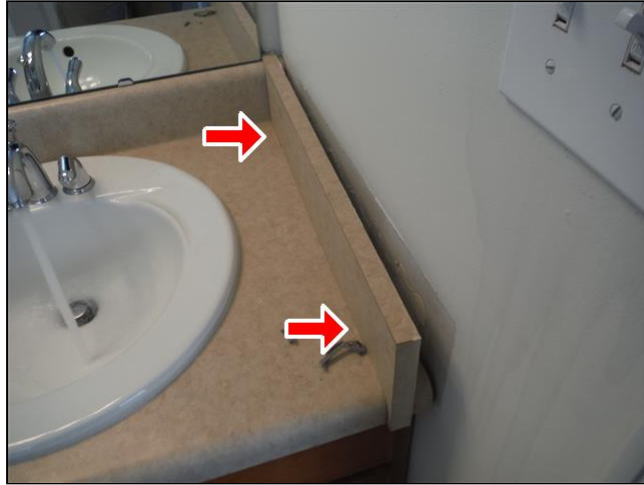
8.5 Item 1(Picture)

Backsplash or sidesplash is loose in the master bathroom (right of sink) and needs securing and sealed at the seams to prevent water intrusion.

Backsplash or sidesplash is loose in the master bathroom (right of sink) and needs securing and sealed at the seams to prevent water intrusion.
