Inspection Report

Property Address:

Home Inspection Professionals of AZ

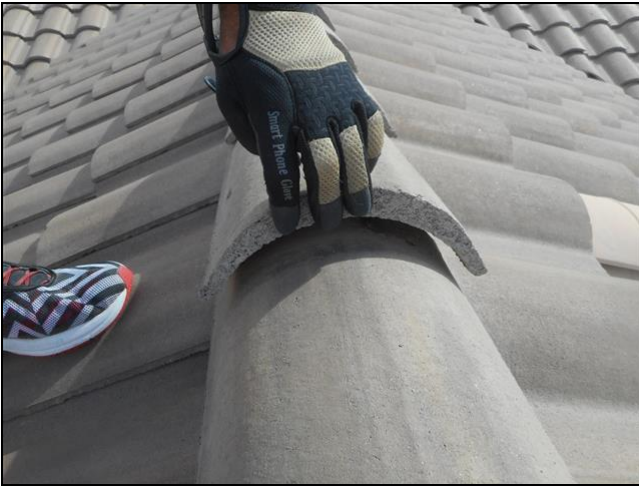
1.0 Item 1(Picture)

1.0 (1) Loose ridge tiles were noted on multiple areas of the roof. Recommend repairs by qualified professional to ensure roofing material is secured.

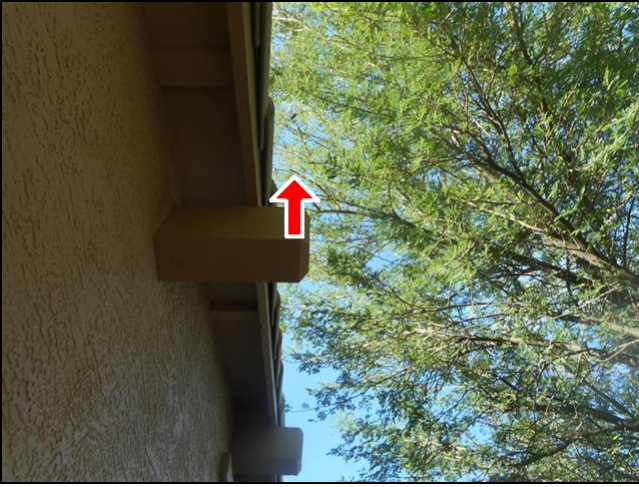
1.0 (3) Vegetation was in contact with the roofing materials. Recommend cutting back vegetation to prevent leaks from debris.

1.0 Item 5(Picture) Front of the home

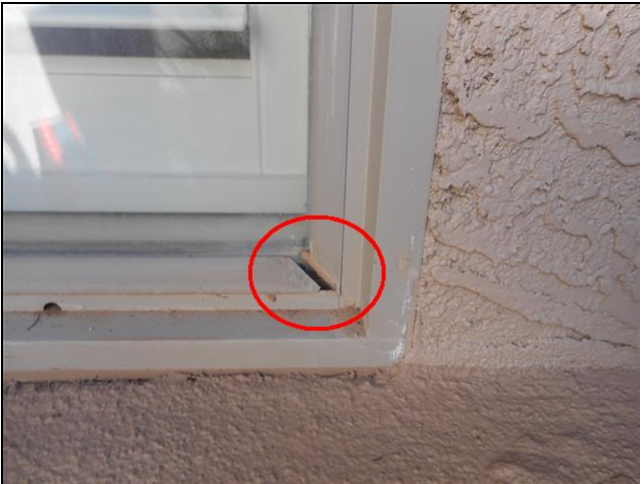
2.2 (1) Gaps were noted in the plastic window trim at the exterior on several windows. Recommend licensed window contractor inspect and repair / replace as needed to prevent moisture and unwanted pest from entering through the walls / window openings into the dwelling.

2.2 Item 1(Picture) Courtyard area

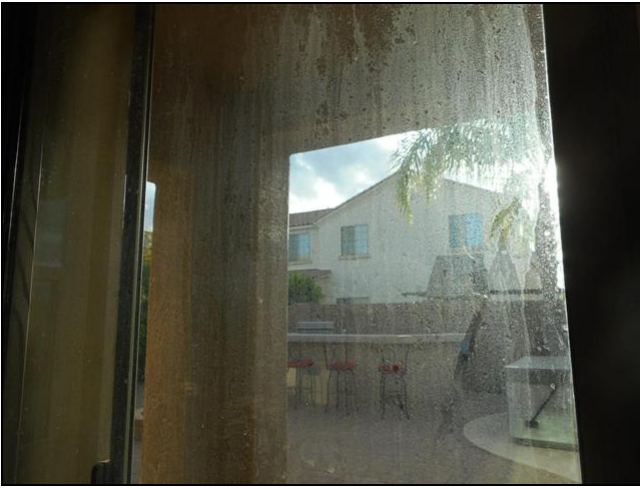
2.2 Item 5(Picture)

2.2 (2) The windows were dirty at the time of the inspection. Inspection is limited.

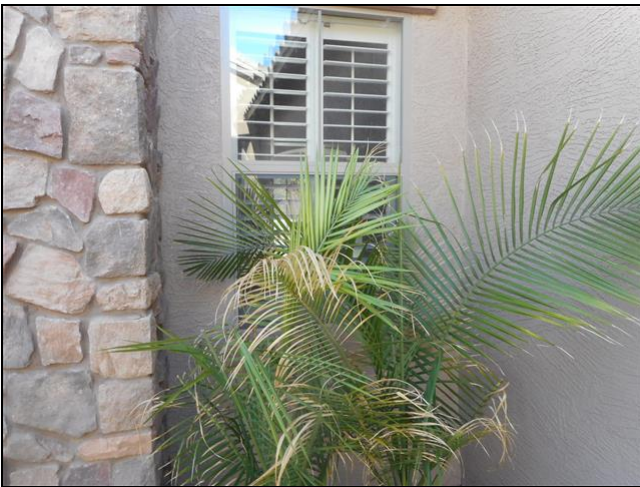
2.4 (1) Vegetation was in contact with the home in multiple areas including the front courtyard and the North side exterior wall. Recommend vegetation is cut back to prevent moisture damage and deterioration to wall cladding.

2.4 Item 1(Picture) Front entry location

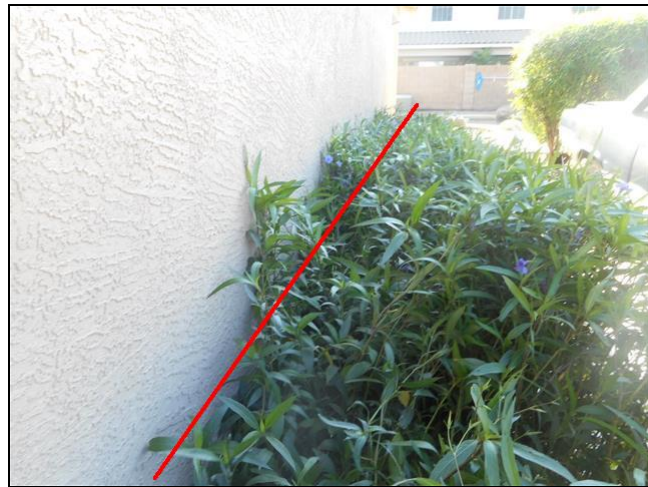
2.4 Item 2(Picture) North side exterior wall

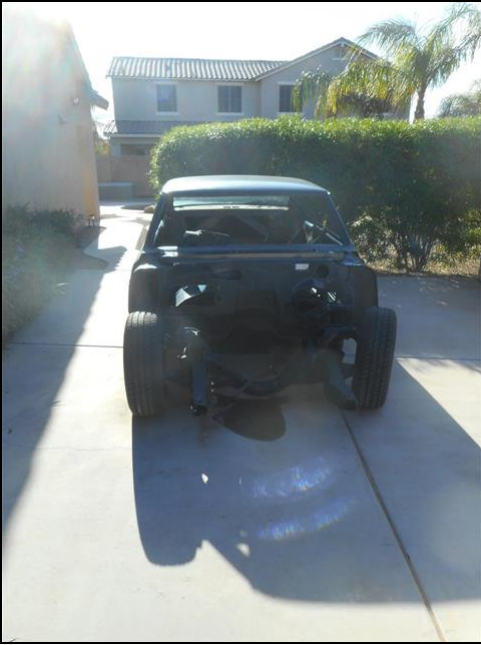
2.4 (2) Occupant belongings were noted at the exterior of the home. Inspection is limited.

2.4 Item 3(Picture) Unable to see under the car

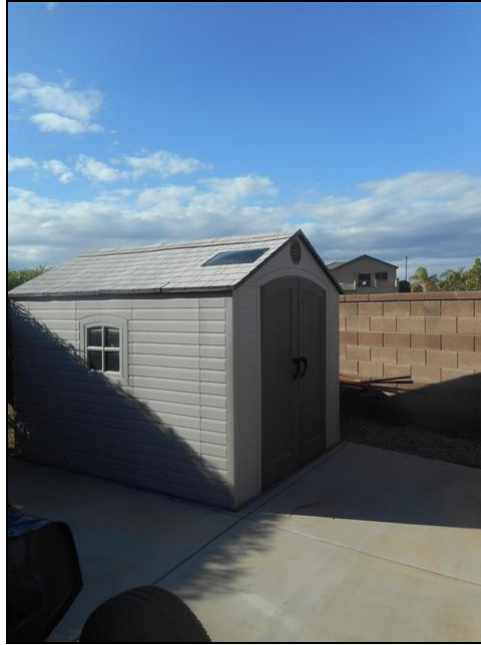
2.4 Item 4(Picture) A detached shed was noted on the RV driveway

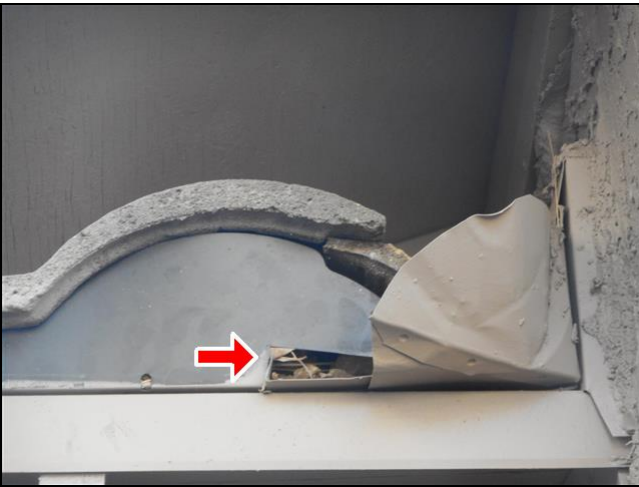
2.5 Item 1(Picture)

2.5 (2) Debris was noted under the entry eave in the flashing. Recommend cleaning out flashing(s) to ensure proper water shed and help prevent leaks.

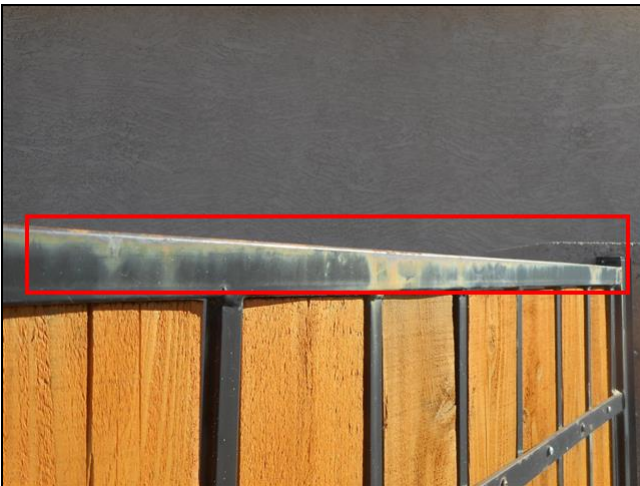
2.7 Item 1(Picture)

2.7 (1) Minor rust and weathering was noted on the metal gates. Recommend regular maintenance / painting to help prevent deterioration and rusting to metal gates.

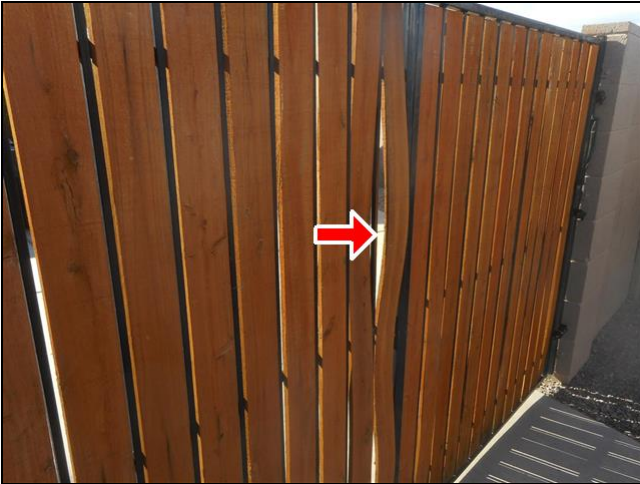
2.7 Item 3(Picture)

2.7 (3) Warped wood slat(s) were noted on the gates. Repairs should be made to help ensure privacy and prevent unknown persons entry to the premises.

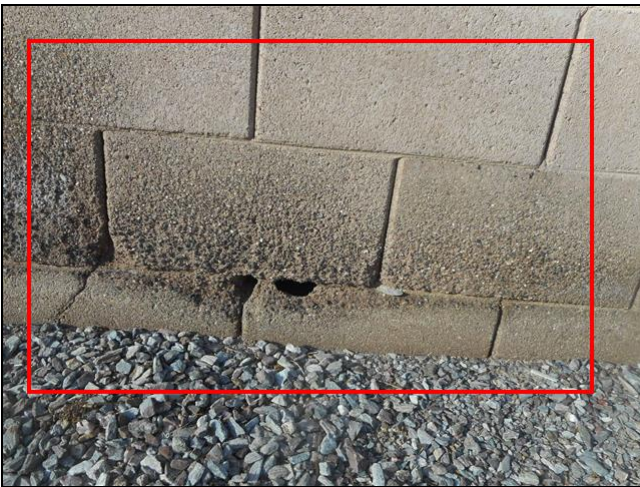
2.7 (4) Moisture damage/ deterioration was noted in several areas of the block walls including the front drive area extending back to the backyard of the property wall divider. Recommend repairs to walls be made to help prevent further deterioration.

2.7 Item 4(Picture) Front of the house on the North adjacent to the driveway

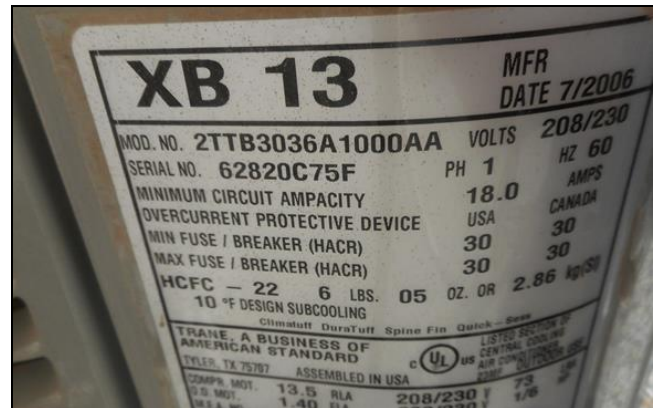
Data plate on HVAC compressor with smaller casing

4.7 (3) The HVAC compressor unit data plates indicate a 2006 manufacture date. Due to the age of the units and temperature split between the return and registers being low at the time of the inspection, it is recommended both units be serviced by licensed HVAC technician to ensure proper operation.

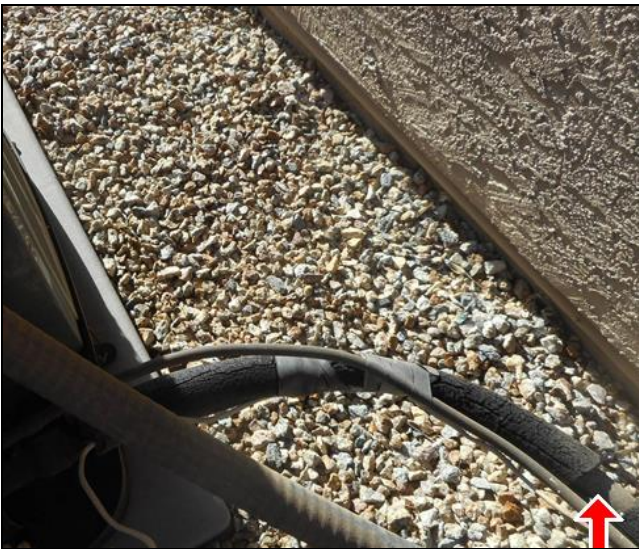
4.7 Item 1(Picture)

4.7 (1) Gaps and deteriorated foam were noted on both HVAC coolant lines. Recommend repairs to ensure maximum efficiency of unit and prevent possible damage to exposed lines.

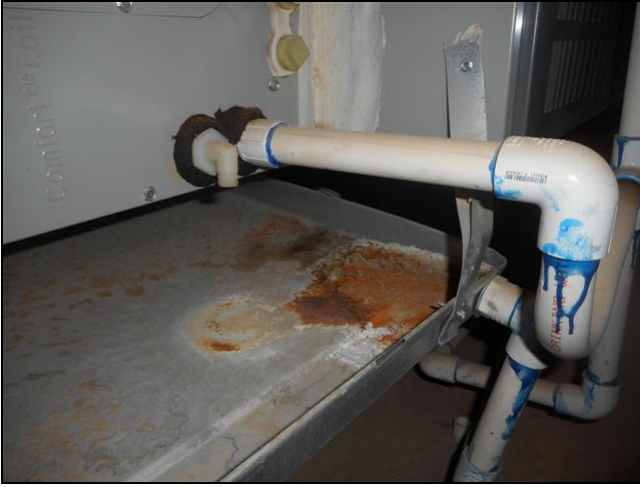
4.7 Item 3(Picture)

4.7 (2) The secondary pan in the garage access attic for the HVAC under the air handler is rusted and indicates possible prior leak. The pan was dry at the time of the inspection. Recommend asking seller about prior HVAC leaks and any HVAC applicable warranties.

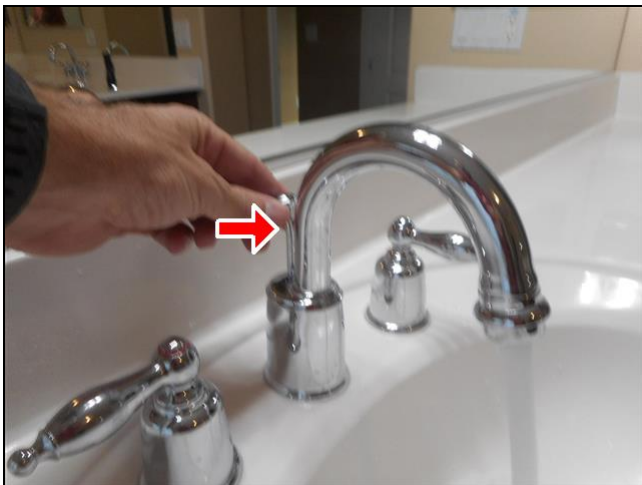
5.1 (3) The master bath sink stopper did not operate properly at the time of the inspection. Recommend repairs to ensure proper operation.

5.1 Item 2(Picture) Faucet next to bath tub

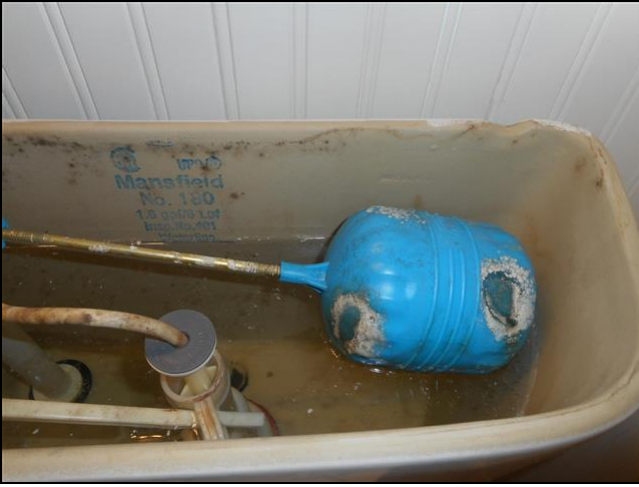
5.1 Item 3(Picture)

5.1 (4) The guest bath toilet float and internals showed signs of wear. Recommend repairs to ensure proper operation and prevent possible leaks.

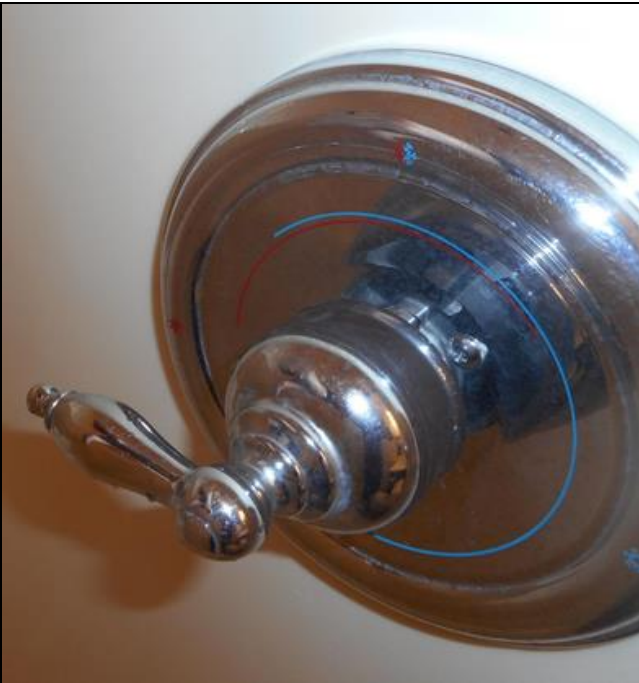
5.1 Item 4(Picture)

5.1 (5) The hot water in bathroom 3 shower did not operate correctly with normal operating controls and would not heat up. Recommend qualified professional inspect and repair/ replace fixture as needed to ensure proper operation.

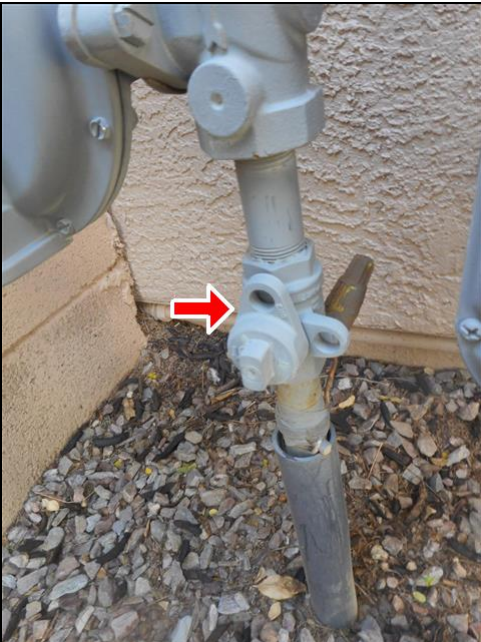
5.5 The main fuel shut off is at gas meter outside on the South side of the house near the electrical panel.

5.5 Item 1(Picture) Main fuel shut off

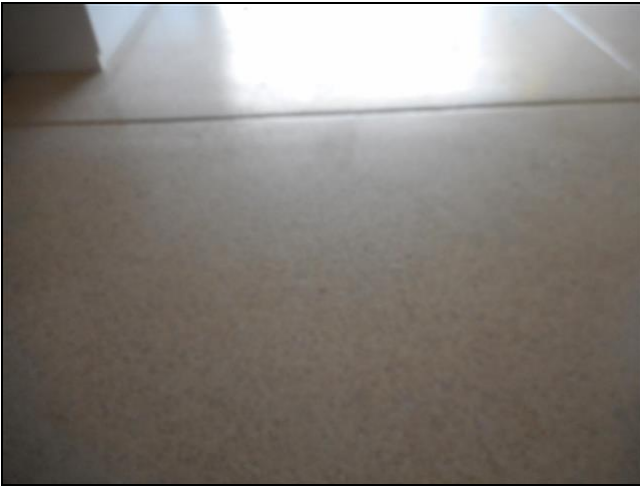
9.2 Item 1(Picture)

9.2 The garage floor is epoxy coated. Inspection is limited.

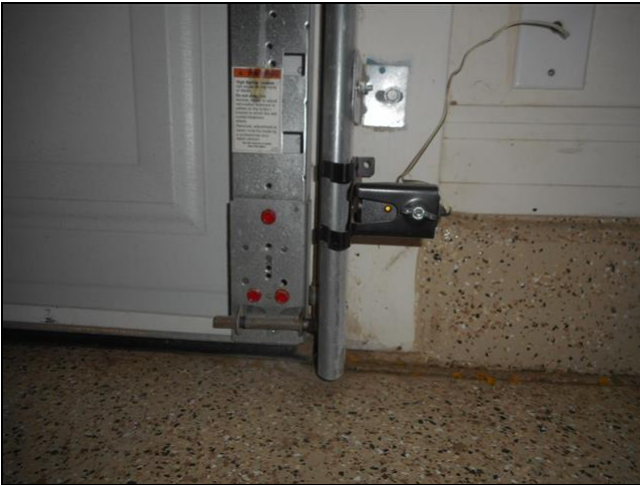
9.5 Item 1(Picture)

9.5 (2) The garage safety sensors did not operate properly when tested at the center of the garage door. They did activate properly when tested on the sides closer to the sensors. Recommend adjustment but qualified garage door professional to ensure proper operation and prevent damage and possible injury.

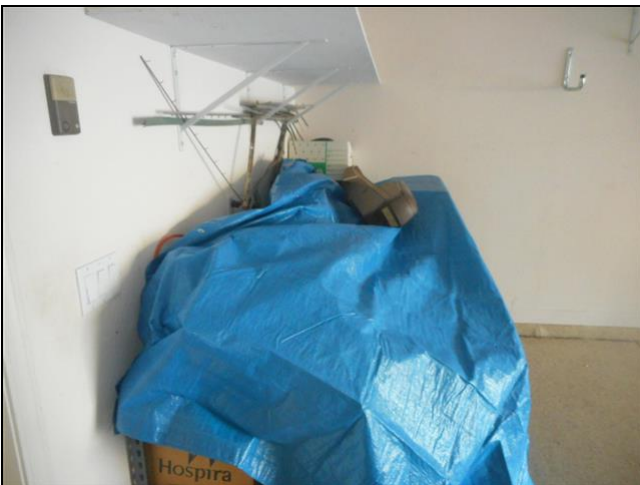
9.6 Item 1(Picture)

9.6 Occupant belongings were covering some areas of the garage floor and walls. Do a thorough check on final walk through.

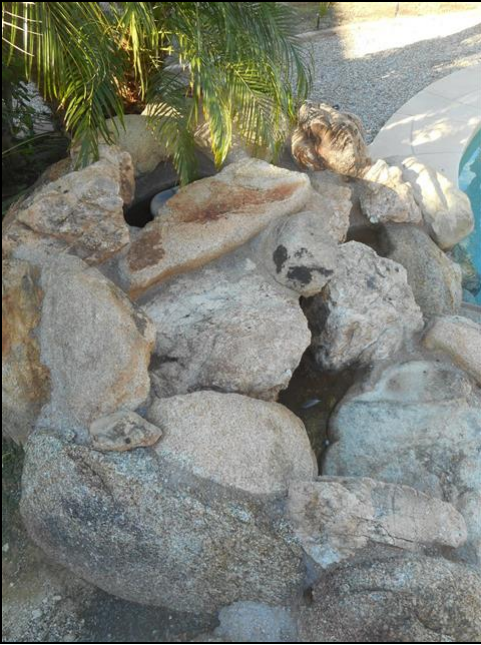
11.3 Item 1(Picture)

11.3 Some deterioration was noted on the rocks at the rock waterfall. A licensed pool contractor should inspect and repair as needed to help ensure proper function and prevent leaks.

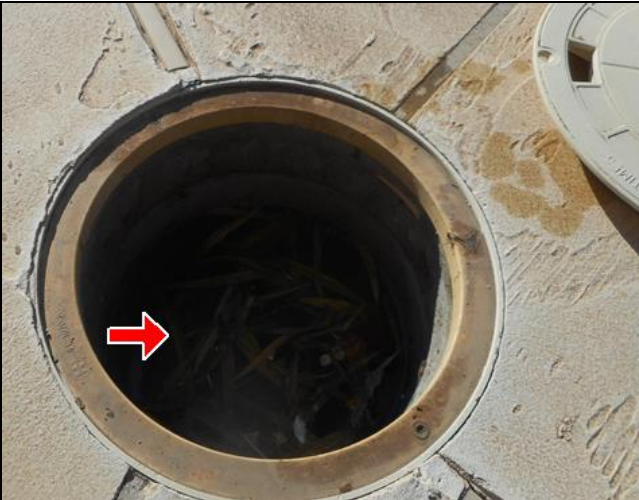
11.8 Item 1(Picture)

11.8 The skimmer basket was dirty at the time of the inspection. Regular maintenance should be performed to help prevent clogs and ensure proper operation of pool equipment.

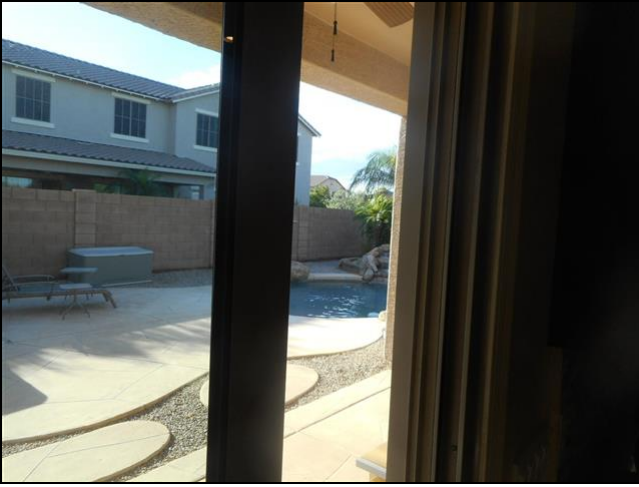
11.18 Item 1(Picture) Back sliding door not self closing self latching

Recommend upgrades to all pool access points including, the garage to exterior and Glass sliding door to backyard, to help prevent possible injury.

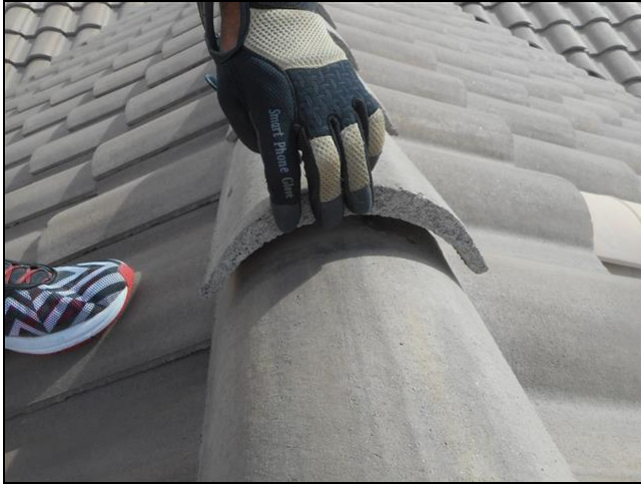
1.0 Item 1(Picture)

(1) Loose ridge tiles were noted on multiple areas of the roof. Recommend repairs by qualified professional to ensure roofing material is secured.

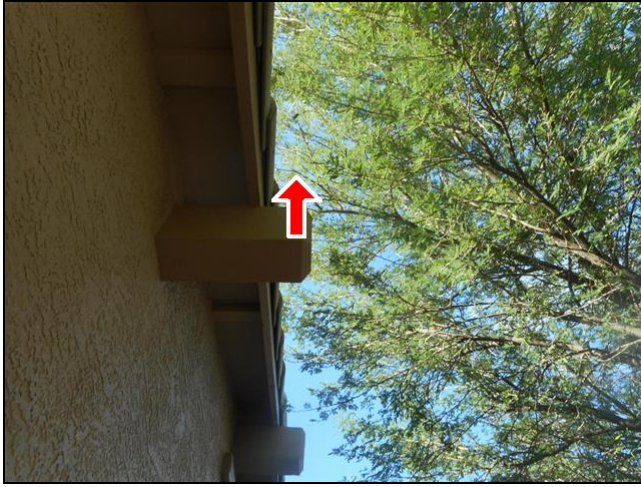
1.0 Item 5(Picture) Front of the home

(3) Vegetation was in contact with the roofing materials. Recommend cutting back vegetation to prevent leaks from debris.

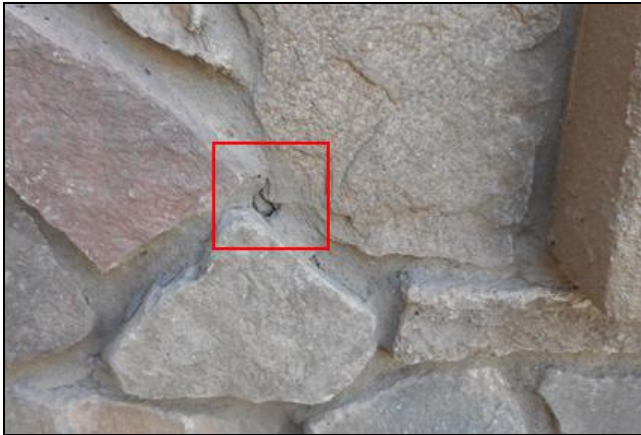
2.0 Item 1(Picture)

Cracks or openings noted in the rock wall cladding. Recommend sealing all cracks and opening to prevent moisture penetration and prevent damage.

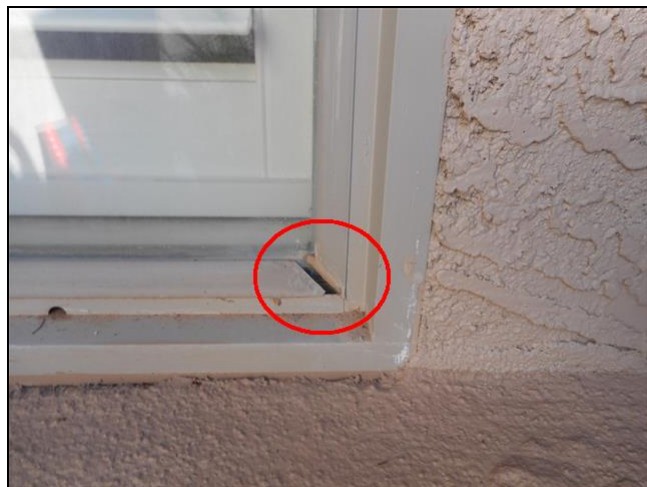
2.2 Item 1(Picture) Courtyard area

(1) Gaps were noted in the plastic window trim at the exterior on several windows. Recommend licensed window contractor inspect and repair / replace as needed to prevent moisture and unwanted pest from entering through the walls / window openings into the dwelling.

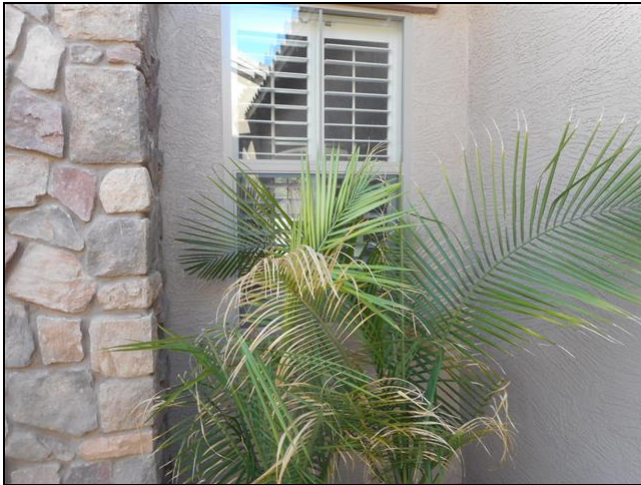
2.4 Item 1(Picture) Front entry location

(1) Vegetation was in contact with the home in multiple areas including the front courtyard and the North side exterior wall. Recommend vegetation is cut back to prevent moisture damage and deterioration to wall cladding.

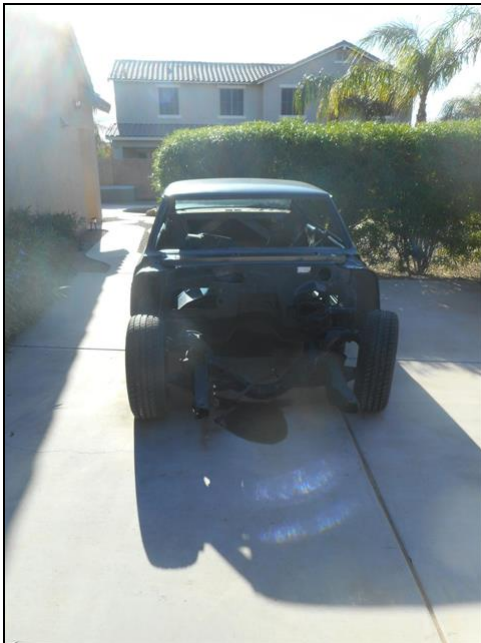
(2) Occupant belongings were noted at the exterior of the home. Inspection is limited.

2.4 Item 3(Picture) Unable to see under the car

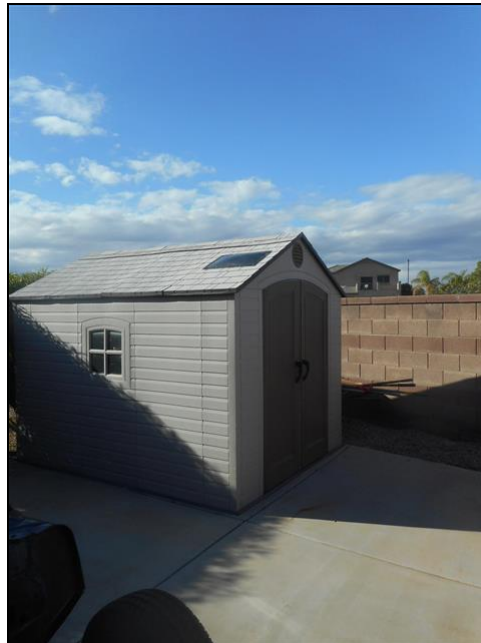
2.4 Item 4(Picture) A detached shed was noted on the RV driveway

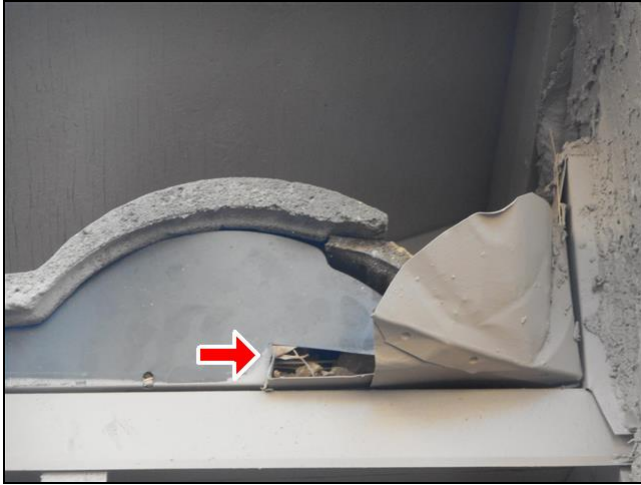
2.5 Item 1(Picture)

(2) Debris was noted under the entry eave in the flashing. Recommend cleaning out flashing(s) to ensure proper water shed and help prevent leaks.

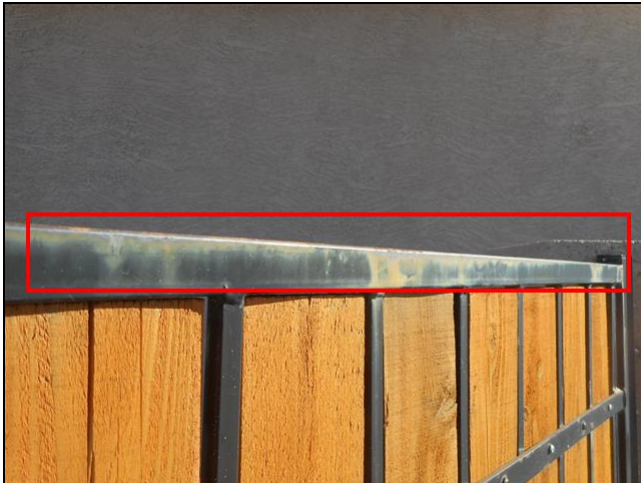
2.7 Item 1(Picture)

(1) Minor rust and weathering was noted on the metal gates. Recommend regular maintenance / painting to help prevent deterioration and rusting to metal gates.

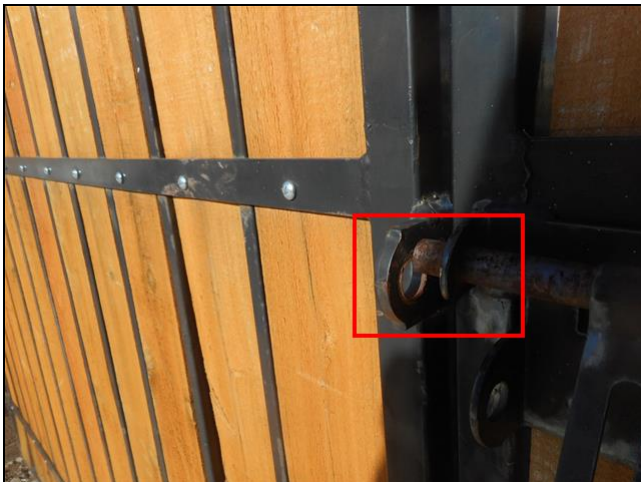
2.7 Item 2(Picture)

(2) The gate was in need of adjustment and did not lock. Recommend adjustment made to ensure proper operation and security as designed

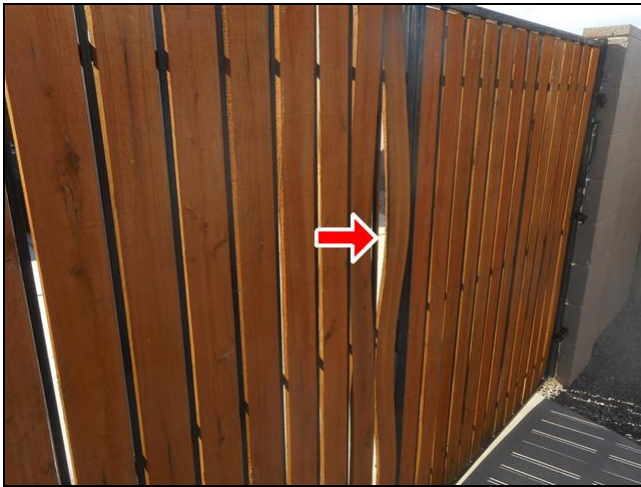
2.7 Item 3(Picture)

(3) Warped wood slat(s) were noted on the gates. Repairs should be made to help ensure privacy and prevent unknown persons entry to the premises.

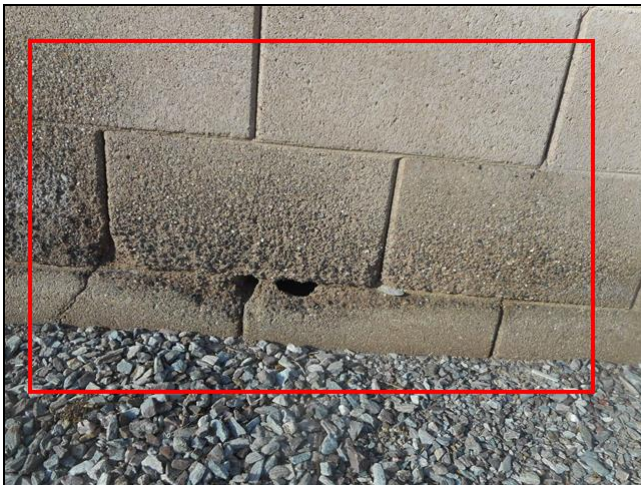
(4) Moisture damage/ deterioration was noted in several areas of the block walls including the front drive area extending back to the backyard of the property wall divider. Recommend repairs to walls be made to help prevent further deterioration.

2.7 Item 4(Picture) Front of the house on the North adjacent to the driveway

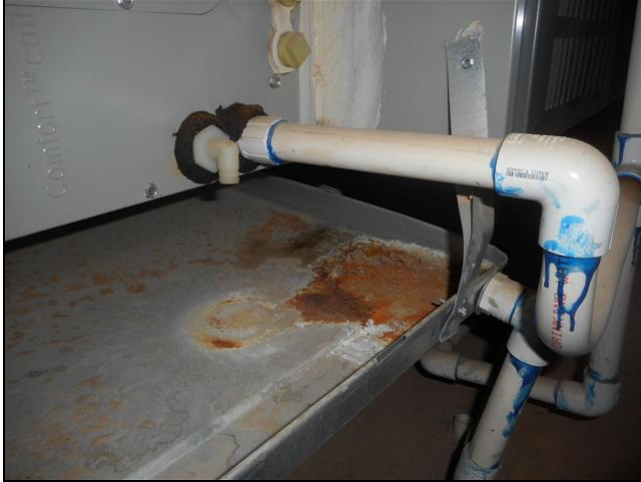
4.7 Item 3(Picture)

(2) The secondary pan in the garage access attic for the HVAC under the air handler is rusted and indicates possible prior leak. The pan was dry at the time of the inspection. Recommend asking seller about prior HVAC leaks and any HVAC applicable warranties.

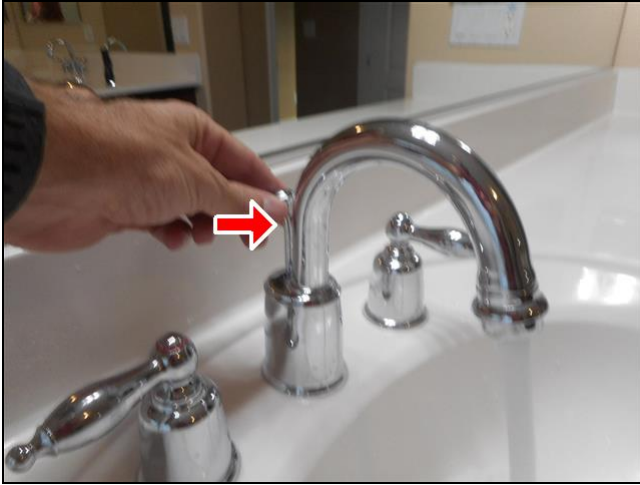
(3) The master bath sink stopper did not operate properly at the time of the inspection. Recommend repairs to ensure proper operation.

5.1 Item 2(Picture) Faucet next to bath tub

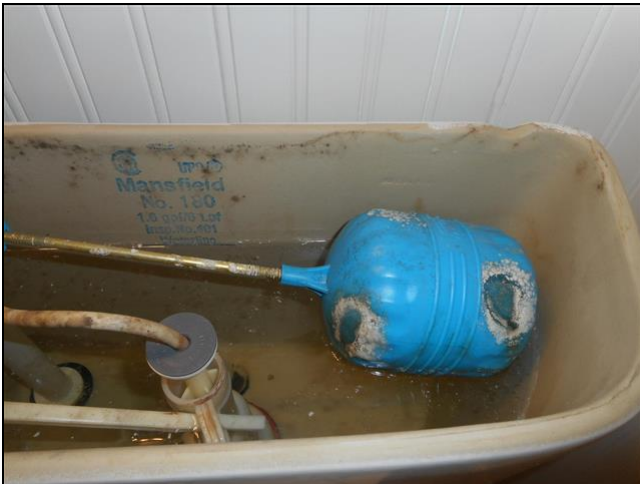
5.1 Item 3(Picture)

(4) The guest bath toilet float and internals showed signs of wear. Recommend repairs to ensure proper operation and prevent possible leaks.

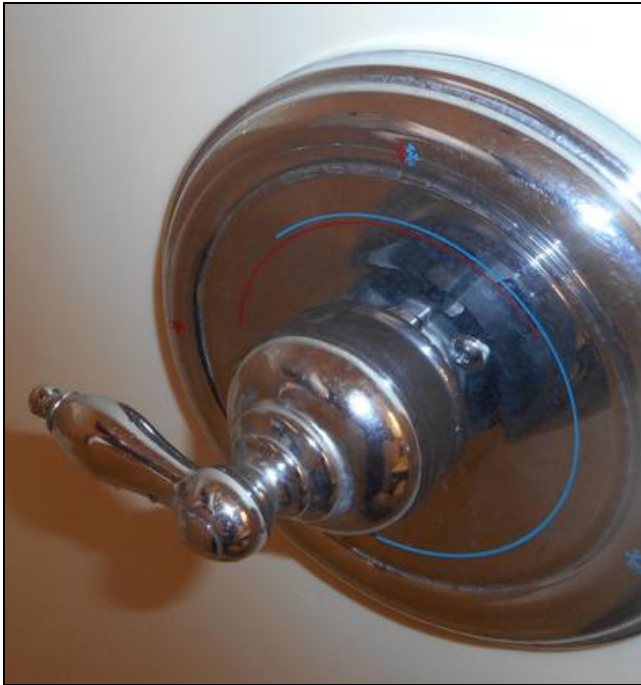
5.1 Item 4(Picture)

(5) The hot water in bathroom 3 shower did not operate correctly with normal operating controls and would not heat up. Recommend qualified professional inspect and repair/ replace fixture as needed to ensure proper operation.

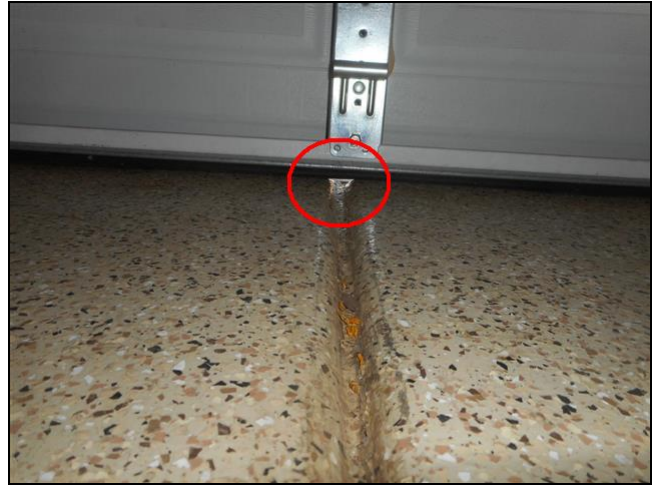
9.3 Item 2(Picture)

Gaps were noted at the garage vehicle door bottom seal trim. Recommend repairs to help prevent moisture penetration and unwanted pests from entering the garage.

9.3 Gaps were noted at the garage vehicle door bottom seal trim. Recommend repairs to help prevent moisture penetration and unwanted pests from entering the garage.

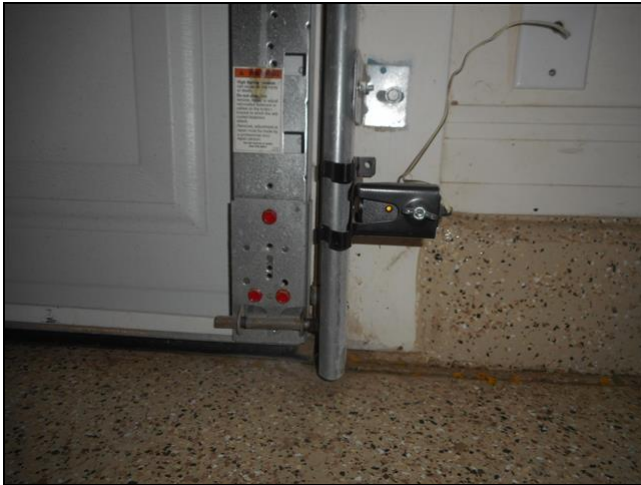
9.5 Item 1(Picture)

(2) The garage safety sensors did not operate properly when tested at the center of the garage door. They did activate properly when tested on the sides closer to the sensors. Recommend adjustment but qualified garage door professional to ensure proper operation and prevent damage and possible injury.

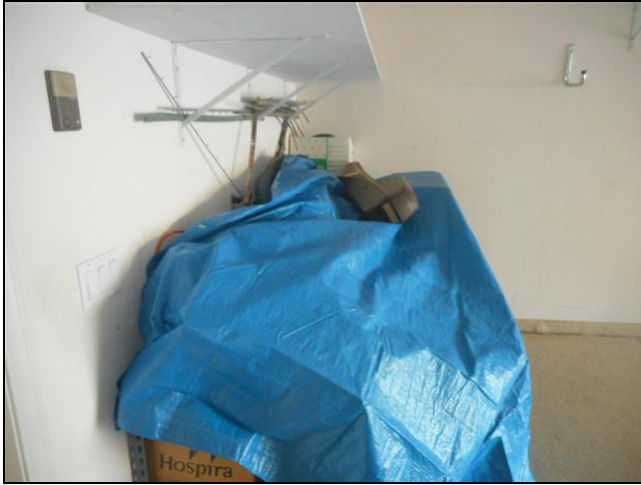
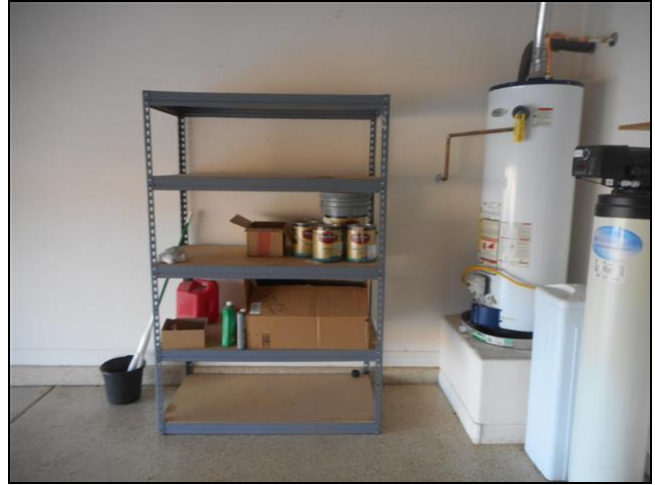
Occupant belongings were covering some areas of the garage floor and walls. Do a thorough check on final walk through.

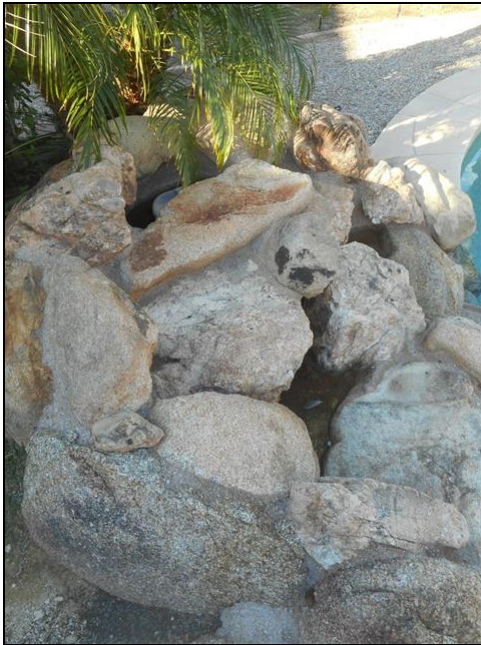
11.3 Item 1(Picture)

Some deterioration was noted on the rocks at the rock waterfall. A licensed pool contractor should inspect and repair as needed to help ensure proper function and prevent leaks.

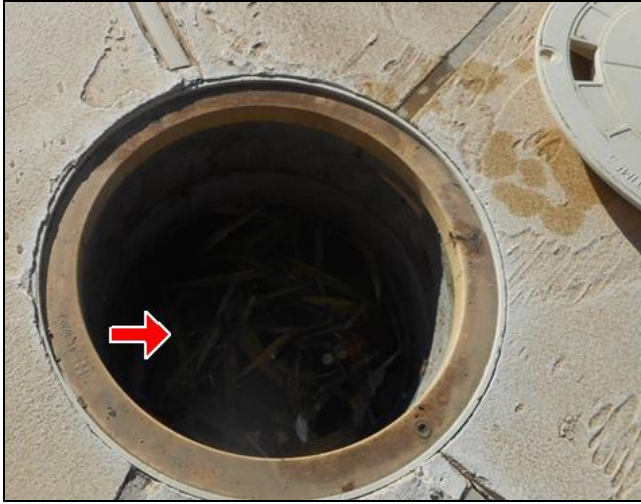
11.8 Item 1(Picture)

The skimmer basket was dirty at the time of the inspection. Regular maintenance should be performed to help prevent clogs and ensure proper operation of pool equipment.

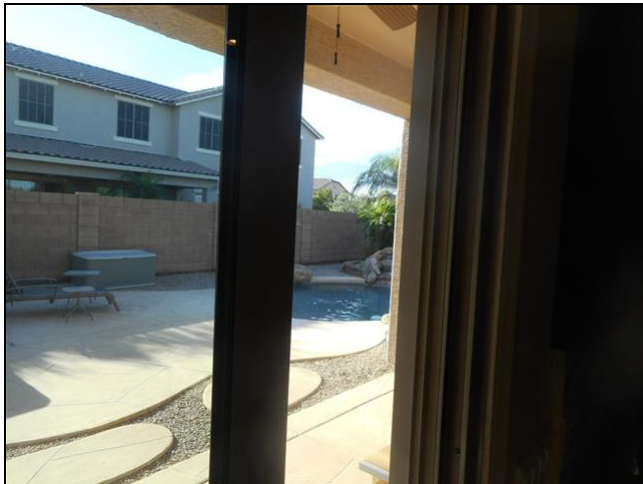
11.18 Item 1(Picture) Back sliding door not self closing self latching

Recommend pool barrier upgrades/ fencing

Recommend upgrades to all pool access points including, the garage to exterior and Glass sliding door to backyard, to help prevent possible injury.
