*Paper No: 03-**IAGT-204***

15TH SYMPOSIUM ON INDUSTRIAL APPLICATIONS OF GAS TURBINES

UPGRADE OF GAS TURBINE CLEANING TECHNOLOGY

**Presented at the 15th Symposium on Industrial Application of Gas Turbines
Banff, Alberta, Canada - October 13 - 17, 2003**

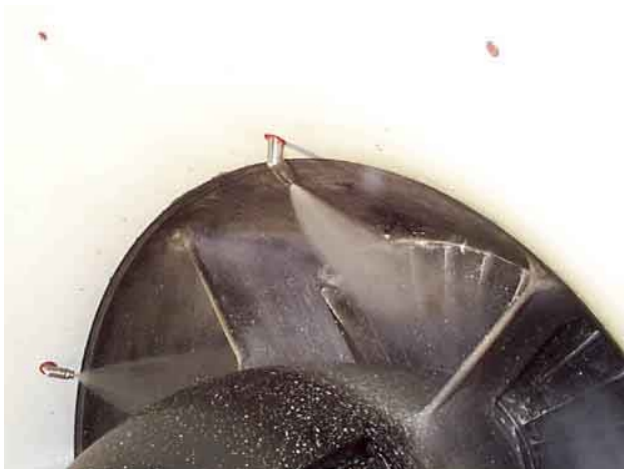
Fig. 2 LM2500 - same nozzles used for crank wash and on-line washing

The installation in practice on a gas turbine like the LM2500 is shown in Fig 2. Only 5 nozzles in total are required, installed between the struts. To assure an optimum spray pattern and liquid flow rate, the nozzles are tailor made for the turbine type and the site specific conditions.

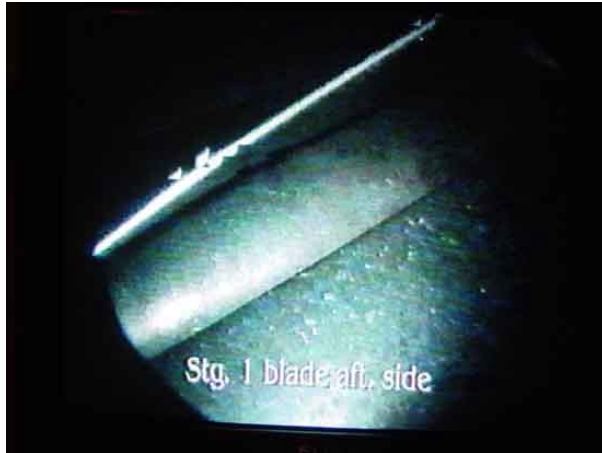
Fig. 8 Borescope image

Borescope inspection, Fig. 8, prior to test gave the general impression that the blades from stage 1 to 5 had a layer of black grease like deposit. The dirt buildup was heavier on the back side than on the front side. In addition to this there was also a salt build-up. At the rear end of the compressor stage 15 did not look dirty but had clearly visible salt deposits.

Borescope inspection after the first run (test B; on-line wash for 1 min.) showed that blades on stage 1 to 5 clearly looked cleaner than before. However there are still streaks of dirt along the blades. All traces of salt are gone. At the rear end of the compressor there has been some improvement but not much.

Borescope inspection after the second run (test C; on-line wash for 3 min.) blades on stage 1 to 5 showed that things are now starting to look very good. The blades are beginning to get a nice shiny appearance on both sides. However there are still some weak dirt streaks to be seen. But the overall impression is a definite improvement, and not missing much to be completely clean. At the rear end of the compressor things are looking very much the same as after the first run.
