# MAXIMIZING GAS TURBINE BLADE LIFE WITH COMPUTED TOMOGRAPHY WALL THICKNESS INSPECTION

**Daniel Pinelli, M.Eng, P.Eng.**

Liburdi Turbine Services Inc. 400 Highway 6 North, Dundas, Ontario, Canada  
[dpinelli@liburdi.com](mailto:dpinelli@liburdi.com)

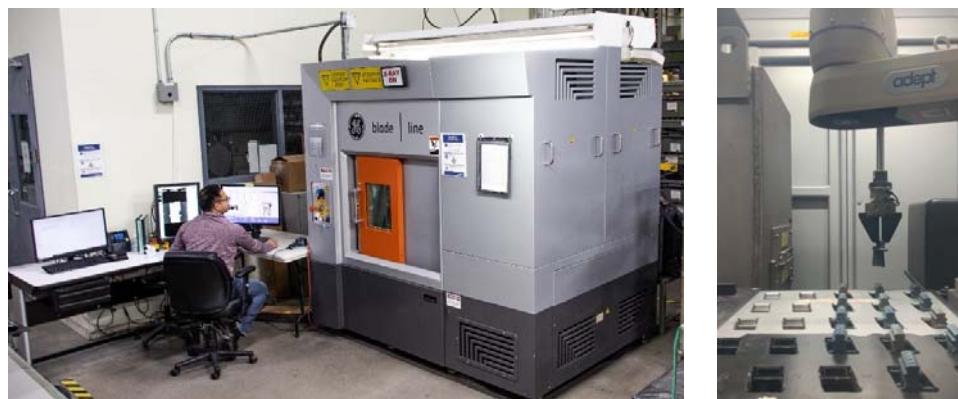
Figure 11 – Bladeline Computed Tomography Machine and Part Holding Bin with Robot Gripper

To measure the wall thickness on production gas turbine blades, the blades are first loaded into a holding system which is typically a flat plate with multiple cut outs placed on top of a hollow bin. The bin is loaded into the CT machine and the door is safely closed. A robotic gripper arm picks up the first blade and passes it slowly through the X ray beam being emitted by the source and received by the detector. This creates a digital radiography (DR) shot of the blade which is similar to a conventional 2D X ray image. This DR shot is later inspected by a certified X ray technician to check for any internal blockages or other relevant X ray criteria. The same blade is then positioned within the X ray beam at the required measurement heights and rotated about its axes. This creates a cross sectional scan at each measurement height that is then post processed into numerical wall thickness results and a cross sectional image of the blade including internal detail. The first blade is then returned to the bin and the process is repeated for the rest of the blades in the set (Figure 11).

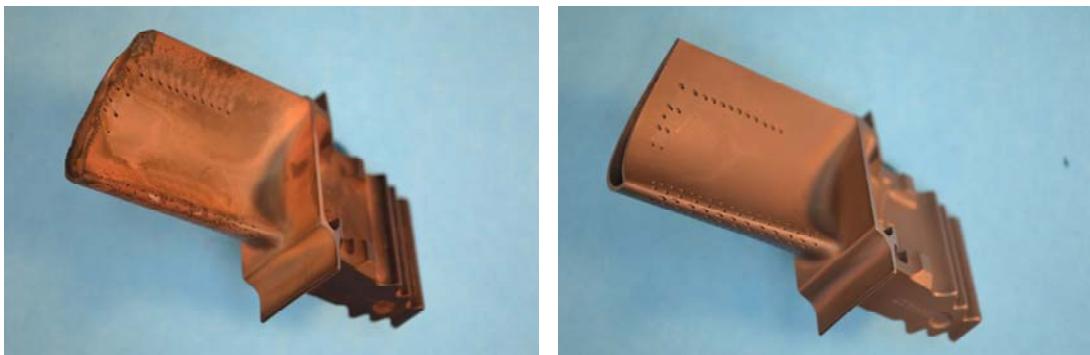
Figure 17 – Post Service (Left) & Fully Repaired (Right) Condition of a GE LM2500 HP1 Blade
