Block Micelles damage to generator injectors

Micelles are a major factor in emergency generator damage, yet traditional filters do not remove them efficiently. Pat Smyth, lecturer in advanced biofuels for BioFuelNet Canada, outlines a better solution

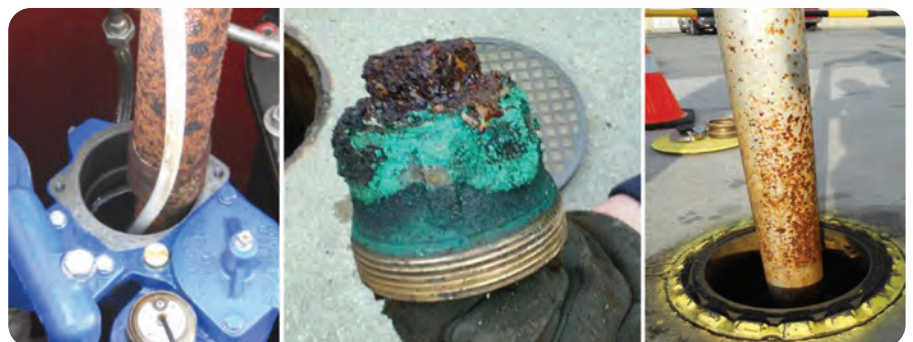
Figure 3. Corroded ULSD equipment: Corroded carbon steel submersible turbine pump (STP) shaft removed from pump housing, CA-1 (left); brass ball float extractor cage plug, NY-2 (middle); aluminium drop tube, NC-1 (right).²

Details of corroded ULSD equipment are shown in Figure 3 and a UST system with steel tank with severe metal corrosion in Figure 4.

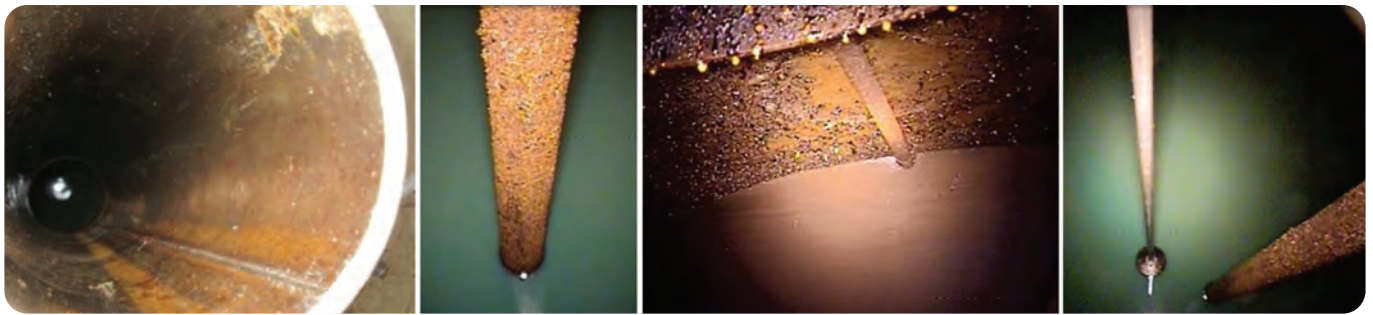
Figure 4. UST system with steel tank with severe metal corrosion (43-MD-ST: [installed 1992; age of filter unknown). From left: fill pipe opening; STP shaft; tank top showing manway; ATG probe and STP shaft.³

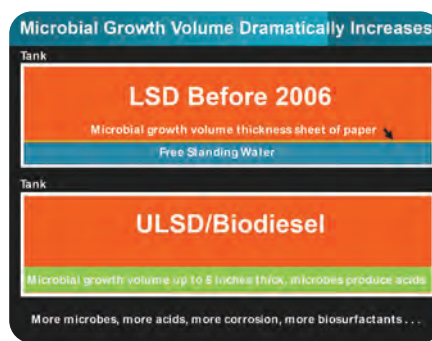
Figure 5.

To give an idea of how much more growth volume microbes now have, a package of paper for a home printer is approximately one inch thick and holds 200 sheets of paper. Each inch of Micelle layer provides 200 times the growth volume for microbes, compared to diesel before ULSD. There could be multiple inches of the Micelle layer. The microbial growth volume has dramatically increased; more microbes make more acids, greatly acidifying the diesel (see Fig 5).
